Marine Archaeological Investigation

Removal and Documentation of the
New Bedford Harbor Superfund Site Unanticipated Discovery Shipwreck #3
from the Lower Harbor Area

Acushnet River, New Bedford, Massachusetts

APRIL 2019

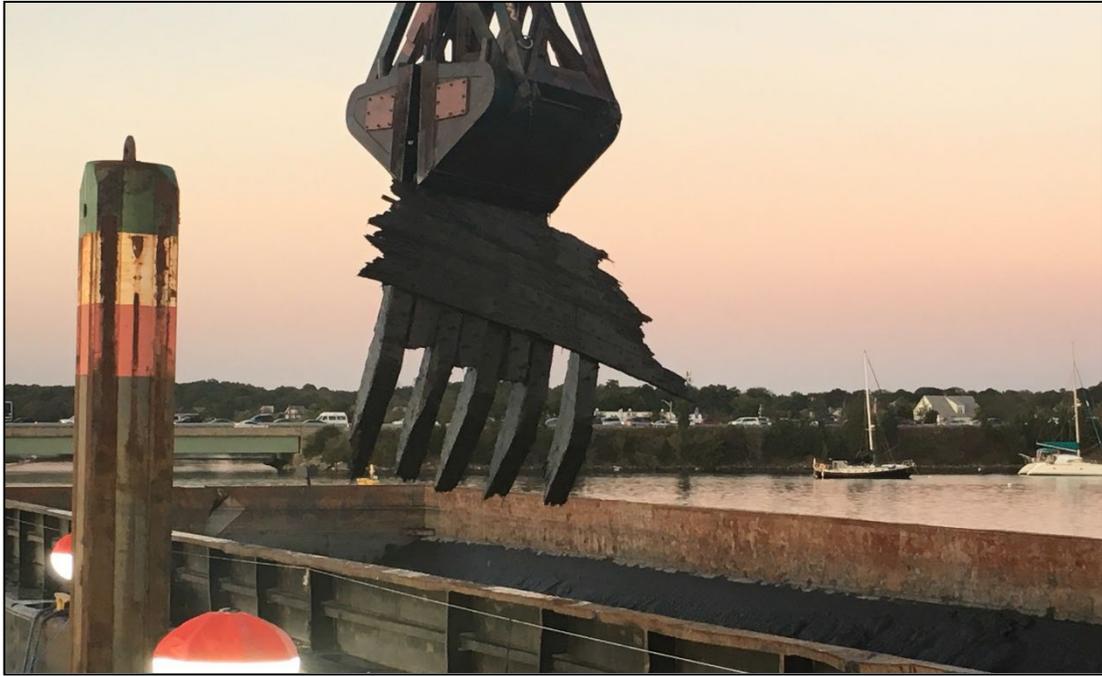
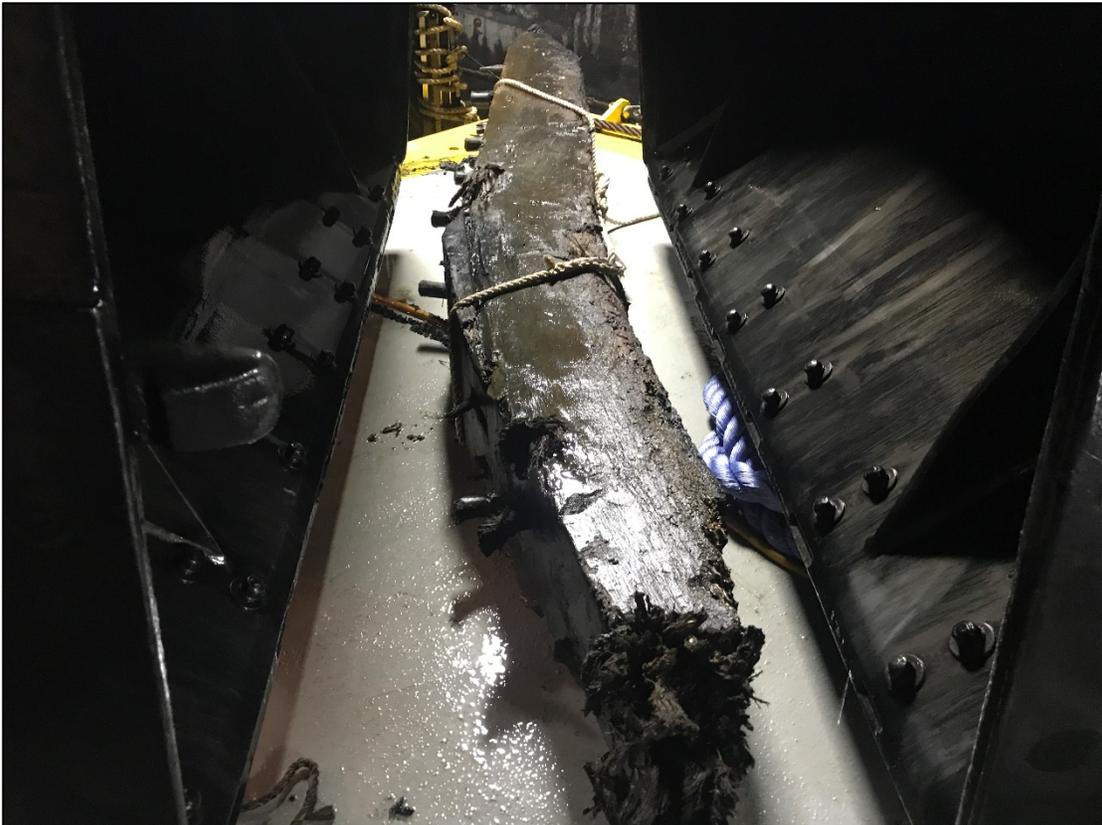
Figure 3. Ship remains encountered and recovered from the NBHSS UAD SW#3 site at the time of their unanticipated discovery on October 4, 2017 (photographs courtesy of Cashman).

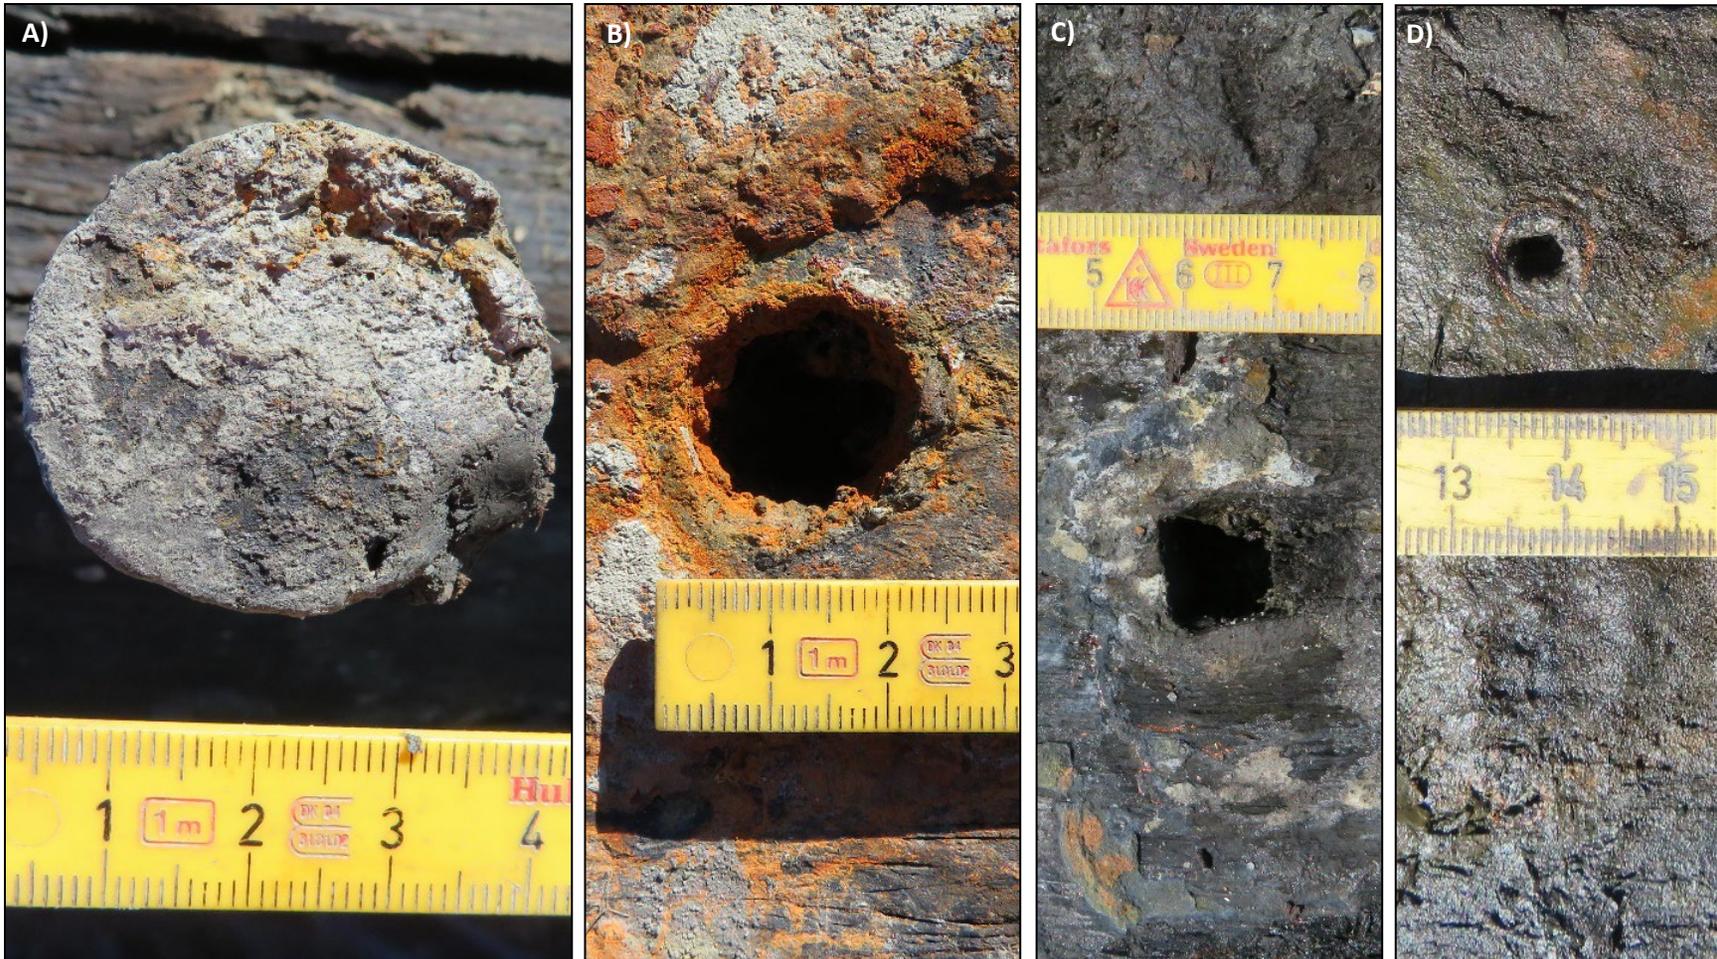
Figure 13. Fasteners documented in the NBHSS UAD SW#3 hull timbers included: A) treenails; B) iron bolts; C) iron spikes; and D) iron nails (photographs by David Robinson, DSRA).

The remaining fastener types used in NBHSS UAD SW#3's hull were made from wrought iron and consisted of bolts, spikes, and nails. The bolts were uniformly 0.8 in [2 cm] round in cross-section. Most were likely once clenched with a washer at their ends when intact, and used to secure each floor timber to the keel with one centrally located bolt per floor. Bolts were also used to secure joints between sections of the keel and to attach aft deadwood timbers to the top of the keel. One preserved bolt had a threaded end and was secured with a nut. Heavily corroded bolt remnants were the only iron fasteners to partially survive in the hull remains. Spikes were used to temporarily fasten hull planking to the frames prior to the drilling of holes and the driving of treenails into them. Based on the size of the spike holes in the ship's timbers, those used in NBHSS UAD SW#3 measured 0.4-inch-square (in²) (1-centimeter-square [cm²]) in section. Iron nails were used for repairs to hull planking and to fasten what is presumed to have been wooden hull sheathing that had once been attached to the exterior of the keel and to the outside of the garboard and hull planking. The iron nails used in the repairs were 0.2 in (0.5 millimeters [mm]) square in section. The sheathing nails were rectangular in section and measured 0.1-x-0.2 in (2.5-x-5 mm).

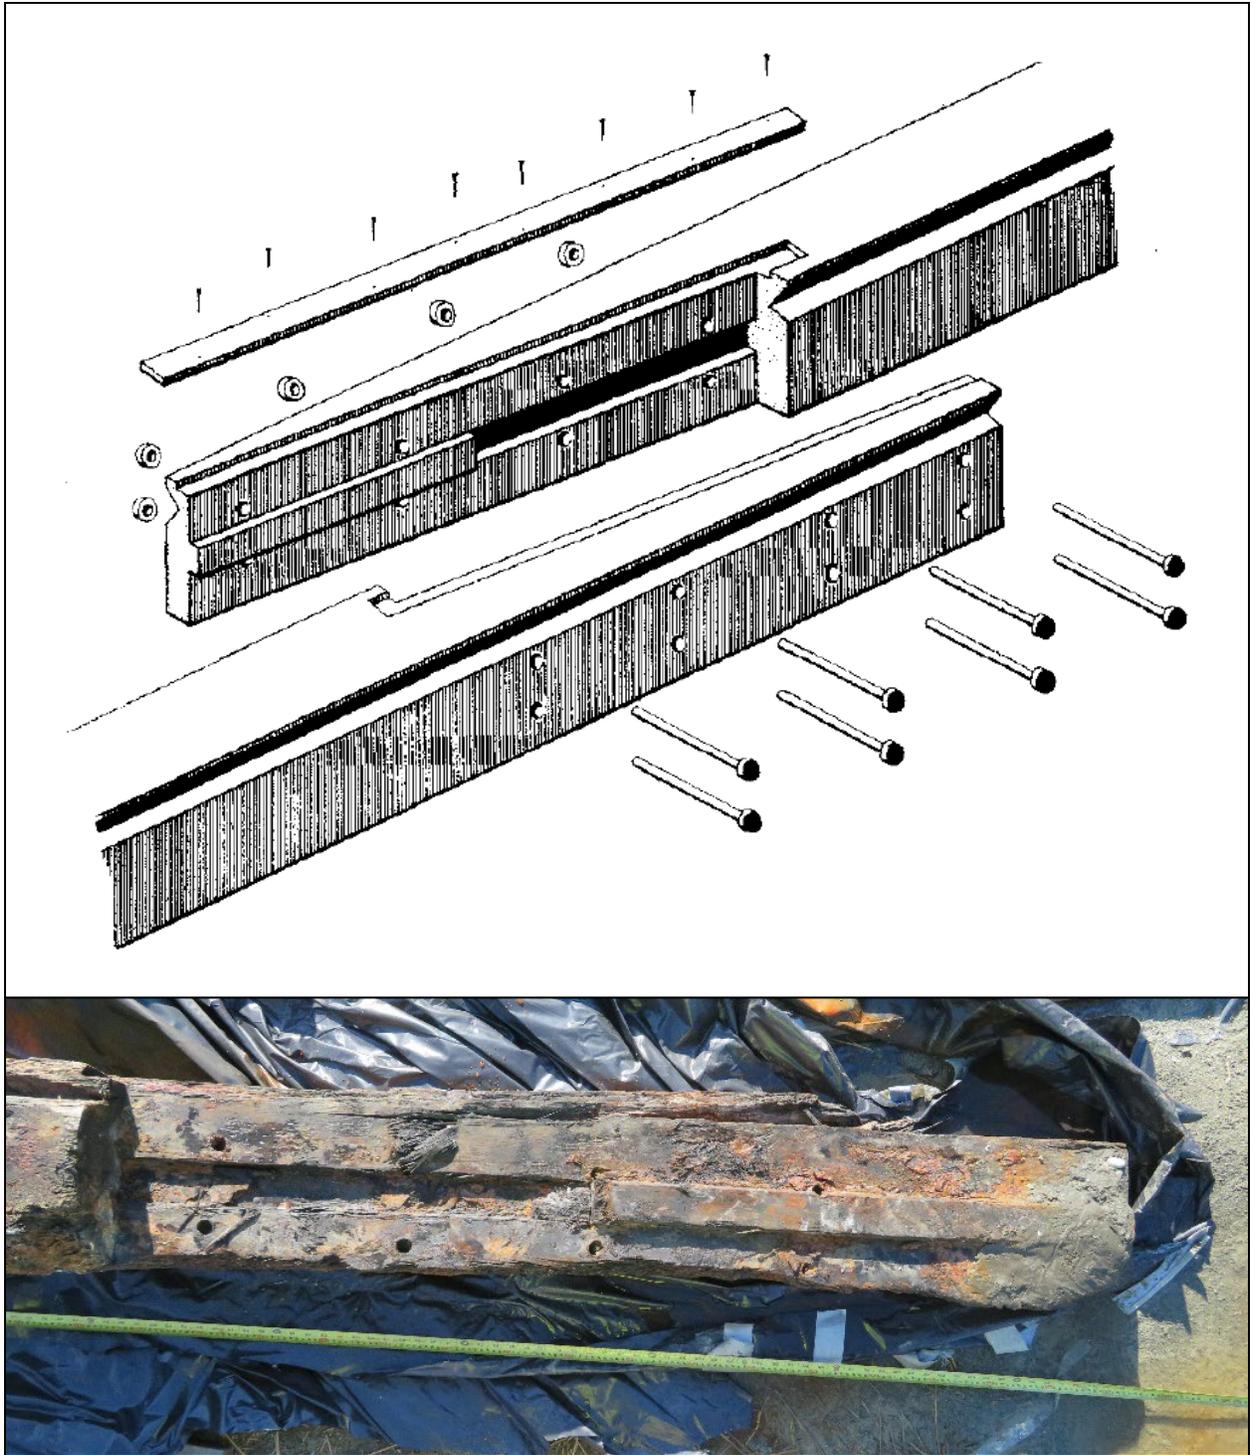
Figure 14. Diagram of the “boxing joint” “tabled” keel scarf documented during the archaeological study of the 1690 shipwreck of the British frigate *Dartmouth* (upper image; after Martin 1978), and the scarf in the keel remains of NBHSS UAD SW#3 (lower image; photograph by David Robinson, DSRA). The similarity between them provides evidence suggesting an English origin for NBHSS UAD SW#3.

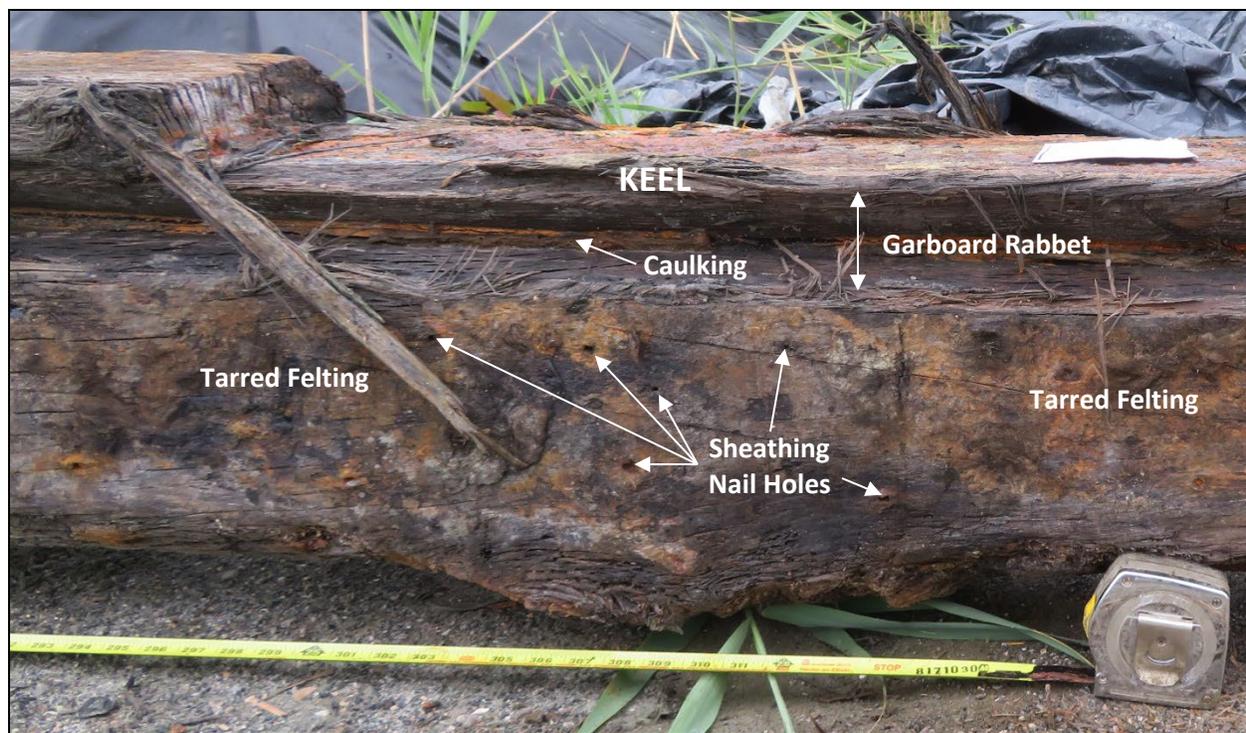
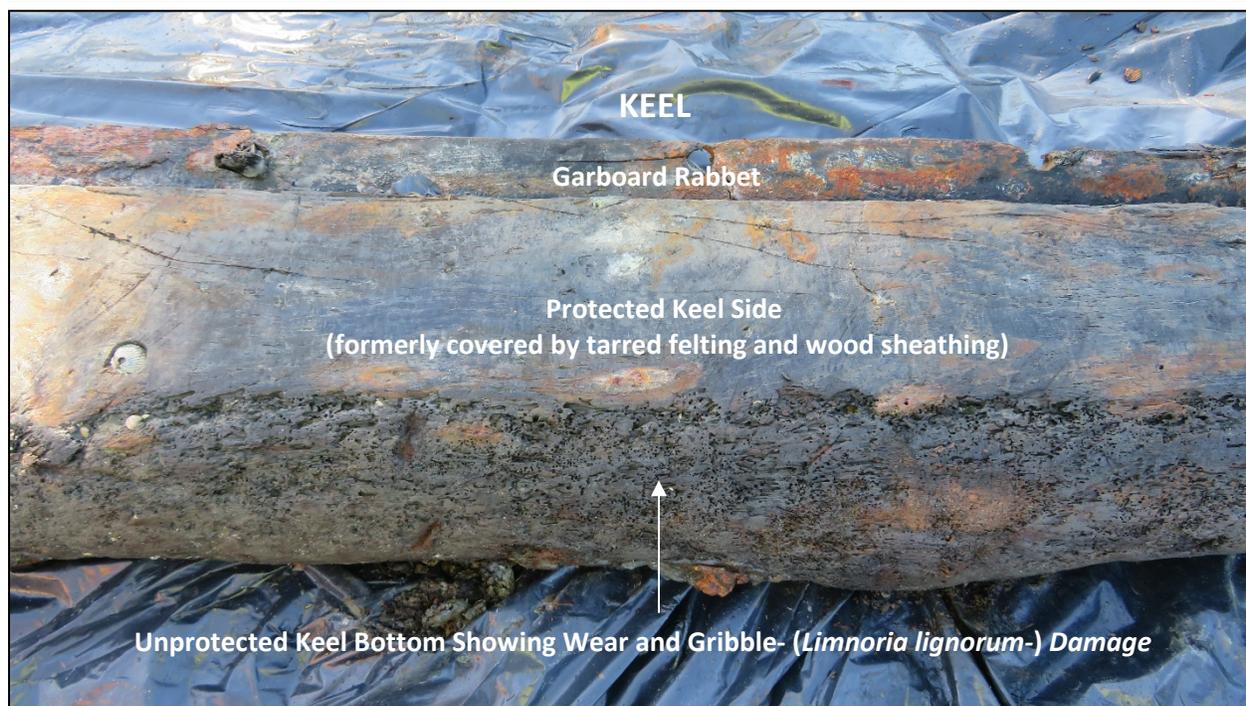
Figure 15. Detailed views of NBHSS UAD SW#3's keel showing evidence that sacrificial wooden hull sheathing, underlain by a layer of tarred animal-hair felting, had extended down and protected the sides of the keel, while the heavily-worn and wood-borer-damaged bottom of the keel does not appear to have been protected by sheathing or a shoe (photographs by David Robinson, DSRA).

A rabbet cut into the keel’s upper corners accommodated and provided a secure seating surface for the lower edge of the lowest run of hull planking (termed the “garboard” or “garboard strake”) that had been attached to both sides of the keel along its length with treenails. Flattened fibrous material that is likely “oakum” or “junk hemp” rope caulking was used to create a water-tight seal between the keel and the vessel’s hull planking. Its remnants were observed in multiple places within the keel’s garboard rabbet (**Figure 15**).

The heavily worn and shipworm- (*Teredo navalis*) and gribble- (*Limnoria lignorum*) damaged condition of the bottom of the keel indicate that it had not been fitted with a protective sacrificial layer of sheathing or with a keel shoe (see Figure 15). Numerous small rectangular fastener holes for sheathing nails, distributed in a generally diagonal pattern and spaced 8.7-9.8 in (22-25 cm) apart that are visible on the sides of the keel (see Figure 15), indicate that it and the vessel’s hull were once covered in protective wood sheathing that had extended down to a point about 5.1 in (13 cm) above the keel’s bottom.

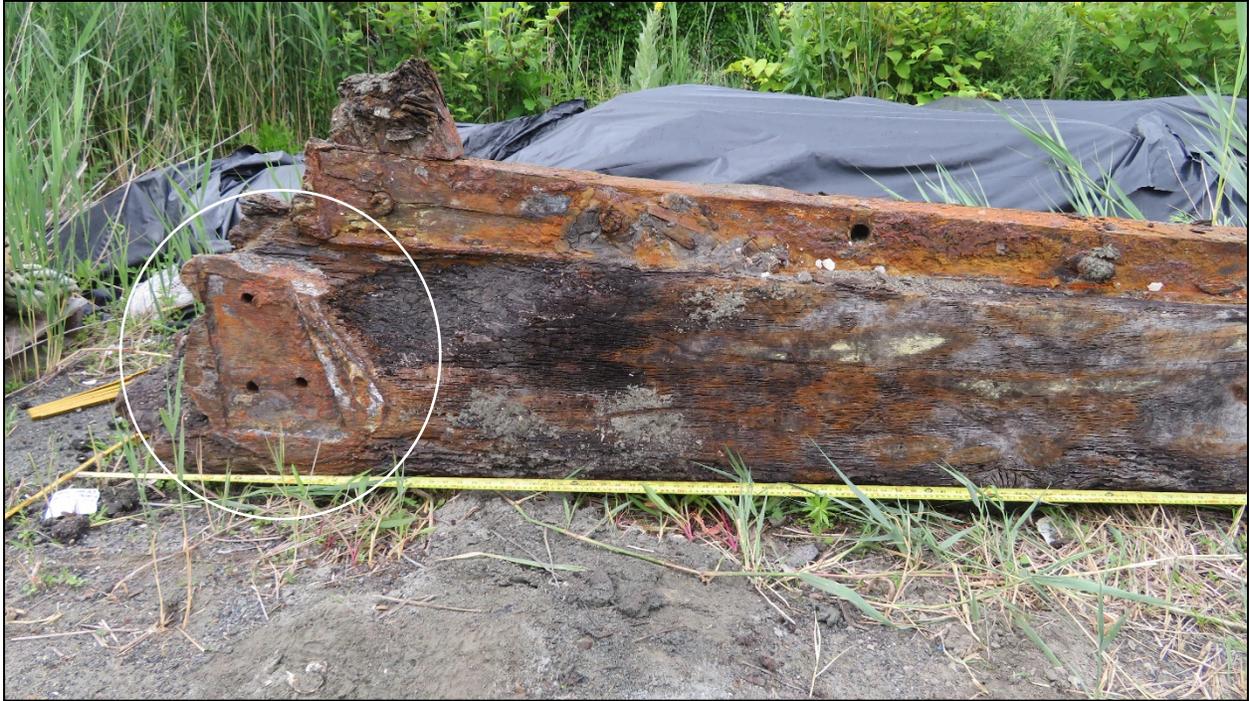
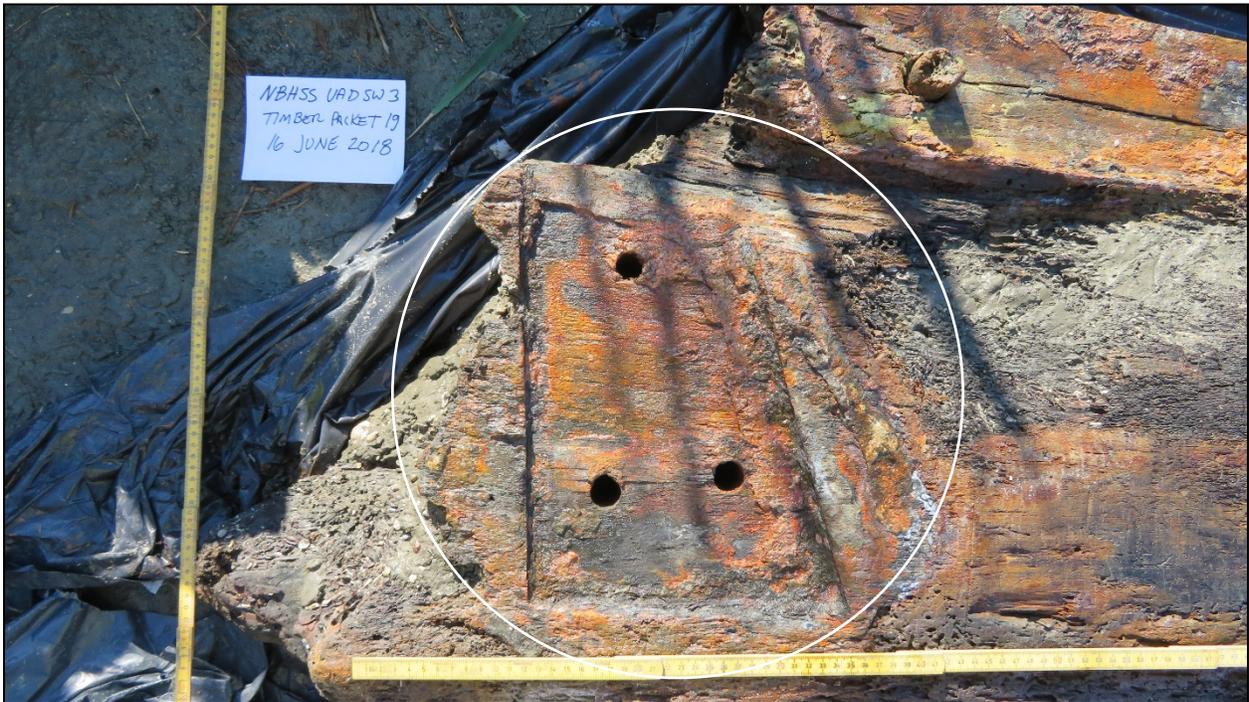
Figure 16. Corrosion-stained recesses or “mortises” cut into both sides of the aft end of the keel once held the lower half of vertically-oriented iron “fishplates.” These through-bolted iron plates extended up the sides of the keel and onto the sides of the lower portion of the sternpost and helped secure the connection between the bottom or “heel” the sternpost and the top surface of the keel’s aft end (photographs by David Robinson, DSRA).

Viewed in profile, the top surface of the keel sweeps upward as it approaches the stern to connect with a vertical sternpost and make the transition from the horizontal keel. At the aft end of the keel on both of its sides are corrosion-stained recesses or “mortises” that once held iron “fishplates” that helped secure the connection between the bottom or “heel” of the sternpost and the top surface of the keel’s aft end (**Figure 16**).

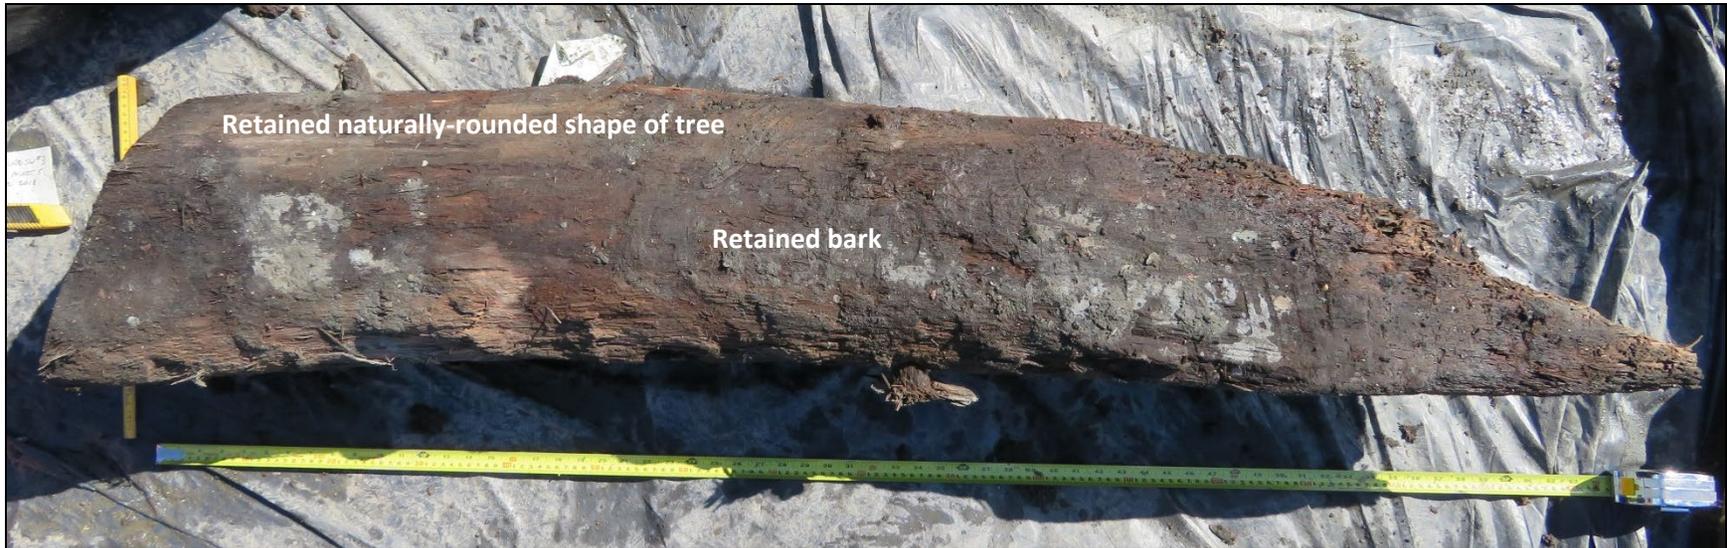
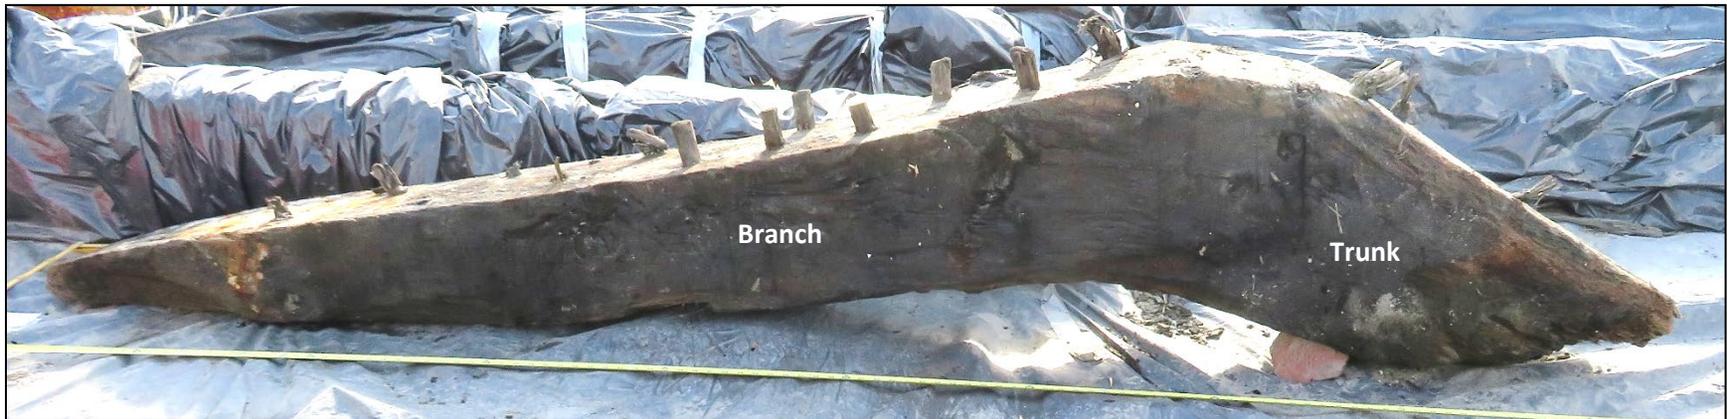
Figure 17. Examination of the surfaces, shapes, and wood grain of NBHSS UAD SW#3's framing timbers revealed several were "rough cut" and retained their source-tree's naturally rounded surfaces and shapes (upper image), and many were fashioned from "compass timbers" that were cut from parts of trees that were selected because their naturally grown shape fit the desired design shape of a particular timber (lower image) (photographs by David Robinson, DSRA).

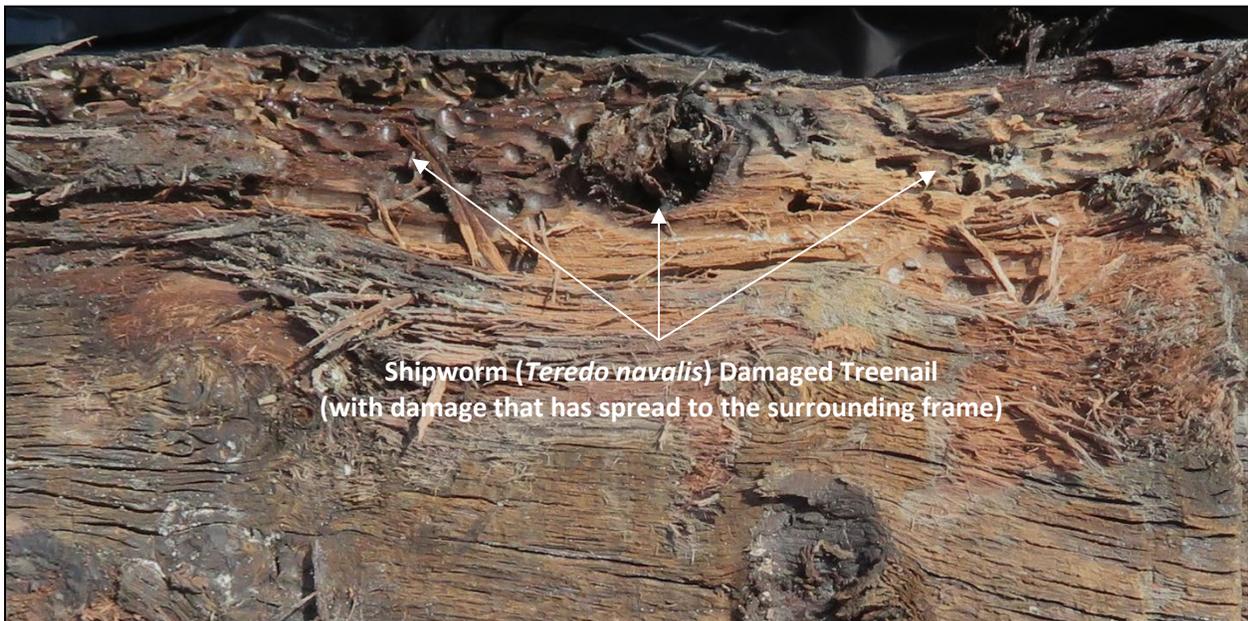
Figure 18. The exposed end-grain of NBHSS UAD SW#3's treenail fasteners made them more vulnerable to shipworm (*Teredo navalis*) penetration and damage than the surrounding planking (upper image). Once infiltrated, the shipworms spread out laterally from the treenails into the surrounding hull planking and framing (bottom image). This damage, which was observed in NBHSS UAD SW#3's treenails, planking, and framing timbers, would have weakened the hull's integrity and caused it to leak (photographs by David Robinson, DSRA).

All of the futtocks were shipworm damaged. All had round (in section) treenails or treenail holes. Treenails were used to fasten the hull planking and the futtocks together. The limited number of recovered futtocks and floors with horizontal treenails indicated that the floors and futtocks were not uniformly "articulated," or fastened together, as was the case in the "double-sawn" framing that was more typical of wooden vessels built in the middle nineteenth century and later. This partial use of compass timbers and use of single, rather than doubled, frames is suggestive of an earlier nineteenth century construction period for NBHSS UAD SW#3.

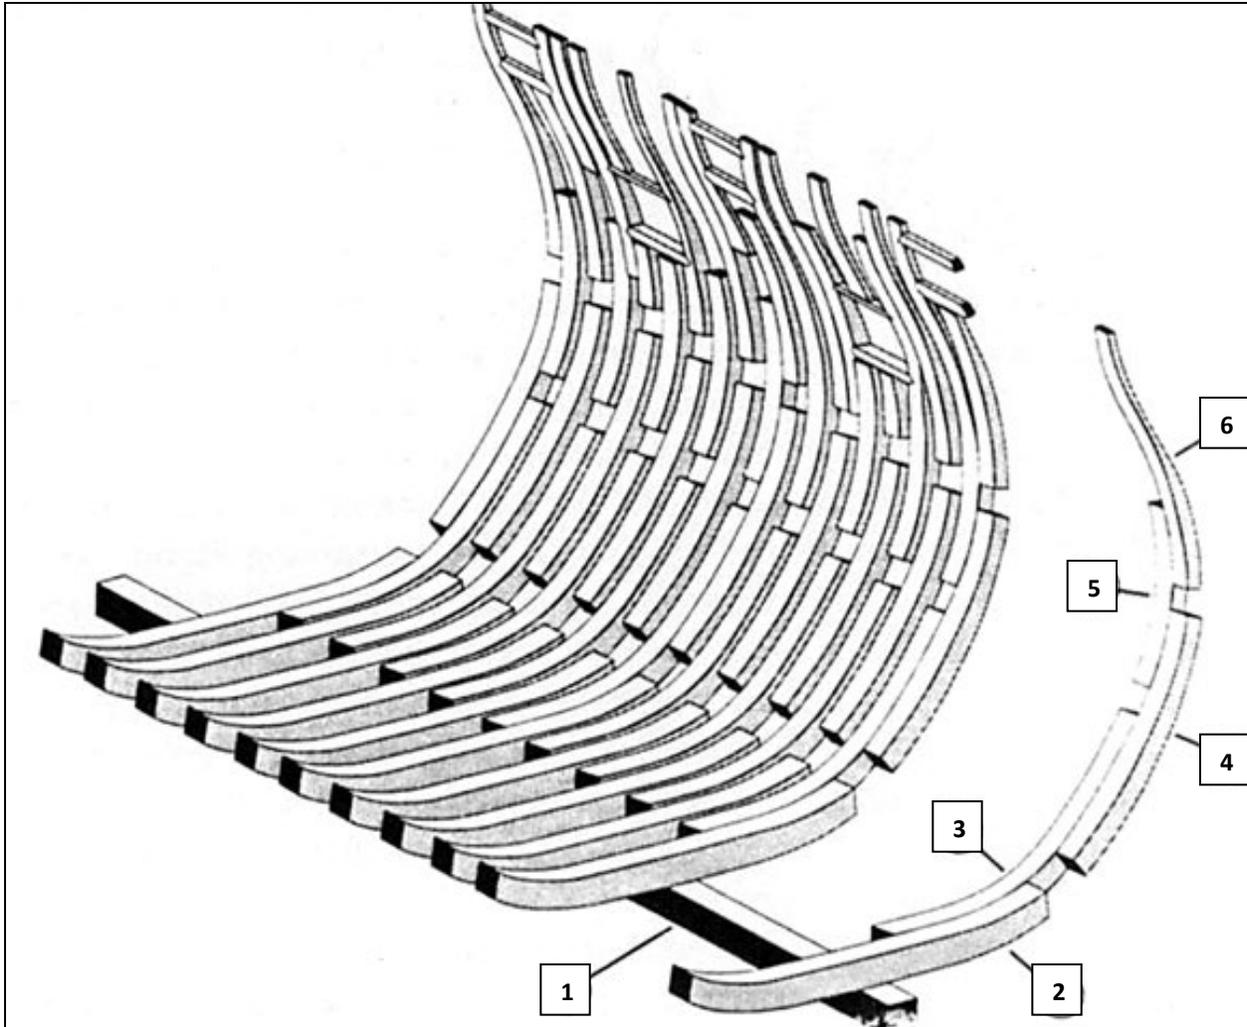
Figure 19. Representative diagram of basic ship framing elements at amidships (showing only on one side for clarity) that approximates what would have been the principal amidships framing elements in NBHSS UAD SW#3's hull when it was intact. The elements of each frame would have been secured to the keel (1) and have included the: 2) floor; 3) first futtock; 4) second futtock; 5) top timber; and 6) rail stanchion. Framing in NBHSS UAD SW#3 would have been much more irregular than is depicted here and would have exhibited more variation in curvature between frames as one moved forward or aft in the hull (after Kenchington 2017).

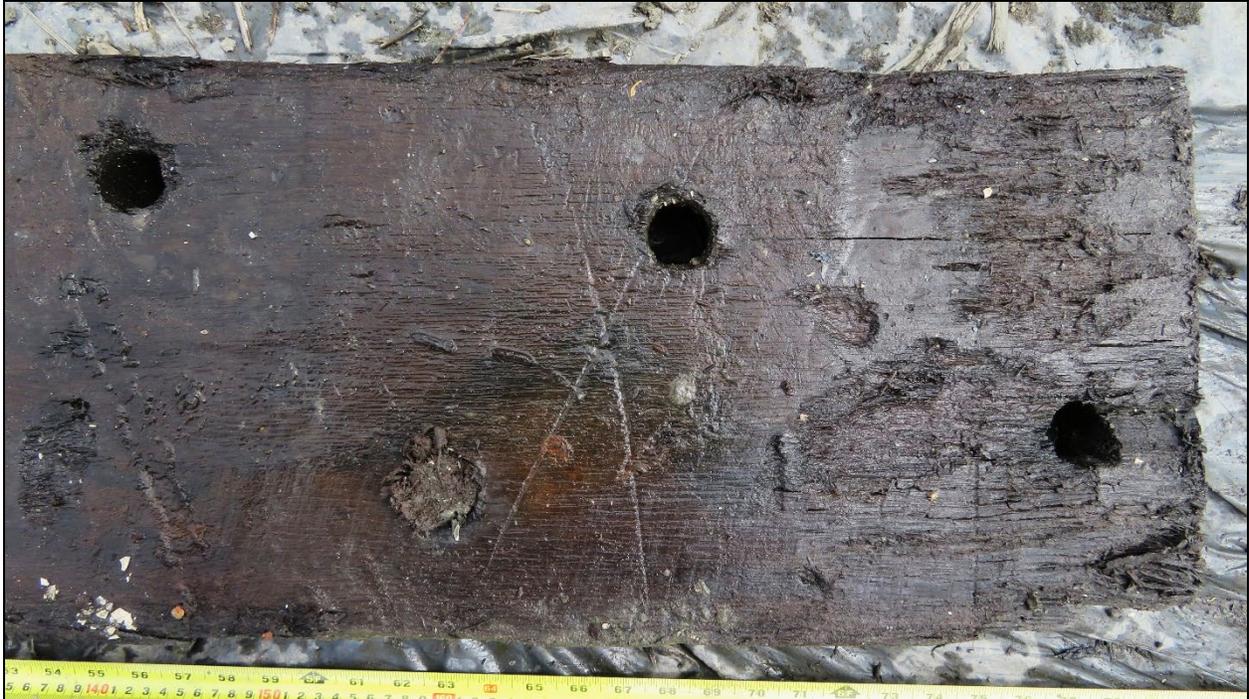
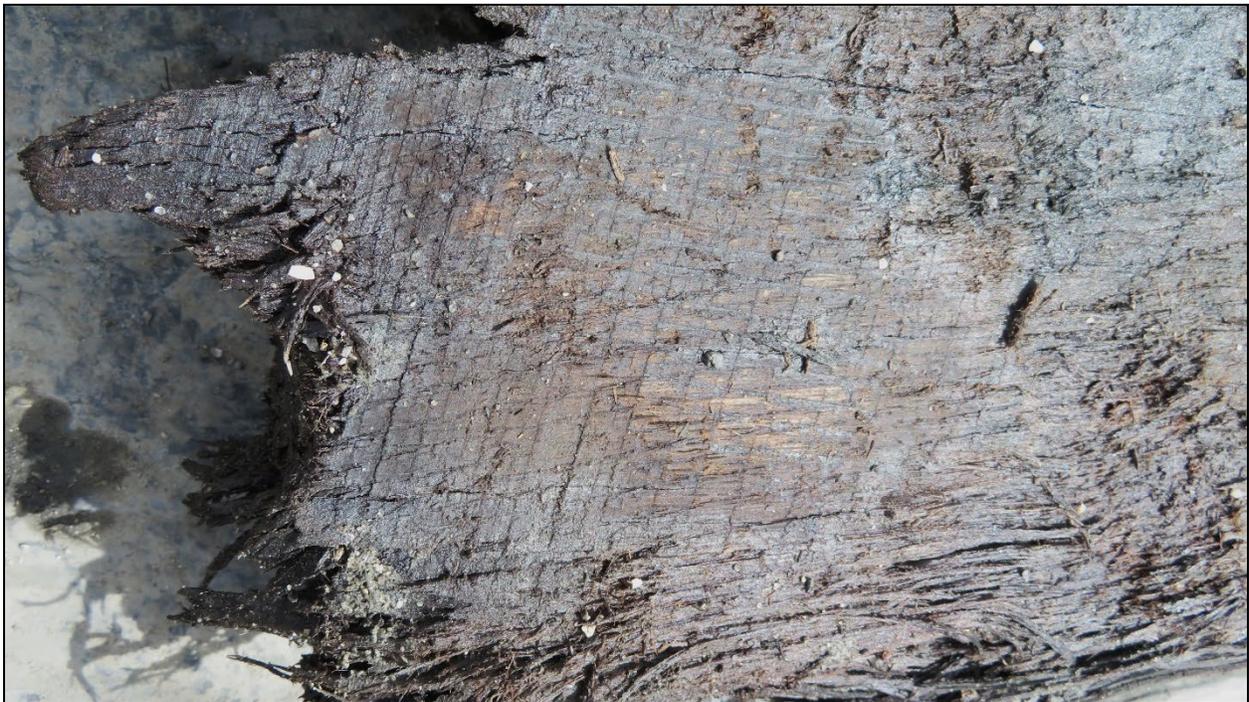
Figure 20. Surface features observed in NBHSS UAD SW#3's hull planking were limited to a single roman numeral scribe-mark ("X") near the intact end of one of the non-garboard hull planking fragments (upper image), and saw kerf marks that were clearly associated with a large circular saw (upper and lower images). Introduced in the 1830s, circular saw blades were commonly used in the sawmills of the eastern United States by the middle 1800s, but were introduced and adopted in English sawmills significantly earlier (i.e., the late 1700s) (photographs by David Robinson, DSRA).

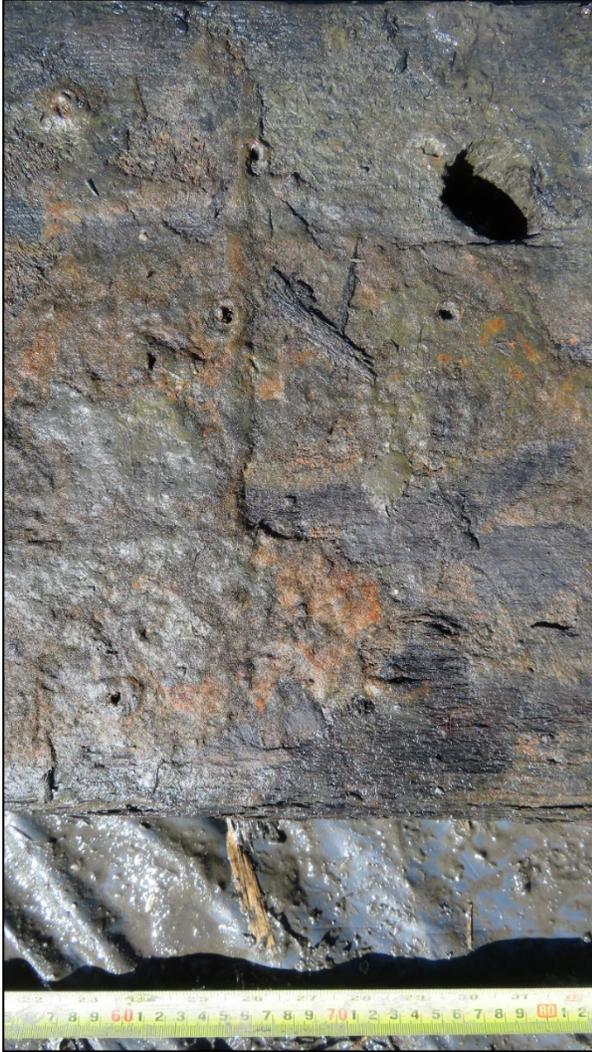
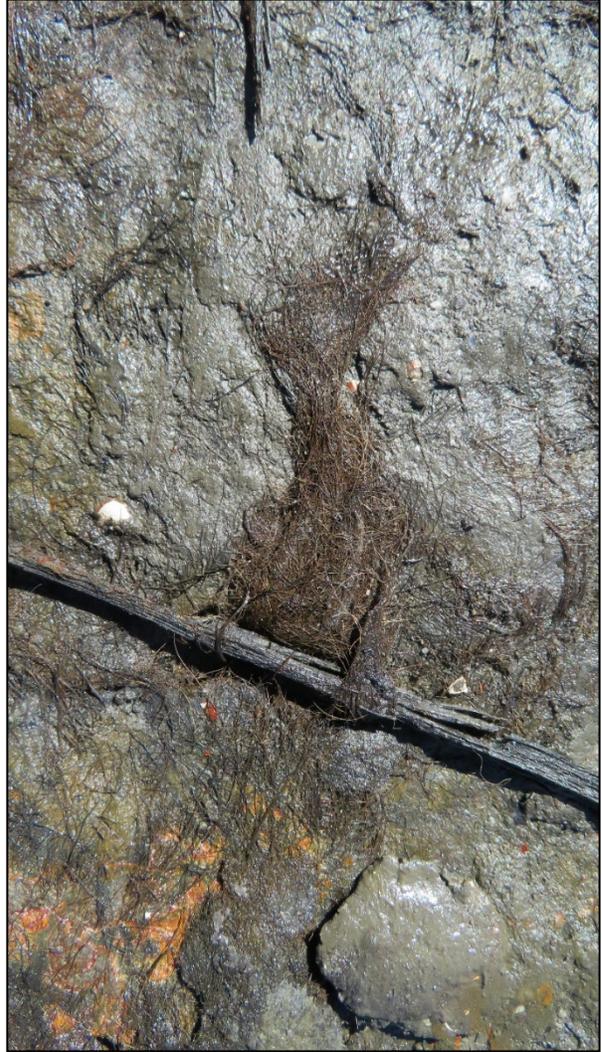
Figure 21. Tared animal hair “felting” and sheathing nail holes on the exterior surfaces of NBHSS UAD SW#3’s hull planking and keel provided evidence that the vessel’s hull had once been sheathed in protective sacrificial wooden hull sheathing (photographs by David Robinson, DSRA).

Use of wooden hull sheathing in the hull of NBHSS UAD SW#3 is inferred from the presence of sheathing nail holes in the outboard surfaces of the hull planking and keel (see Figures 15 and 21) and the absence of cuprous sheathing nails, cuprous corrosion staining, or cuprous or lead sheathing fragments embedded in the wood at the surface of the planking. No hull sheathing planks were seen to be preserved and recovered from the NBHSS UAD SW#3 site.

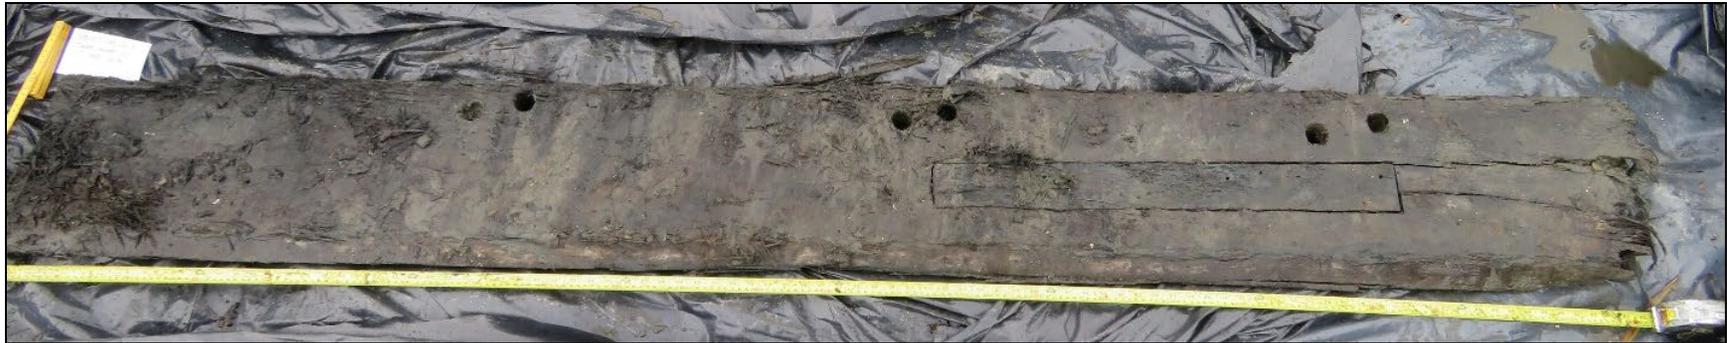
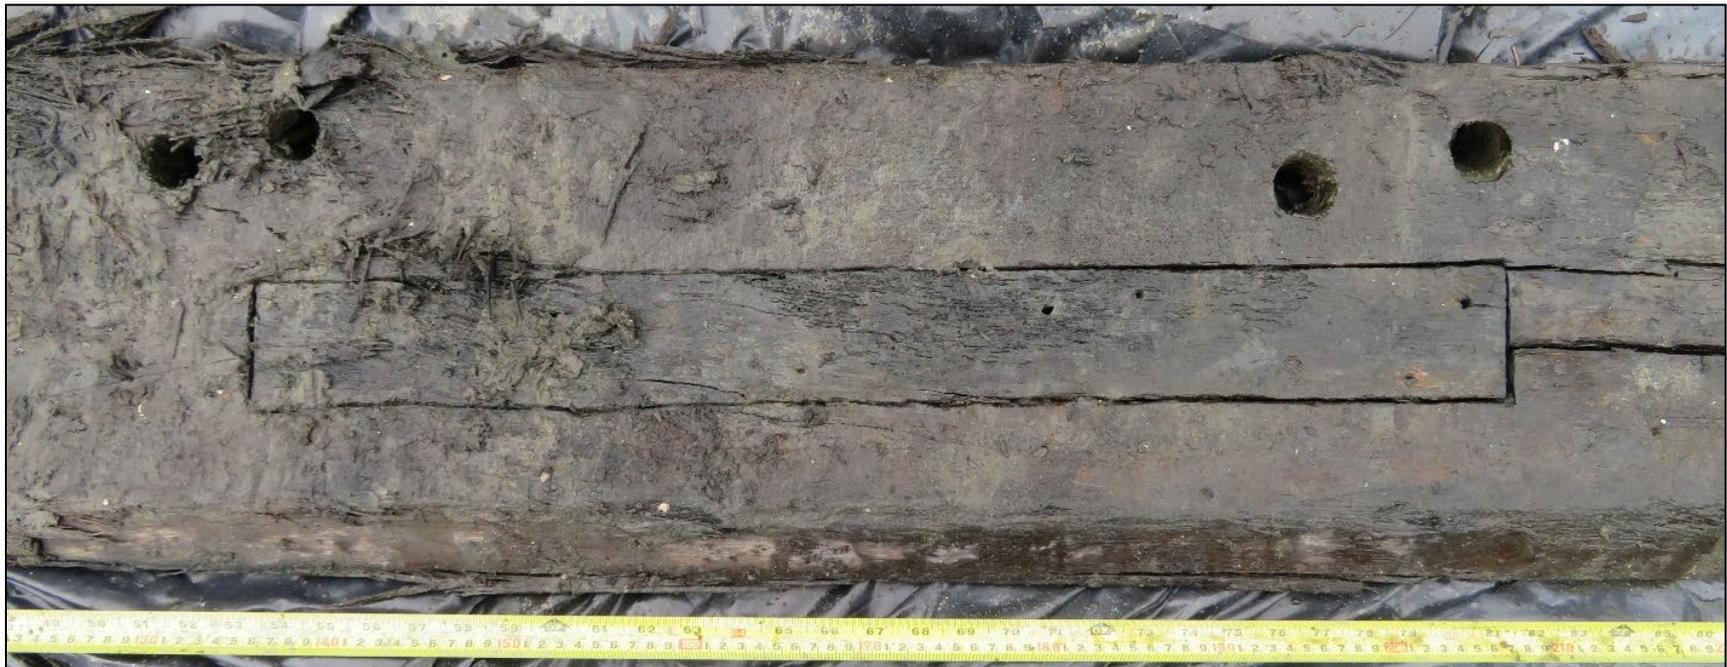
Figure 22. NBHSS UAD SW#3's hull remains included evidence of multiple repairs. Among them was a repair to one of the garboard strake fragments that had been made while the plank was in-place on the hull. The repair consisted of a small wooden "butt-block" patch that was inserted and nailed into place in a hole cut into the garboard near its end where the plank had split. The repair was made, presumably, to prevent the plank from splitting further along its length and causing the hull to leak (photographs by David Robinson, DSRA).

edge that would have fit into a groove or “rabbet” cut into the upper corners of the keel, thus indicating that these hull planking fragments were from the lowest “run” or “strake” of planking in the ship’s hull. Fastening patterns in the garboard strake fragments indicate that the garboard was treenailed into every other frame (most likely the floors) with two treenails per frame that were generally set diagonal to each other. The treenail fastening pattern observed in the (non-garboard) hull planking fragments was the same (i.e., two treenails per frame with them set diagonally to each other), except that they were fastened at every frame location. The hooding ends of the hull planking were fastened to the framing with one and two treenails. Surface features observed in the hull planking included one roman numeral scribe-mark (“X”) near the intact end of one of the non-garboard hull planking fragments, and saw marks clearly associated with a large circular saw (**Figure 20**). Round-bladed saws were commonly used in the wood-mills of the eastern United States by the 1860s, but were common in English shipyards much earlier (i.e., in the late 1700s). Tared animal hair felting residue and numerous small sheathing nail holes preserved on/in the outboard surfaces of some of the garboard and hull planking strake fragments provided additional evidence of the use of sacrificial wood hull sheathing (**Figure 21**). Evidence of repairs was present in one of the garboard strake fragments and in one of the non-garboard hull planking fragments (**Figure 22**). In the garboard strake fragment, the repair had been made to the plank while it remained in place and consisted of a small (27.6 in-x-2.4 in wide [70 cm long-x-6 cm wide]) wooden butt-block patch that had been inserted into a hole cut into the garboard at the end of a double split in this particular plank. The repair was made presumably to prevent the plank from splitting further along its length. The other evidence of a repair also appears to have been made while the plank was in place. This repair consisted of two angular recessed or rabbeted areas that were cut into the exterior surface of the hull planking fragment. One is roughly square in shape and is located at one corner of the intact end of the plank where it encompasses the former location of a treenail. Small rectangular nail holes with iron staining indicate the type of fasteners that were used to secure the patch in place within this recess in the plank’s surface. The other recess or rabbet is located near the edge of the plank and also corresponds with the location of a treenail. There is significant shipworm damage visible within this recess. It may have been that the repair was intended to replace a shipworm-damaged treenail and the surrounding wood.

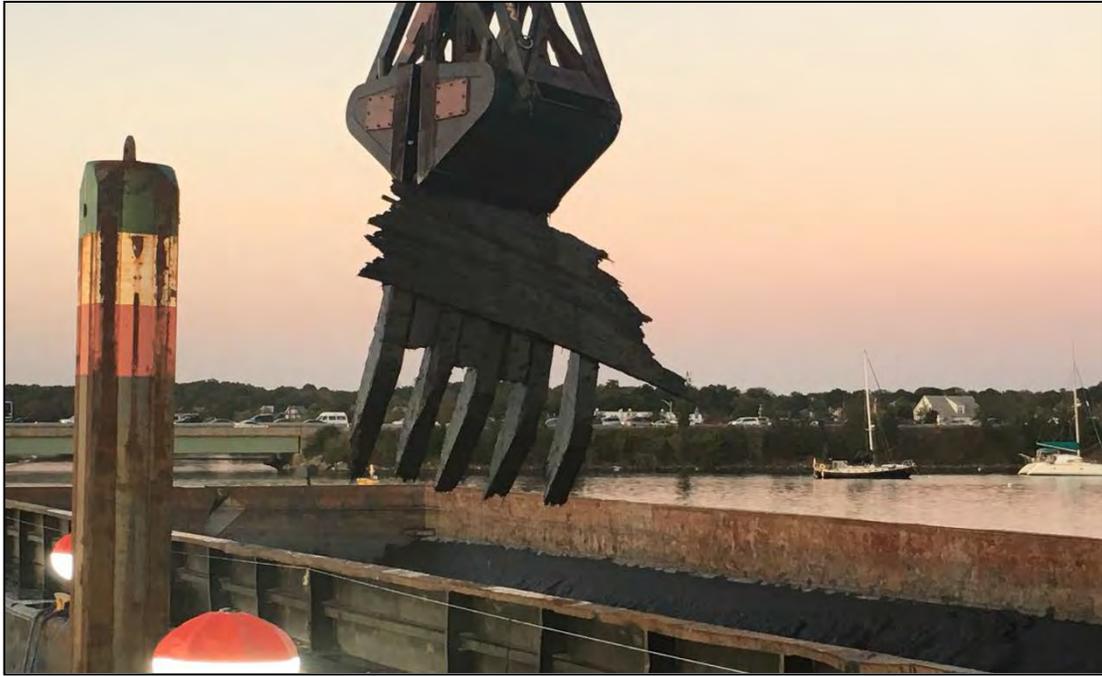
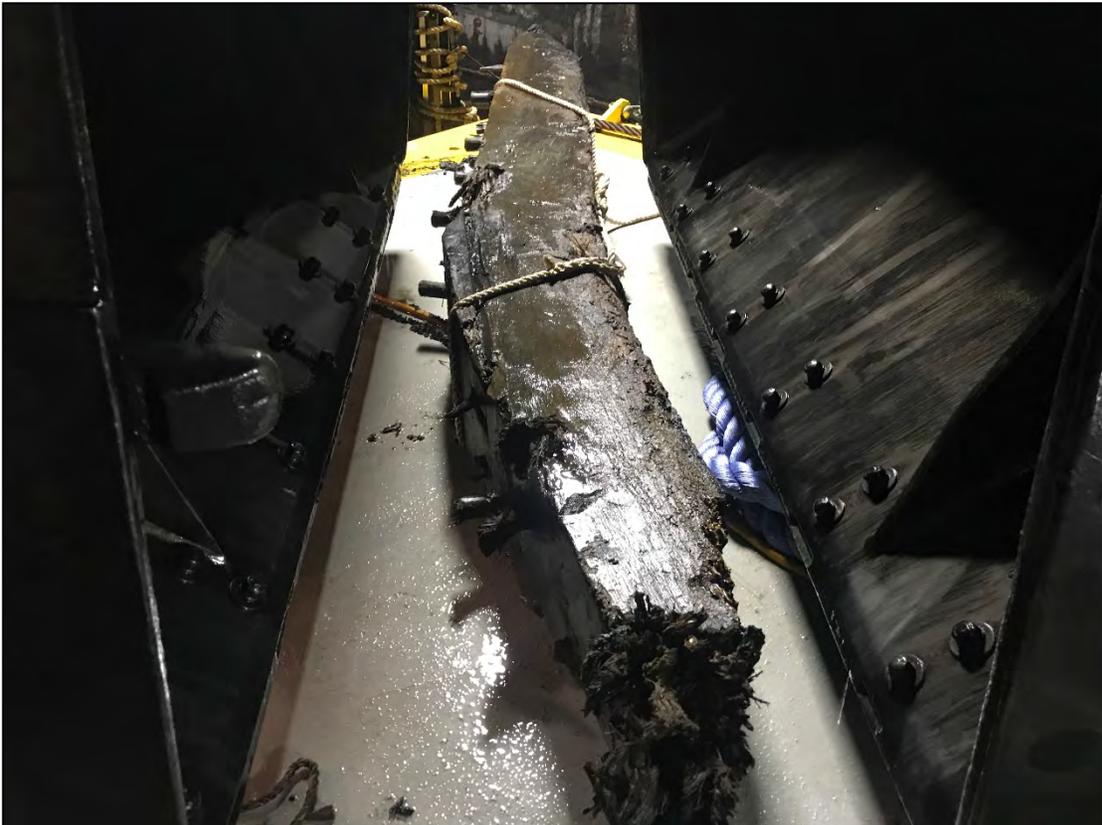
Figure 2. Ship remains encountered and recovered from the NBHSS UAD SW#3 unanticipated discovery find site at the northern end of the NBHSS Lower Harbor Area.
