Marine Archaeological Investigation

Removal and Documentation of the
New Bedford Harbor Superfund Site Unanticipated Discovery Shipwreck #3
from the Lower Harbor Area

Acushnet River, New Bedford, Massachusetts

APRIL 2019

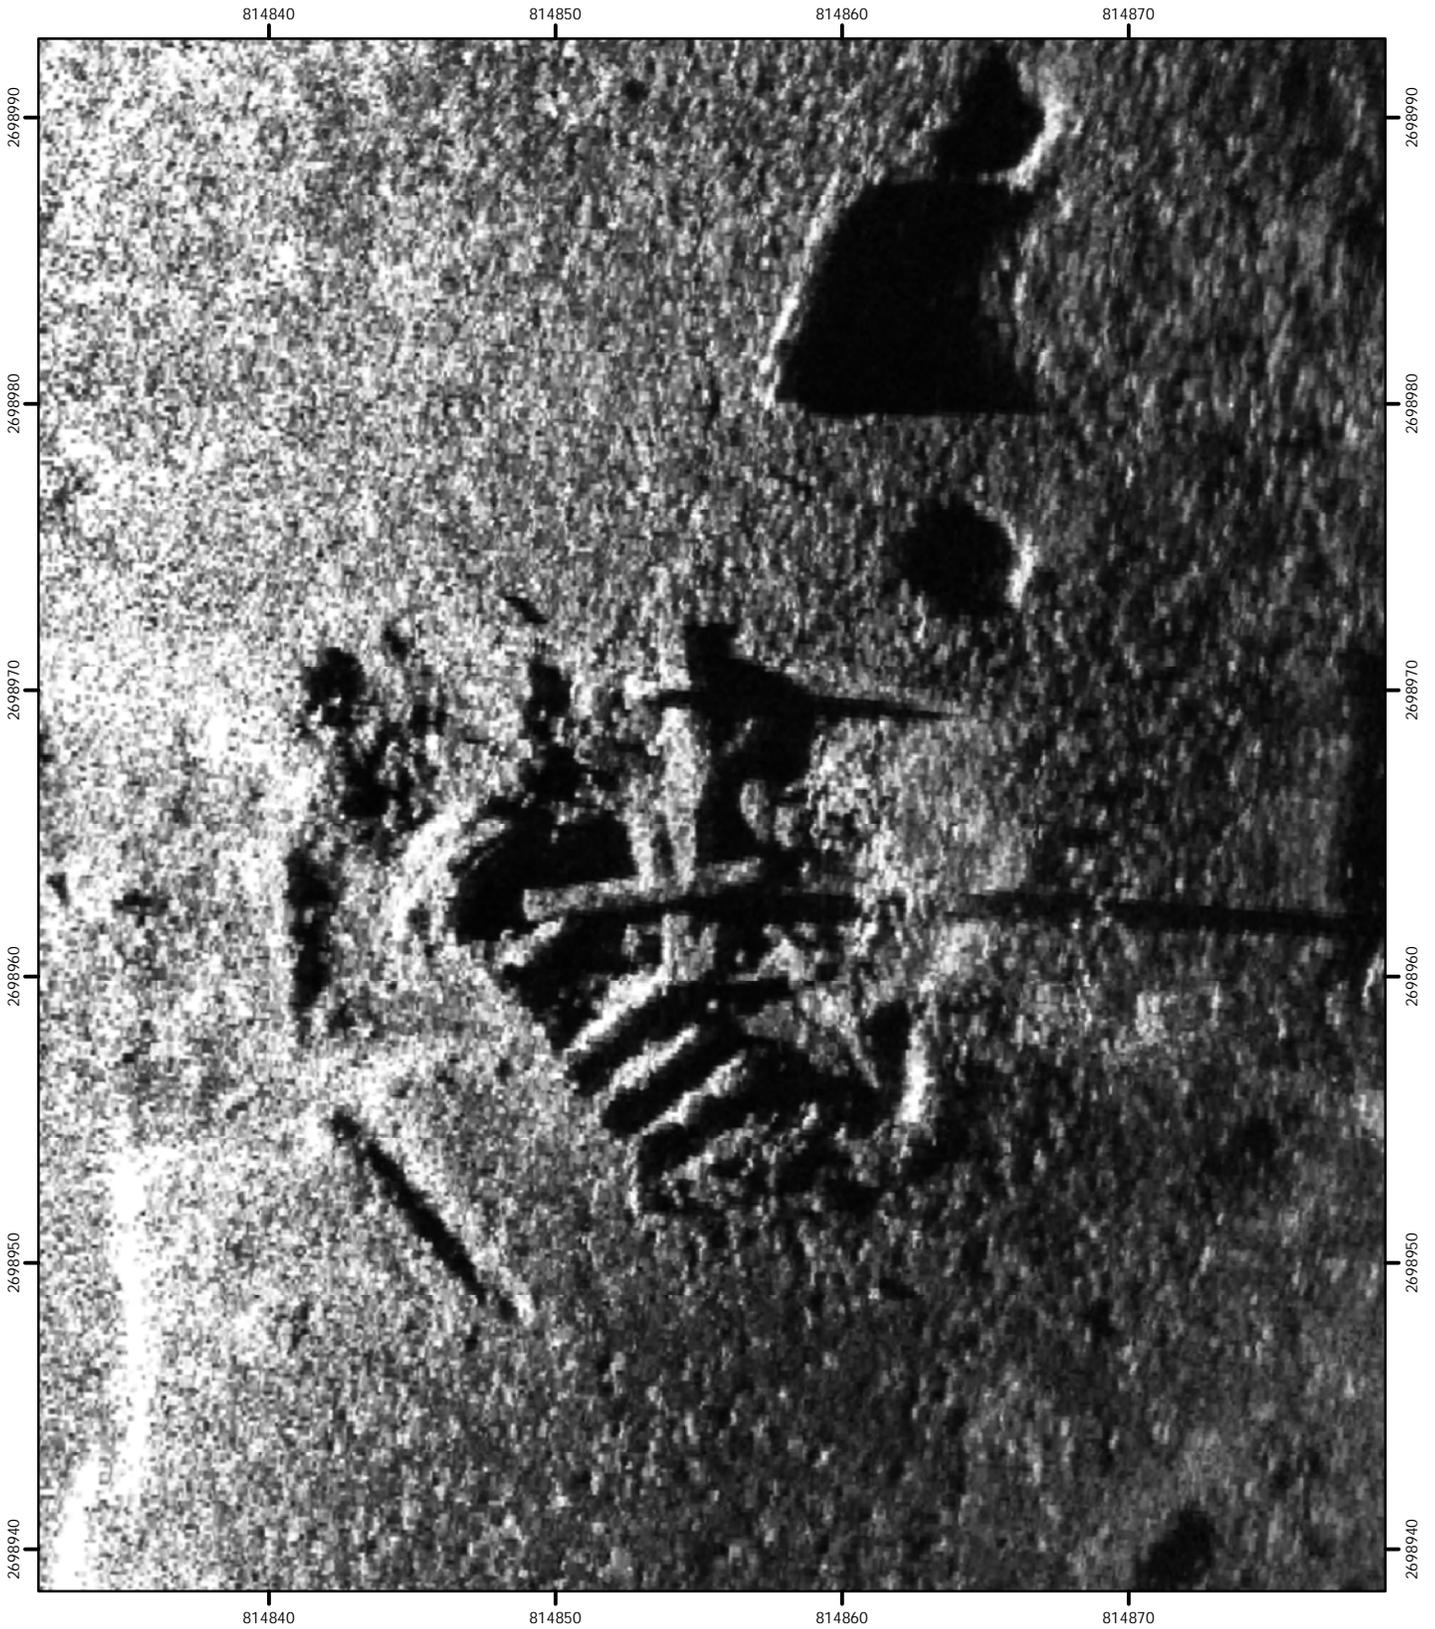
www.crenvironmental.com	<p>900 kHz SIDE SCAN SONAR RECORD UNANTICIPATED DISCOVERY NO. 3 New Bedford Harbor</p>

<p>NOTES: 1) Survey conducted October 11, 2017. 2) Grid MA State Plane NAD 83 US Ft 3) Inverted grey scale. 4) Scale 1:80</p>	<p>Figure 4</p>

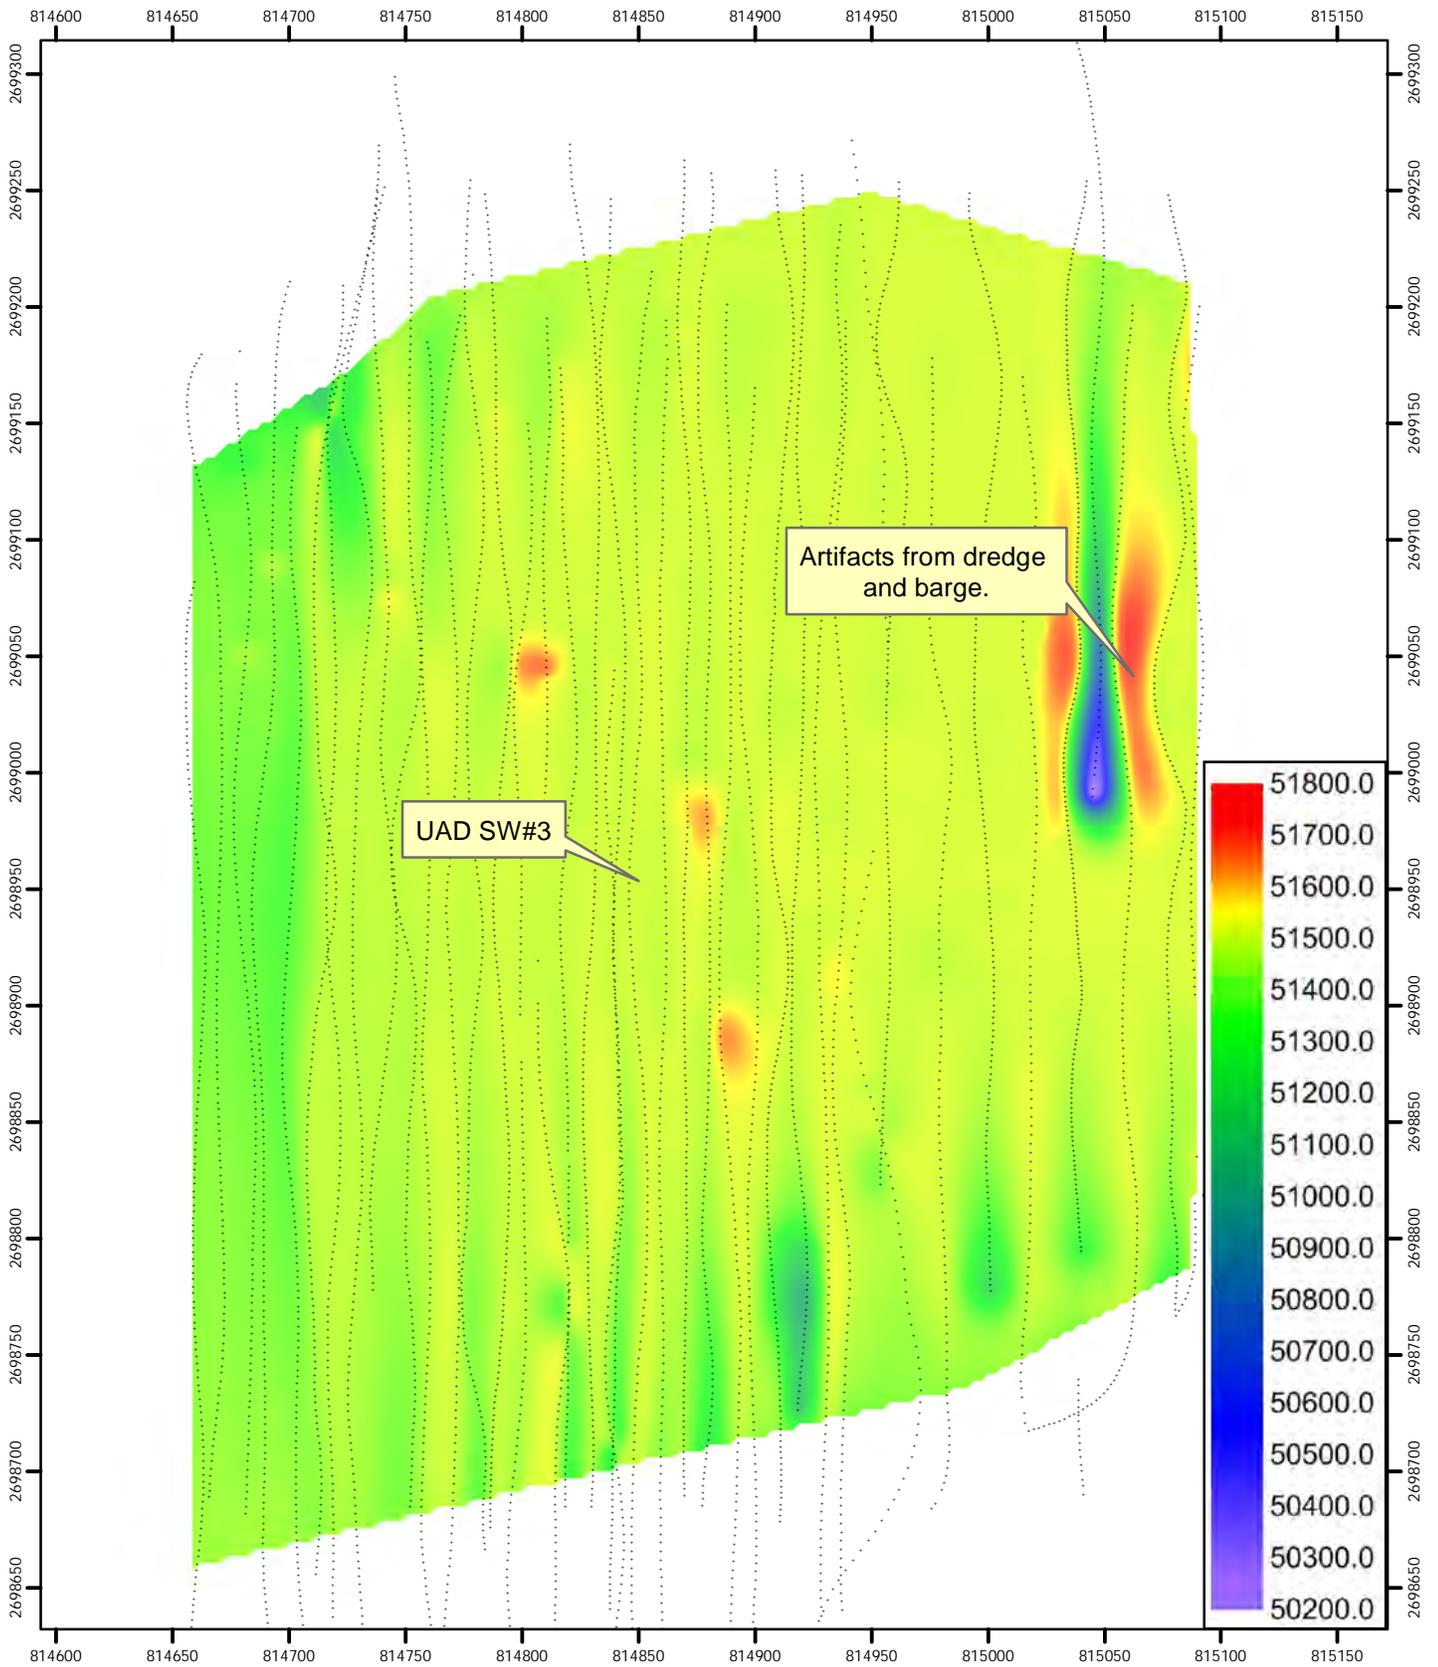
www.crenvironmental.com	<p>TOTAL FIELD MAGNETISM (nT) UNANTICIPATED DISCOVERY NO. 3 New Bedford Harbor</p>

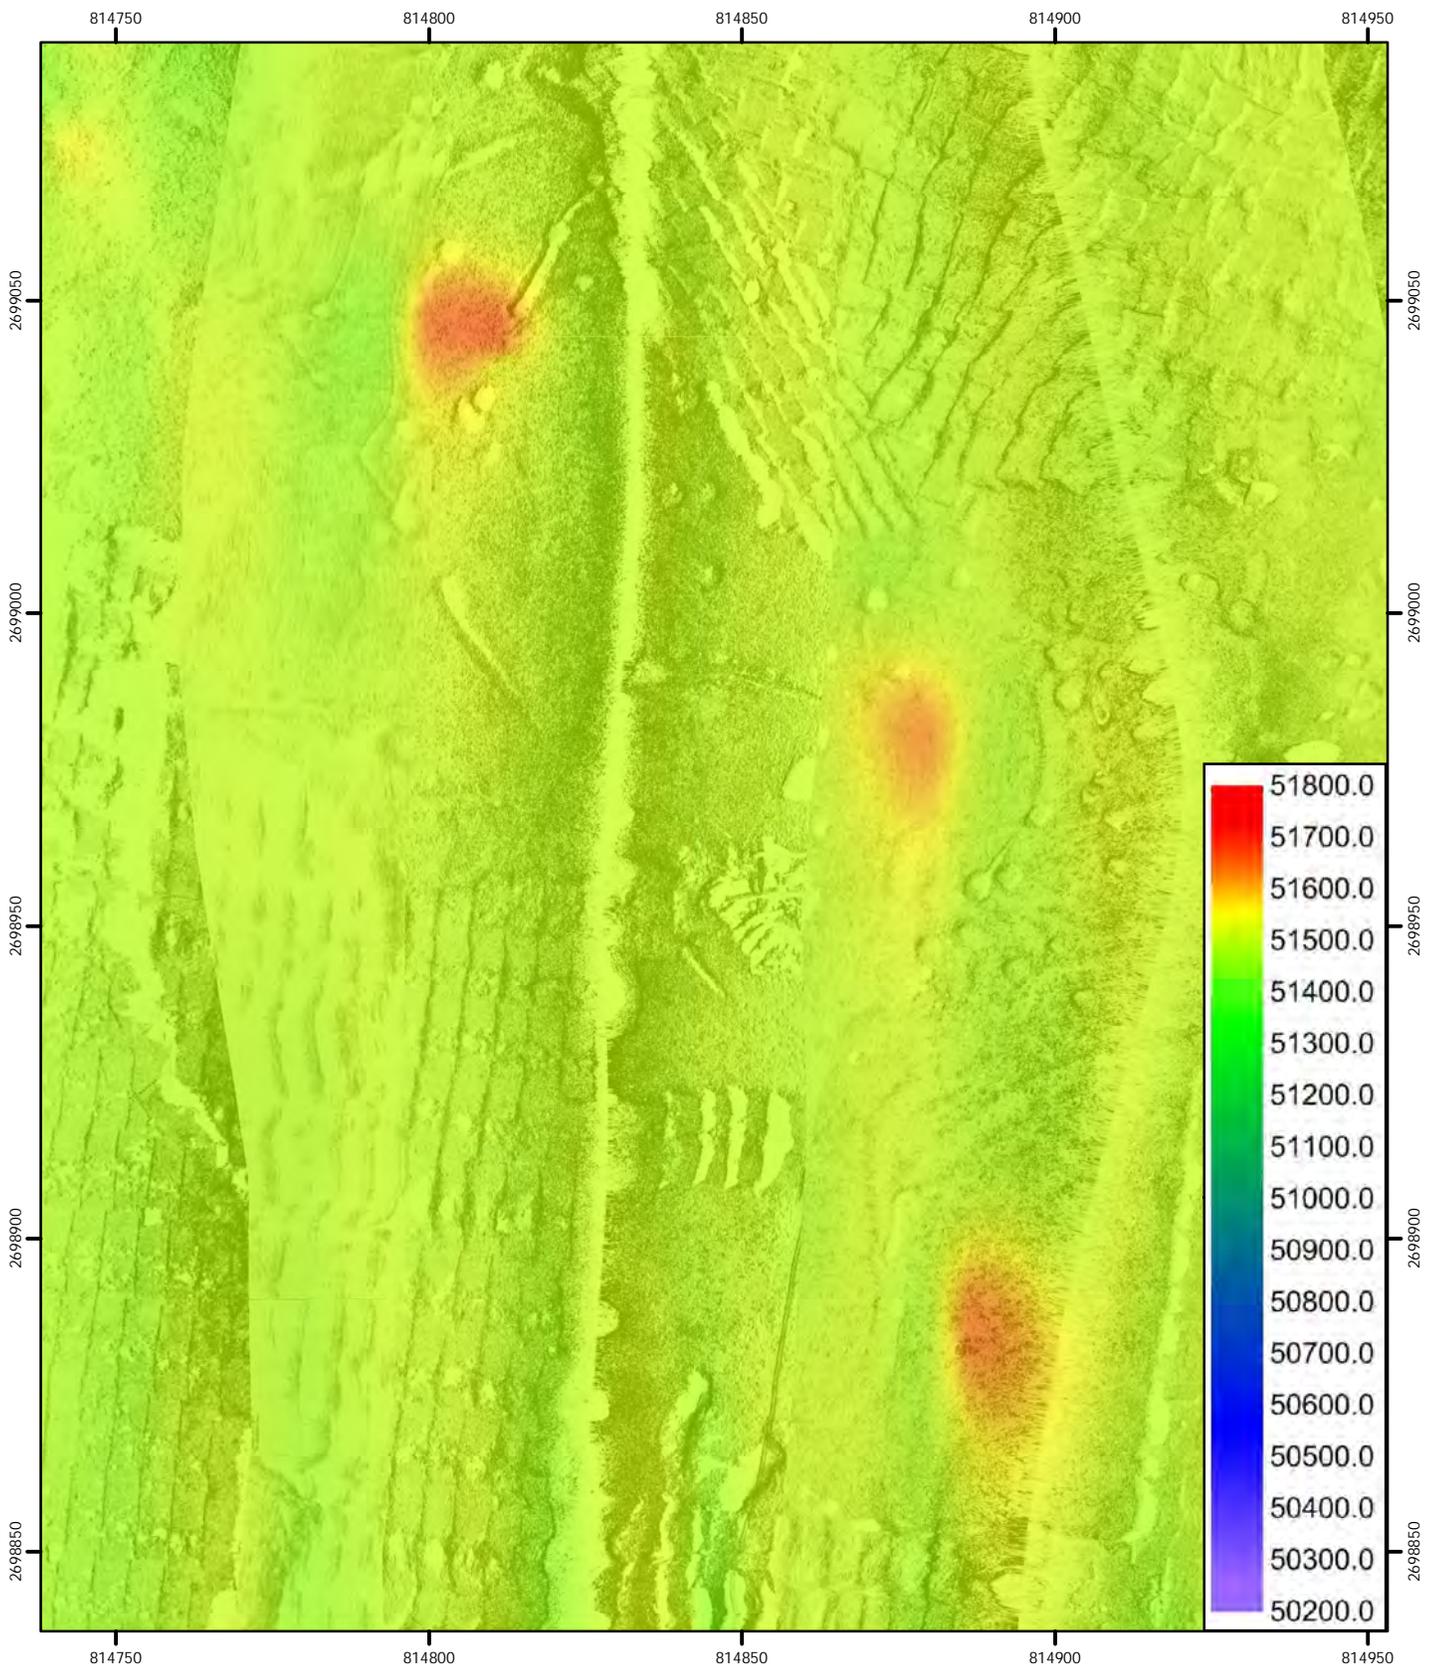
</div>	<p>Figure 6</p>

<p>TOTAL FIELD MAGNETISM & SIDE SCAN UNANTICIPATED DISCOVERY NO. 3 New Bedford Harbor</p>

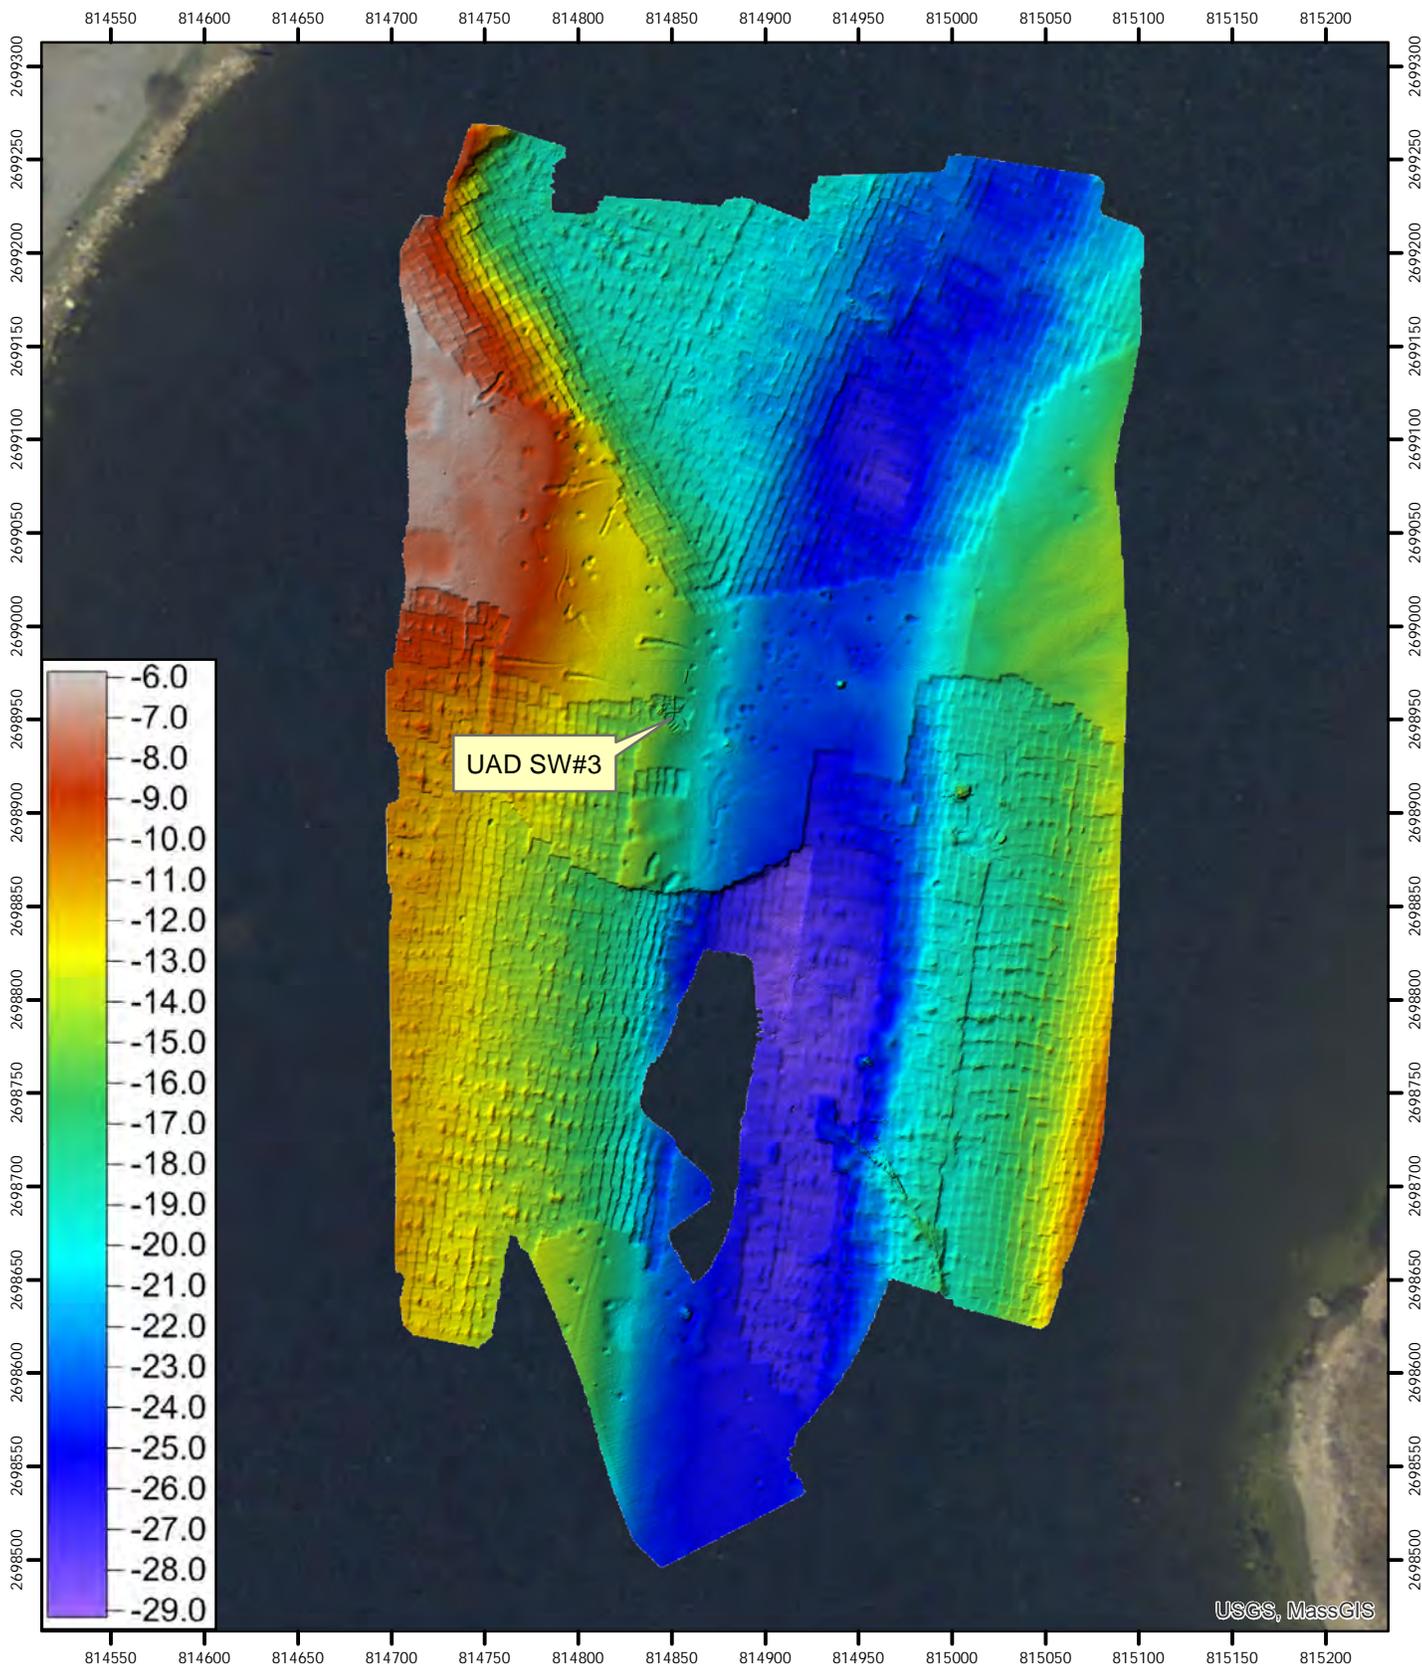
<p>Figure 7</p>

<p>www.crenvironmental.com</p>	<p>400/700 KHZ MULTIBEAM BATHYMETRY - MLLW (Feet) UNANTICIPATED DISCOVERY NO. 3 New Bedford Harbor</p>

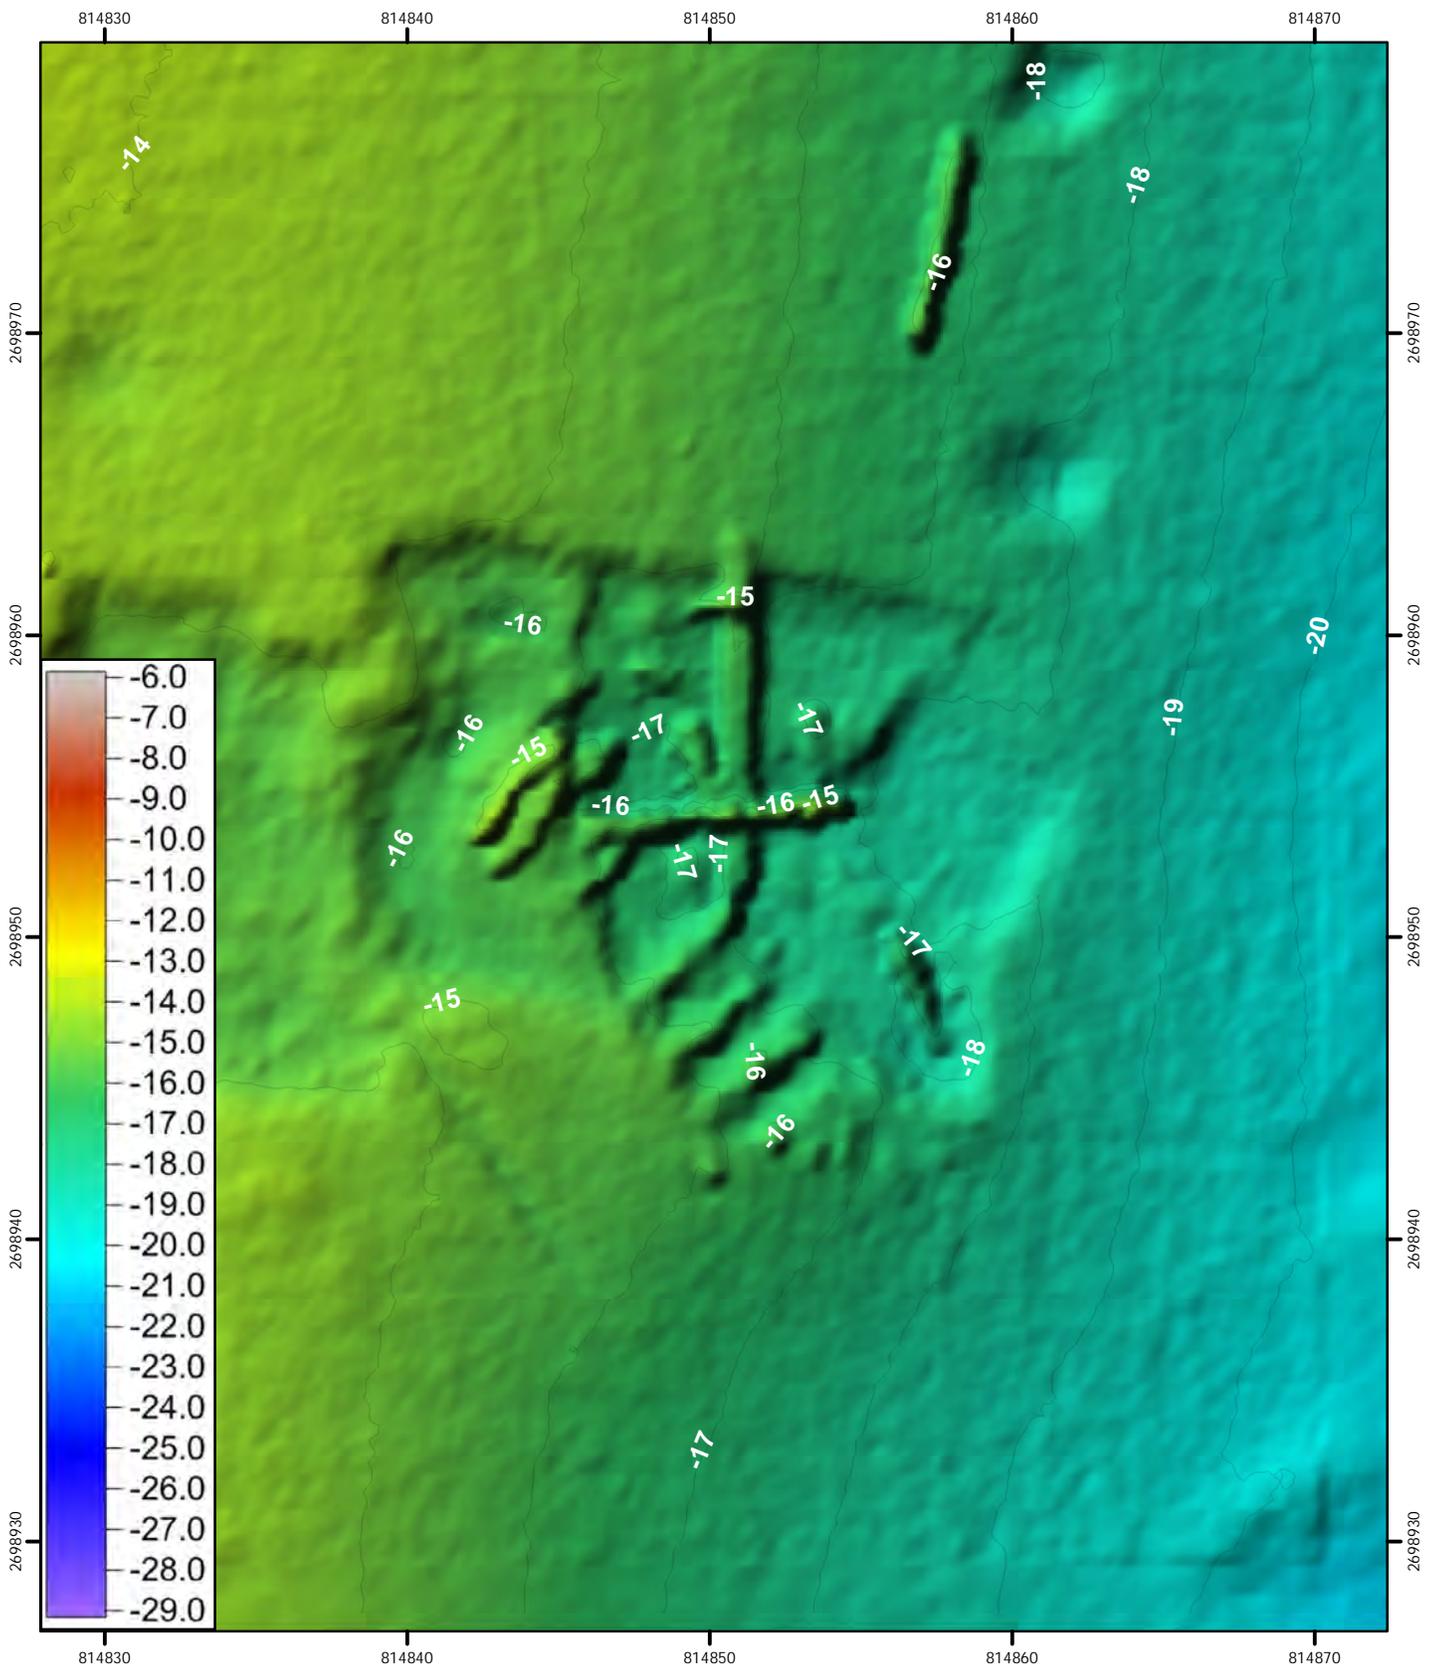
</div>	<p>Figure 8</p>

<p>www.crenvironmental.com</p>	<p>700 KHZ MULTIBEAM BATHYMETRY - MLLW (Feet) UNANTICIPATED DISCOVERY NO. 3 New Bedford Harbor</p>

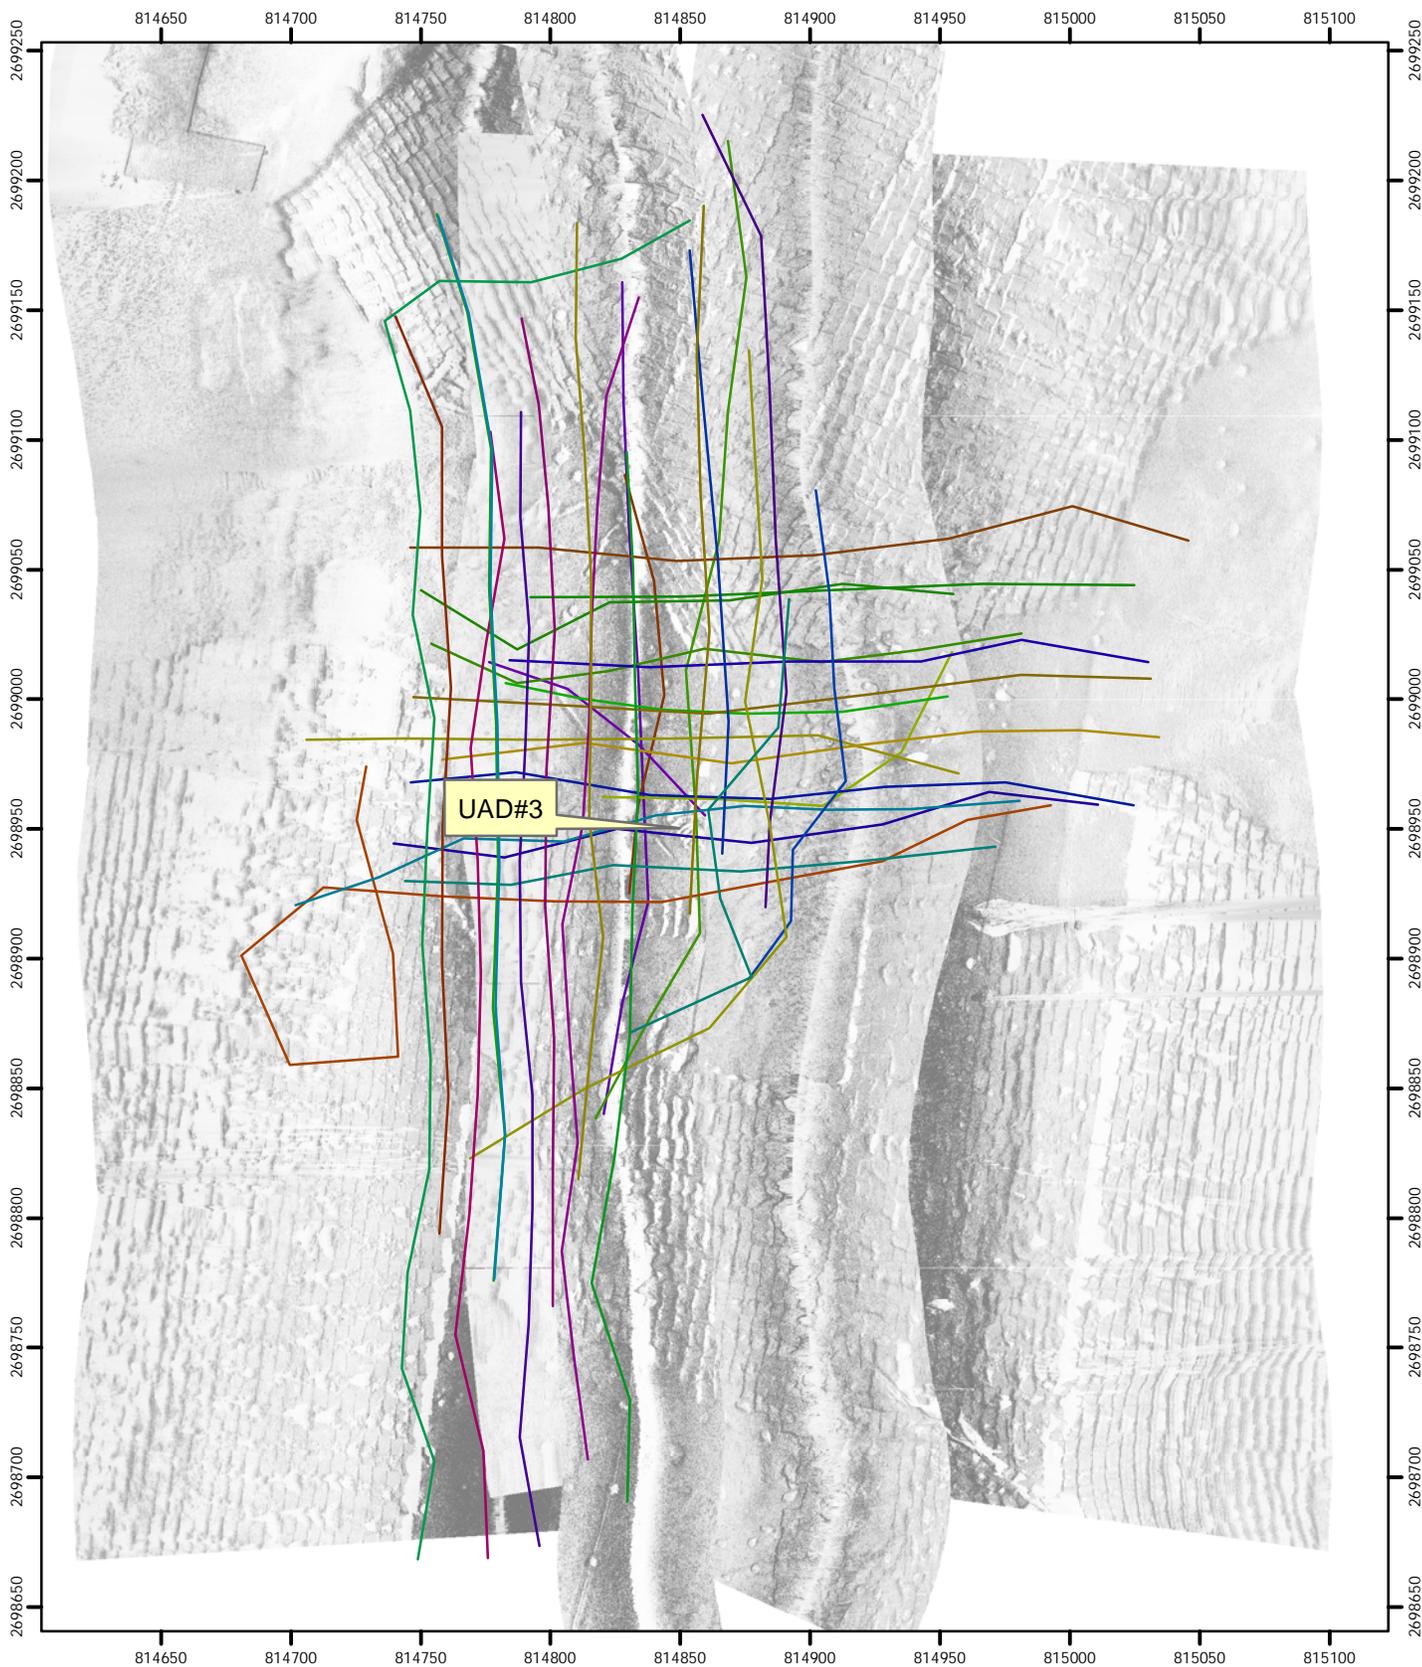
Figure 9

SUB-BOTTOM PROFILER SURVEY TRACKLINES
 UNANTICIPATED DISCOVERY NO. 3
 New Bedford Harbor

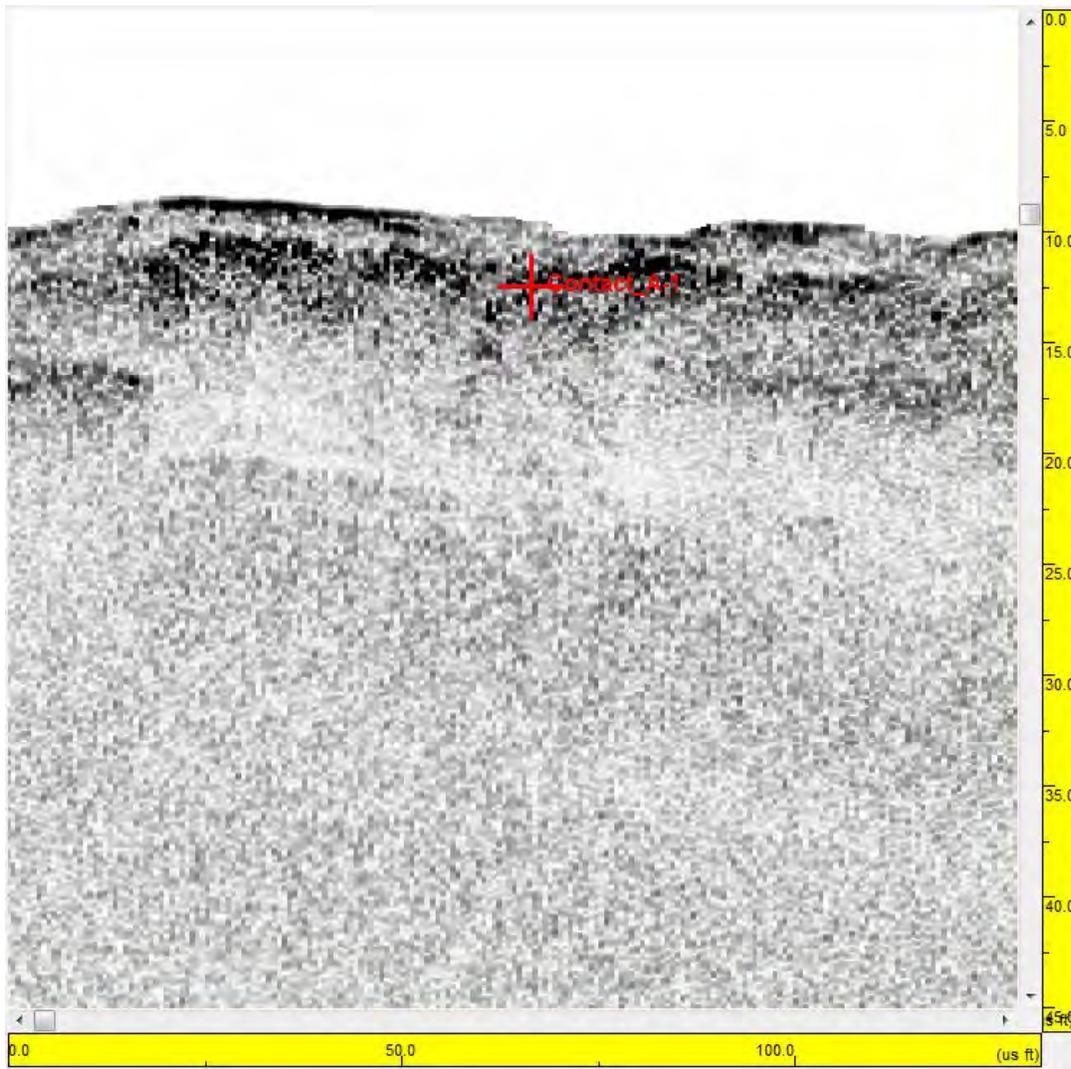
Contact_A-1

- Sonar Time at Target: 10/12/2017 12:03:23.546
 - Click Position (Lat/Lon Coordinates)
41.6526197890 -70.9194216795 (WGS84)
 - Click Position (Projected Coordinates)
(X) 814834.96 (Y) 2698980.42
 - Map Proj: MA83F
 - Acoustic Source File: E:\projects\2017_NBH_Wreck-3\SB\raw\NBHSB.003.jsf
 - Ping Number: 3994
 - Range to Target: 5.46 US Feet
 - Fish Height: 4.18 US Feet
 - Heading: 0.000 degrees
 - Event Number: 0
 - Water Depth: 0.00
 - Line Name: NBHSB.003
- Target Height: = 0.00 US Feet
Target Length: 0.00 US Feet
Target Shadow: 0.00 US Feet
Target Width: 0.00 US Feet
Classification 1: Possible parabolic reflector NW of wreck

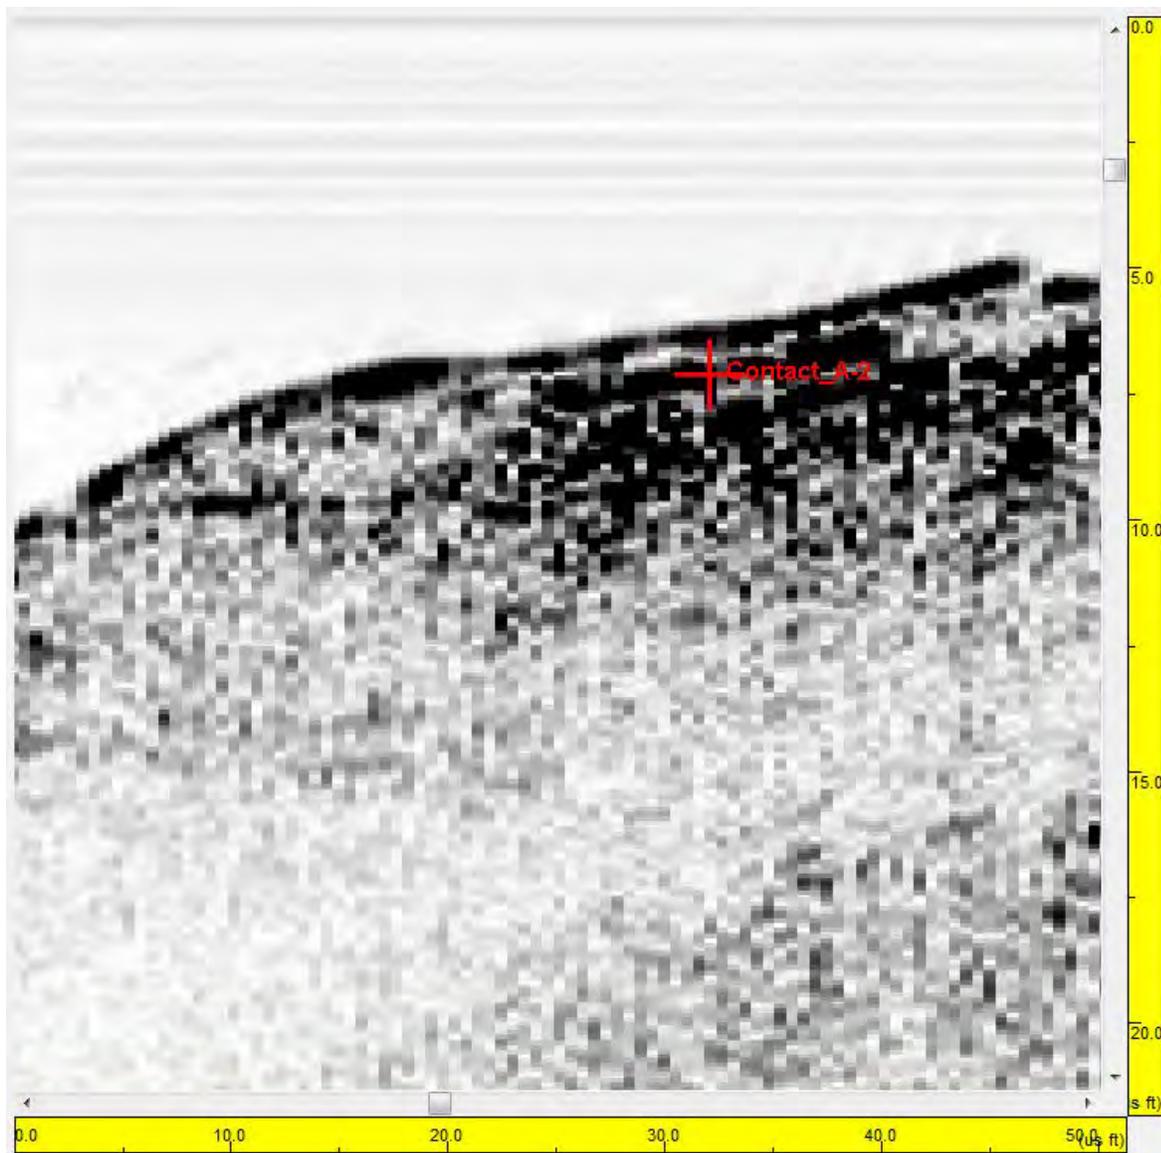
Contact_A-2

- Sonar Time at Target: 10/12/2017 11:53:00.064
 - Click Position (Lat/Lon Coordinates)
41.6525688417 -70.9195030788 (WGS84)
 - Click Position (Projected Coordinates)
(X) 814812.84 (Y) 2698961.70
 - Map Proj: MA83F
 - Acoustic Source File: E:\projects\2017_NBH_Wreck-3\SB\raw\NBHSB.jsf
 - Ping Number: 1508
 - Range to Target: 4.27 US Feet
 - Fish Height: 0.00 US Feet
 - Heading: 0.000 degrees
 - Event Number: 0
 - Water Depth: 0.00
 - Line Name: NBHSB
- Target Height: = 0.00 US Feet
Target Length: 2.05 US Feet
Target Shadow: 0.00 US Feet
Target Width: 23.32 US Feet
Classification 1: debris

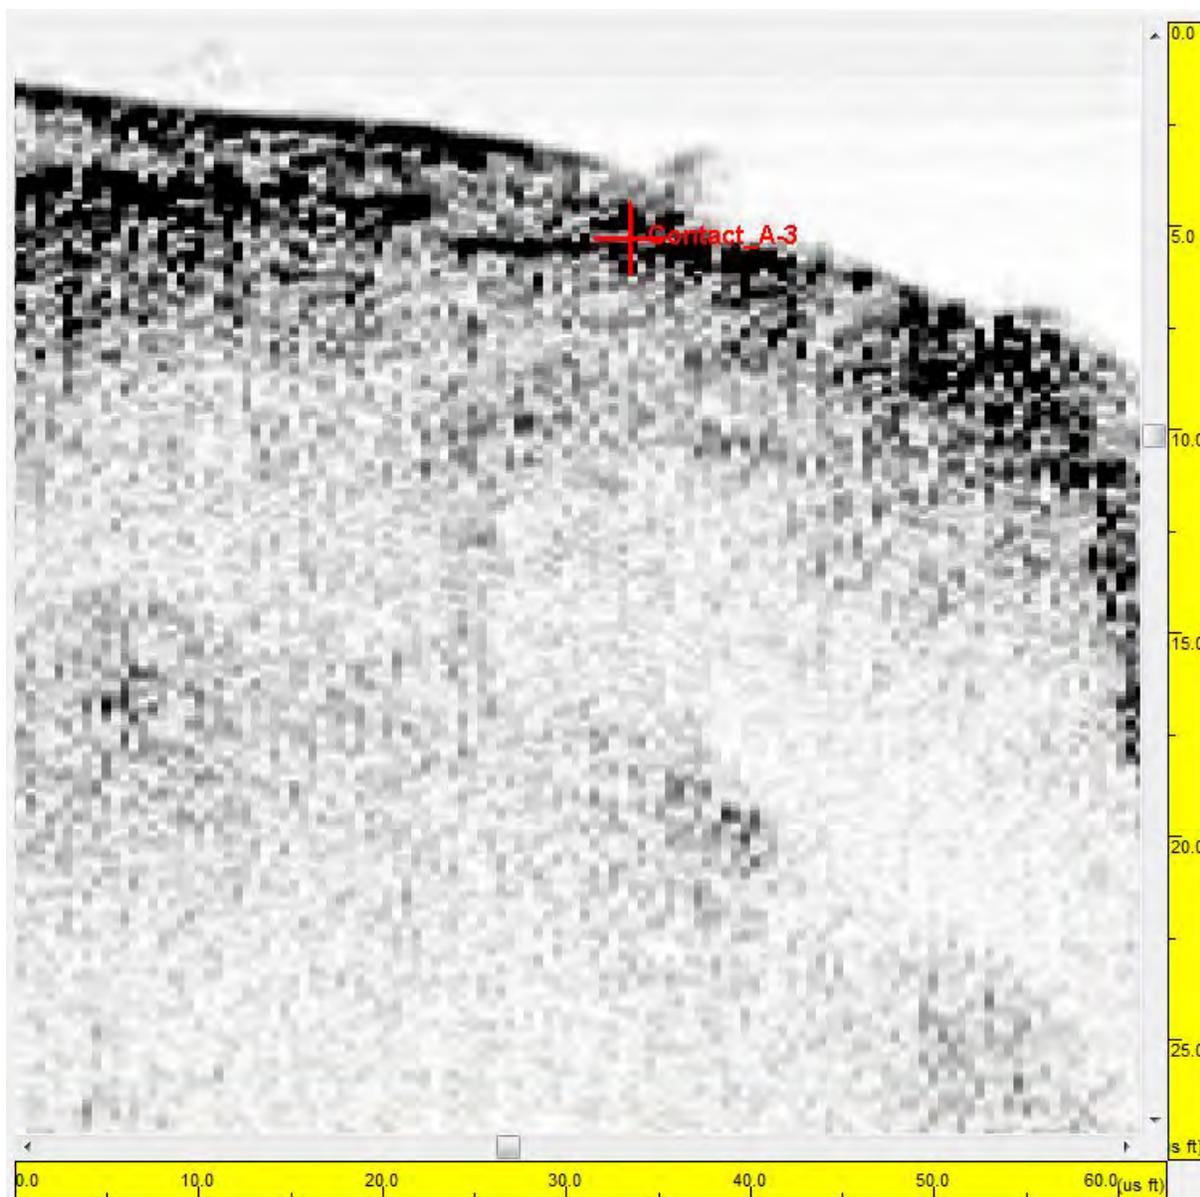
Contact_A-3

- Sonar Time at Target: 10/12/2017 11:50:16.565
 - Click Position (Lat/Lon Coordinates)
41.6525632722 -70.9193513752 (WGS84)
 - Click Position (Projected Coordinates)
(X) 814854.31 (Y) 2698959.95
 - Map Proj: MA83F
 - Acoustic Source File: E:\projects\2017_NBH_Wreck-3\SB\raw\SonarData.001.jsf
 - Ping Number: 854
 - Range to Target: 5.31 US Feet
 - Fish Height: 0.00 US Feet
 - Heading: 0.000 degrees
 - Event Number: 0
 - Water Depth: 0.00
 - Line Name: SonarData.001
- Target Height: = 0.00 US Feet
Target Length: 0.00 US Feet
Target Shadow: 0.00 US Feet
Target Width: 27.38 US Feet
Classification 1: debris

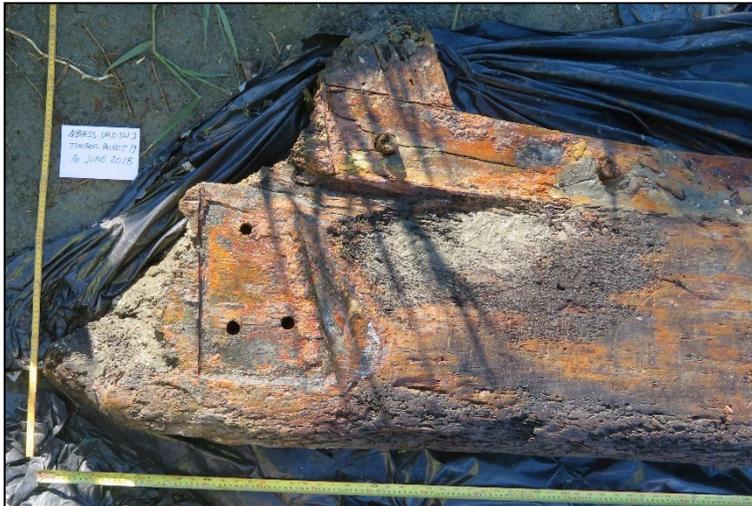
**TIMBER PACKET 19
(aft keel section)**

AFT KEEL SECTION

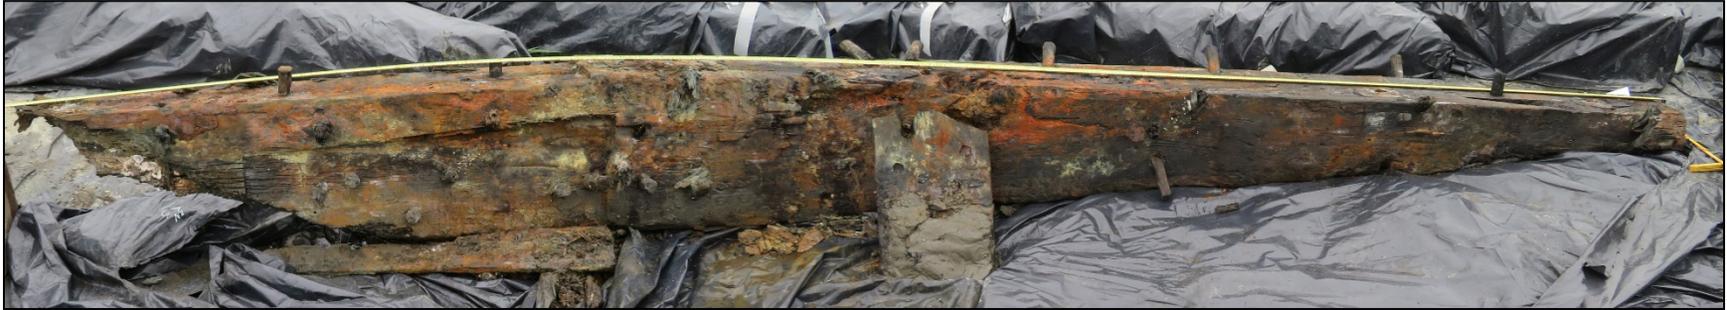
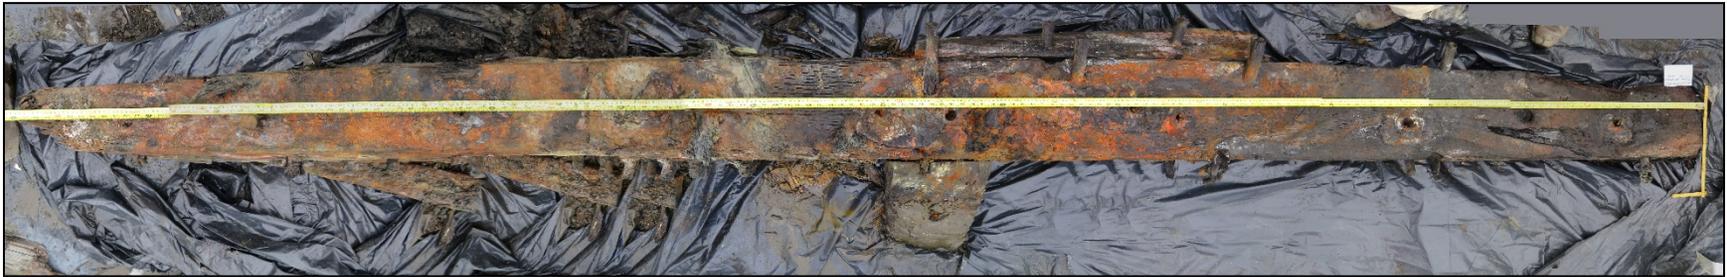
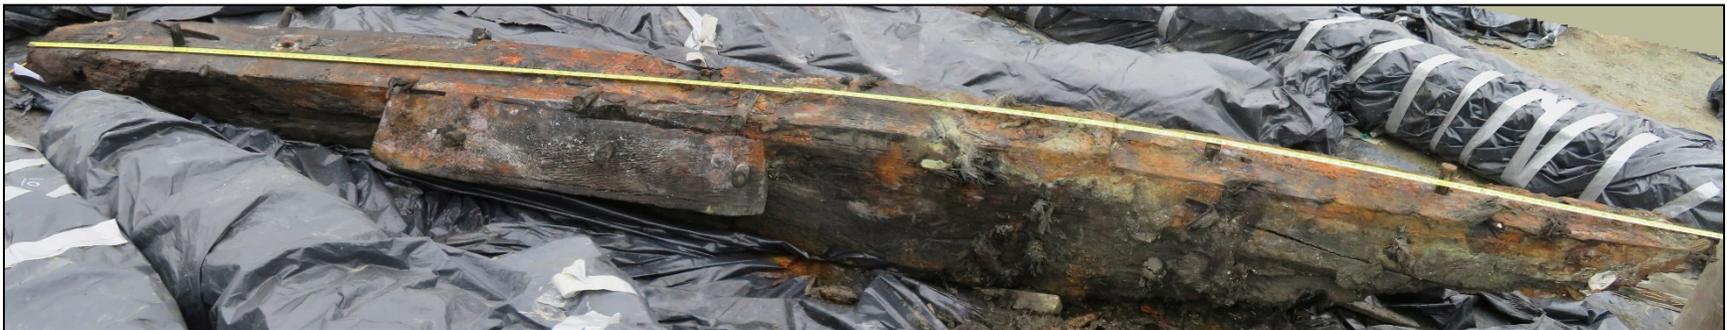
TIMBER PACKET 23
(aft deadwood)

AFT DEADWOOD
