New Bedford Harbor Superfund Site
U.S. Army Corps of Engineers New England District
Final North Street Saltmarsh After Action Report
ACE-J23-35BG2000-M17-0043
November 2018

Project No: 35BG2000
Document Title: Final North Street Saltmarsh After Action Report
Document No.: ACE-J23-35BG2000-M17-0043
Revision:
Date: November 2018
Client Name: U.S. Army Corps of Engineers New England District
Project Manager: Beth Anderson
Author: Mike Morris

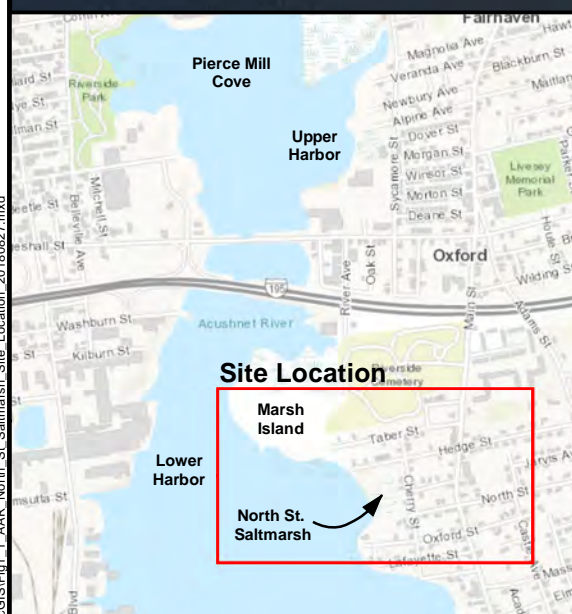
Figure 1-1

Remediation and restoration of the North Street Saltmarsh (NSSM) intertidal zone were conducted by Jacobs Engineering Group (Jacobs) under U.S. Army Corps of Engineers – New England District (NAE) Interim Remediation Action Contract No. W912WJ-14-D-0002 between May 7, 2018 and July 25, 2018. The primary objective of remedial action at NSSM was to remove soil and sediment with polychlorinated biphenyl (PCB) levels greater than the site-specific target cleanup levels (TCLs) as established in the *1998 Record of Decision (ROD) for the New Bedford Harbor Superfund Site* (U.S. Environmental Protection Agency [EPA] 1998), and to restore the site to baseline or comparable conditions. Although the North Street Saltmarsh is unlikely to be developed as a residential property due to the various wetland protection statutes and regulations, it is also directly adjacent to over a dozen existing residential homes in close proximity. In light of that setting, EPA determined that the TCL for the cleanup would be that for residential areas in the 1998 Record of Decision. The TCL used for the NSSM site was the 1 milligram per kilogram (mg/kg) level for intertidal sediment and soil in residential areas, including fringe saltmarshes bordering homes, for the 0 to 1-foot (ft.) depth interval below ground surface (bgs). Compliance was reached based on the 95% upper confidence limit (UCL) of the mean as described in the ROD for dermal exposure. Details are included in Section 2.3. NSSM is located on the eastern side of New Bedford Harbor extending from residential areas and Hedge Street to the north, residential property to the south, residential properties and Cherry Street to the east, and the Harbor to the west ([Figure 1-1](#)).

North Street Saltmarsh
Site Location and Pre-Excavation Features

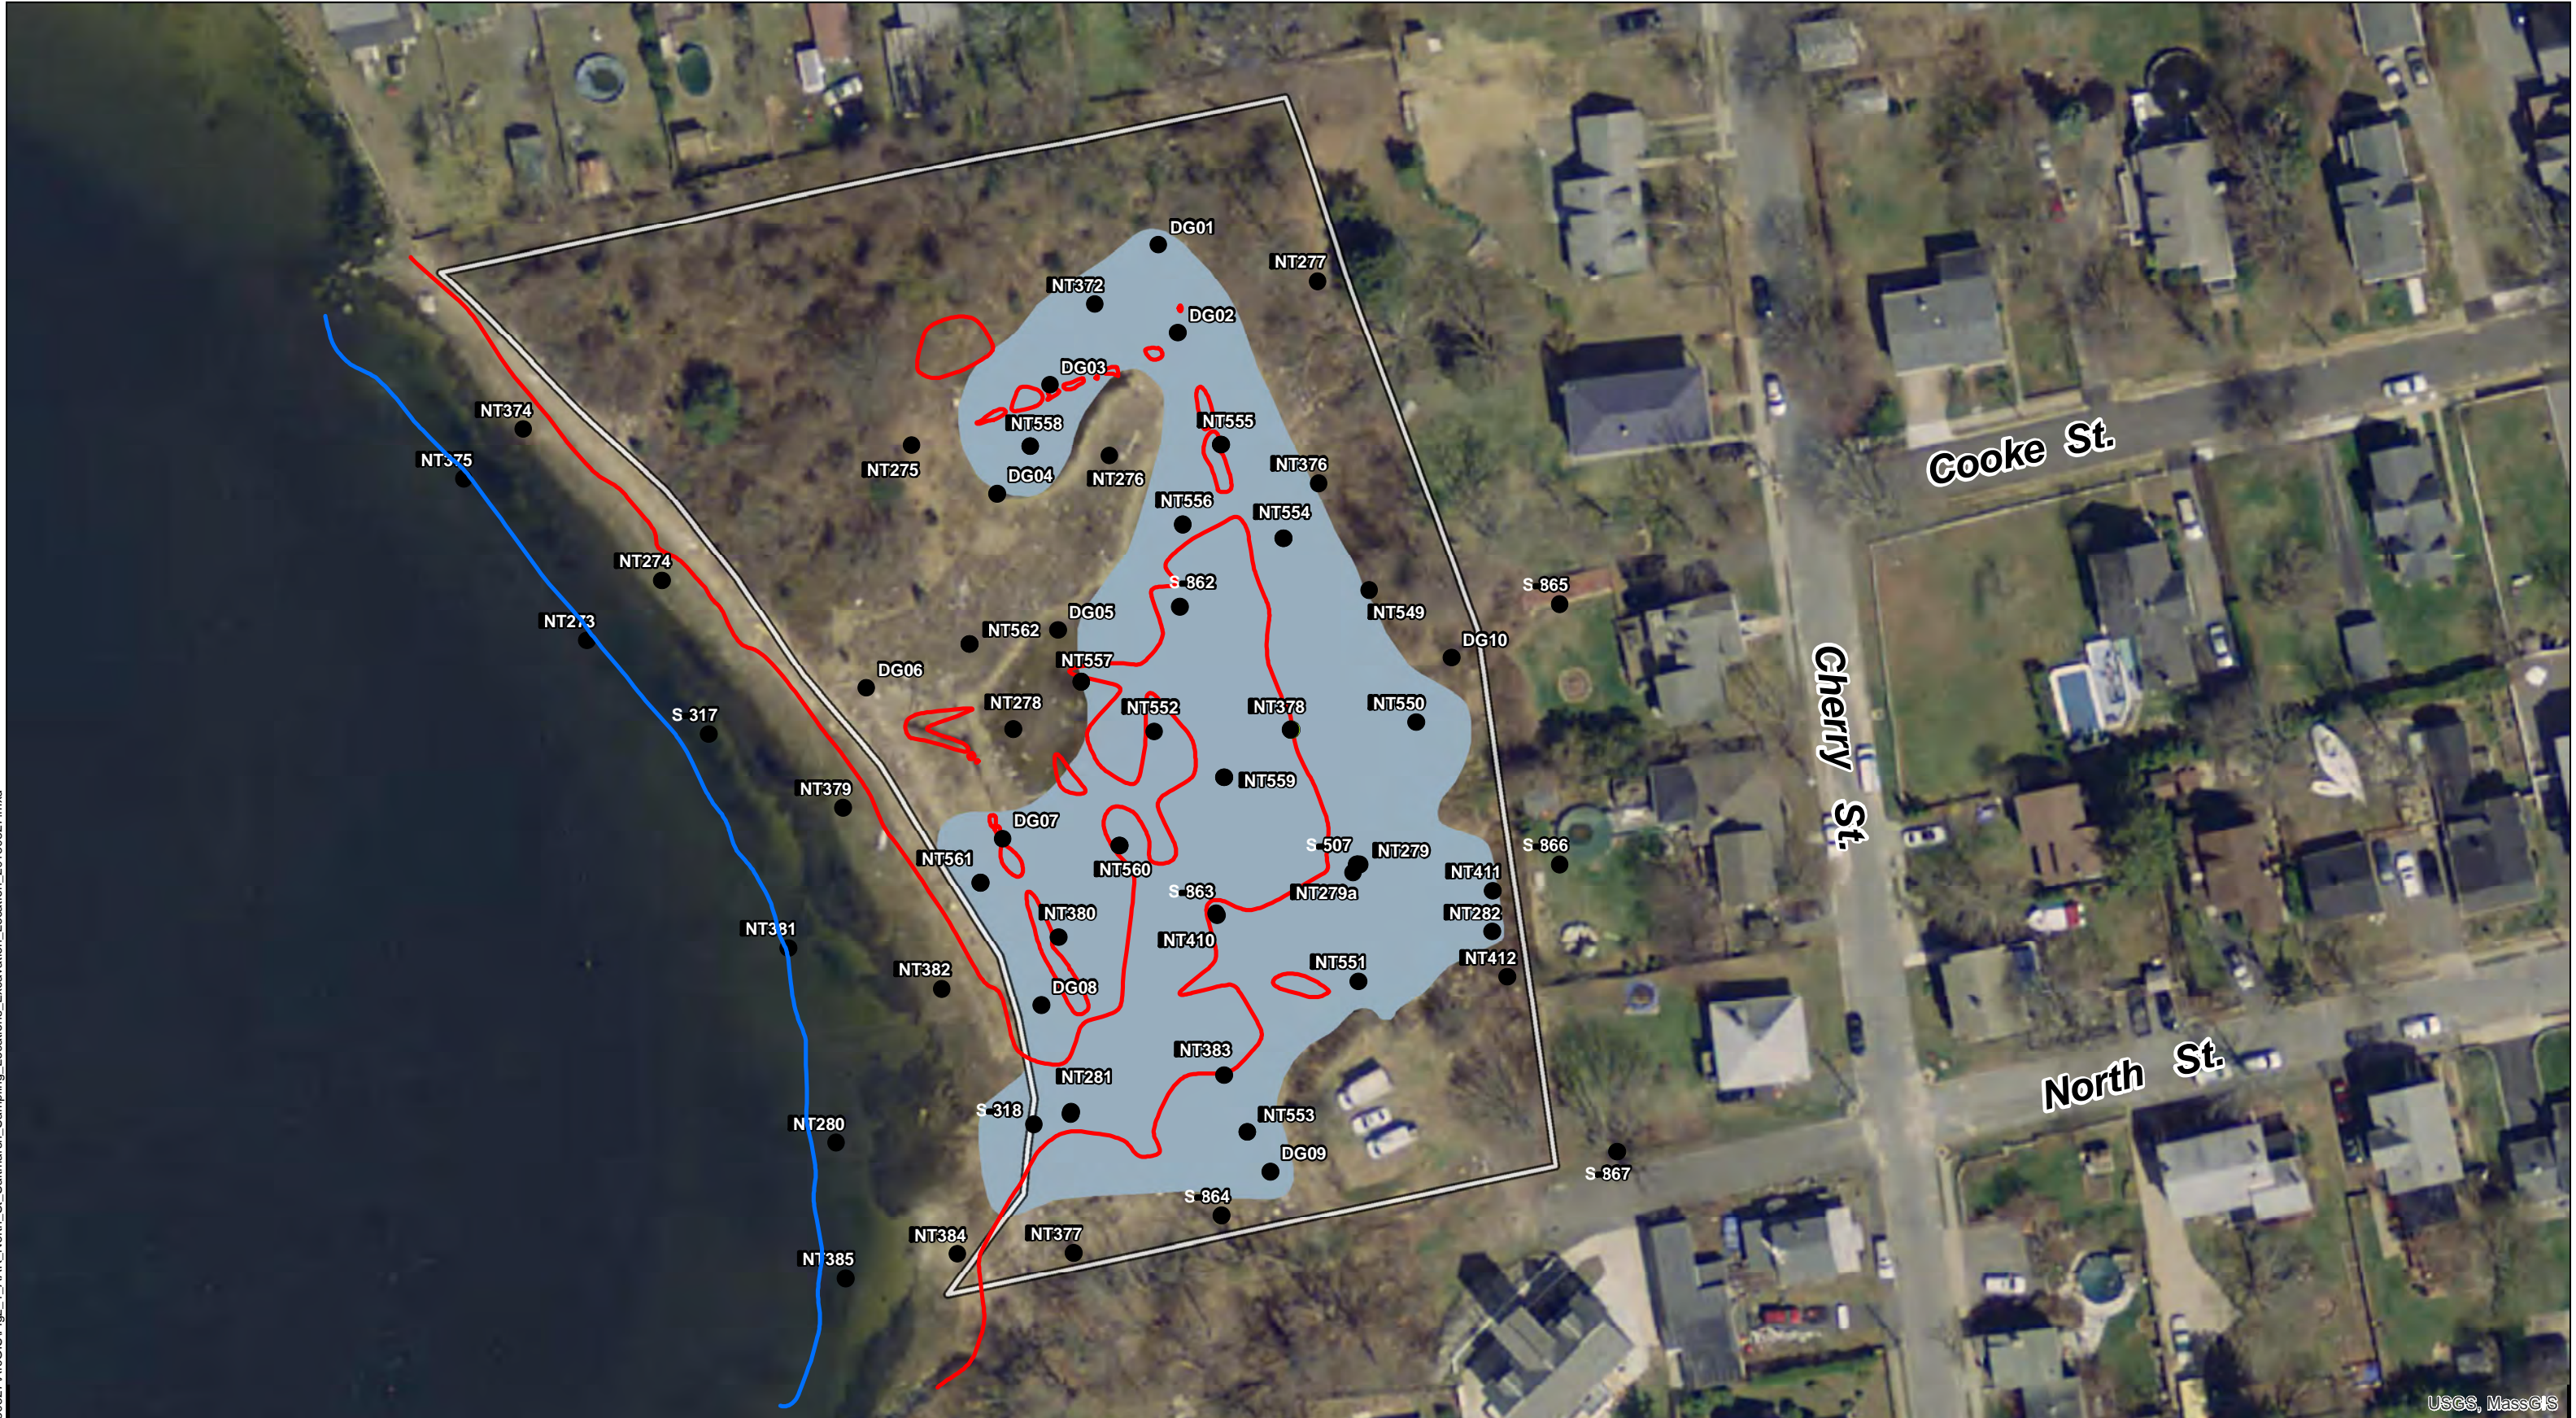
Figure 2-1

Sampling of sediment and soil from the subtidal, intertidal, and vegetated areas around NSSM was conducted between 1999 and 2008, which provided the horizontal and vertical boundaries for PCB-contaminated sediment excavation. [Figure 2-1](#) and [Table 2-1](#) present the pre-excavation sampling locations and PCB concentrations in sediments for the NSSM intertidal zone. Additional grid-based sediment and soil sampling was performed in 2017, as discussed below in Section 2.3.

North Street Saltmarsh Pre-Excavation Contaminant Boundary

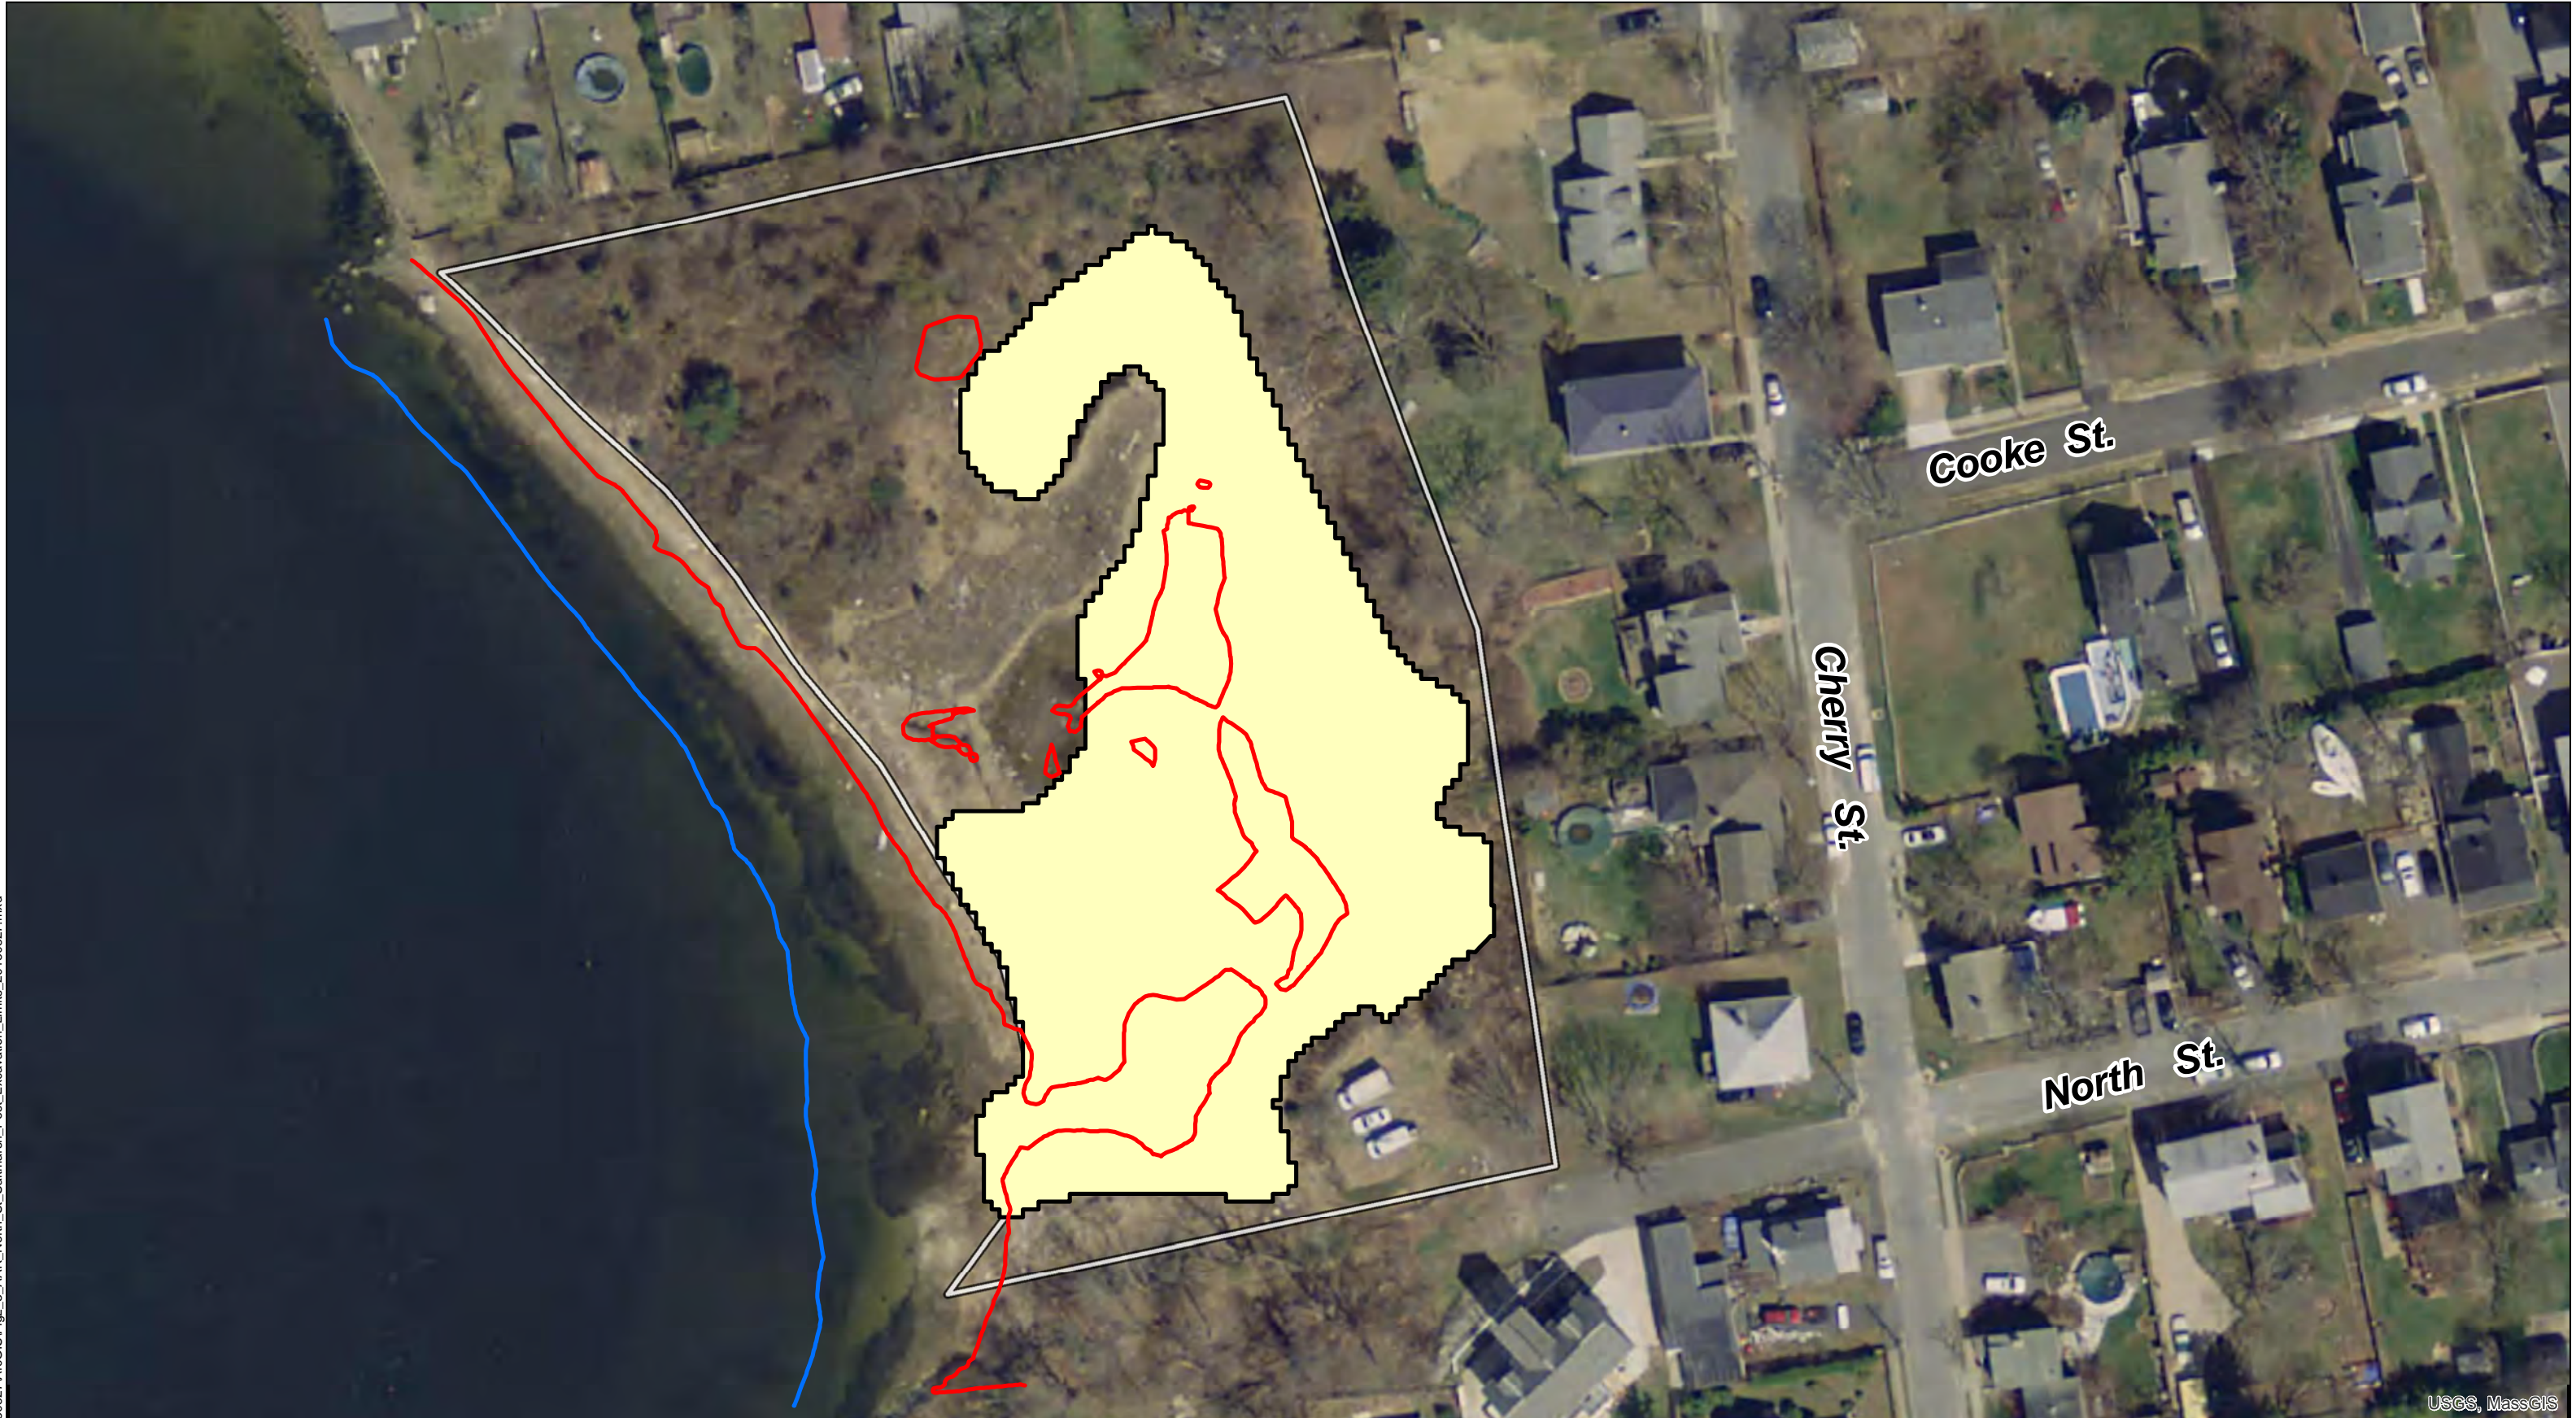
Figure 2-3

An estimated total of 1,987.4 cubic yards (cy) of contaminated sediments was removed from the NSSM intertidal zone during field activities based on estimates derived from the pre-excavation and post-excavation survey data. The limits of excavation are presented on [Figure 2-3](#).

**North Street Saltmarsh
Post-Excavation Limits**

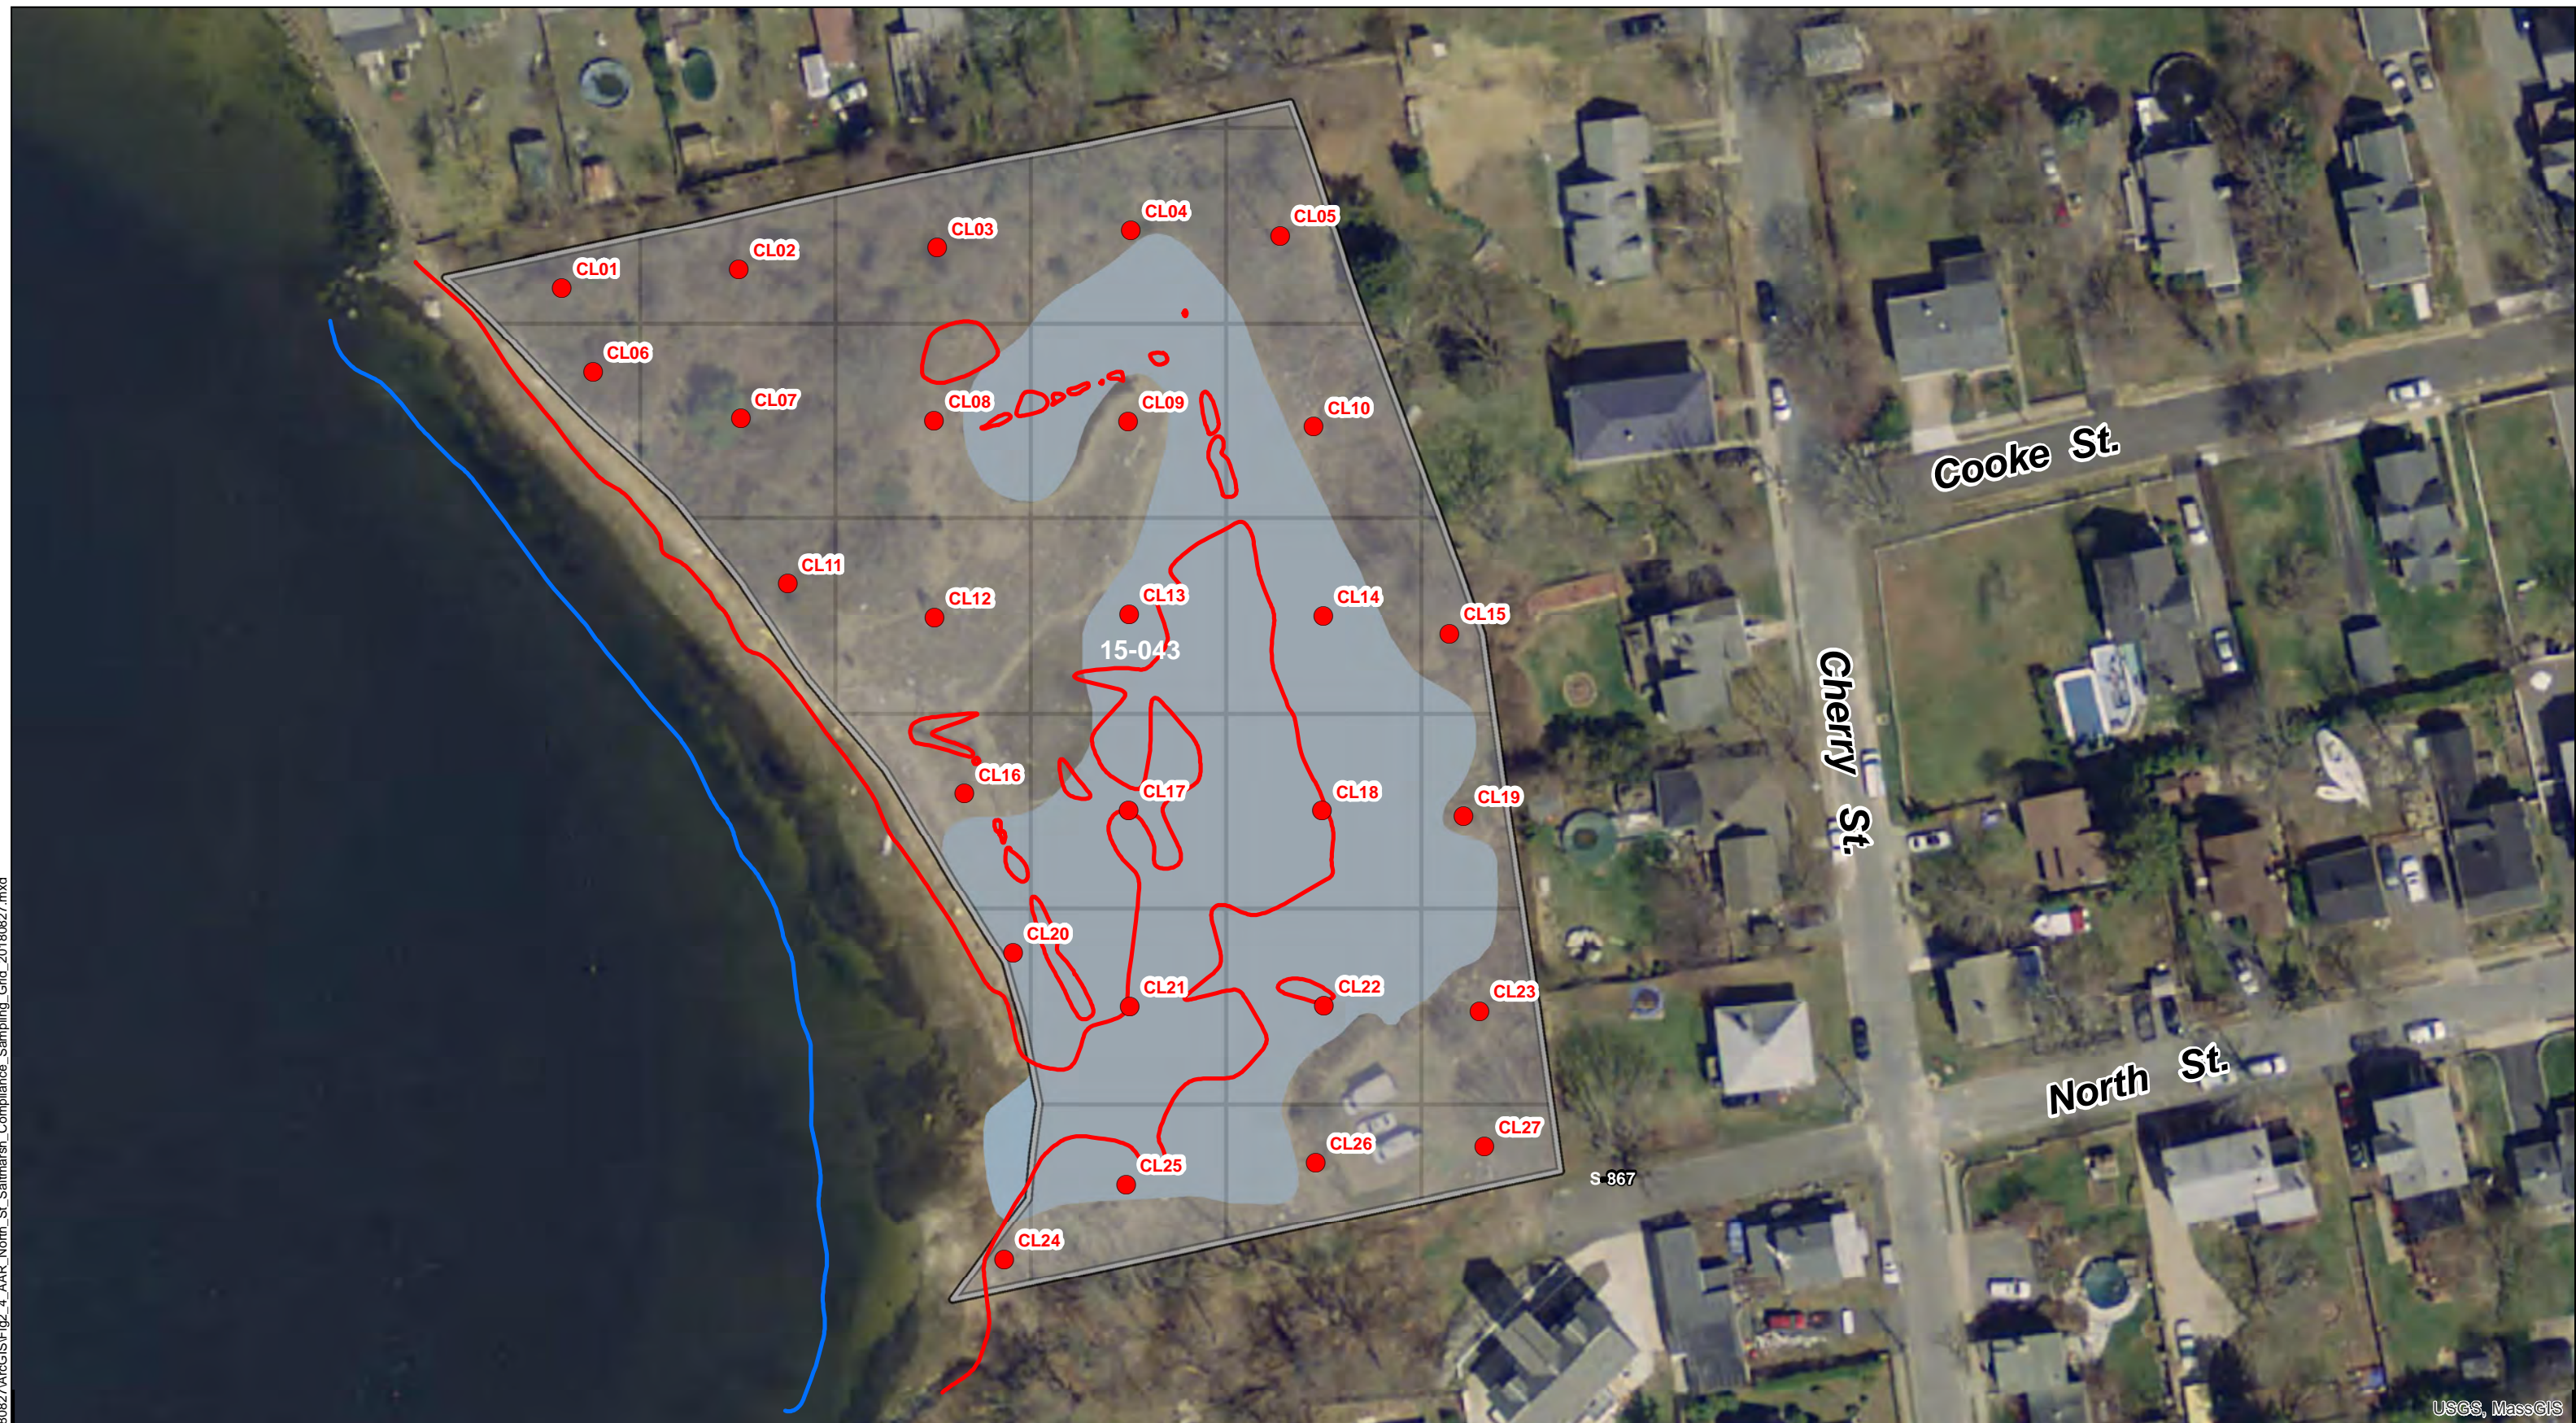
Figure 2-4

To assess residential dermal exposure to intertidal soils and sediments, a 95% UCL of the mean was calculated for the final remediated and restored condition of the top foot of the entire NSSM intertidal zone (i.e., remediated areas as well as areas not requiring remediation) ([Figure 2-4](#)). For this evaluation, the previous PCB data collected from the 0 to 1-ft. depth interval was used for grid locations outside the excavation zone. Samples located within the excavation zone, which were backfilled with clean material, were assigned a PCB concentration of 0.01 mg/kg because the clean fill would occupy the top 1.0 ft. of the soil column within the excavation zone ([Table 2-2](#)). Per the ROD, a 95% UCL compliance calculation was performed on the proposed final remediated and restored condition of the top foot of the entire NSSM intertidal zone to ensure PCB concentrations were below the residential TCL of 1.0 mg/kg. Because the material within the excavation footprint was replaced with clean backfill, a value slightly above zero (0.01 mg/kg) was used in the calculations to represent PCB concentration in the excavated area. This 95% UCL is calculated to be 1.0 mg/kg, as detailed further in [Attachment 1](#).

**North Street Saltmarsh Compliance
Sampling Grid for 95% UCL Calculations**

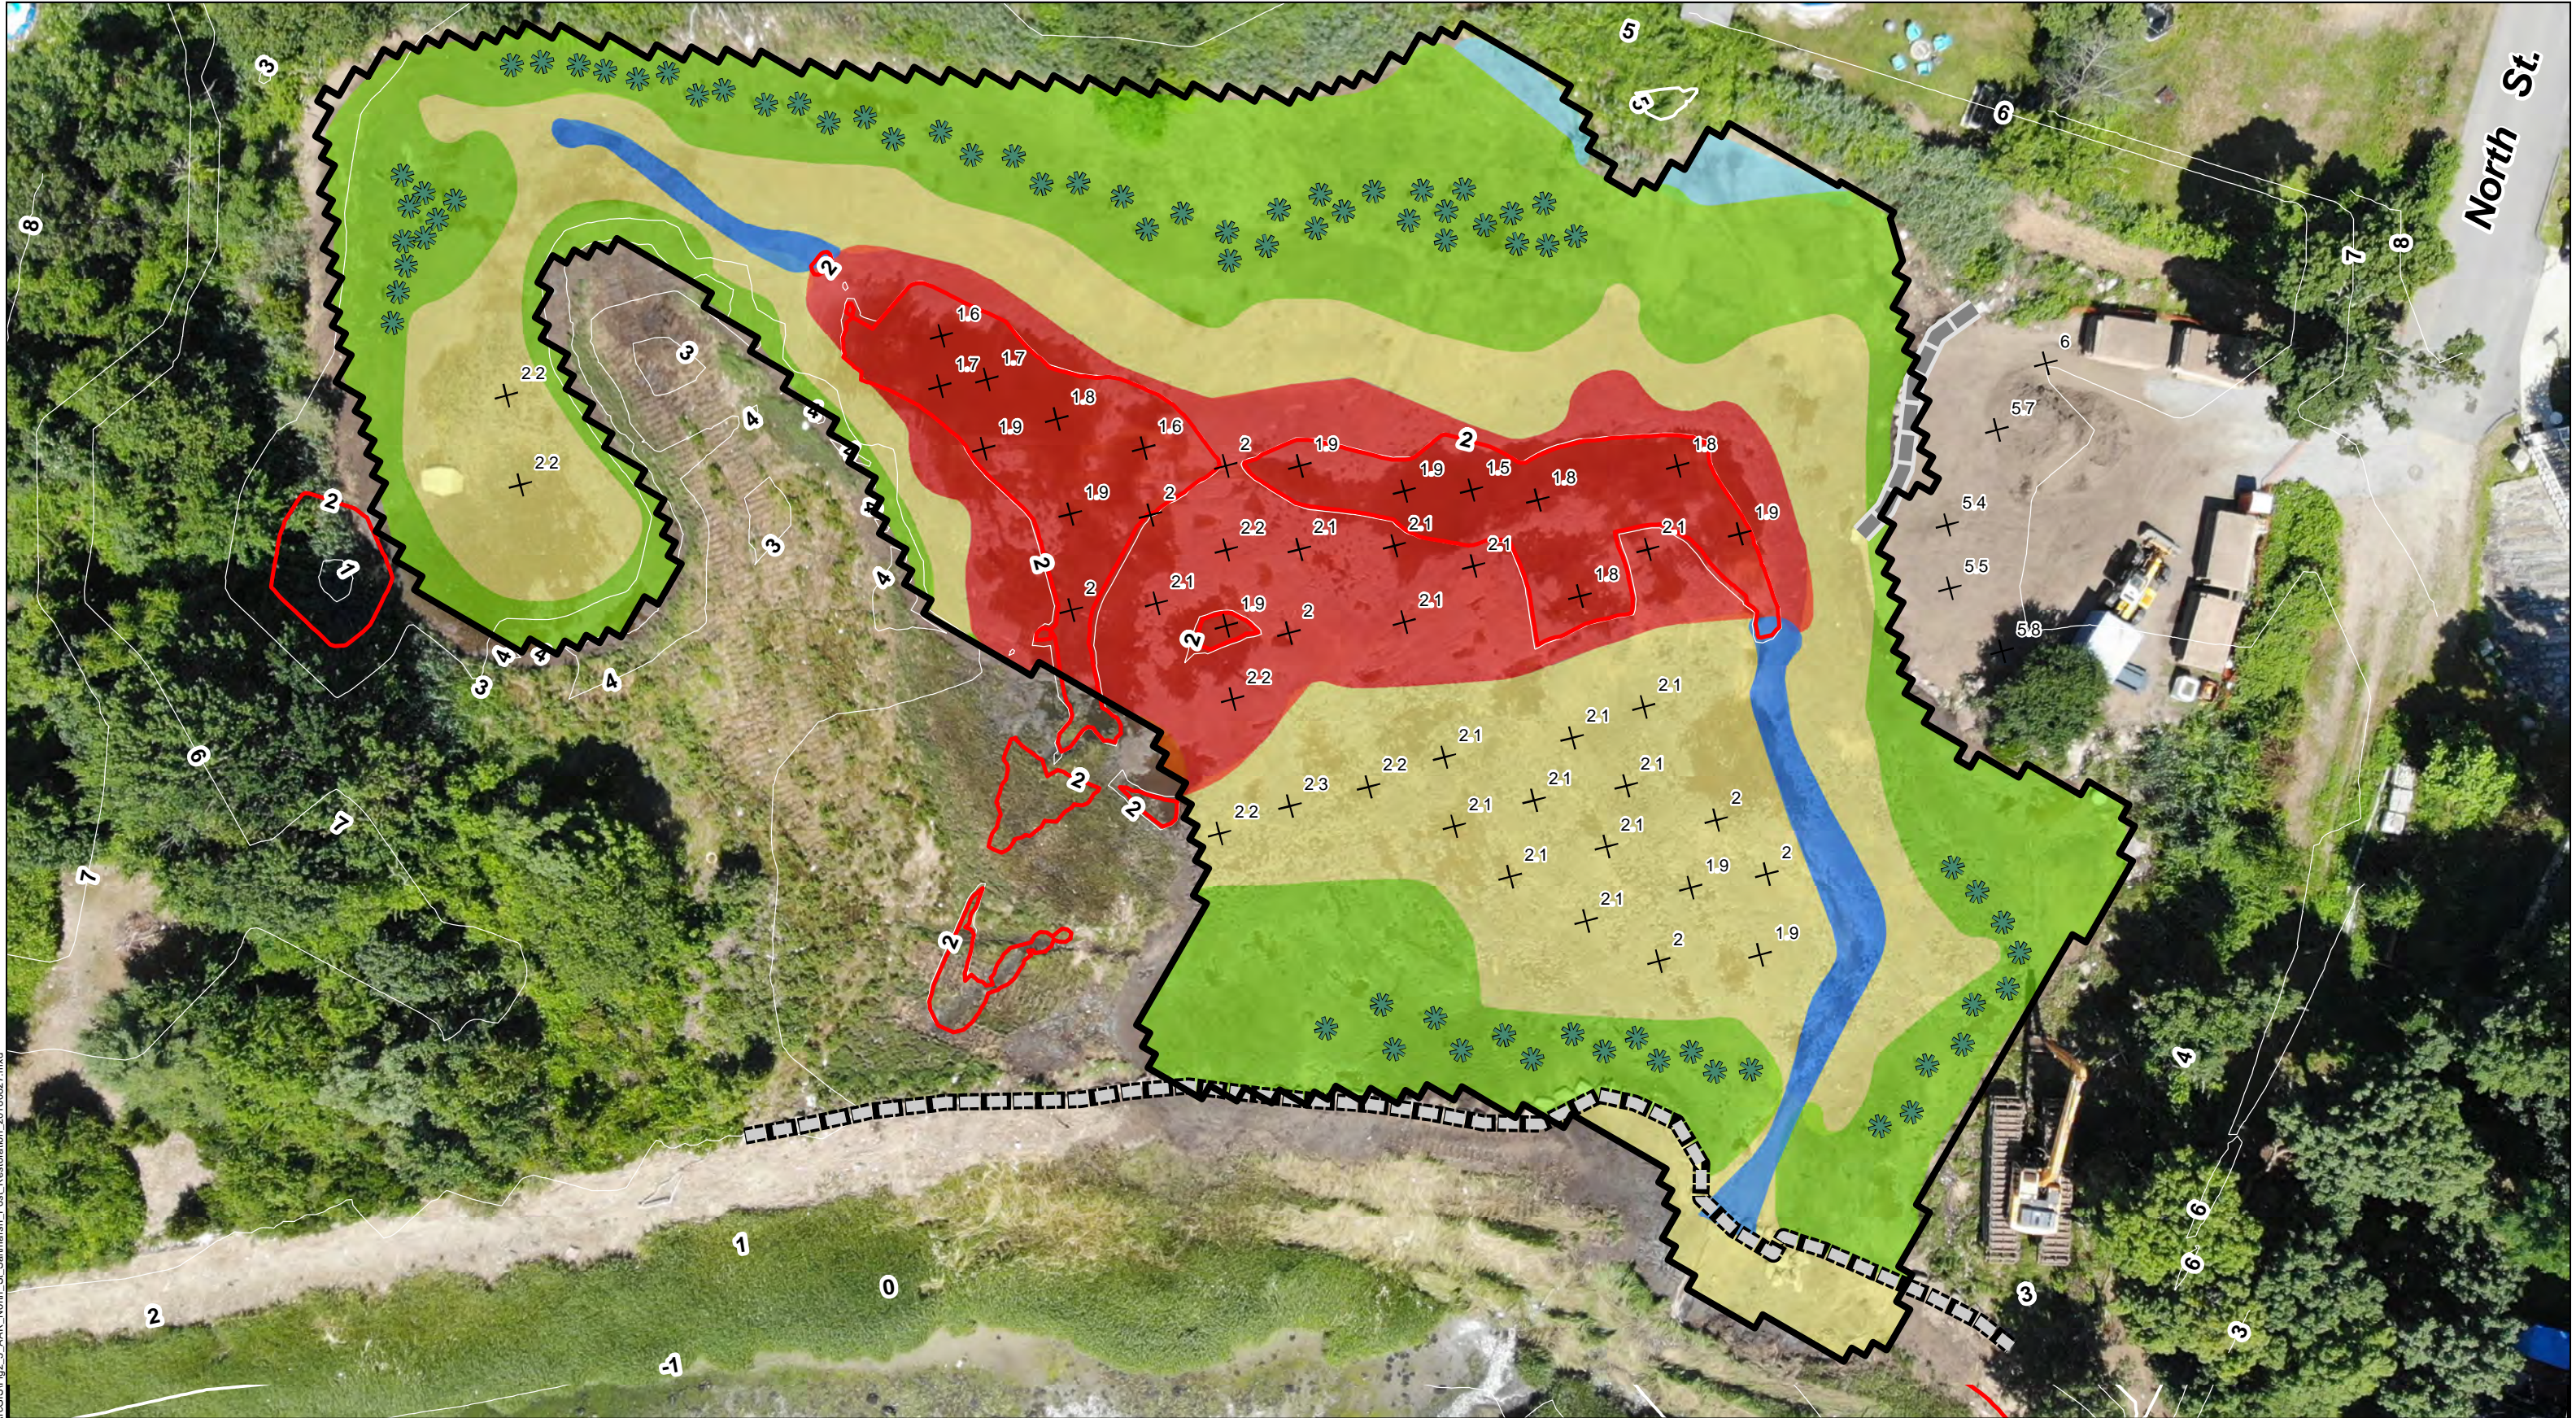
Figure 2-5

The plant community composition at the Site was restored on an approximate 1:1 basis, as compared to a pre-excavation survey (Work Plan Figure 6-1). A post-excavation wetlands cover map is presented in [Figure 2-5](#).

**North Street Saltmarsh
Post-Excavation Restoration**
