New Bedford Harbor Superfund Site

Draft Final Intertidal Work Plan for East Zone 5

ACE-J23-35BG6000-M1-0056|0

March 2020

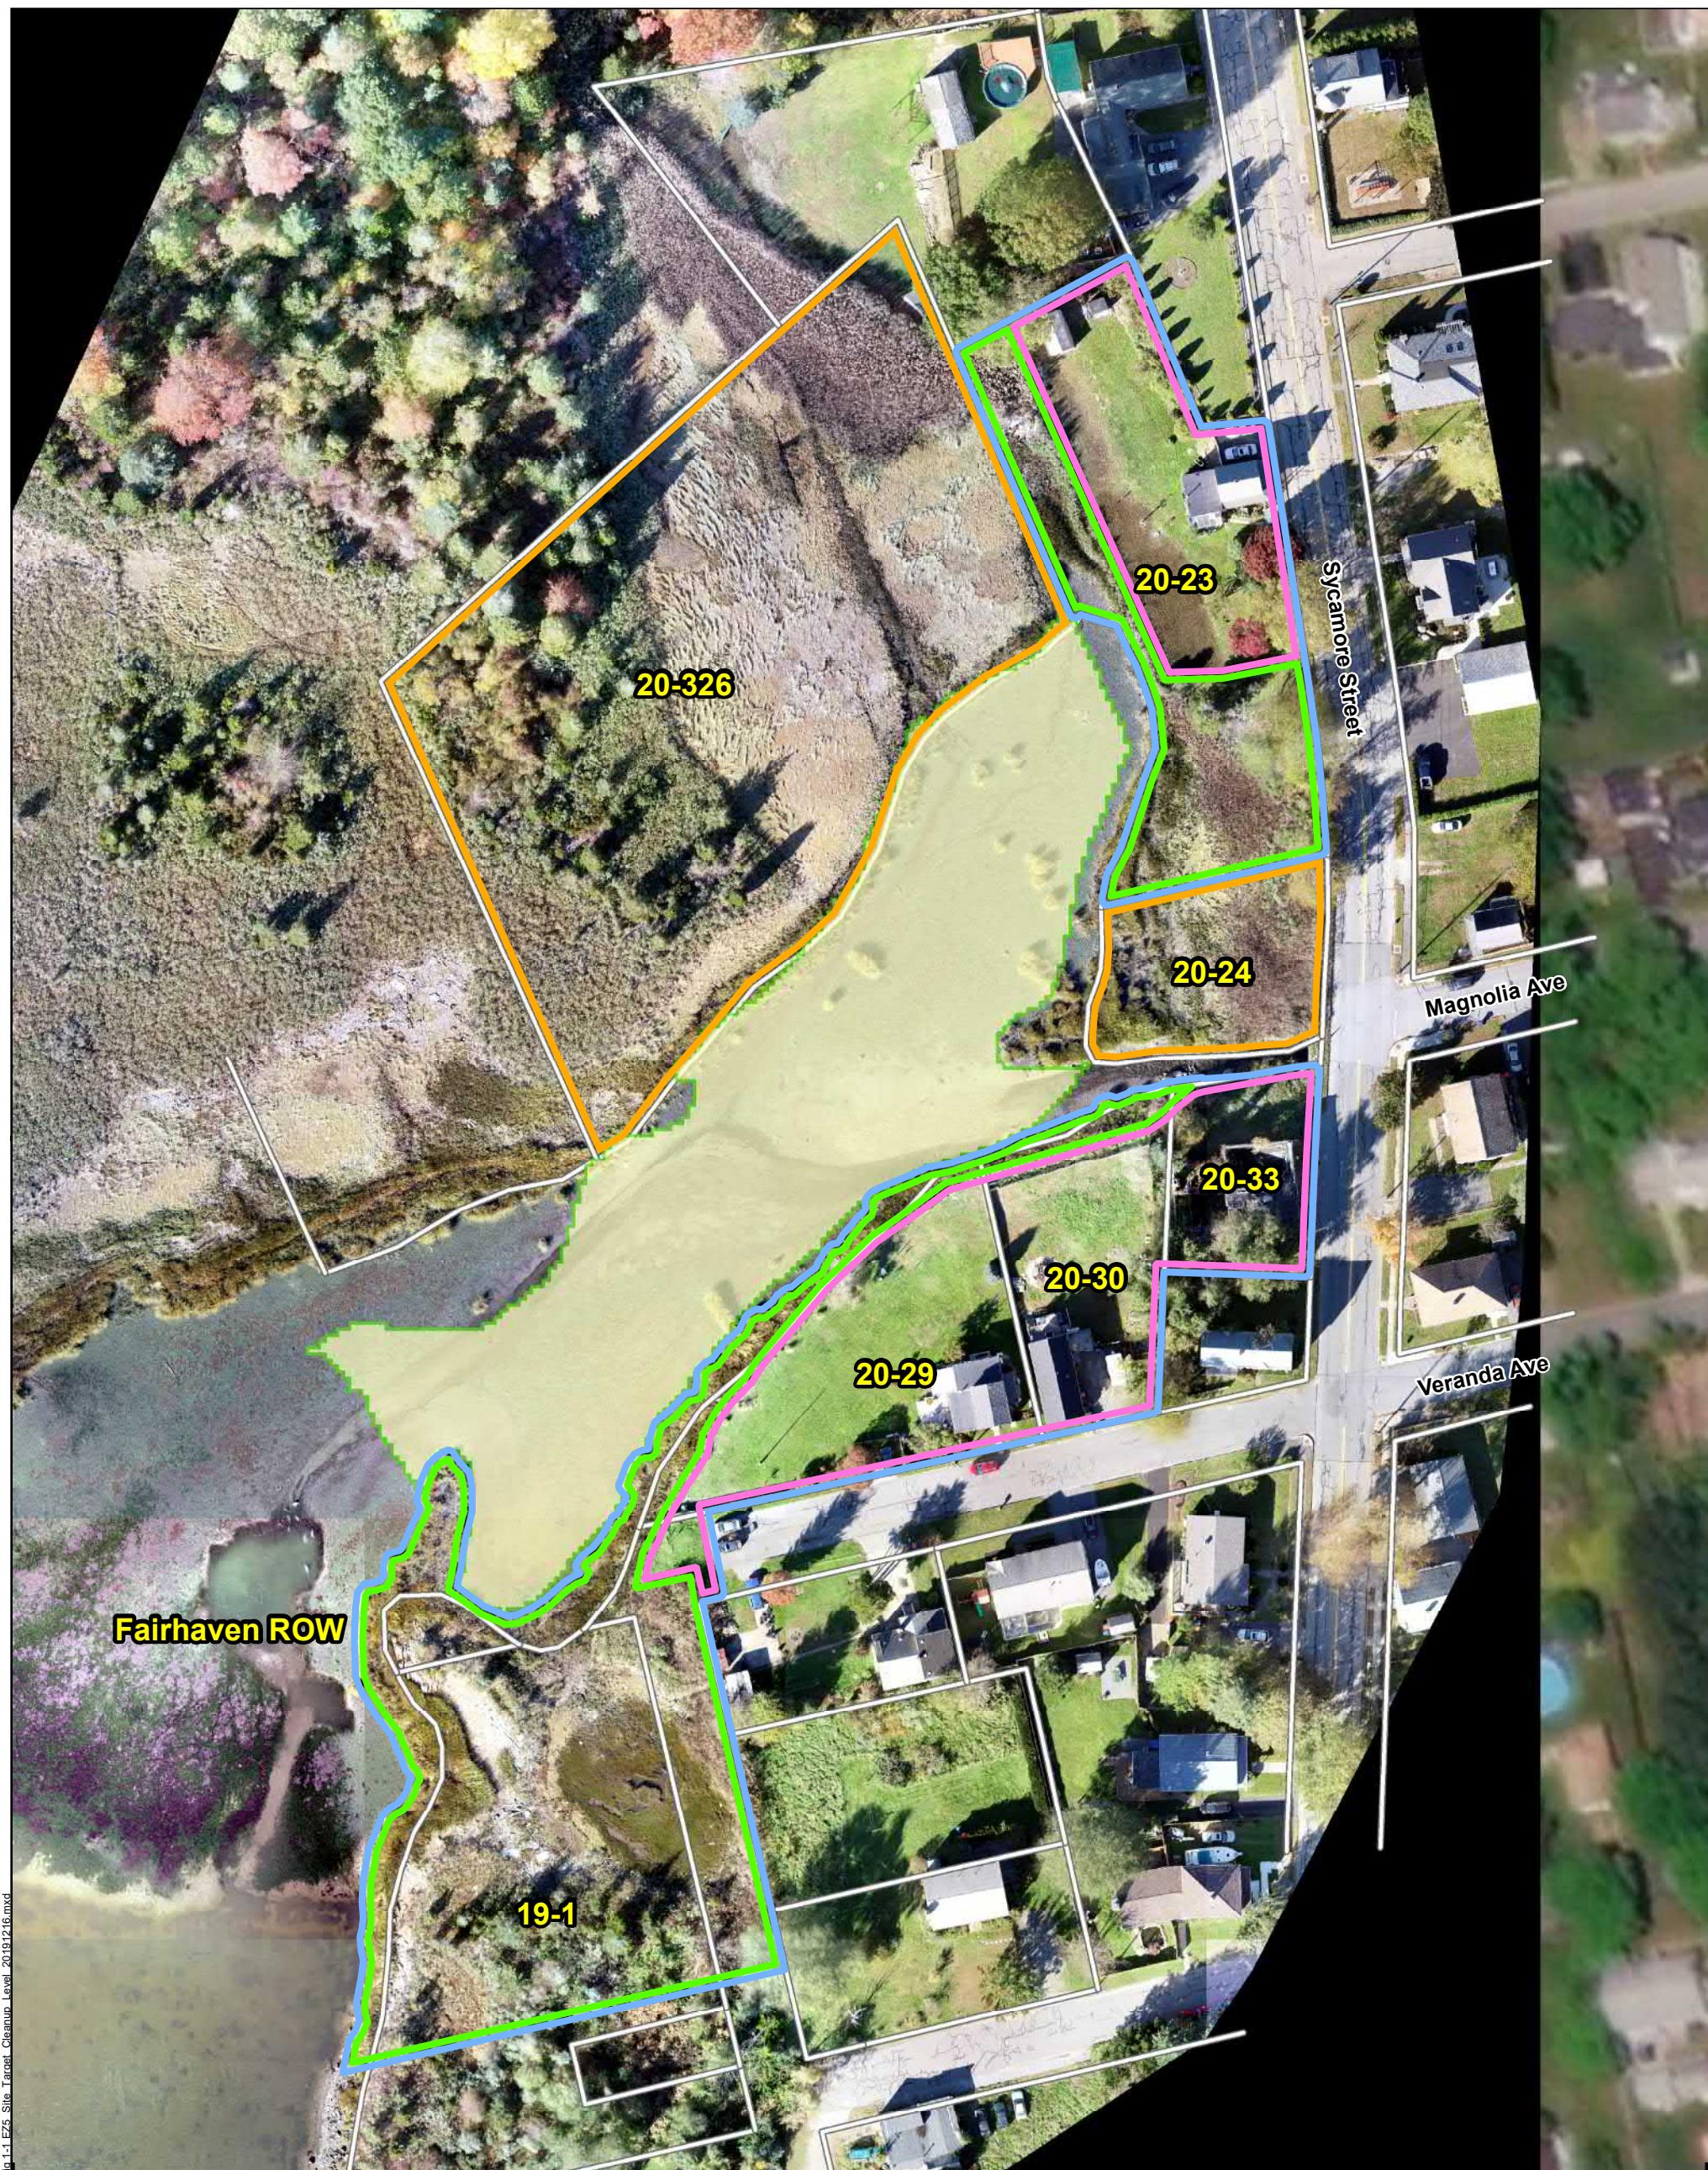
Figure 1-1

As described herein, certain areas of the sediment and soil on the parcels contain PCB contamination that exceeds the established target cleanup levels (TCLs) for intertidal sediment. The PCB TCLs are provided in the 1998 U.S. Environmental Protection Agency (EPA) Record of Decision (ROD) for the NBHSS (EPA 1998). The TCLs for the top 1 foot (ft) of intertidal sediment in East Zone 5 are as follows ([Figure 1-1](#)):

- 1 milligram per kilogram (mg/kg) PCB in residential areas, including fringe saltmarshes bordering homes in Veranda inlet in Fairhaven (95% upper confidence limit (UCL) of the average).
- 10 mg/kg in intertidal mudflats (average).
- 25 mg/kg in intertidal areas prone to recreation/beach combing (95% UCL of the average).

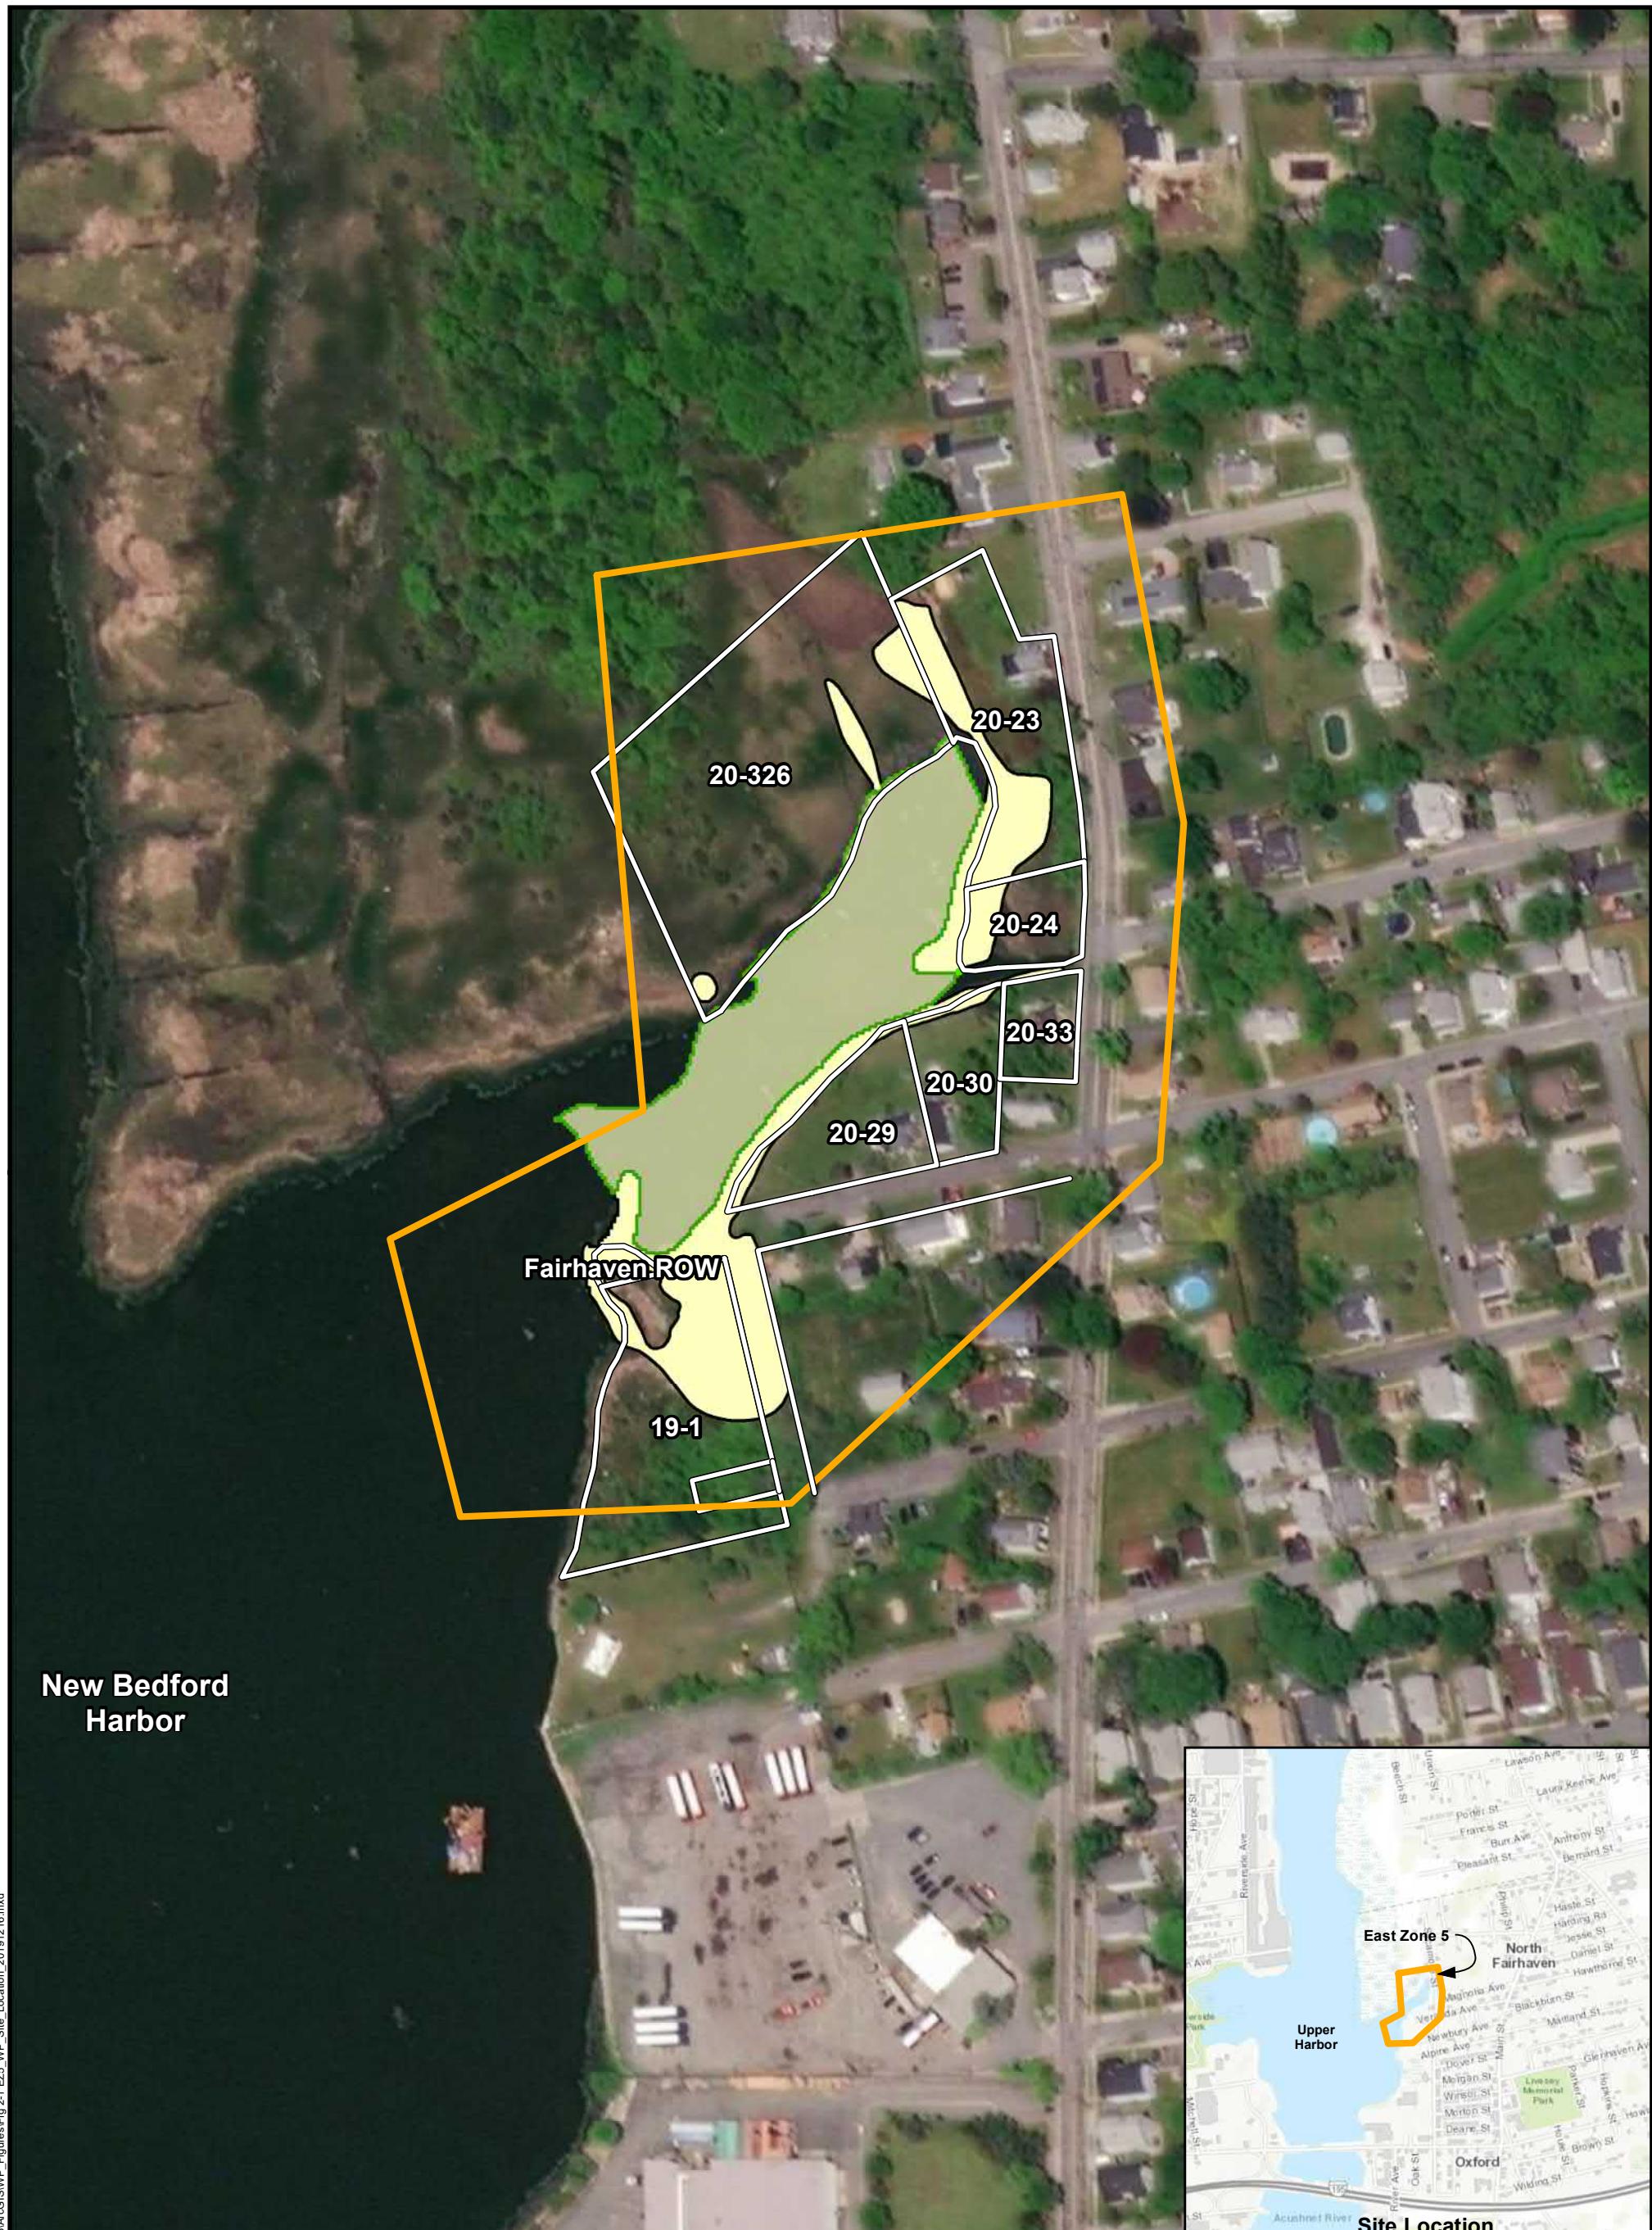
Figure 2-1

The intertidal management area referred to as East Zone 5 is located on the eastern shore of the Upper New Bedford Harbor in Fairhaven, MA. East Zone 5 consists of two parcels (20-326 and 20-23) and five groups of parcels that were each assigned a single parcel number for reference in this work plan (20-24, 20-33, 20-30, 20-29, and 19-1). Portions of each parcel or group of parcels will be remediated. A site location map showing the East Zone 5 parcels and the limits of the planned excavations is provided in [Figure 2-1](#).

Intertidal East Zone 5 Site Location and Features

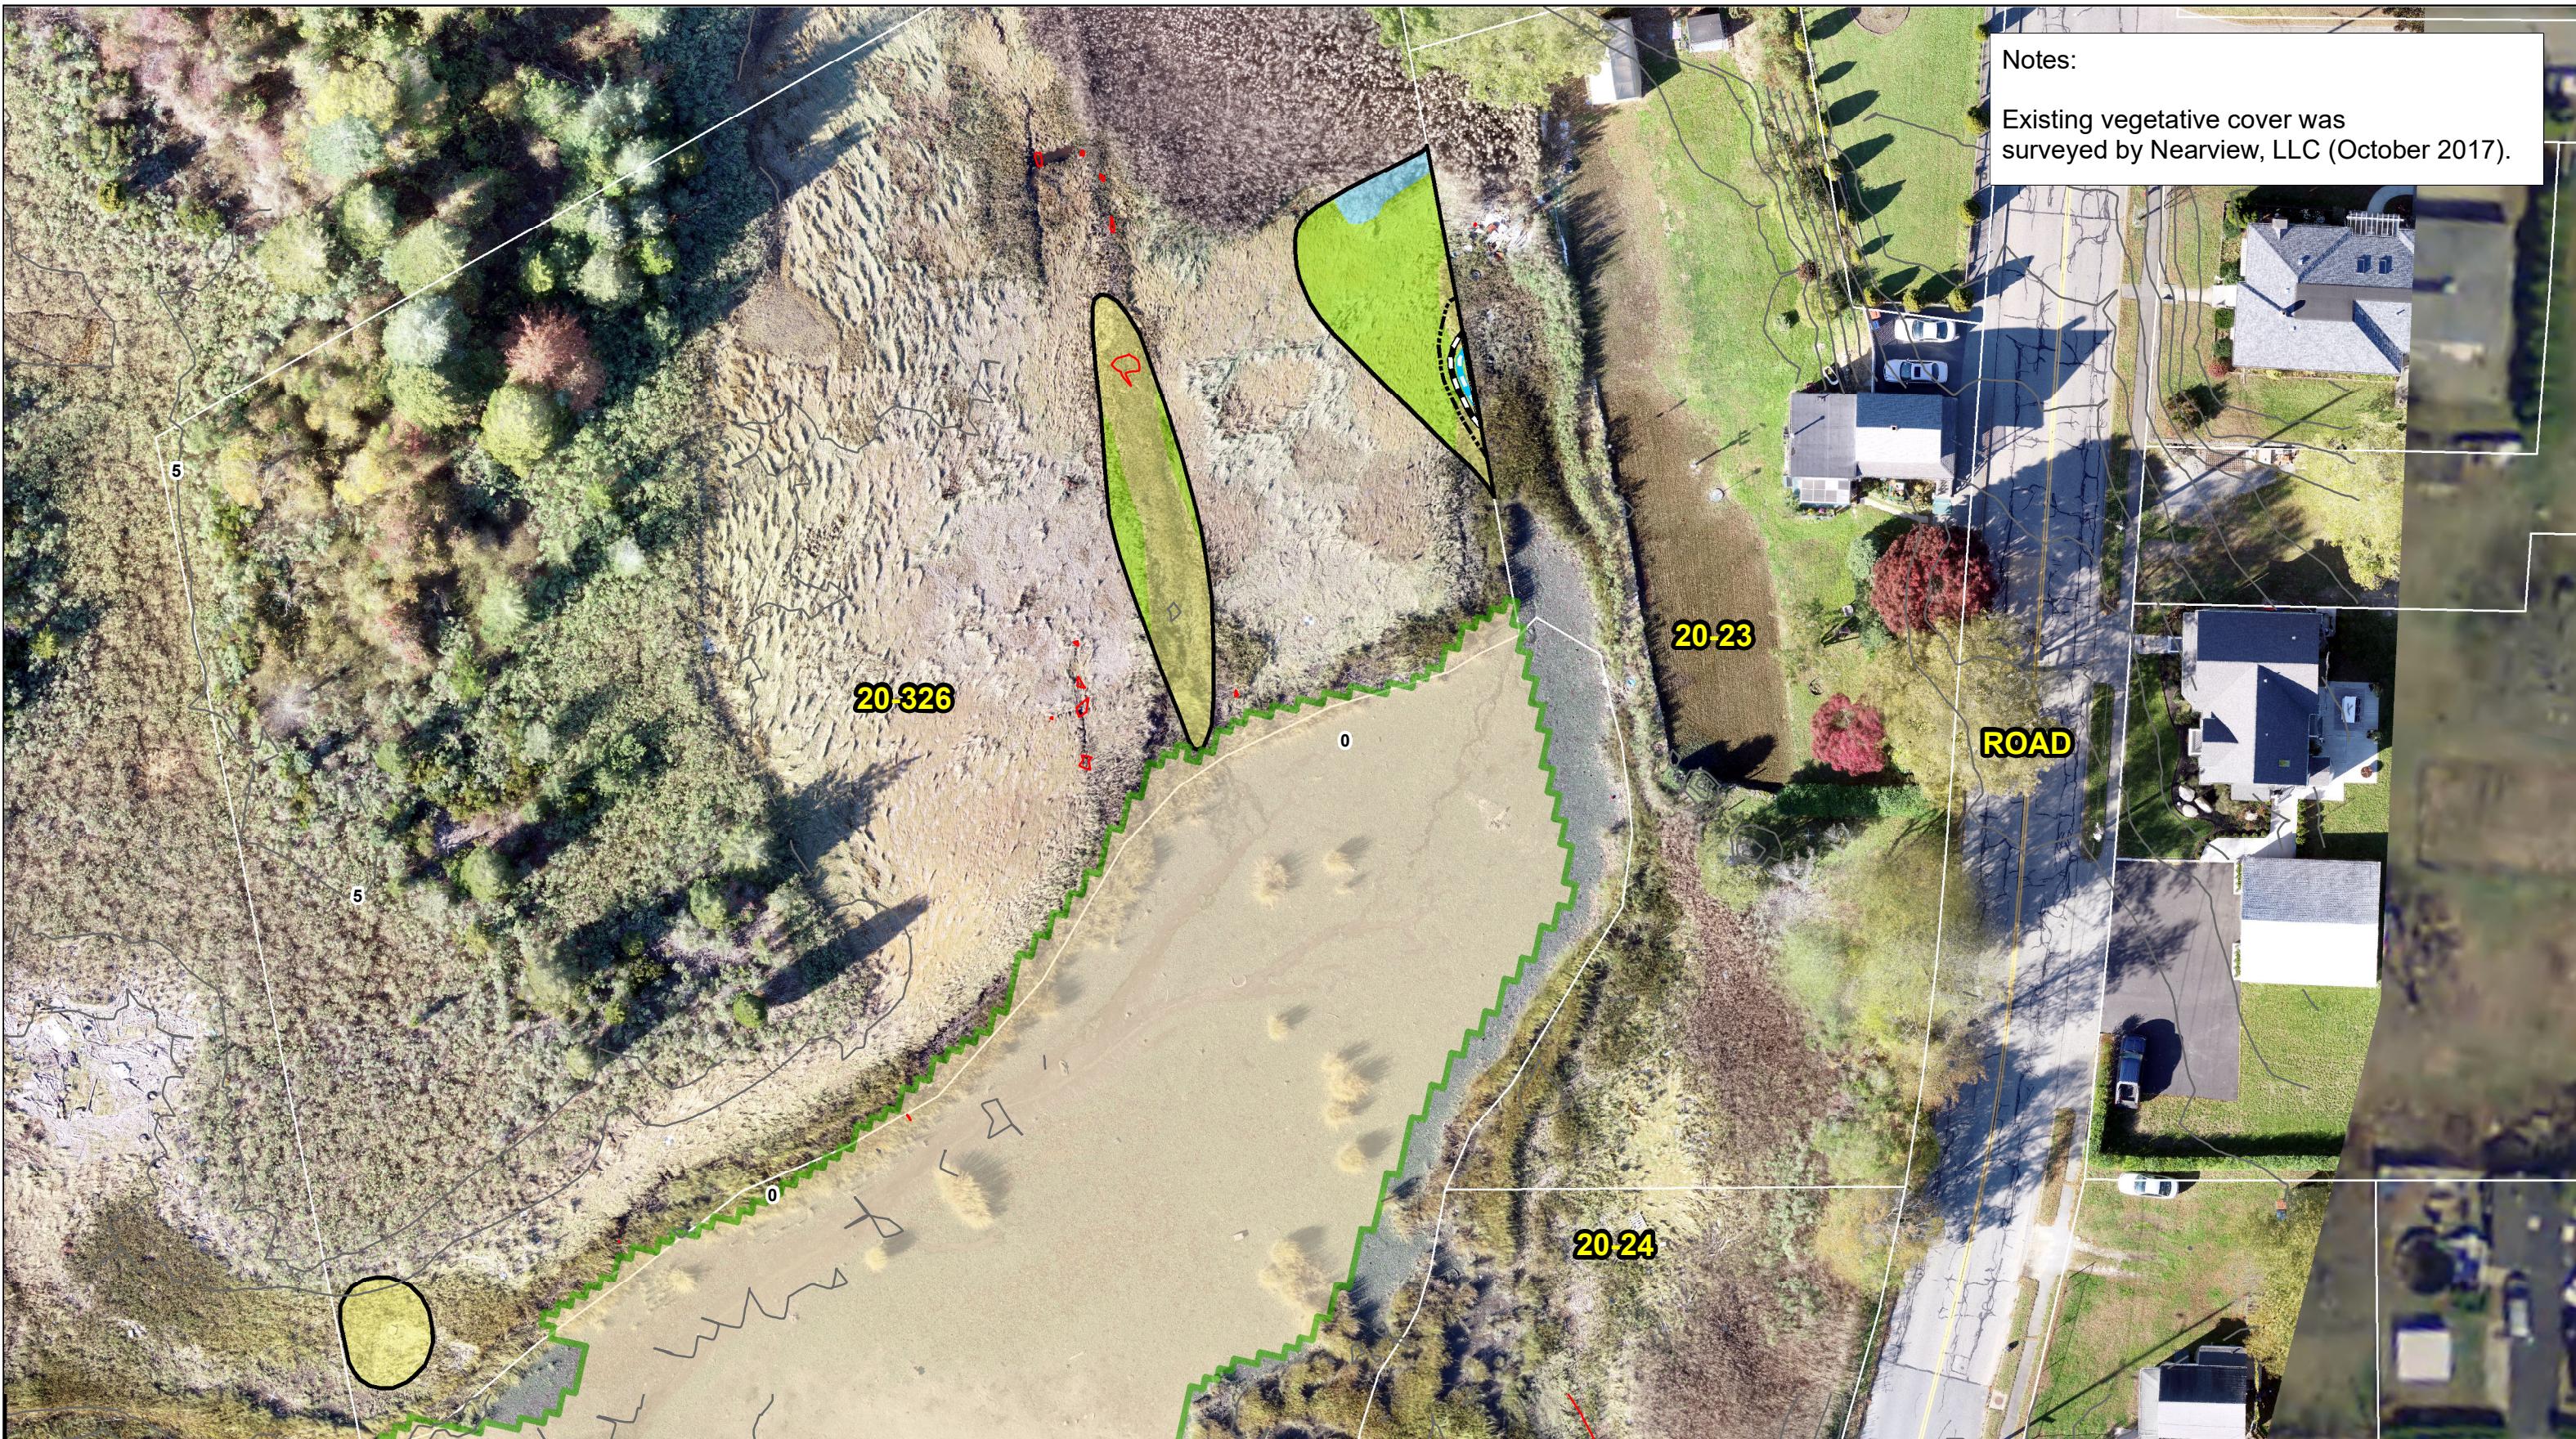
Figure 2-2a

The existing wetland vegetation was surveyed by Jacobs in 2017. The mapped survey results and the outlines of the excavation areas are provided in [Figures 2-2a](#) through [2-2g](#). The excavation areas include low marsh, high marsh, upland, a few small areas of mudflat, and the invasive grass, *Phragmites australis*. Sediment and soil samples collected during the site investigation/characterization phase were analyzed for total PCBs by both immunoassay (IA) and congener methods. The analytical results summarized in [Tables 2-1a](#) through [2-1g](#) were used to support remediation planning. The sample locations used to delineate the extent of PCB contamination within East Zone 5 are shown in [Figures 2-3a](#) through [2-3g](#). A subset of these locations was also designated as confirmatory sample locations, which are described further in Section 3.3.

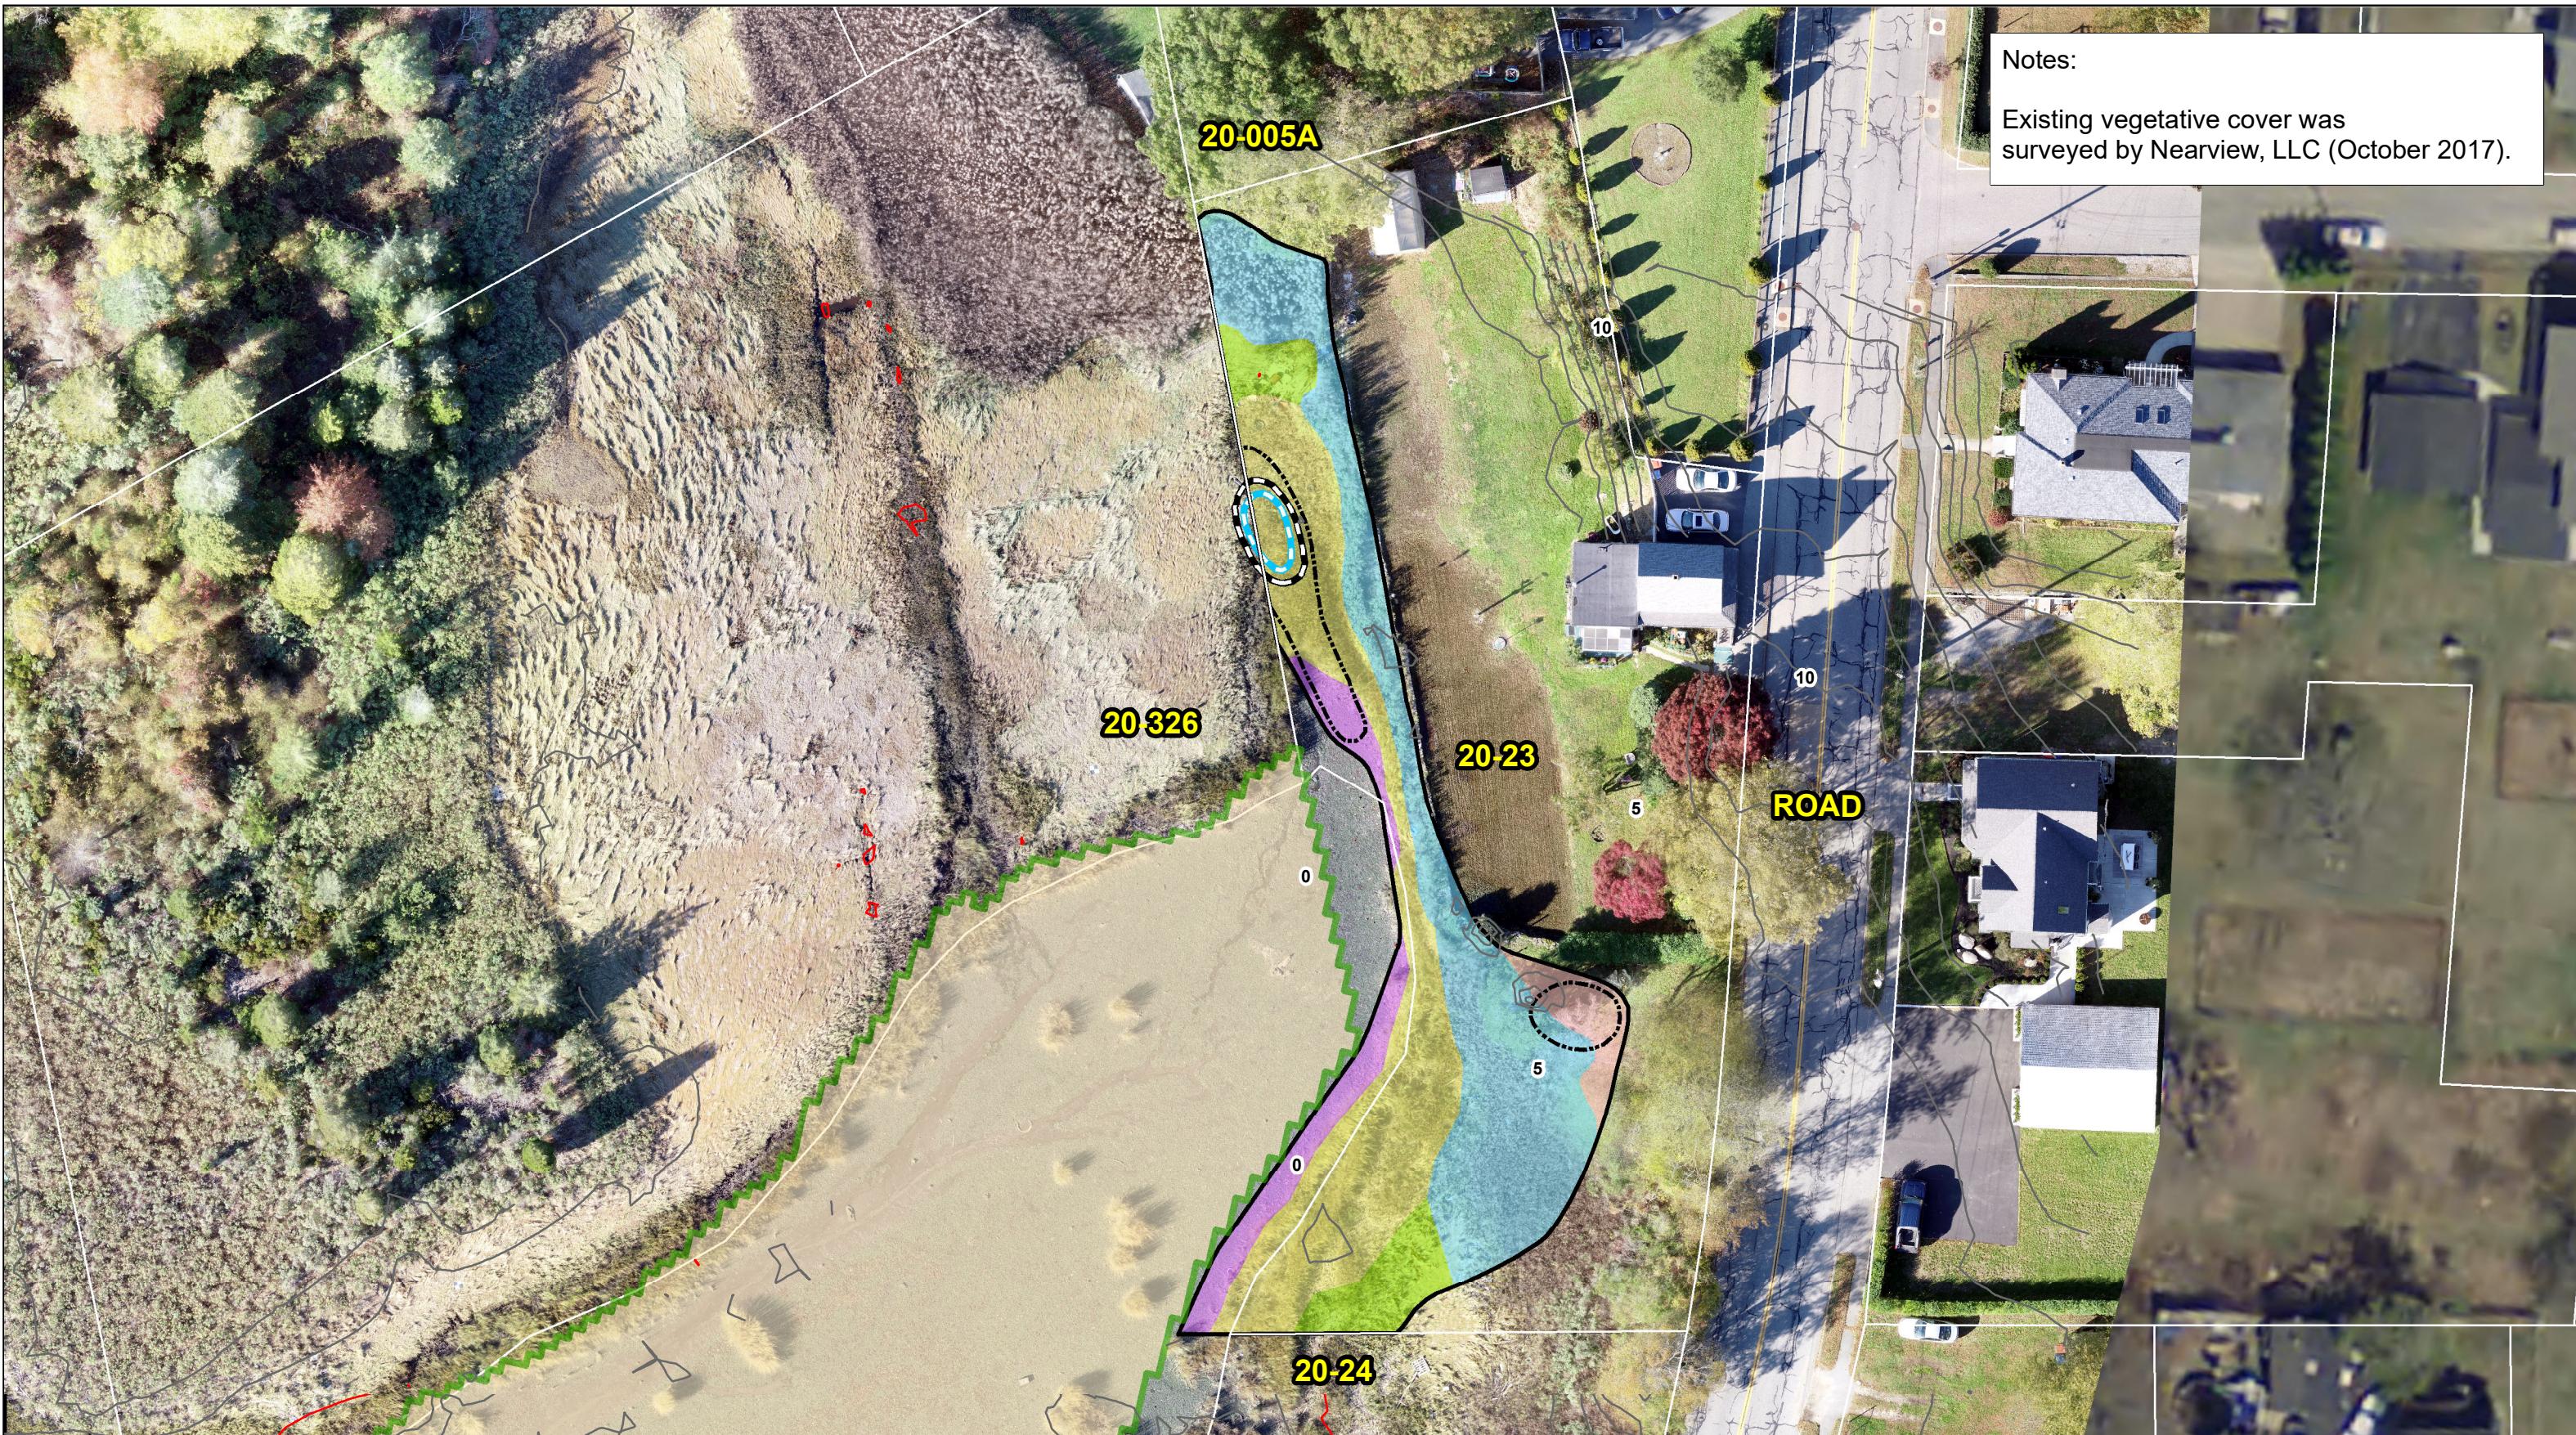
Figure 2-2b

**Intertidal East Zone 5
Parcel 20-23**
Existing Vegetation, Topography, and Excavation Areas
New Bedford Harbor Superfund Site

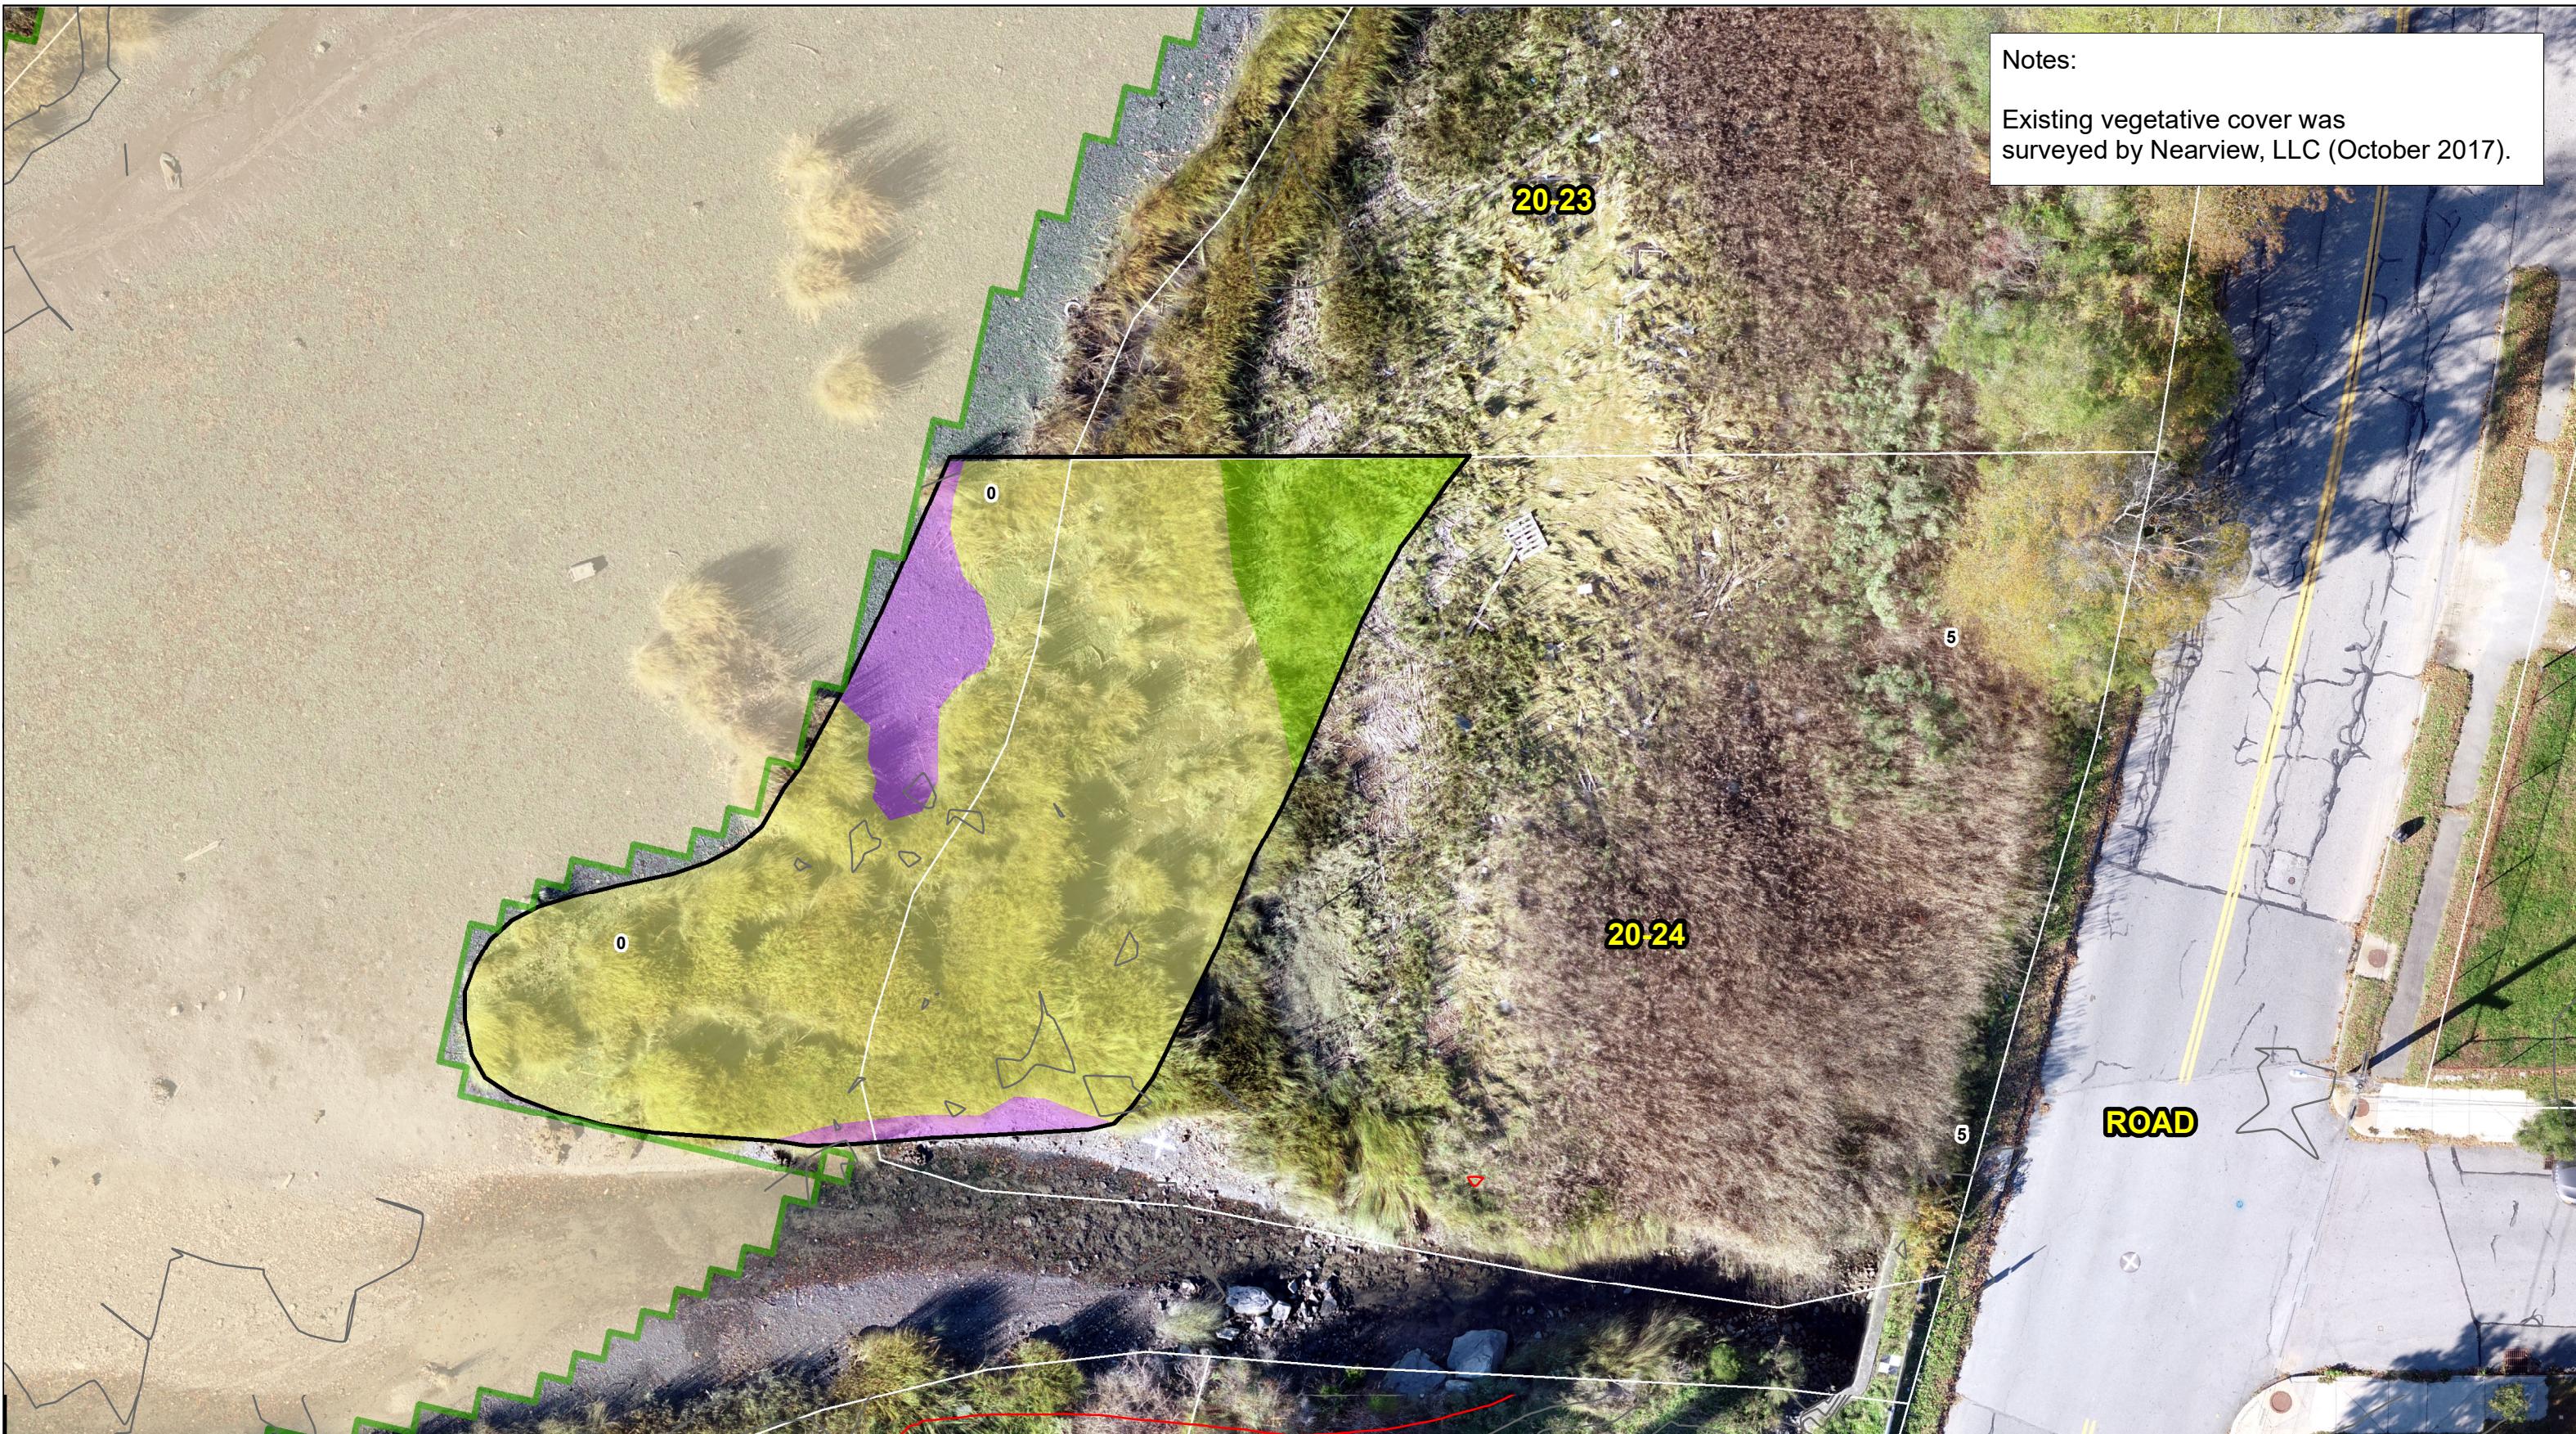
Figure 2-2c

**Intertidal East Zone 5
Parcel 20-24**
Existing Vegetation, Topography, and Excavation Areas
New Bedford Harbor Superfund Site

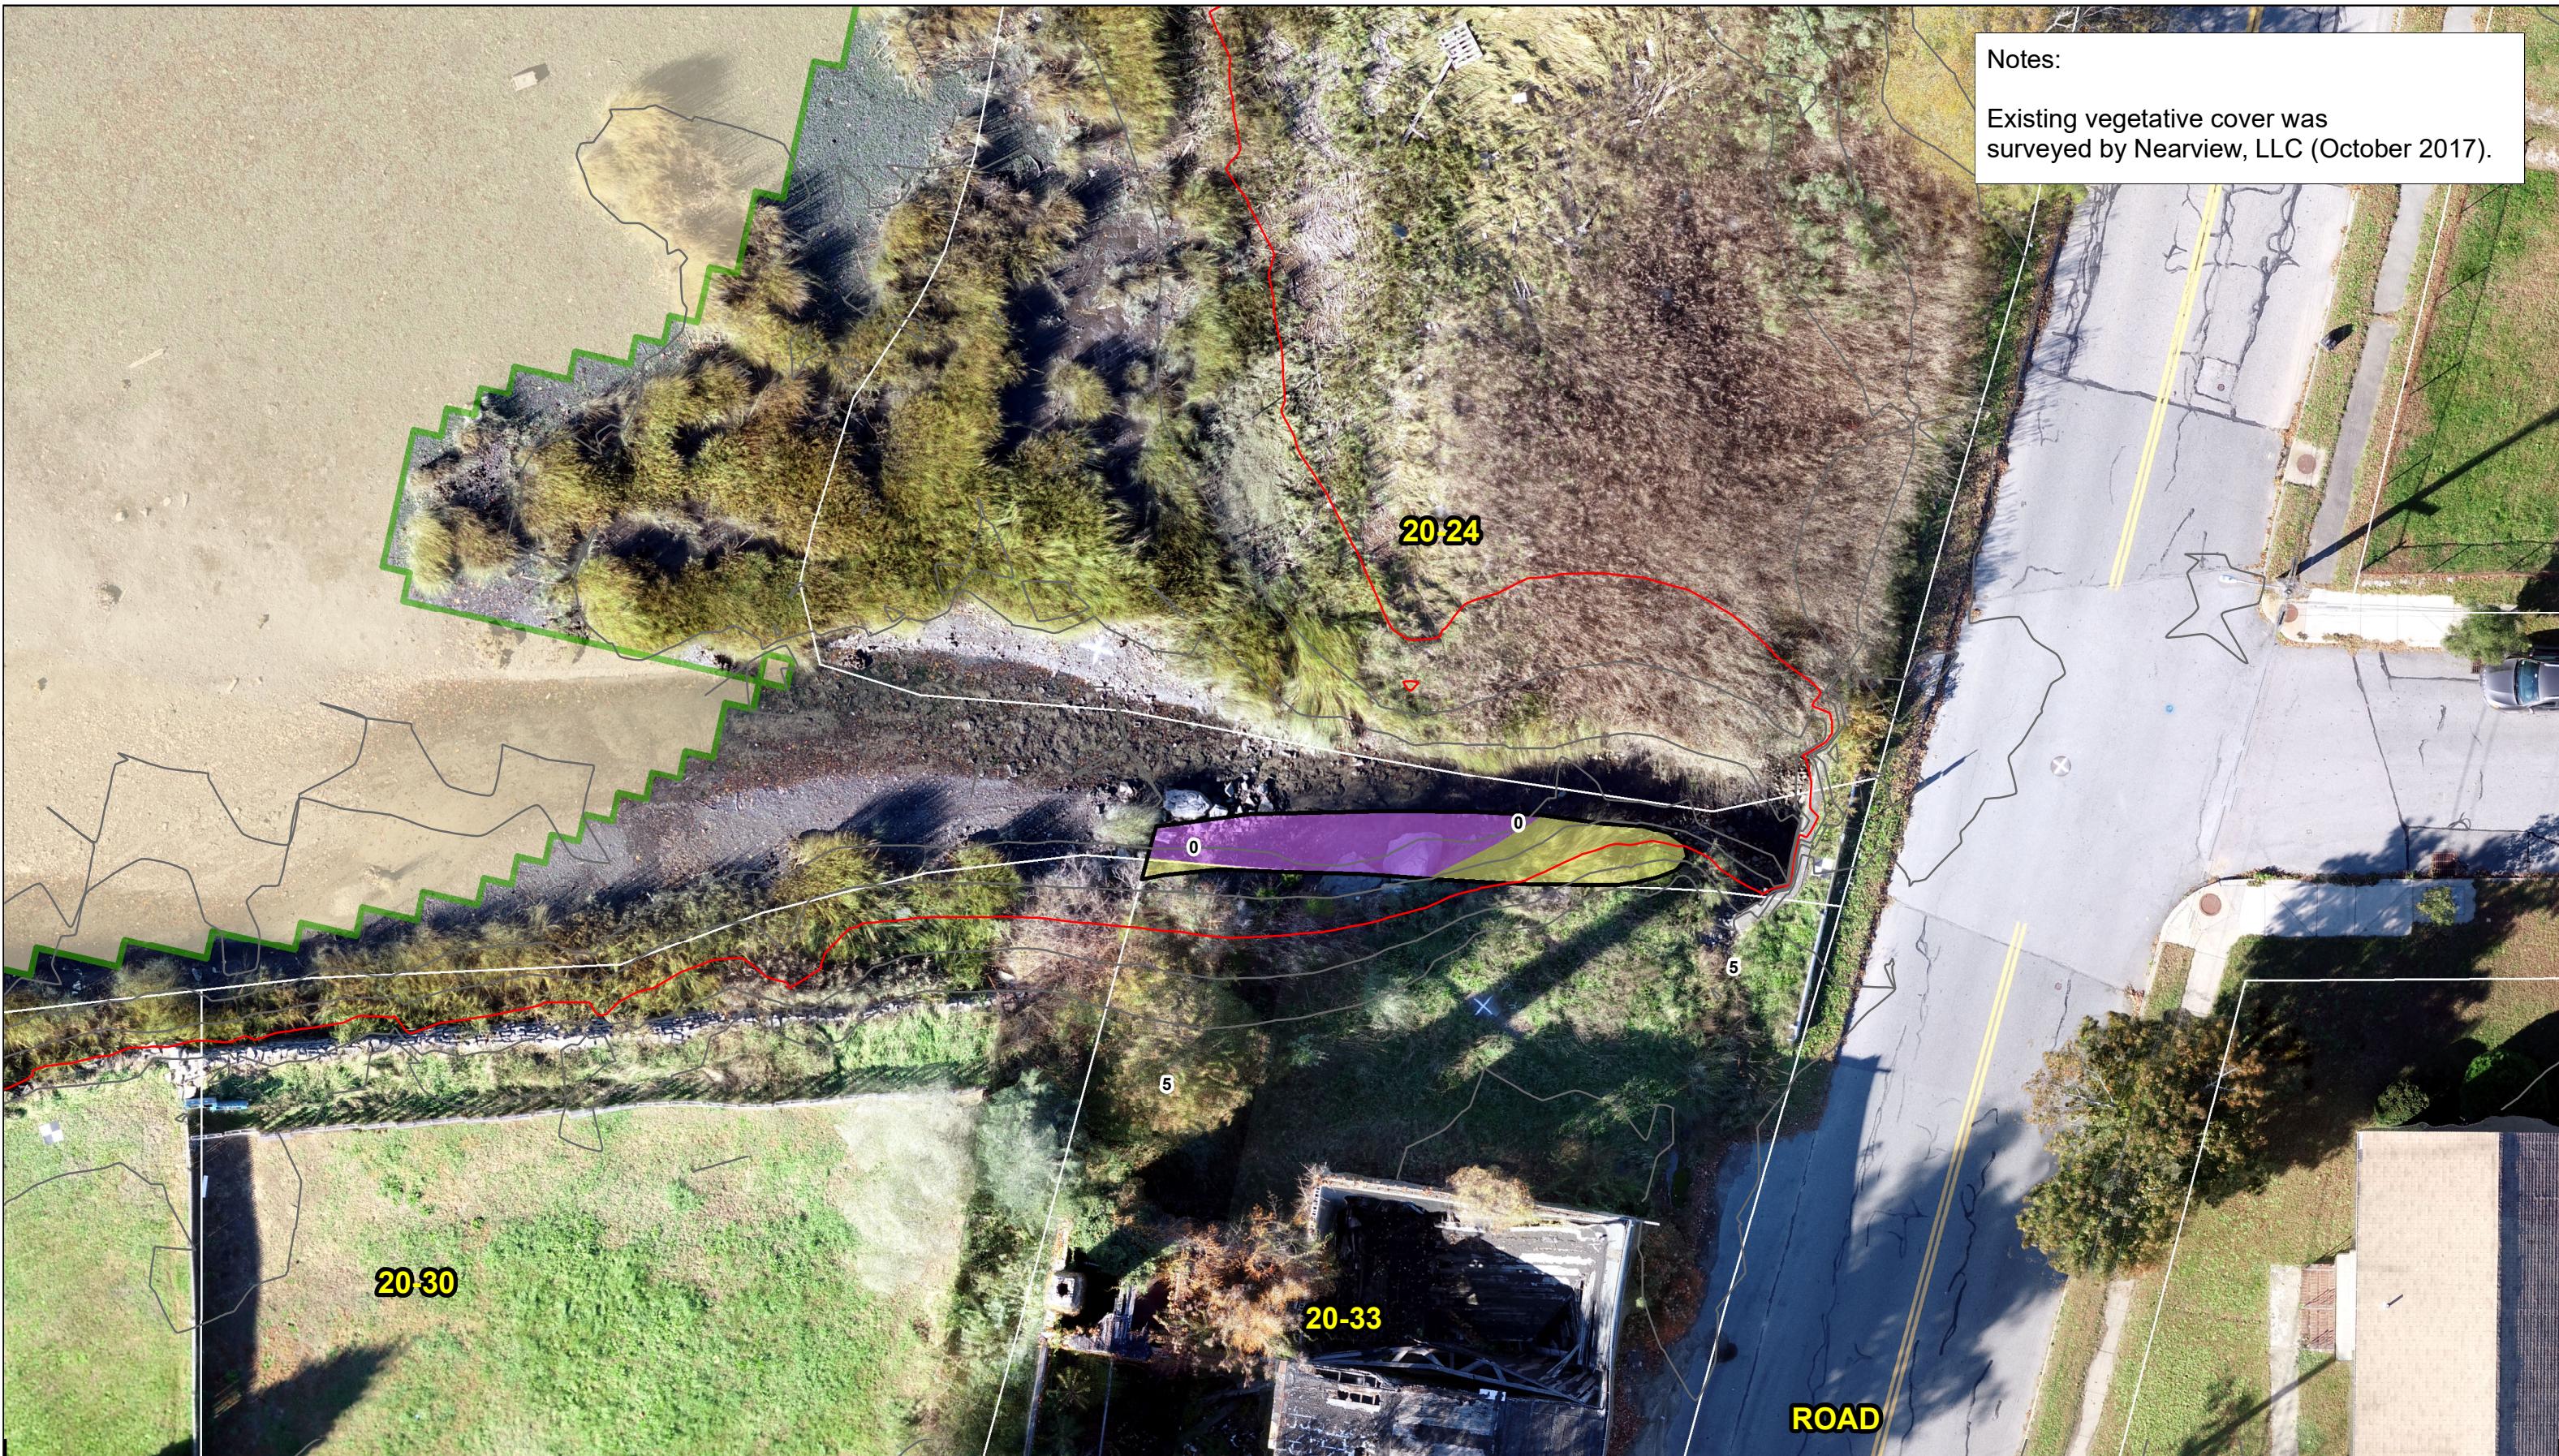
Existing vegetative cover was surveyed by Nearview, LLC (October 2017).
