New Bedford Harbor Superfund Site

Draft Final Intertidal Work Plan for East Zone 5

ACE-J23-35BG6000-M1-0056|0

March 2020

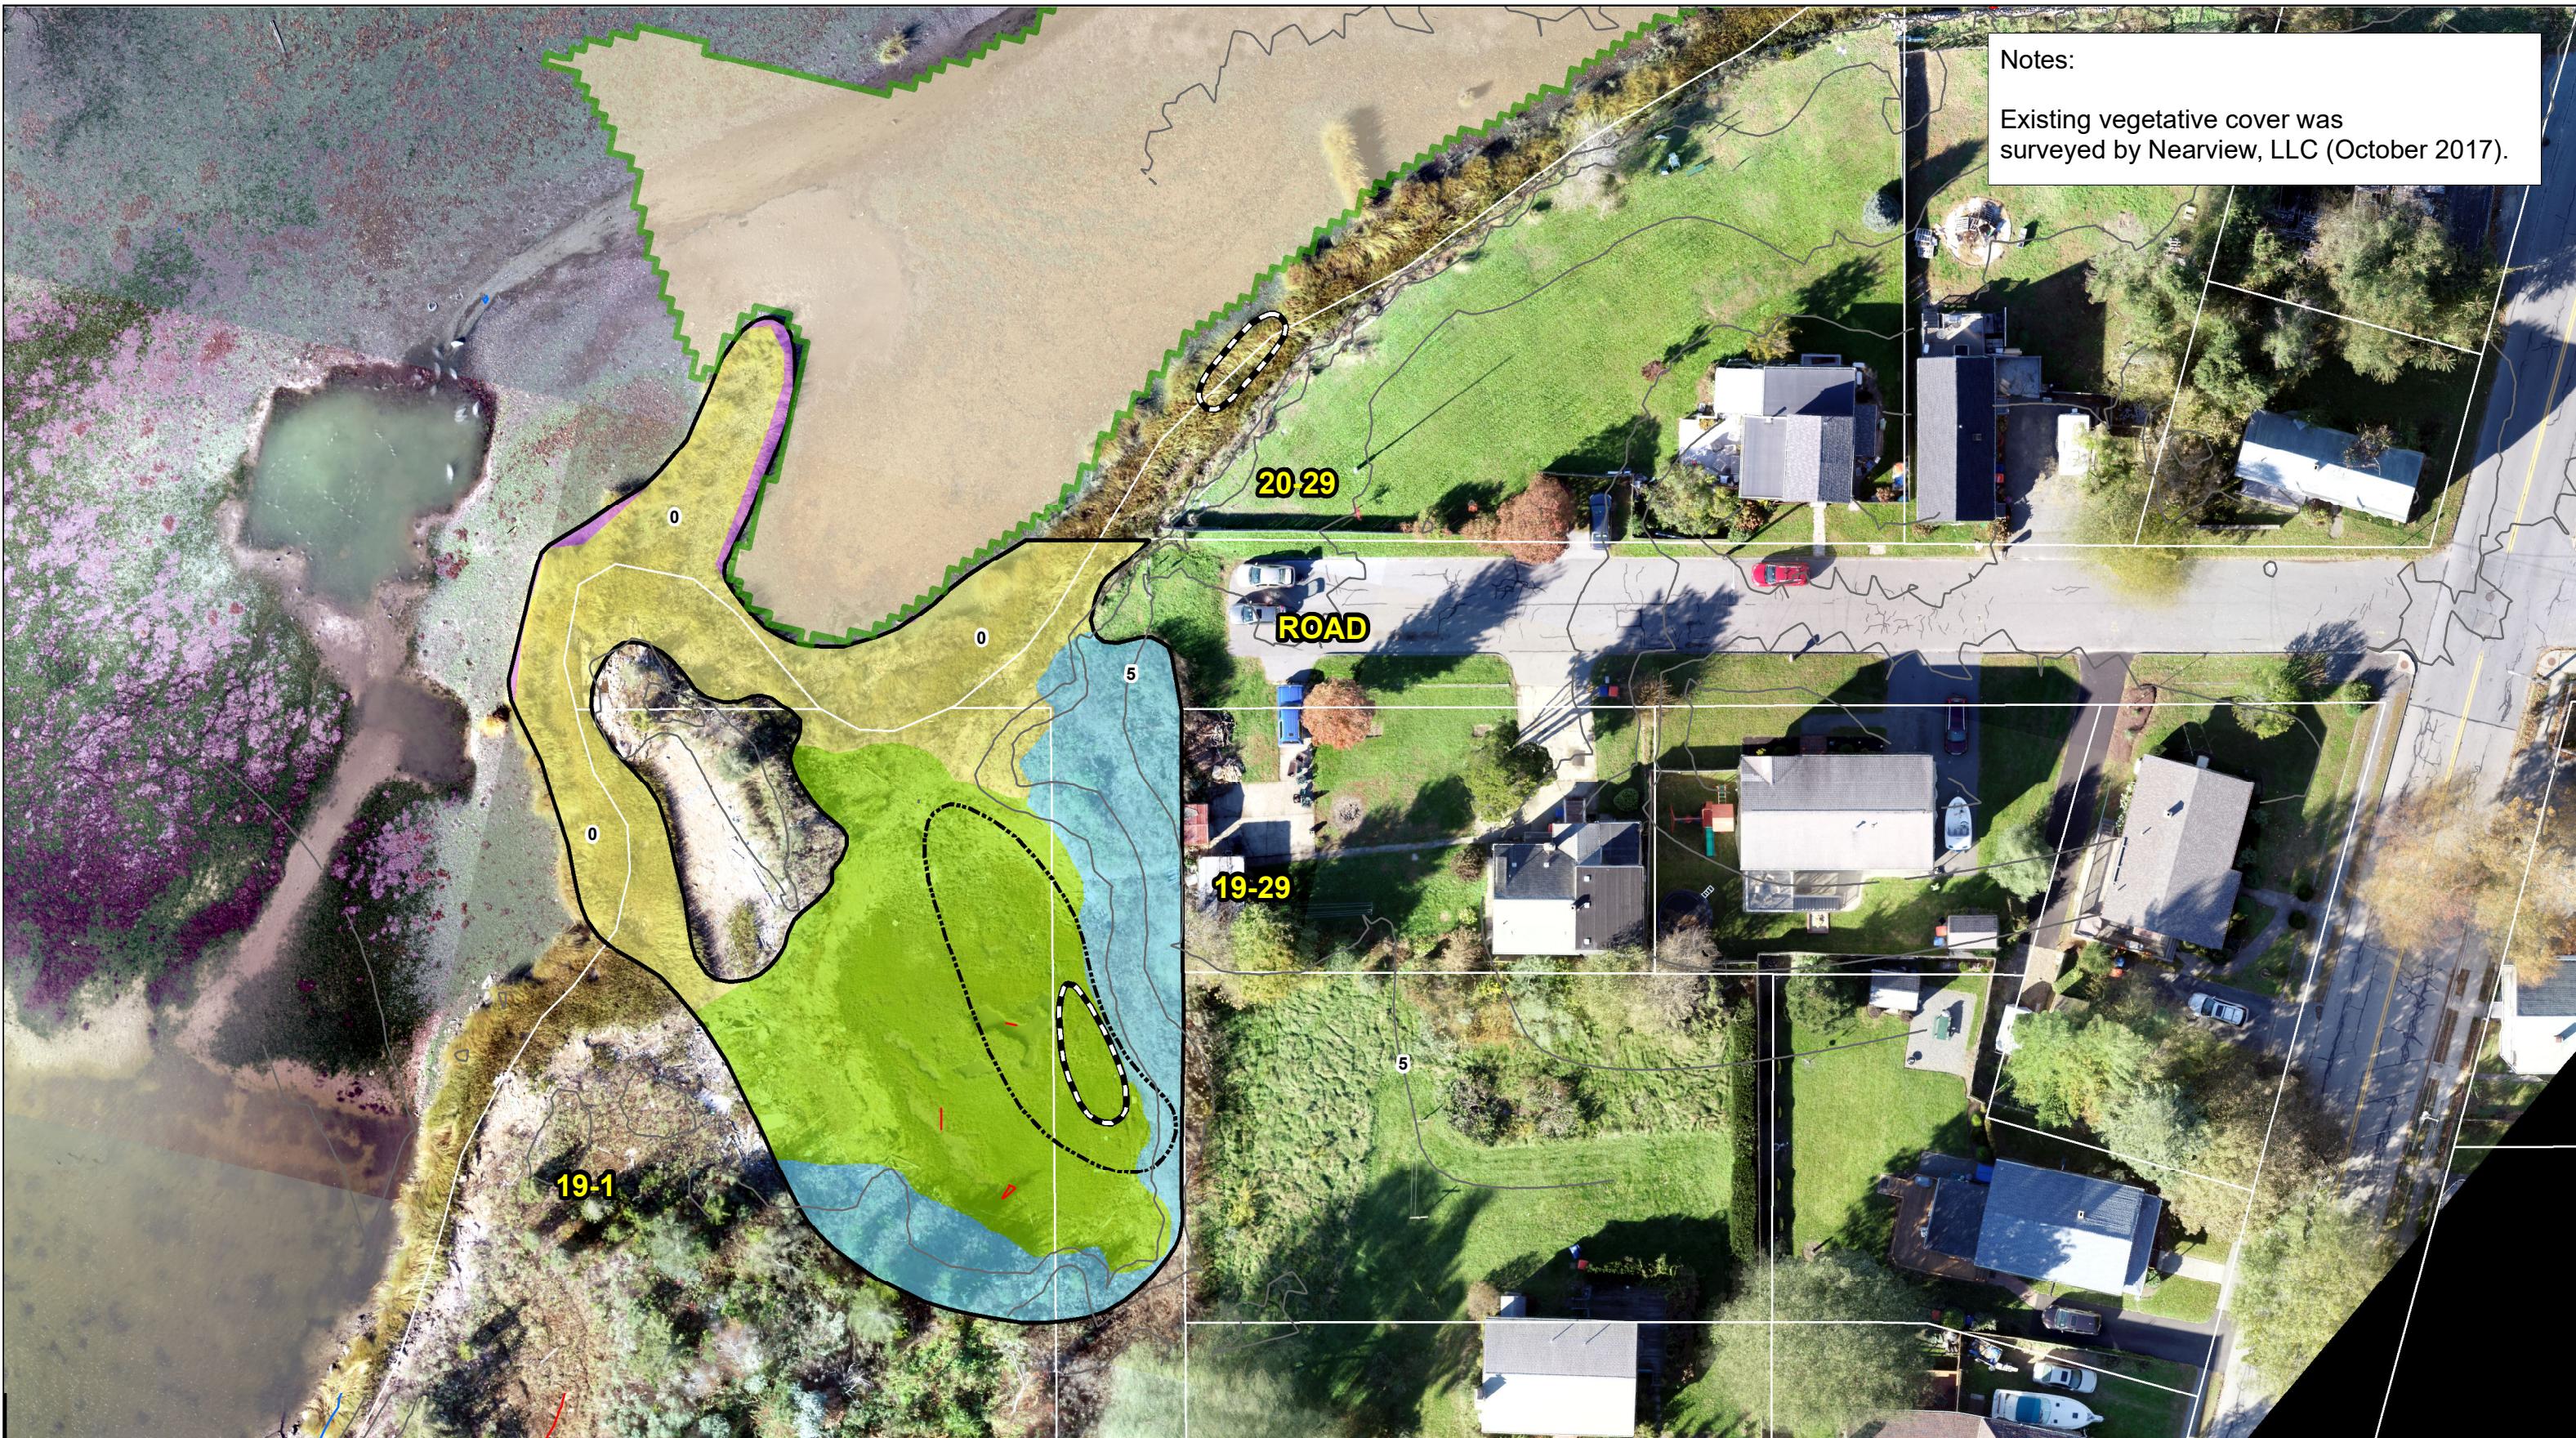
Figure 2-2g

Intertidal East Zone 5
Parcel 19-1 and ROW
Existing Vegetation, Topography, and Excavation Areas
New Bedford Harbor Superfund Site

The existing wetland vegetation was surveyed by Jacobs in 2017. The mapped survey results and the outlines of the excavation areas are provided in [Figures 2-2a](#) through [2-2g](#). The excavation areas include low marsh, high marsh, upland, a few small areas of mudflat, and the invasive grass, *Phragmites australis*. Sediment and soil samples collected during the site investigation/characterization phase were analyzed for total PCBs by both immunoassay (IA) and congener methods. The analytical results summarized in [Tables 2-1a](#) through [2-1g](#) were used to support remediation planning. The sample locations used to delineate the extent of PCB contamination within East Zone 5 are shown in [Figures 2-3a](#) through [2-3g](#). A subset of these locations was also designated as confirmatory sample locations, which are described further in Section 3.3.

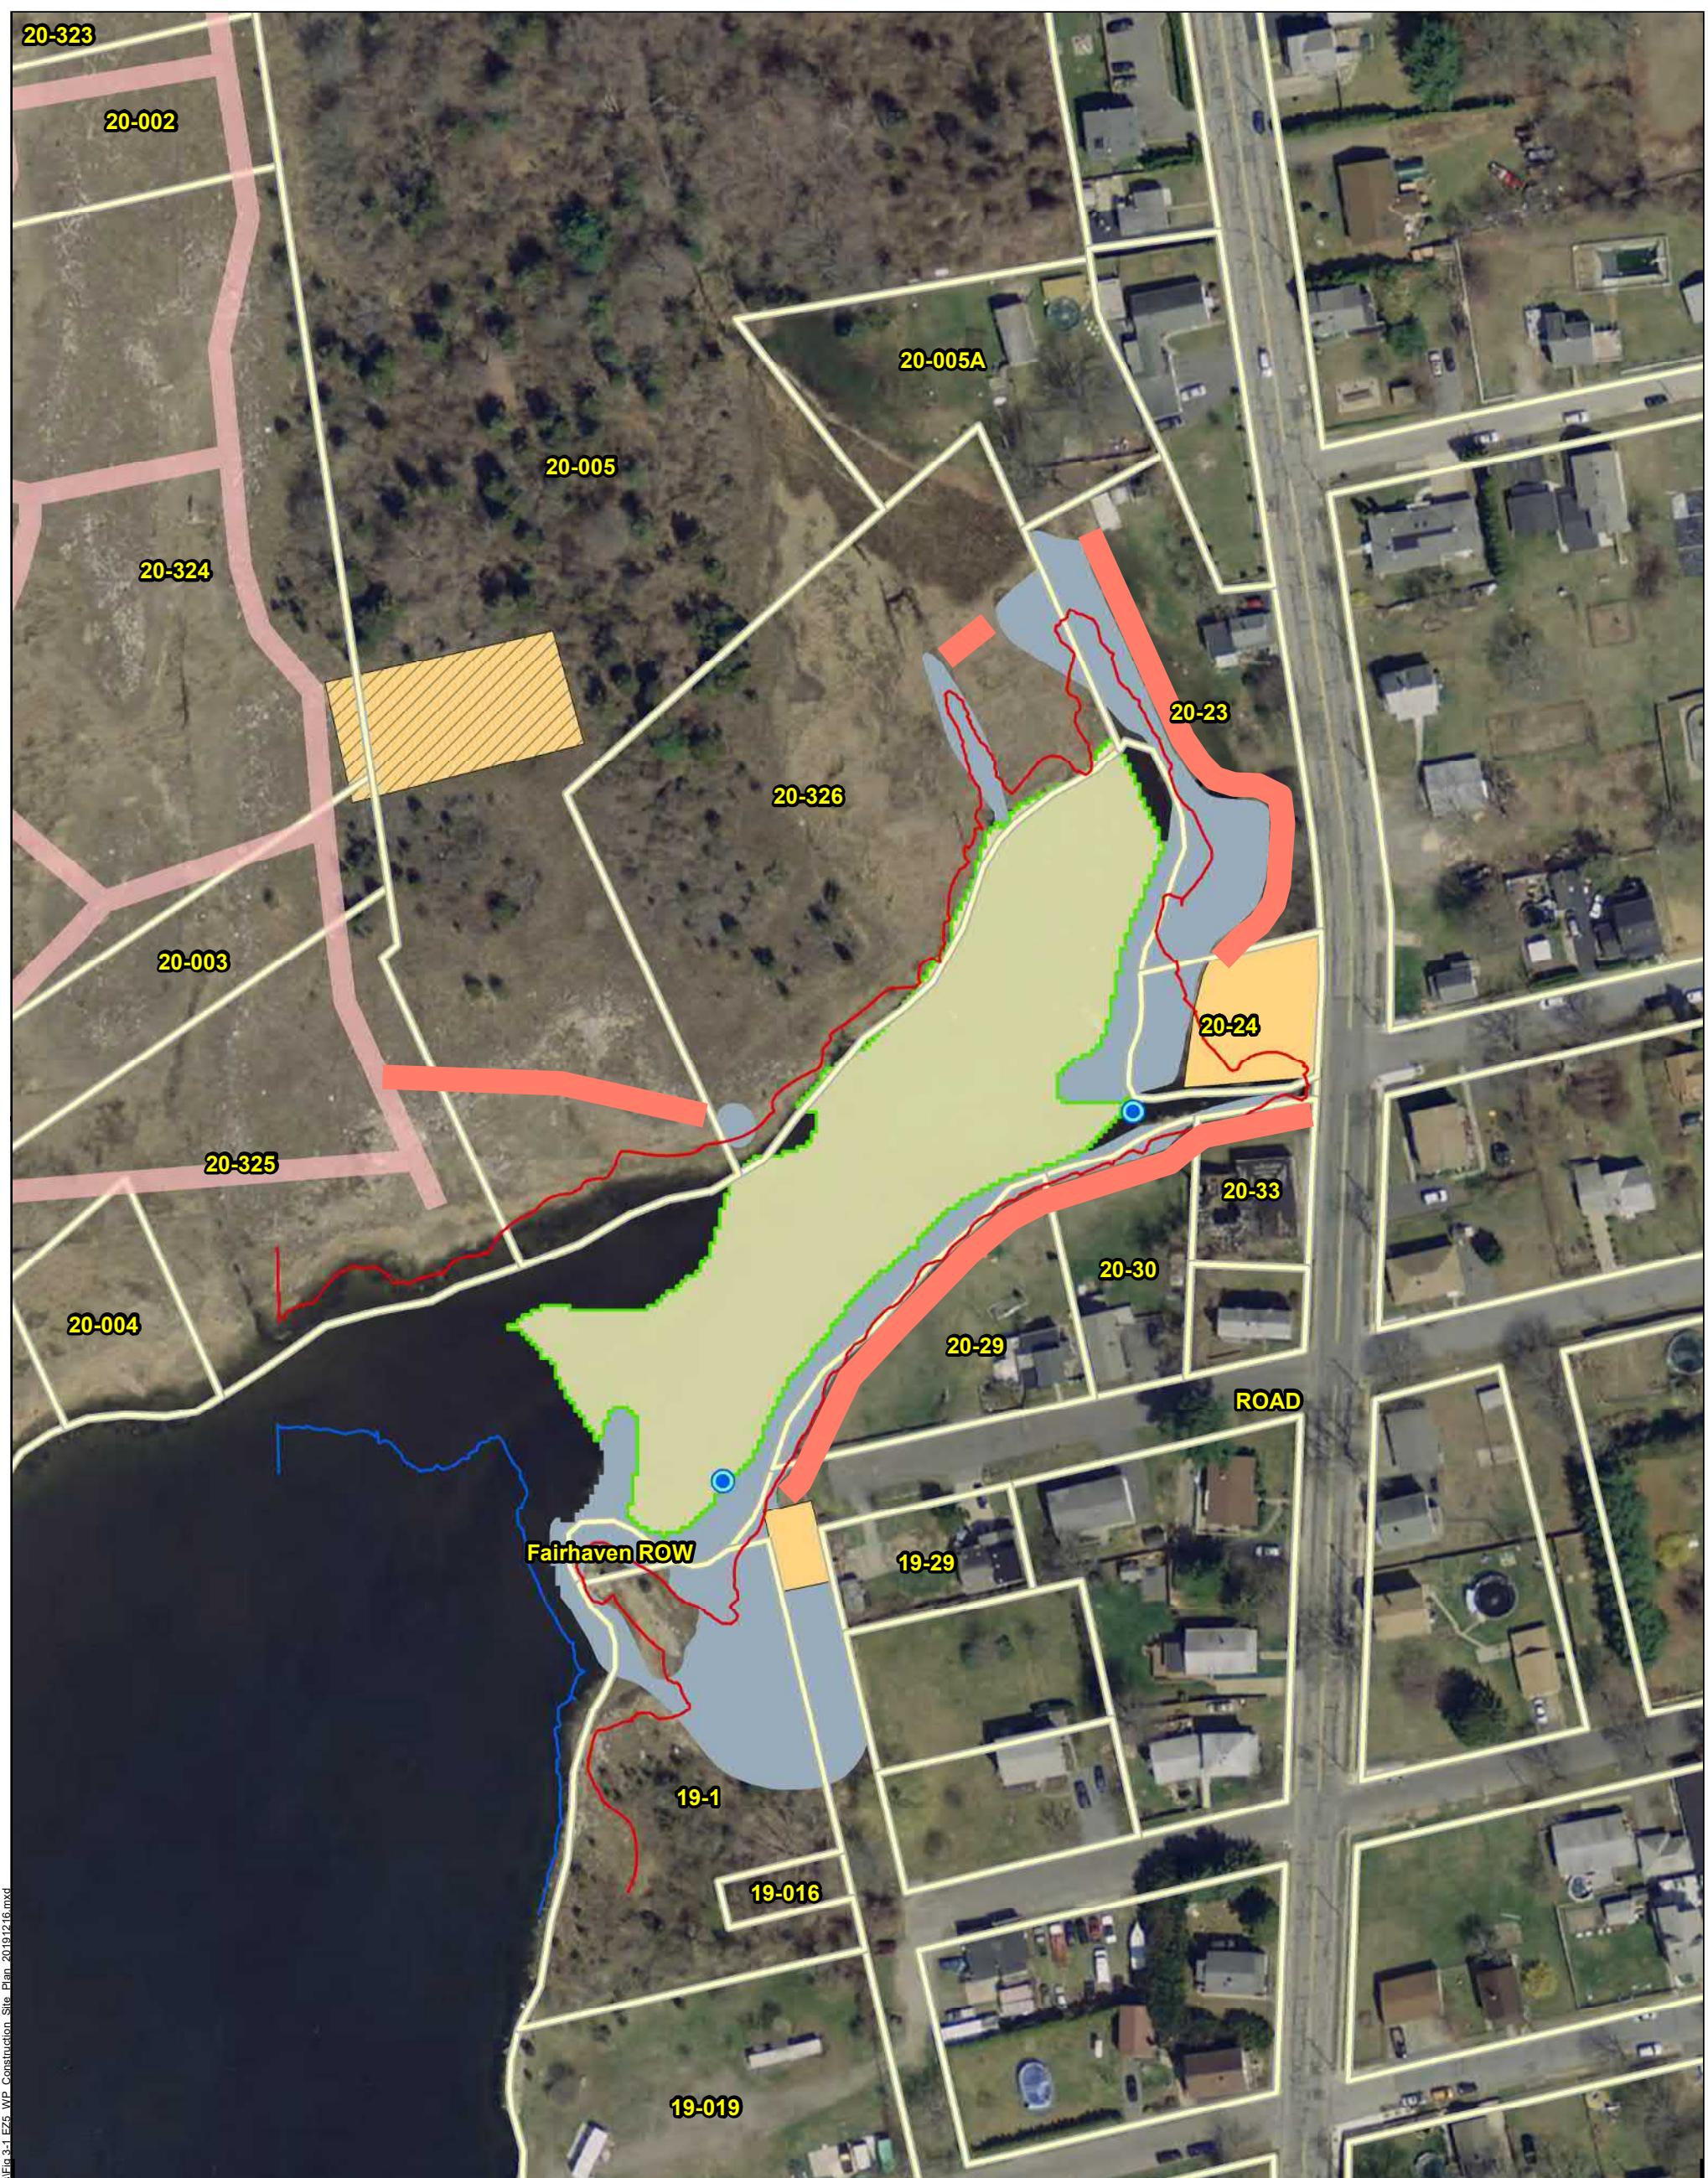
Figure 3-1

- EZ5 Temporary Gravel Access Road
- EZ4 Temporary Gravel Access Road
- Proposed Limits of Excavation
- Veranda Inlet
- MHHW (1.99ft)
- MLLW (-1.97ft)
- Approximate Treated Wastewater Discharge Point
- EZ5 Proposed Staging Area / Containment Cell
- EZ4 Proposed Staging Area / Containment Cell
- Parcel Boundary

Access to the portions of the parcels requiring remediation will be through private property that is currently under access agreements obtained by EPA. Temporary roads will be built to create equipment access to the remediation areas. A construction site plan showing the excavation areas, staging and containment areas and temporary access roads is provided as [Figure 3-1](#). The dimensions and final locations of the staging areas may be altered based on field conditions. A small excavation area in the southwest corner of Parcel 20-326 will be accessed from the extension of a temporary access road to be constructed during the remediation of East Zone 4.

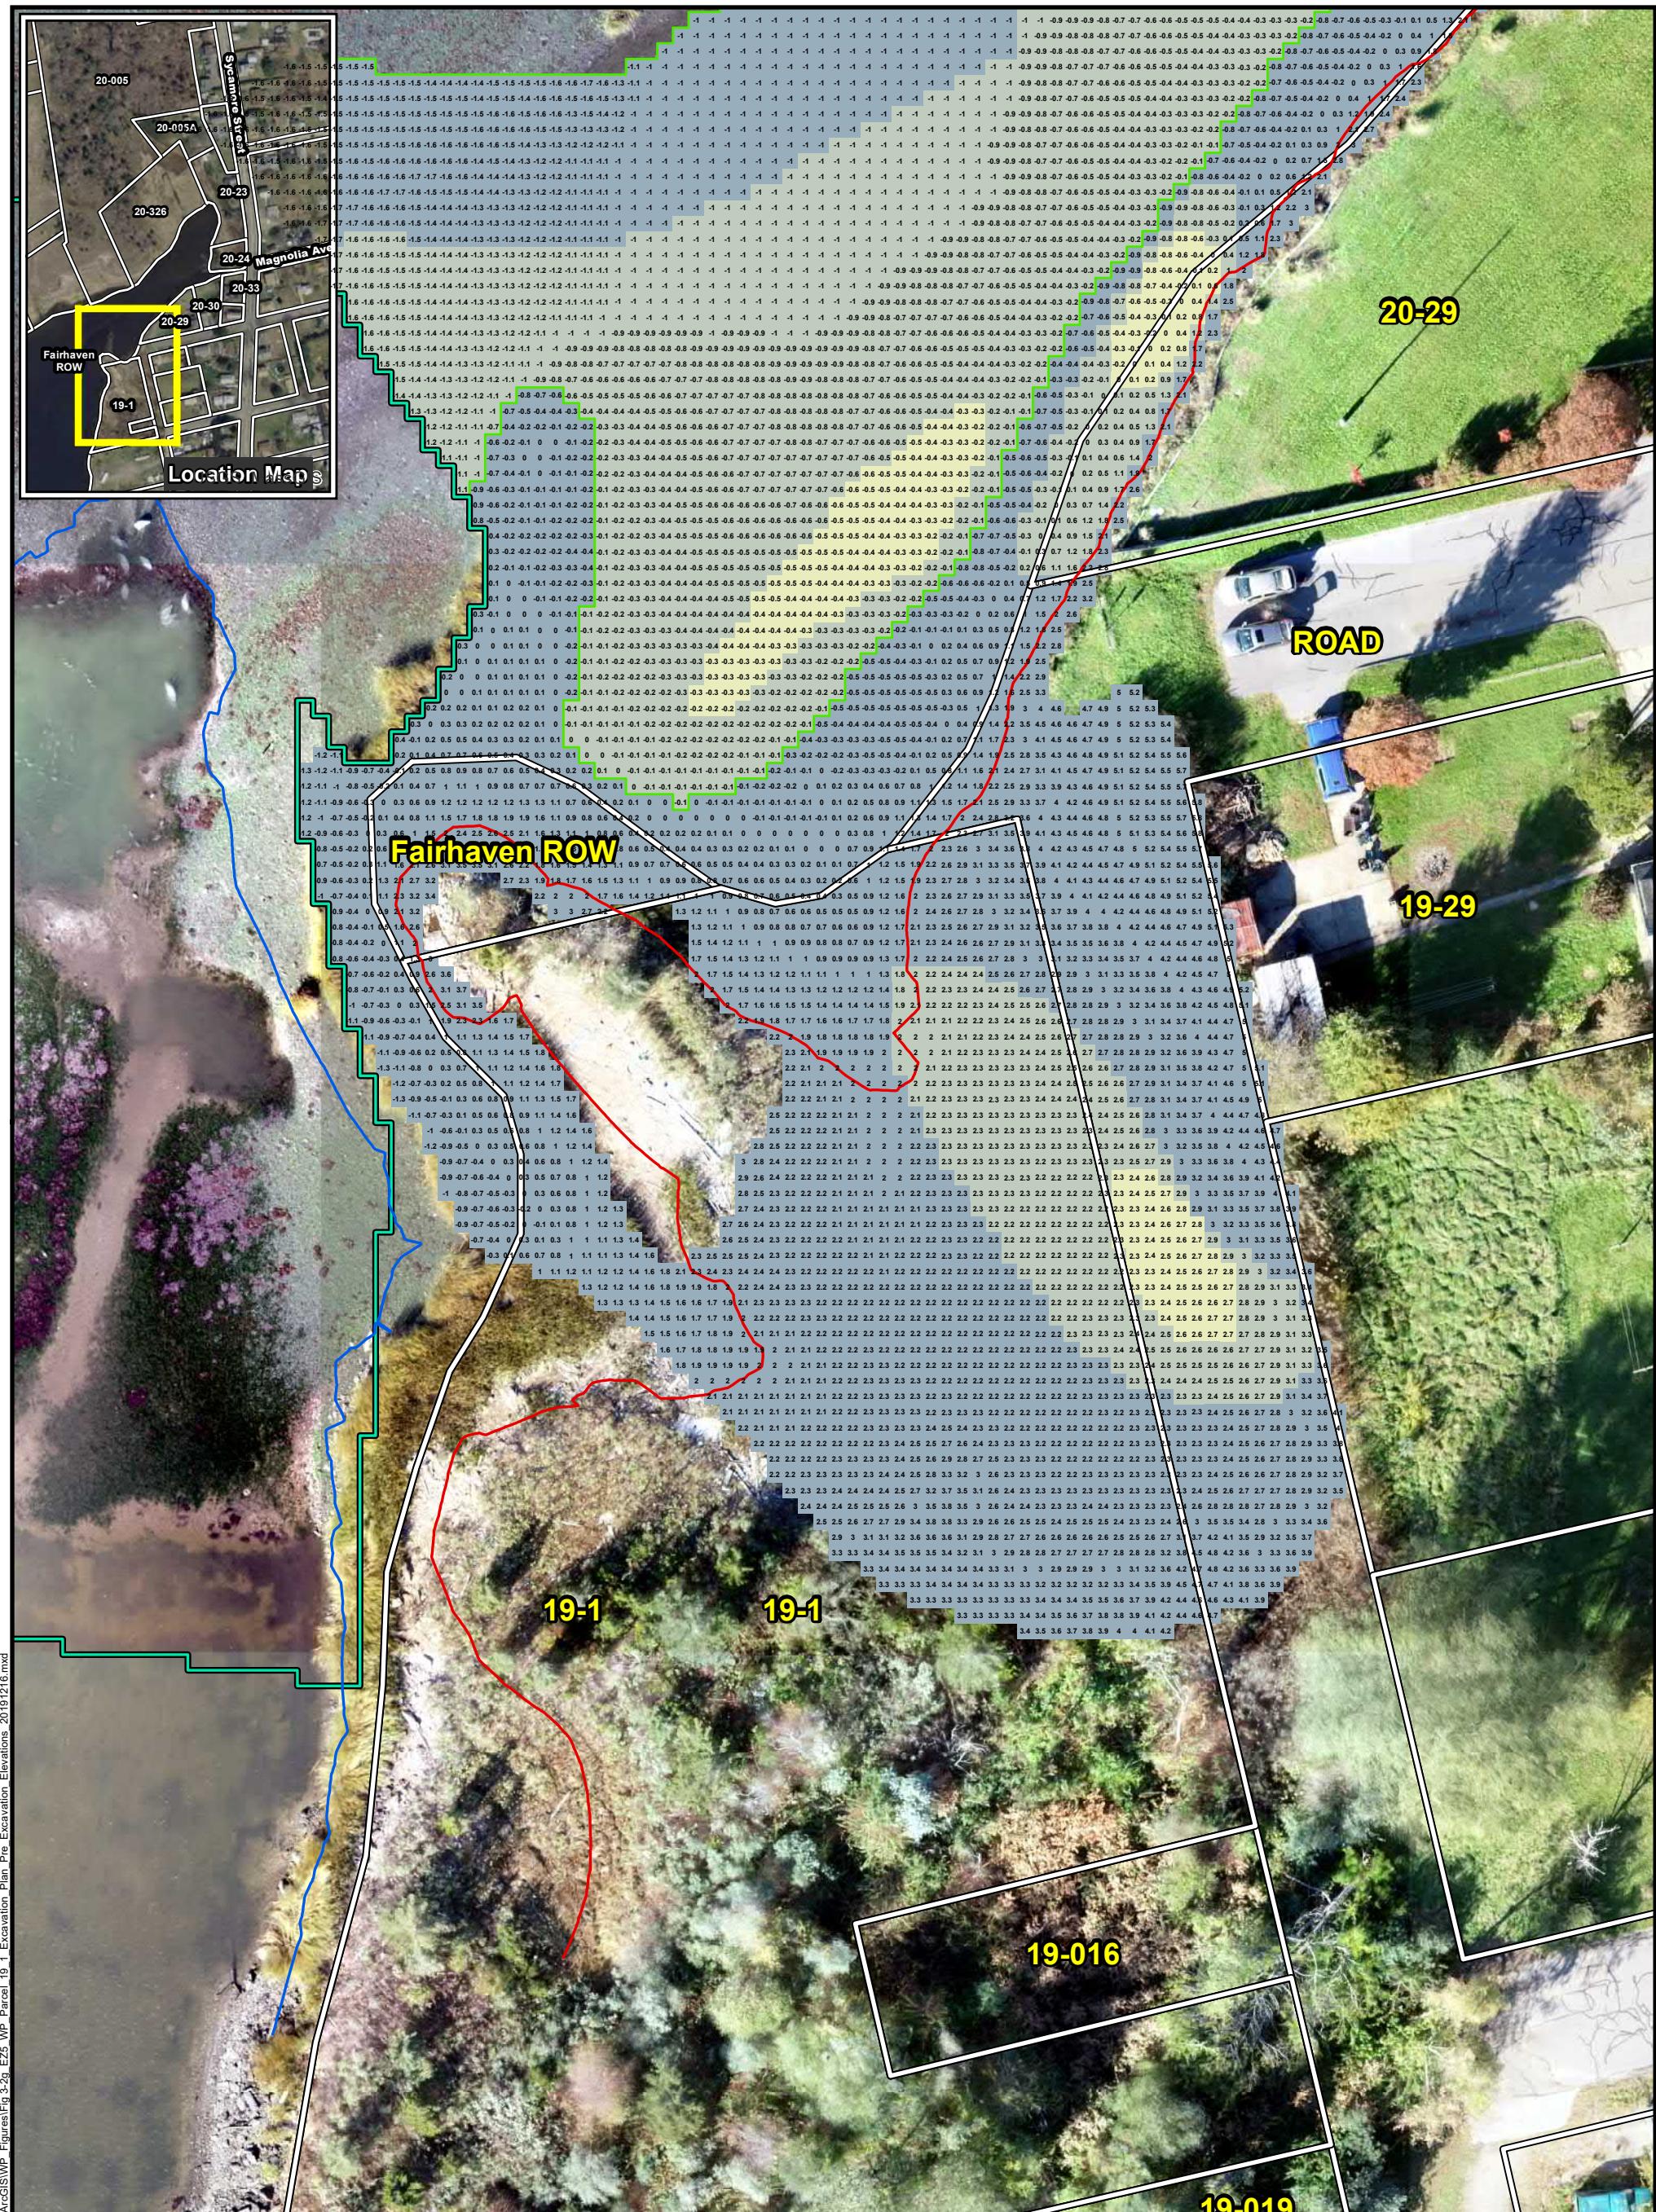
Figure 3-2g

Intertidal East Zone 5
Parcel 19-1 and ROW
Excavation Plan
Showing Cut Depths and
Pre-Excavation Elevations

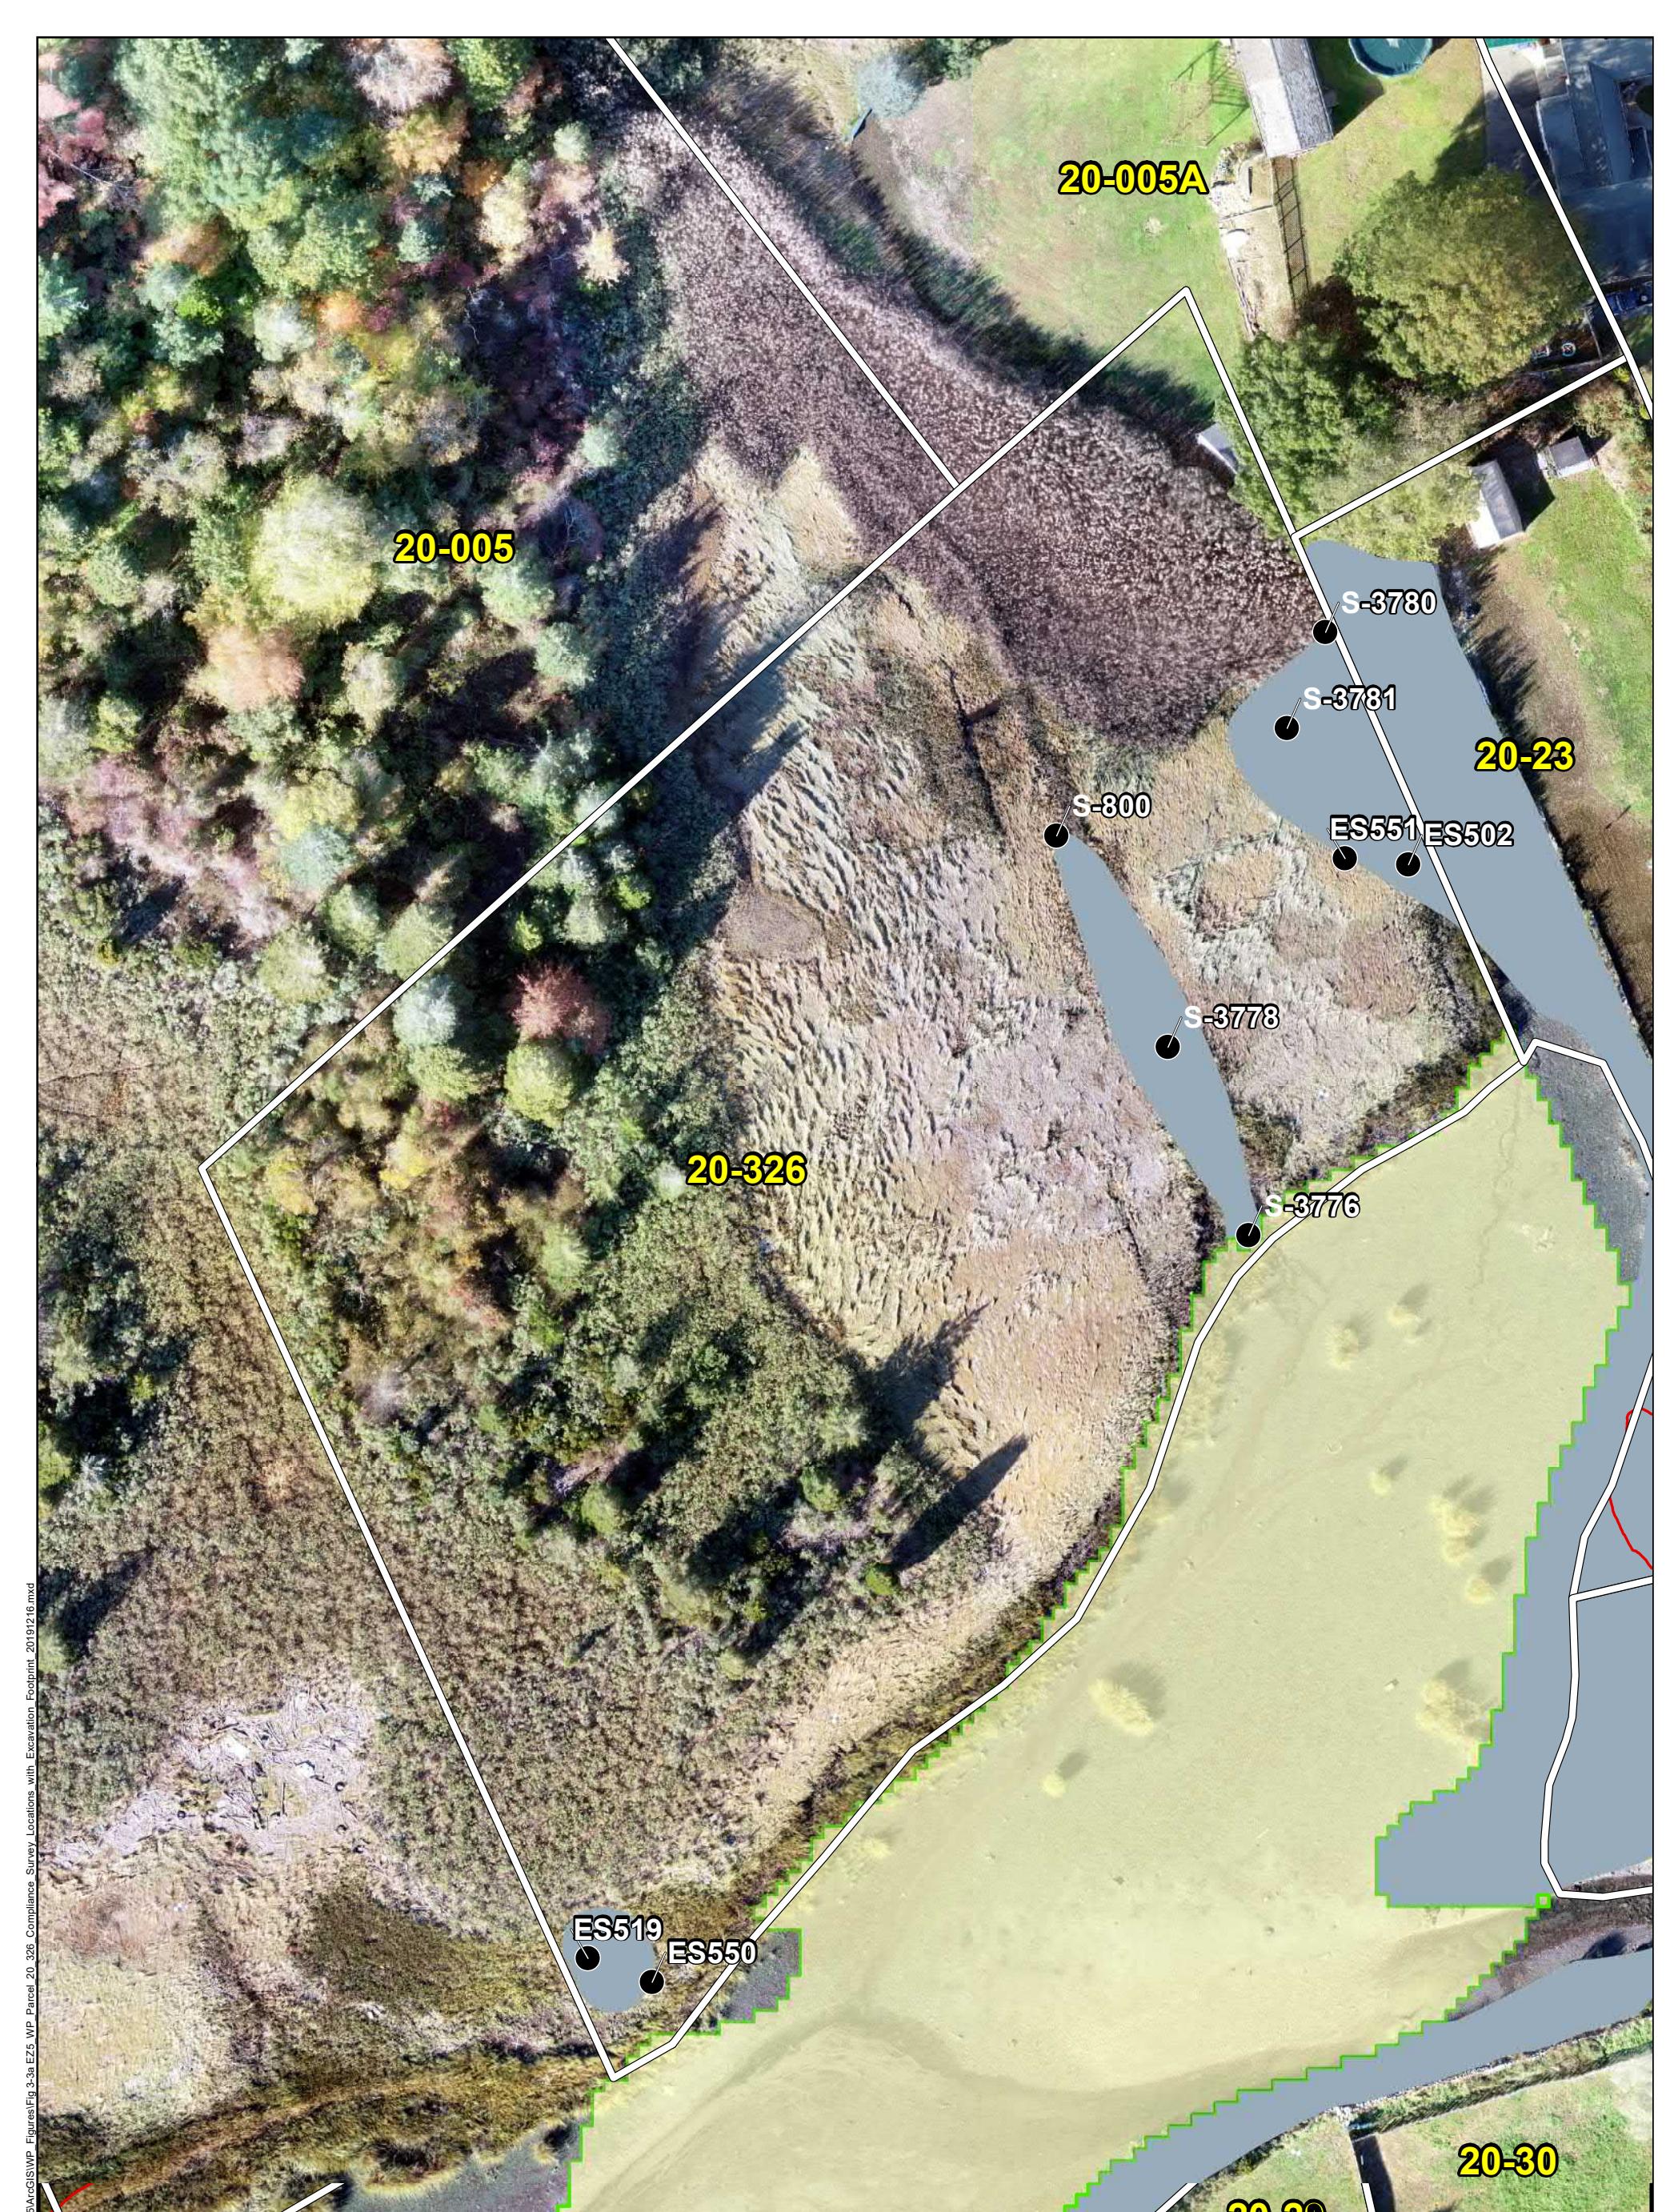
Figure 3-3a

Intertidal East Zone 5
Parcel 20-326
Compliance Survey Locations with
Excavation Footprint
(0-1 ft Depth Interval)
New Bedford Harbor Superfund Site
December 2019

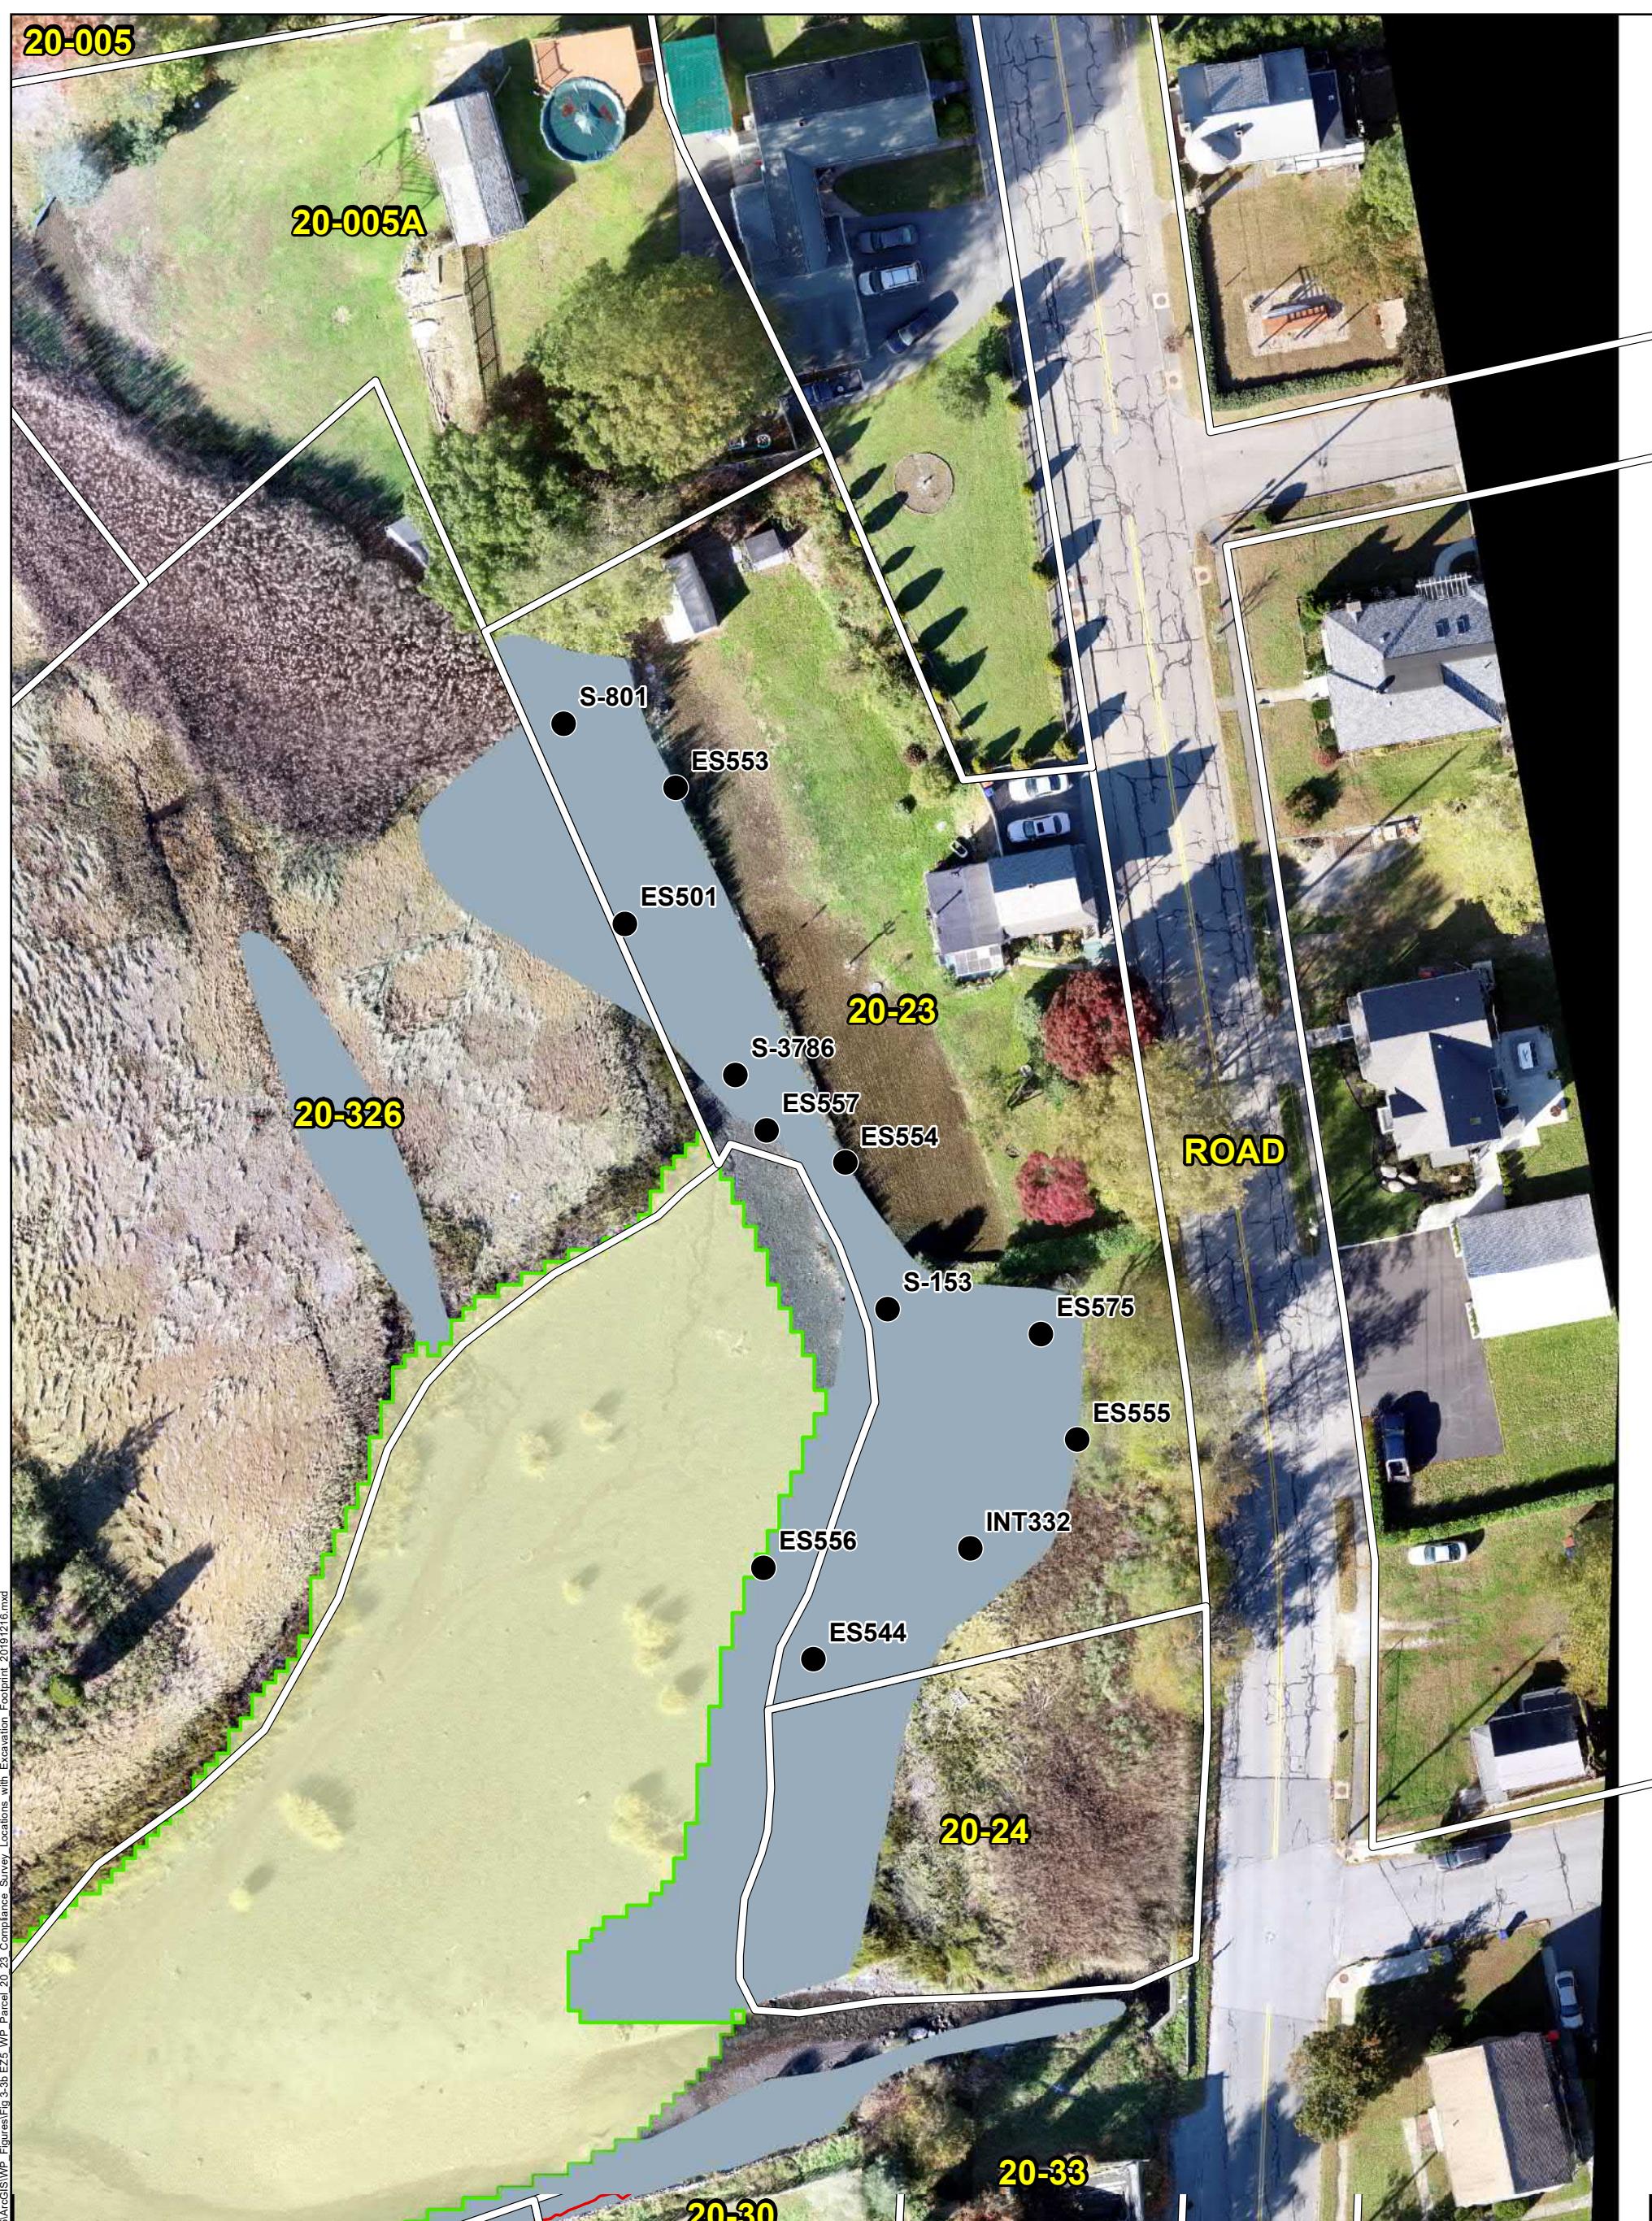
Figure 3-3b

Intertidal East Zone 5
Parcel 20-23
Compliance Survey Locations with
Excavation Footprint
(0-1 ft Depth Interval)
New Bedford Harbor Superfund Site
December 2019
