New Bedford Harbor Superfund Site

Draft Final Intertidal Work Plan for East Zone 5

ACE-J23-35BG6000-M1-0056|0

March 2020

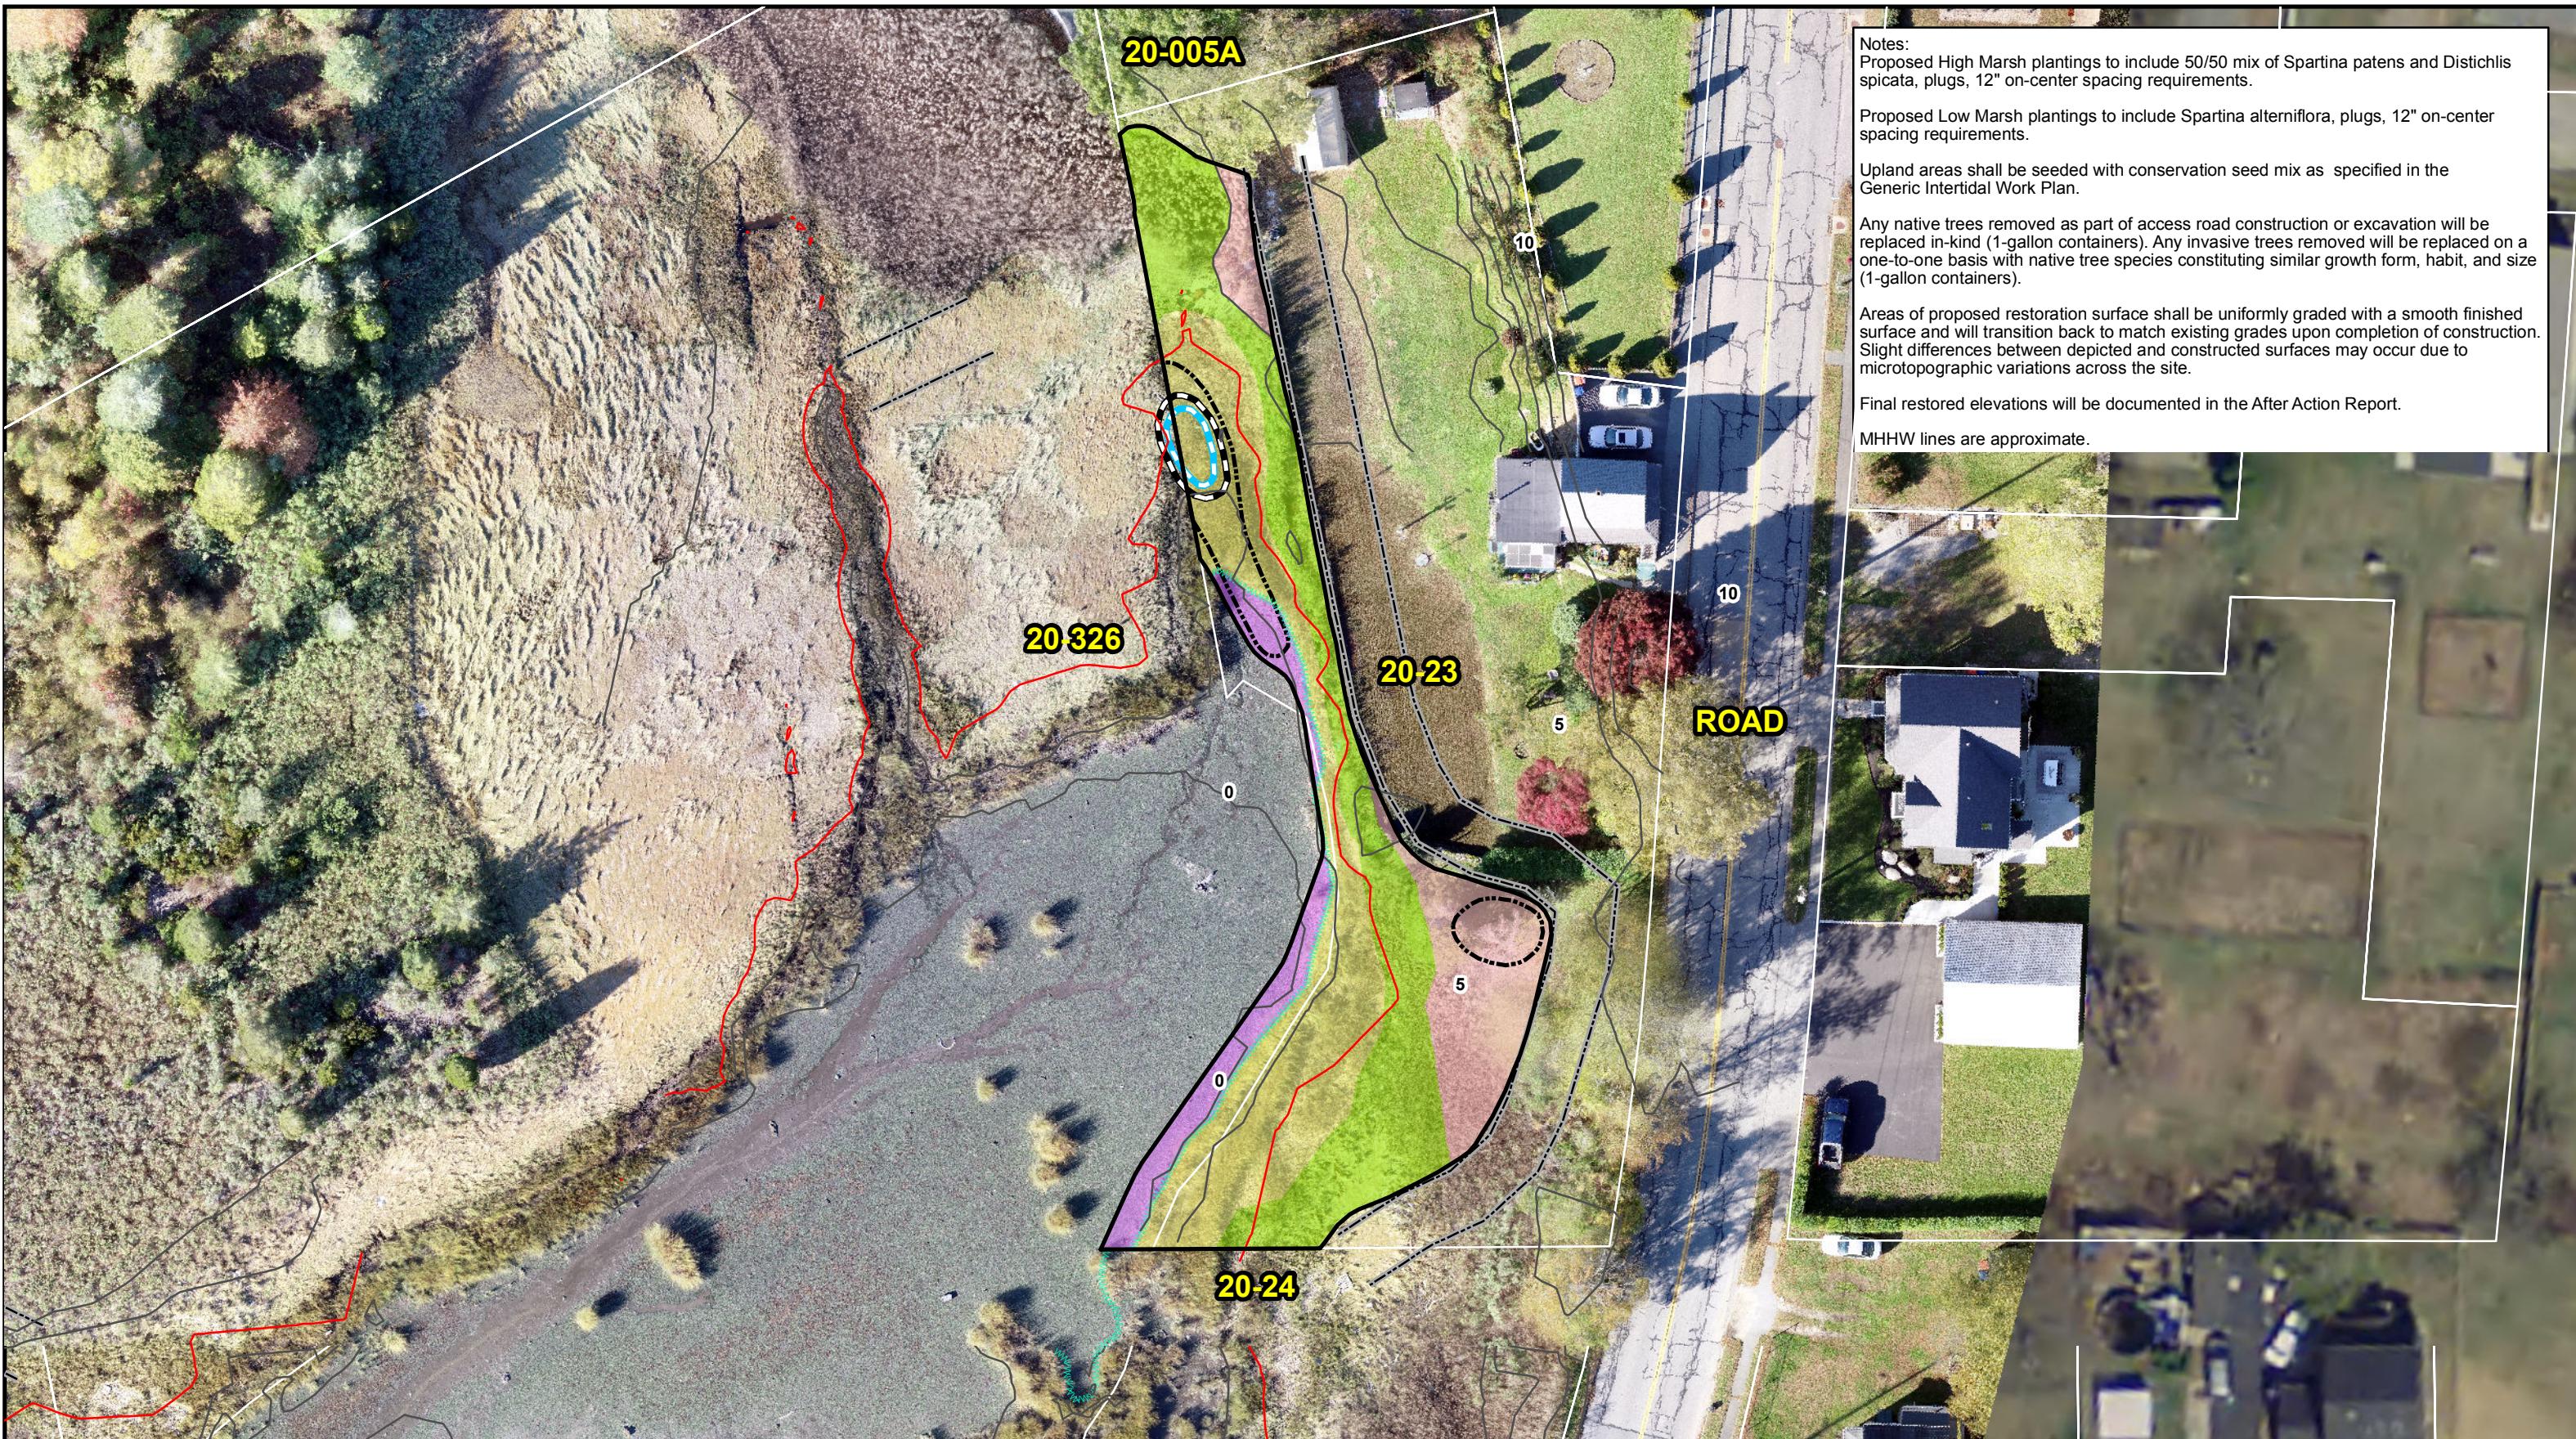
Figure 7-1b

Intertidal East Zone 5
Parcel 20-23
Proposed Wetland Cover Types and Topography
New Bedford Harbor Superfund Site

All excavated areas will be backfilled, regraded, and revegetated to best replicate the pre-remediation conditions. A pre-construction tree and shrub inventory of plants within the excavation and access road areas are included in [Appendix A](#). The pre-construction wetland cover conditions shown on [Figures 2-2a, 2-2b, 2-2c, and 2-2g](#) include several stands of the non-native invasive grass *Phragmites*. *Phragmites* that occurs within the excavation areas will be removed and disposed of with the excavated sediment and replaced with the appropriate wetland species. Restored vegetation types within the remediation area are shown in plan view in [Figures 7-1a through 7-1g](#). A rip rap apron will be installed adjacent to Parcel 20-33 to slow storm water flow from the culvert under Sycamore Street ([Figure 7-1d](#)). The estimated volume of material to be removed to construct this apron (about 4 cy) is included in the total volume of sediment to be removed as presented in Section 3.2. A conceptual as-built cross section is provided in [Figure 7-2](#) and construction cross sections are provided in [Appendix B](#). The existing and proposed post-restoration acreages of each cover type are provided in [Tables 7-1a through 7-1g](#). Shrub species identified for restoration on Parcel 20-29 are included in [Table 7-2](#). Plantings notes are included in [Figures 7-1a through 7-1g](#).

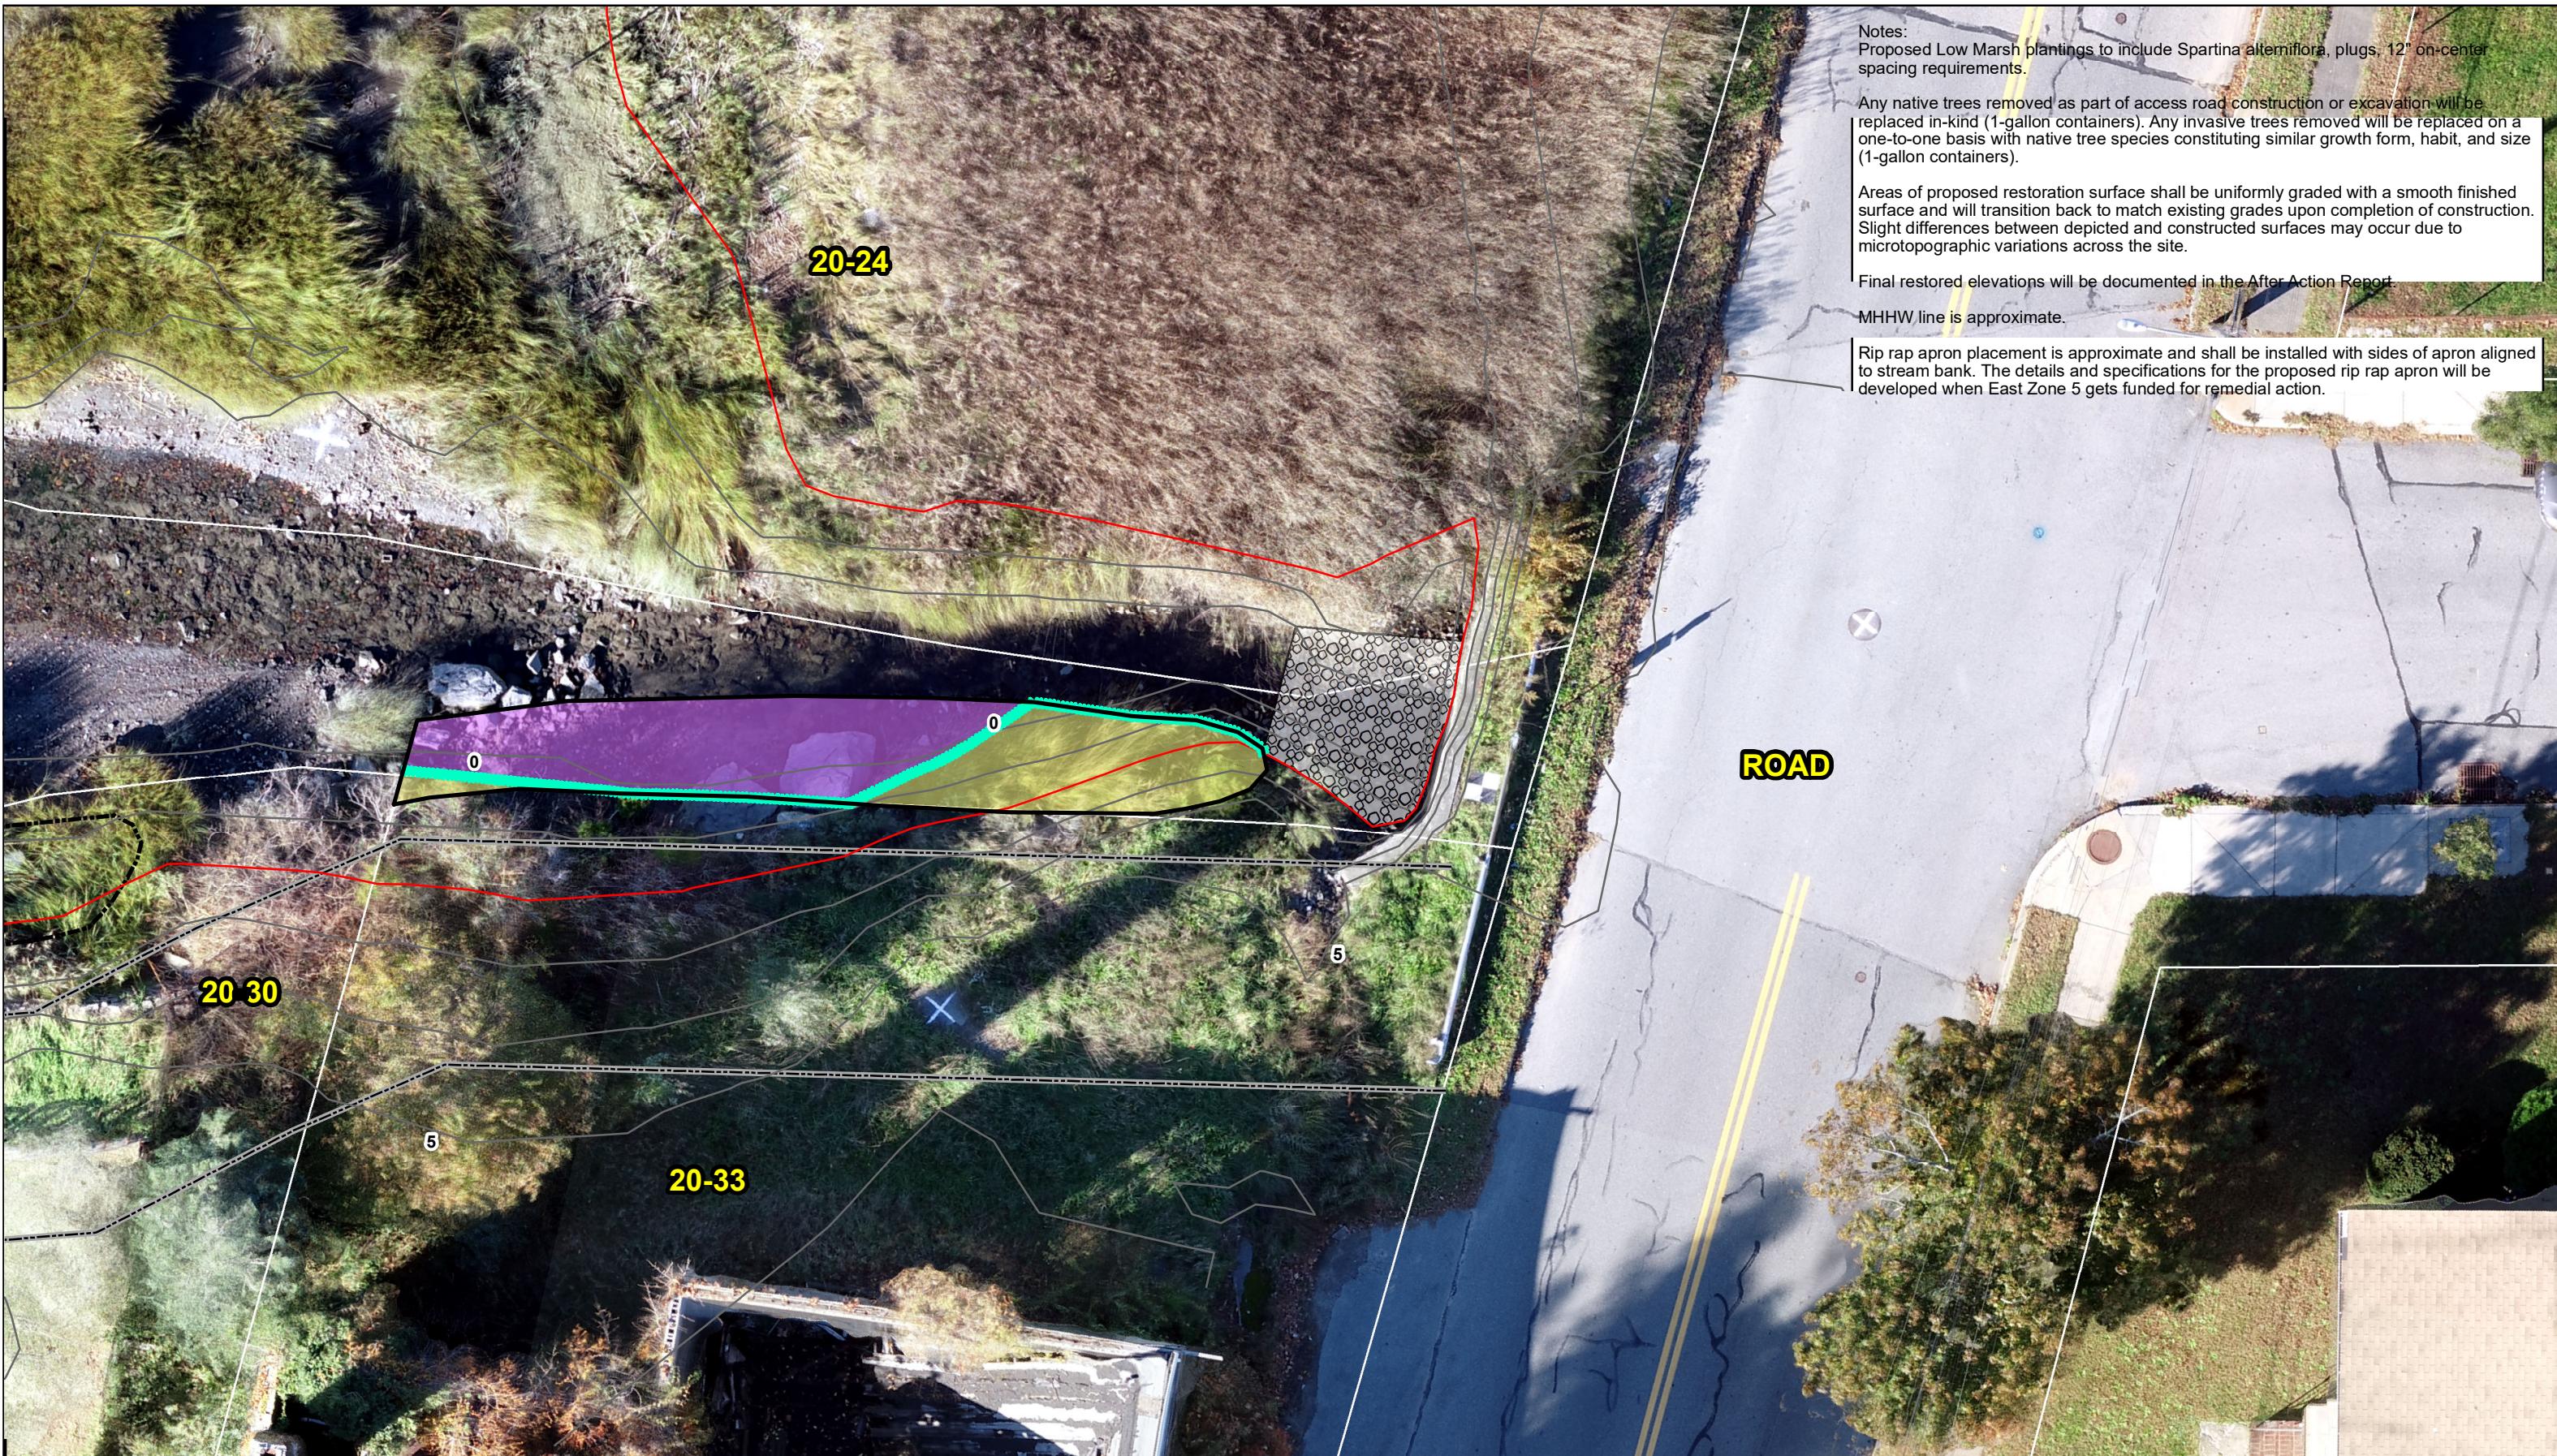
Figure 7-1d

**Intertidal East Zone 5
Parcel 20-33
Proposed Wetland Cover Types and Topography**
New Bedford Harbor Superfund Site

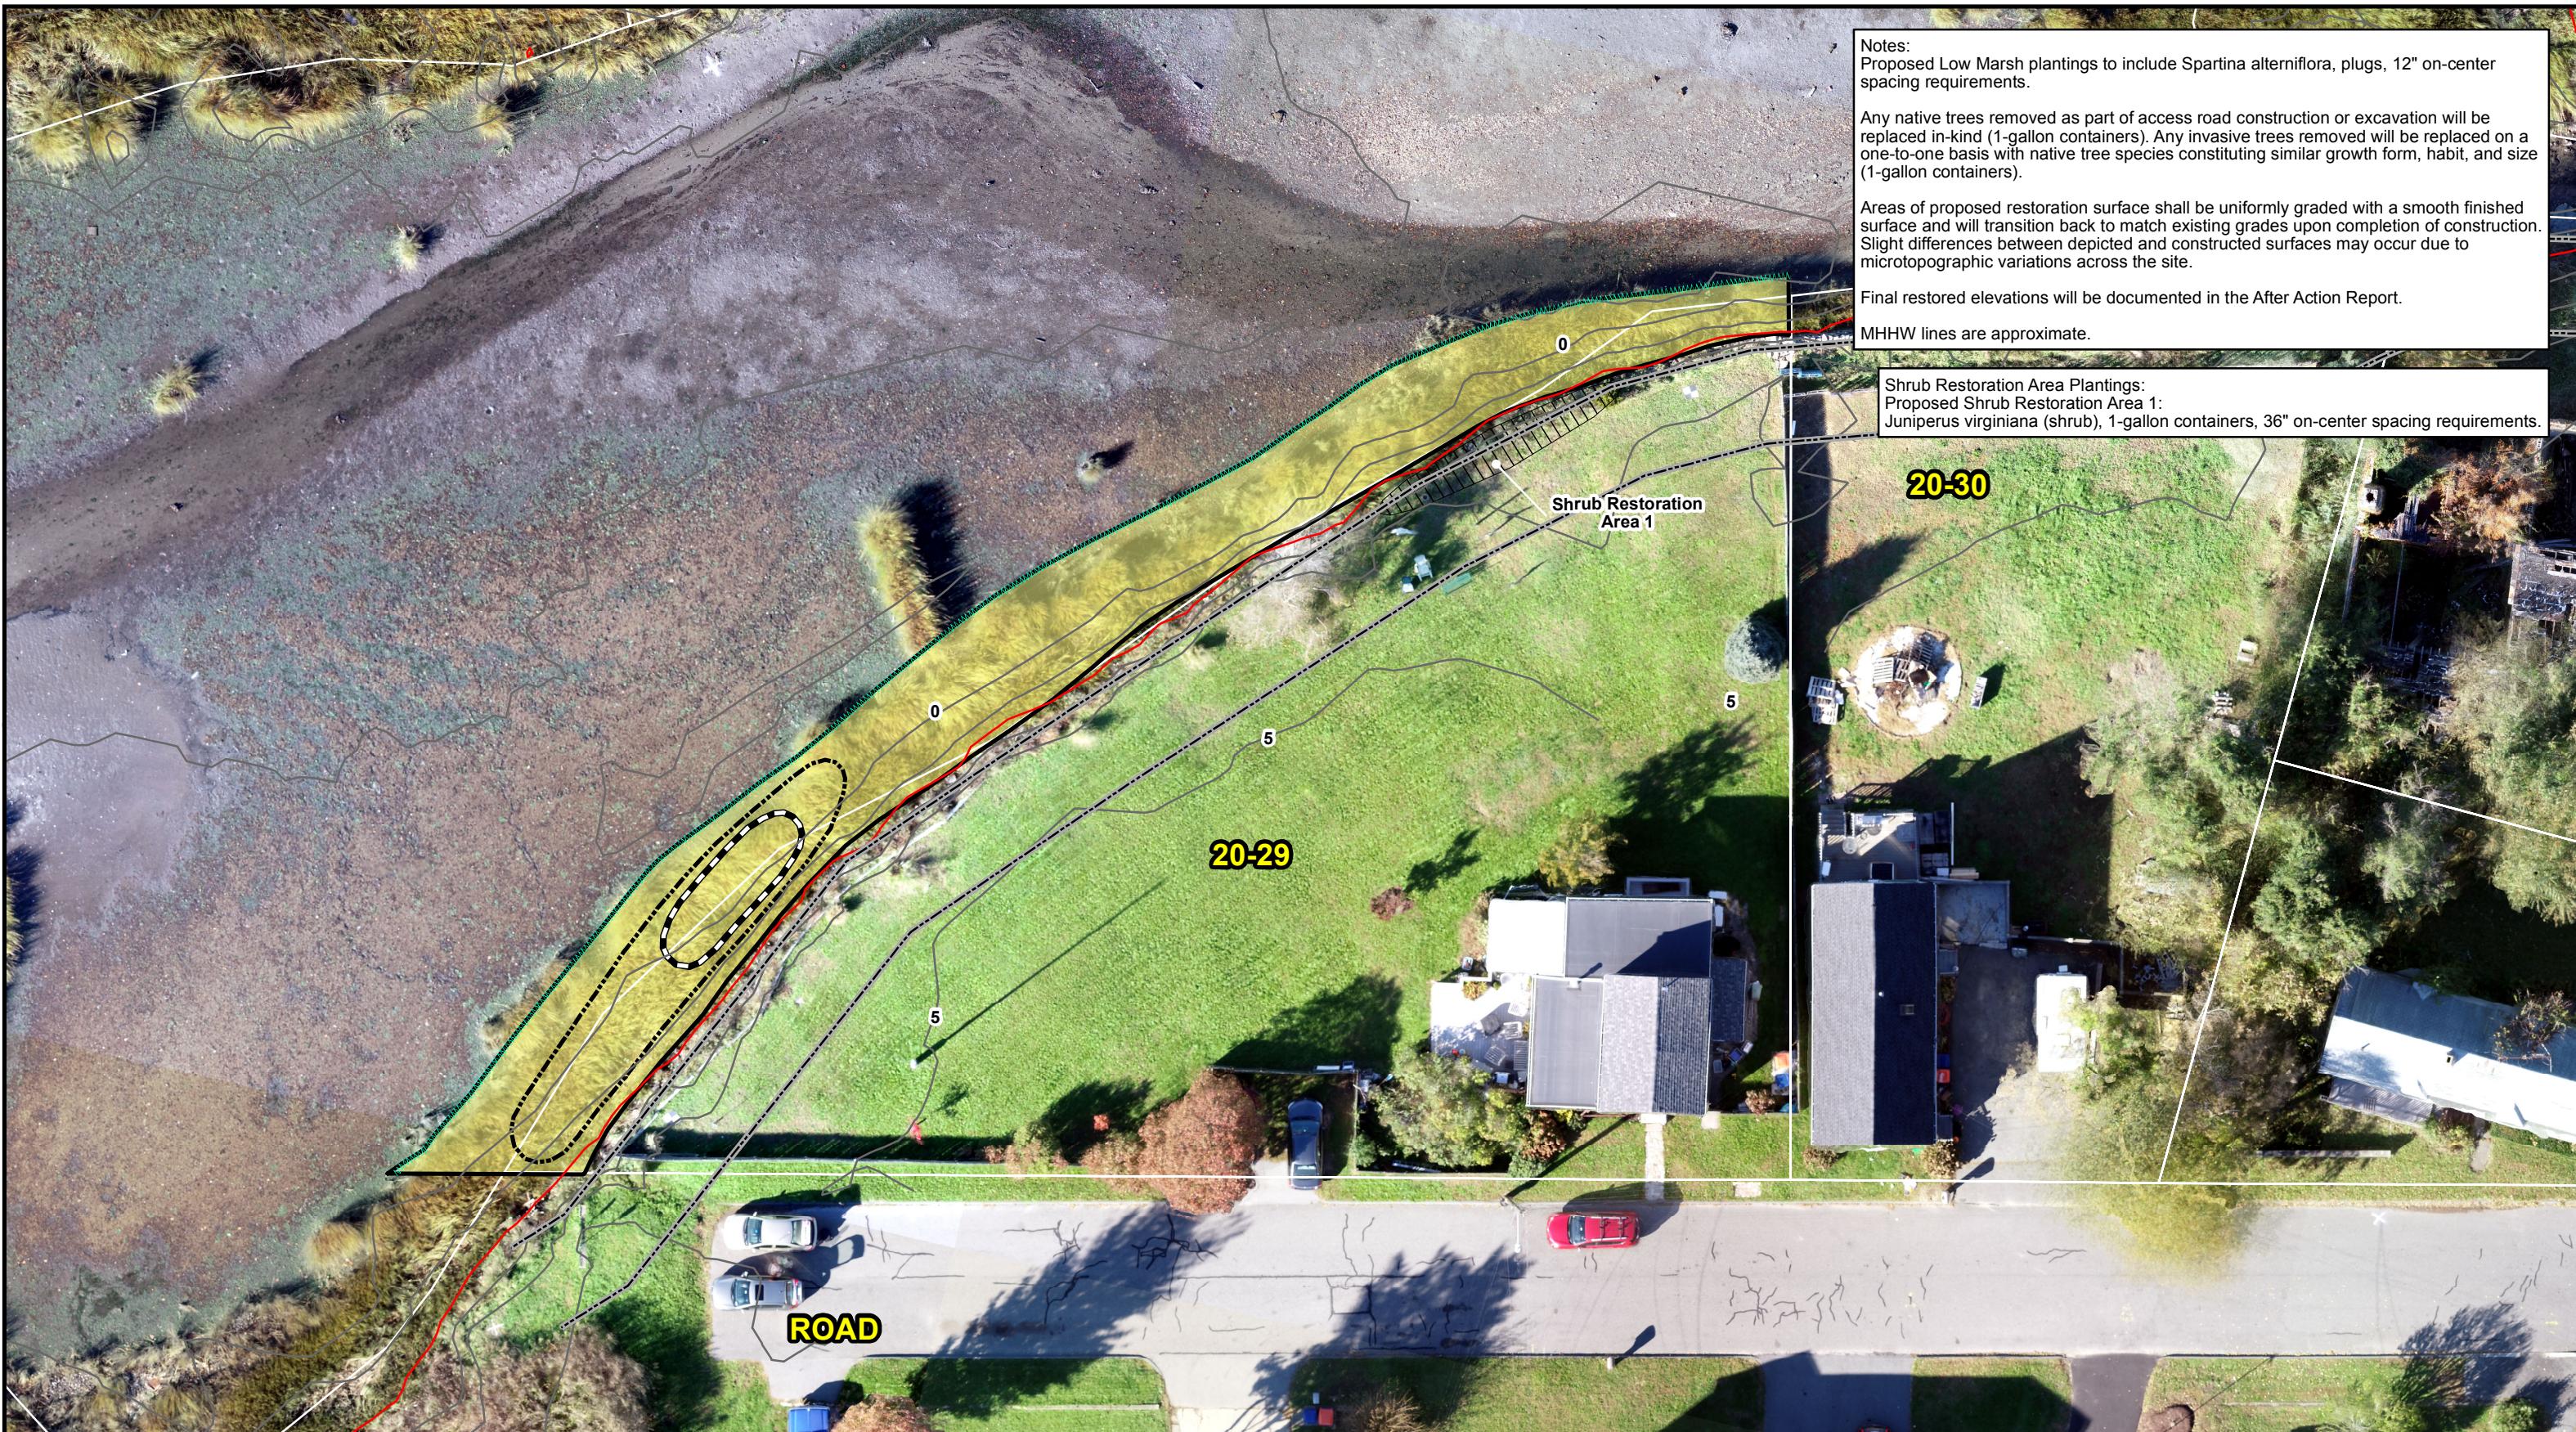
Figure 7-1f

**Intertidal East Zone 5
Parcel 20-29**

Proposed Wetland Cover Types and Topography

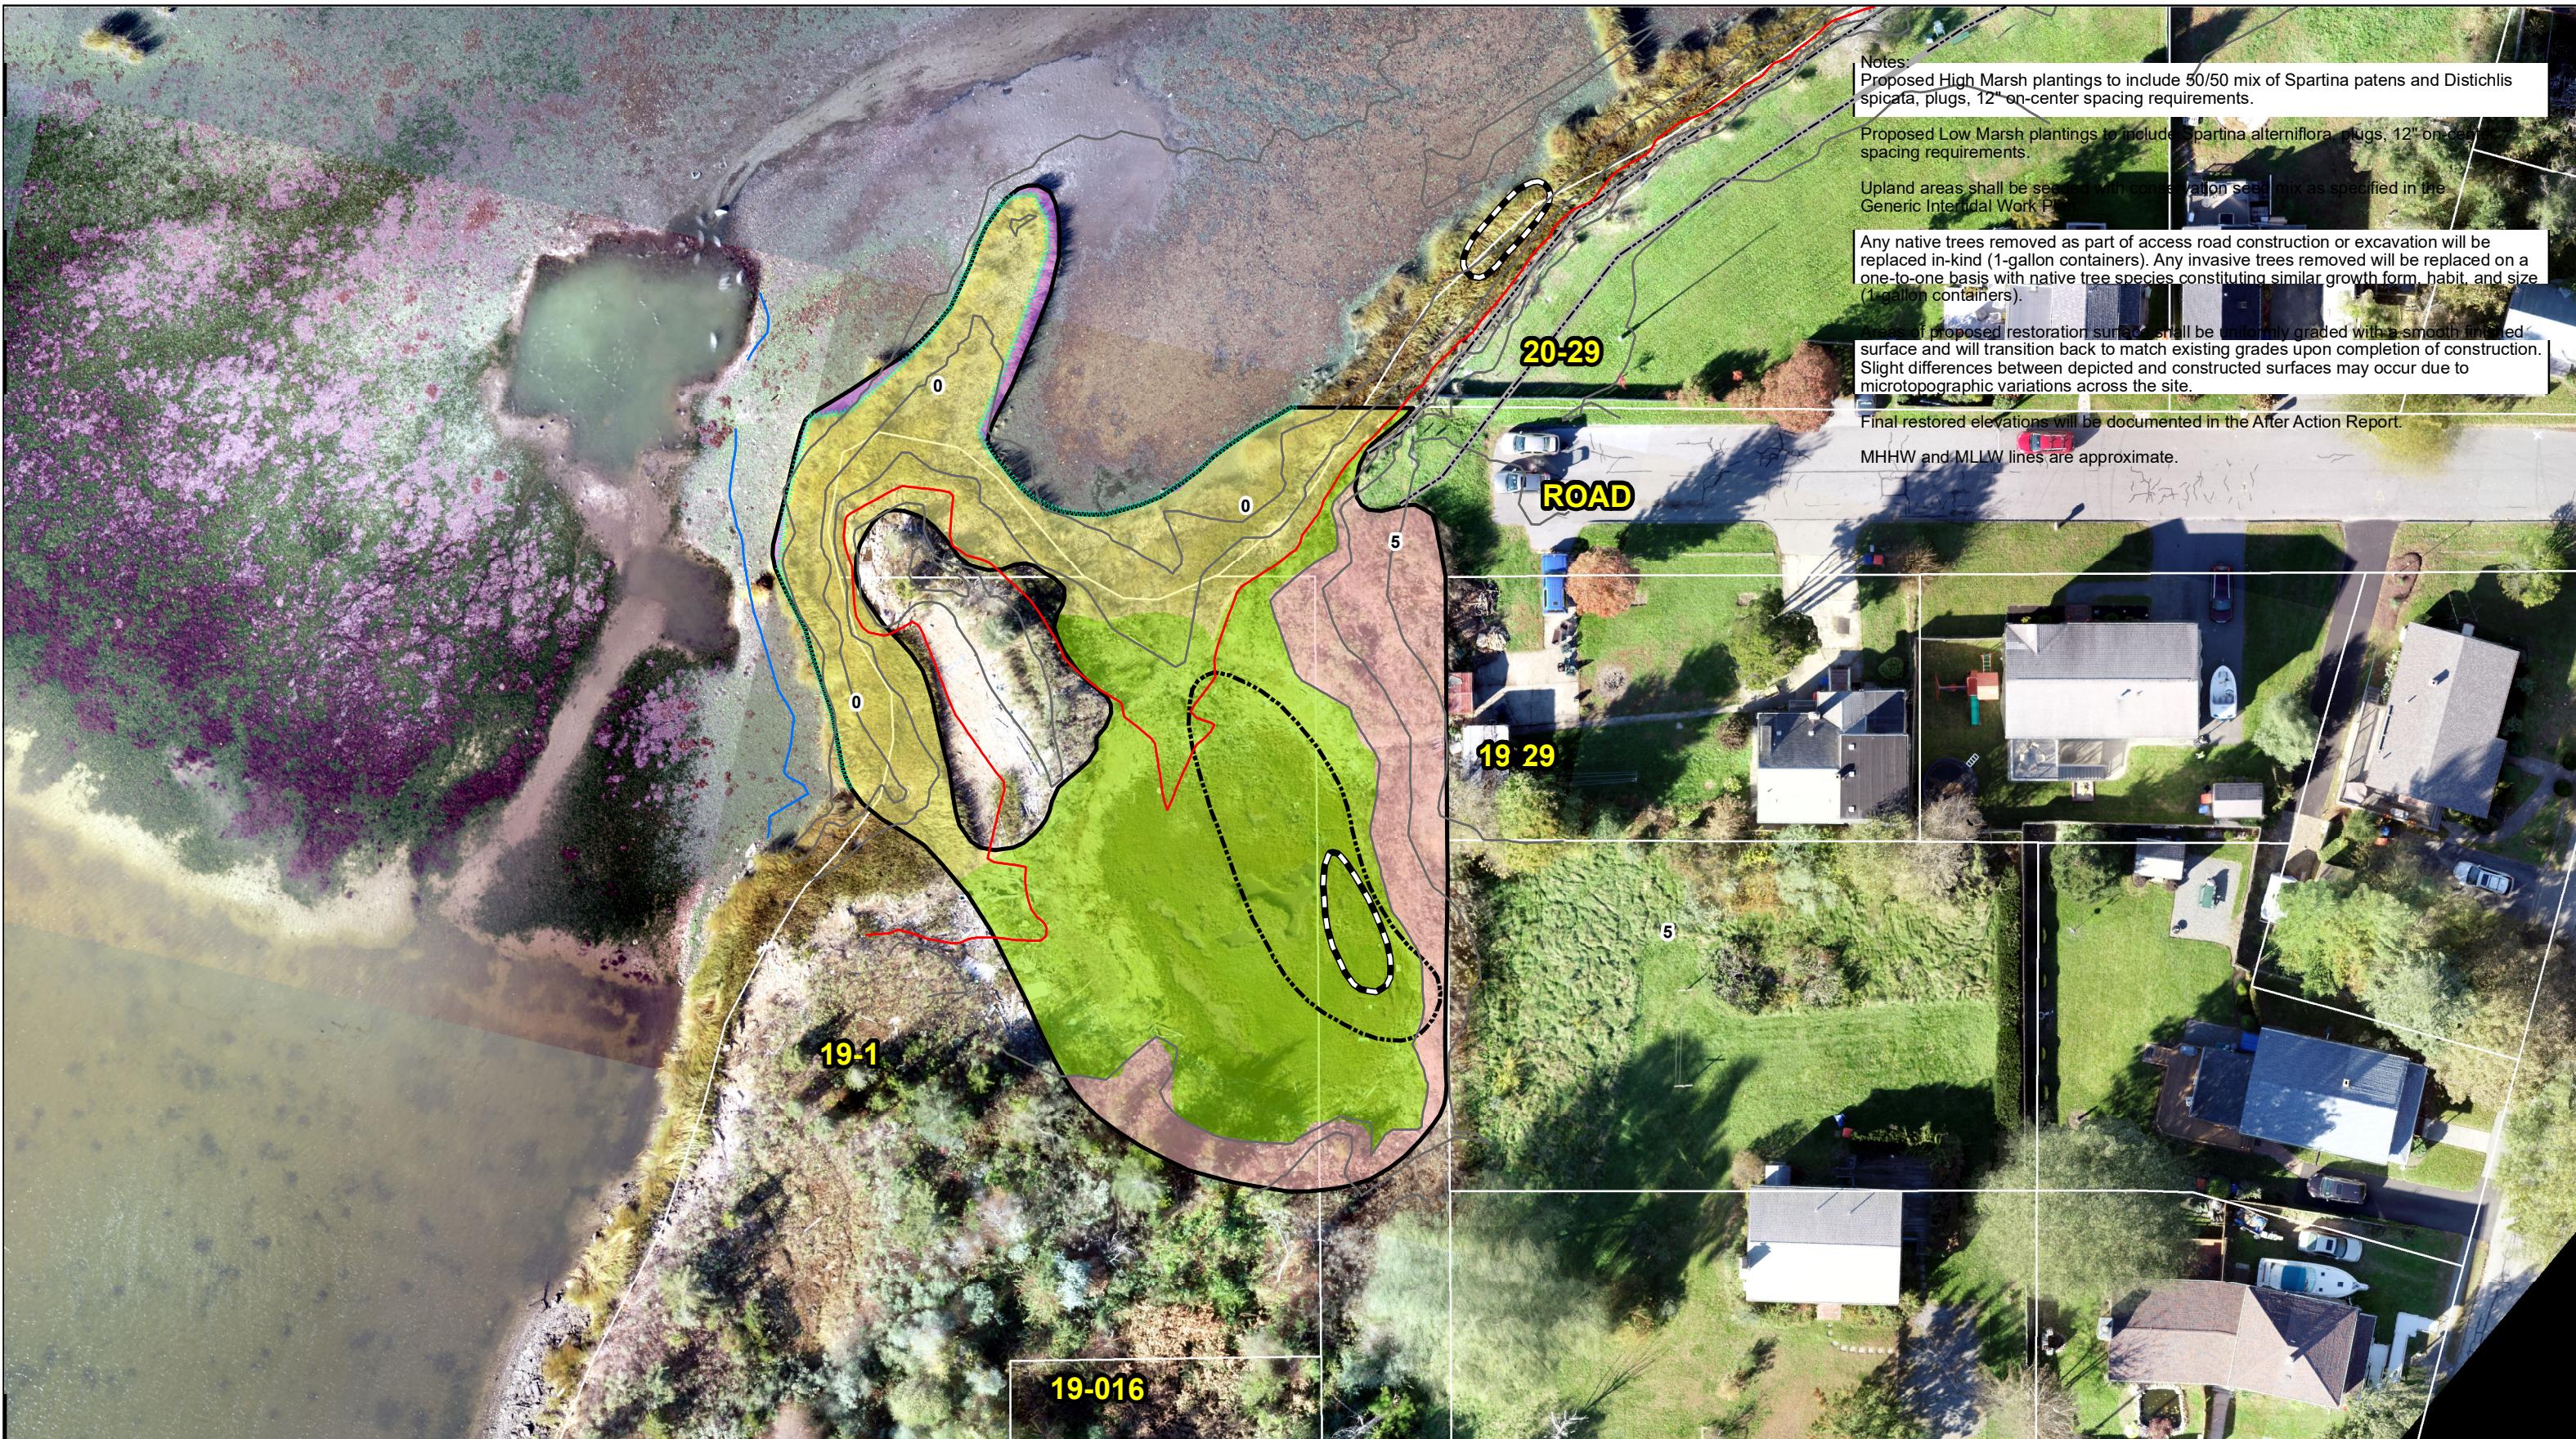
Figure 7-1g

Intertidal East Zone 5
Parcel 19-1 and ROW
Existing Vegetation, Topography, and Excavation Areas
New Bedford Harbor Superfund Site

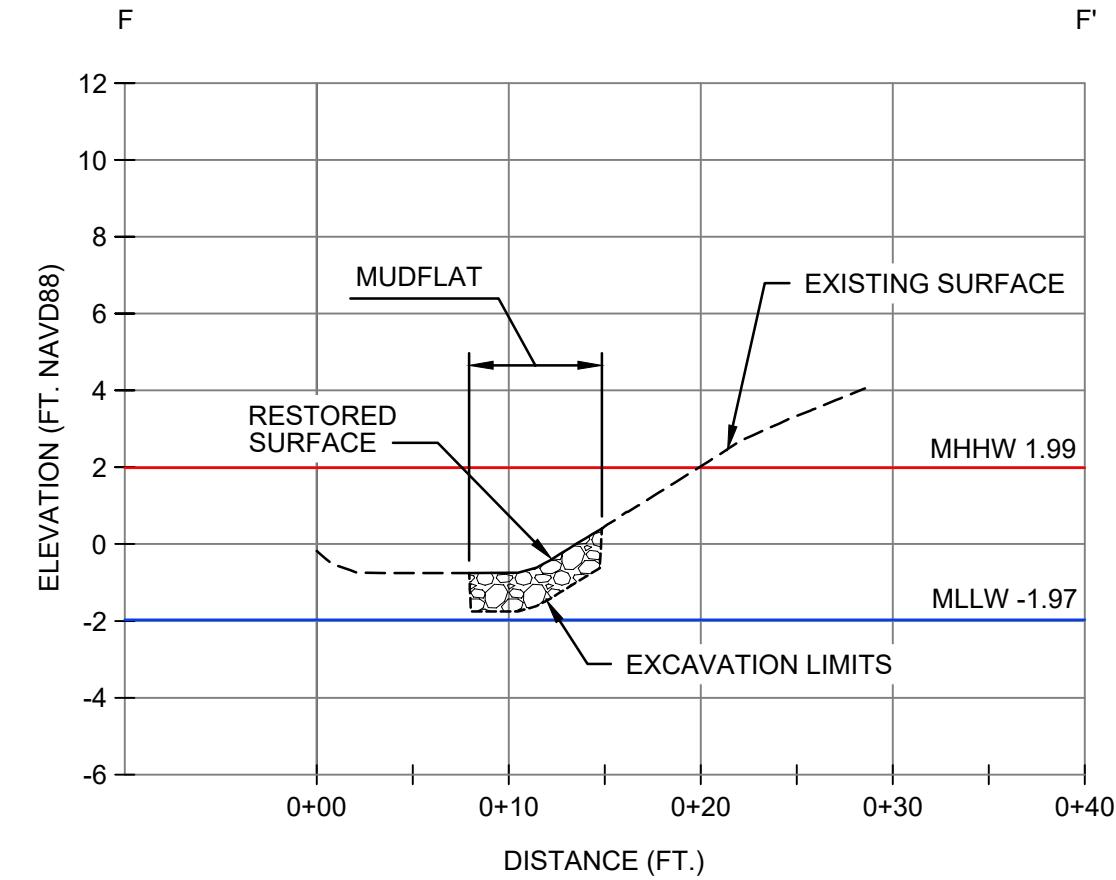
- MLLW -1.97 (blue line)
- MHHW 1.99 (red line)
- GRAVEL BACKFILL (hatched square)

1. MUDFLATS WILL BE BACKFILLED TO PRE-EXCAVATION ELEVATIONS.

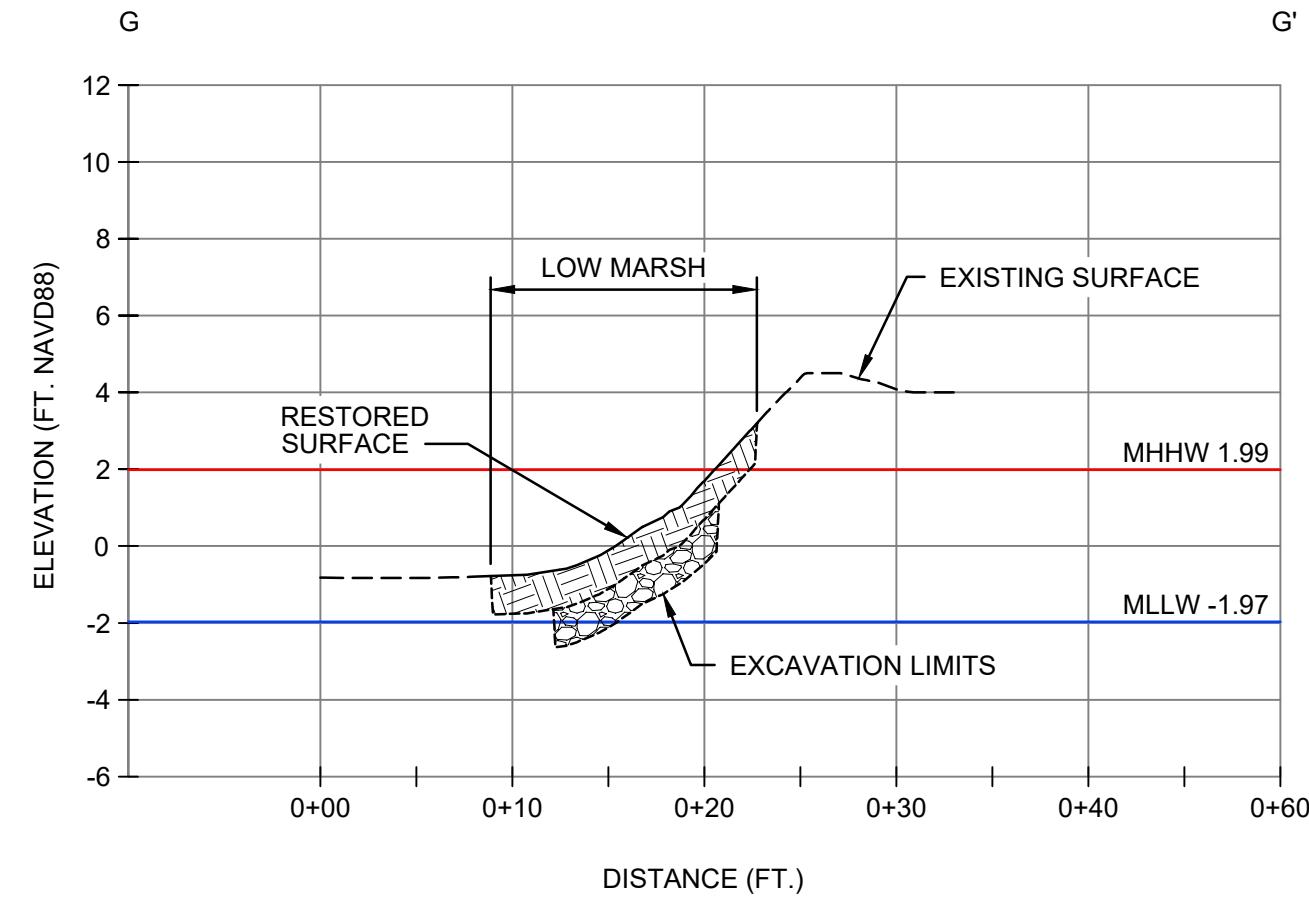
- MLLW -1.97
- MHHW 1.99
- TOPSOIL BACKFILL
- GRAVEL BACKFILL

- COIR LOG WILL BE INSTALLED AT THE SEAWARD EDGE OF THE RESTORED LOW MARSH.

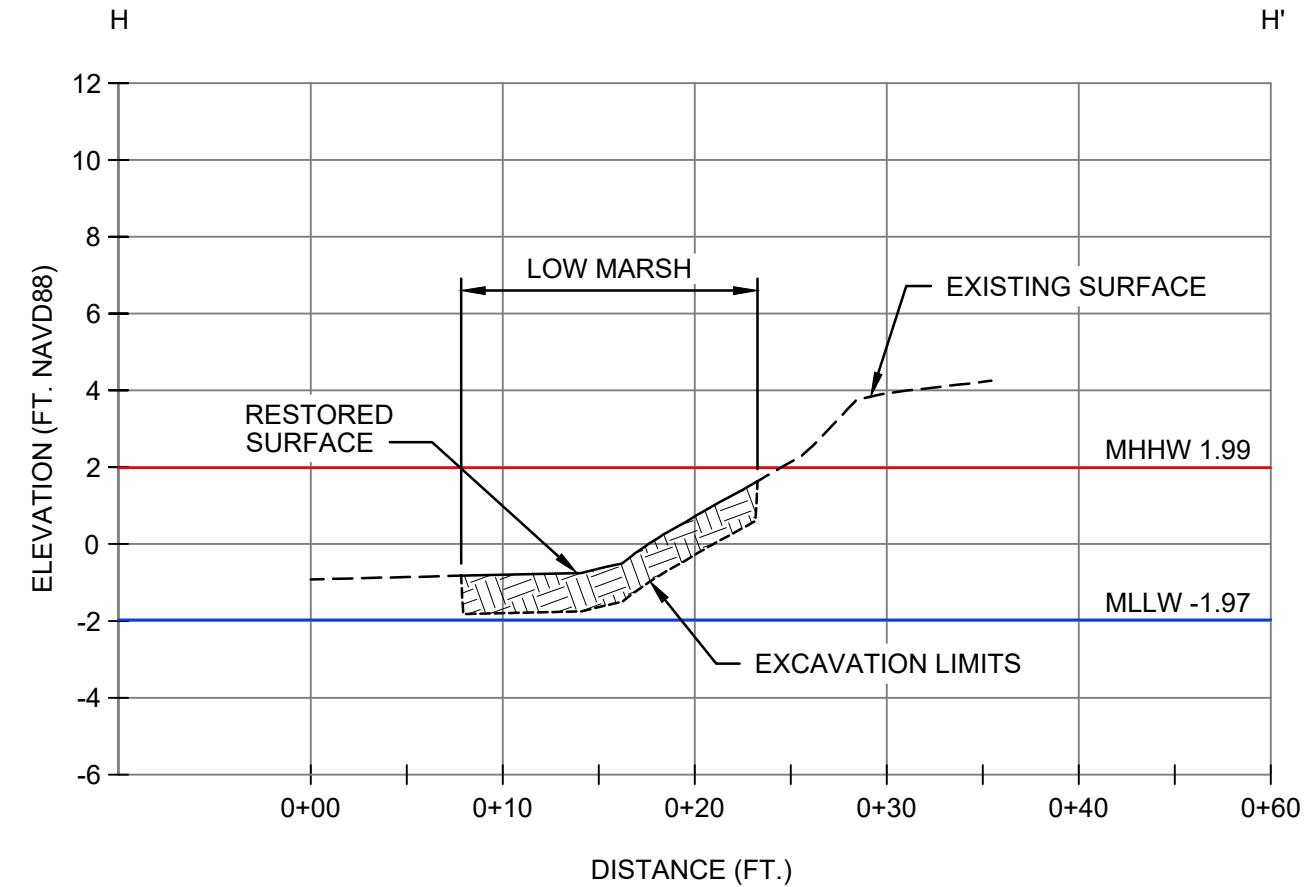
- MLLW -1.97
- MHHW 1.99
- ▨ TOPSOIL BACKFILL

1. COIR LOG WILL BE INSTALLED AT THE SEAWARD EDGE OF THE RESTORED LOW MARSH.

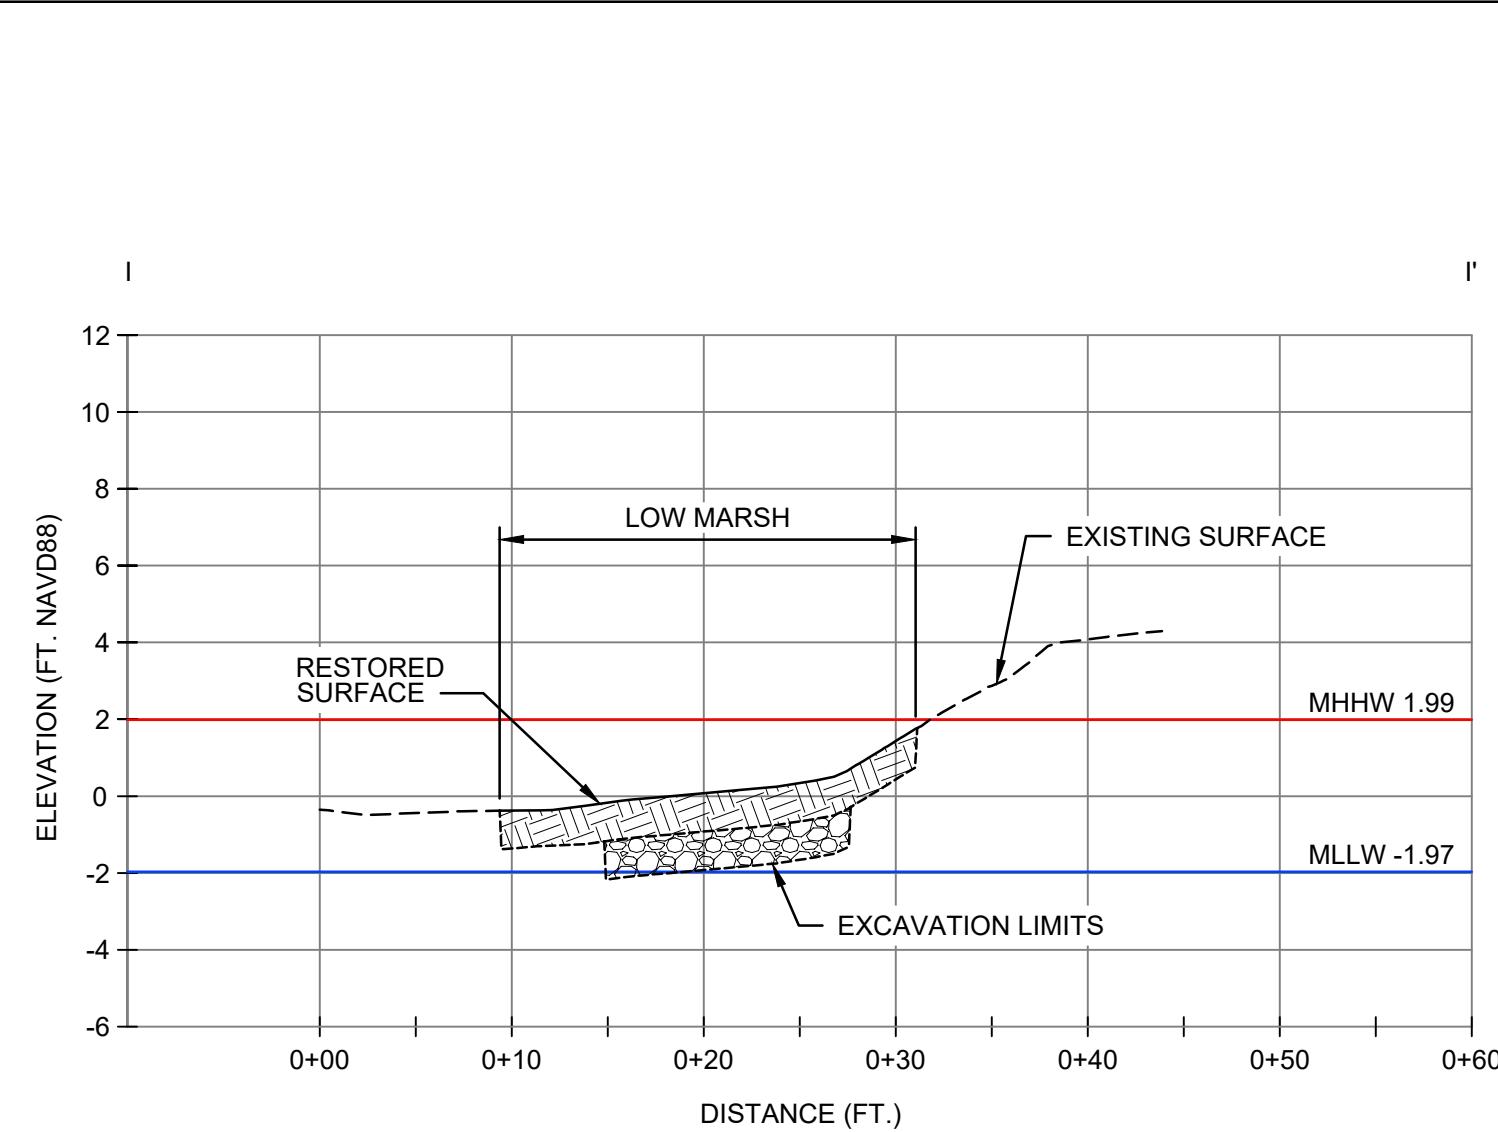
- MLLW -1.97
- MHHW 1.99
- TOPSOIL BACKFILL
- GRAVEL BACKFILL

- COIR LOG WILL BE INSTALLED AT THE SEAWARD EDGE OF THE RESTORED LOW MARSH.
