New Bedford Harbor Superfund Site Virtual Public Meeting

January 13th, 2021

Review of 2020 Accomplishments

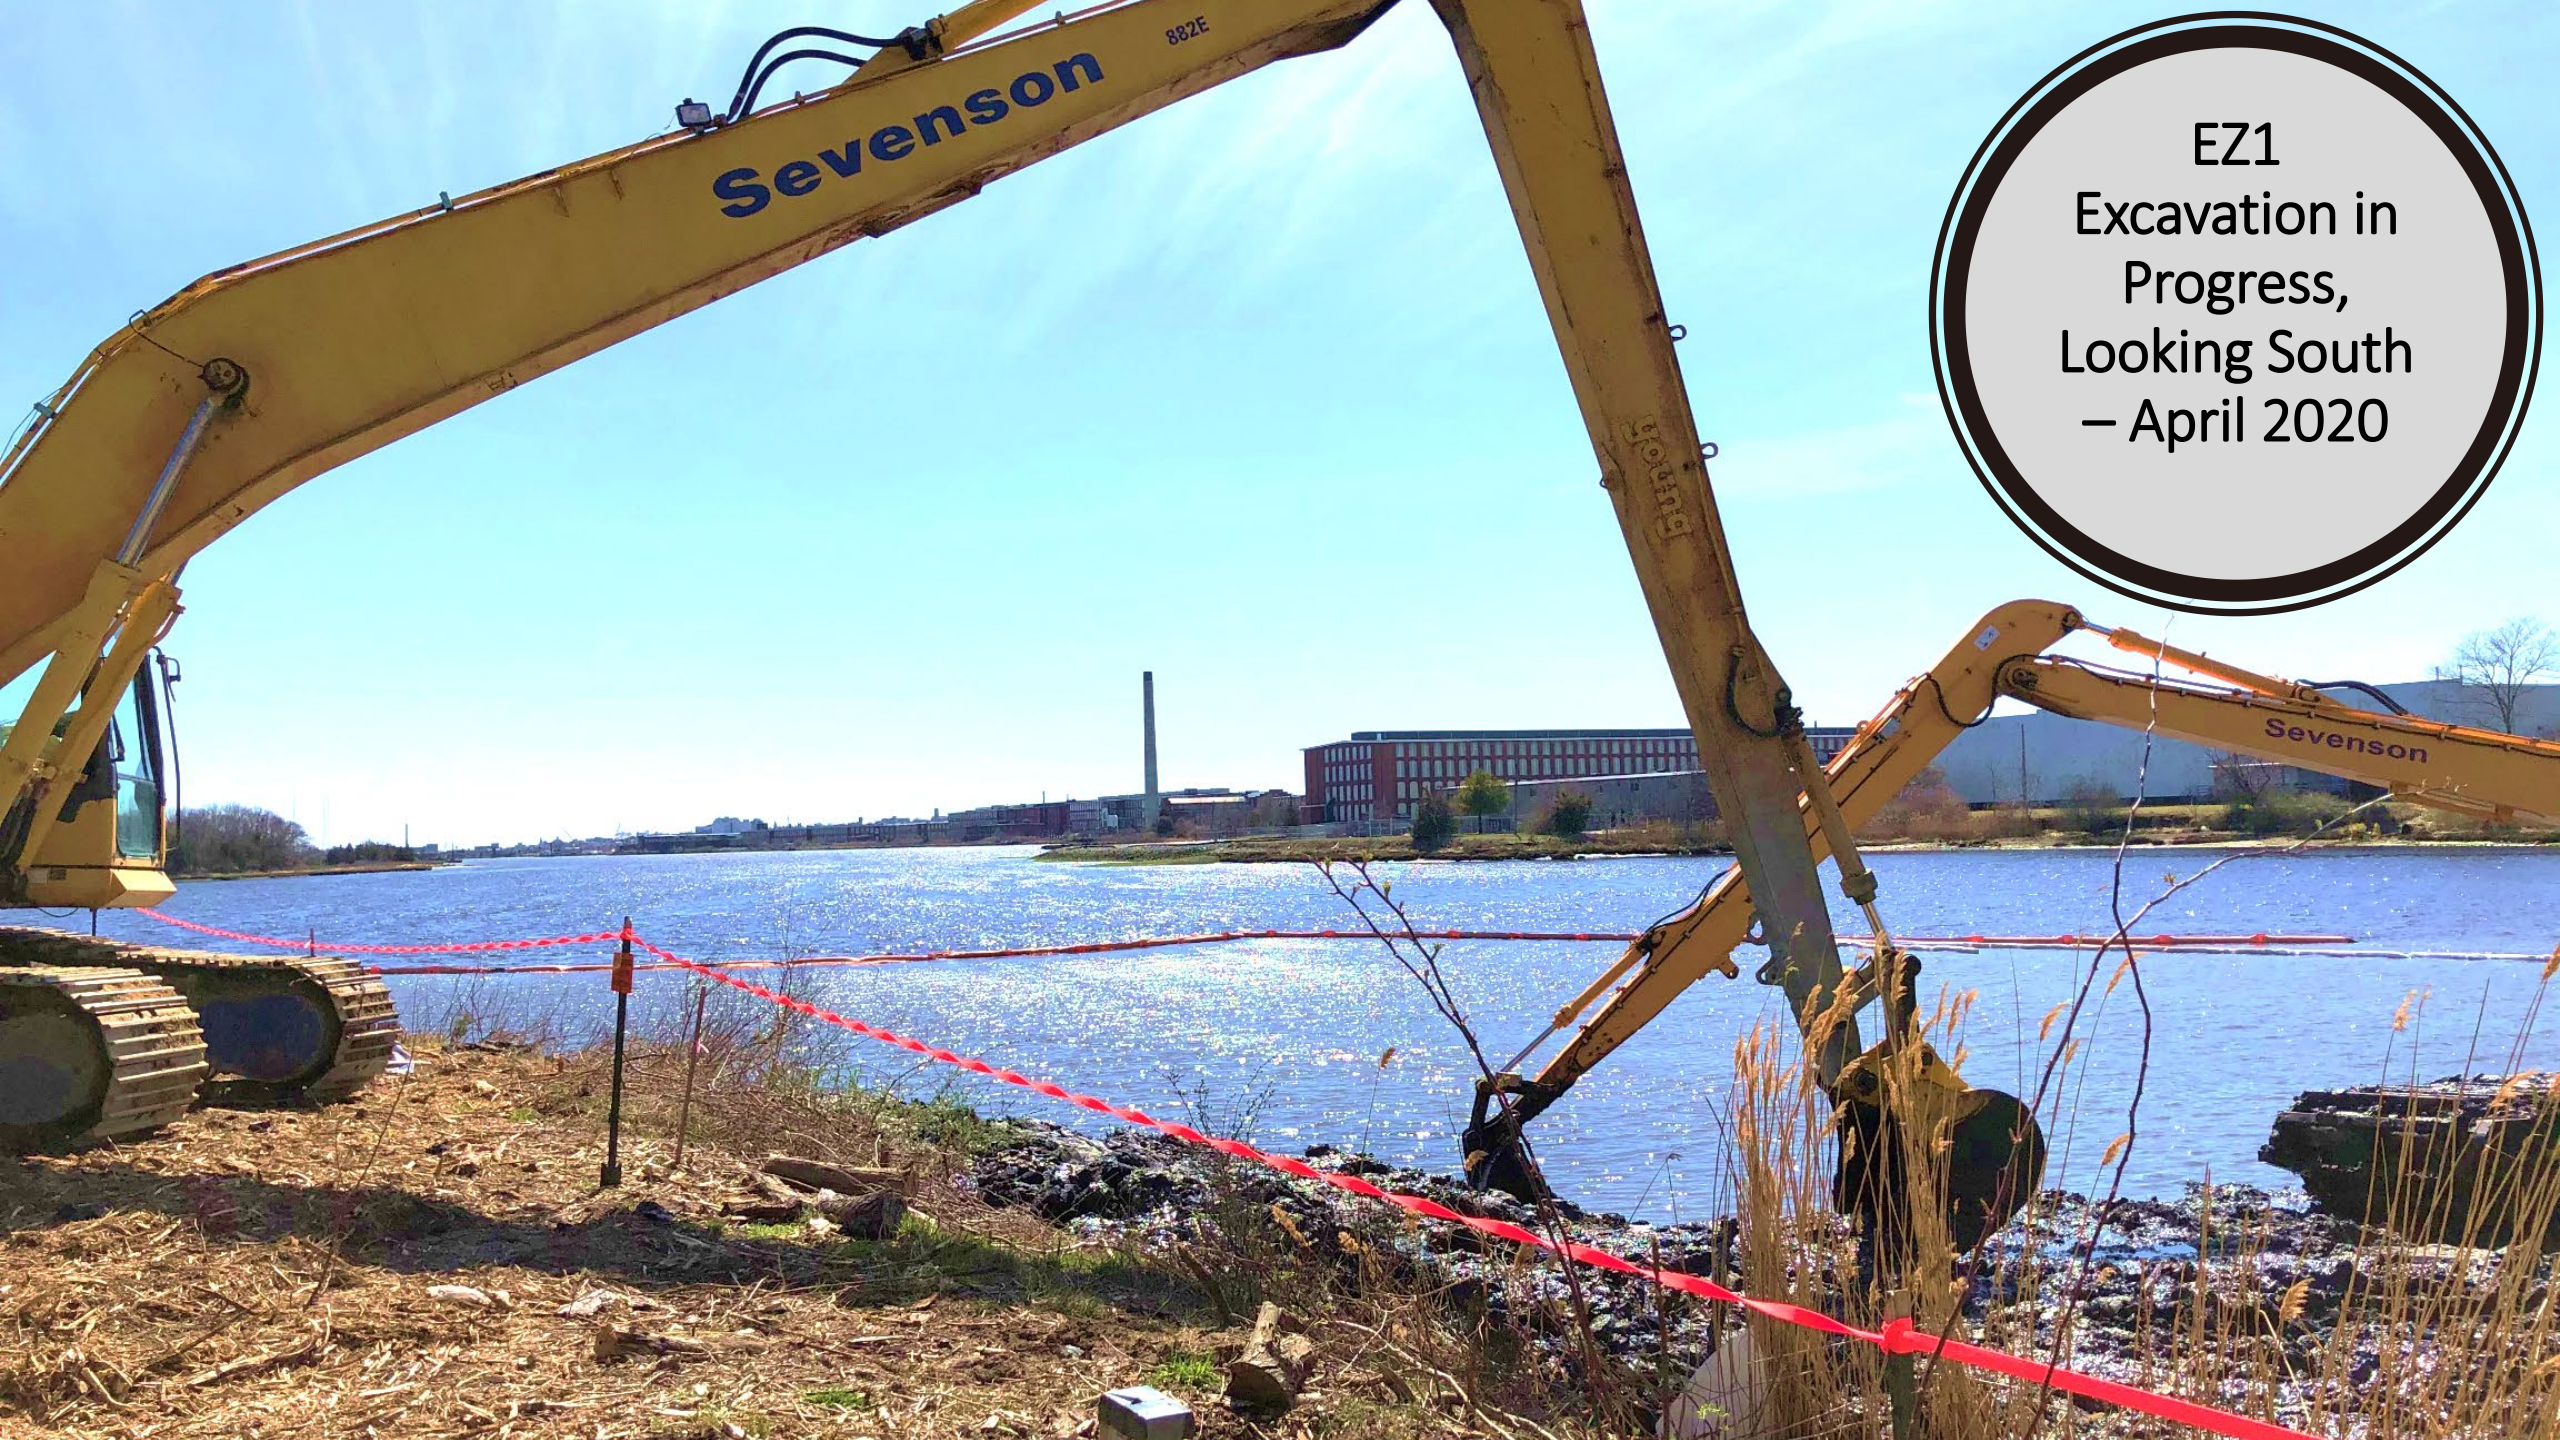
EZ1
Excavation in
Progress,
Looking South
– April 2020

<u>Before Excavation</u>	<u>After Excavation, <i>Prior to Backfill</i></u>	<u>After Excavation, <i>After Backfill</i></u>
Top foot average	1,427	1.8	0.01 (ND)
Top foot maximum	21,000	8	0.01 (ND)

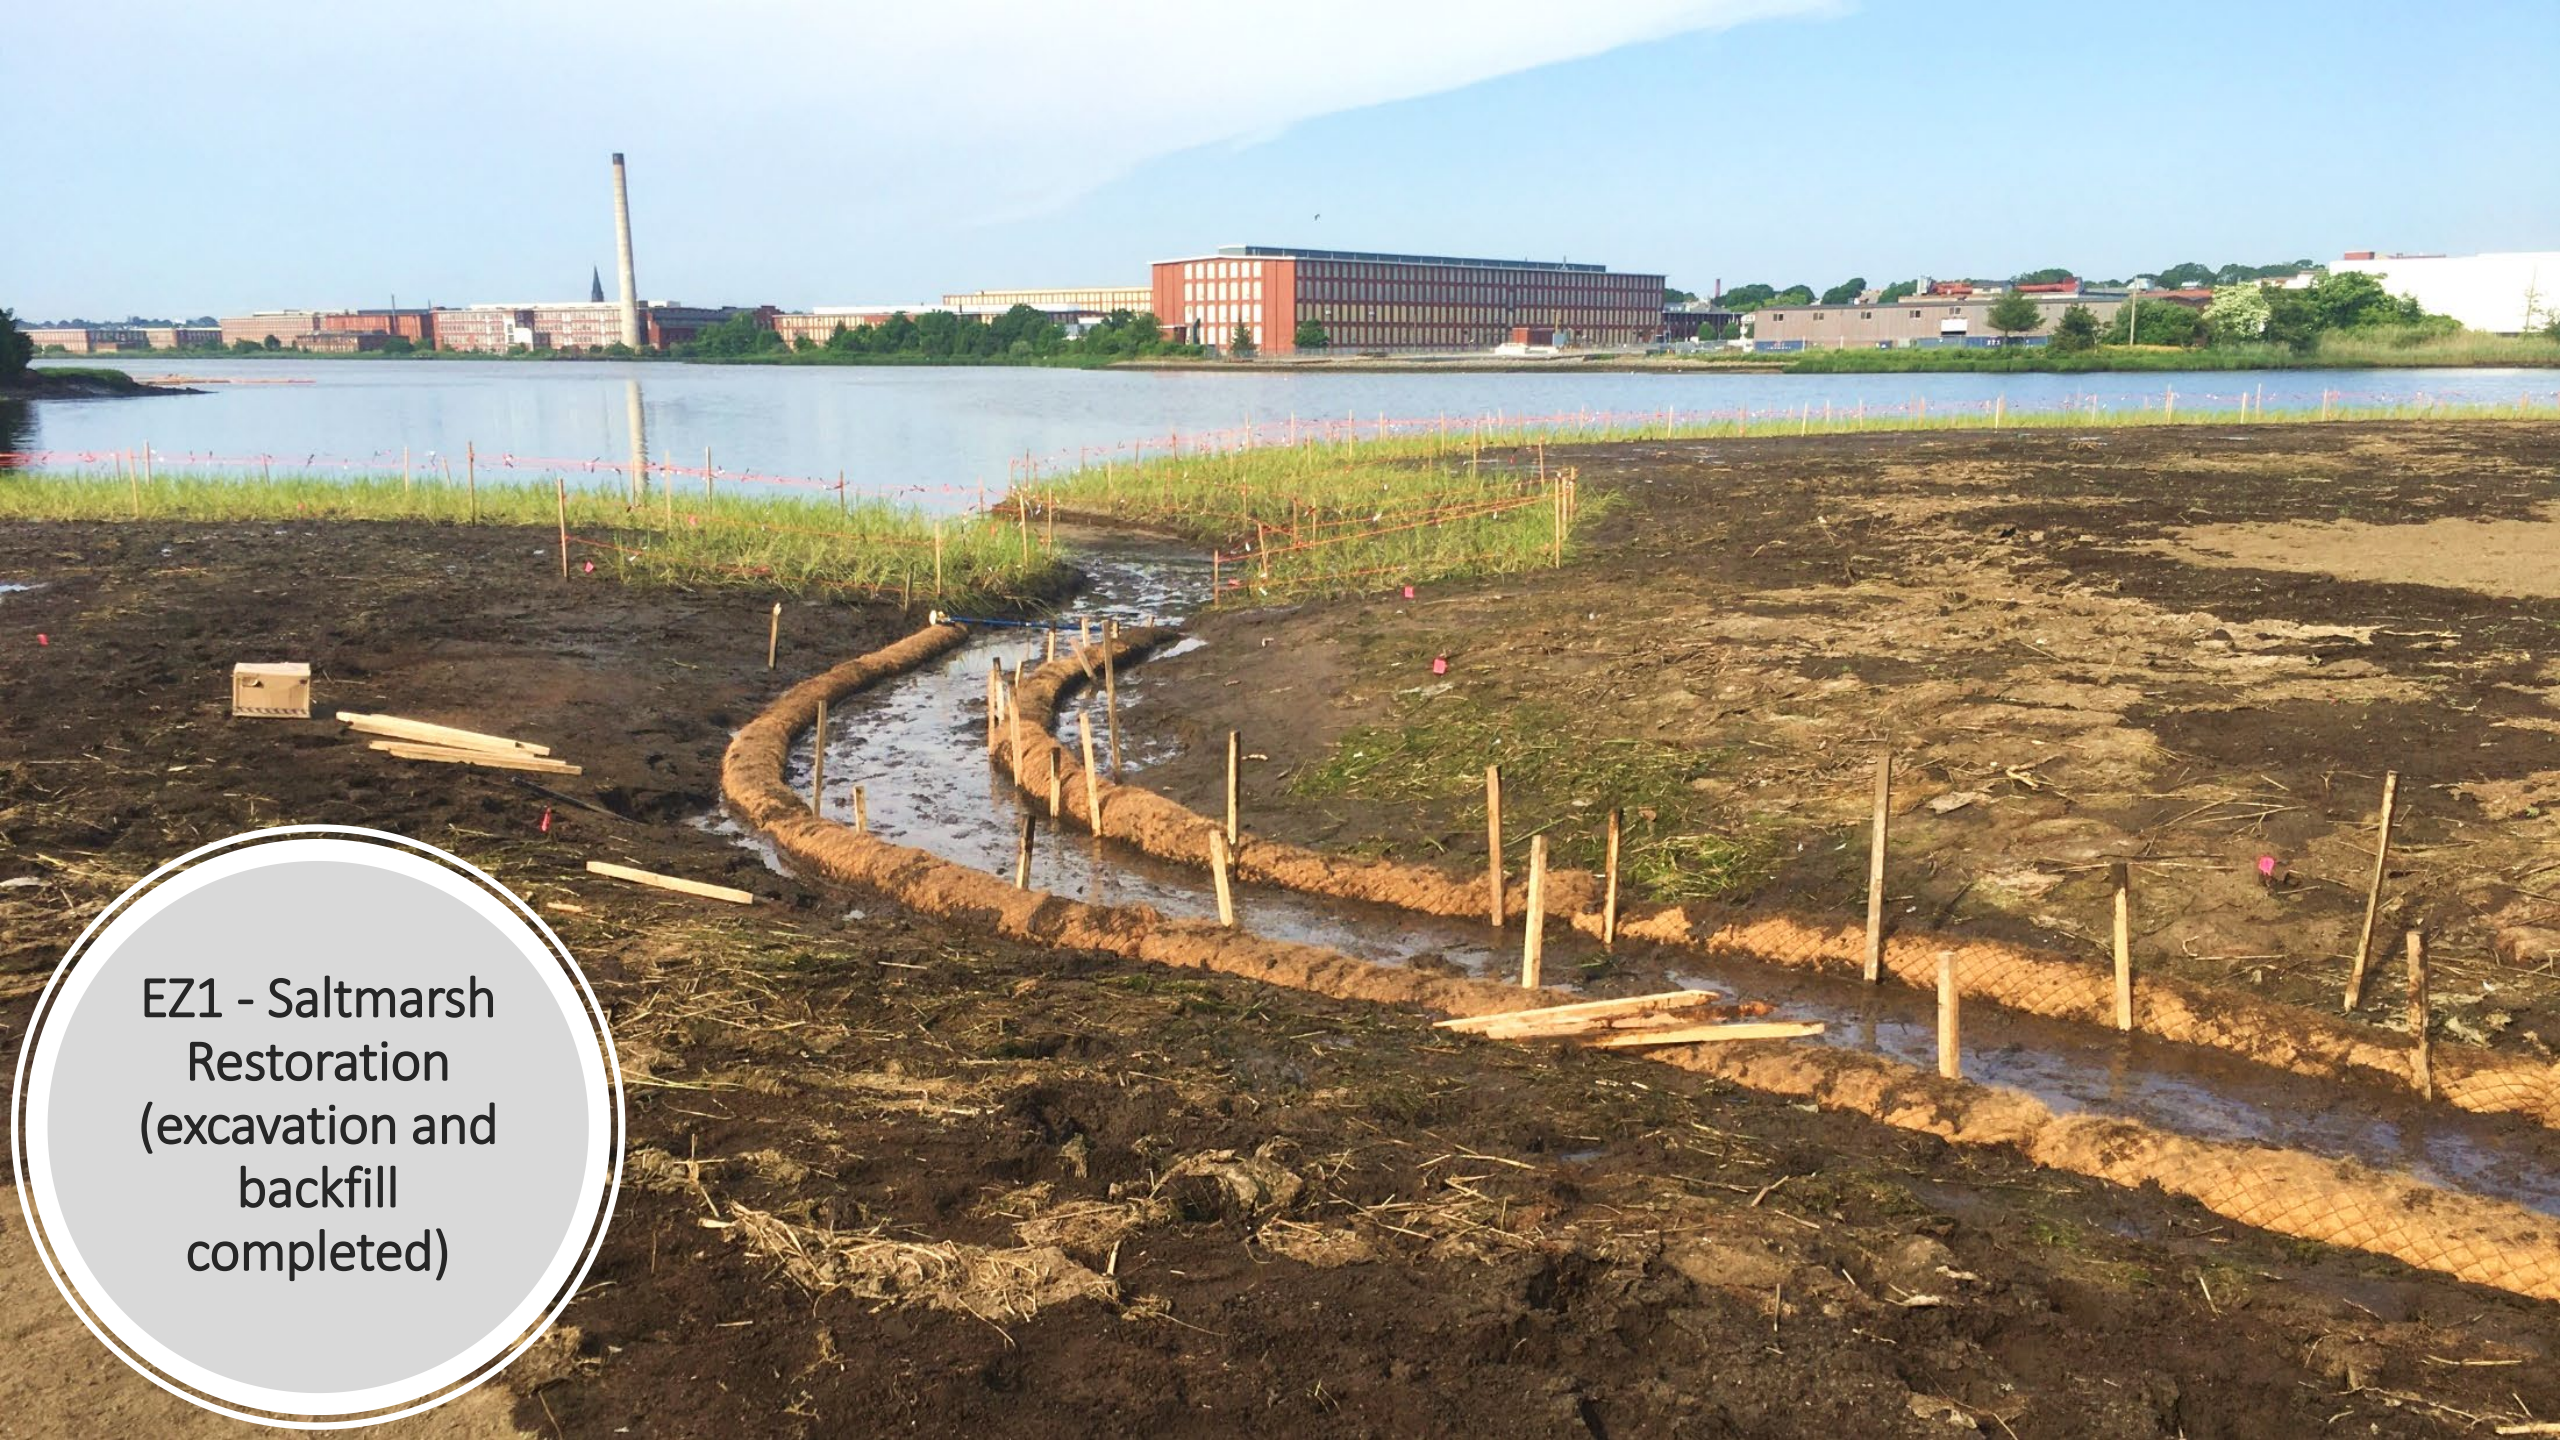
EZ1 - Saltmarsh
Restoration
(excavation and
backfill
completed)

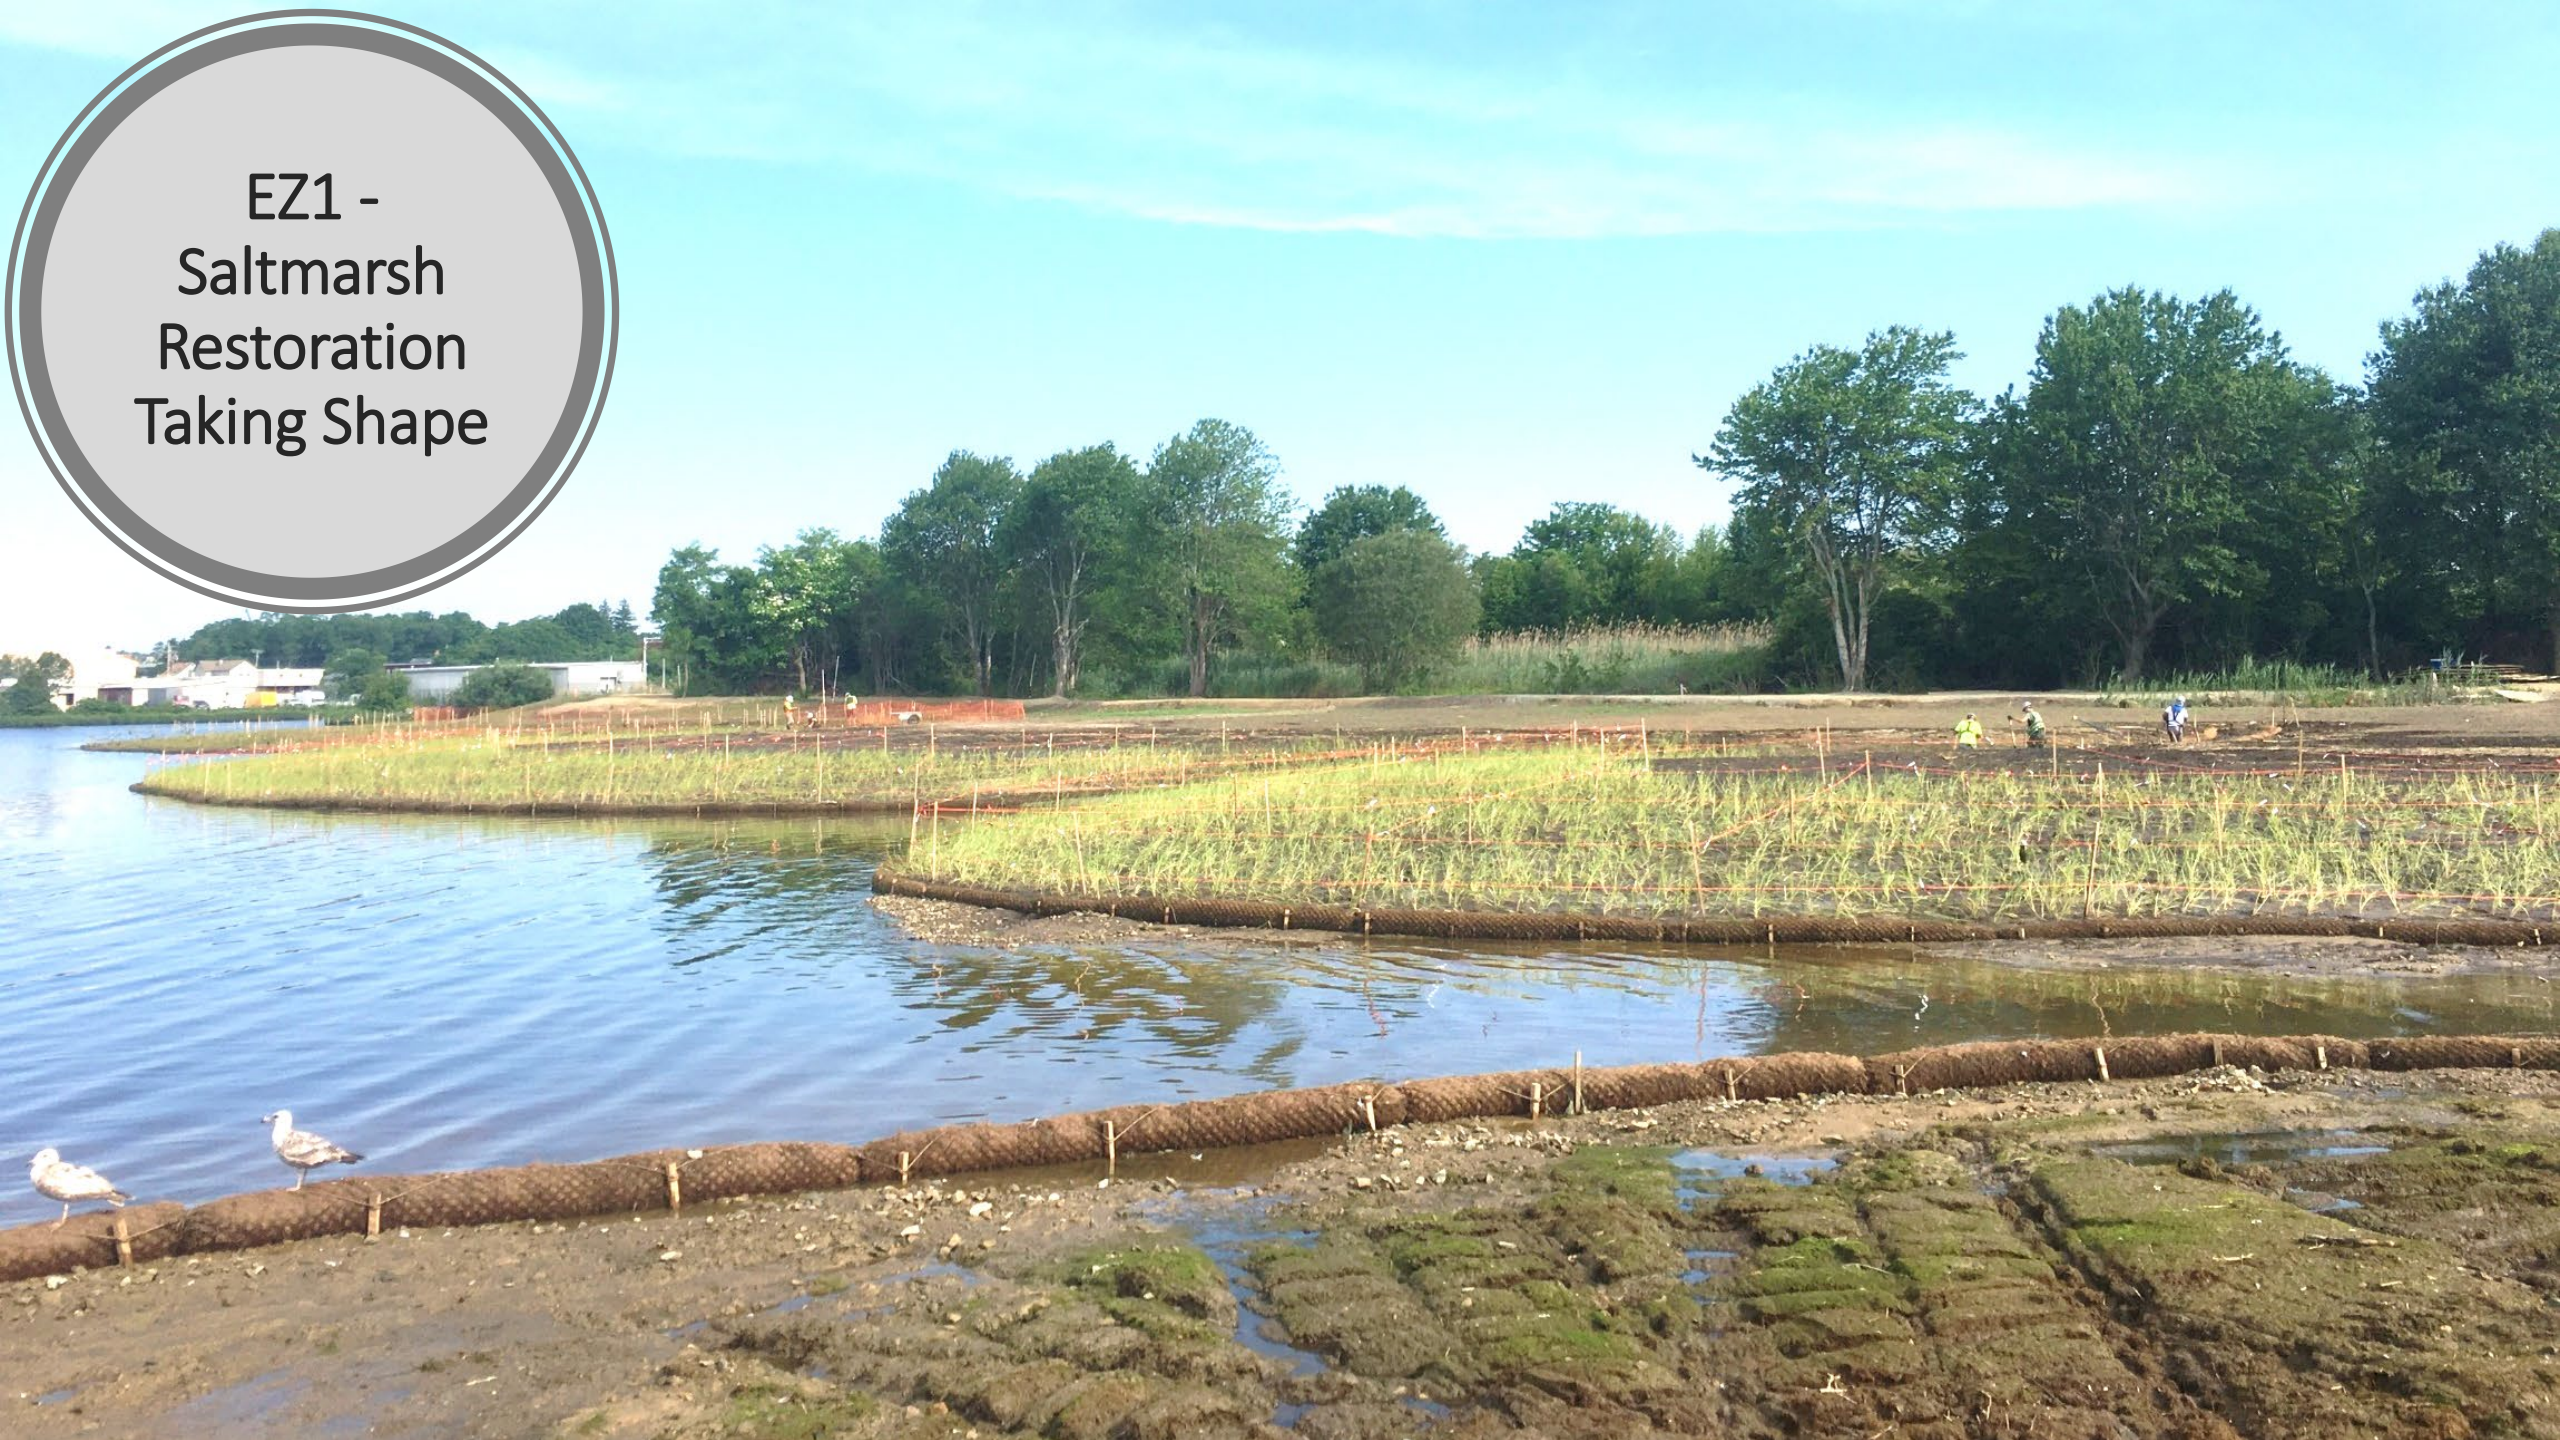
EZ1 -
Saltmarsh
Restoration
Taking Shape

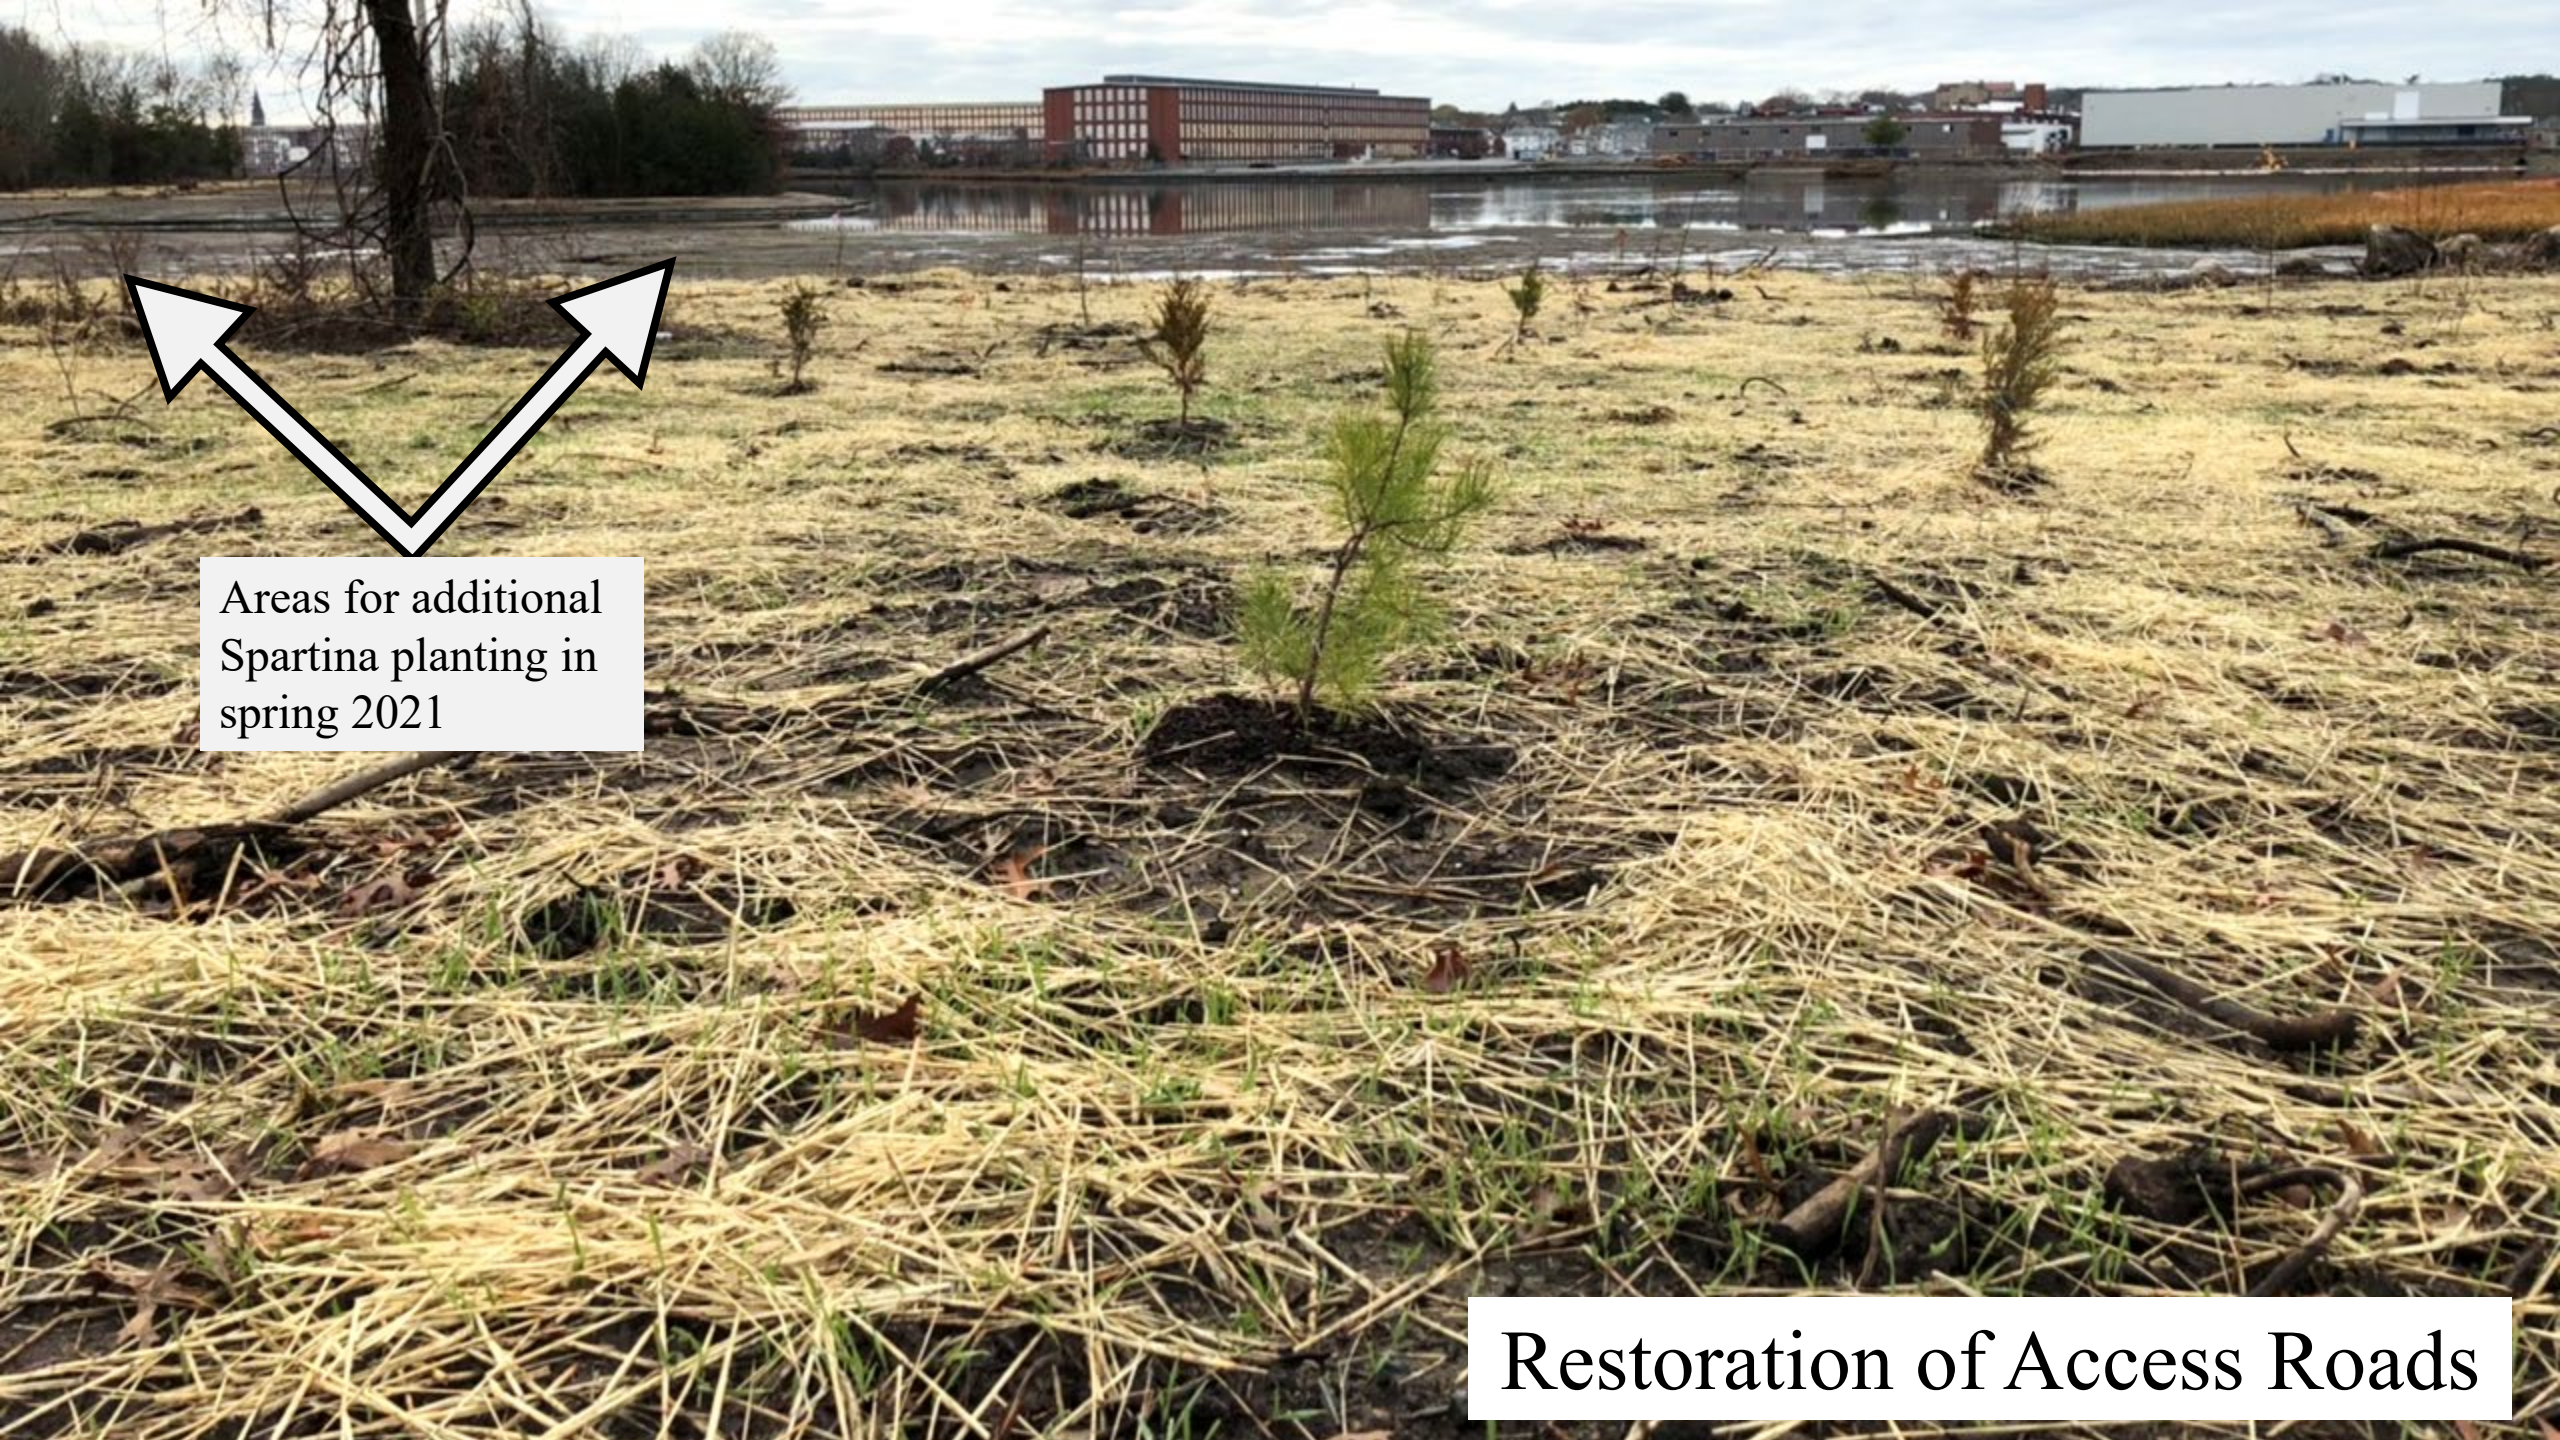
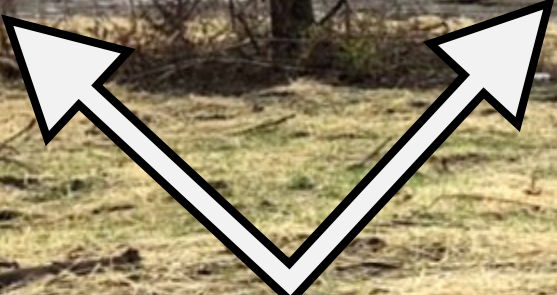
Areas for additional
Spartina planting in
spring 2021

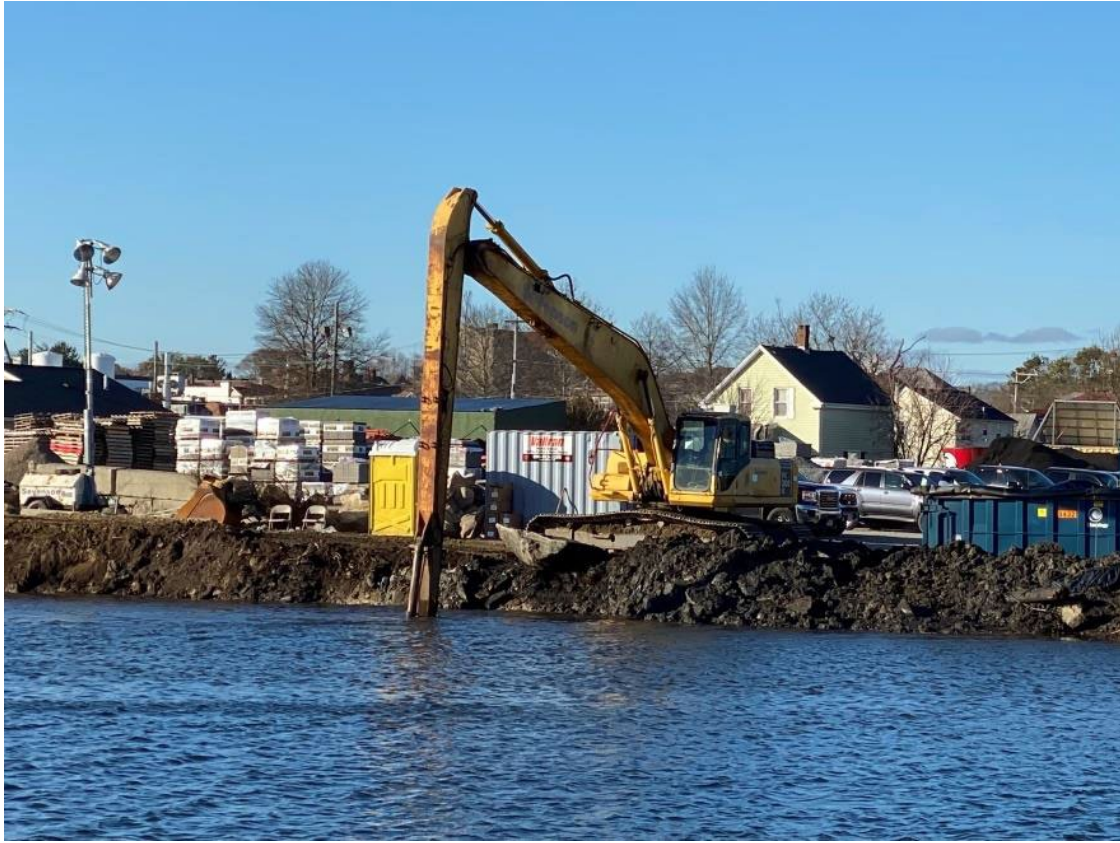
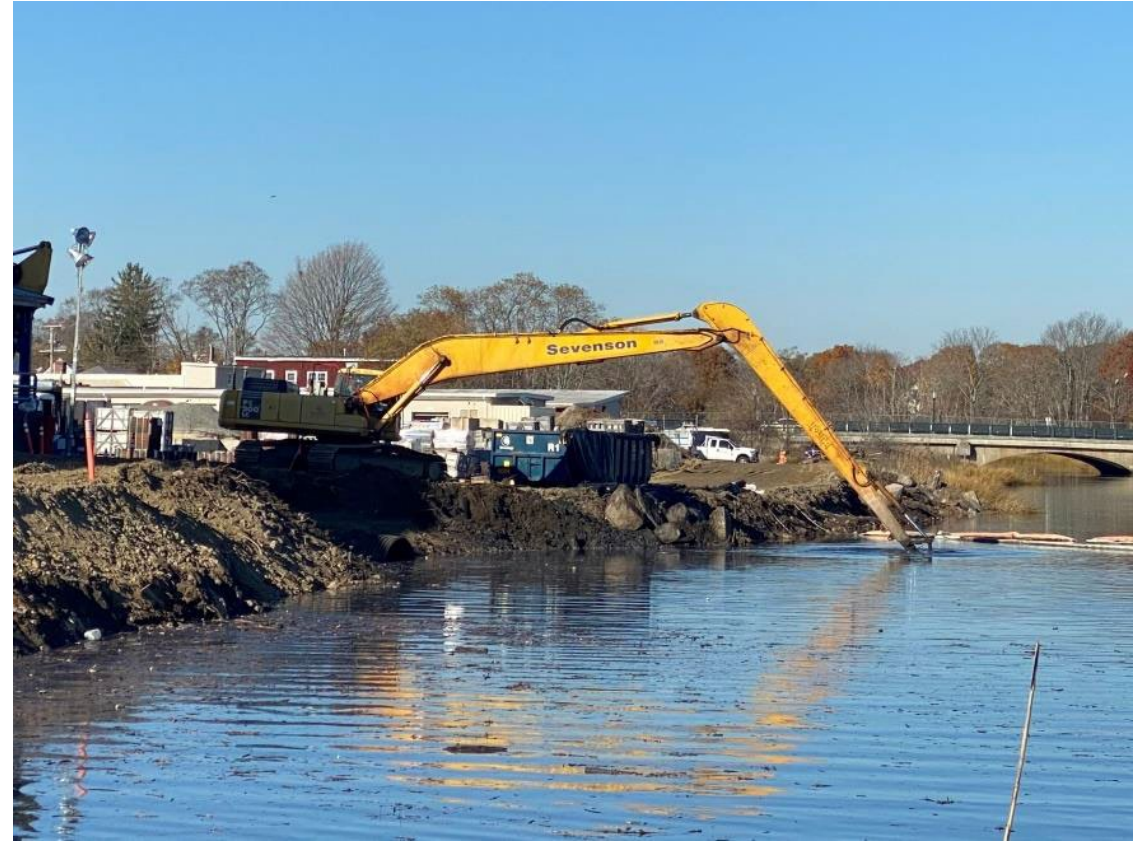
WZ1 Excavation in Progress – November 2020

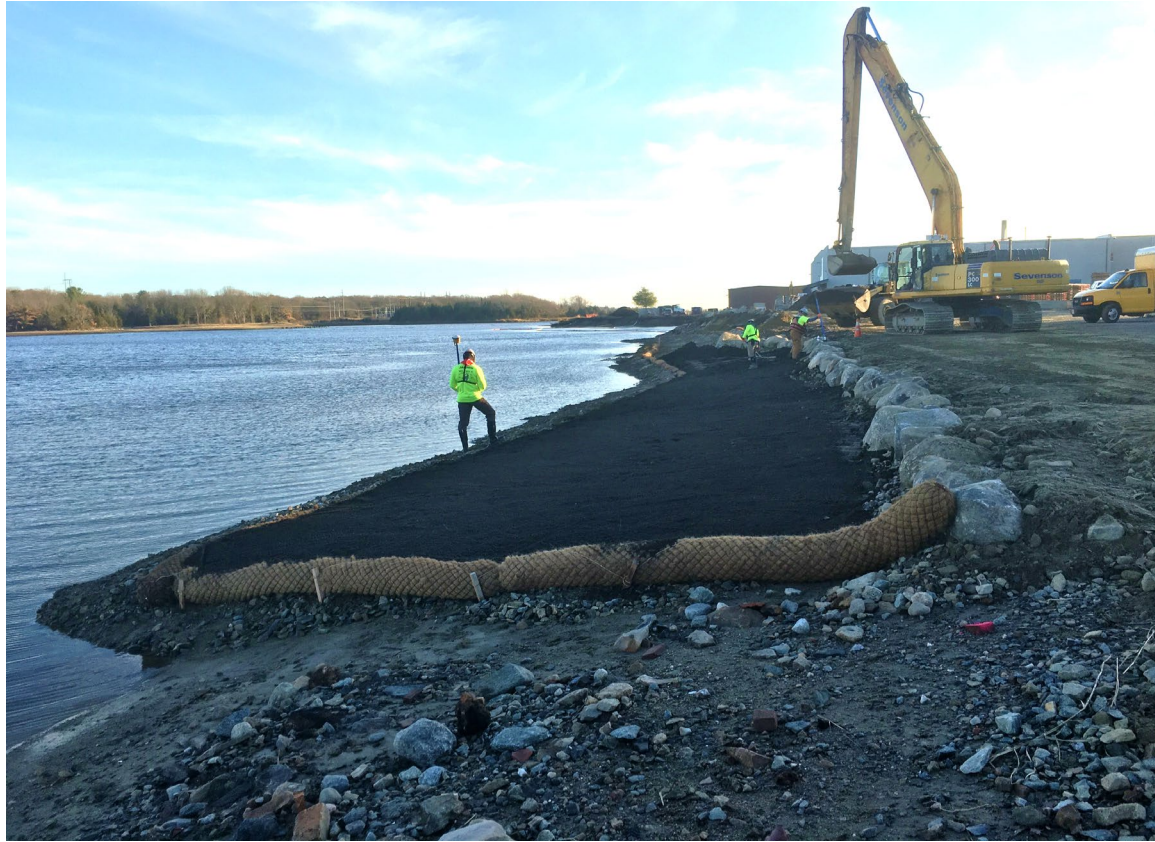
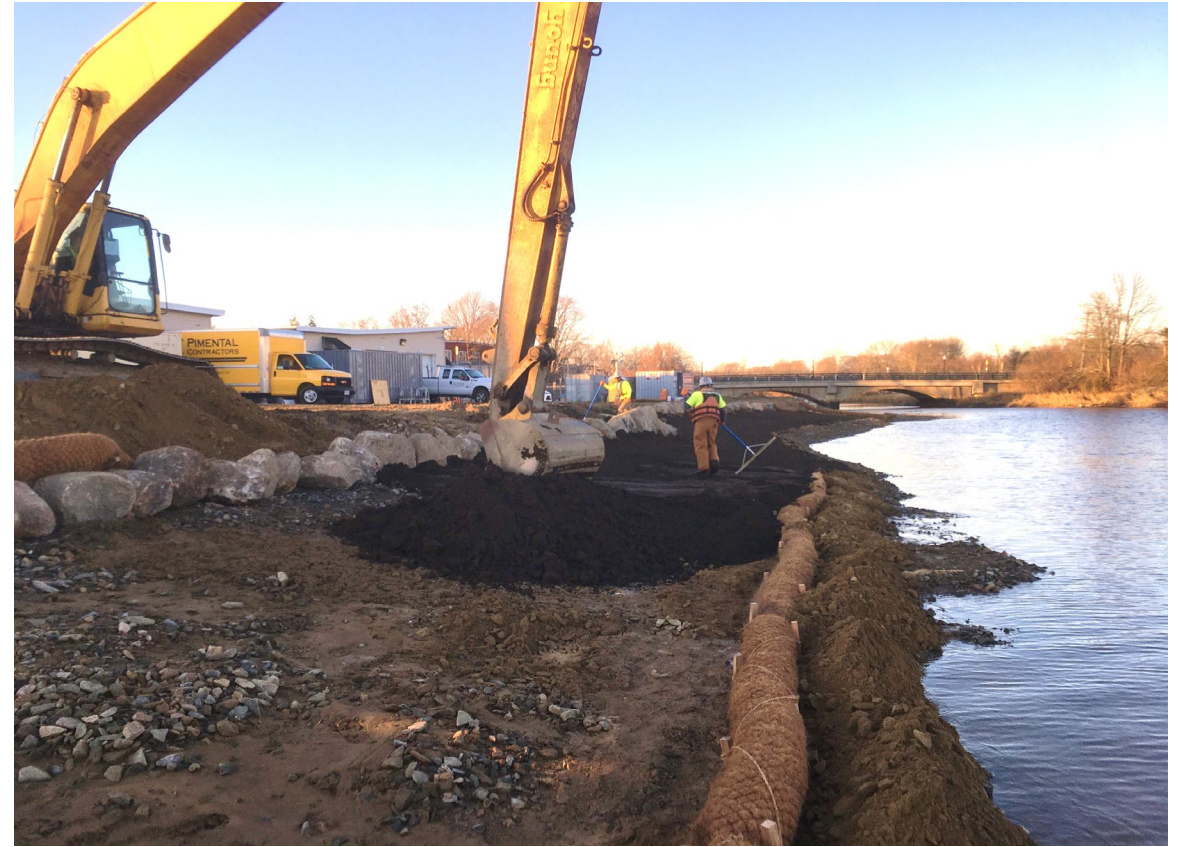
WZ1 Restoration (backfilling) in Progress - December 2020

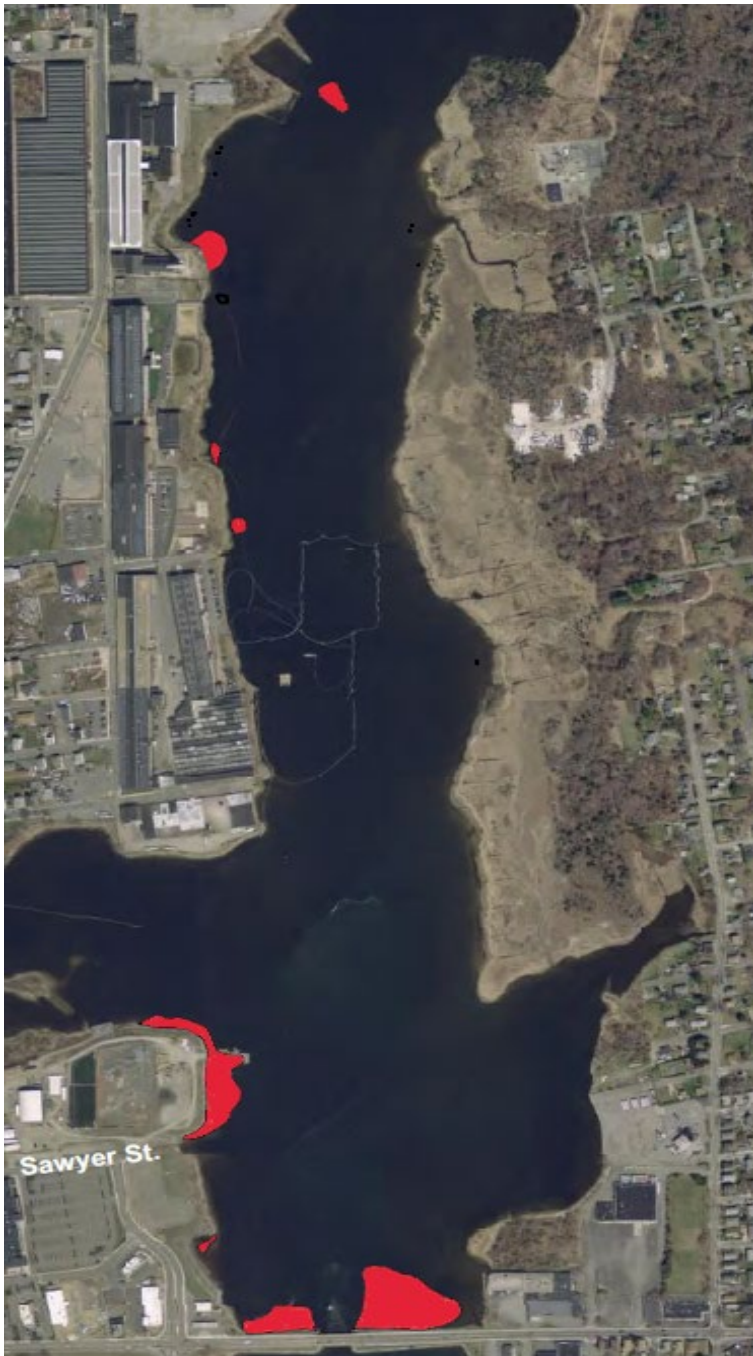
Upper Harbor Sediment Caps (shown in red)

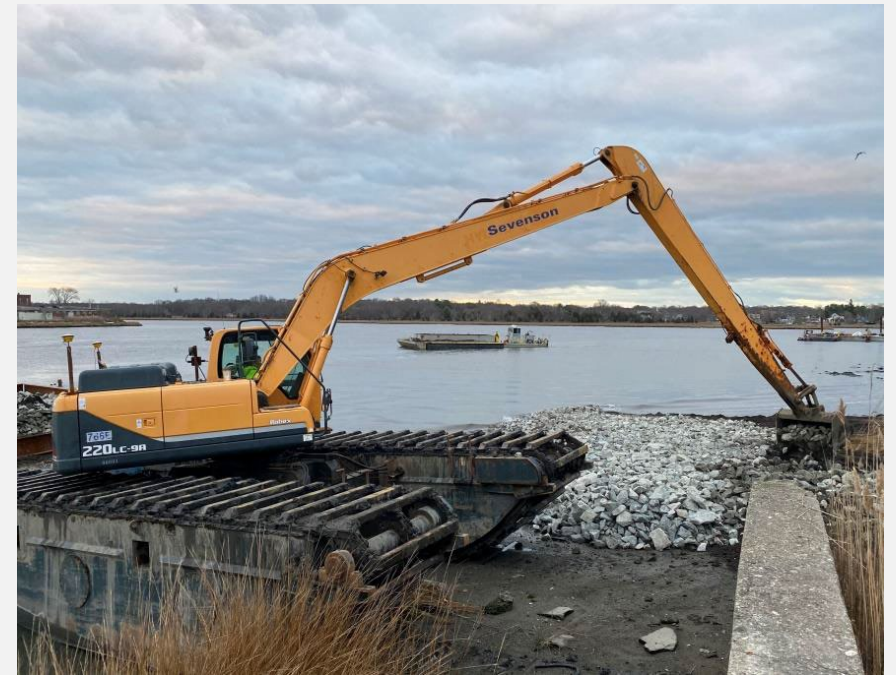
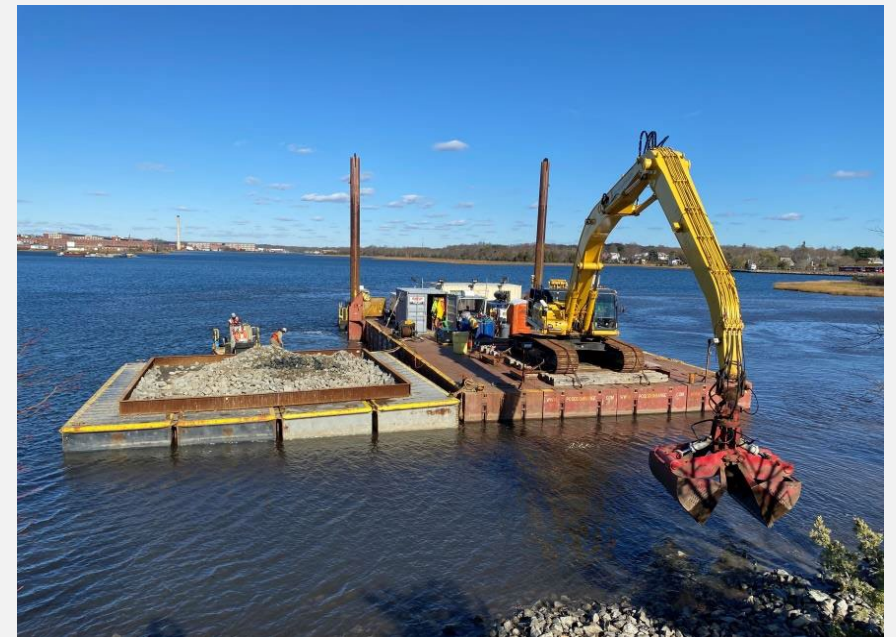
**Two Layers for
Upper Harbor
Sediment Caps**

12 – 20” Armor Stone

(scour protection and PCB-free habitat layer)

24” Silty Sand

(1.5% organic carbon for PCB isolation)

Existing river sediment
