New Bedford Harbor Superfund Site Virtual Public Meeting

January 13th, 2021

Review of 2020 Accomplishments

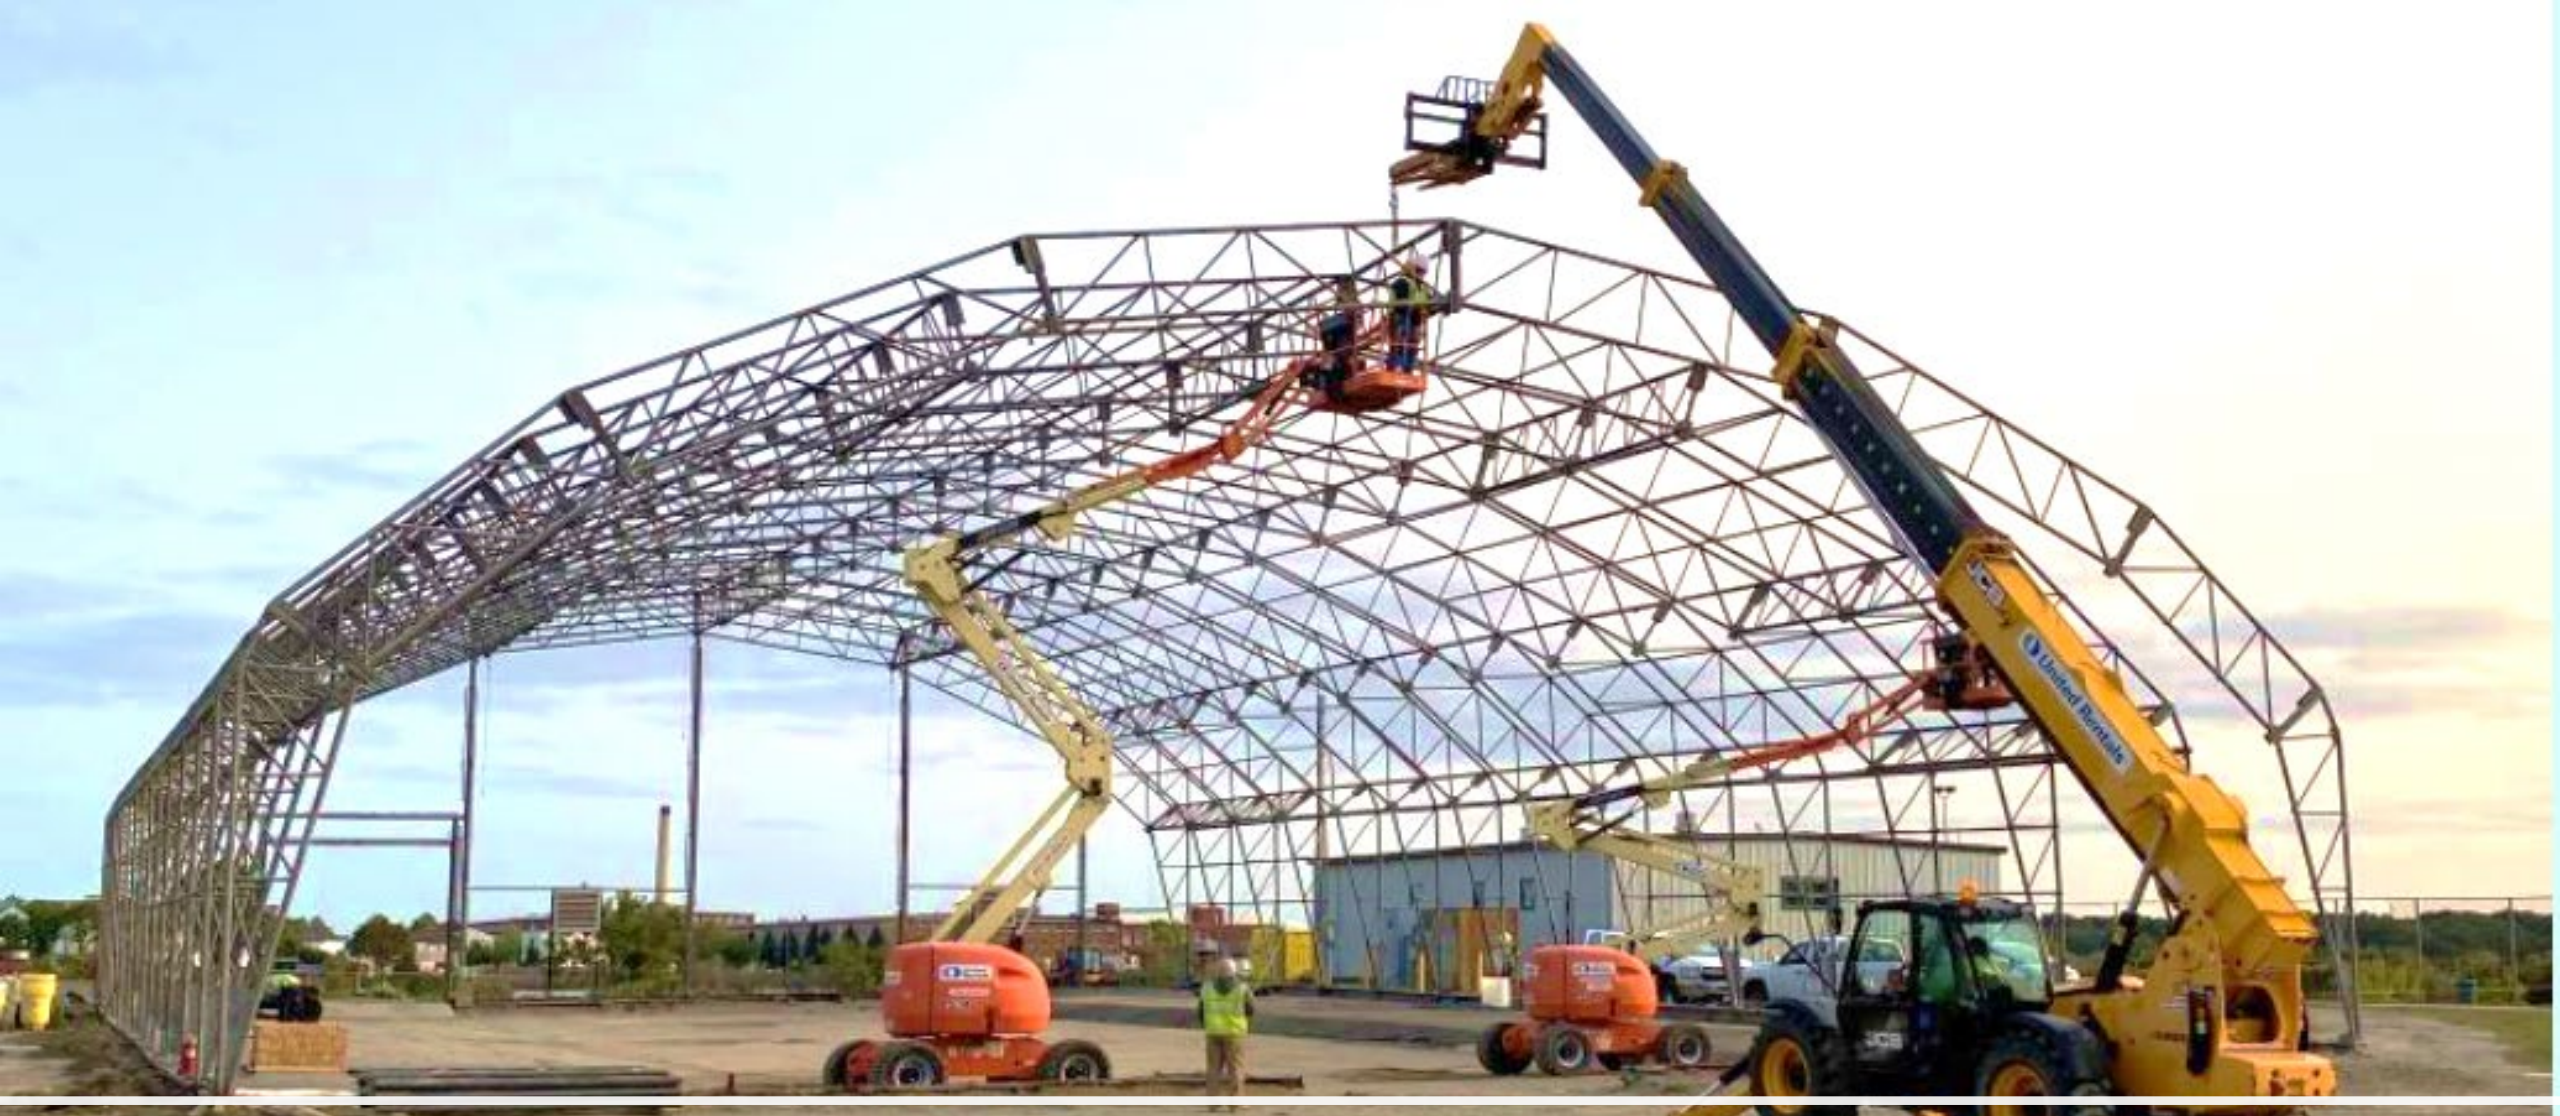
Deconstruction and Transfer of the Sawyer Street Desanding Facility to the City of New Bedford
September 2020

Deconstruction of the Desanding Facility, Support Facilities, and U.S. Army Corps Office

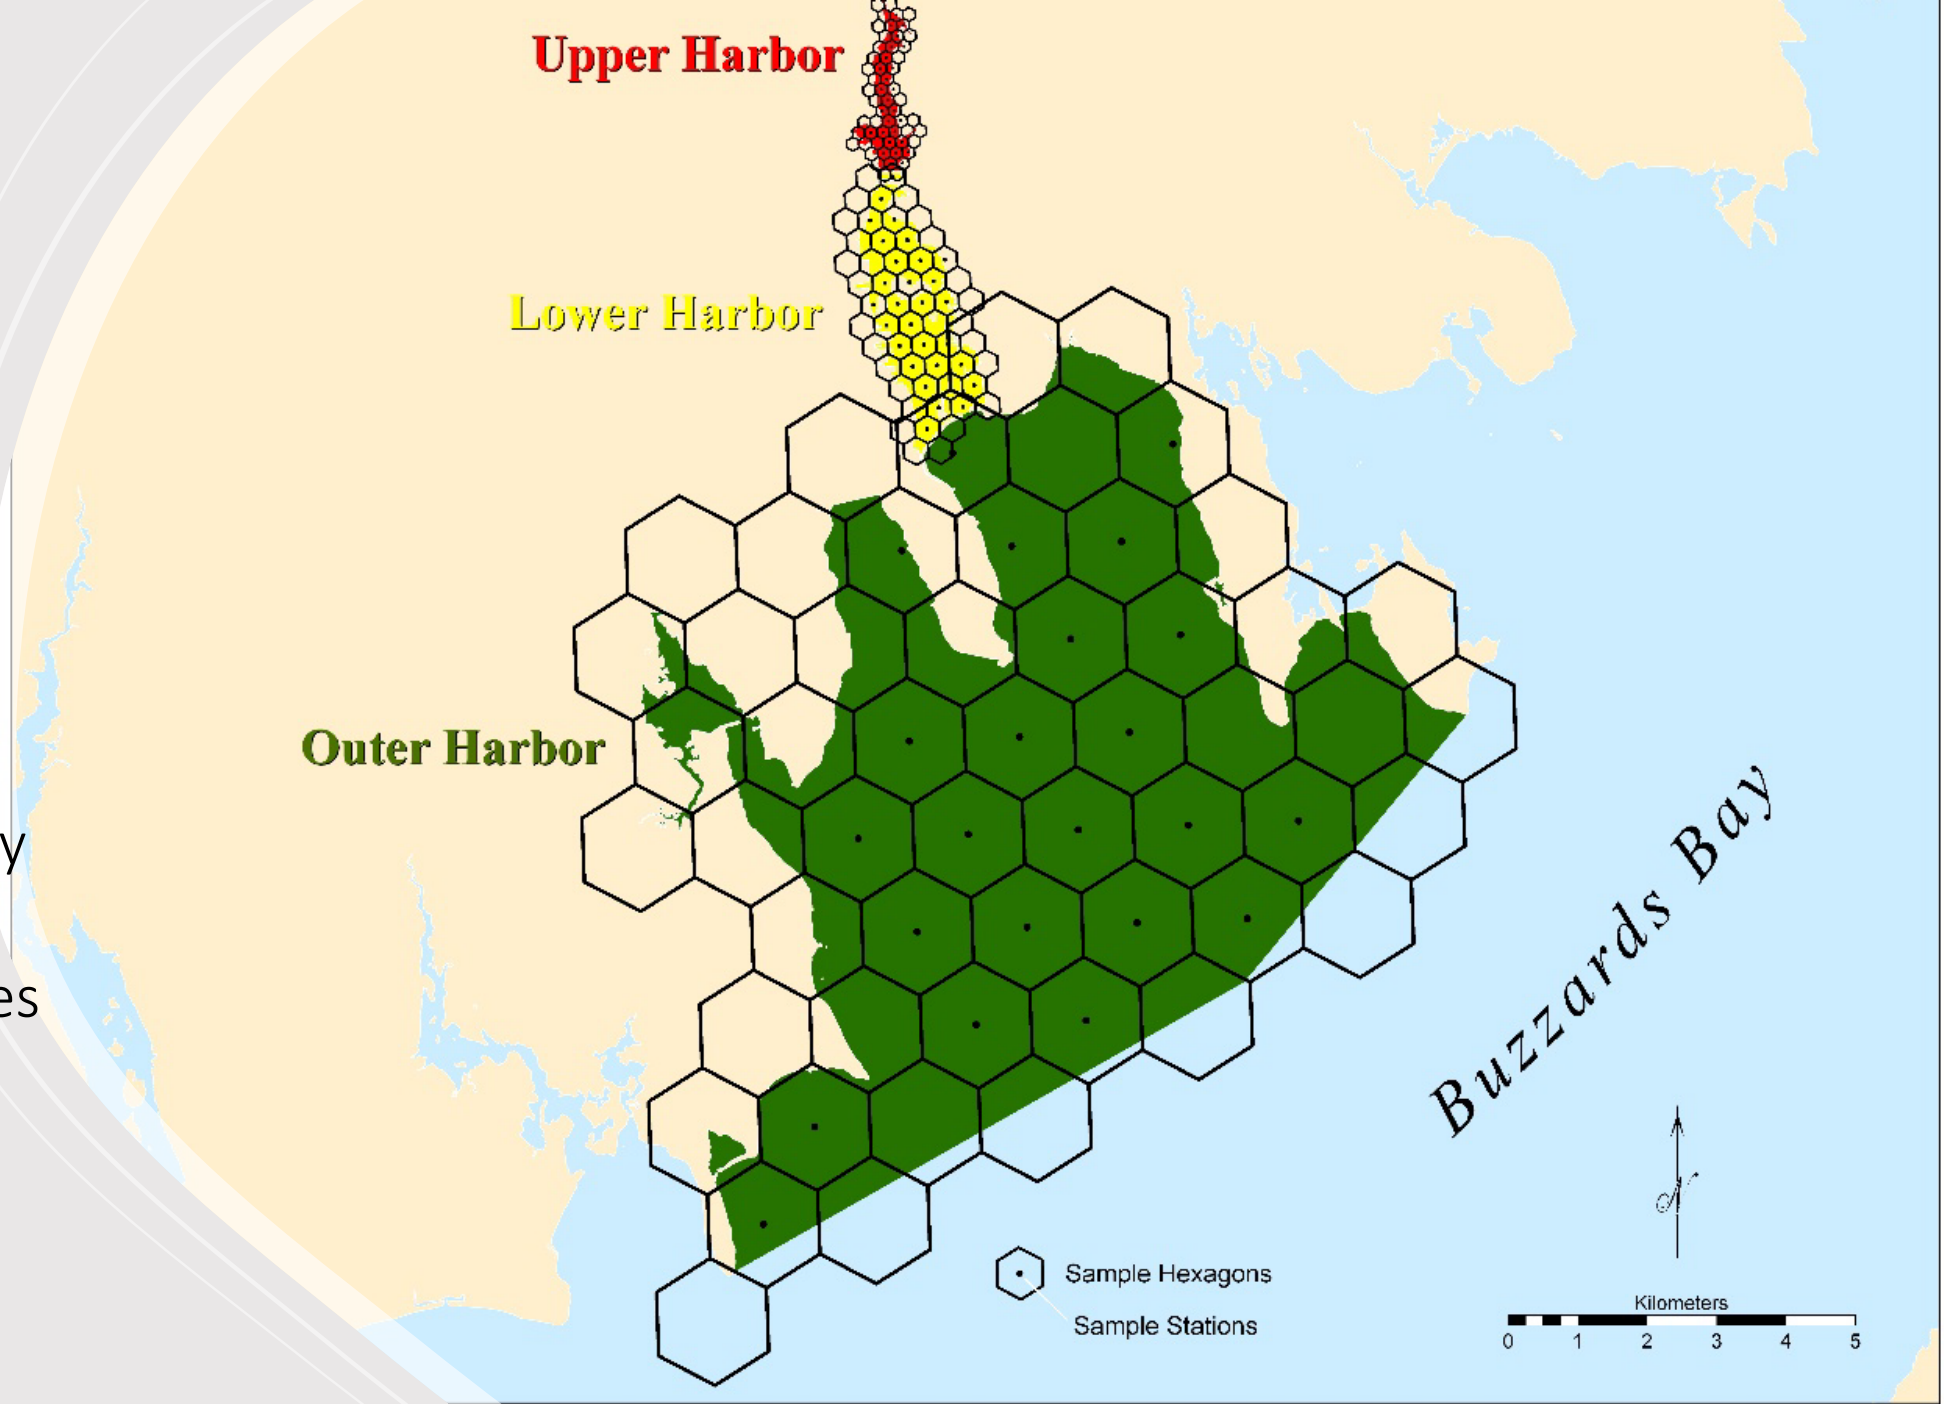
Long Term Monitoring

Completed October 2020

- 18,000 acres
- Sediment chemistry
- Sediment properties
- Benthic organism counts

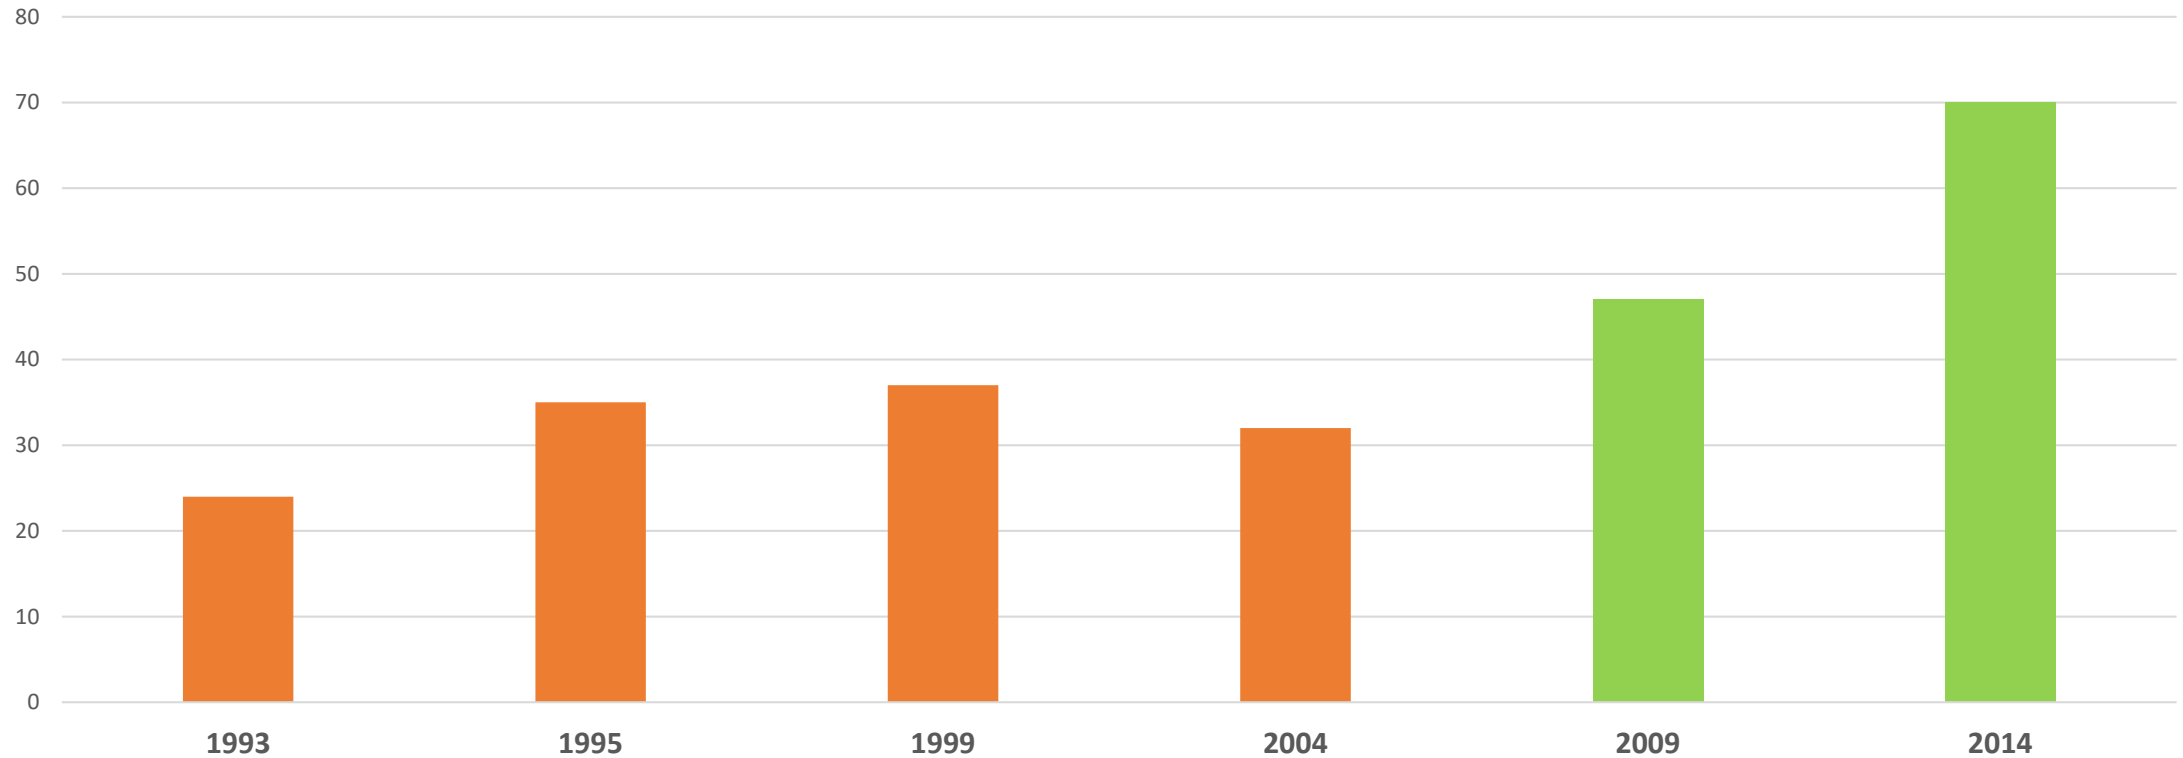
Improvements in Benthic Community Surveys 1993 – 2014

Percent of Stations with Positive Benthic Index in Lower Harbor, USEPA Long-Term Monitoring Program for NBH

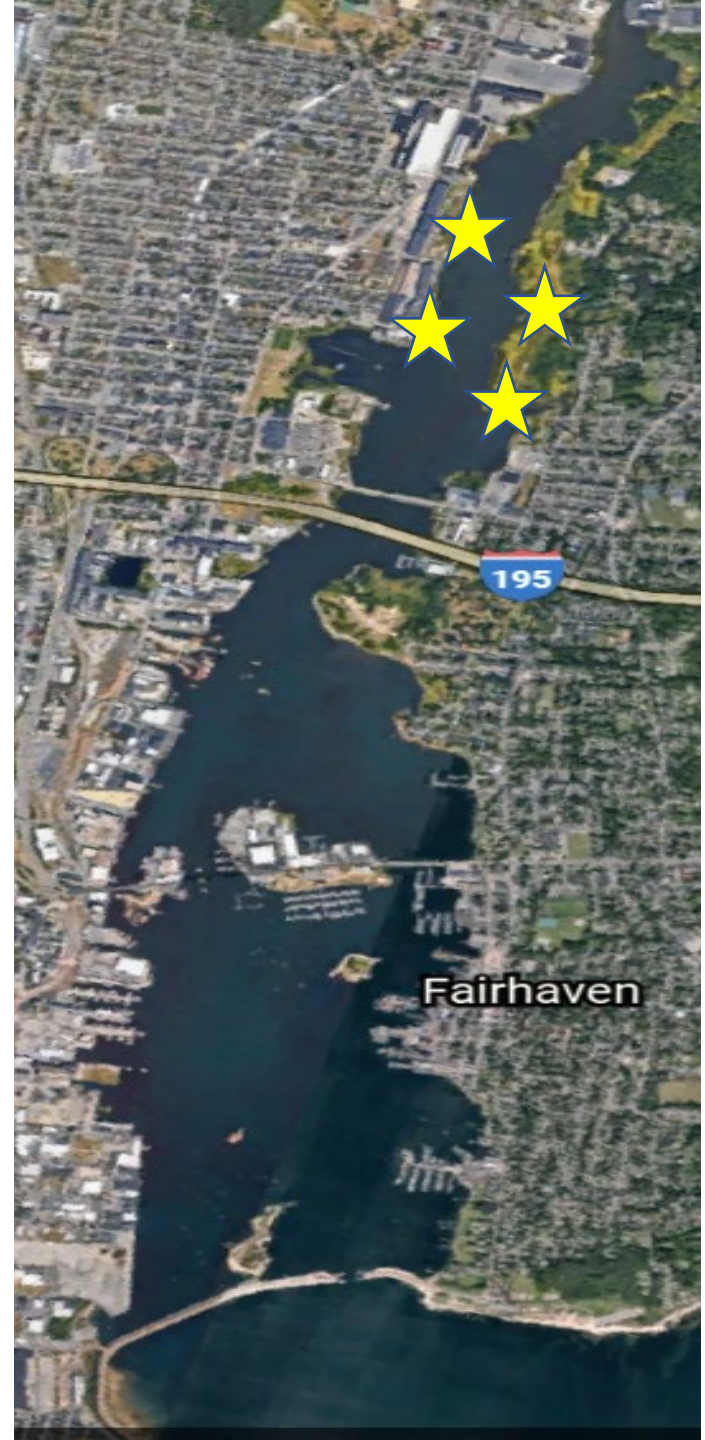
2021 Shoreline Remedial Actions

1. East Zone 4 (EZ4) and East Zone 5 (EZ5) shoreline remediation and restoration
 2. West Zone 4 (WZ4) and West Zone 5 (WZ5) shoreline remediation and restoration
 3. Saltmarsh plantings at Parcel 265, EZ1 and WZ1
-
