**SIXTH FIVE-YEAR REVIEW REPORT FOR  
W.R. GRACE & CO., INC. (ACTON PLANT) SUPERFUND SITE  
MIDDLESEX COUNTY, MASSACHUSETTS**

**U.S. Environmental Protection Agency  
Region 1  
Boston, Massachusetts**

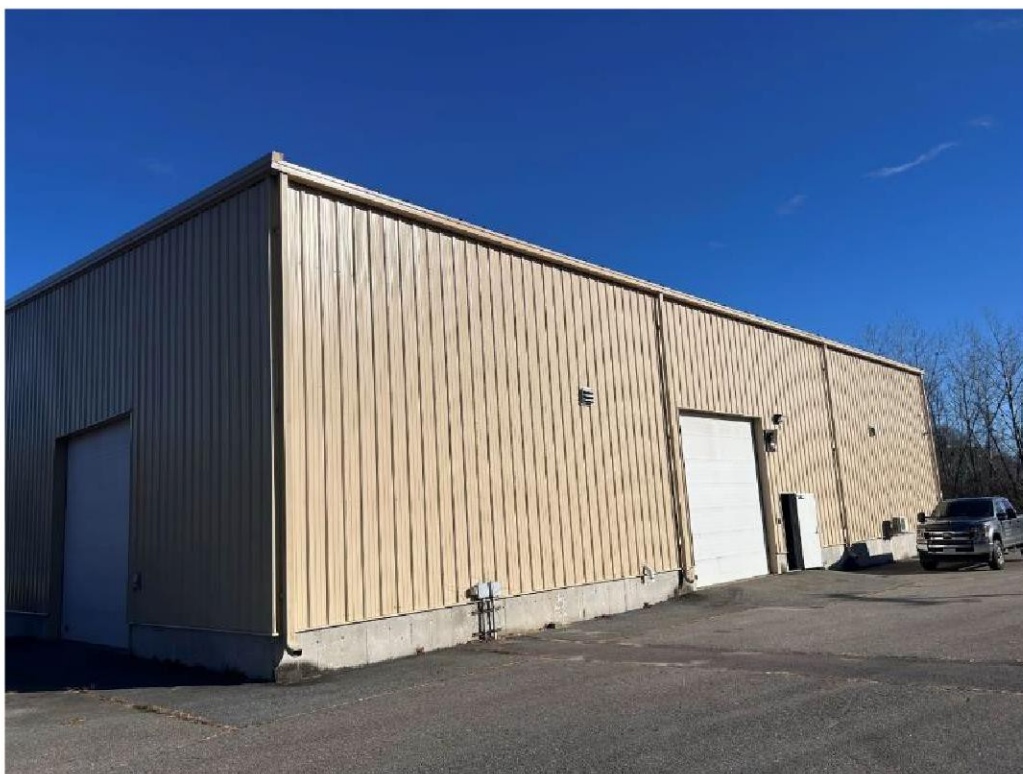
Site inspection participants toured the LATS and the LATS building. The building and system were in excellent condition. Participants discussed the treatment process that currently targets metals removal as VOC concentrations in the influent are relatively low. The system no longer treats 1,4-dioxane because the influent is below 3 µg/L. Site inspection participants also viewed the Industrial Landfill cap and drainage. The cap had been recently mowed and was well vegetated. The drainages were mostly clear of vegetation. Along the northern boundary, the drainage has some standing water, which results in more vegetative growth. The growth did not appear to impede flow. From the top of the landfill, participants viewed the solar array on the Town of Concord owned parcel.

LATS

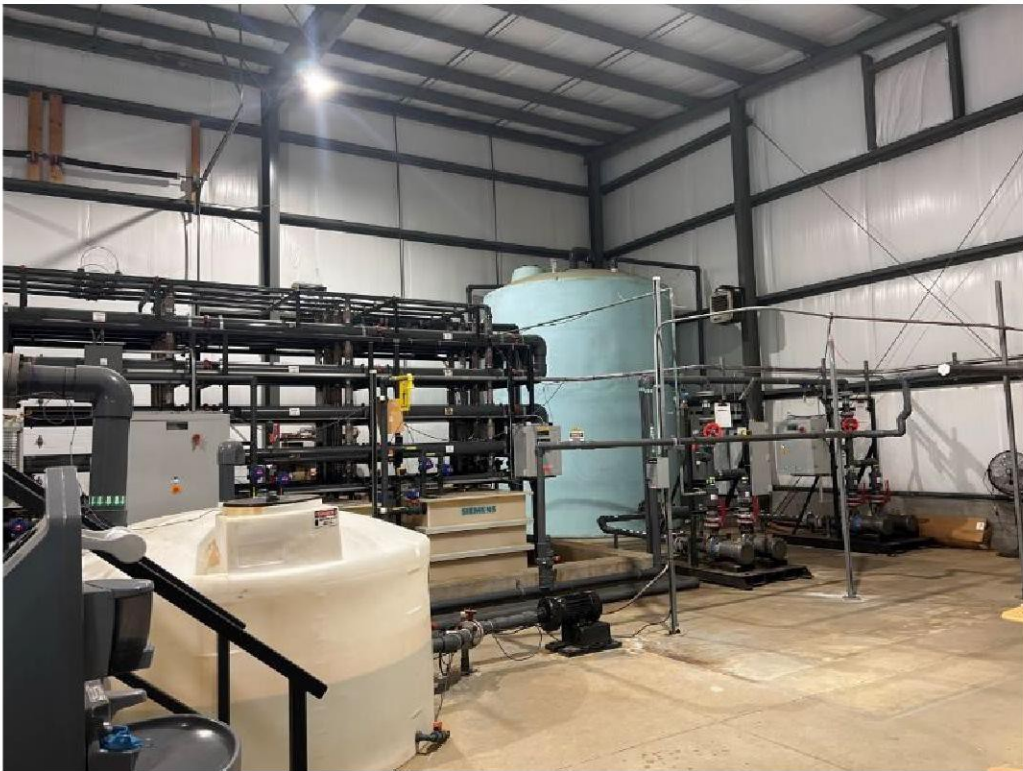
Interior of the LATS building

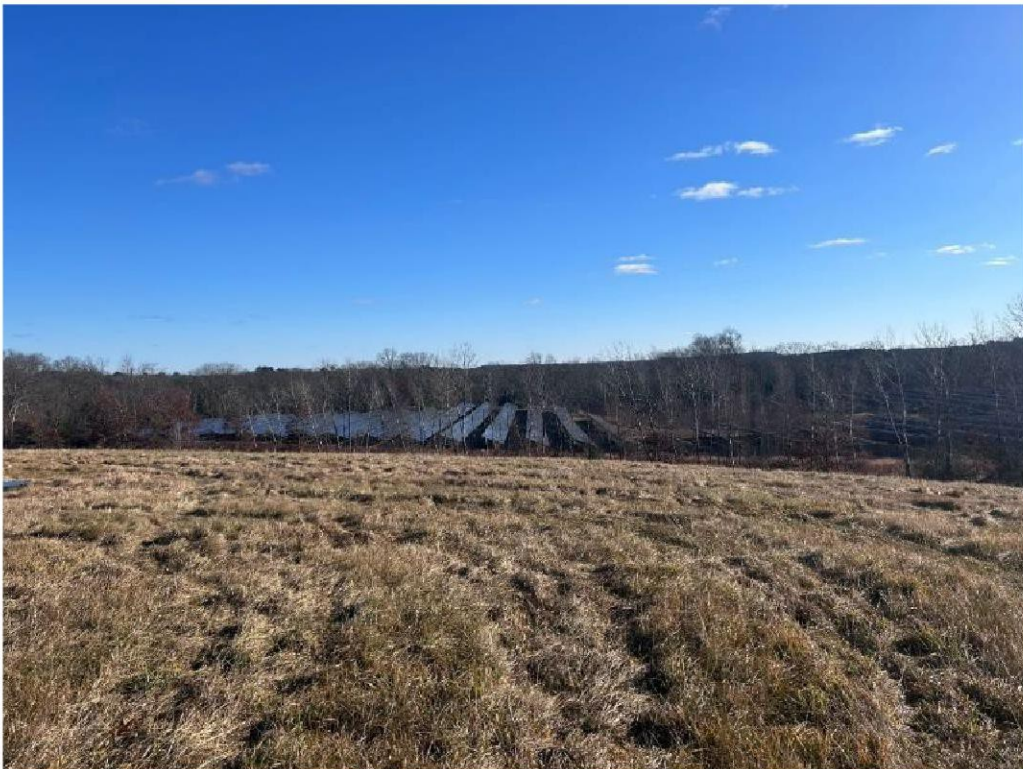
Landfill cap with the solar facility in background

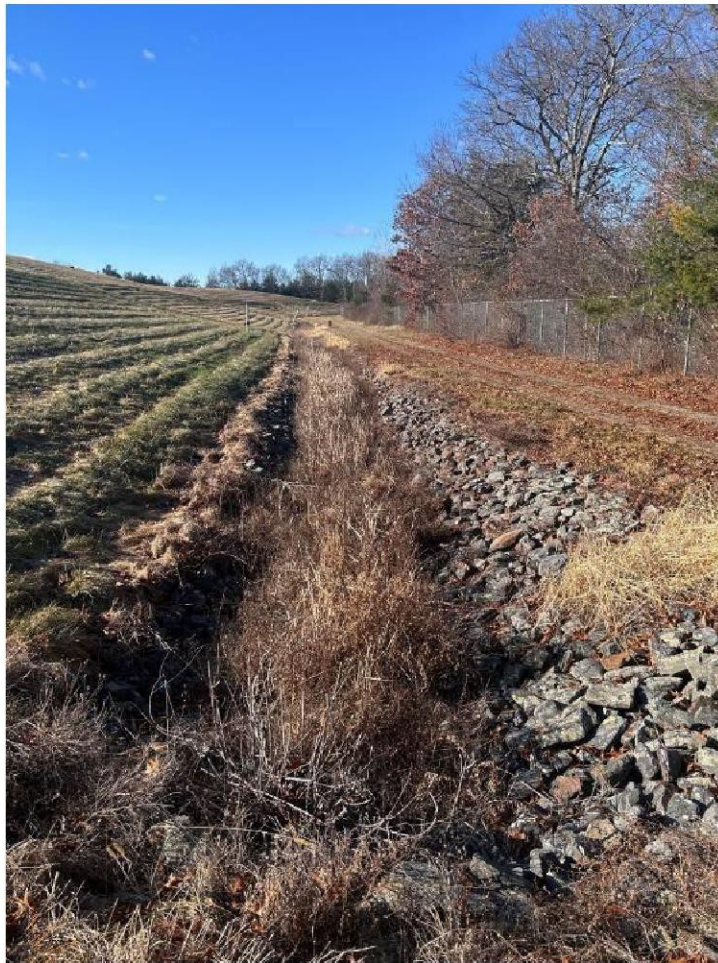
Stormwater drainage with some vegetative growth

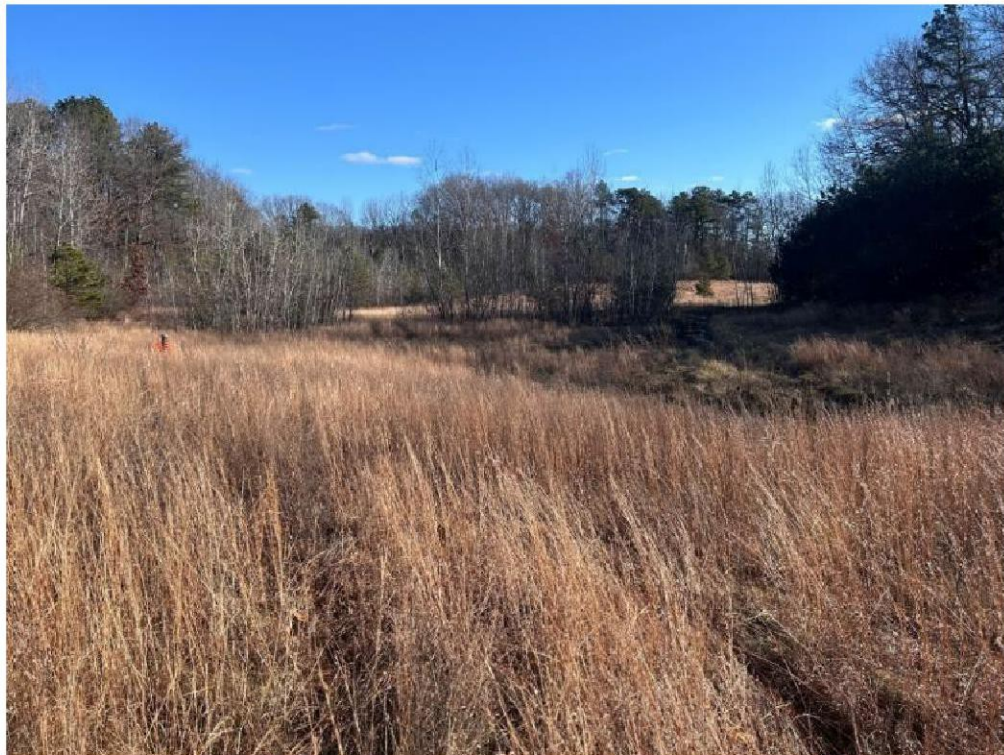
Former Lagoon Area

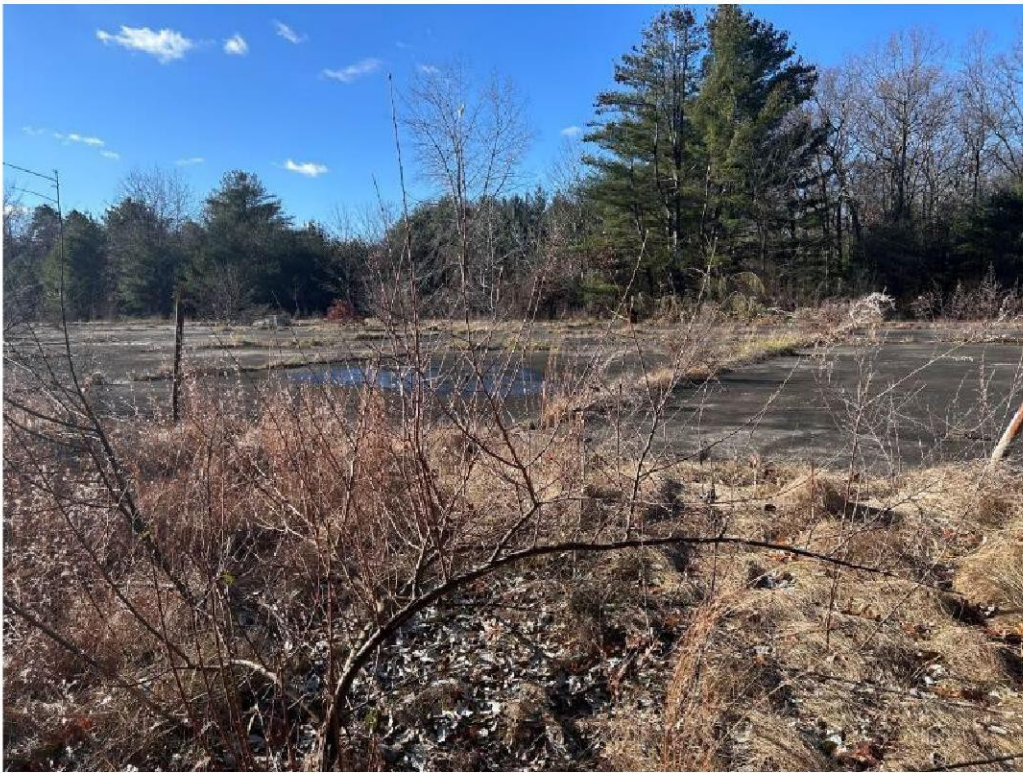
Former building area with remaining pavement and slabs

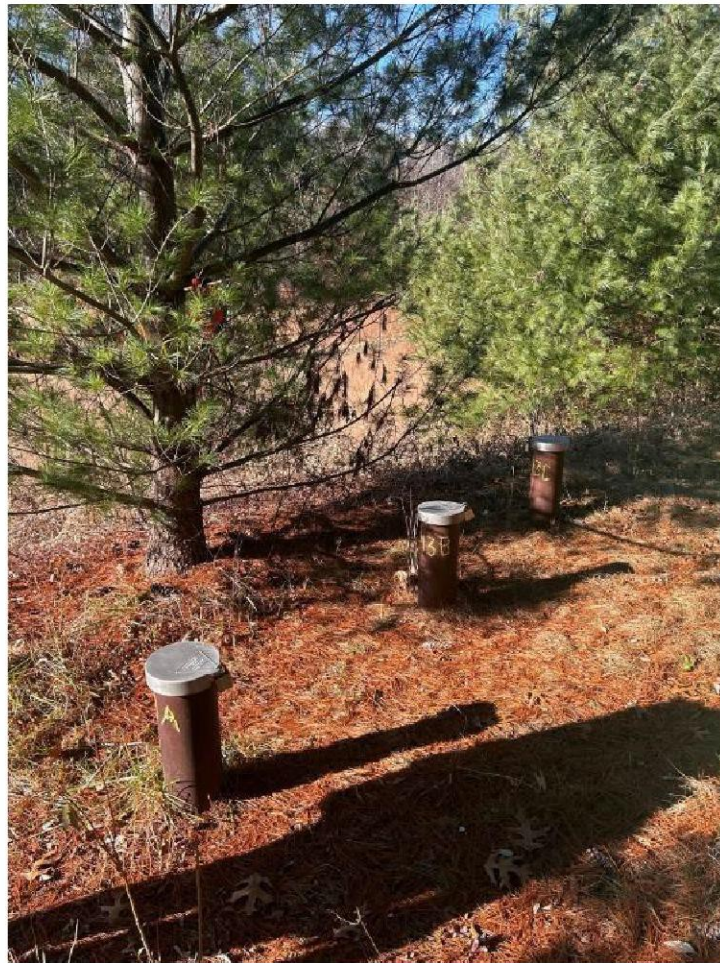
- VOC plumes are contained. In 2022, the maximum concentrations of VDC and vinyl chloride were observed in the OSA-13 well cluster, located in the Former Lagoon Area. Due to variability observed at this well cluster (an anomalous spike in 2010 to 2012, when VDC was detected at a maximum concentration of 900 µg/L), Grace initiated quarterly sampling in 2016 for VOCs at OSA-13B and OSA-13C, along with annual sampling for VOCs at select nearby wells. For the past several years, Grace has been collecting more data and doing additional analysis to determine the source of contamination causing the increase in VOC concentrations in the OSA-13 well cluster. As of 2022, concentrations in OSA-13C are increasing. Grace plans to submit an investigation plan designed to identify the location of the source of that contamination to EPA in 2024.

Monitoring wells OSA-13 A, B and C

| | <b>Recommendation:</b> Continue investigating the increasing concentrations of VOCs observed in the OSA-13 well cluster area and identify the source of that contamination. | | | |

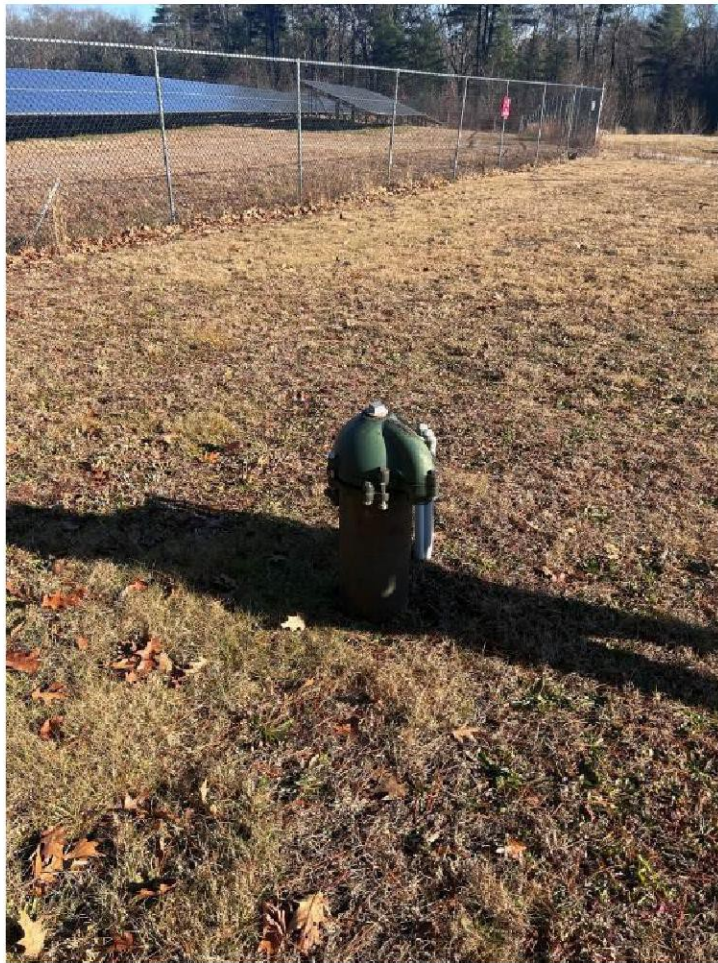
In 2017, without notifying or consulting either EPA or MassDEP, the town of Concord installed a groundwater extraction well intended to provide non-potable water to clean buses at the bus maintenance facility. This 8-inch diameter well was advanced to a depth of about 500 feet in bedrock. EPA became aware of the well after personnel repairing the monitoring wells damaged during construction of the solar array discovered it. EPA issued a letter on March 21, 2024 restricting the use of this well out of concern that it may draw contaminated groundwater from the Site, with potential to pose a risk to human health and adversely affect the groundwater remedy. Concord responded to EPA's letter on April 9, 2024 and stated that the well has never been used and will be decommissioned in Spring/Summer 2024.

Inactive pumping well on Concord Bus Facility

| | <b>Recommendation:</b> Properly abandon the groundwater extraction well at the bus facility. | | | |
