FINAL PRE-DESIGN FIELD TEST DREDGE TECHNOLOGY EVALUATION REPORT NEW BEDFORD HARBOR SUPERFUND SITE New Bedford, Massachusetts

August 2001

U.S. Army Corps of Engineers New England District Concord, Massachusetts

Foster Wheeler Environmental Corporation 133 Federal Street Boston, MA 02110

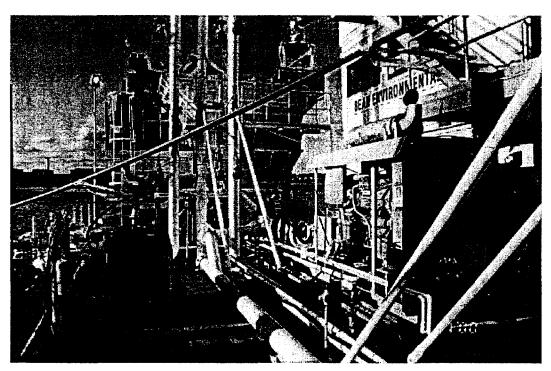
Figure 2-6 Slurry Processing Unit

The SPU system is a proprietary hydraulic slurry transport system that delivers high percent solids concentrations, by introducing controlled amounts of water to mechanically dredged material. The *in situ* material conditions dictate the theoretical maximum achievable slurry density (i.e., it is not possible to achieve solids concentrations that are higher than that of the *in situ* material).

Sensors located on three specific gravity loops (inverted u-tube manometers) placed along the discharge line on board the dredge measure parameters by which the solids maximization process is managed. The SPU system can be operated in manual or automatic mode. In automatic mode the SPU operator selects the upper and lower limit values for the slurry density and for the discharge velocity. Based on the measured values of slurry density, and comparison with the *in situ* density ranges for the dredge area, the computer will adjust the slurry pump speed and/or add water to the system. In manual mode the SPU operator, not the computer, adjusts the slurry pump speed and/or adds water to the system. He also instructs the excavator operator to add more or less sediment to the system.

A key feature of the SPU is the ability to input decant water from the disposal site back into the system, thereby substantially reducing the overall quantity of water added to the CDF, and reducing the amount of water that must be treated.

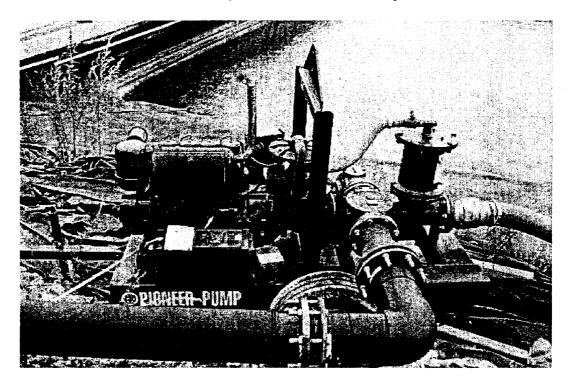
Figure 2-7 Recirculation System Return Water Pump, Cell 2

The make up water system for the SPU can be obtained from either return water from the CDF or harbor water via a sea chest. During the PDFT dredging, however, only return water from the CDF was used to supply the make-up water pump installed on board the dredge. The make-up pump increased the pressure of the make-up water to a maximum of 150 psi. The make-up water supply, available at a charged manifold, was used by BELLC for a number of operations, including SPU water injectors, suction line debris jets, and the mini excavator (grizzly) debris jet.

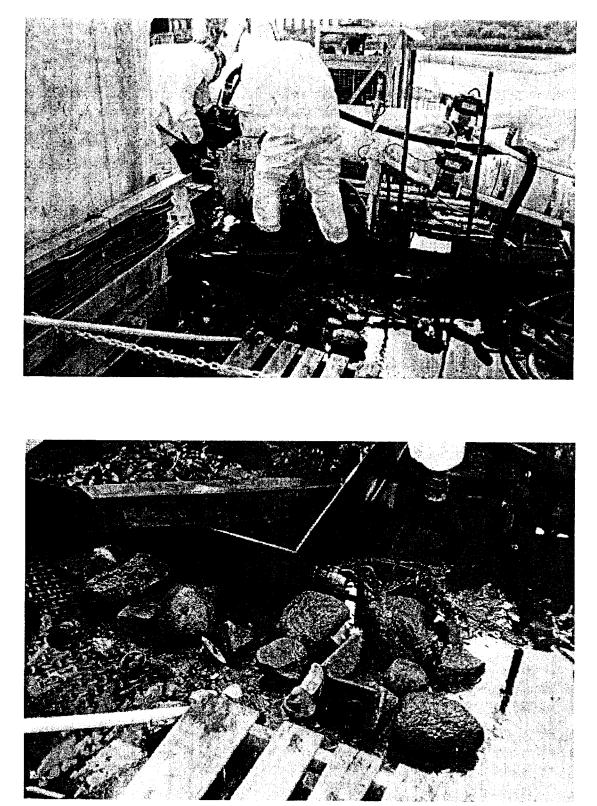
Figure 3-8 Clearing Rockbox of Debris, note cobbles at base of Rockbox

As the inside diameter of the discharge line was 7.13 in., another debris collector, termed the "rockbox", with a screen mesh of 4 in. was installed in the suction line between the hopper bottom and the slurry pump. A significant amount of smaller debris caused the frequent clogging of the screen in the rockbox. The debris consisted of smaller cobbles, plastic debris, horseshoe crabs and a significant amount of quahogs. After some significant downtime and impacts to the overall dredge production due to clogging of the rockbox by this smaller debris, the ultimate remedy for maintaining a clear rockbox was the installation of two additional high pressure water jets, again using recirculation water, on either side of the rock box. Additionally, by experience, the clogging could be avoided by declutching the dredge pump and backflushing the screen of the rockbox periodically. While this preventative measure did reduce the SPU production by a small amount, it was a lesser amount than that attributable to the shutdown of the system to open and clear the rock box and/or pump, a process that took between 24 to 51 minutes, depending on a number of factors, namely volume and type of debris clogging the suction line. Despite delays due to debris on the hydraulic transport process, the excavator production generally could continue most of the time due to the buffering capacity of the hopper.

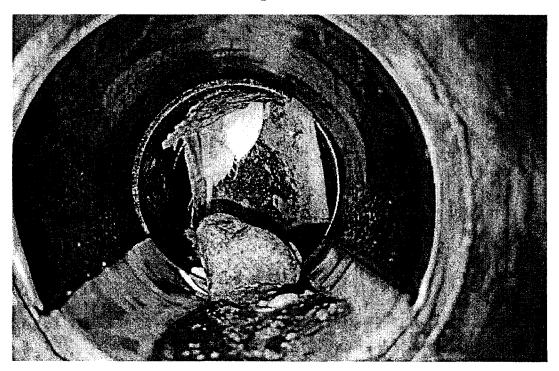
Figure 3-9 Steel Plate Lodged in Suction Line

One significant downtime event did occur however due to debris. On Saturday August 12, at approximately 12:20 hrs., the dredge encountered suction pressure problems on the SPU. It was not known whether this was a problem caused by debris clogging, poor pump performance or some other reason. After about 12 hrs. of downtime to not only resolve the suction pressure issue, and perform other optimization measures, it was discovered that a ¼-inch thick piece of angle iron, roughly 10 in. long by 5 in. high, had managed to pass through the grizzly screen, through the horizontal augers and become lodged in the suction line between the hopper bottom and the rockbox. Based on the photo taken below, it would appear that the metal was effectively choking the suction pipe by about 80%. The piece of metal was removed, and along with the activation of another suction jet at the base of the hopper, the suction problems encountered until that time were drastically reduced.

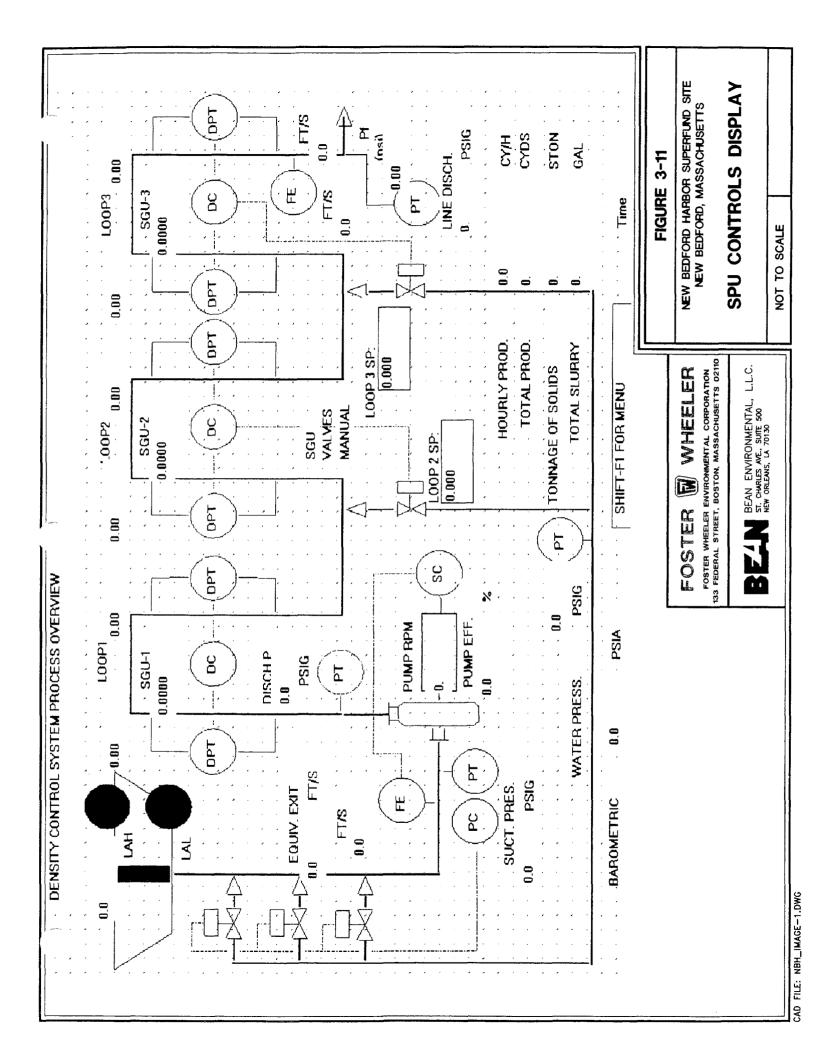
The SPU worked properly during the dredge test and appeared to be stable in the automated mode. The SPU controls permitted easy adjustment of the hydraulic transport parameters such as discharge velocity and maximum allowable slurry density. The automated injection of recirculation water at the three supply points appeared to work correctly. All process parameters were observed clearly at the operators desk panel gauges and on the SPU computer monitor. A screen dump of the SPU controls display is presented in Figure 3-11.

The hydraulic transport capacity of the SPU was designed to be higher than the maximum excavator production, to optimize the production potential of the dredge. The design production limit is therefore on the excavator process. As a significant volume of debris between approximately 3 and 6 in. was encountered, the rockbox clogged frequently despite the adaptation of a number of jets intended to break up such clogging. As such, the dredge (SPU) operator was required to add more recirculated water than is typically necessary to move slurry without risking the plugging of the discharge pipe. In adding more water the density of the slurry, and thereby the dredge production, decreases.
