**Technical Report
Marine Archaeological Documentation and Assessment**

**New Bedford Harbor Superfund Site
Unanticipated Shipwreck Discovery
Acushnet River
Acushnet, Massachusetts**

September 2010

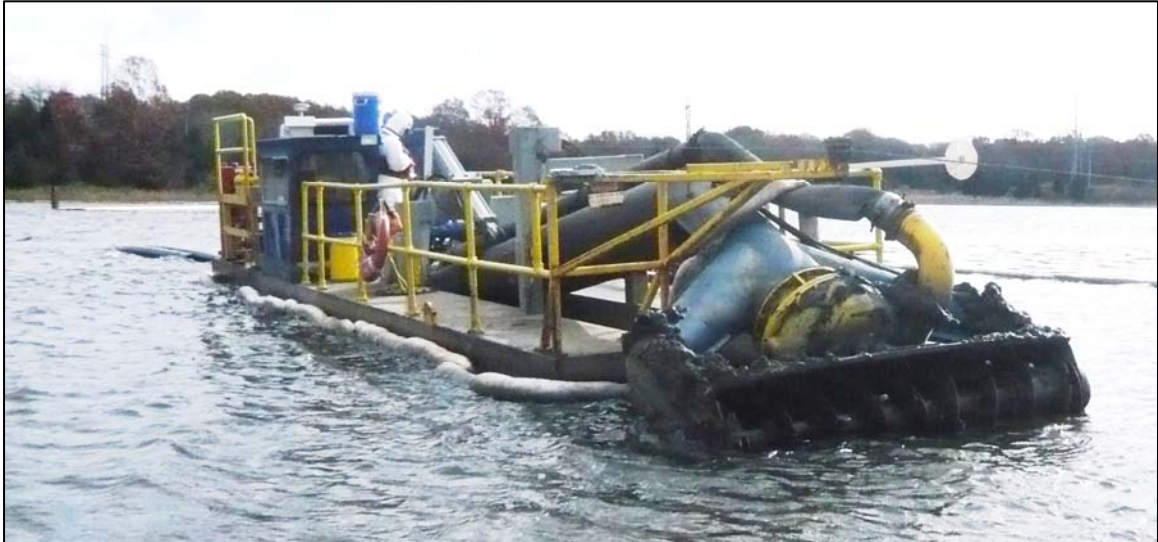
Figure 1-3. NBHSS hazardous sediments dredging barge. Note the horizontal auger-like dredge-head at the barge's bow (photograph by David Robinson).

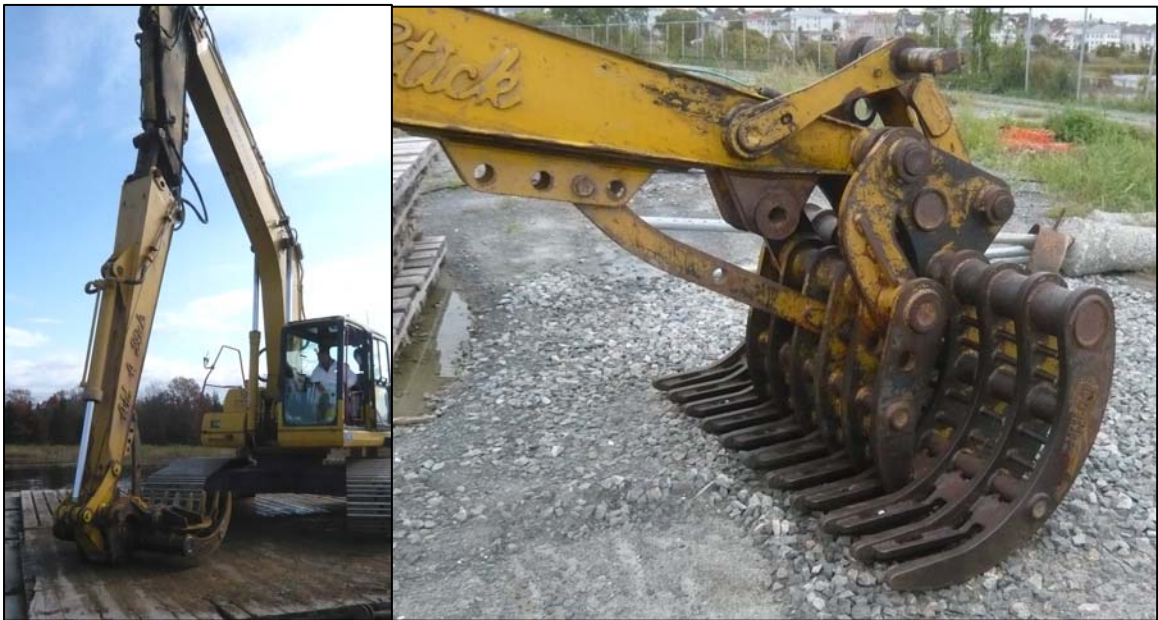
Figure 1-4. NBHSS debris removal machine equipped with "grabber" attachment (photographs by David Robinson).

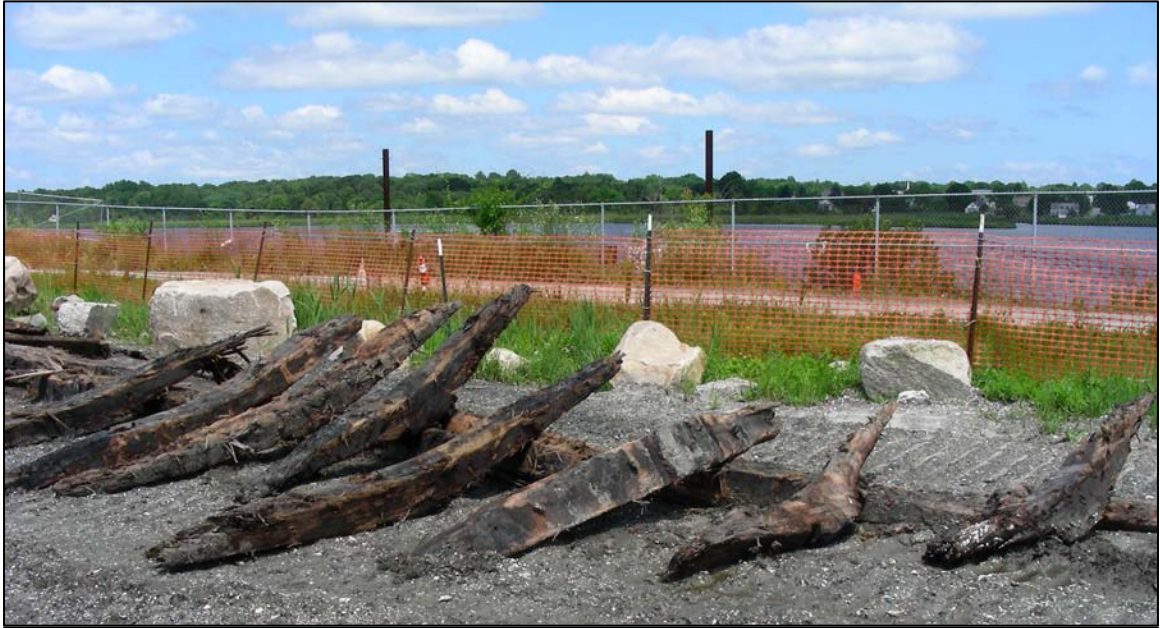
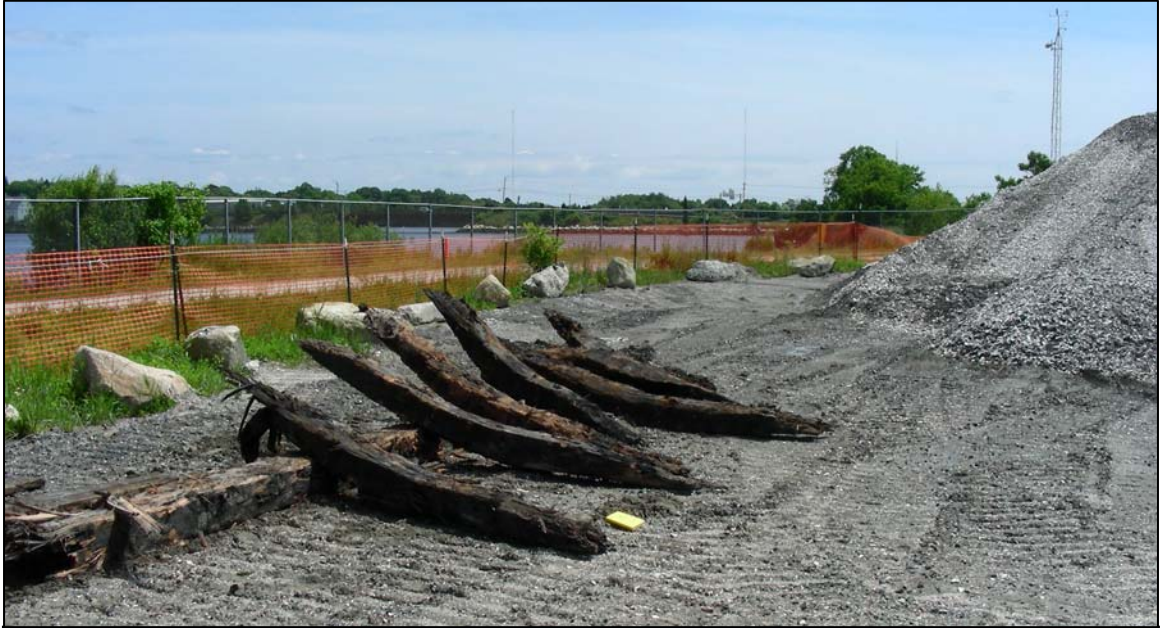
Figure 1-8. Shipwreck timbers as they appeared shortly after their July 2009 recovery during debris removal operations (photographs by Josh Cummings, courtesy of the USACE-NED).

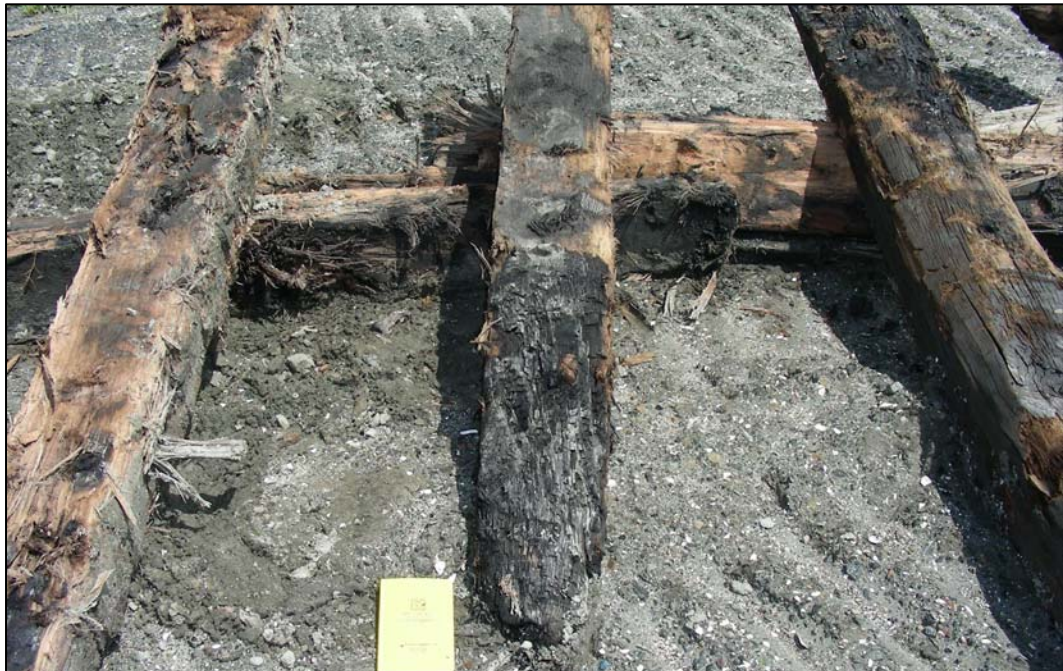
Figure 1-12. Charring that was visible in places on the surfaces of the timbers, such as at the end of the floor timber in the middle of this photograph, indicated that the vessel was exposed to fire (photograph by Josh Cummings, courtesy of the USACE-NED).

The condition of the wooden timbers, particularly their surfaces, was observed to be poor during the July 16 inspection. This condition was presumed to be a result of the previously waterlogged timbers' uncontrolled exposure to air and direct sunlight following their recovery. Unfortunately, this post-recovery exposure had allowed the water in the timbers to rapidly evaporate, thereby causing irreversible damage (shrinking, splitting/cracking, and checking) to the structure of the wood. In addition to this recent damage, charred areas on the ends of the floors and on the surfaces of some of the planking fragments indicated that the vessel had burned (Figure 1-12).

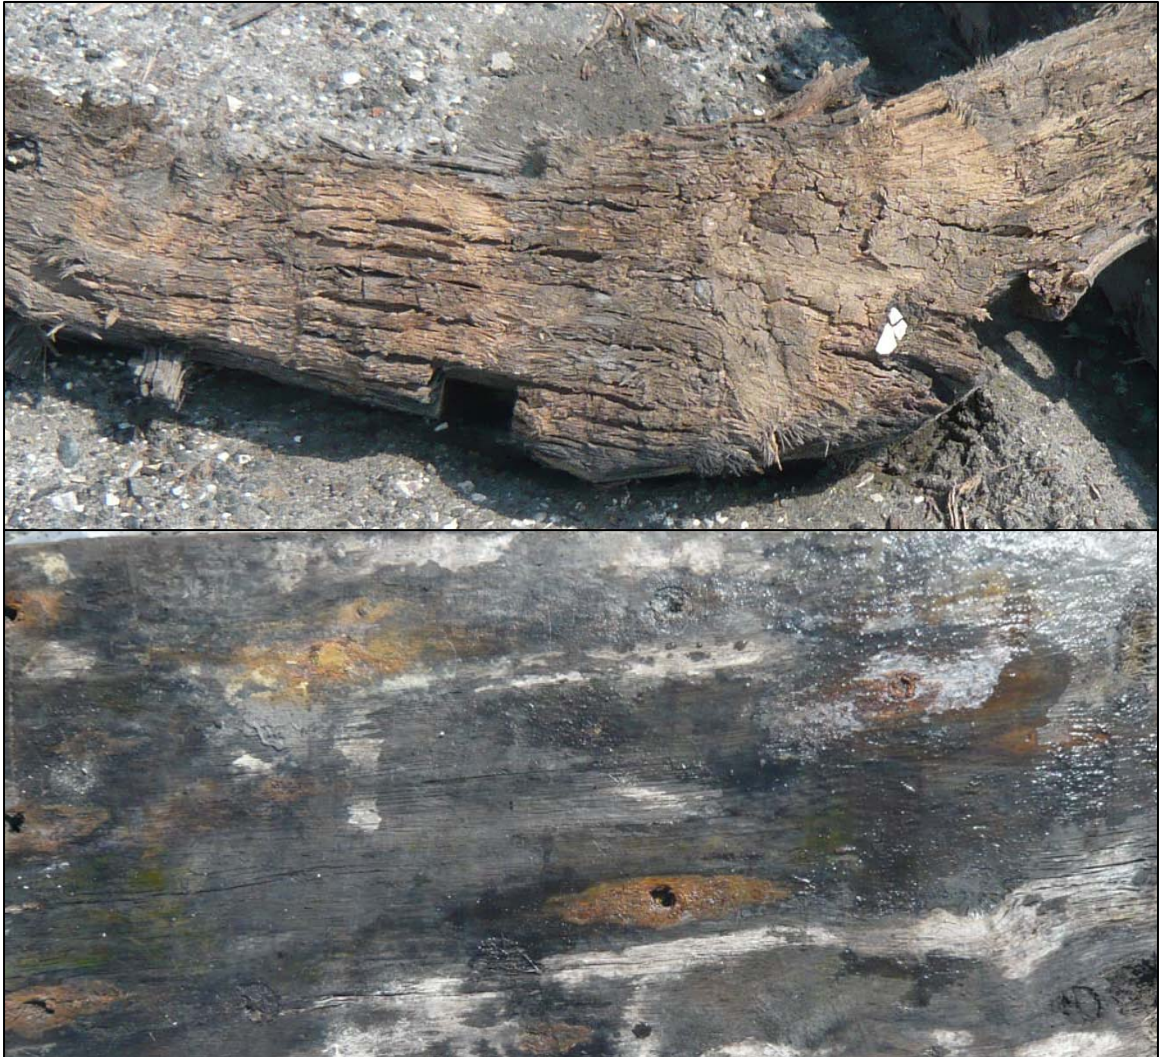
Figure 1-13. Recovered ship timbers inspected on July 16, 2009 were in generally poor condition, their surfaces split and checked from shrinkage caused by their exposure to air (top image). Preservation of the ship's iron fasteners, even in the timbers recovered in November 2009 that were kept wet prior to their documentation, was minimal with holes and rust stains providing the primary archaeological evidence of their existence (bottom image) (photographs by David Robinson).

The condition of the hull's iron fasteners was observed to be worse than that of the wood. In fact, the fasteners were essentially gone, as they were completely corroded with little or none of their ferrous parent metal preserved. In most cases, the only surviving evidence for their presence was the rust-stained holes left behind in the wood (Figure 1-13).

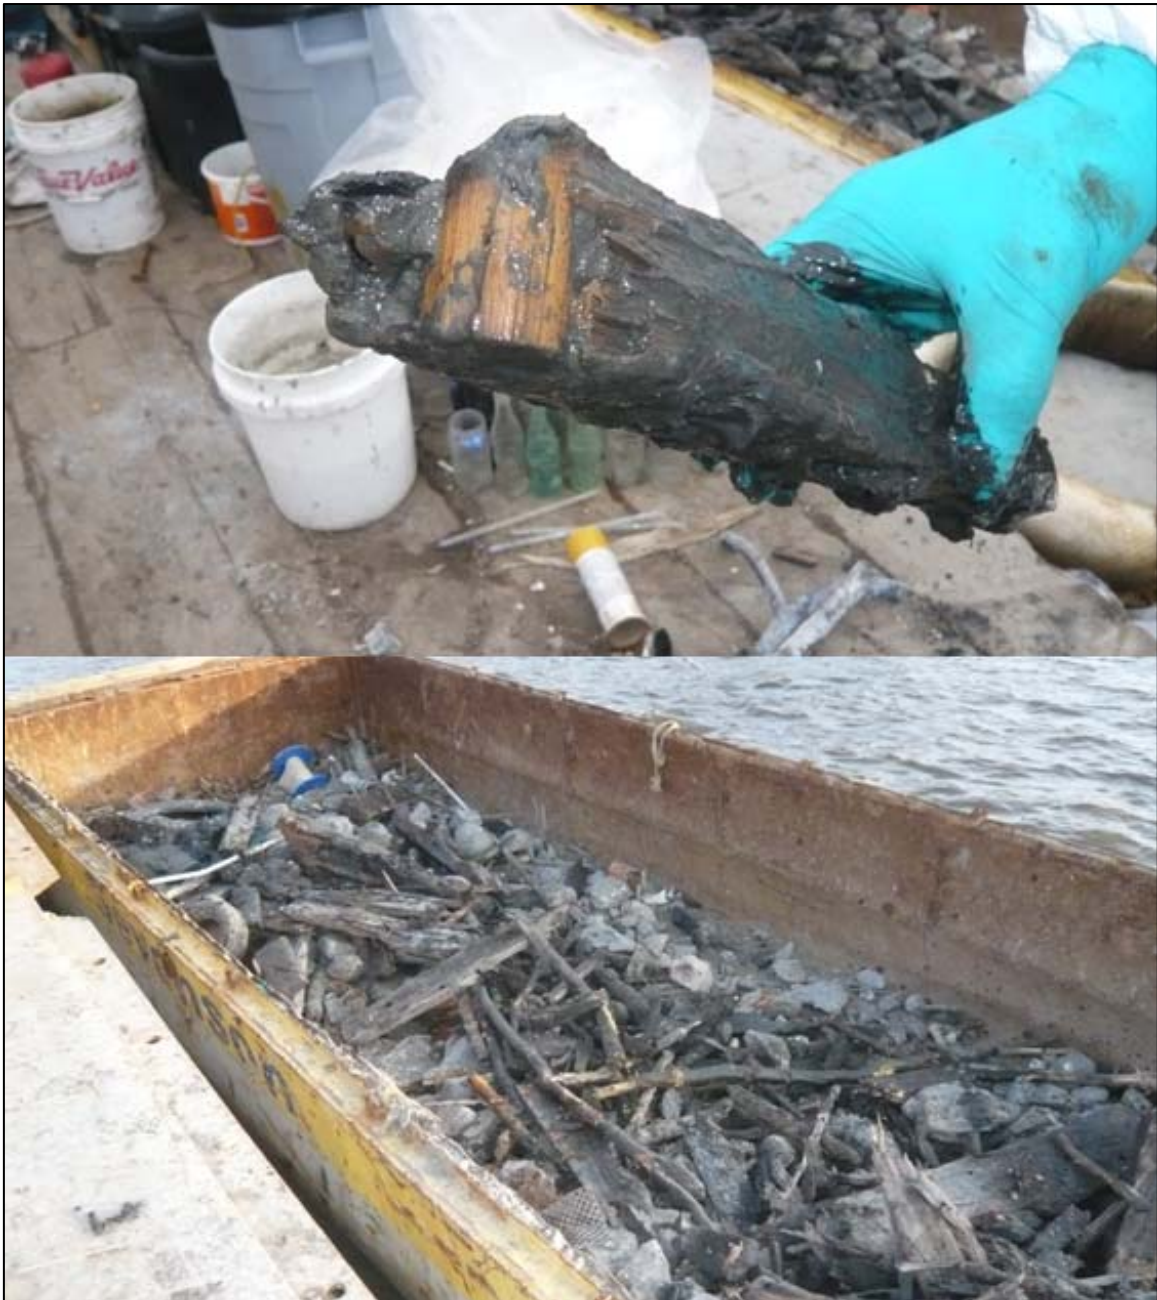
Figure 2-4. Heavily damaged and non-diagnostic hull fragments and miscellaneous debris unrelated to the shipwreck recovered during the November 2009 debris removal and ship timber recovery task were examined by the project archaeologist and then discarded into a hopper barge (photographs by David Robinson).

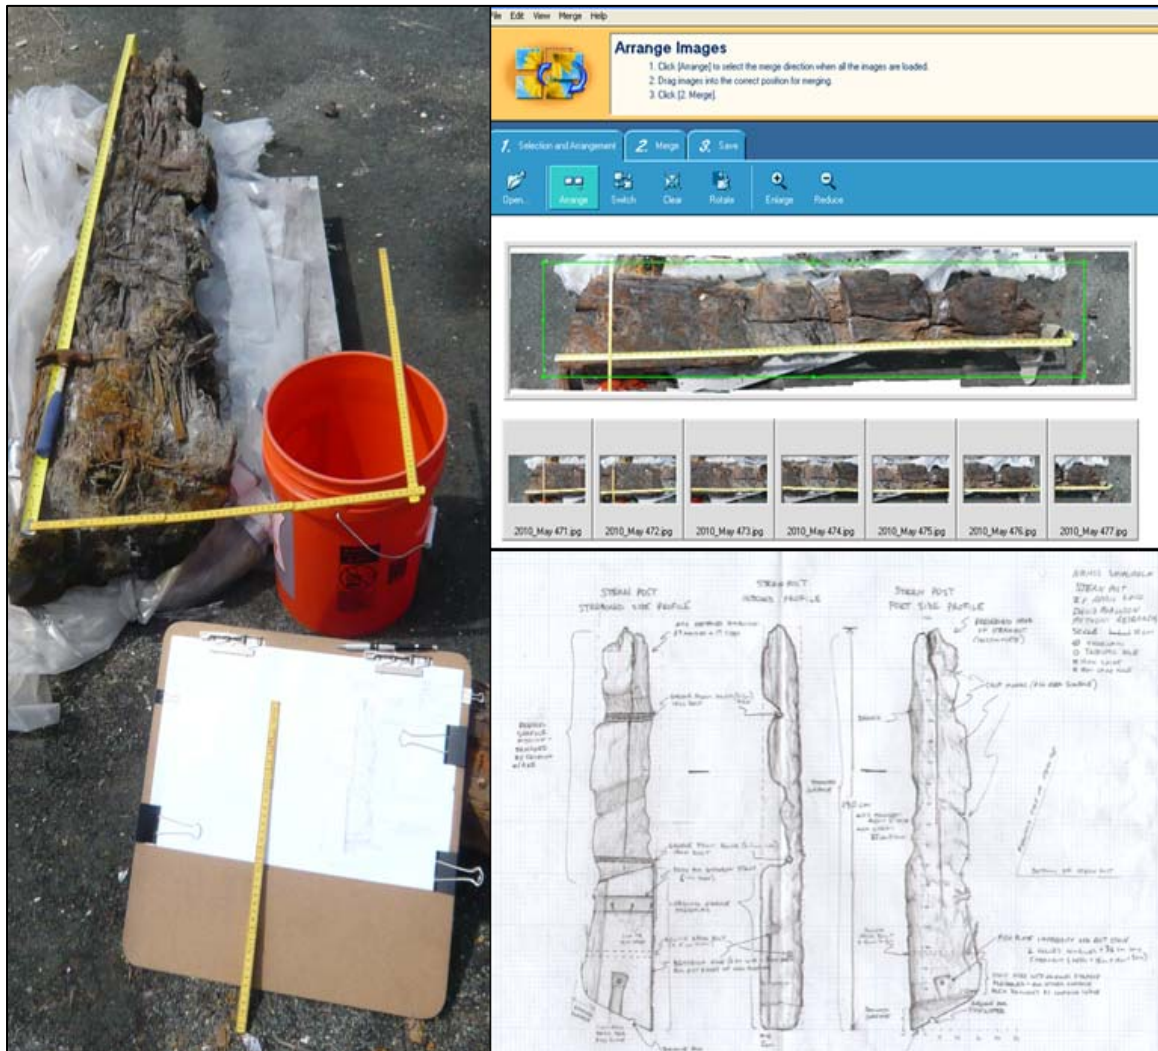
Figure 2-5. Photographs (including photomosaics created using Cannon’s PhotoStitch 3.1 computer software) and measured 2-D plan, profile, and section scale-drawings were prepared by the project archaeologist for each of the recovered timbers as part of the shipwreck’s archaeological documentation process (drawings and photographs by David Robinson).

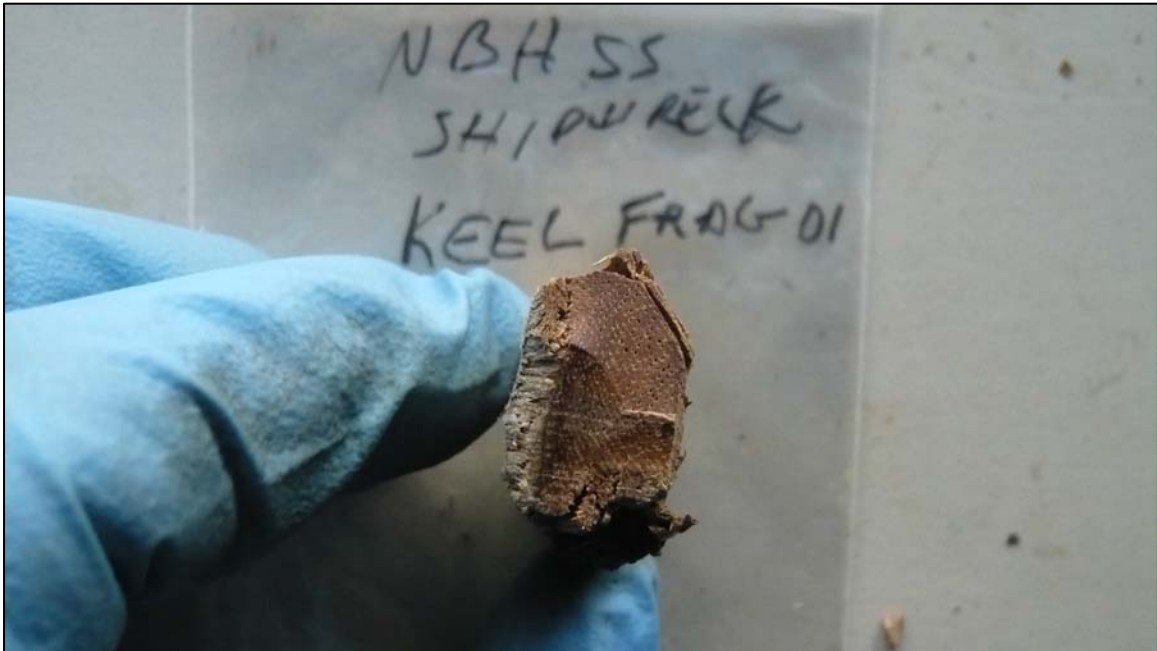
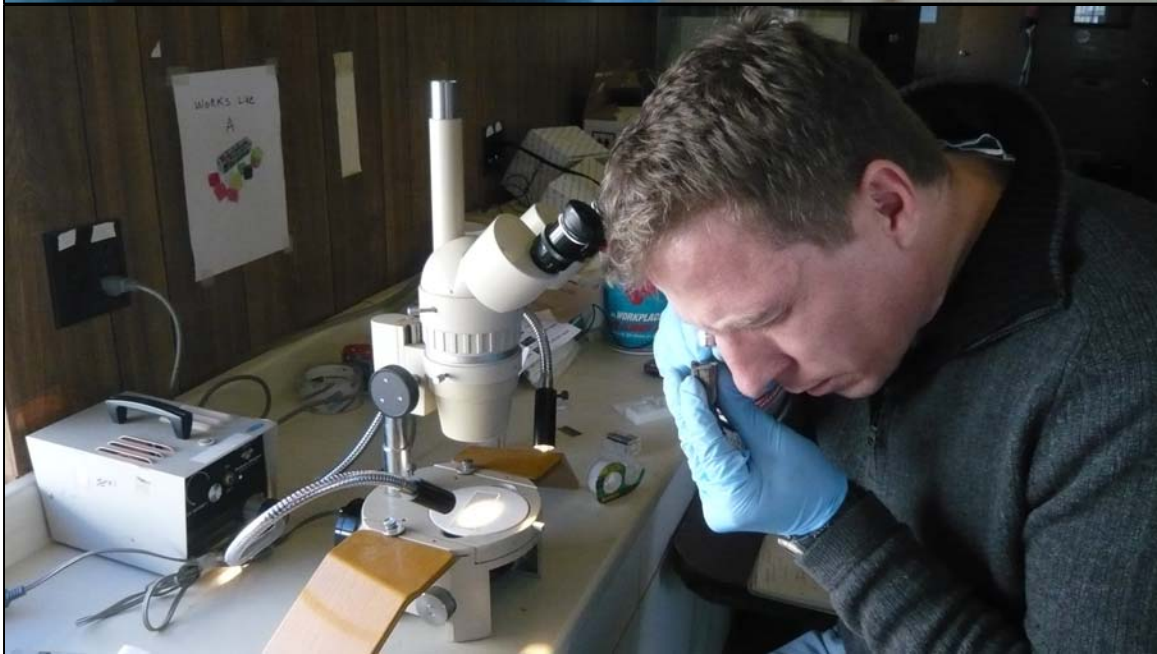
Figure 2-8. Wood samples from a select representative sample of key structural elements of the shipwreck's hull were extracted and subjected to macro- and microscopic analyses in January 2010 by the project archaeologist and archaeological wood specialist, Dr. Brian Jordan. The purpose of this analysis was to identify the wood species used in the vessel's construction, to determine whether the wood was extracted from "old" or "new" growth forests, and to develop hypotheses regarding the general age and origin of the raw materials used in the vessel's construction (photographs by David Robinson).

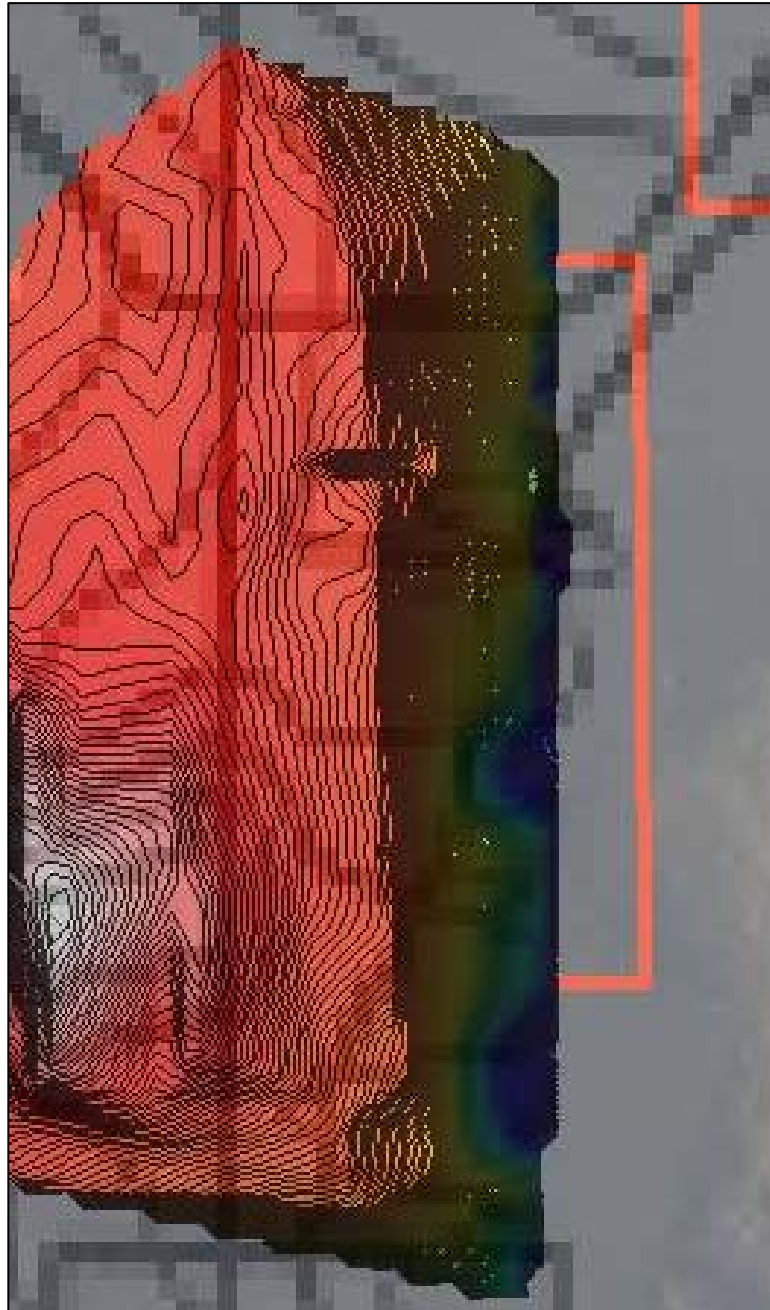
Figure 3-2. Color-coded contour plot of magnetic data recorded during the 2009 geophysical survey of the NBHSS shipwreck study area (image courtesy of CRE).
