Silver Lake Cleanup – Overview Slide

Silver Lake – Progress to Date

Site Name: GE – Housatonic River

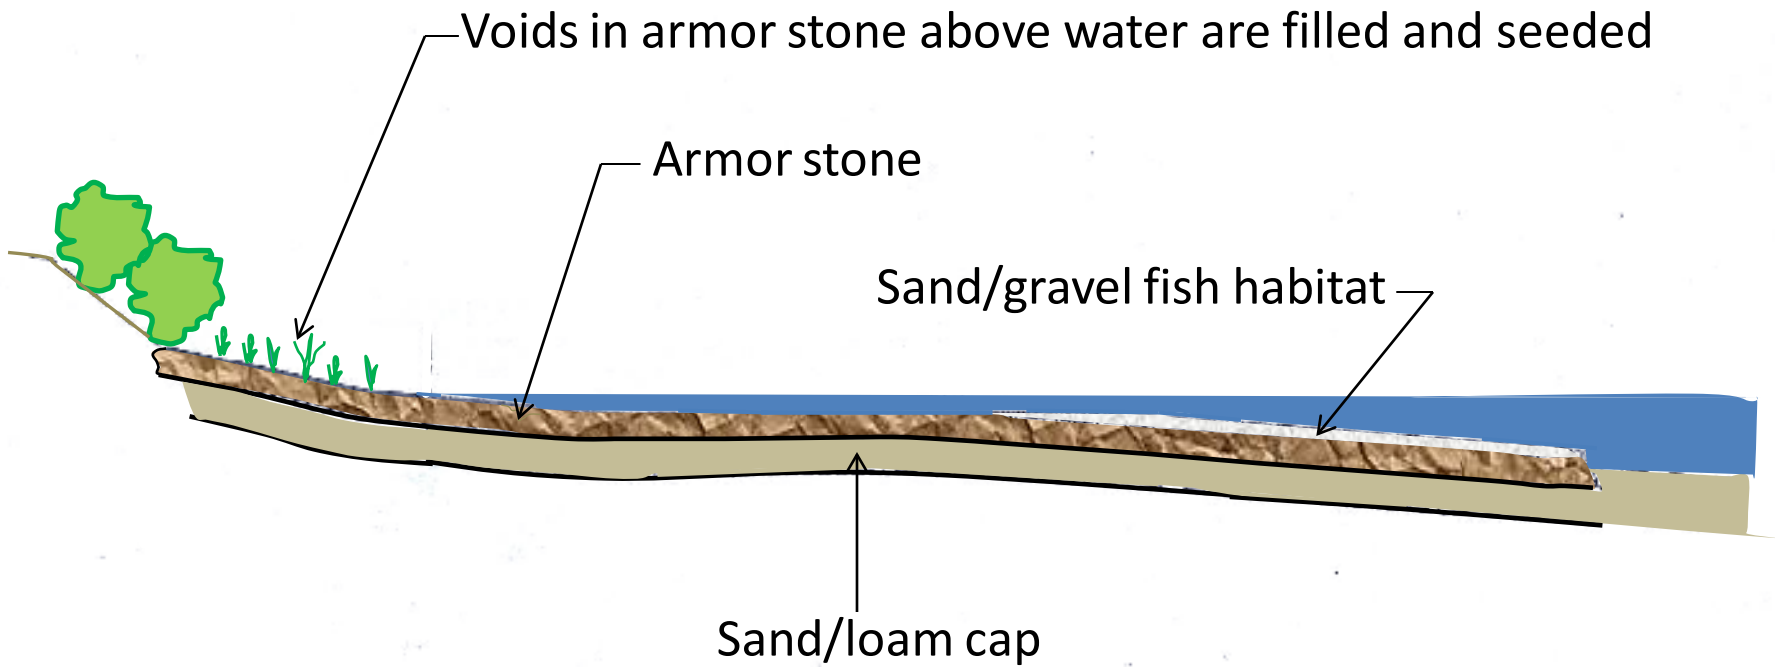
- Soil & sediment removed/replaced (app. 13,500 cy)
-

- Near-shore cap installed

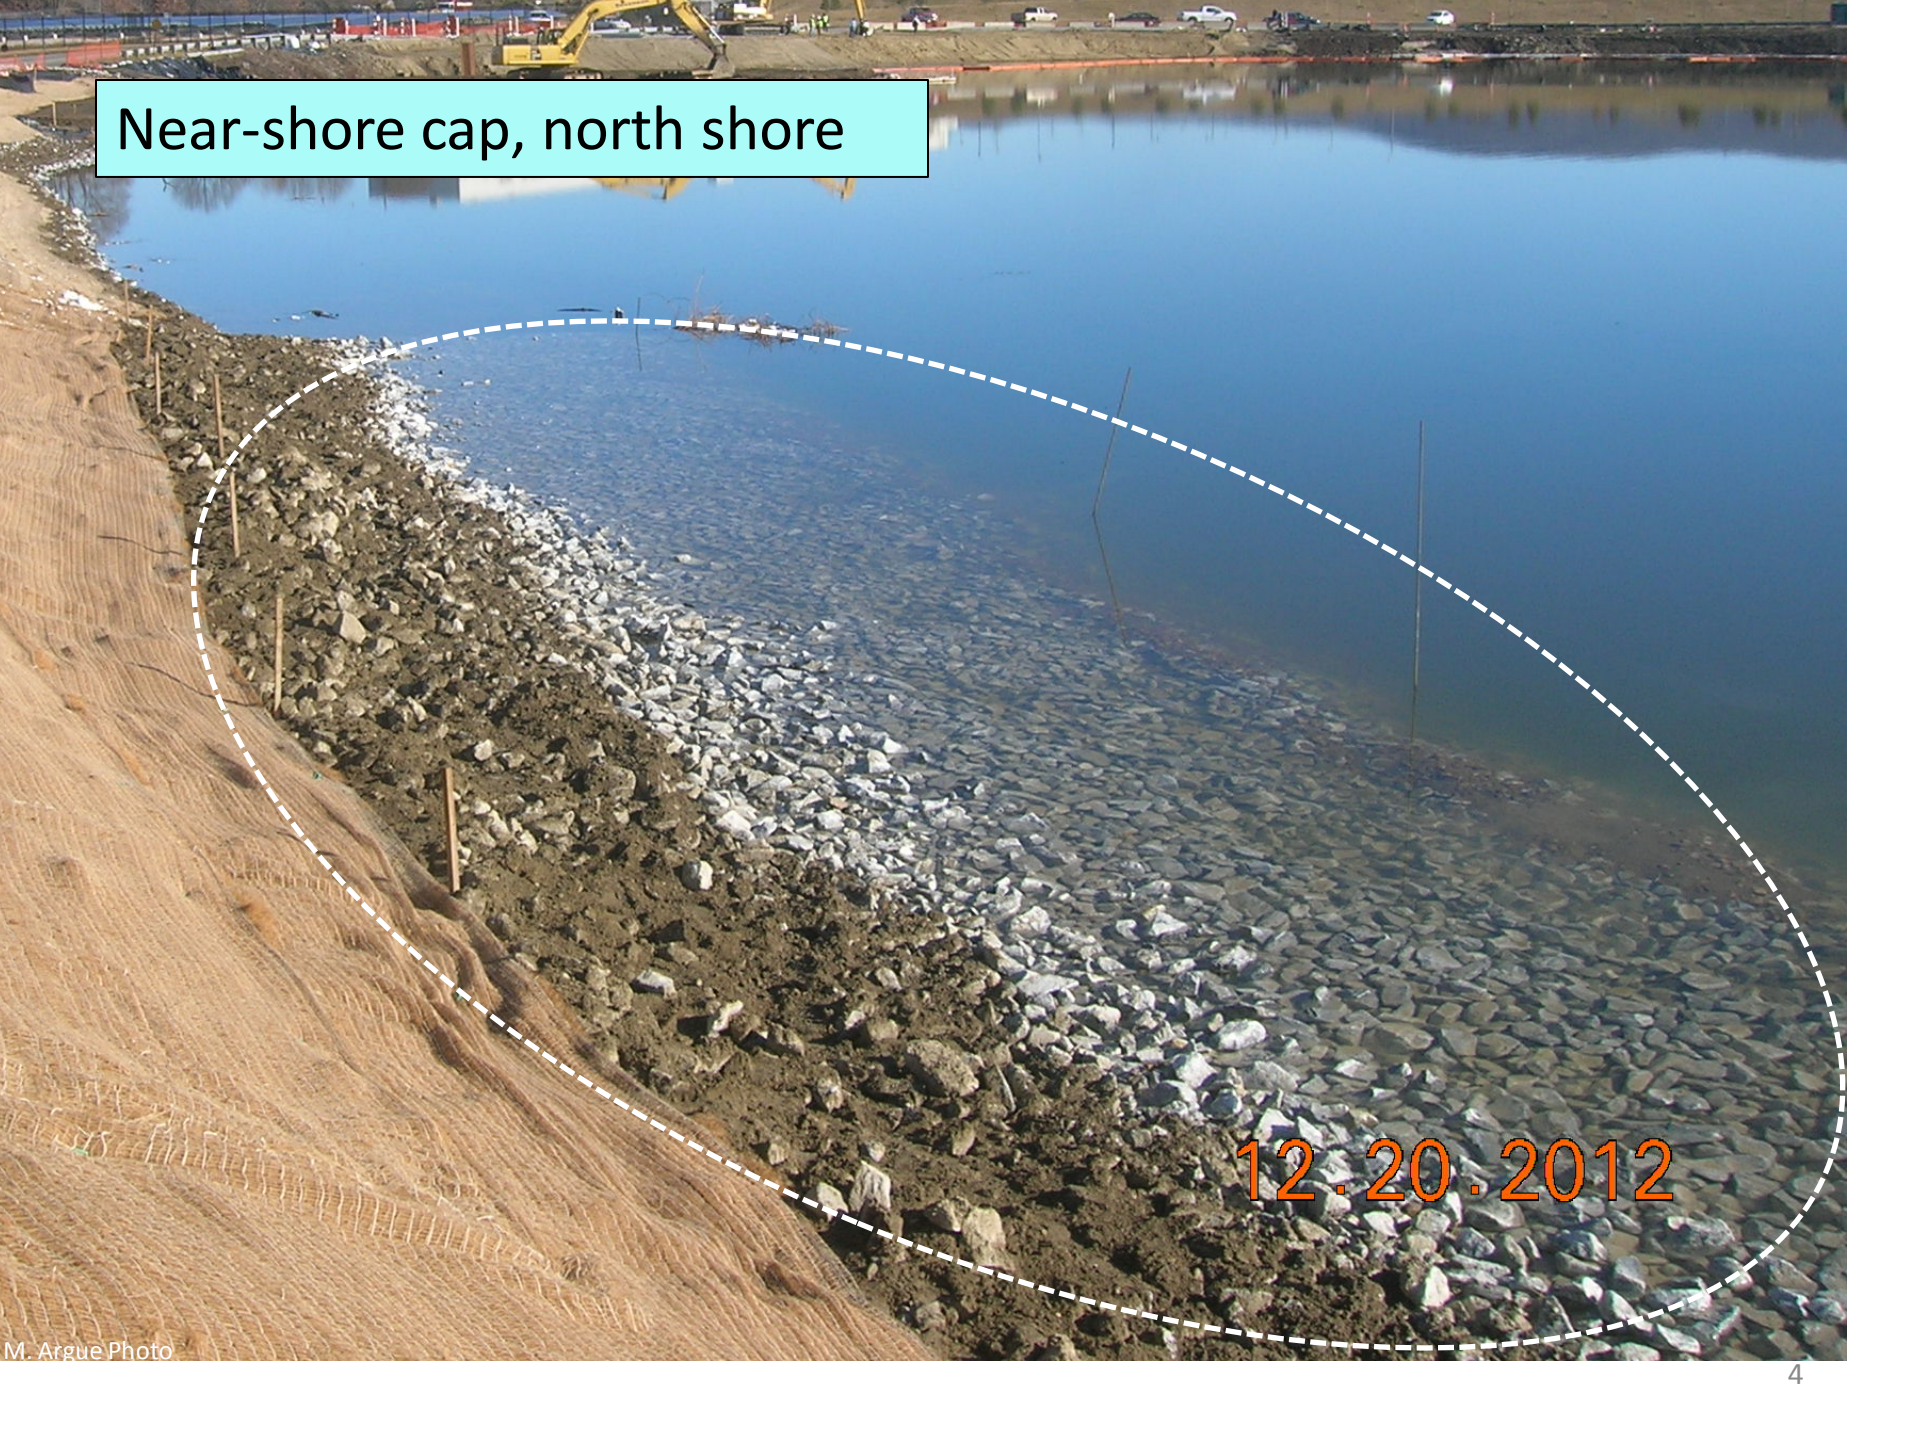
Silver Lake – near-shore cap

Near-shore cap, north shore

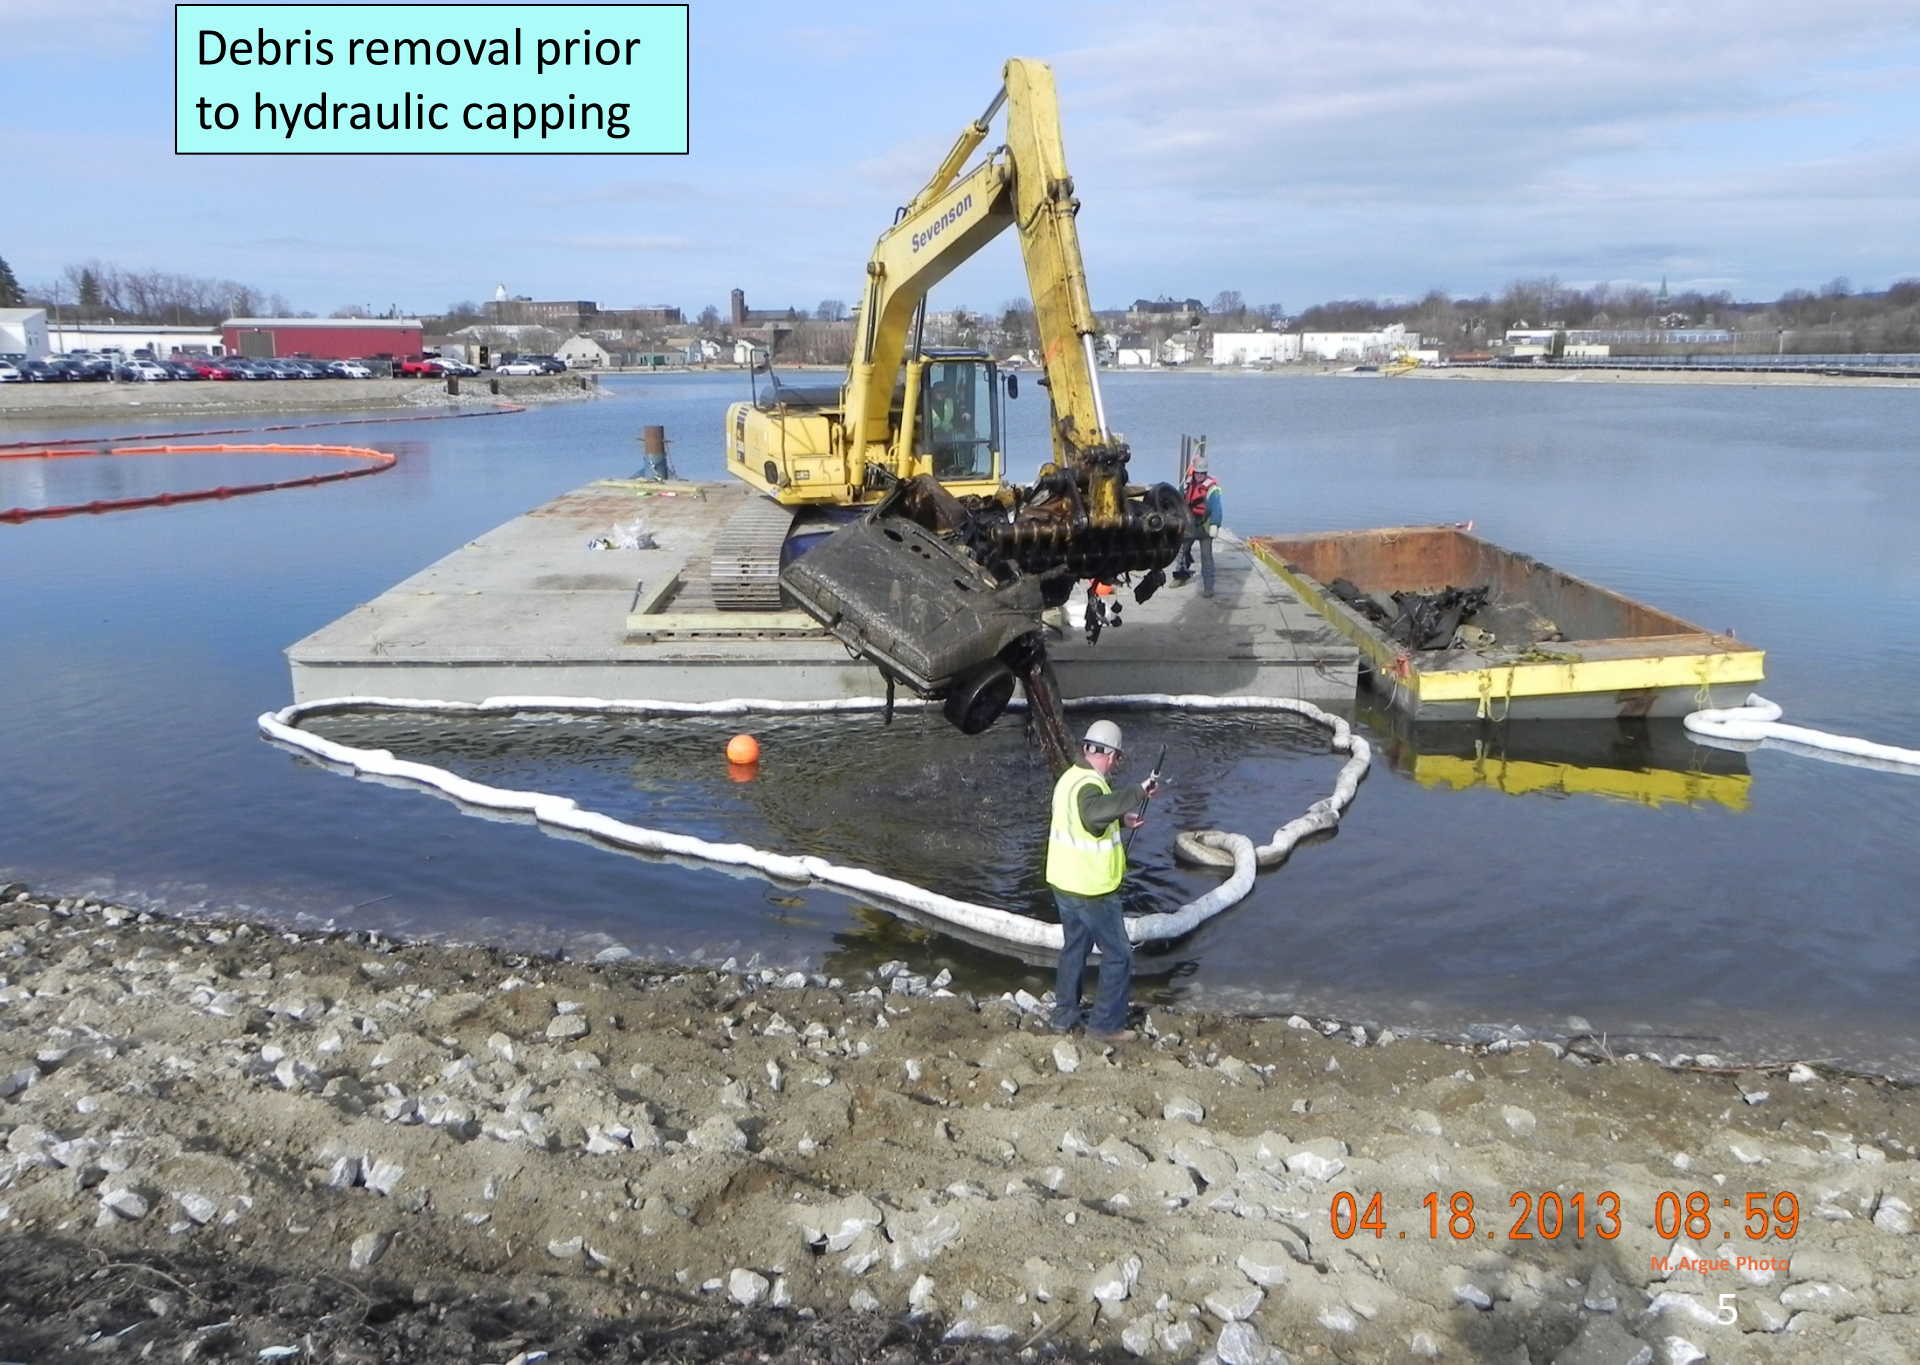
Debris removal prior
to hydraulic capping

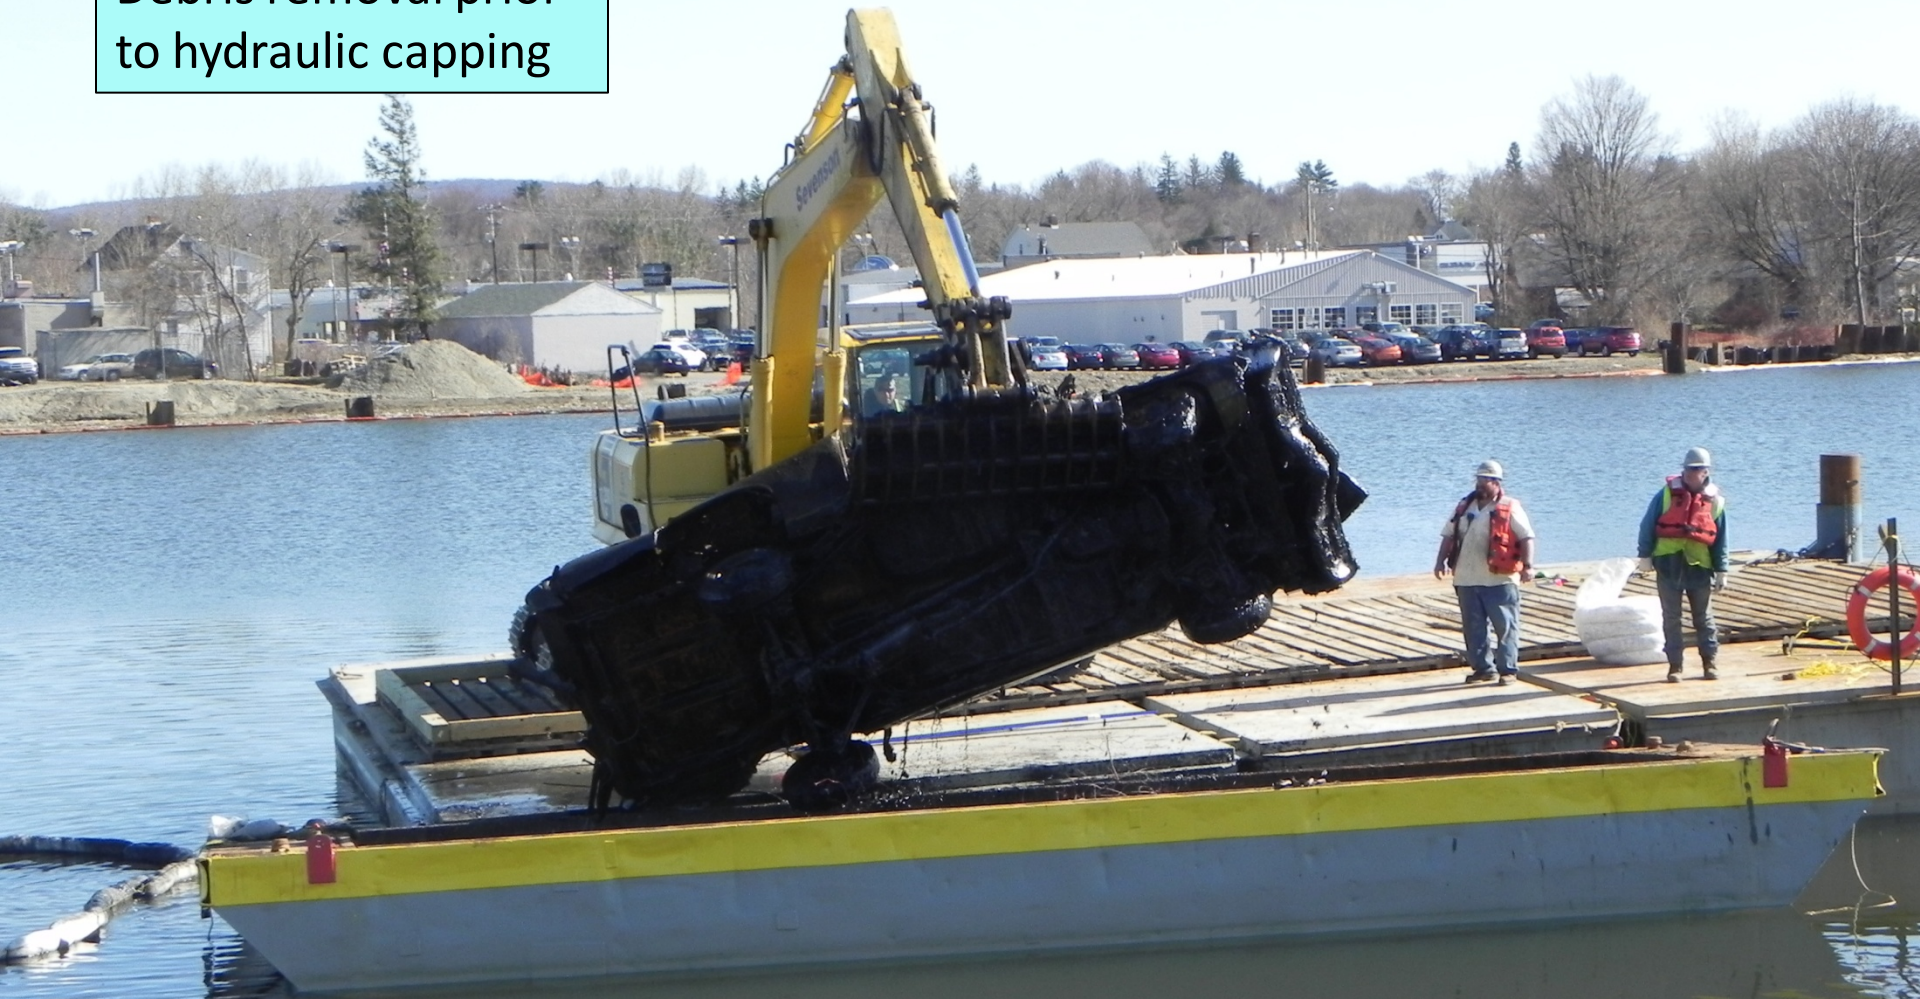
Debris removal prior
to hydraulic capping

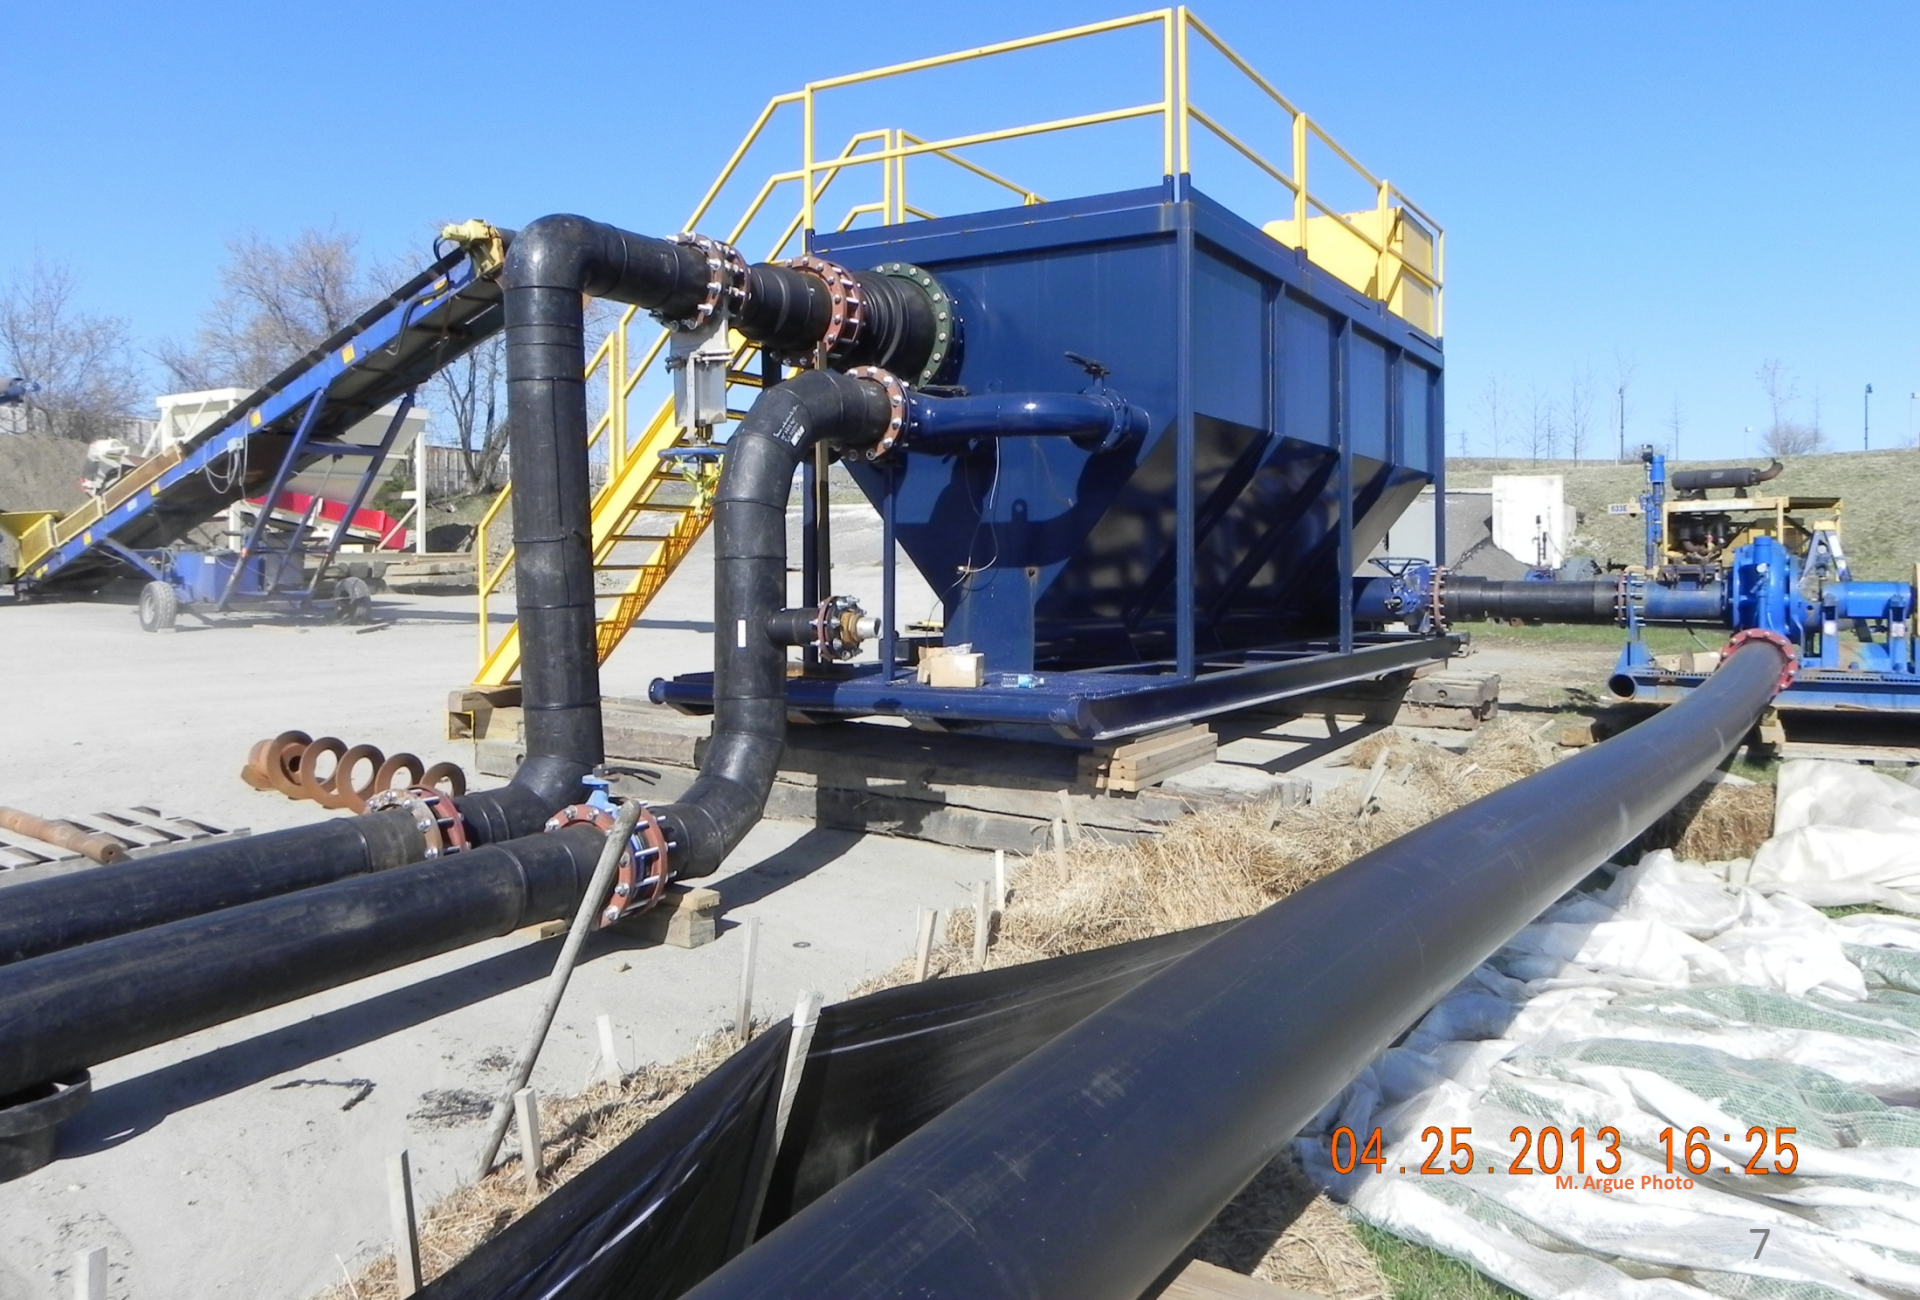
Hydraulic capping process equipment

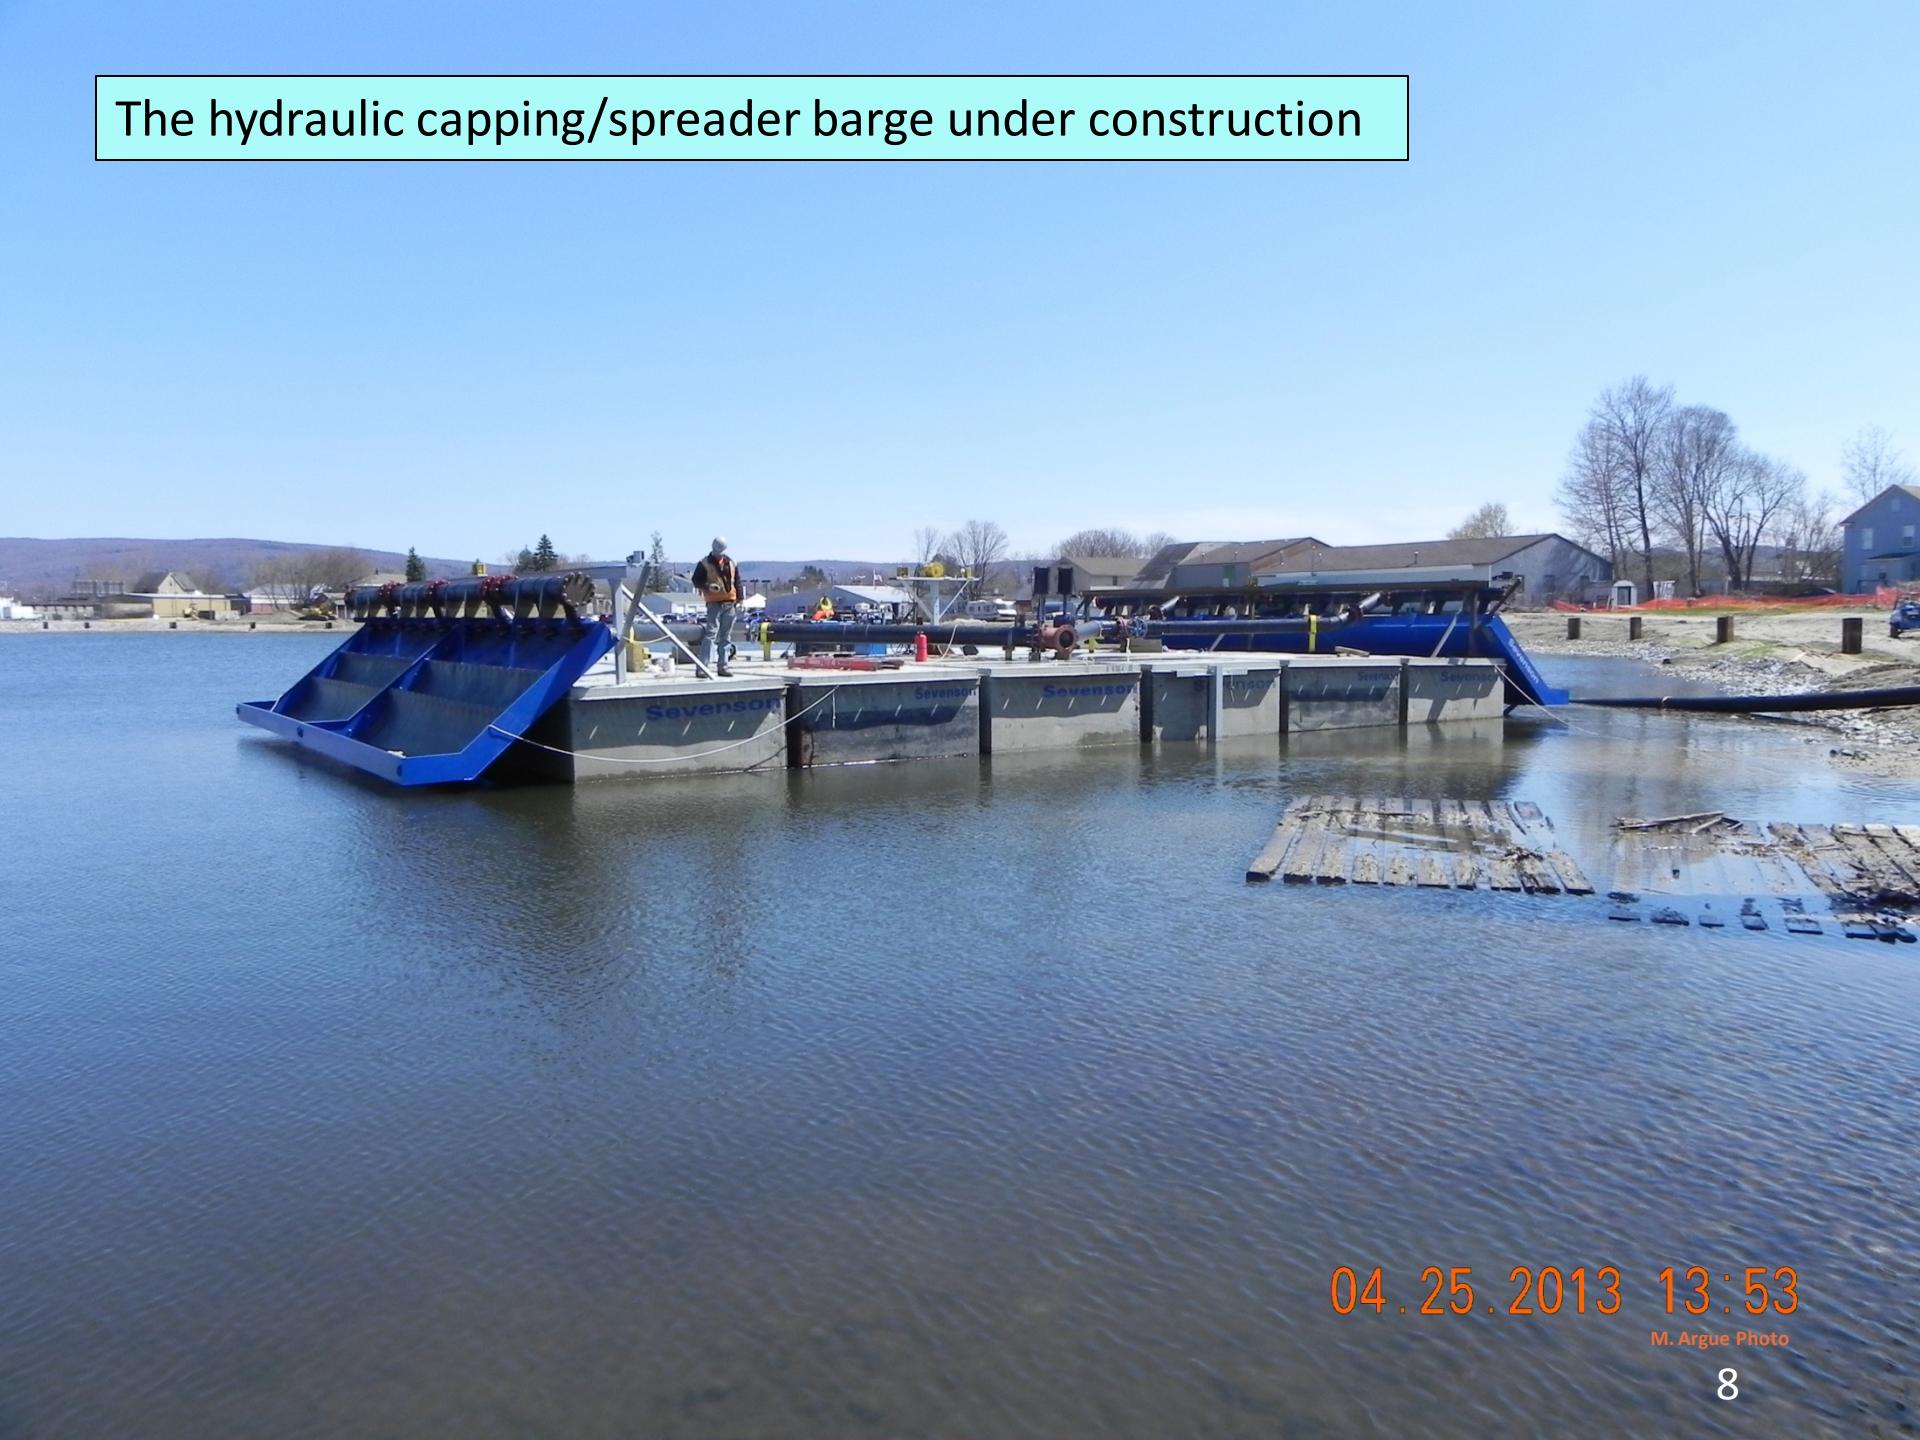
The hydraulic capping/spreader barge under construction

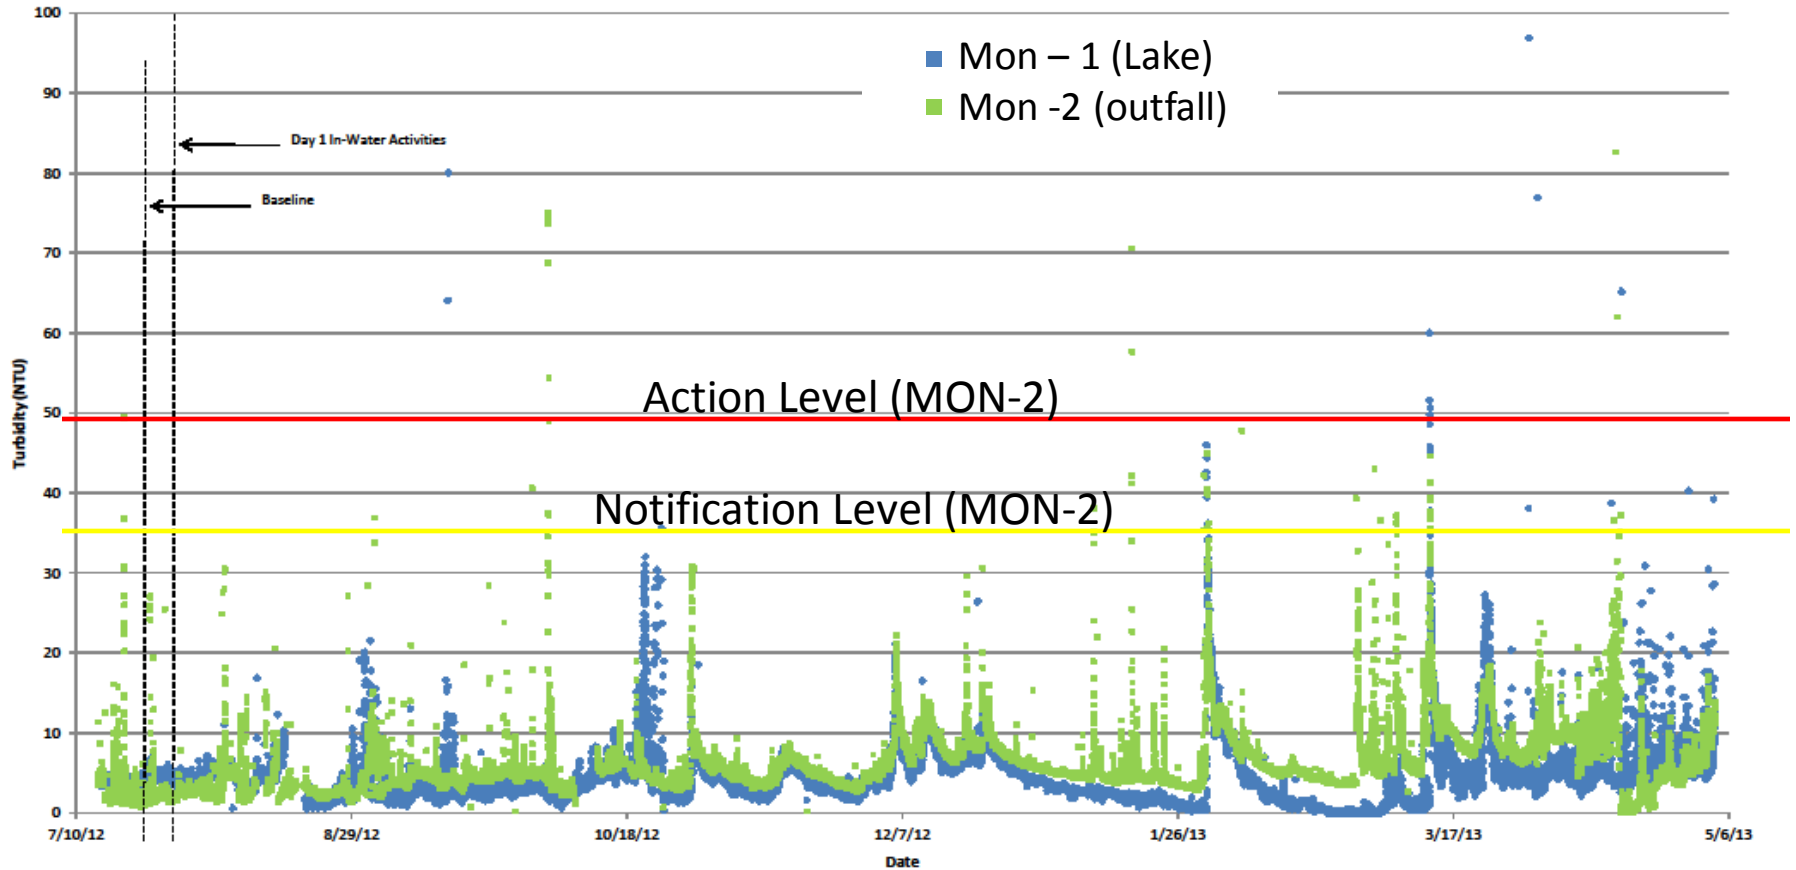
Turbidity Monitoring - Silver Lake 2012/13

1. Major tick marks along the horizontal axis are at midnight. Turbidity measurements were recorded every 15 minutes.
2. During non-work hours, strong storms in the Pittsfield area resulted in exceedances above 50 NTU at MON-2 on 7/24, 8/5, 8/17, 8/27, 9/5, 9/8, 9/22, and 9/30 (in 2012) and 1/31 (in 2013). As these exceedances were caused by weather events and were not attributed to active construction, the observations have been removed from the above Figure.

3. A water quality sample was collected due to the exceedance above 50 NTU at MON-2 on 10/3/12, 1/17/13, 4/15/13.
4. Malfunctions in the real-time turbidity monitor (used to collect the date presented in this Figure) indicated turbidity levels exceeded 50 NTU at MON-1 and/or MON-2 at certain times during and outside of work hours. At such times (or before work was started the following day), manual readings and/or visual observation were performed at MON-2 to confirm that turbidity levels were below the early action level of 35 NTU. The most extraneous of these exceedances have been removed from the above Figure.

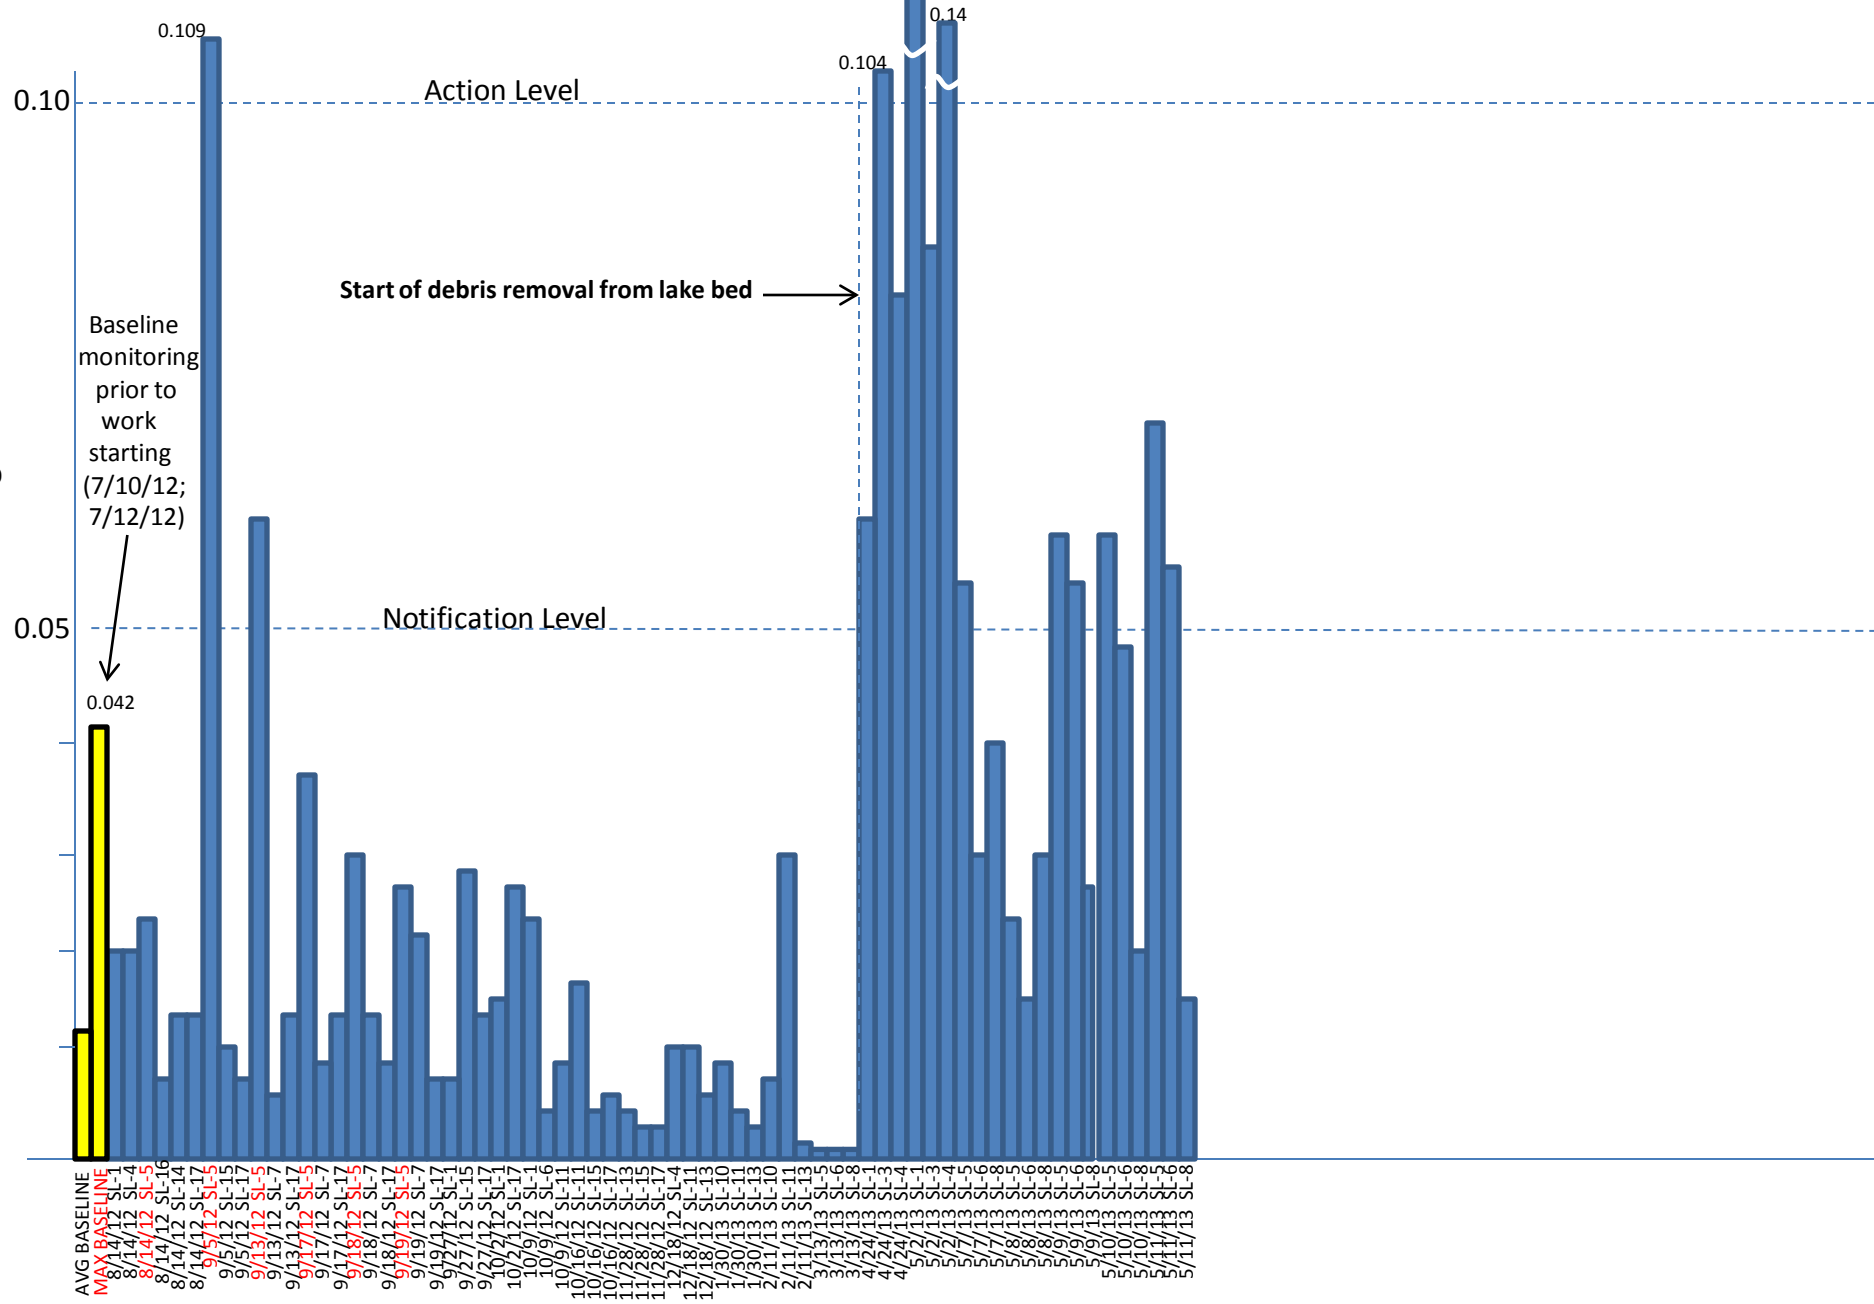
Silver Lake Airborne PCB Data – 2012/2013

Airborne PCB level - ug/m3

Start Date and Location of 24-hour Air Monitoring Events

Corrective Actions to Control Emissions During Debris Removal

- Daily PCB air sampling during debris removal operations
- Additional PCB air sampling locations
- Use of vapor-suppressant foam to cover removed debris
- Minimize/eliminate holding time in debris stockpile prior to shipment
- Covering debris stockpile with poly sheeting as needed
- Second oil boom and silt curtain around removal operations
- Use of sheen-dispersant as needed, with extra patrol boat

- Dive team to locate and place cables/floats on debris targets (eliminated use of rake attachment to find debris and thus minimized disturbance of lake sediments)
- Minimize/eliminate use of barge anchors (“spuds”) due to dive team’s pre-placed cables/floats
