**Re: GE-Pittsfield/Housatonic River Site
Unkamet Brook Area (GECD170)
Summary of 2015 Annual ERE Inspection Activities**

ERE ANNUAL INSPECTION CHECKLIST
UNKAMET BROOK AREA - PARCEL NO. L12-1-4
(For Use Prior to Recordation of Notice of Completion)

ERE ANNUAL INSPECTION CHECKLIST
UNKAMET BROOK AREA - PARCEL NO. L12-1-101
(For Use Prior to Recordation of Notice of Completion)

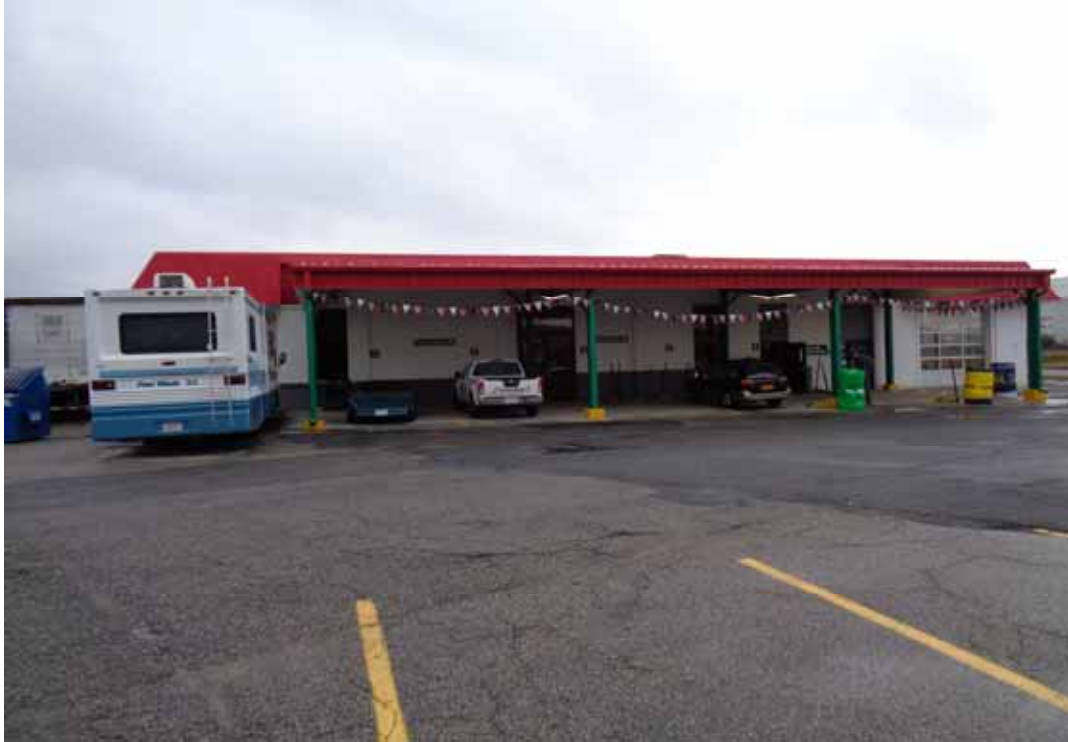
The asphalt pavement removal and soil excavation that had been observed during the November 2014 inspection for the installation of eight concrete foundation footings and a concrete pad for a canopy, as well as the construction of those footings, pad, and canopy, had been completed. The completed construction is shown on attached Photos #1 and #2.

Photo #1: Completed installation of eight concrete foundation footings and installation of a concrete pad on Parcel L12-1-4.

It was also observed that, on Parcel L12-1-4, the asphalt pavement removal and soil excavation that had been taking place during the November 2014 inspection (pursuant to an approved Conditional Exception under the ERE) for the installation of eight concrete foundation footings and a concrete pad for a canopy, as well as the construction of those footings, pad, and canopy, had been completed. The completed construction is shown in photographs attached to the inspection checklist for Parcel L12-1-4.

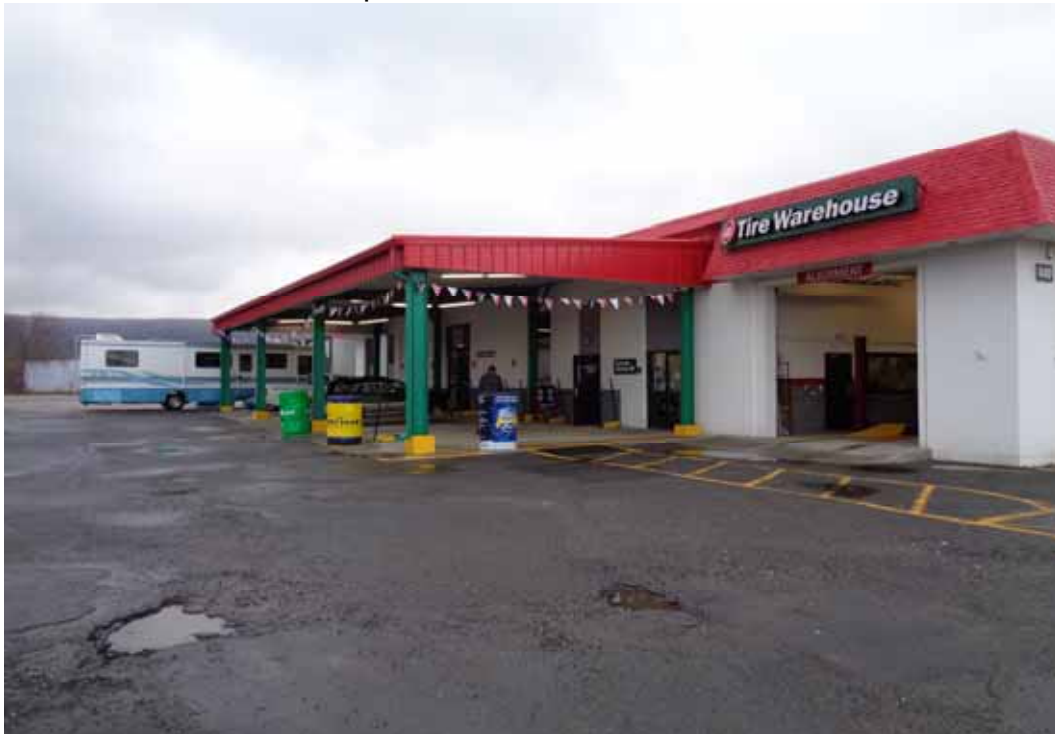
Photo #2: Completed installation of eight concrete foundation footings and installation of a concrete pad on Parcel L12-1-4.

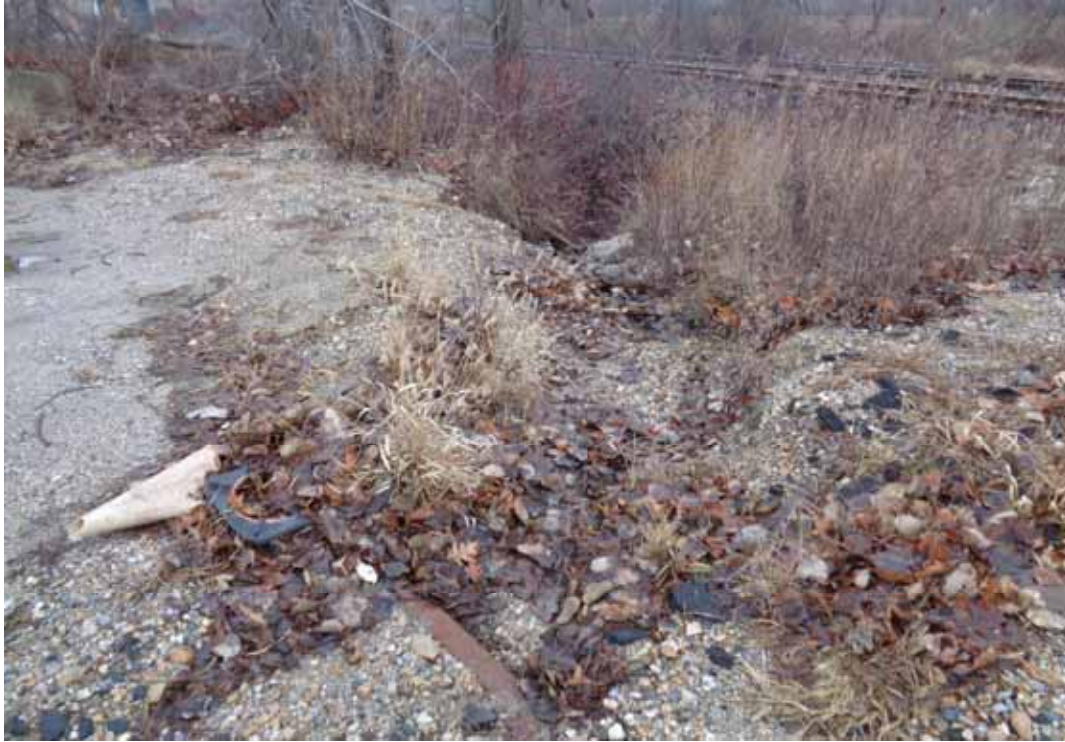
The same soil erosion rill that had been observed during the 2013 and 2014 ERE inspections in the gravel driveway/parking area adjacent to Unkamet Brook continued to be present and appeared to be in the same condition as observed during those prior inspections. The approximate location of this erosion rill is identified on the attached figure, and the erosion is shown on attached Photos #3 and #4. This erosion will be addressed as part of the remediation activities in this portion of the Unkamet Brook Area.

Photo #3: Erosion present on Parcel L12-1-101.

As also indicated in the attached inspection checklists, the visual on-site inspection conducted on December 3, 2015 revealed no significant changes in the physical condition of any of these properties and no evidence of any of the other above-listed conditions at any of the properties since the last inspection, with one exception: On Parcel L12-1-101, an erosion rill in the gravel driveway/parking area adjacent to Unkamet Brook, which had been observed during the November 2013 and November 2014 ERE inspections, was still present and was observed to be in the same condition as during those prior inspections. This rill is located near the southeast corner of the building and has created a small gully that is eroding into Unkamet Brook. The location of the erosion on this property is identified on a drawing and shown in photographs attached to the inspection checklist for Parcel L12-1-101. It is anticipated that this erosion will be addressed as part of the remediation activities in this portion of the Unkamet Brook Area.

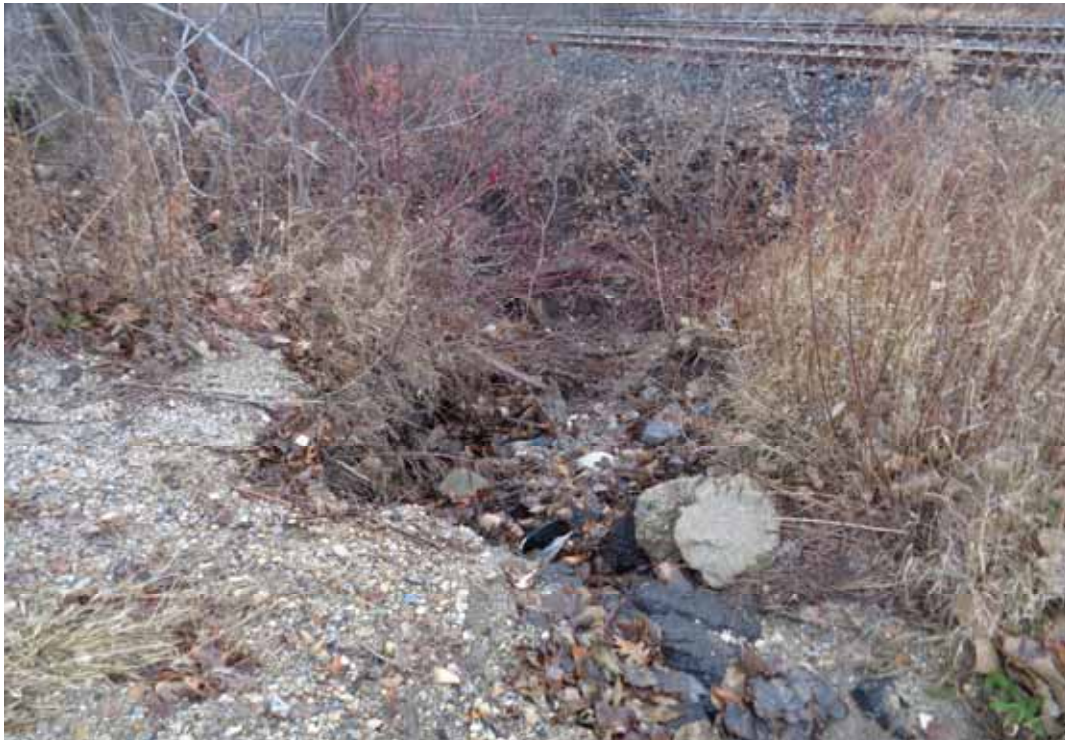
Photo #4: Erosion present on Parcel L12-1-101.
