**Re: GE-Pittsfield/Housatonic River Site
Rest of River (GECD850)
Baseline Restoration Assessment Report for Reach 6**

Baseline Restoration Assessment Report For Housatonic Rest of River Reach 6

October 2024

Prepared by
AECOM
500 Enterprise Drive
Rocky Hill, Connecticut 06067

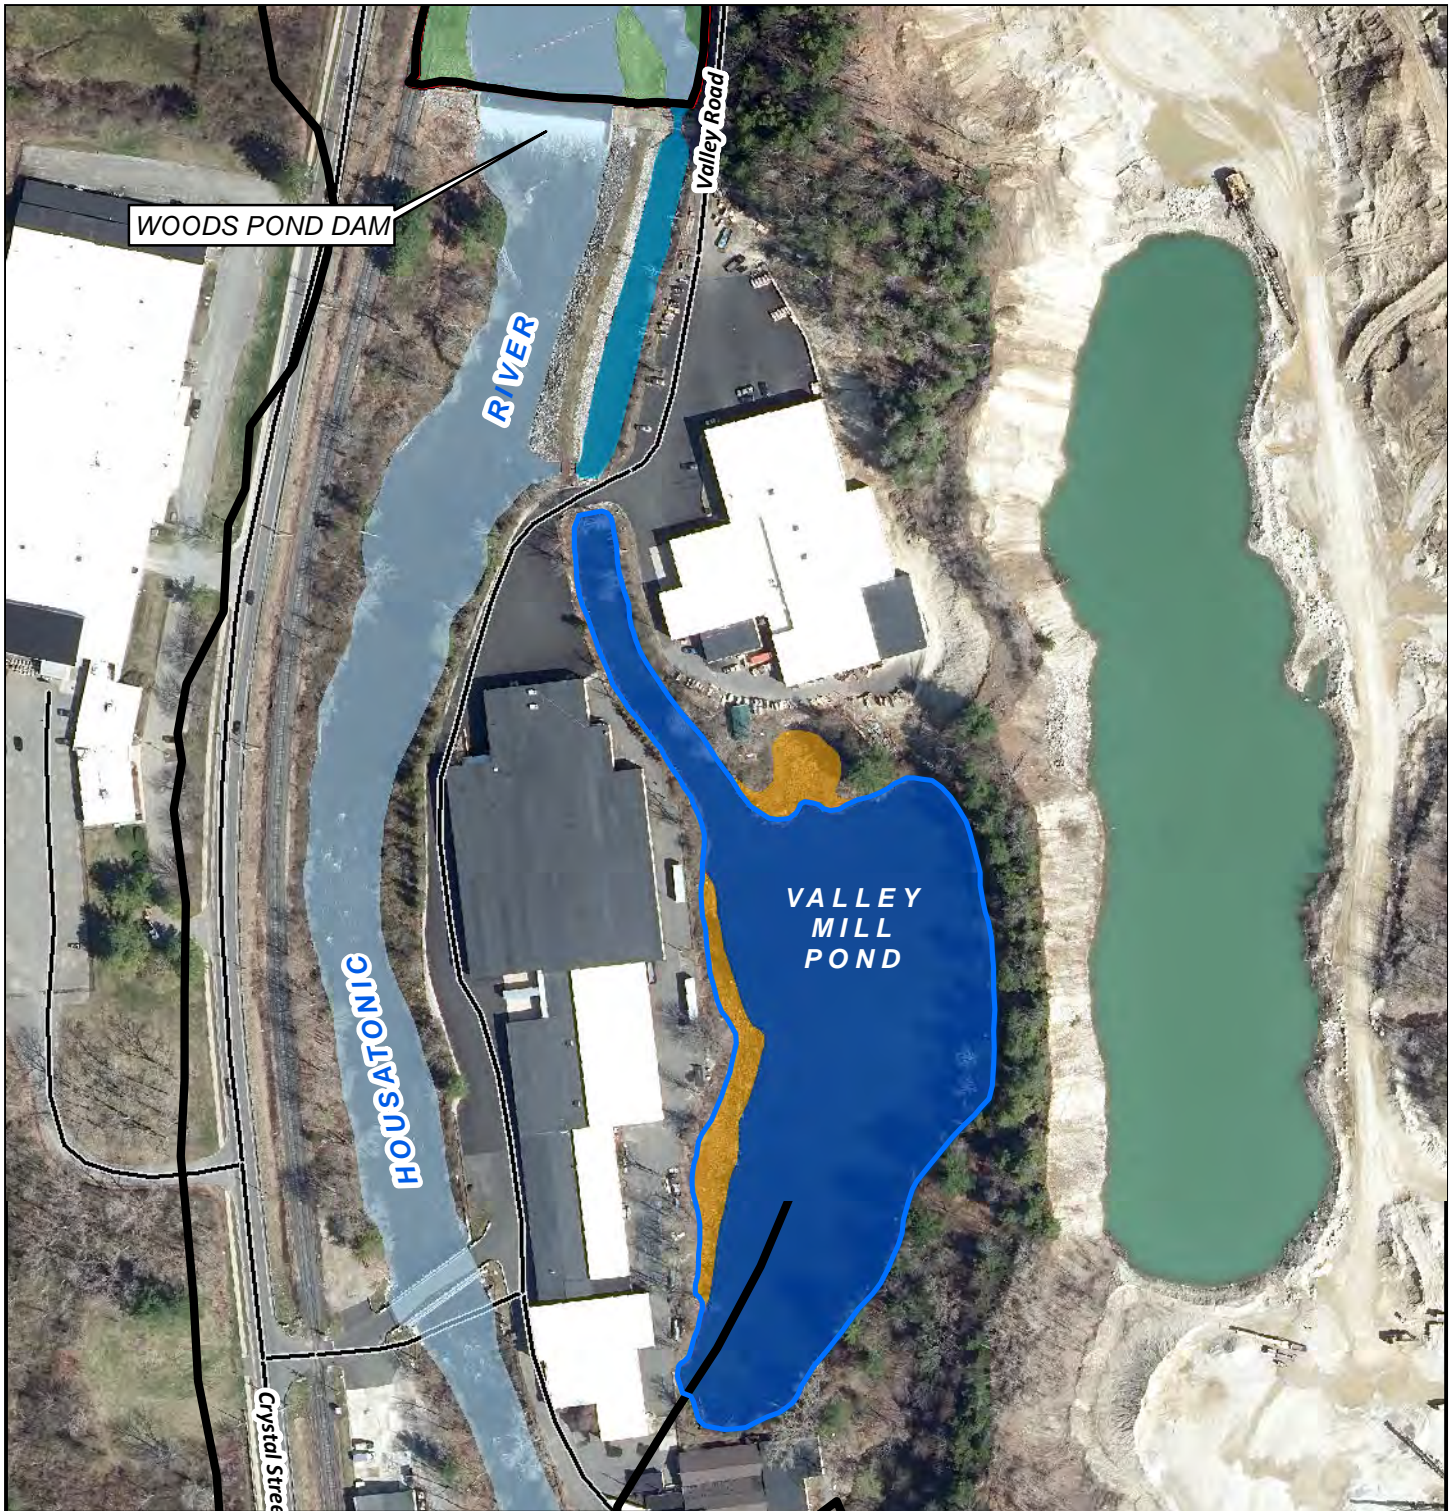
Figure 3-2b
Map Sheet 2 of 2

Reach 6 / Woods Pond Side Scan Sonar Habitat Survey Reach 6 Baseline Restoration Assessment Report
Housatonic River - Lee and Lenox, MA

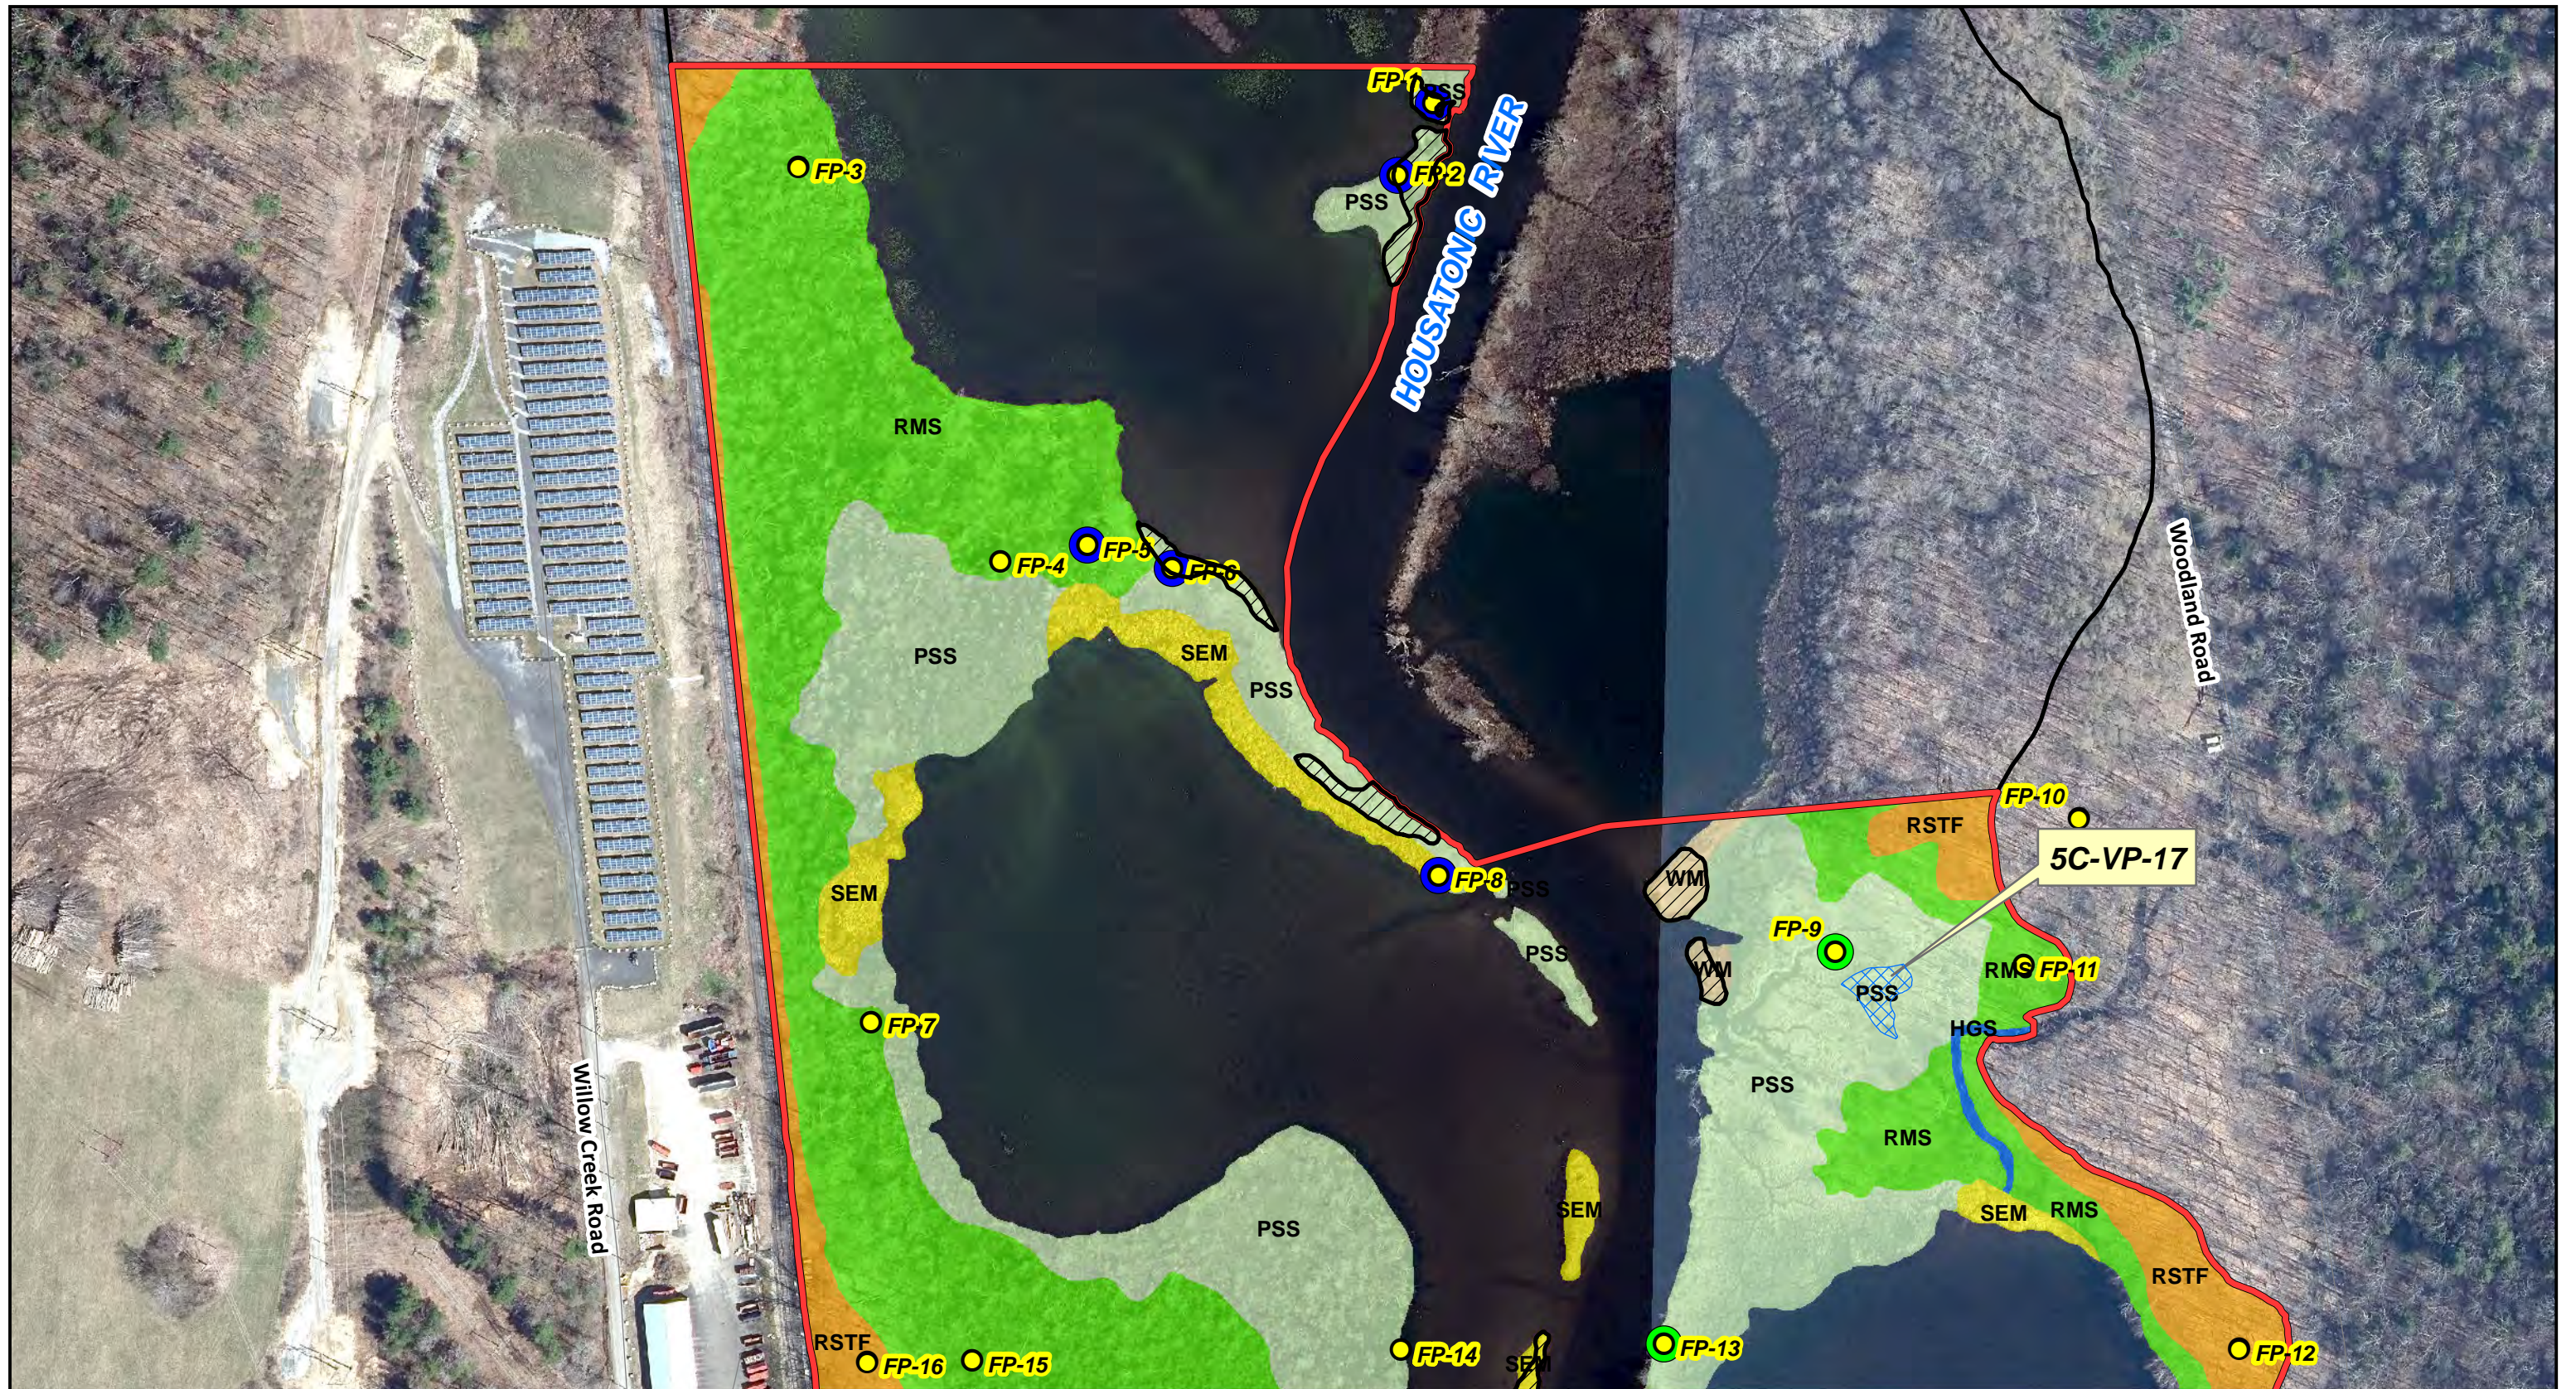
Figure 3-3

Valley Mill Pond is a roughly 4.6-acre ponded area situated along the eastern side of the Housatonic River just downstream (south) of the Woods Pond Dam (**Figure 3-3**). The pond is hydraulically connected to the raceway channel that extends off the eastern side of the dam. Just upstream of the structure that regulates the raceway discharge back to the Housatonic River is a culvert that connects the raceway to the northern end of Valley Mill Pond; that culvert appears to be capped at the current time, although it is unclear whether and to what extent water from the raceway is conveyed into Valley Mill Pond under current conditions and operations. There is a constricted outlet at the southern end of the pond that directs waters southwestward, beneath paved areas, and back into the Housatonic River. The pond was reportedly used for past hydropower (UASCE 1987).¹⁴

During the brief field survey of Valley Mill Pond, two invasive plant species were noted. The submerged aquatic macrophyte Eurasian watermilfoil was observed within the actual pond, and common reed was abundant in an emergent wetland near the northern inlet area (**Figure 3-3**).

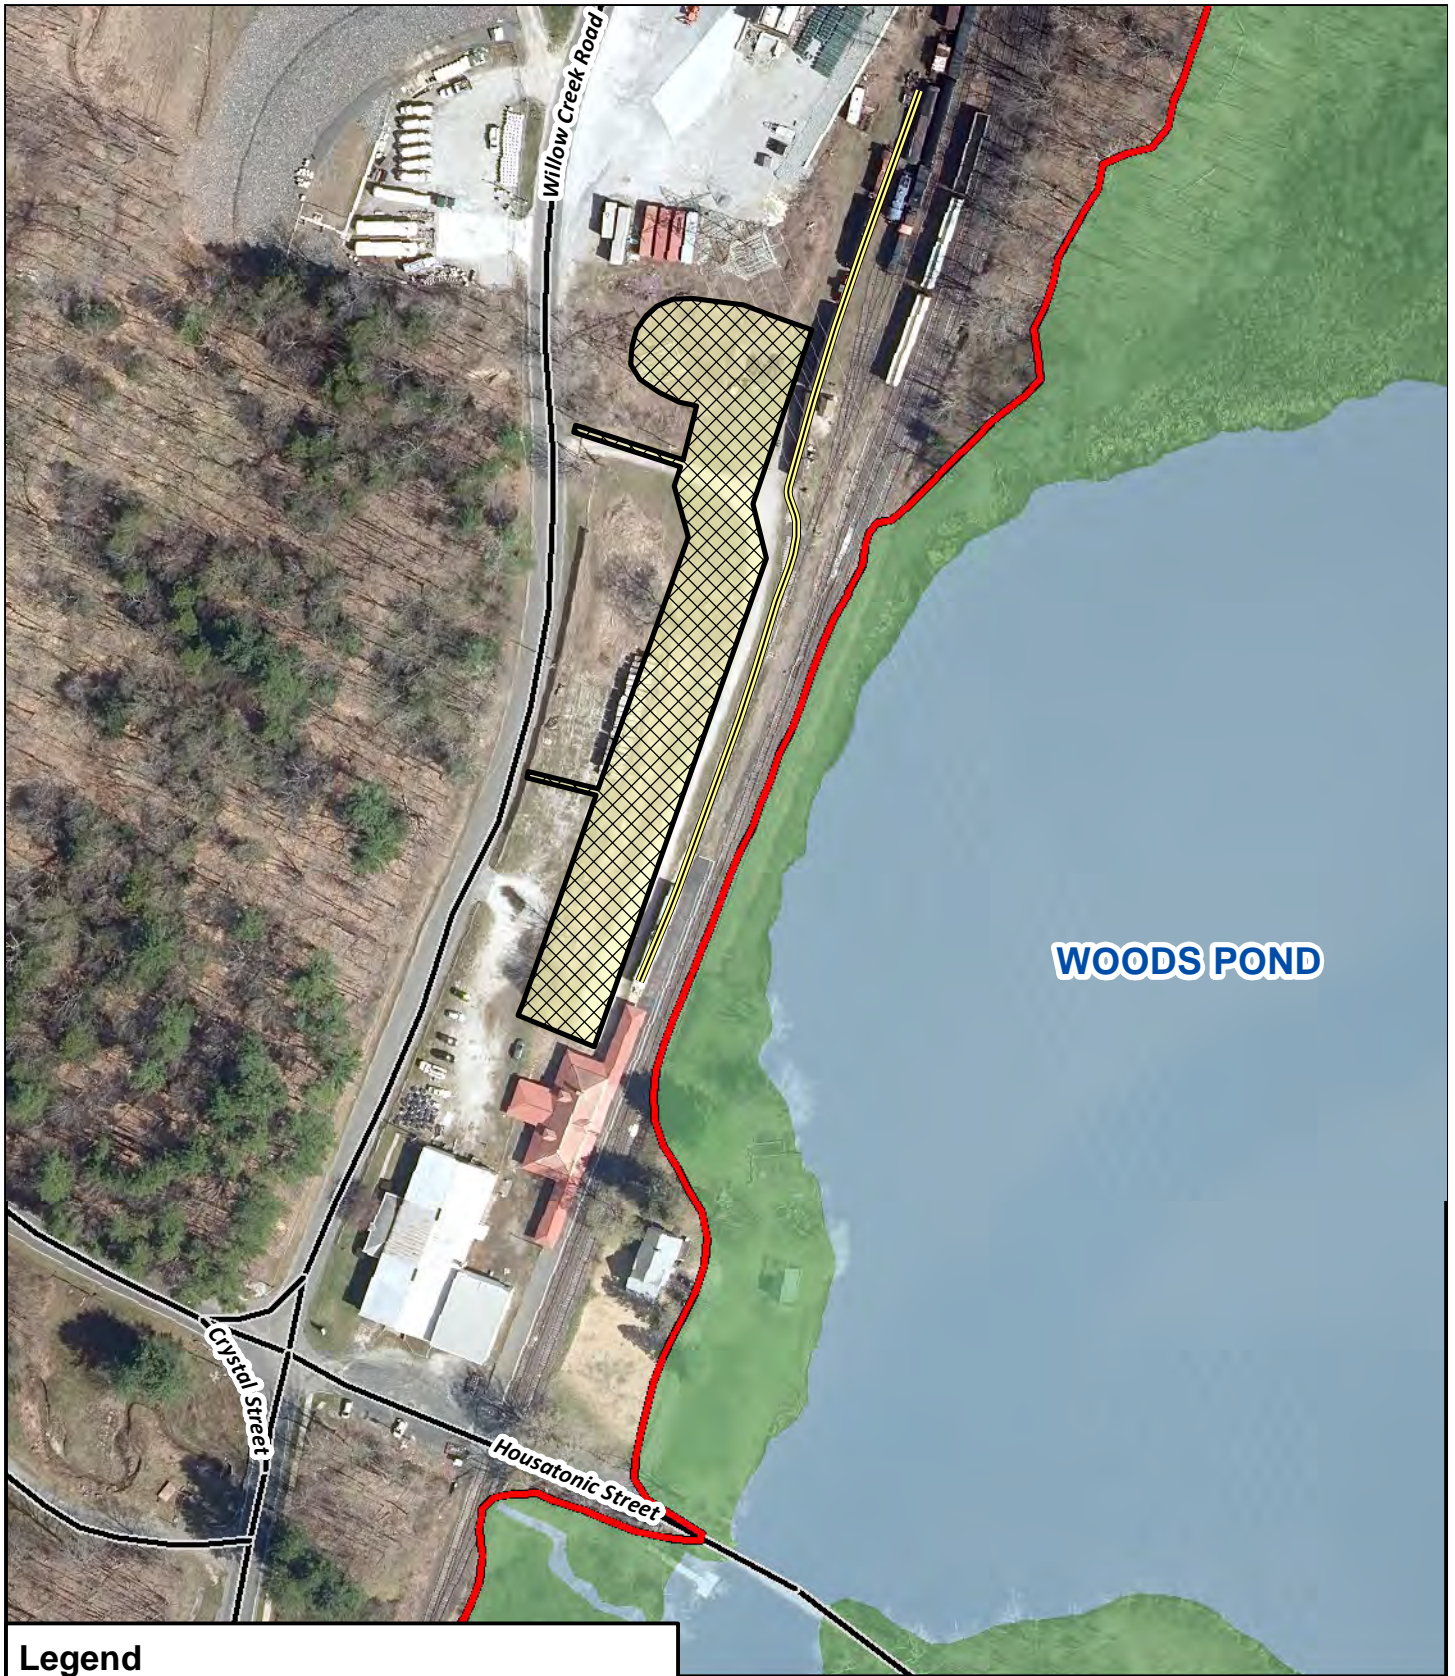
Figure 6-2

The proposed pipeline to convey dredged sediment from Woods Pond to the UDF will cross Woodland Road at the shoreline support facility, and then extend to the south along the western side of Woodland Road for just over 1,000 feet before turning southwest to cross into and through the UDF area (**Figure 6-2**). Most of the habitat along the pipeline route is mature woodland, and has been surveyed in detail and reported on in the *Second Revised Ecological Characterization and Habitat Assessment Report for the UDF Area* (UDF Habitat Report; AECOM 2024b). Vegetative cover types along Woodland Road which the pipeline route will pass along or through include, in decreasing order of prevalence, northern hardwood forest, eastern white pine forest, and palustrine swamp hardwood forest. The swamp hardwood forest borders the pipeline route for only a short distance at the southern end of the pipeline route as it turns west onto the UDF. It should also be noted that, to the extent practicable, the pipeline corridor will pass along the roadside of Woodland Road, and as such will largely border the adjacent woodlands rather than require clearing of the forest. The composition of these three forested cover types is summarized as follows:

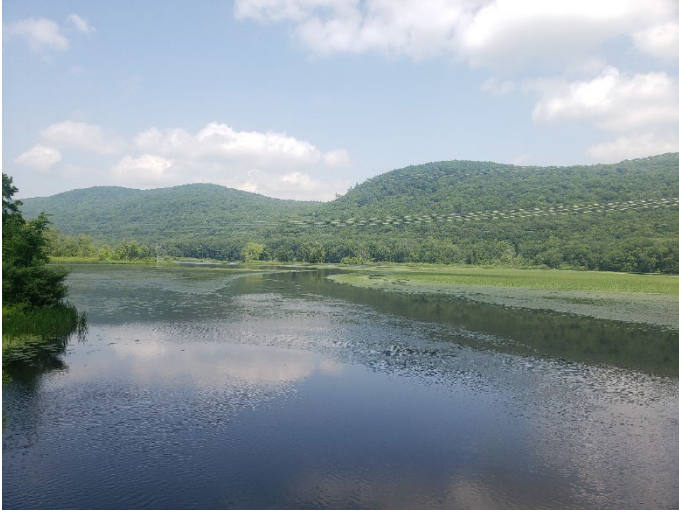
Client Name: General Electric Company, Pittsfield, MA		Site Location: Housatonic River Reach 6 BRA		Project No. 60736371	
Photo No. 1		Date: 6/29/2023		Photo No. 2	
Description: View north-northeast of Wood Pond from the footbridge.		Description: View south of outlet channel from the footbridge

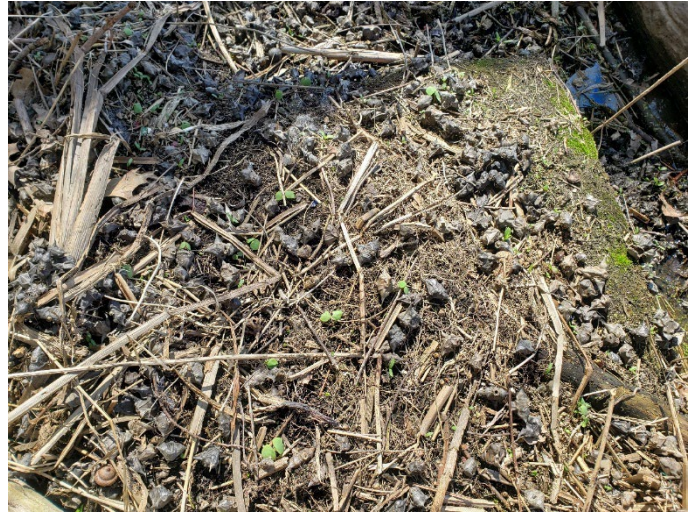
Description: 1000's of water chestnuts along the shoreline.

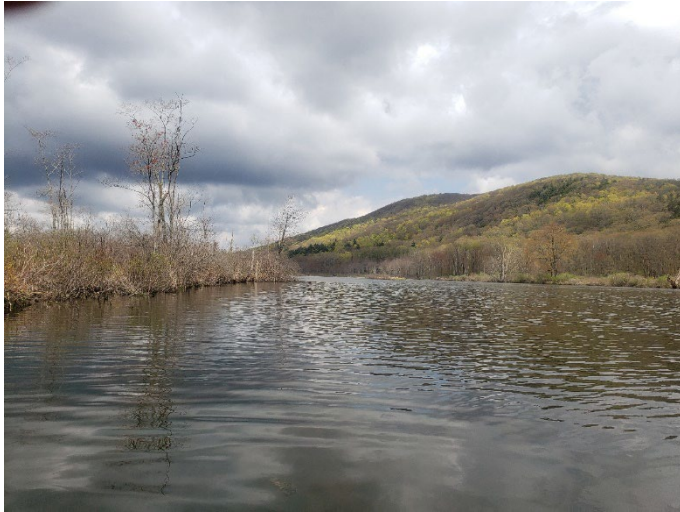
Description: View south looking at the Housatonic River through the transition zone.	Description: View north looking at the Housatonic River through the transition zone along the western river shoreline.
---	---

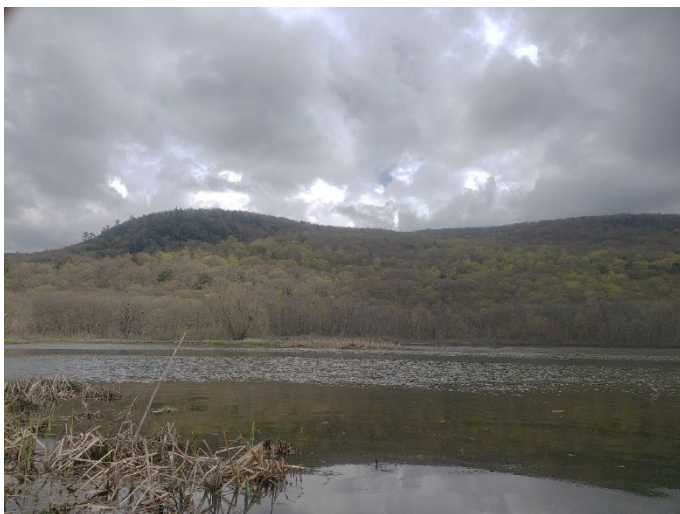
Photo No. 15	Date: 4/27/2023	Photo No. 16	Date: 4/9/2023
---------------------	------------------------	---------------------	-----------------------

Description: View looking east across Woods Pond at the transition line between Woods Pond proper and the Transition Zone	Description: View east of Woods Pond with dense cover of water chestnut and duckweed.
--	--

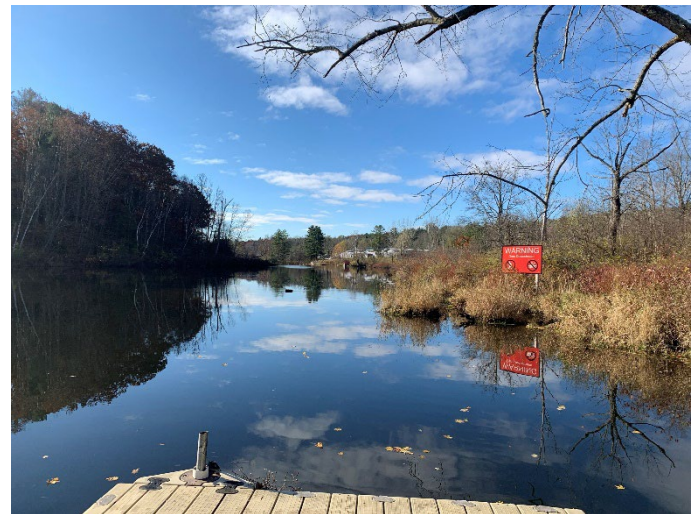
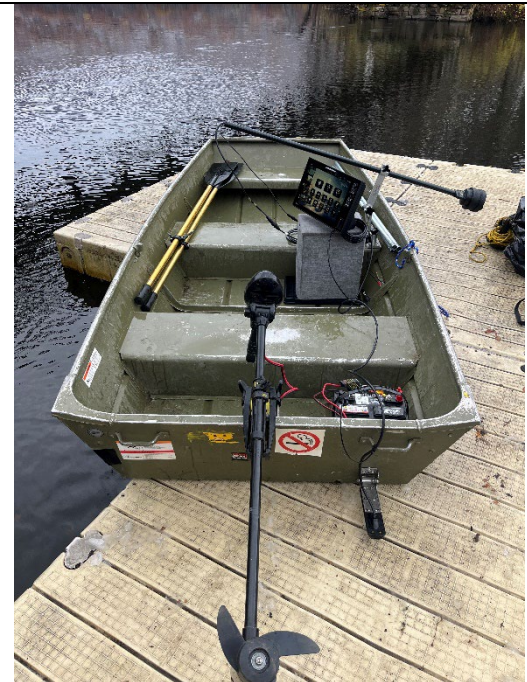
Photo No. 19	Date: 11/1/2023	Photo No. 20	Date: 11/1/2023
---------------------	------------------------	---------------------	------------------------

Description: View South of outlet channel / Housatonic River from boat dock.	Description: Side scan sonar boat set-up
---	---

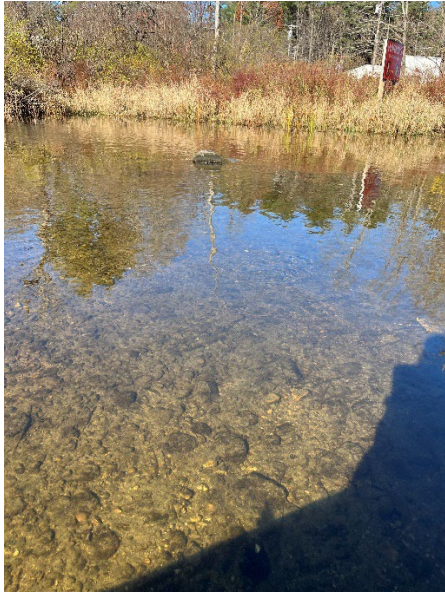
Description: Sandy/gravelly substrates in outlet channel	Description: Mucky bottom substrates with floating-leaved aquatics (yellow pond-lily).
---	---

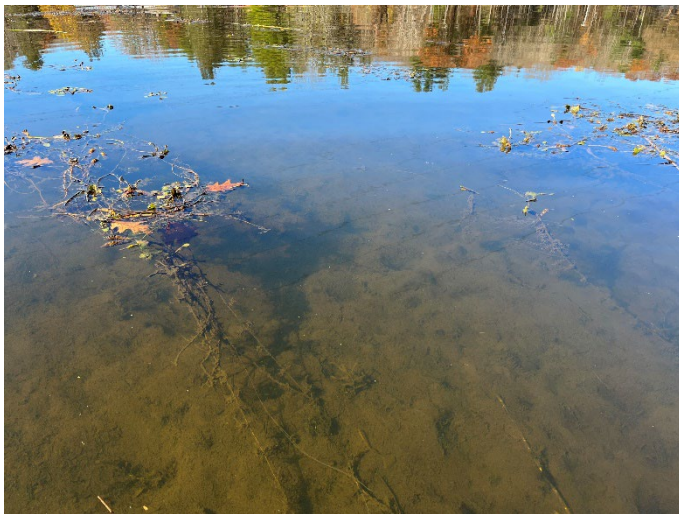
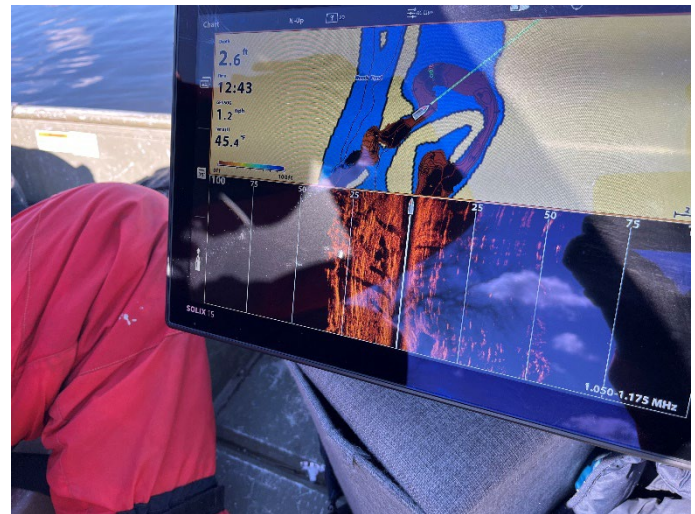
Description: Mucky bottom substrates with submerged aquatics including coontail, Robbins' pondweed and water chestnut	Description: Side scan sonar operation
--	---

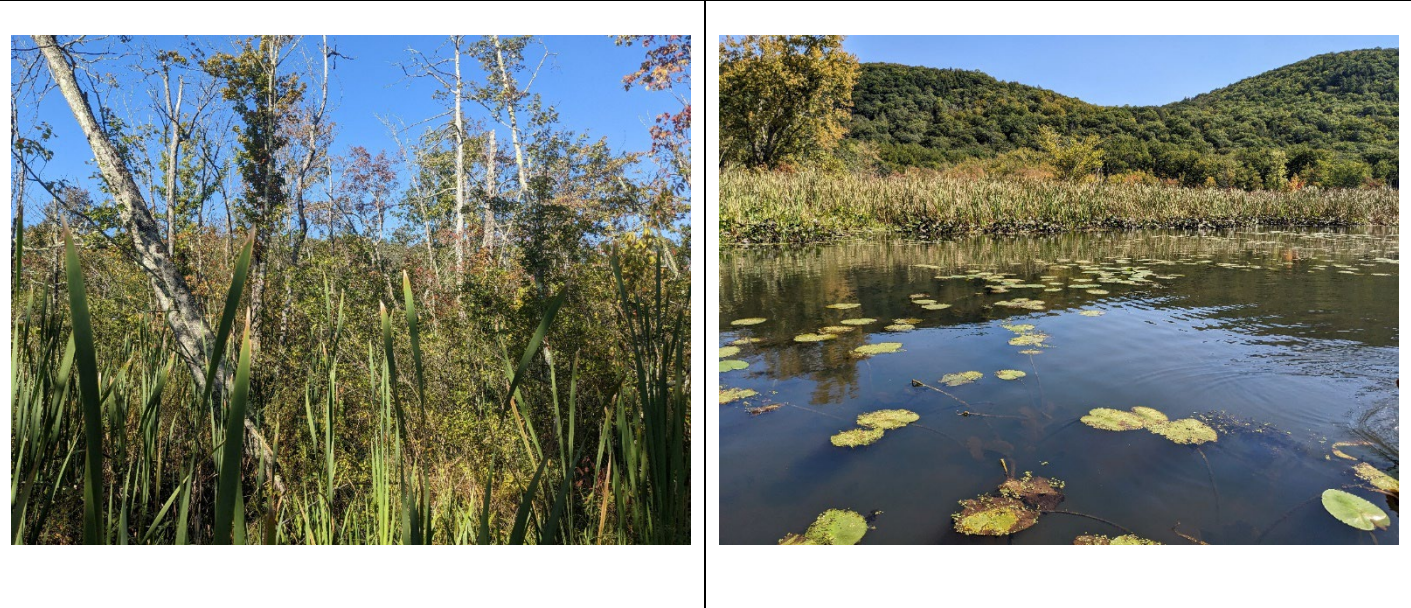
Description: View west, red maple swamp at FP-3.	Description: View east, shallow emergent marsh dominated by broad-leaved cattail.
---	--

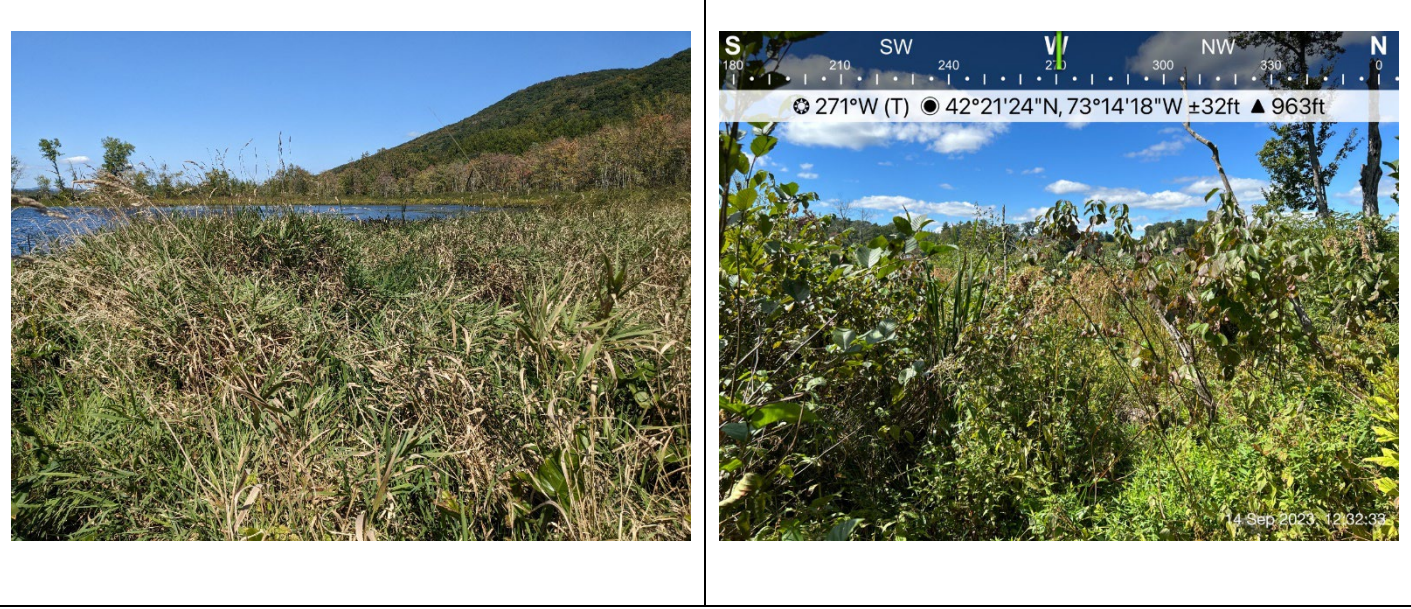
Description: View north, wet meadow habitats dominated by reed canary grass	Description: View west, shrub swamp at FP-9.
--	---

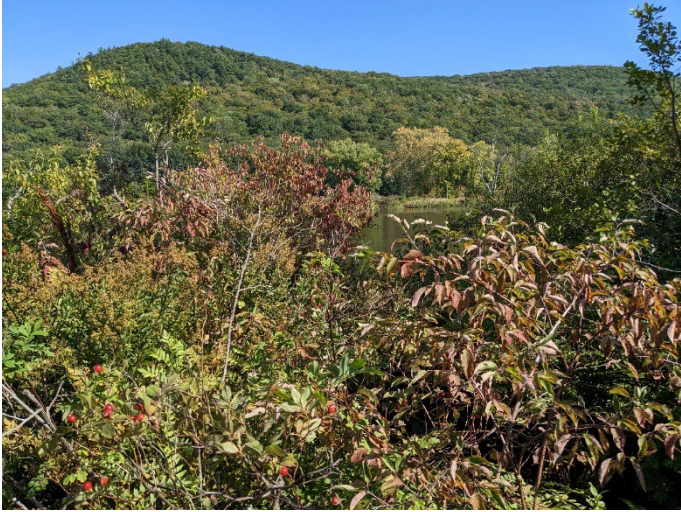
Client Name: General Electric Company, Pittsfield, MA		Site Location: Housatonic River Reach 6 BRA		Project No. 60736371	
Photo No. 5		Date: 9/20/2023		Photo No. 6	
Description: View east, shrub swamp at FP-19.				Description: View south, red maple swamp at FP-16

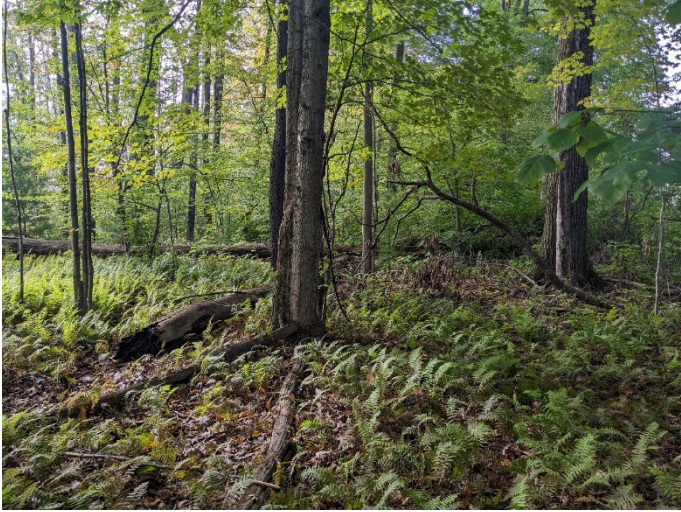
Photo No. 7		Date: 9/21/2023		Photo No. 8	
Description: View south, red oak-sugar maple-transition forest at FP-16.				Description: View east, shrub swamp dominated by silky dogwood at FP-20.

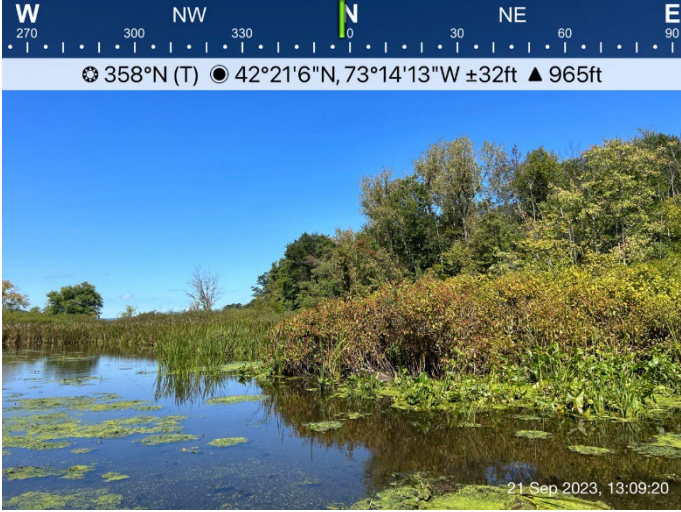
Client Name: General Electric Company, Pittsfield, MA		Site Location: Housatonic River Reach 6 BRA		Project No. 60736371	
Photo No. 13		Date: 9/14/2023		Photo No. 14	
Description: View north, shrub swamp and shallow emergent marsh habitats looking towards FP-31.		Description: View north of Woods Pond and adjacent residential property from foot bridge.

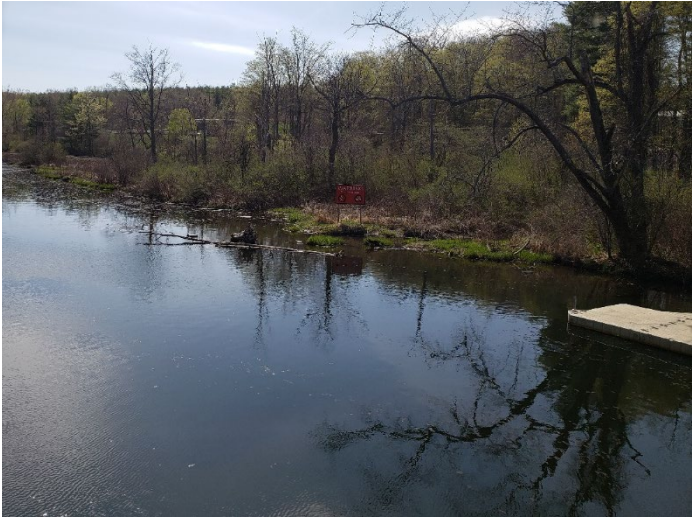
Photo No. 15		Date: 9/21/2023		Photo No. 16	
Description: View southwest from foot bridge of boat dock and shrub swamp habitats at FP-43.		Description: View northeast of foot bridge from FP-43

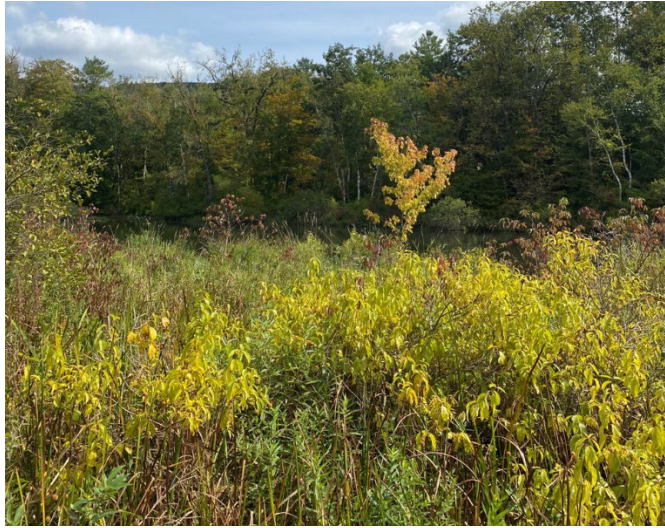
Client Name: General Electric Company, Pittsfield, MA		Site Location: Housatonic River Reach 6 BRA		Project No. 60736371	
Photo No. 17		Date: 9/22/2023		Photo No. 18	
Description: View east, shrub swamps along the river at FP-47.		Description: View east of Woods Pond with dense cover of water chestnut

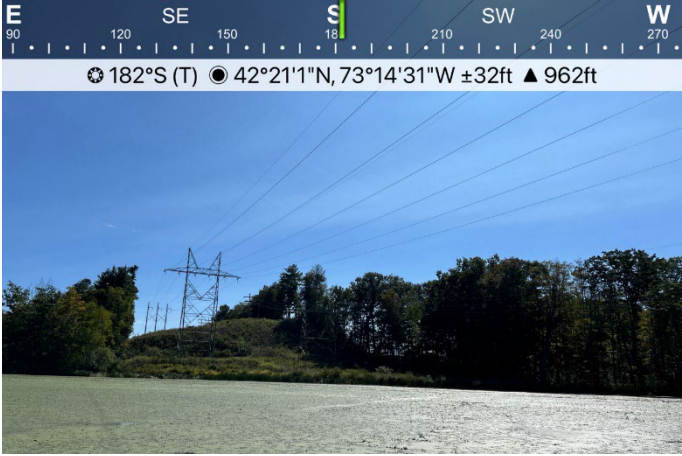
Photo No. 19		Date: 9/21/2023		Photo No. 20	
Description: View north across Woods Pond (covered in water chestnut) and Housatonic River channel (open water areas). Looking towards FP-33		Description: View south across Woods Pond and powerline easement

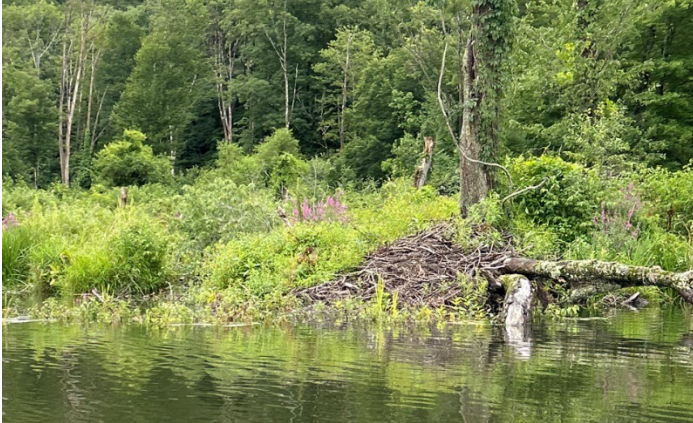
Client Name: General Electric Company, Pittsfield, MA		Site Location: Housatonic River Reach 6 BRA		Project No. 60736371	
Photo No. 21		Date: 8/7/2024		Photo No. 22	
Description: View east, beaver lodge on bank of the Housatonic River		Description: View east of eagle perched on snag tree

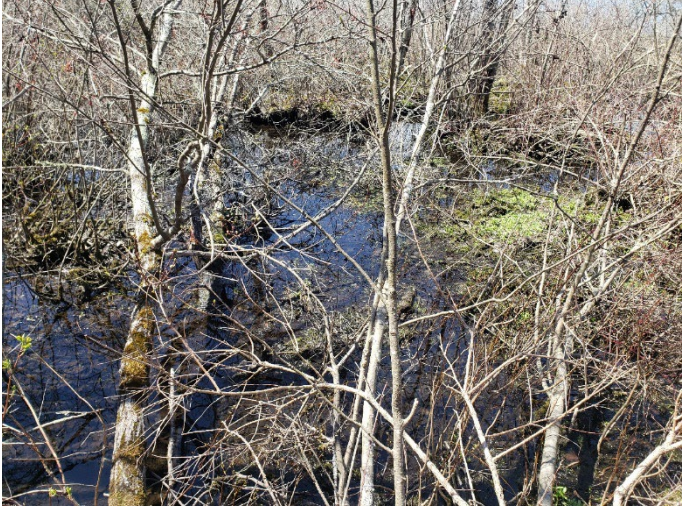
Client Name: General Electric Company, Pittsfield, MA		Site Location: Housatonic River Reach 6 BRA		Project No. 60736371	
Photo No. 5		Date: 5/4/2023		Photo No. 6	
Description: 5C-VP-17, wood frog tadpole. One of many observed.		Description: View west, 6-VP-1

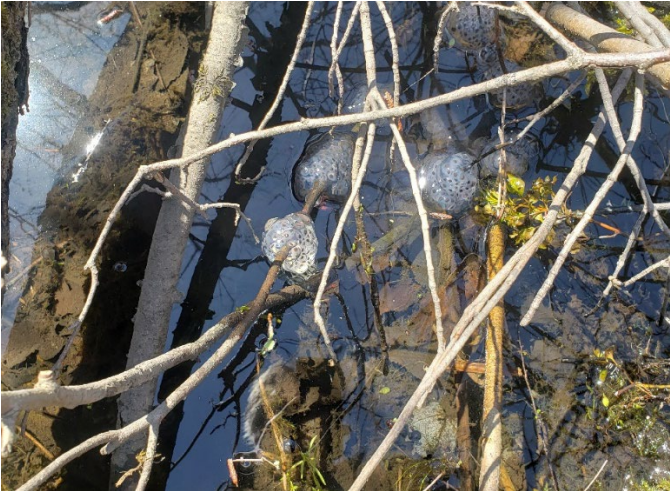
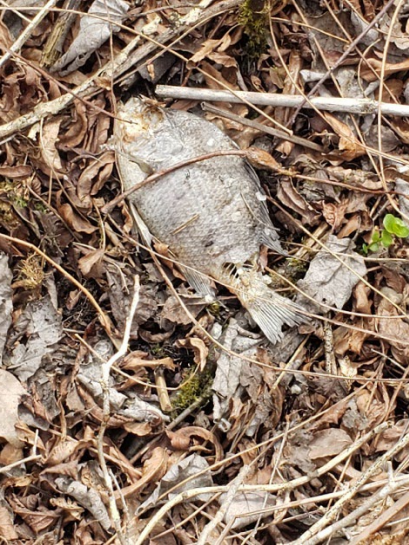
Photo No. 7		Date: 5/4/2023		Photo No. 8	
Description: 6-VP-1, Spotted salamander egg masses		Description: 6-VP-1, dead fish (genus: <i>Lepomis</i>)
