New Bedford Harbor Superfund Site

Final Upper Harbor Sediment Caps Remedial Action Report

ACE-J23-35BG6000-M16-0010 | 0

April 2021

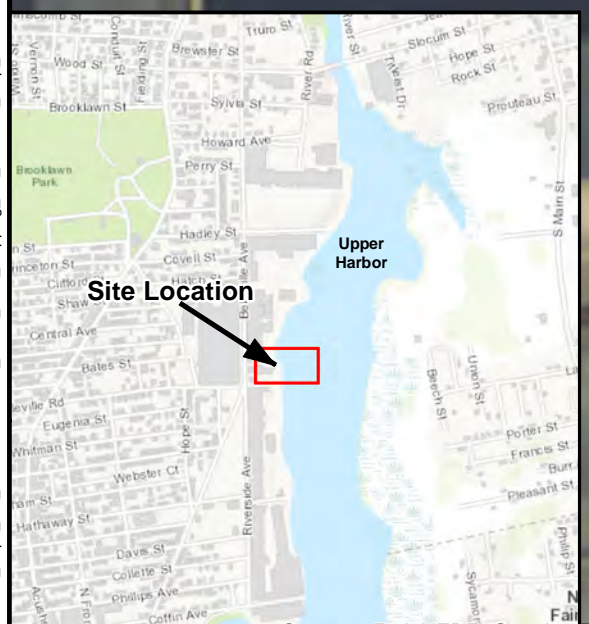
- Full depth engineered cap
- Site Drainage Outlet
- MLLW
- MHHW
- Cap limits at the toe of slope
- 1ft contour line
- A94 Crib Cap Coordinates (full set of coordinates located in Appendix G) Datum: NAD1983 StatePlane Massachusetts Mainland FIPS 2001 Feet

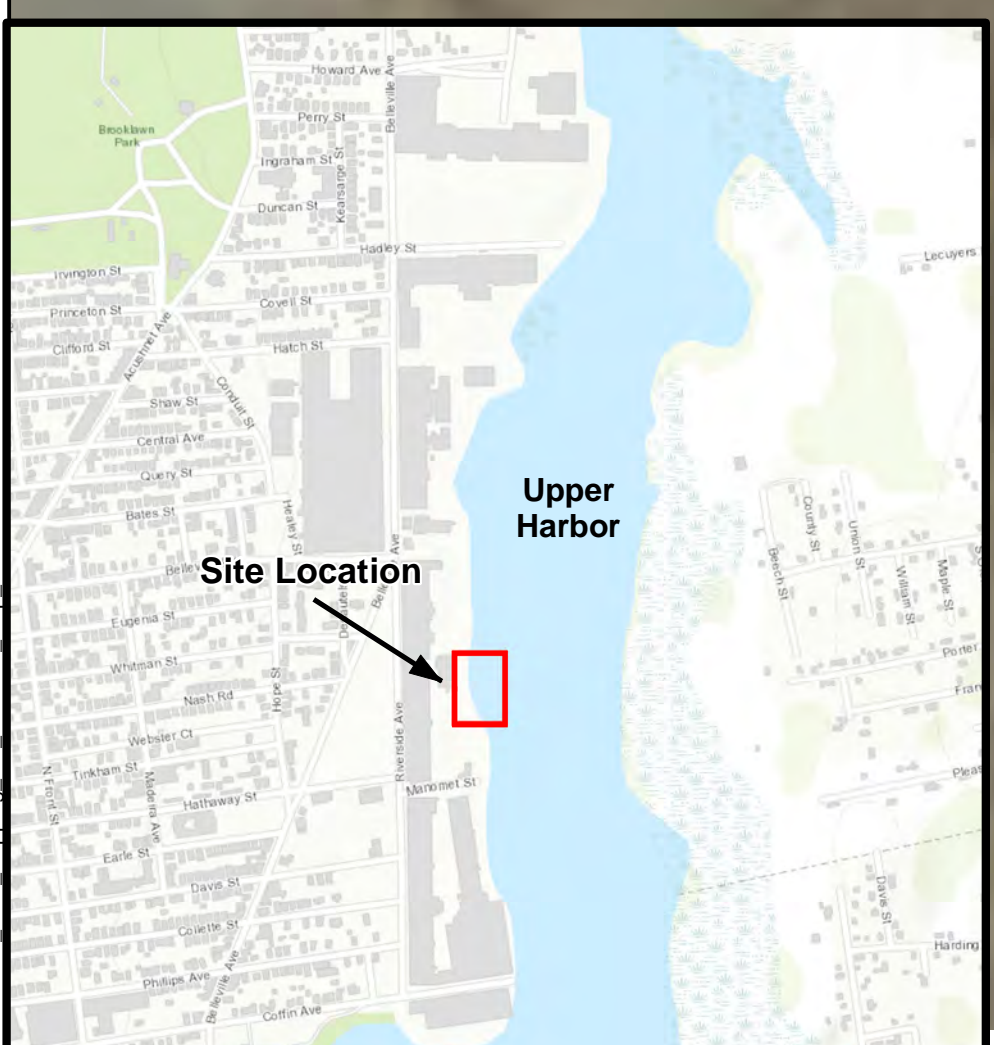
- Full depth engineered cap
- Cap limits at the toe of slope
- Excavation Extent with Sand Backfill and Cap
- 1ft contour line
- A60 L-014 Cap Coordinates (full set of coordinates located in Appendix G) Datum: NAD1983 StatePlane Massachusetts Mainland FIPS 2001 Feet
- MLLW
- MHHW

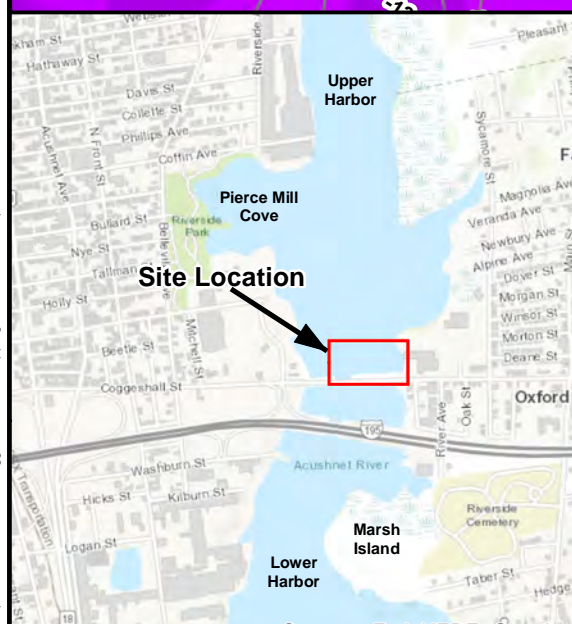
Cap bathymetry: 11/30/20 and 12/22/20;
Background bathymetry 08/22/19
Elevations within the cap limit represent
post-capping conditions.

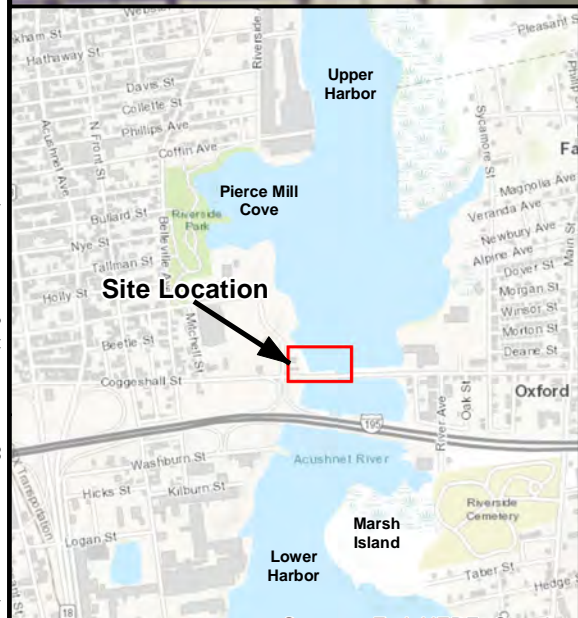
Figure 8

Cap bathymetry: 12/22/20 and 01/11/21; Background bathymetry 8/22/19
Elevations within the cap limit represent post-capping conditions.

push cores were collected to affirm sufficient isolation layer thickness (Table 2, Appendix B, C). Approval was received to move forward without the collection of cores PC20, PC021 and PC22 due to their proximity to the shoreline and the difficulties of the material remaining in place along the embankment (Project Note 007). The armor stone layer was completed on 17 November 2020 using a total of 1,984 cy of material. Armor stone layer thickness ranged from 9.6 inches to 32.4 inches resulting in an average of 21.3 inches (Table 3). At the direction of USACE, additional stone was added along the eastern shoreline of the cap on 15 December 2020 totaling 20 cy. This additional stone was blended into the existing shoreline armor layer on the Coggeshall Street Bridge embankment to further reinforce the steep sloped area and prevent erosion. Material totals are found in Table 3. A final third-party bathymetric survey of the Cogg-West Cap and berm, performed on 22 December 2020, is shown in Figure 8.

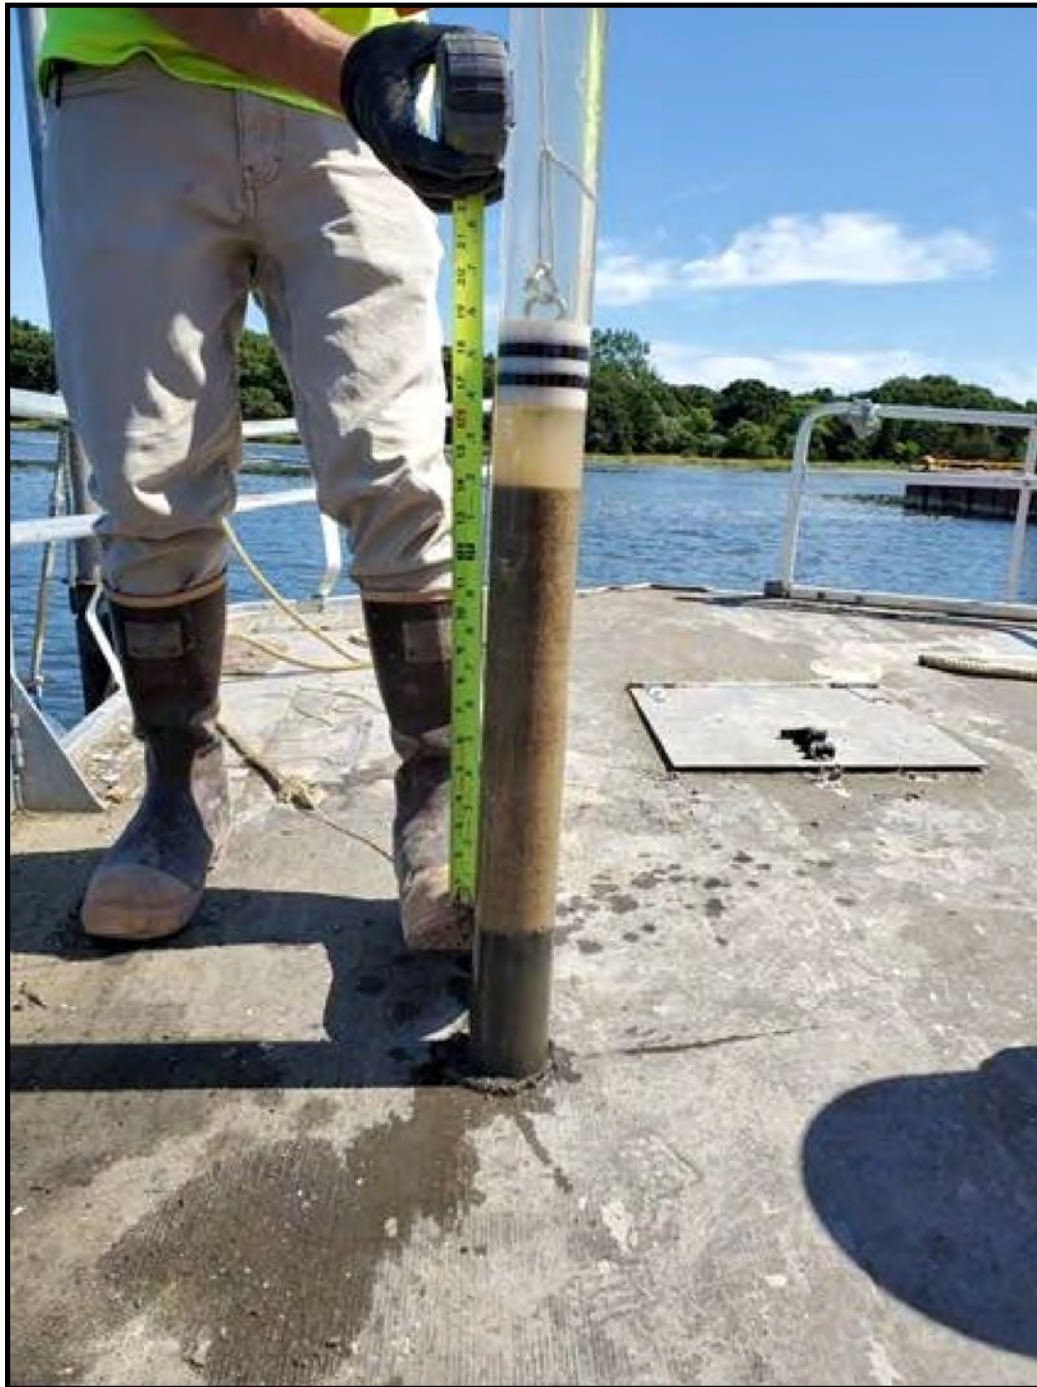
Note: A confirmatory sediment core showing 14-in of cap material placed over the existing sediment.

Push cores were collected after bathymetric or RTK GPS pole-rover surveying indicated adequate isolation layer thickness was achieved. Once collected, sediment cores were brought onto the survey vessel and the isolation layer height was measured and photo documented. An example of a confirmatory sediment core showing 14 inches of cap material placed over the existing sediment is shown in [Figure 10](#). At this location (O-711 cap) the design thickness of the isolation layer was 12 inches (see Section 3.1 above). The isolation layer height was identified as the distance from the top of the placed sediment to the point of transition between the native material. A complete set of sediment core photos can be found in [Appendix C](#).
