**REMOVAL PROGRAM
PRELIMINARY ASSESSMENT/
SITE INVESTIGATION REPORT
FOR THE
MOHAWK TANNERY SITE
NASHUA, NEW HAMPSHIRE
11 AUGUST 1999**

Roy F. Weston, Inc.
Superfund Technical Assessment and Response Team
217 Middlesex Turnpike
Burlington, MA 01803

October 1999

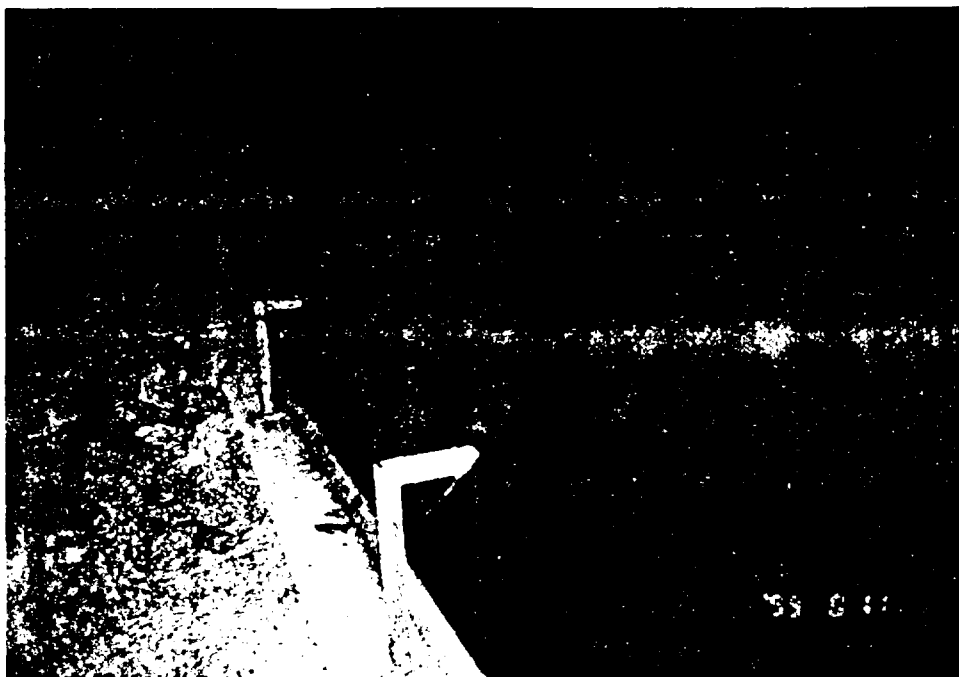
FRAME NUMBER: 06 **DATE:** 11 August 1999
PHOTOGRAPH BY: Mandy Butterworth
CAMERA: Minolta **SETTING:** Automatic

SCENE: View of the eastern end of the clarifier unit. Photograph taken facing east.

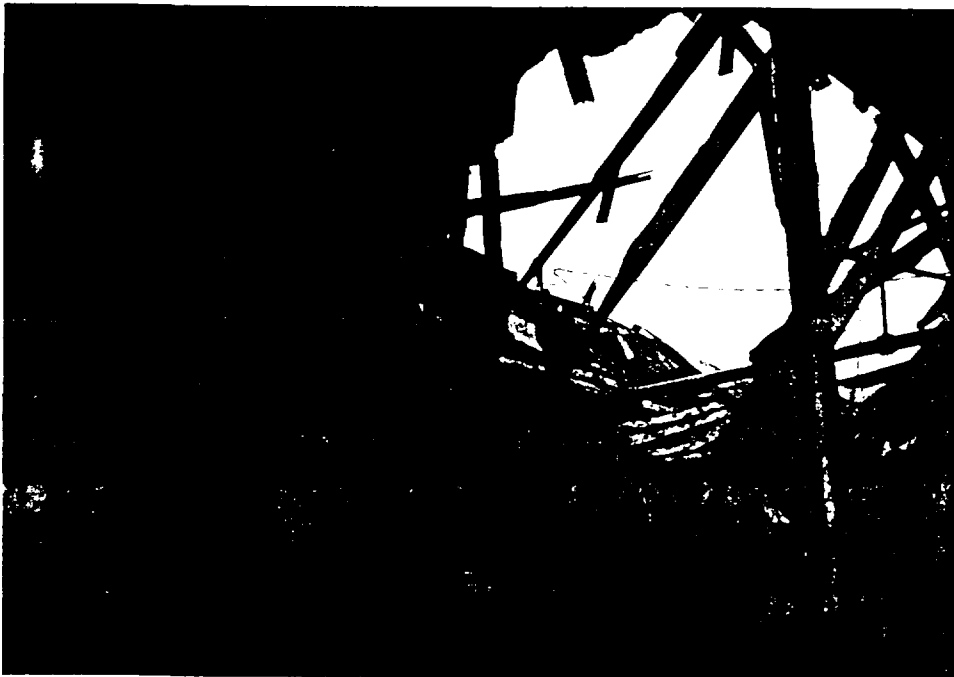
FRAME NUMBER: 16 **DATE:** 11 August 1999
PHOTOGRAPH BY: Mandy Butterworth
CAMERA: Minolta **SETTING:** Automatic

The main site building is in a dilapidated condition, with the southern portion of the site open to the elements. Several large wooden tumblers were noted inside the main site building, as was a large steel pressure vessel. The perimeter of the main site building is crowded with vehicles in various states of disrepair, large locked box-type trailers, and drums.

SCENE: View of the structural damage to the ceiling of the main site building. Photograph taken facing northwest.

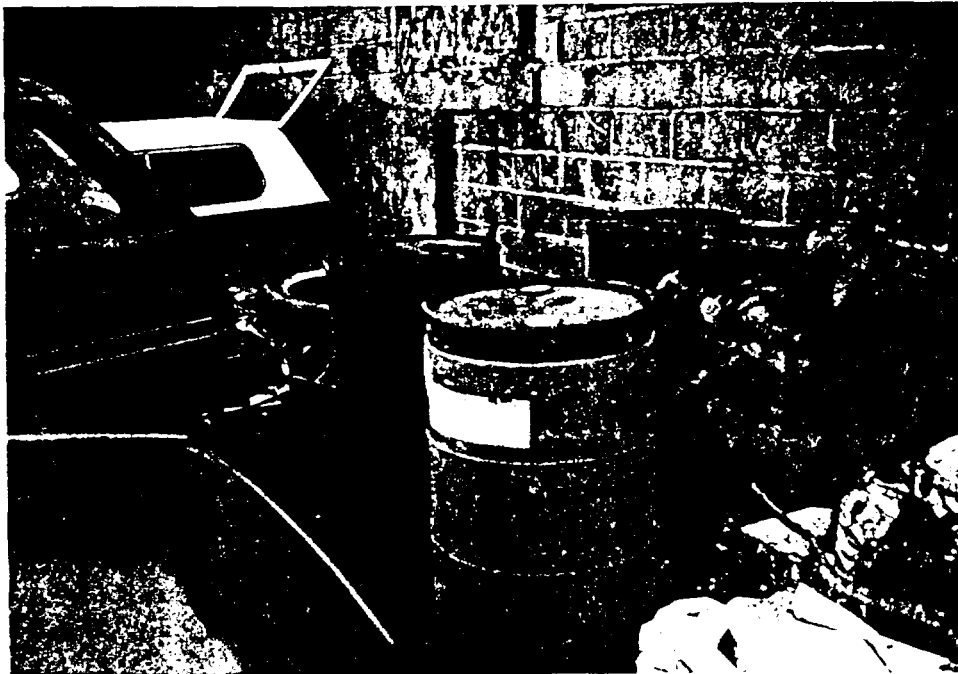
FRAME NUMBER: 20 **DATE:** 11 August 1999
PHOTOGRAPH BY: Mandy Butterworth
CAMERA: Minolta **SETTING:** Automatic

SCENE: View of drum sample location D-001. Photograph taken facing southwest.

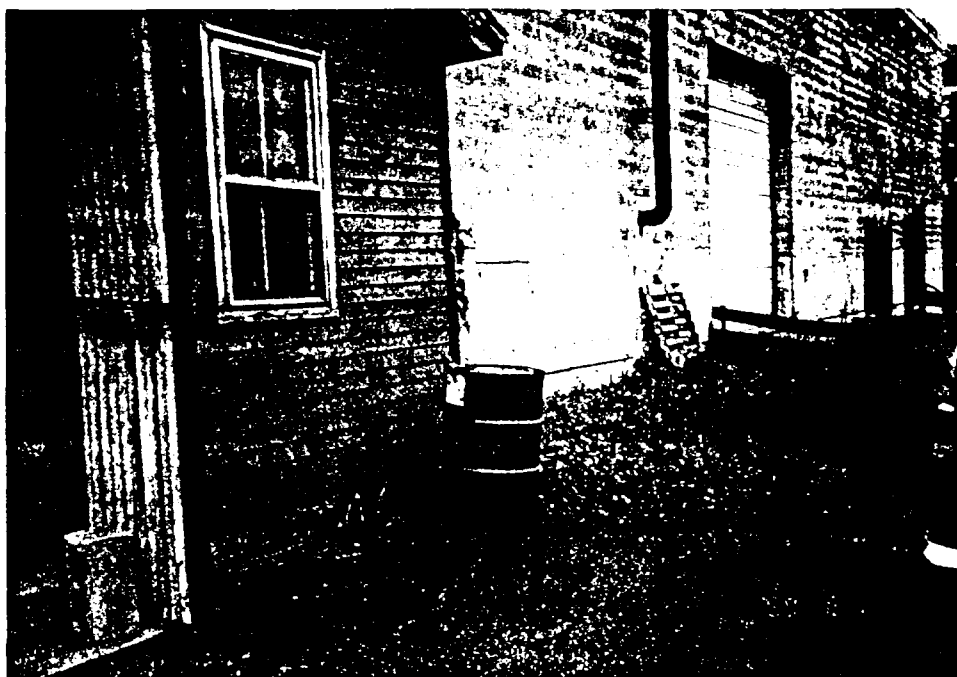
FRAME NUMBER: 22 **DATE:** 11 August 1999
PHOTOGRAPH BY: Mandy Butterworth
CAMERA: Minolta **SETTING:** Automatic

SCENE: View of drum sample location D-006. Photograph taken facing southwest.
