**Re: GE-Pittsfield/Housatonic River Site  
Rest of River (GECD850)  
Phase IB Cultural Resources Survey Work Plan for Reach 5A**

## Phase IB Cultural Resources Survey Work Plan for Reach 5A

Prepared for General Electric Company  
Pittsfield, Massachusetts

**Prepared by**  
AECOM  
500 Enterprise Drive  
Rocky Hill, Connecticut 06067

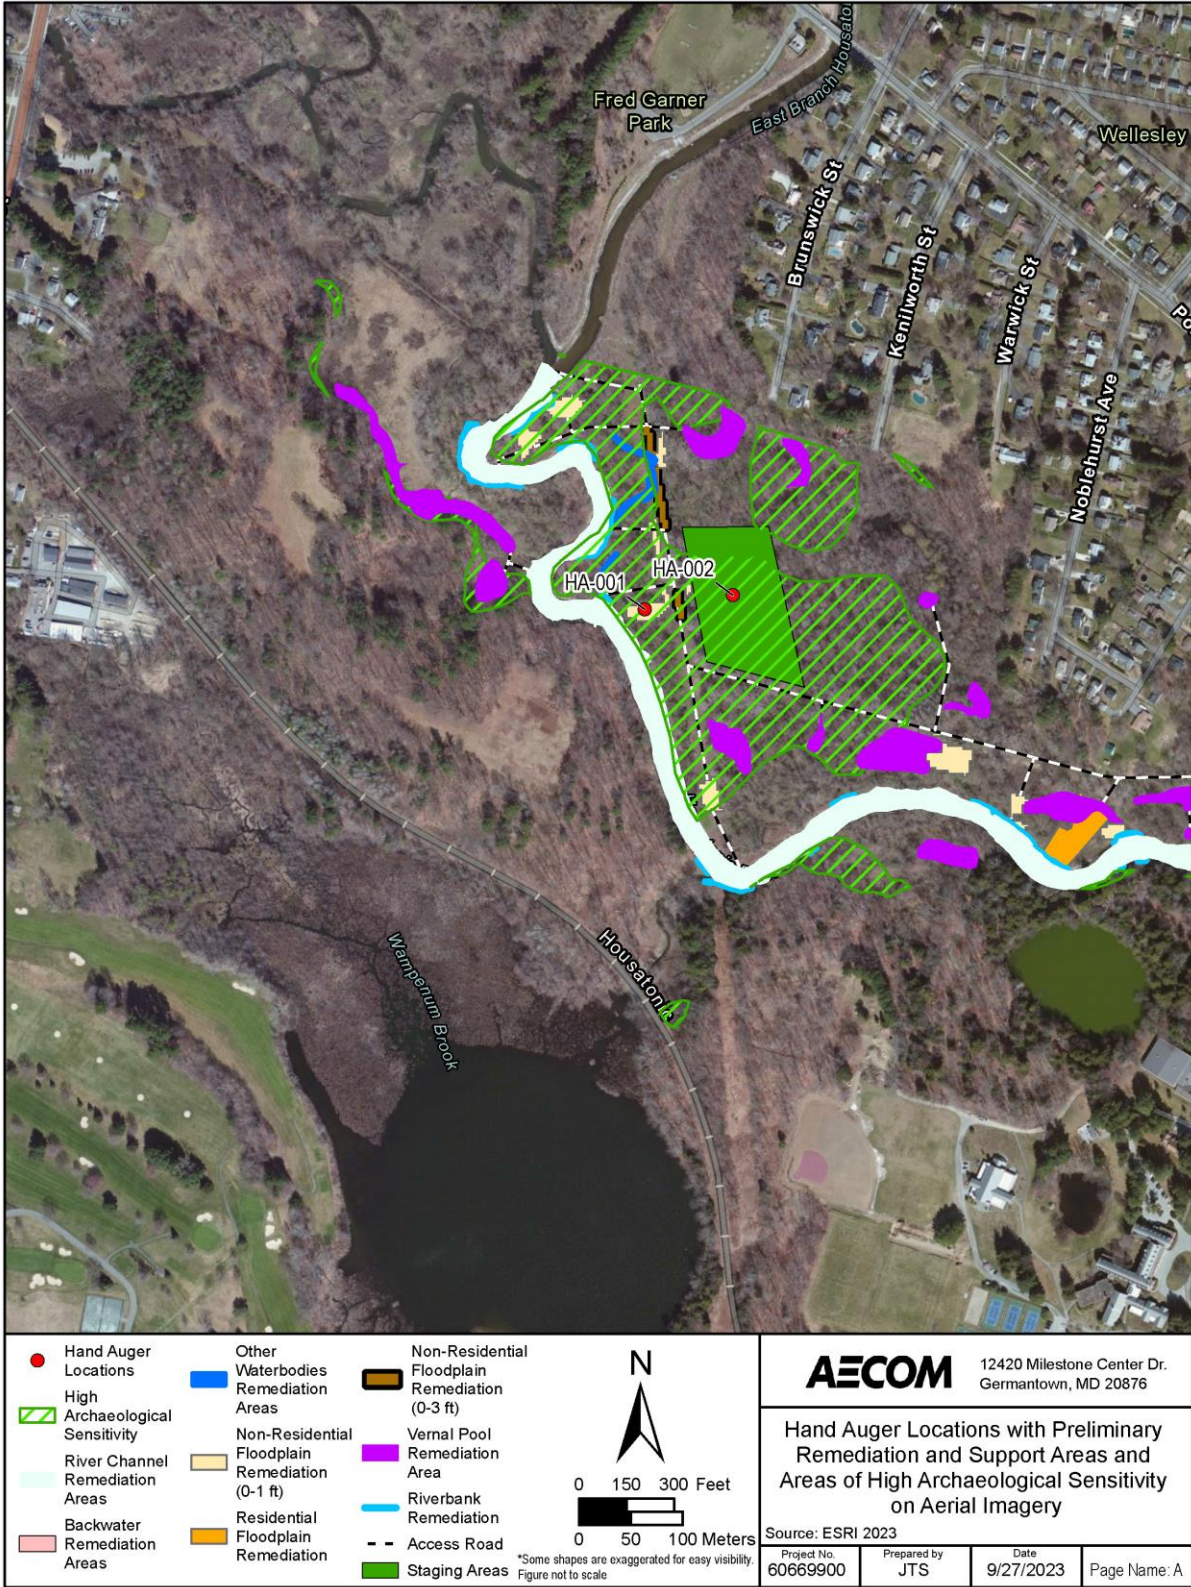
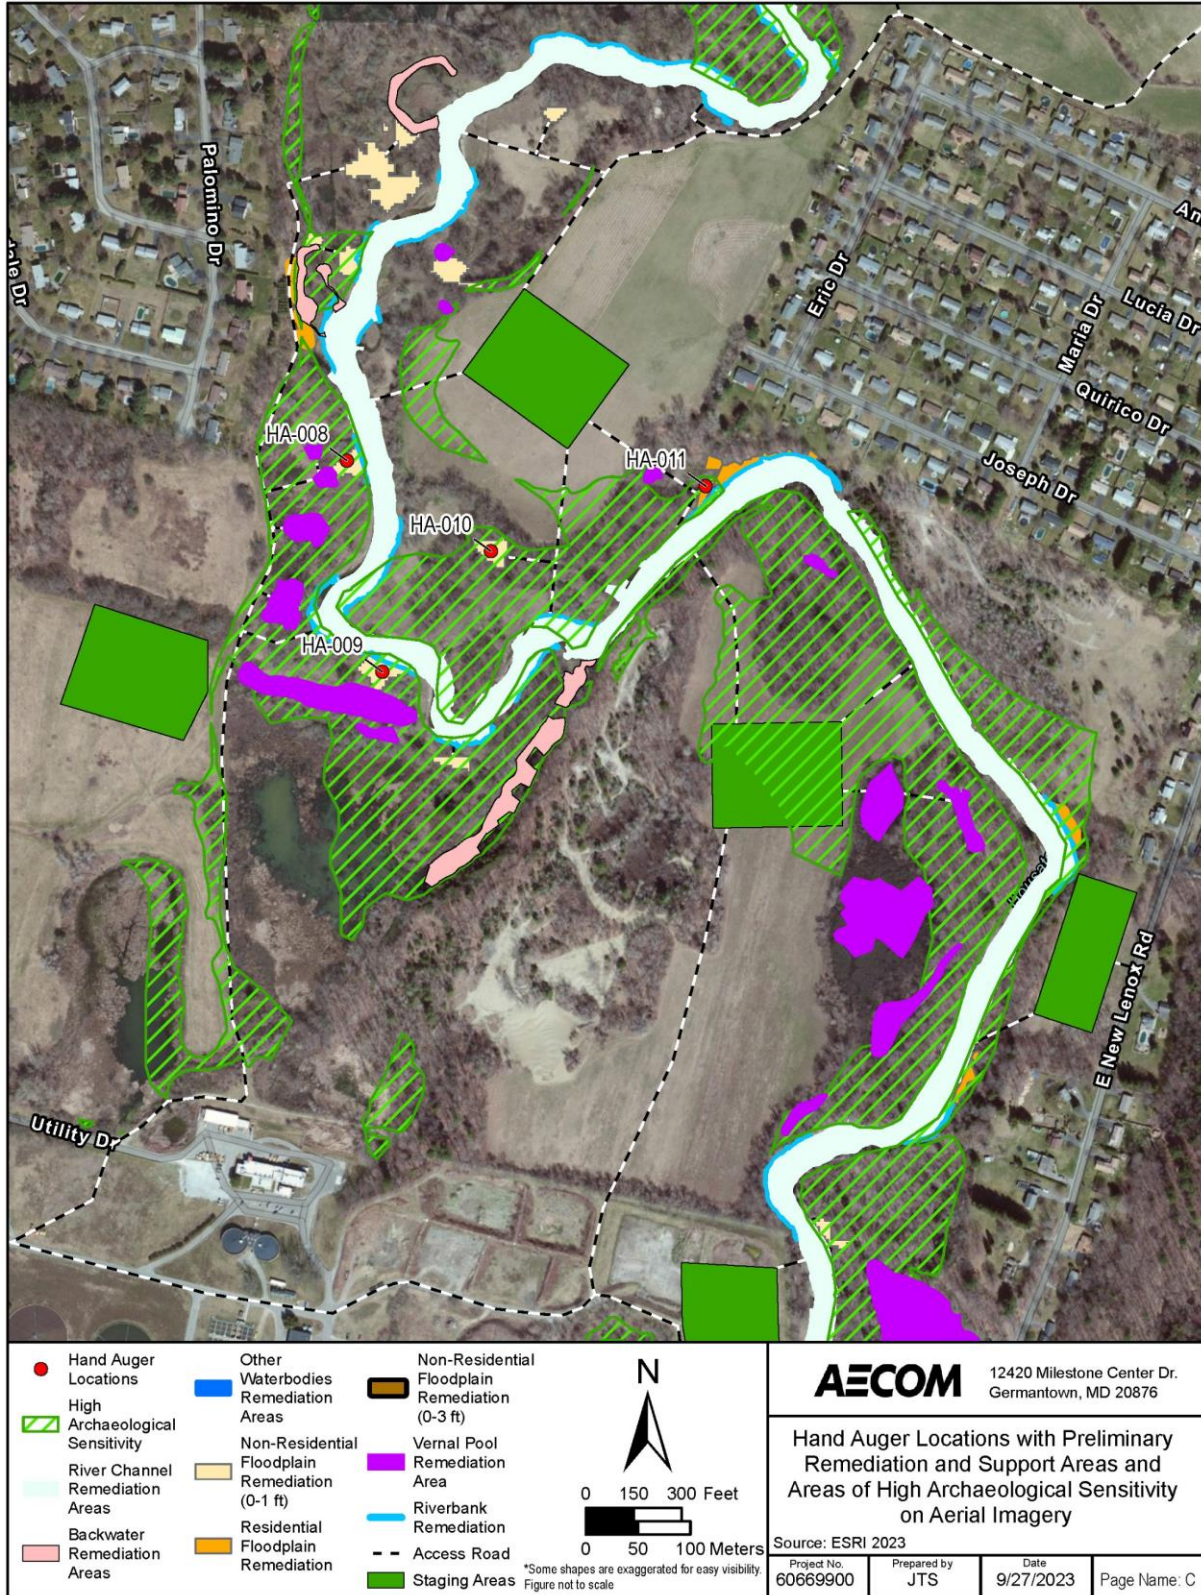
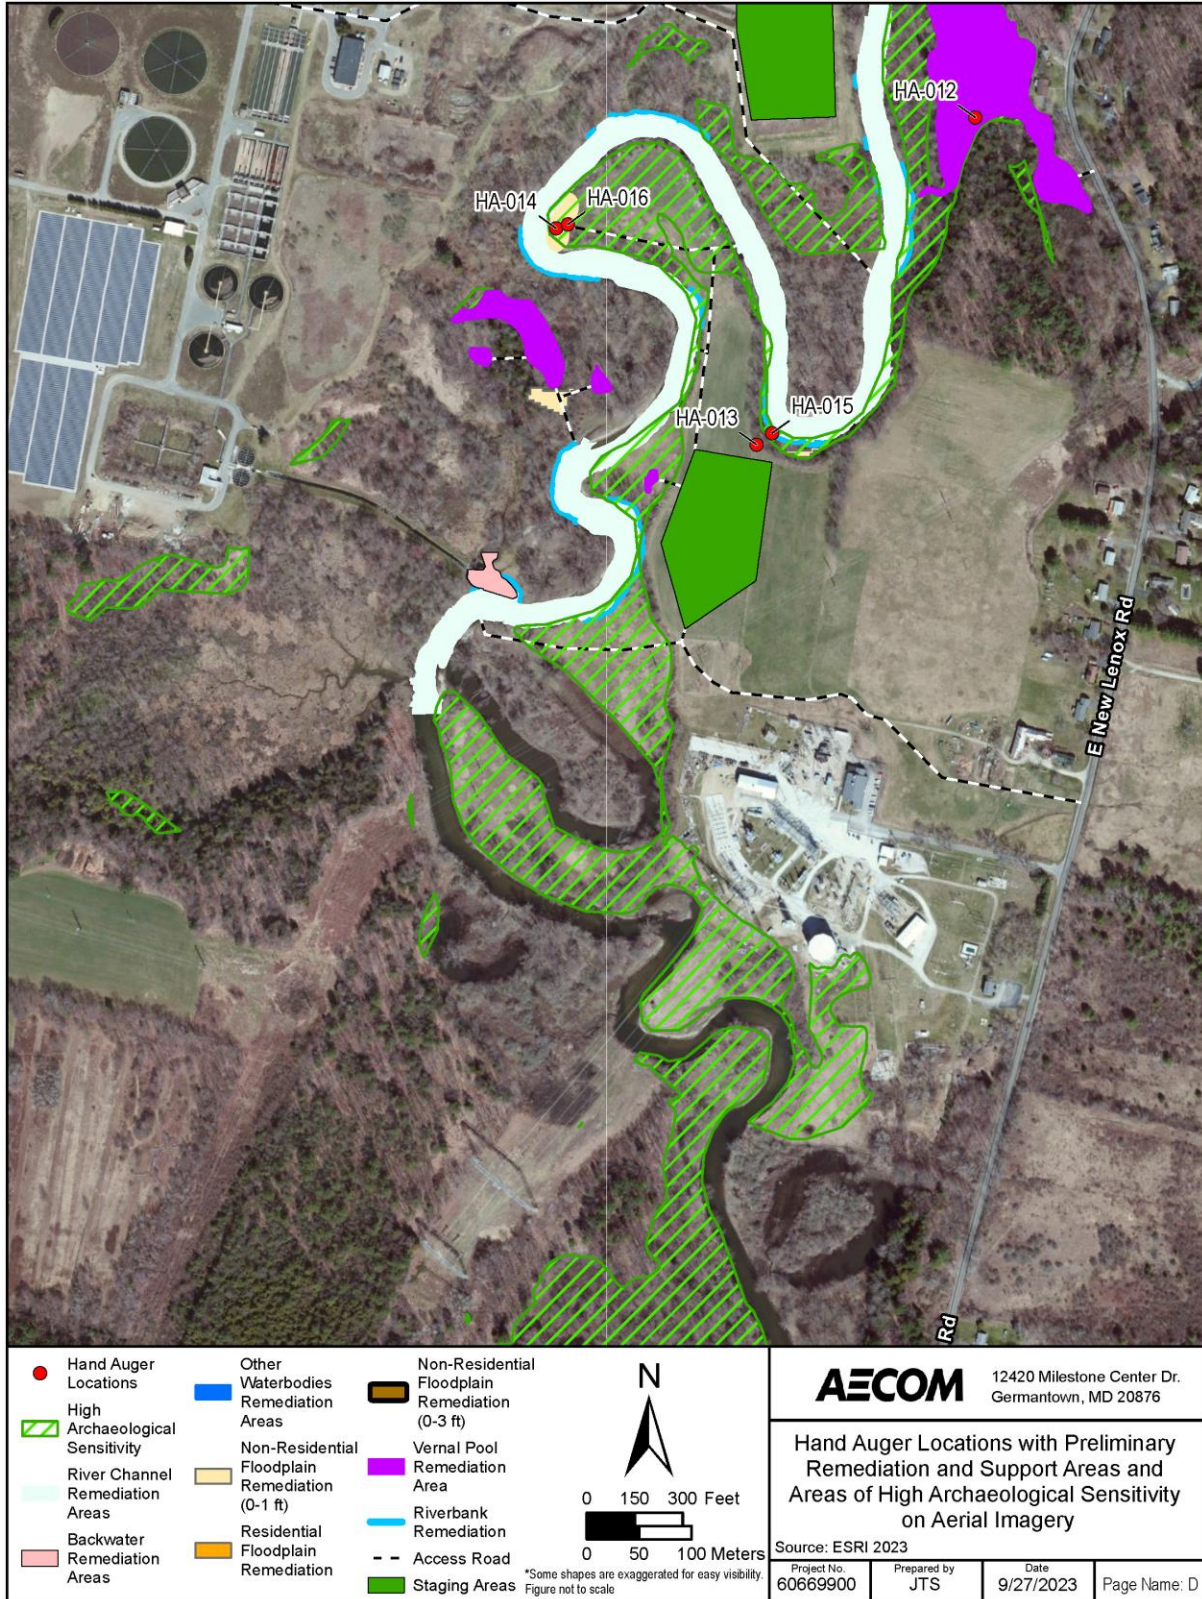
Figure A-1. Location of Hand Auger Borings in Reach 5A (Map 1 of 4).

Figure A-2. Location of Hand Auger Borings in Reach 5A (Map 2 of 4).

Figure A-3. Location of Hand Auger Borings in Reach 5A (Map 3 of 4).

Figure A-4. Location of Hand Auger Borings in Reach 5A (Map 4 of 4).

The information gained from these cores is summarized in Table A-1. The results can be divided into five categories according to preservation potential for archaeological resources and relative age, as indicated by the soil/subsoil horizons found in the borings. Borings with buried A (Ab) horizons have a higher than average probability for preservation of deeply buried resources since there are more opportunities for *in situ* burial of sites. Borings with Bt horizons have a higher than average probability for containing pre-contact materials since the argillic characteristics of Bt horizons take a significant amount of time to develop, and therefore, the landform would have been stable earlier in the Holocene Epoch. Borings in which Bw horizons were documented indicate a younger soil profile, where older pre-contact material will likely not be found. In light of the horizons identified in the soil borings, the borings have been grouped in the categories listed in Table A-1 to help inform guide field testing strategies.

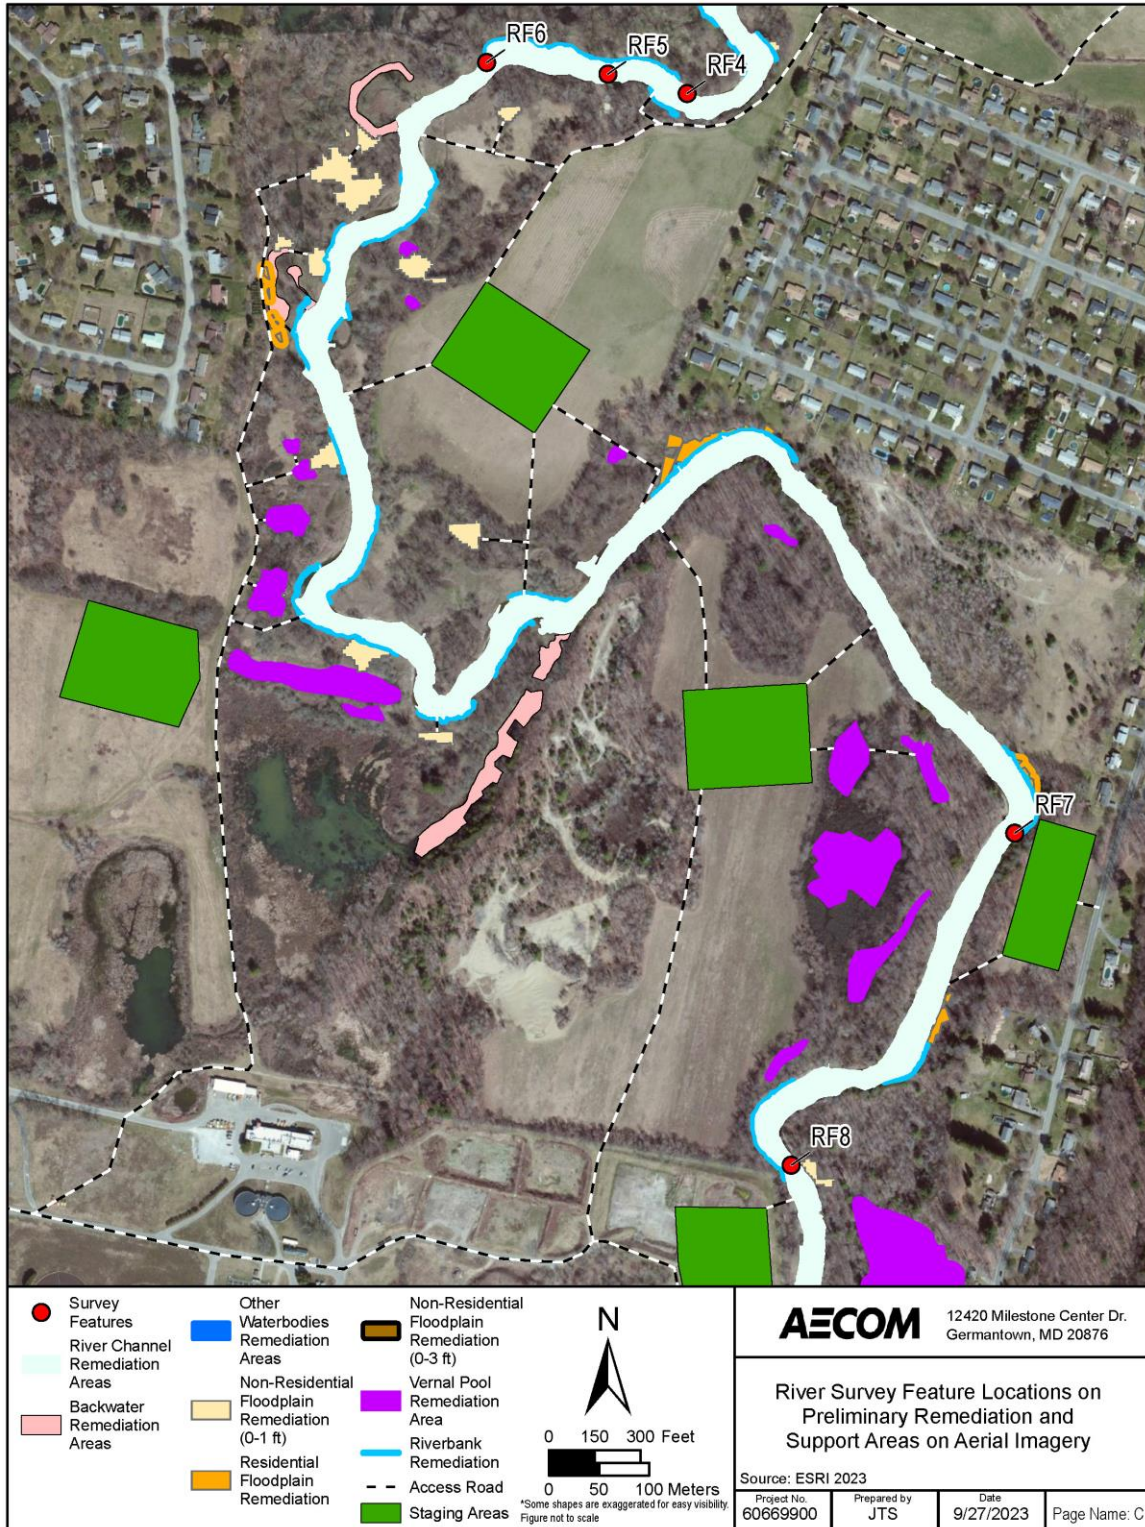
Figure A-5. Location of River Channel Features in Reach 5A (Map 1 of 2).

Figure A-6. Location of River Channel Features in Reach 5A (Map 2 of 2).

Eight definite or potential man-made features were identified and photographed in or immediately adjacent to the river, and their locations were recorded with a sub-meter accurate GPS unit, as shown on Figures A-5 and A-6. These consist of two sets of bridge abutments (cut stone and concrete), two concentrations of large cut stones, two locations of conical piles of cobbles, and two linear cobble features that are possible weirs or dams. Photographs of these features are provided on Figures A-7 through A-16 along with information about each feature. Since these features are all in or immediately adjacent to river areas that will be remediated, they will all be revisited during the Phase IB survey work to be more closely examined, recorded, and evaluated.

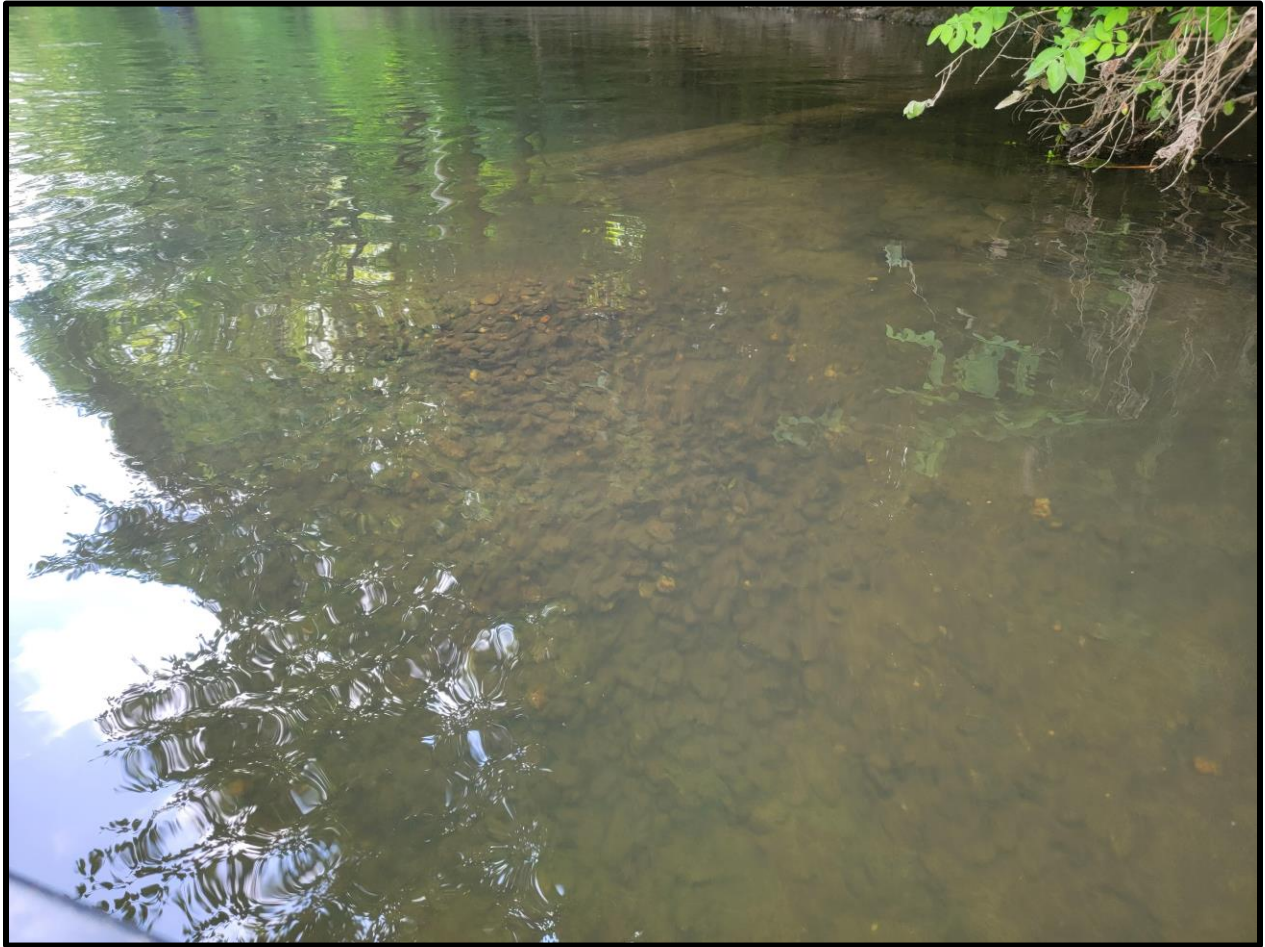
RF1

Figure A-7. RF#1: A rock pile located off along the western bank that is composed of small rounded cobbles and gravel with diameters from 120 cm to 10 cm. The pile is slightly covered in silt. The depth range is from 26 to 75 cm. The total depth is 49 cm.

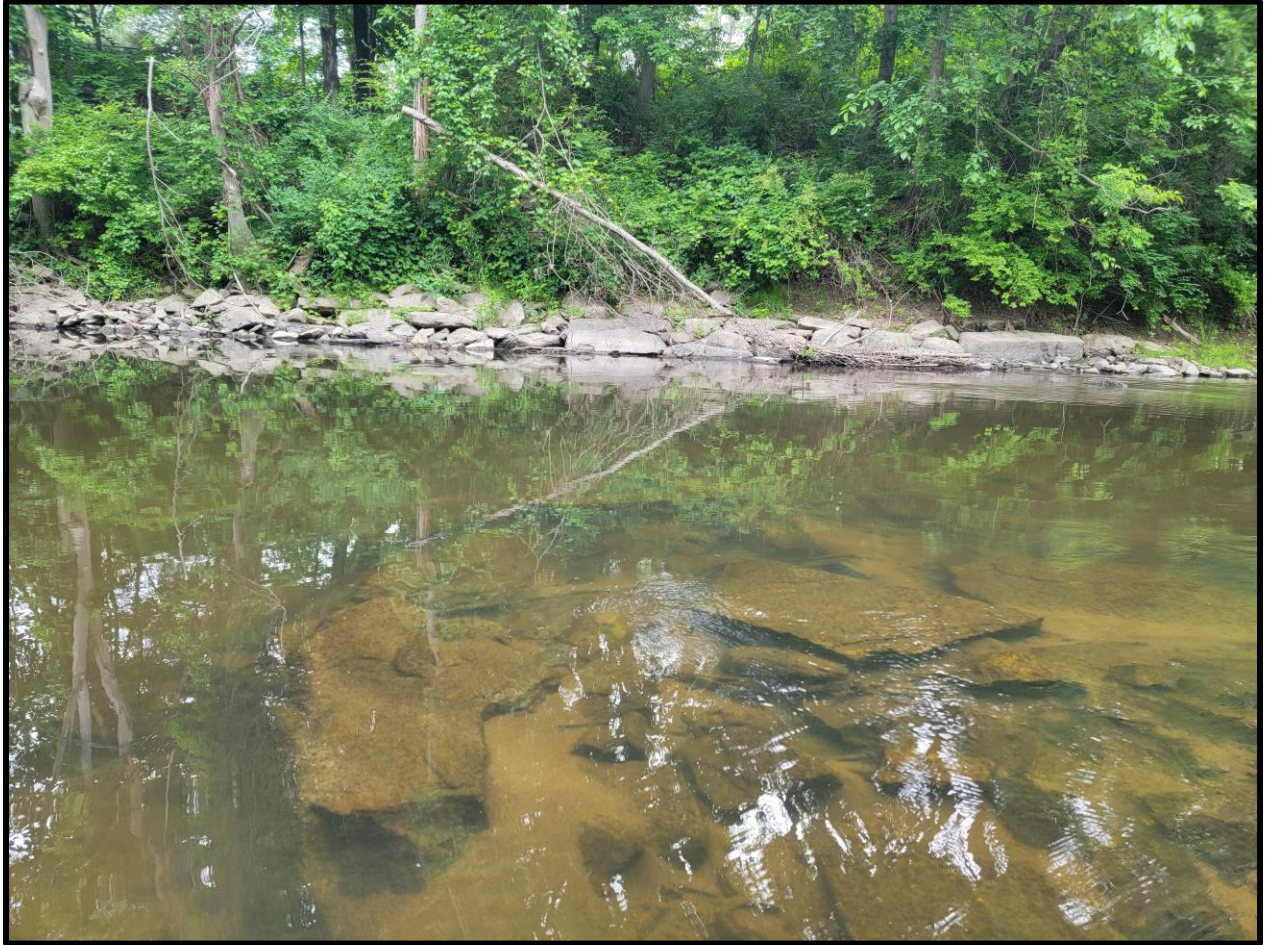
RF2

Figure A-8. RF#2: An assemblage of large rectangular cut stones in bank and in channel.

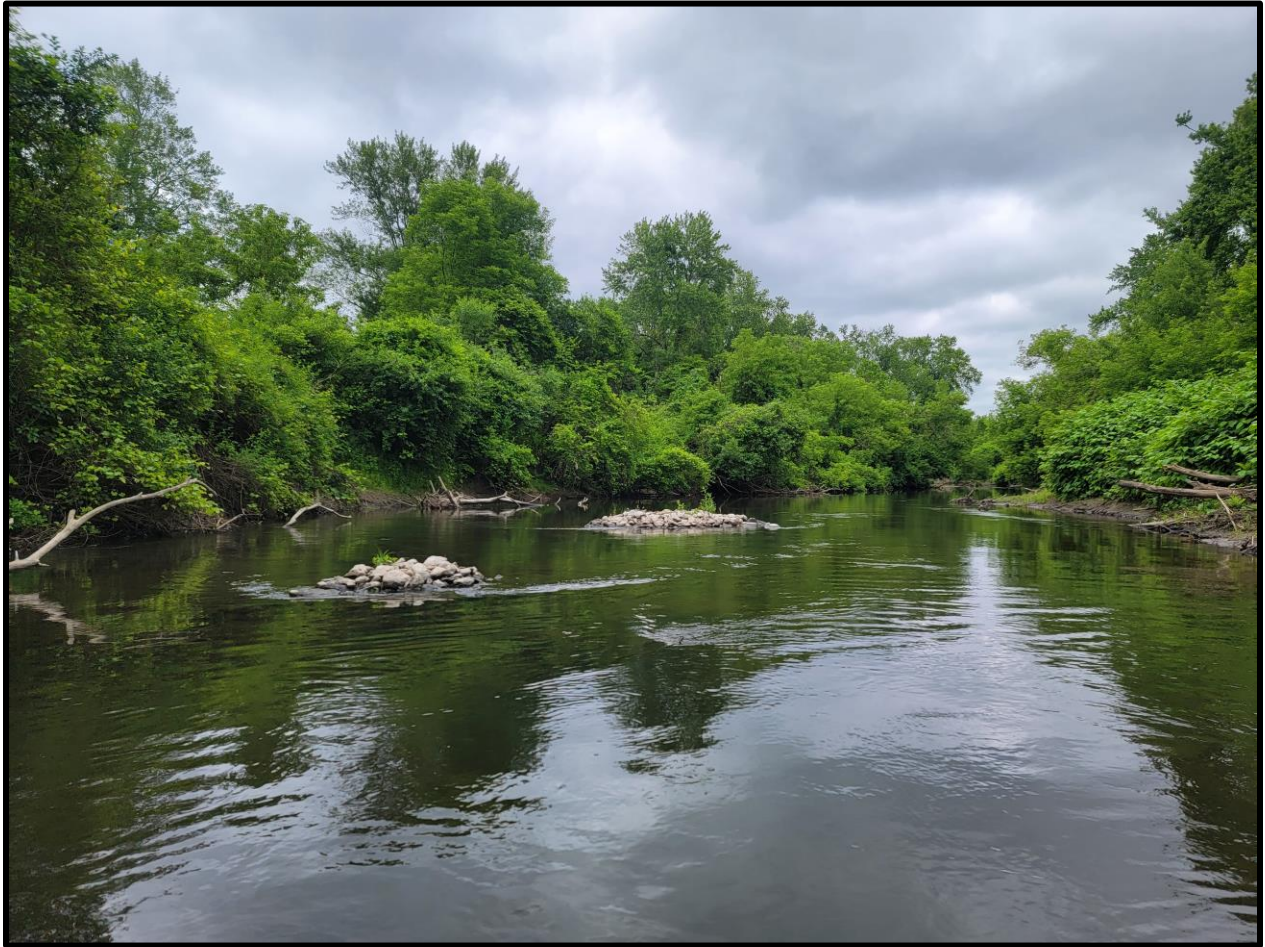
## RF3

Figure A-9. RF#3: This feature includes two adjacent piles of medium to large cobbles and is the same feature identified as Rock Piles during the 2007 reconnaissance and reported in the Phase IA CRA Report.

Pile 1 = Oval-shaped with the current. Dimensions: width = 3 meters; length = 4 meters Located in the central channel. Pile 1 is north of Pile 2.

Pile 2 = Tear-shaped with the current. Dimensions: width = 5 meters; length = 7 meters Located in the central channel. Pile 2 is south of Pile 1.

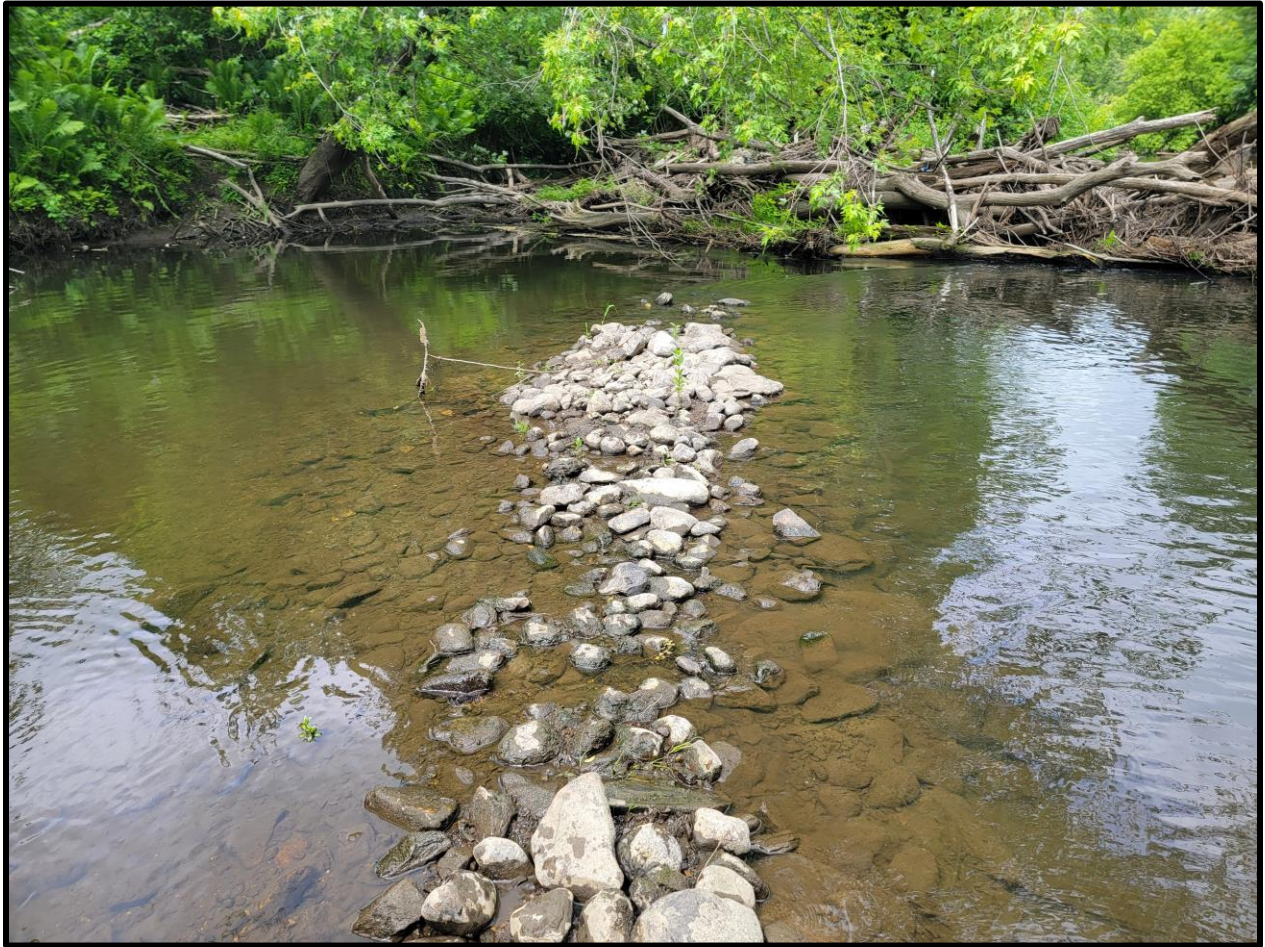
RF4

Figure A-10. RF#4: A linear feature composed of medium to large cobbles running roughly in a north to south direction with a slight curve running downstream – possibly a weir. The eastern bank section of the feature is obstructed by large tree falls and debris. Width = 2 to 3 meters.

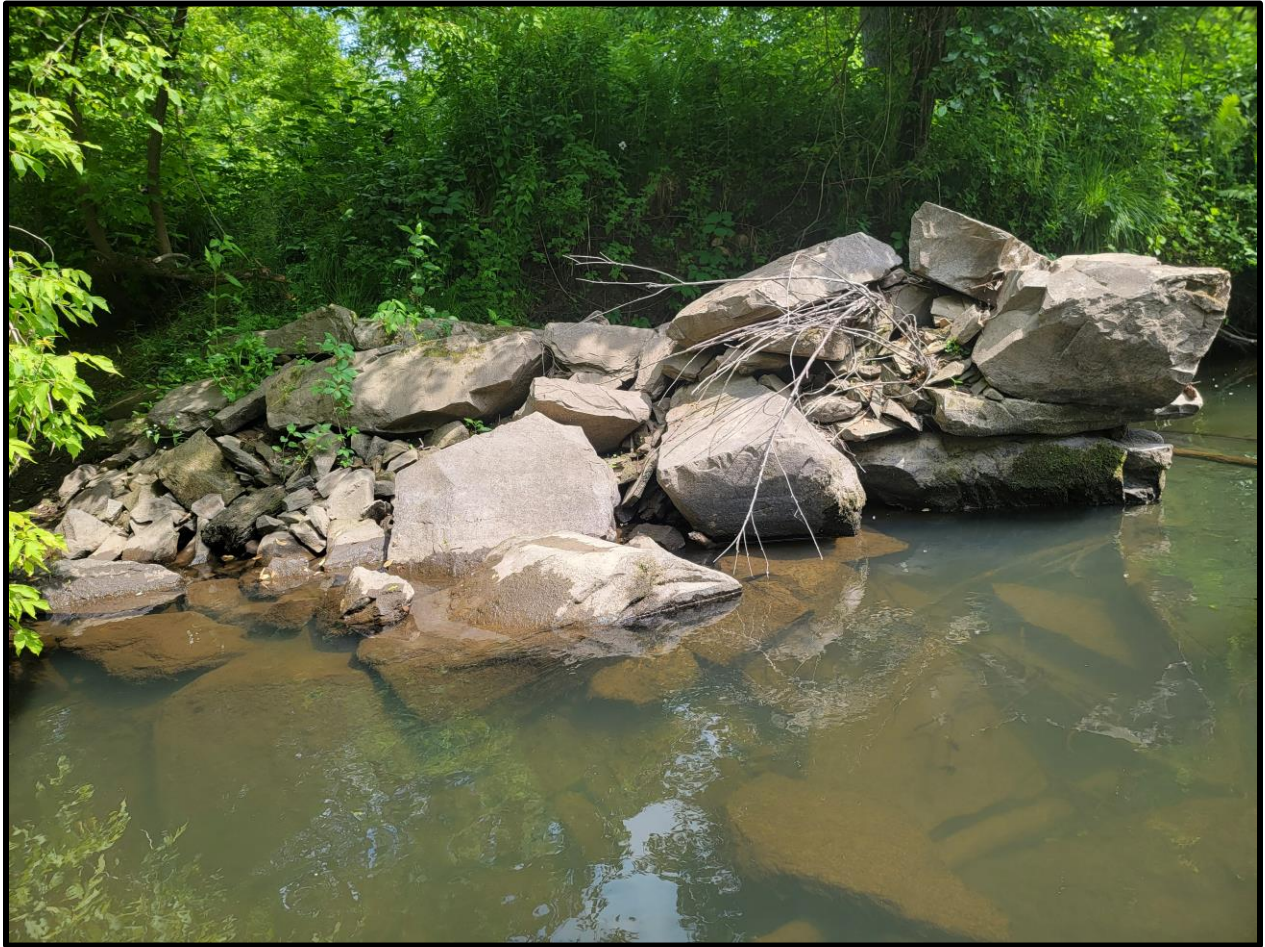
RF5

Figure A-11. RF#5, Abutment 1: A bridge abutment composed of medium and large cut stones with smaller rocks used as fill between the larger stones. Located on the western bank.

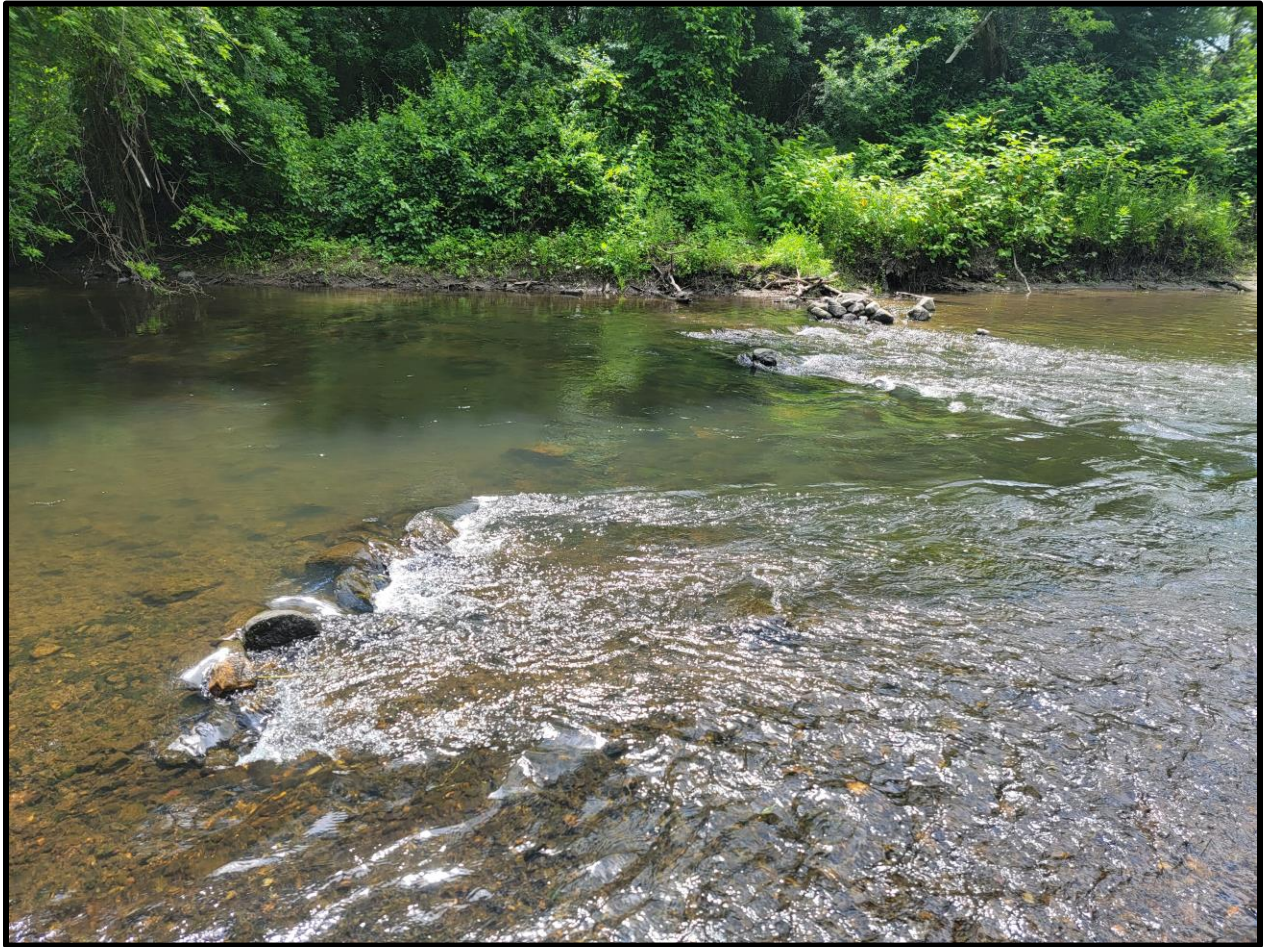
RF6

Figure A-13. RF#6: A possible linear weir or dam composed of large cobbles and sub-angular rocks. The rocks do not cross completely through the river, with large gaps located in the central channel and western bank. Some rock coursing, but inconclusive.

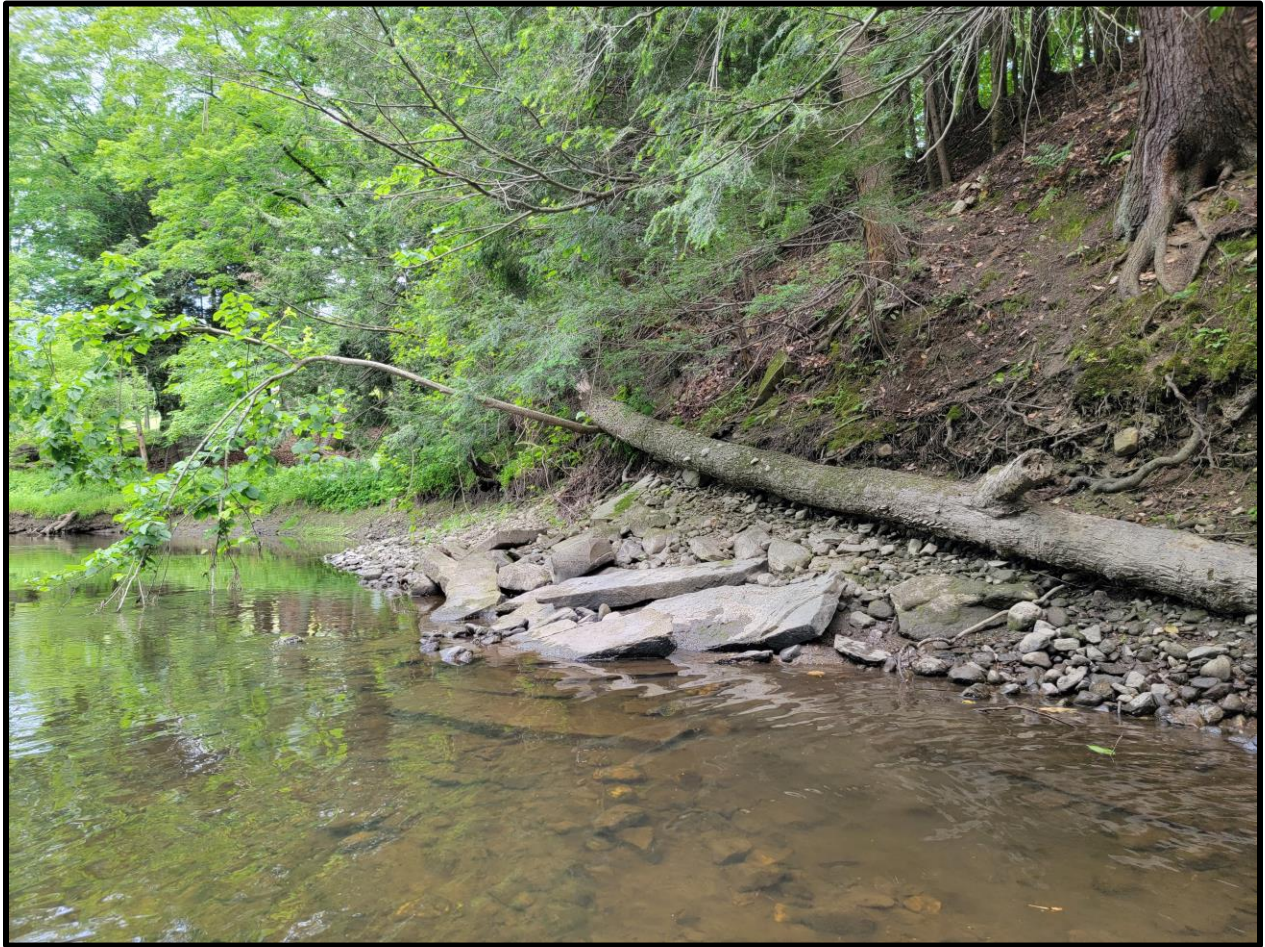
RF7

Figure A-14. RF#7: Multiple very large cut tabular cut rocks located along the eastern bank. The cut rocks are roughly 4 to 5 meters long and 1 to 2 meters wide. Among the cut rocks are small to medium cobbles and sub-angular rocks. The eastern bank is very steep and has a coniferous vegetation.

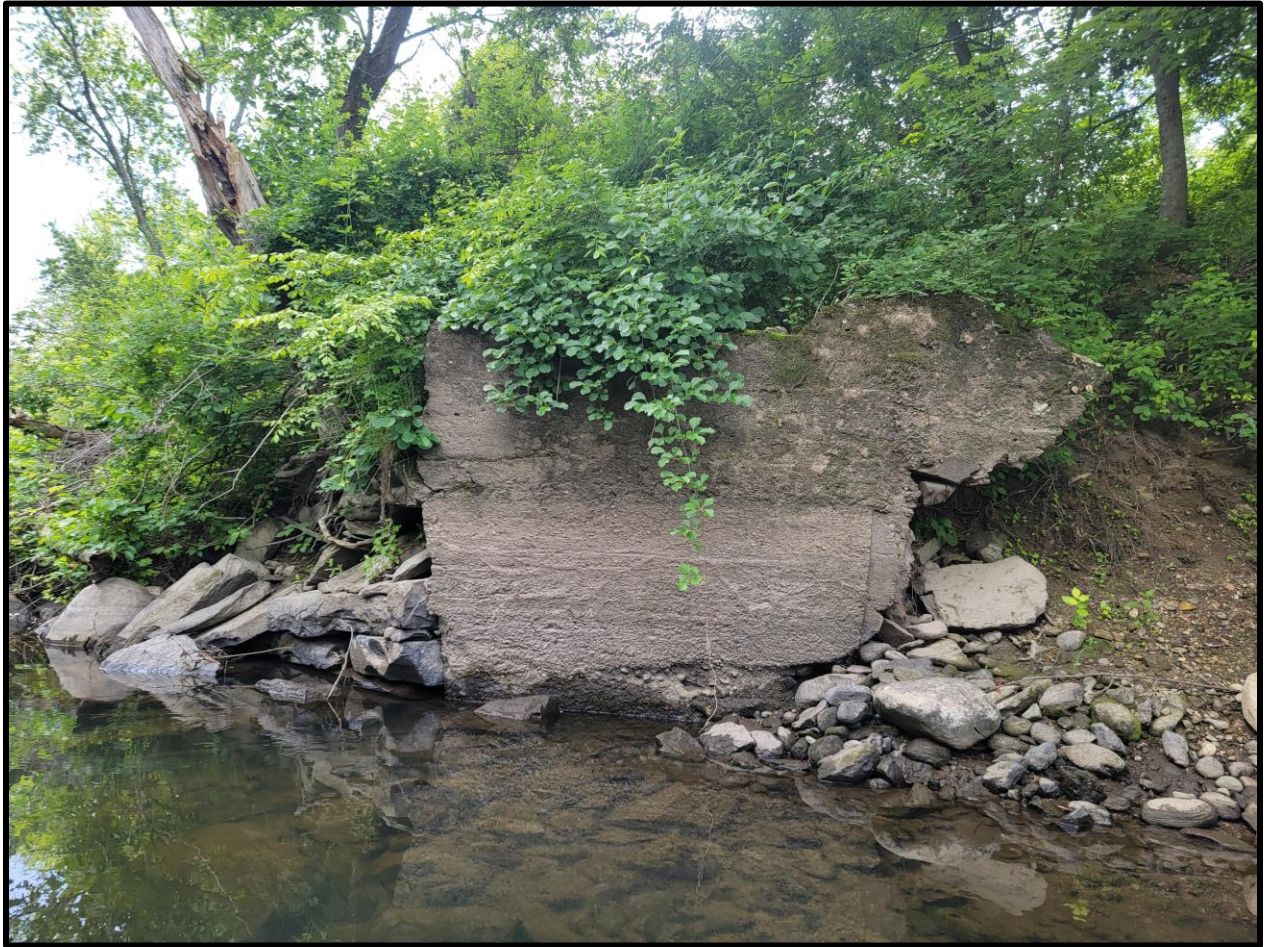
RF8

Figure A-15. RF#8, Abutment 1: A bridge abutment composed of medium to large cut stones with a concrete mixture used as mortar between the stones. One of the sides is faced with the concrete mixture. The concrete mixture includes small angular rocks, rounded rocks, and coarse sand. Located on the western bank. Dimensions: height = 2 meters; width = 2.5 meters.

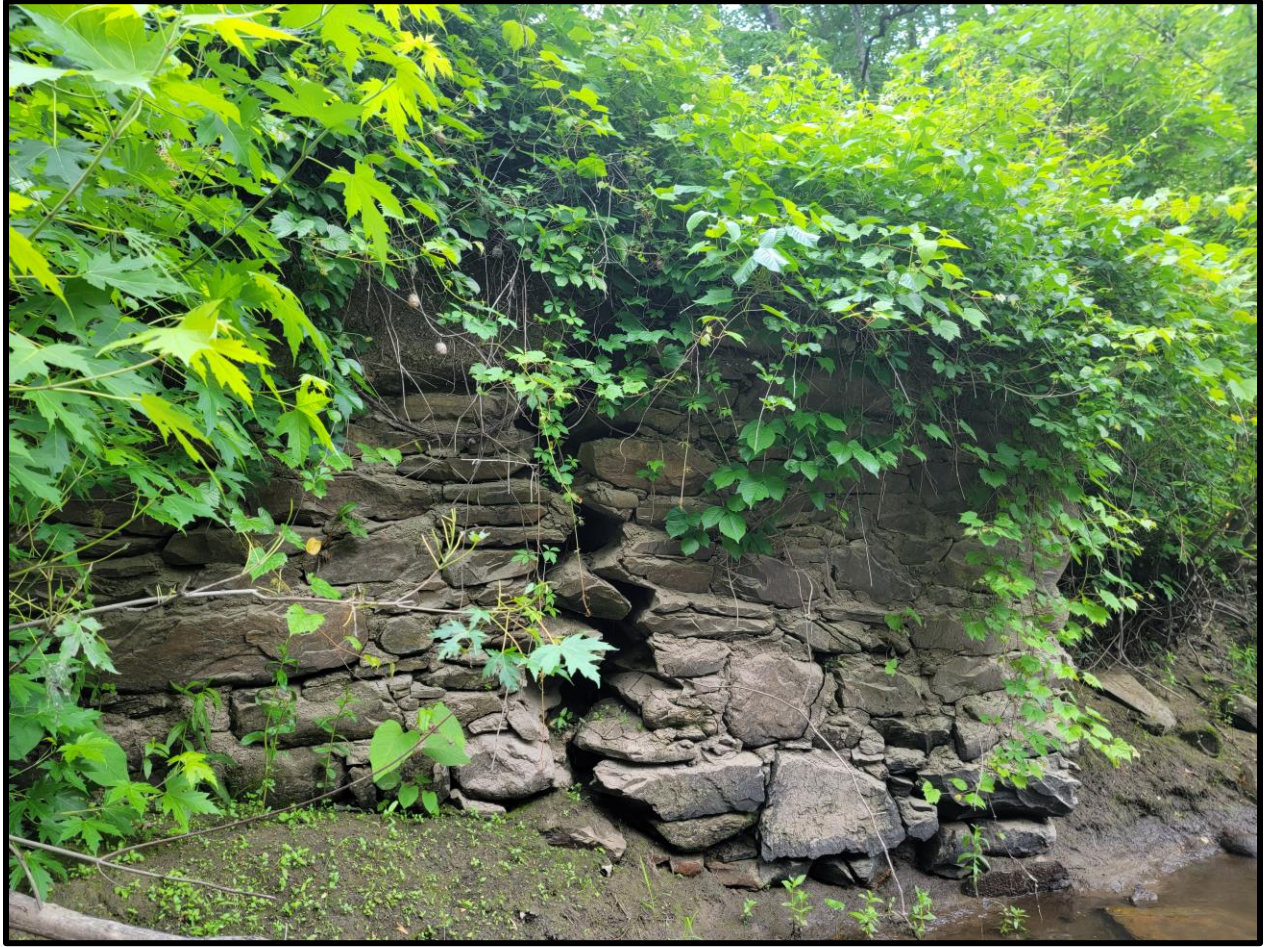
Figure A-16. RF#8: Abutment 2: A bridge abutment composed of medium to large cut stones with a concrete mixture used as mortar between the stones. The concrete mixture includes small angular rocks, rounded rocks, and coarse sand. The cut stones seem to be roughly coursed between each layer. The abutment is obscured by thick vegetation. Located on the eastern bank. Dimensions: height = 2 meters; width = 4 meters.
