**Re: GE-Pittsfield/Housatonic River Site
Rest of River (GEC850)
2025 Road Assessment Report**

2025 Road Assessment Report

**Housatonic River – Rest of River
Pittsfield, Massachusetts**

February 2026

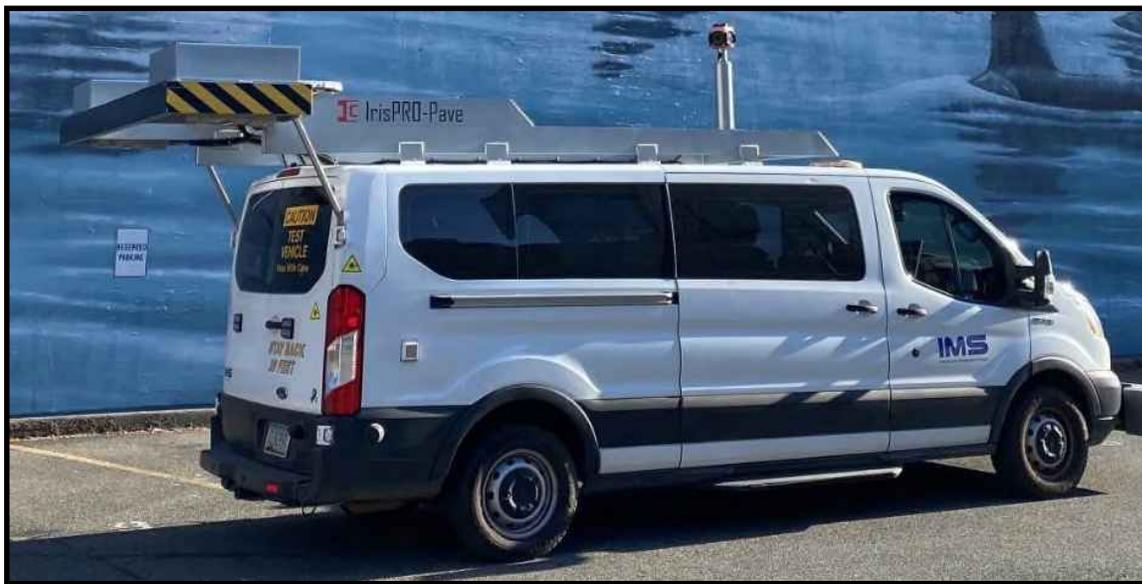
Figure 1 - IMS Integrated Road Information System platform (IRISpro Pave)

In September of 2025, IMS Infrastructure Management Services (IMS) utilized a cutting-edge Integrated Road Information System (IRISpro Pave) (**Figure 1**) to capture continuous, high-resolution pavement images that were used to assess pavement cracking, rutting, and roughness on 3 miles of predominantly asphalt roadways in the Town of Lenox, MA and Town of Lee, MA. IMS followed the American Society for Testing and Materials (ASTM) D6433 standard to analyze the images and distress data collected by the IRISpro to determine the Pavement Condition Index (PCI) for each segment of the road. PCI values were recorded to provide an indication of the surface conditions and structural integrity of a pavement.

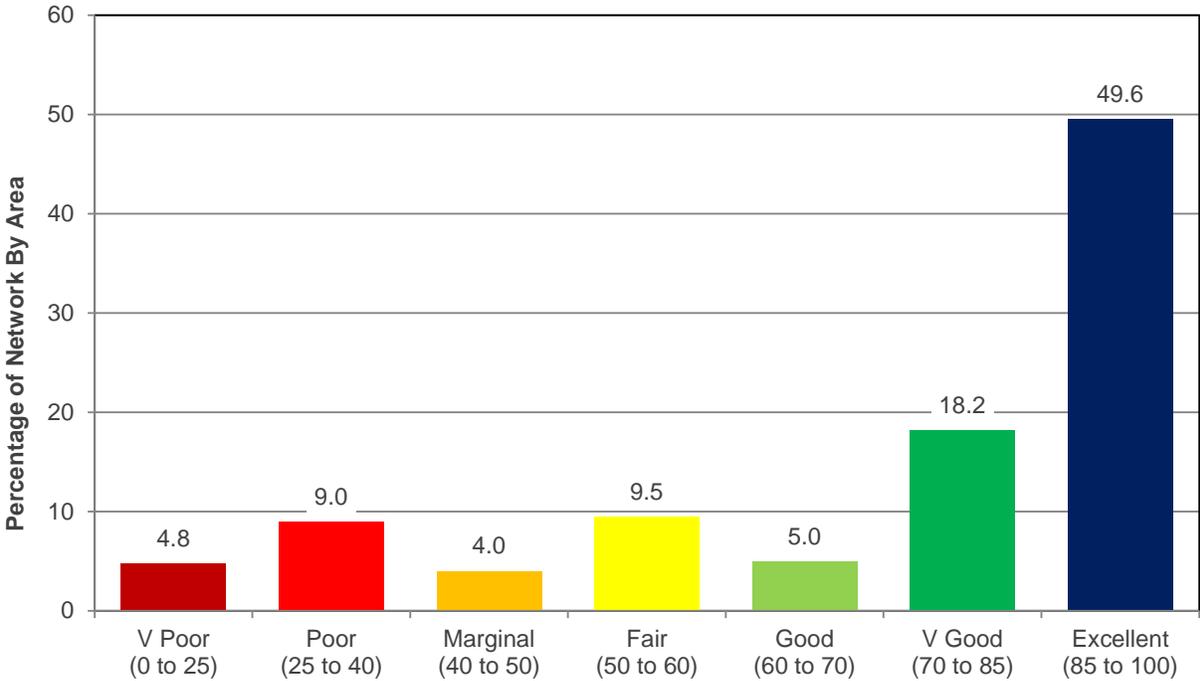
Figure 2 – Roadway Network Present Status on a Condition Scale

The roadways included in the 2025 survey were generally found to be in very good condition with an average PCI of 77. **Figure 2** provides a visual breakdown of the distribution of pavement area across different PCI categories at the time of analysis. Approximately 68% of the roadways included in the 2025 survey were found to be in Excellent or Very Good condition and approximately 14% of the roadways included in the 2025 survey were found to be in the Poor or Very Poor condition (pavements with a PCI below 40).

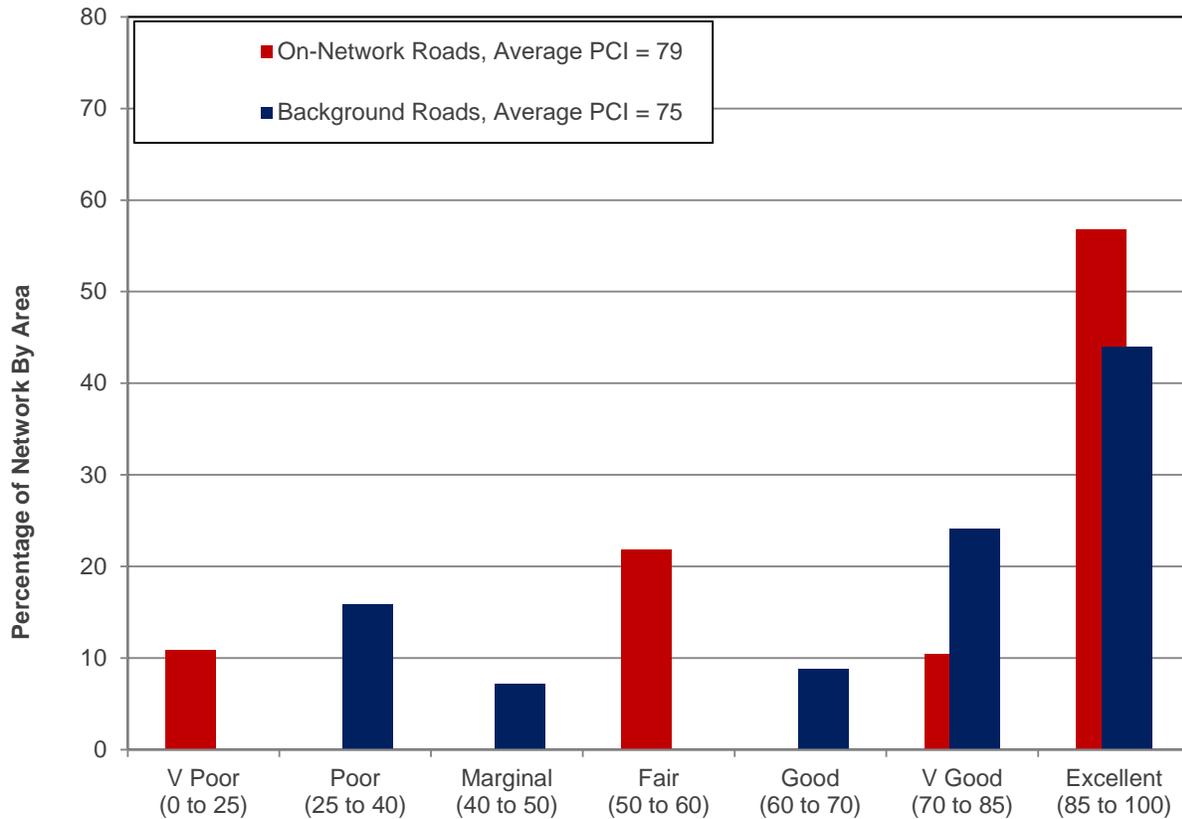
Figure 3 - Condition Rating by Functional Classification

The On-network Roads include routes first associated with UDF construction and represent 44% of the roads surveyed in 2025, with an average PCI of 79 observed in 2025.

The Background Roads include routes included in assessment for background conditions associated with routes first associated with UDF construction and represent 64% of the roads surveyed in 2025, with an average PCI of 75 observed in 2025.

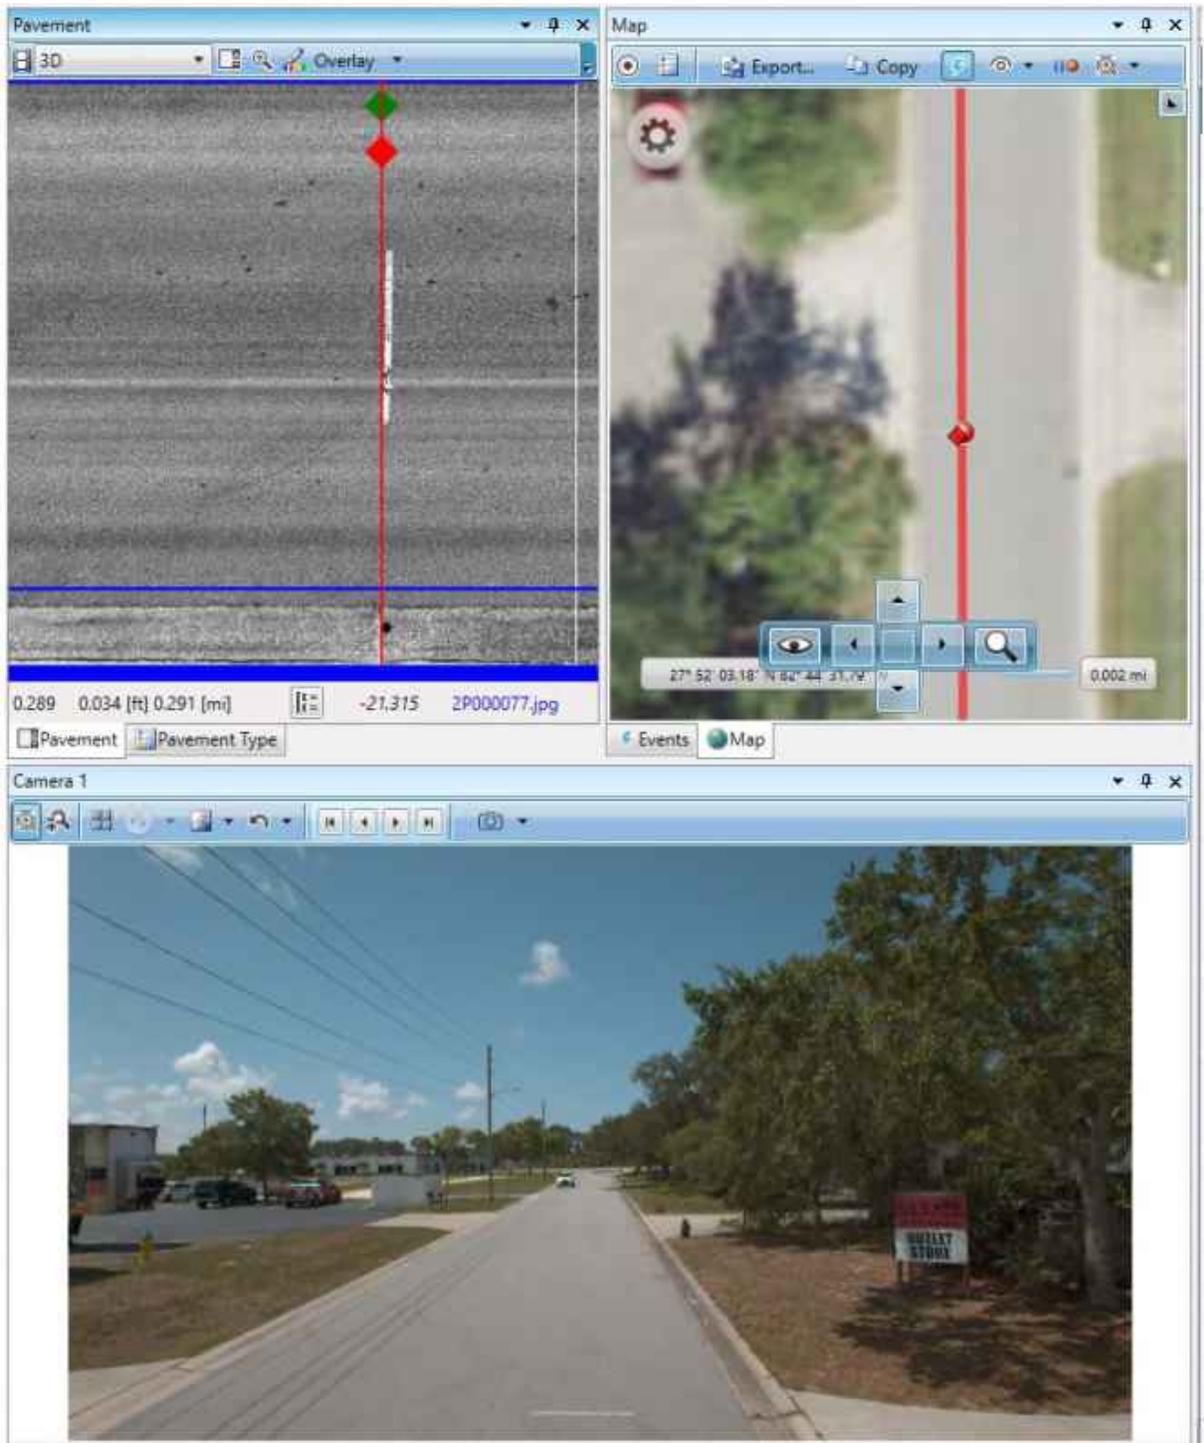
Figure 6 – Lever Arms Final Validations Check

- The pavement window (top left) shows that the profiler and the LCMS are in sync, as the target position (the white stripe in the LCMS pavement image marked by the green square) matches the position (profiler), indicated by the red vertical line centered on the red square.
- The map (top right) shows that the GPS position is correct, as the event position (profiler), indicated by the red square box is where the tape is on the ground.
- The forward image (bottom) shows that the target tape is close to the bottom of the image.

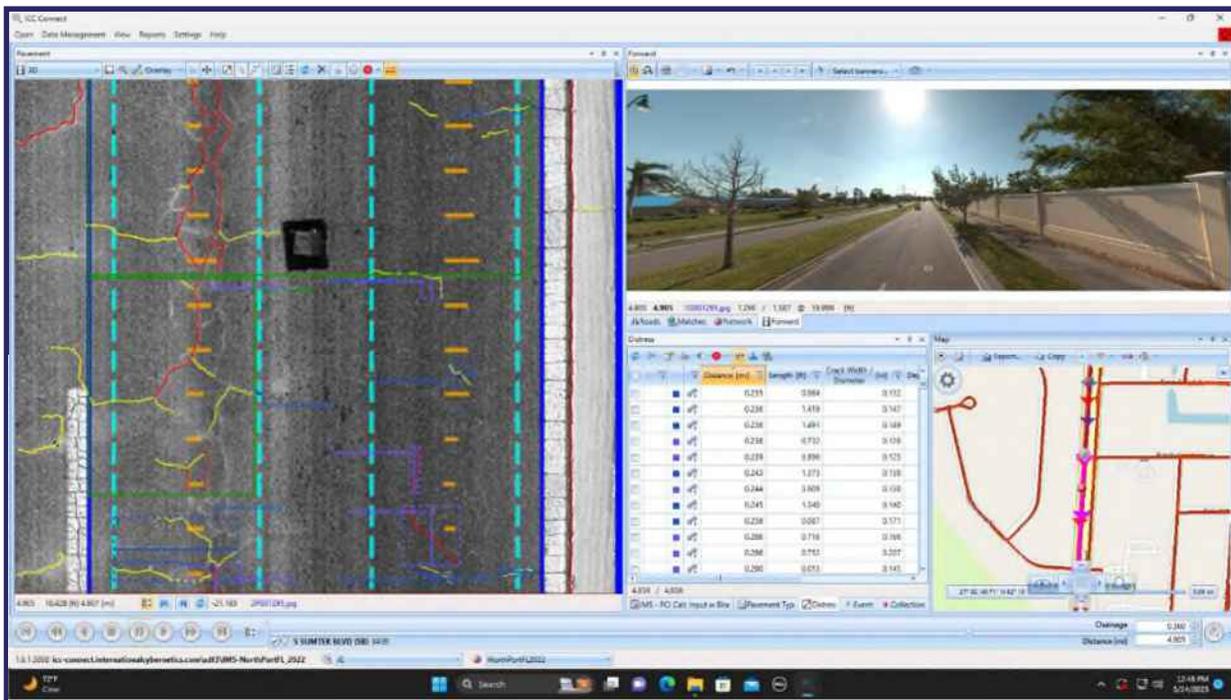
Figure 7 - QC Image from Connect™ Software

To ensure the accurate determination of PCI scores, the field data undergoes a rigorous series of processing phases and quality checks. These checks encompass synchronized assessment of both processed and raw data streams. The automatic distress identification and classification process involves various steps: First, different rules and processing parameters are applied on different pavement types; next, the auto detected lane markings are manually adjusted to exclude non-pavement areas and limit the assessment area for cracking and rutting to between the lane markings and invalidation rules are applied to exclude additional anomalies (e.g. near railroad crossing or bridge decks) from the assessment area. Finally, a team of pavement raters who are well-versed in both the distress standards and the data in its digital format review images and make the necessary corrections on areas with gross under/over detection.

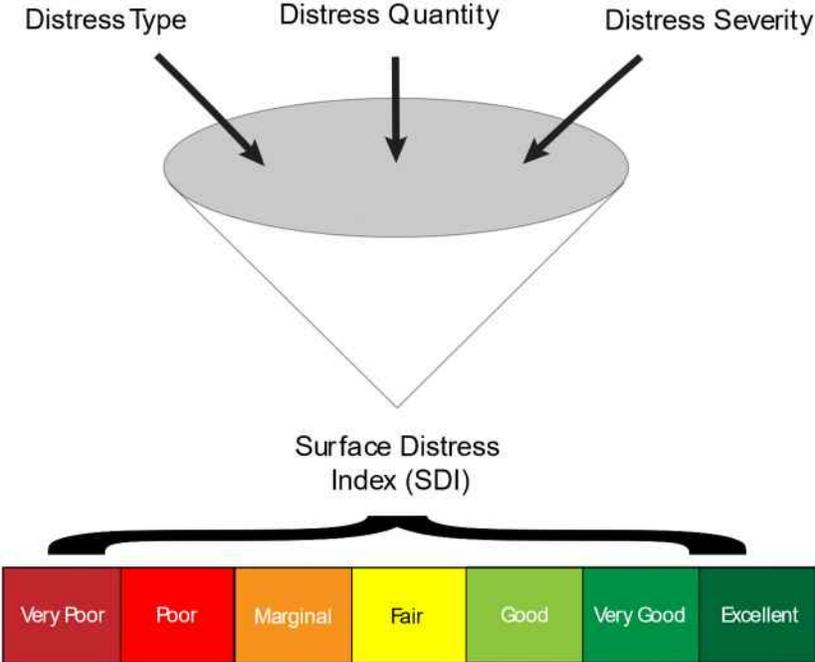
Figure 8 - SDI Inputs and Detailed Scale

ASTM D6433 provides a method of categorizing surface distress observations for both asphalt and concrete pavements, based on the extent and severity of distresses along the roadway. The Surface Distress Index (SDI) is used to represent the observed pavement defects on a scale from 0 to 100. However, not all surface distresses are given equal weight. Load-associated distresses (LAD), such as rutting or alligator cracking on asphalt streets, and divided slabs on concrete streets, have a greater impact on the SDI than non-load associated distresses (NLAD), such as raveling or longitudinal and transverse cracking. Even when present in low extents and moderate severity, LAD can significantly decrease the SDI. The SDI inputs are shown in **Figure 8**.

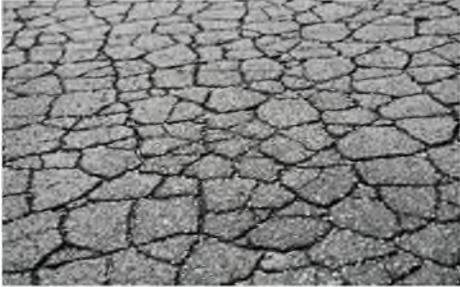
Distress Type	Pavement Type	Description	Example
Alligator Cracking	Asphalt	<ul style="list-style-type: none"> • Quantified by severity and square footage • Caused by the repeated bending from vehicle loads • Propagate from the bottom, meaning that structural failure has occurred • An LAD with significant impact on the condition score, even at low extents

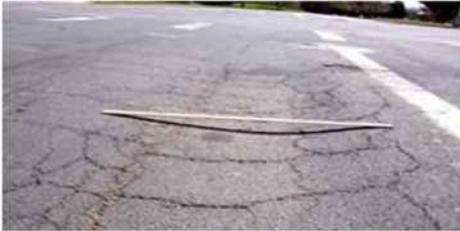
Rutting	Asphalt	<ul style="list-style-type: none"> • Caused by the permanent deformation of the pavement and/or subgrade layers • Even in Low densities can have a large impact on the final condition score due to their implication of possible structural failure

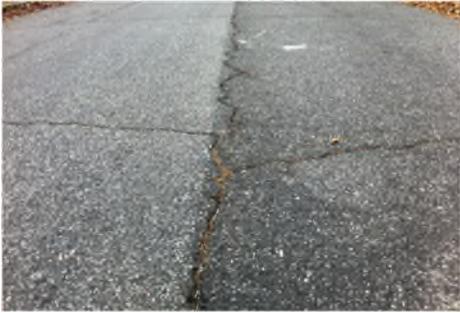
Longitudinal & Transverse Cracking	Asphalt	<ul style="list-style-type: none"> • Quantified by their length and width • Results from pavement shrinkage due to natural daily and seasonal temperature cycles, construction issues, or other factors

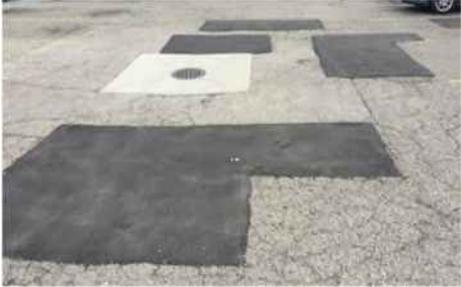
Distress Type	Pavement Type	Description	Example
Patching	Asphalt	<ul style="list-style-type: none"> • Quantified by the square footage and severity • Always considered a surface defect • Affects ride quality and condition of a pavement

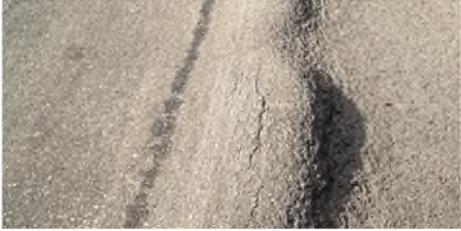
Distortion	Asphalt	<ul style="list-style-type: none"> • Bumps and sags, depressions, swell, corrugation, and shoving • Caused by several factors, such as construction issues, subgrade mixture failure, environmental influence, etc.

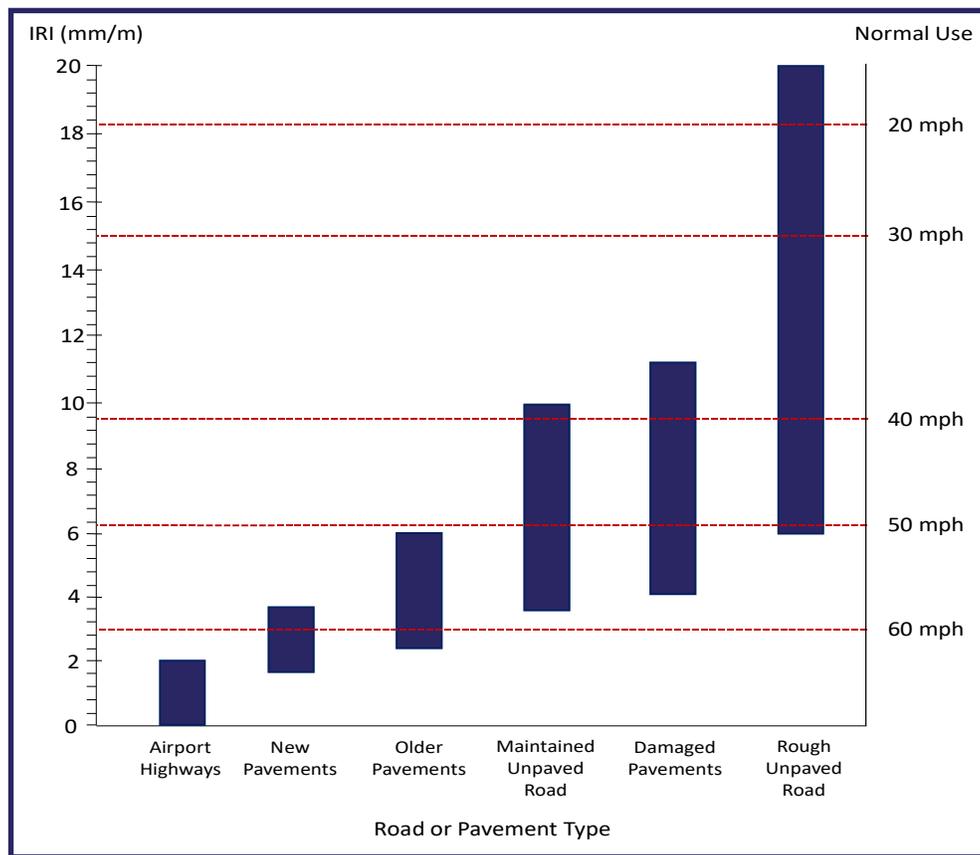
Figure 9 - IRI Scale Definitions

The Roughness Index (RI) provides a quantifiable measure of ride quality, which is determined using the industry-standard ASTM E1926 for calculating the IRI. This value is derived from the longitudinal profile captured by the LCMS as it records the change in elevation over a distance. Once calculated, it is expressed as a slope and reported in millimeters per meter (mm/m). Typical IRI levels for new, older, and damaged pavements are displayed in **Figure 9**. The IRI is lower on average for roads or pavements that are normally used for higher speed travel.

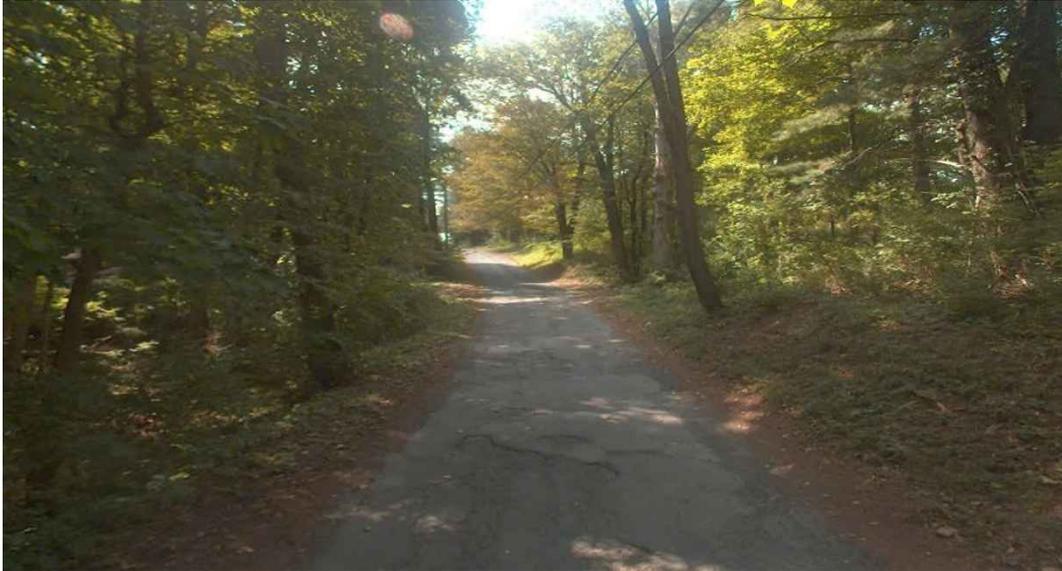
Very Poor (PCI = 0 to 25)

Willow Hill Road (On-Network, PCI = 23) – Rated as Very Poor, this street displays a large quantity of alligator and block cracking severe enough to suggest that the pavement structure is inadequate for current traffic loads. The rehabilitation of roads in this condition through a mill and overlay is generally ineffective, as the failures usually extend to the bottom of the pavement layer. Streets in this condition require rehabilitation that involves removal and replacement of the asphalt layer, base stabilization, or complete reconstruction based on design requirements.

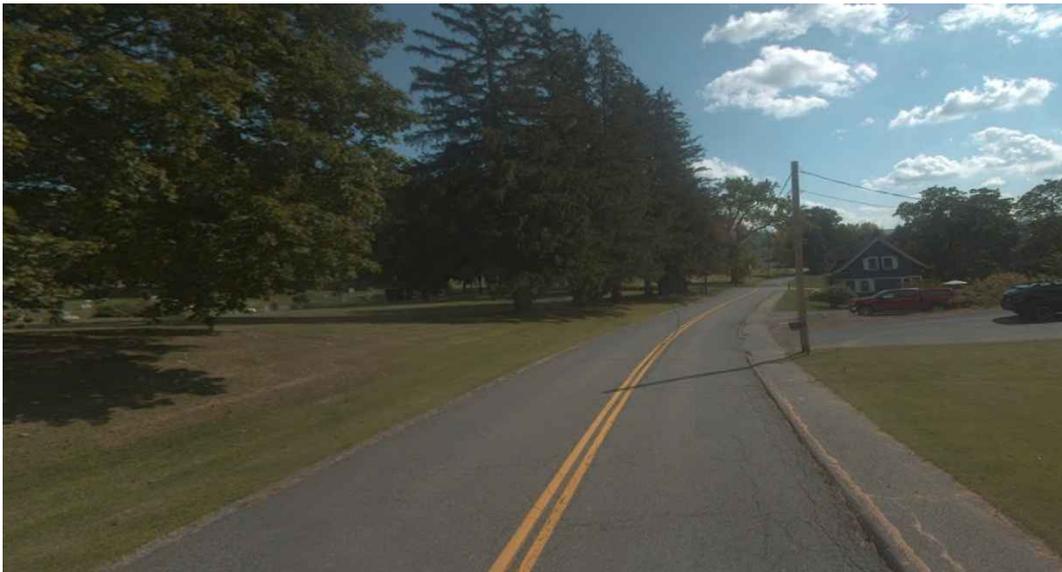
Poor (PCI = 25 to 40)

Greylock Street (Background, PCI = 36) – Rated as Poor, a fair amount of the segment contains alligator cracking. There are also deep longitudinal and transverse cracks, particularly along the edges of the pavement. If left untreated, a partial to full reconstruction would be required within a short period of time.

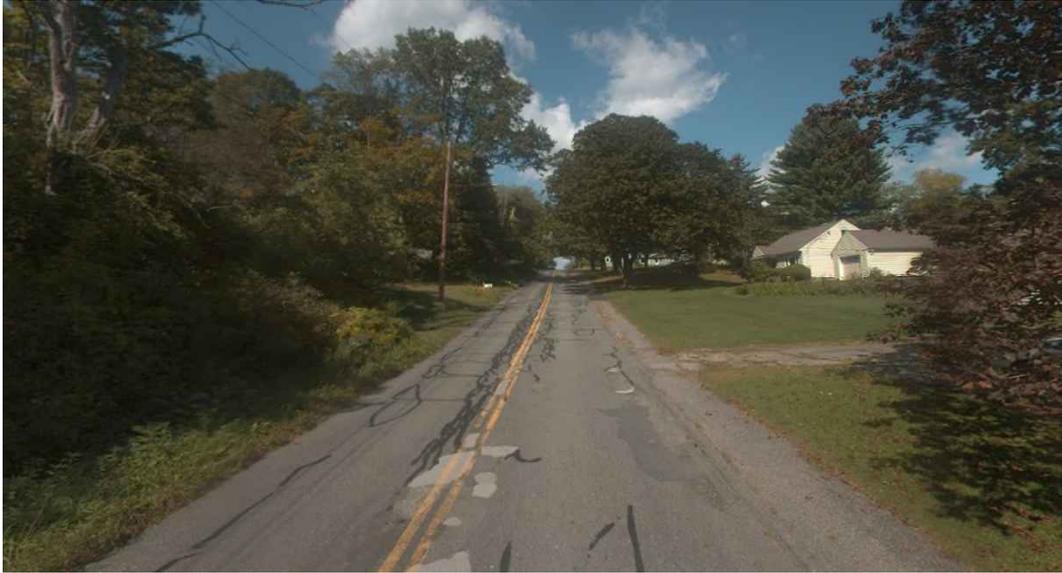
Marginal (PCI = 40 to 50)

Greylock Street (Background, PCI = 45) – This street displays transverse and longitudinal cracking across the middle and edges of the pavement. There are sections of alligator cracking dispersed along the segment as well.

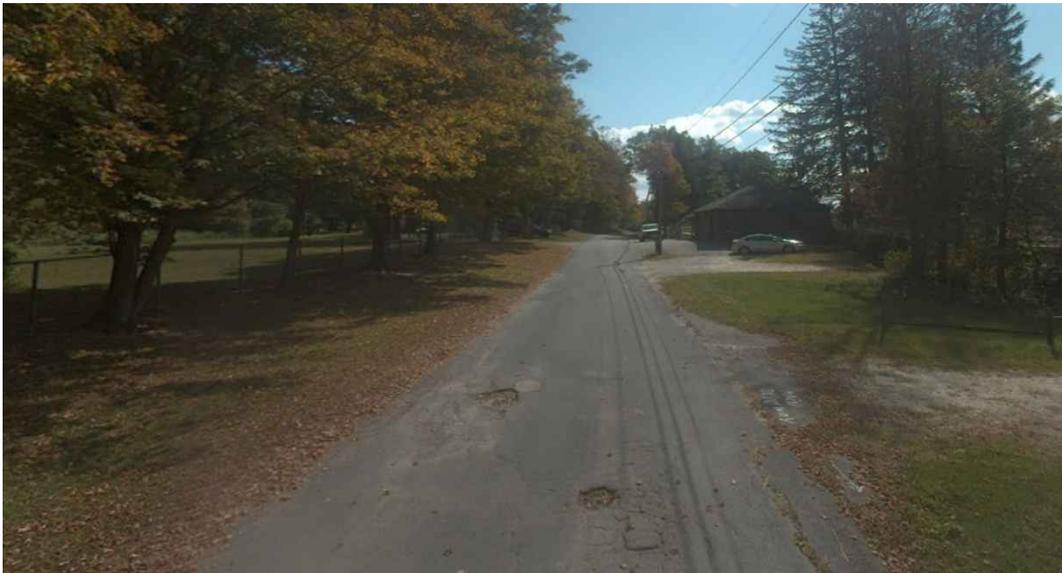
Fair (PCI = 50 to 60)

Woodland Road (On-Network, PCI = 55) – Fair streets have similar characteristics to Marginal streets in that the distresses present tend to be localized and moderate in severity; however, the distresses will predominately be non-load related (i.e., caused by environmental or other factors). This street displays block cracking towards the middle of the pavement. There are moderate amounts of longitudinal and transverse cracking, with some cracks being deep but localized.

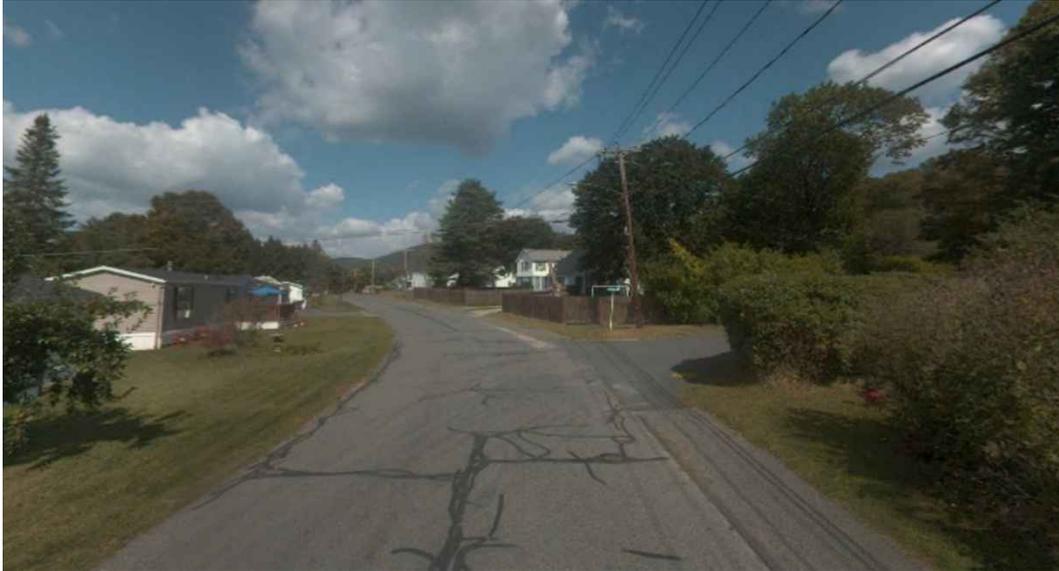
Good (PCI = 60 to 70)

Bradley Street (Background, PCI = 63) – Rated as Good, the primary cause of deterioration for this street is the longitudinal and transverse cracking. The pavement surface could be restored with spot patching to remedy the more heavily distressed areas.

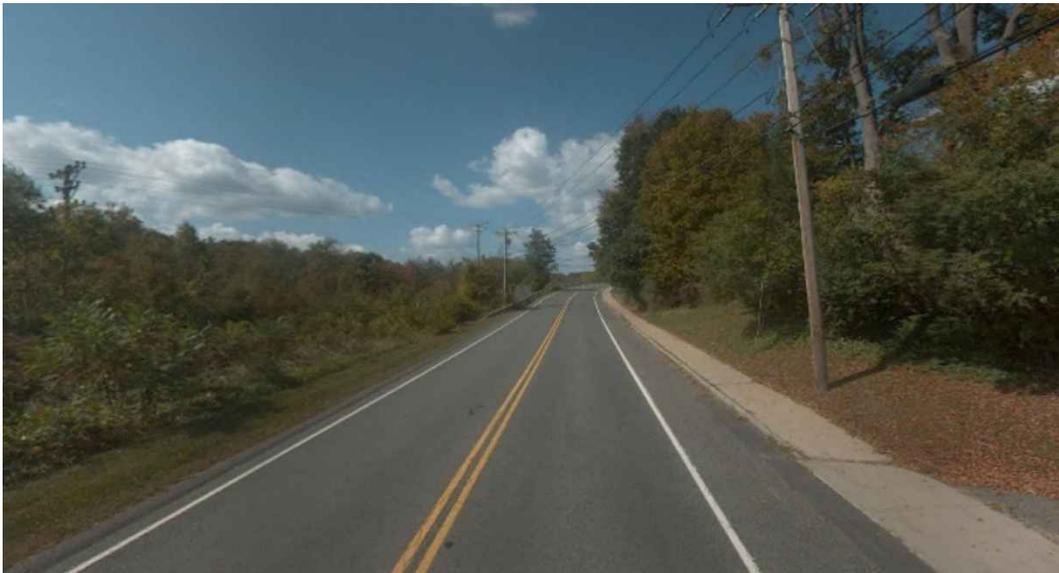
Very Good (PCI = 70 to 85)

Mill Street (On-Network, PCI = 75) – Rated as Very Good, this street displays minor amounts of transverse cracking. It is an example of a candidate for preventive maintenance to extend the life of the roadway.

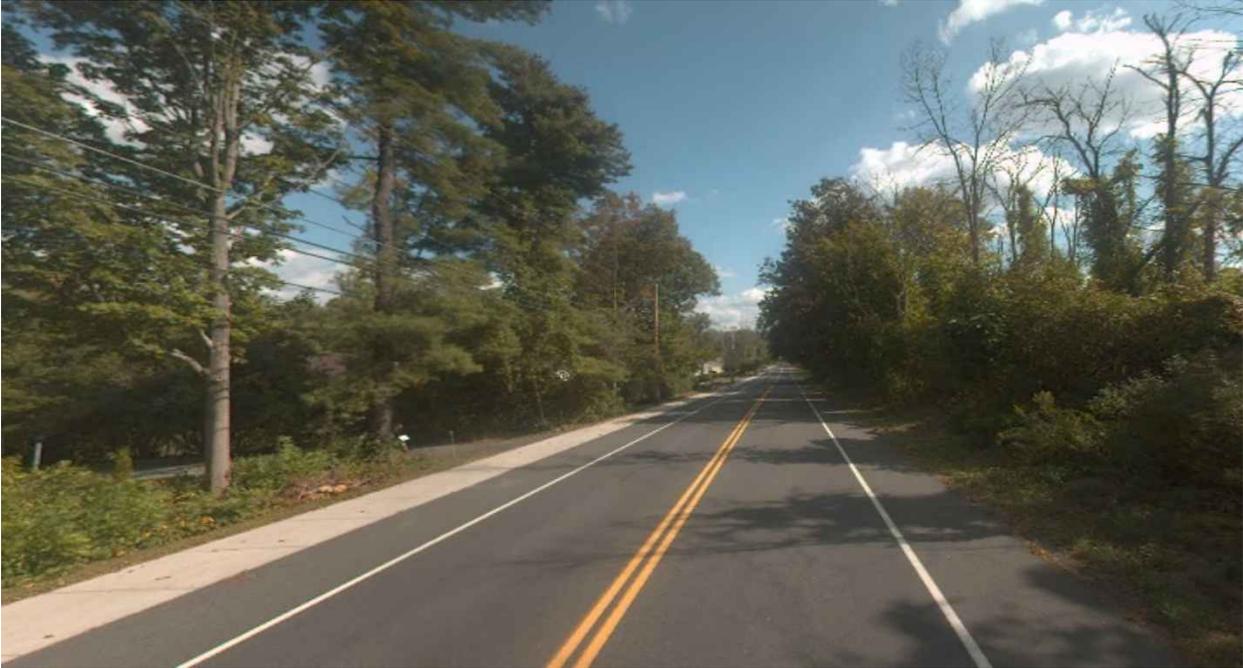
Excellent (PCI = 85 to 100)

Walker Street (On-Network, PCI = 100) – Rated as Excellent, this pavement displays little to no surface distresses. The ride is smooth, and the surface and the base are intact.

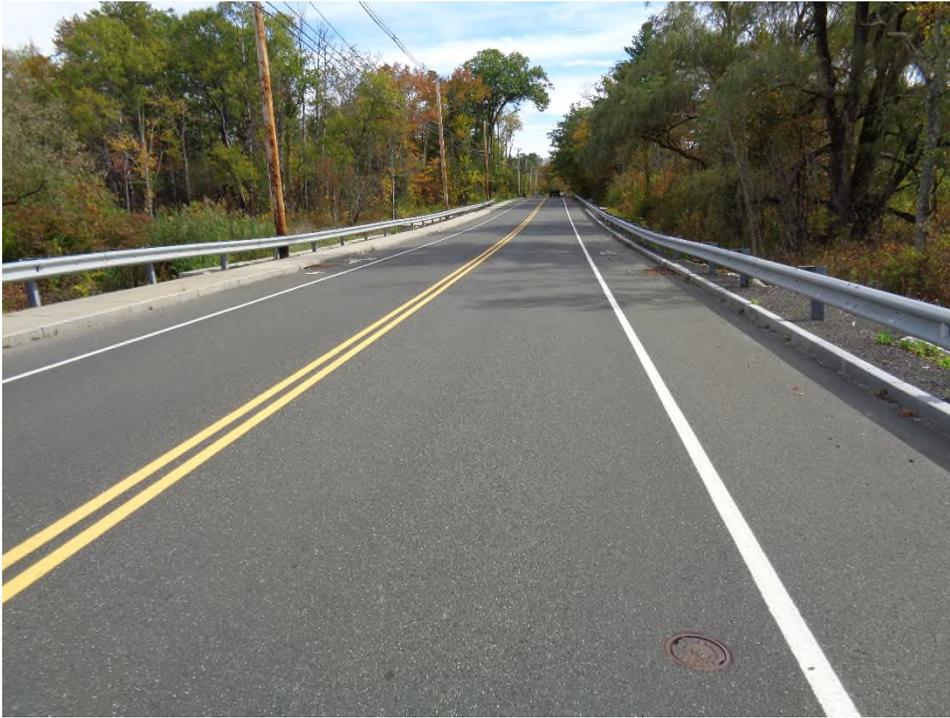
Photograph: 3

Description:
Walker Street –
Bridge/Culvert over
Creek
