**Re: GE-Pittsfield/Housatonic River Site
Rest of River (GECD850)
Conceptual Design Plan for Rail Transload Areas in Reaches 5 and 6**

Conceptual Design Plan for Rail Transload Areas in Reaches 5 and 6

**Housatonic River – Rest of River
Pittsfield, Massachusetts**

February 2026

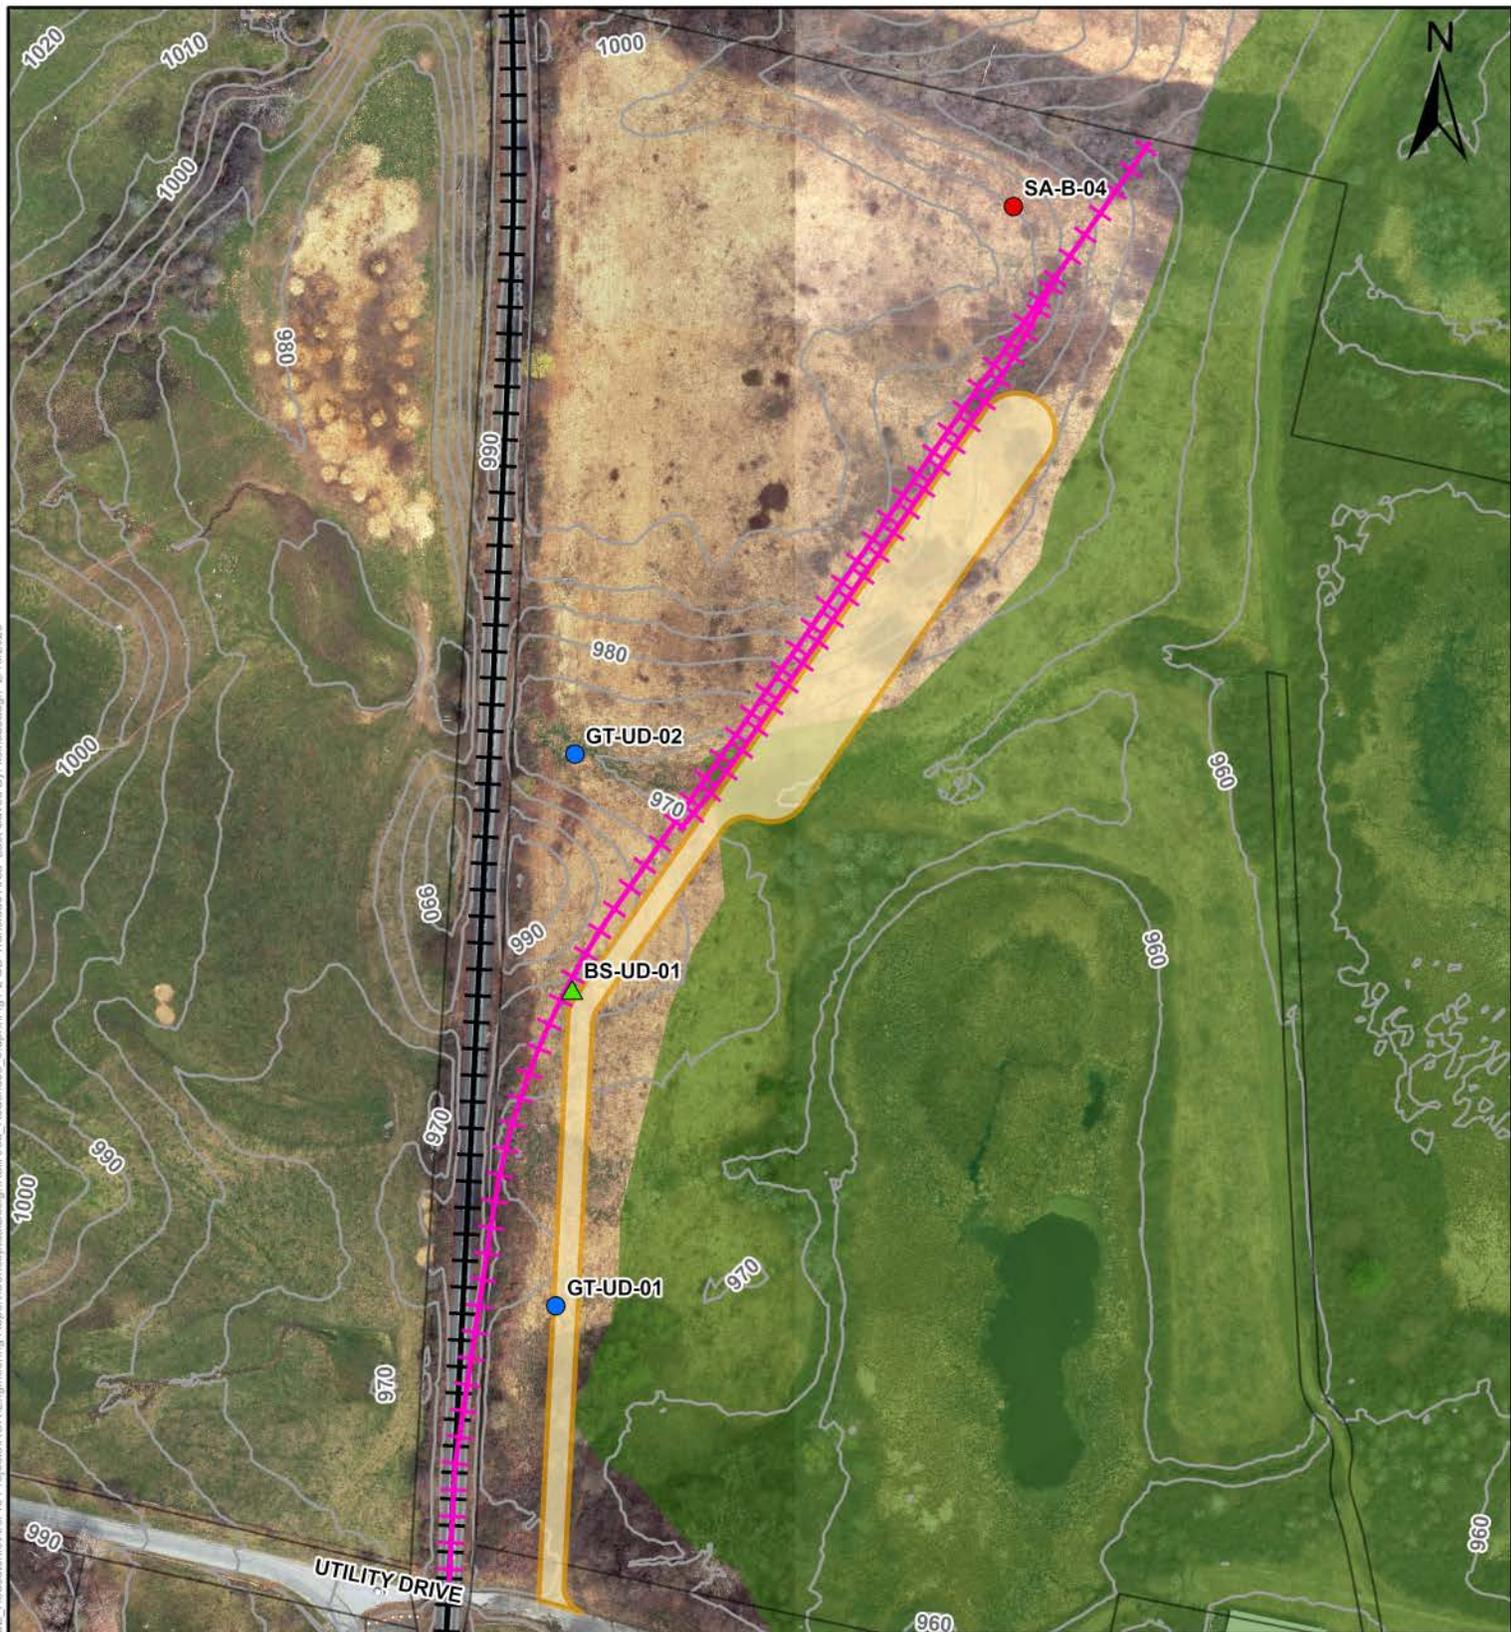
FIGURE
1-2

The properties on which the Utility Drive and Woods Pond Spur rail transload areas will be constructed are shown on Figures 1-2 and 1-3, respectively, including the conceptual footprint of the rail transload areas on those properties, which are subject to modification as consultation with the relevant parties progresses and the design process continues. As noted above, some of the PDI activities (e.g., soil geotechnical and CRS investigations) were focused on the footprint of the rail transload areas proposed in the Rail PDI Work Plan. However, since approval of the Rail PDI Work Plan, the conceptual design alignment of the rail transload areas has been adjusted and expanded based on the results from the PDI as well as coordination with relevant parties. For example, the orientation of the Utility Drive rail transload area was rotated so that it extends eastward at an angle from the railroad mainline for a number of reasons: (a) to reduce the distance between the rail loading/unloading area and the Reach 5A staging area planned for the same property; (b) to reduce disturbance to existing topography; and (c) to allow adequate room for the rail length required for Housatonic Railroad Corporation (HRRC) and ROR RA operations without impacting the more densely vegetated adjacent property owned by the Massachusetts Division of Fisheries and Wildlife (MassDFW) to the north. The Woods Pond Spur rail transload area footprint was expanded and adjusted primarily based on input received from the property owner, the Berkshire Scenic Railway Museum (BSRM).

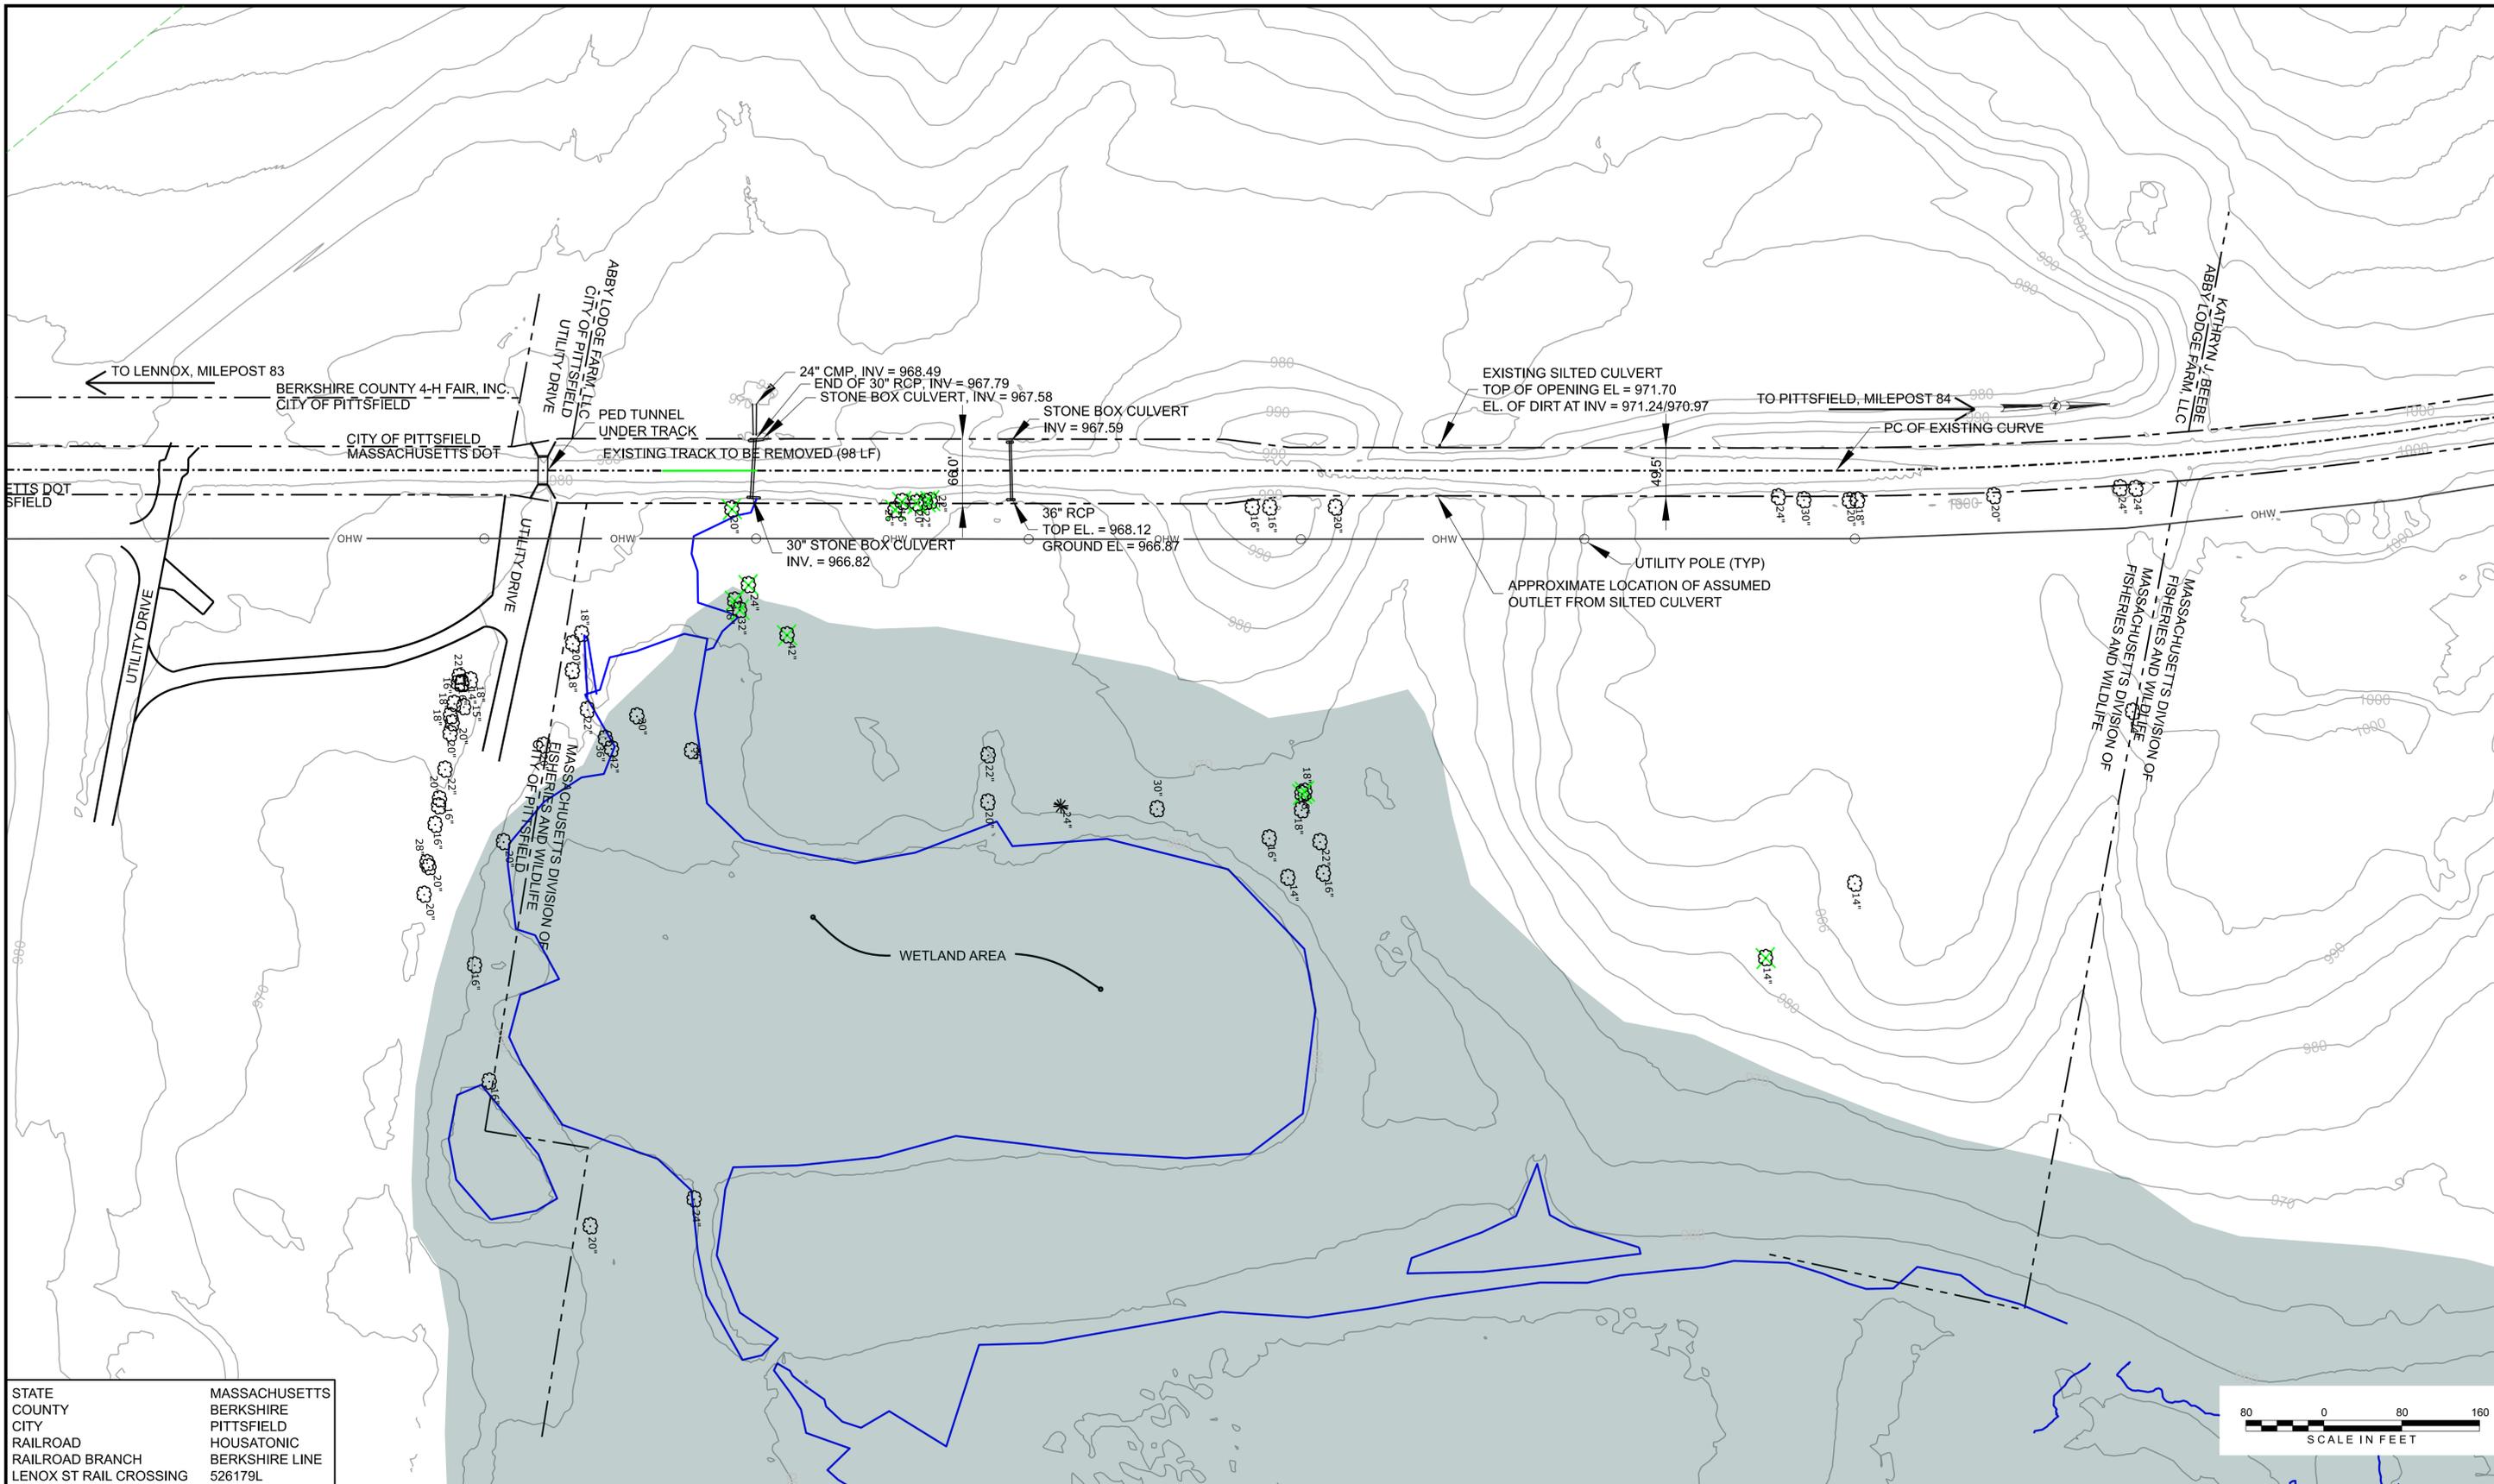
ARCADIS Project No. 30318691.3000
 Date FEBRUARY 20, 2026
 ARCADIS ONE LINCOLN CENTER 110 WEST FAYETTE STREET SYRACUSE, NEW YORK 13202 TEL. 315.446.9120
RT-101

As illustrated on Conceptual Design Drawing RT-101, two large visible culverts and a silted and partially buried culvert currently extend under the railroad mainline and discharge onto the Utility Drive rail transload area property, and the existing drainage pattern is generally west to east and towards the wetland observed on the property. The two large visible culverts will be extended such that the discharge will be east and downgradient from the rail transload area, and site grading will ensure that other surface flow and stormwater, including from the silted culvert, are diverted away from the existing railroad mainline and the rail transload area. Existing drainage

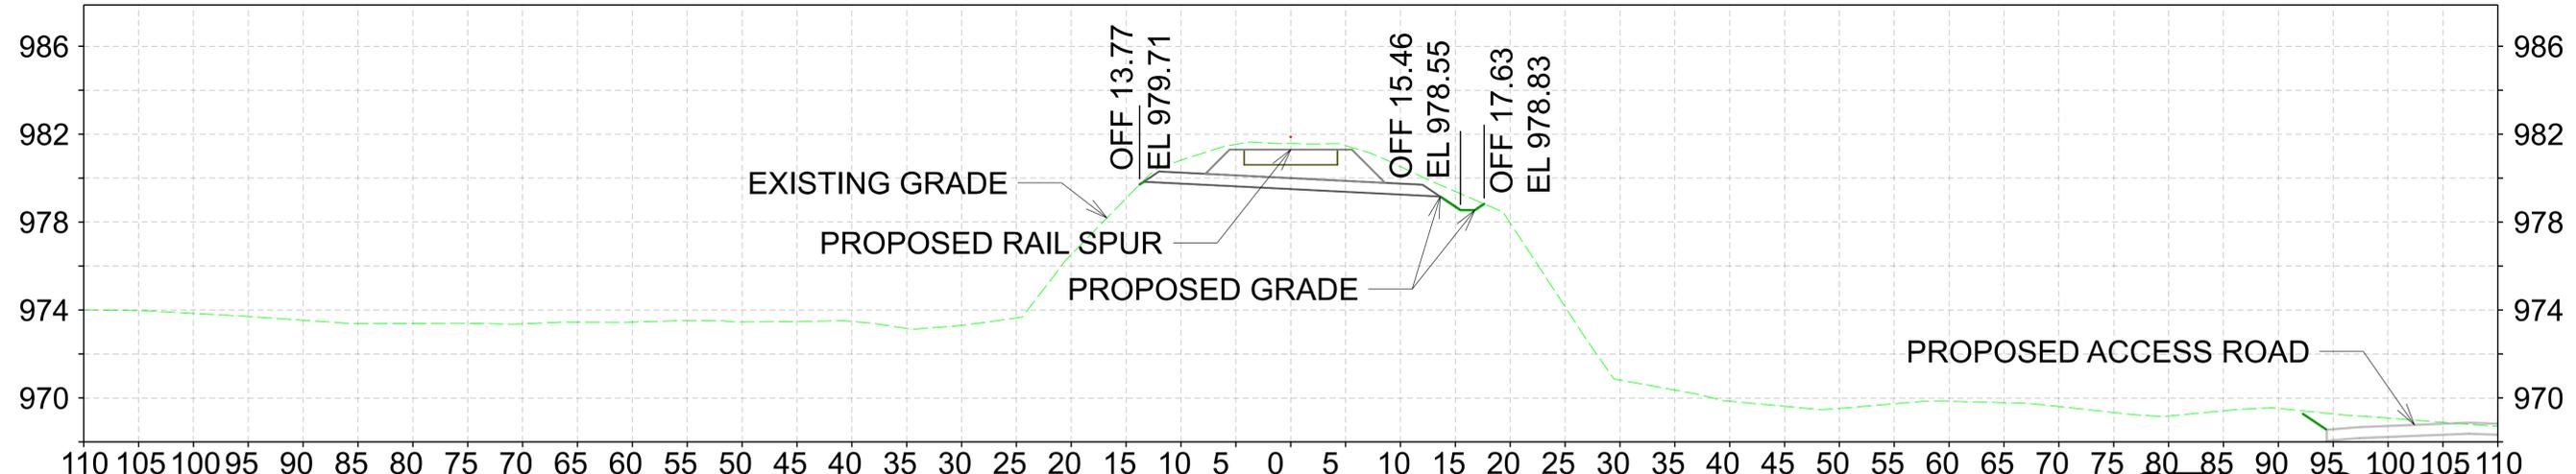
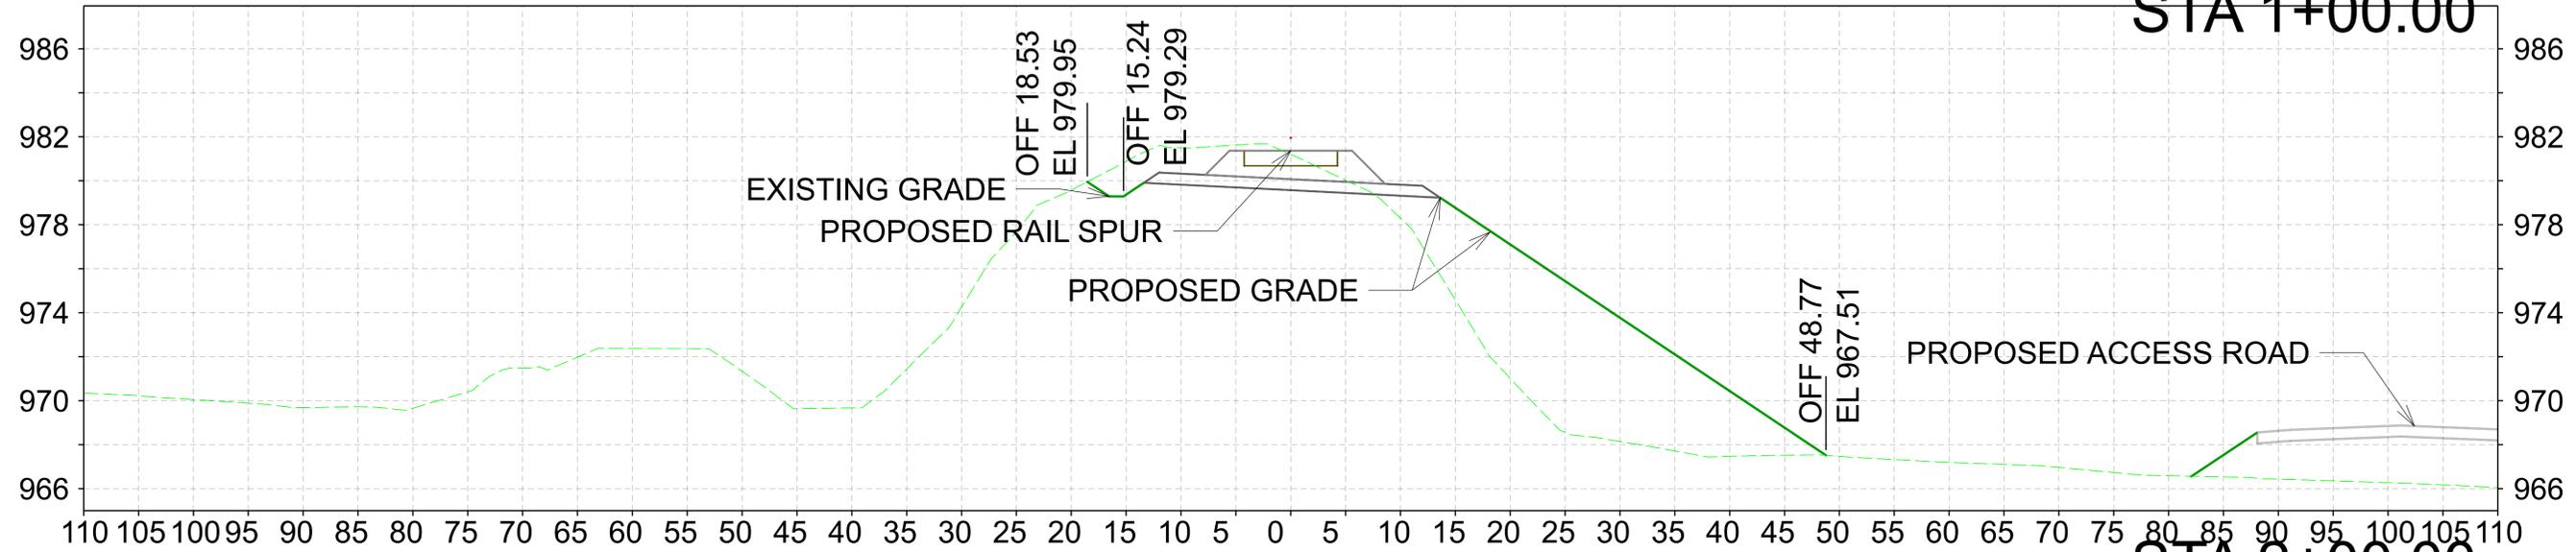
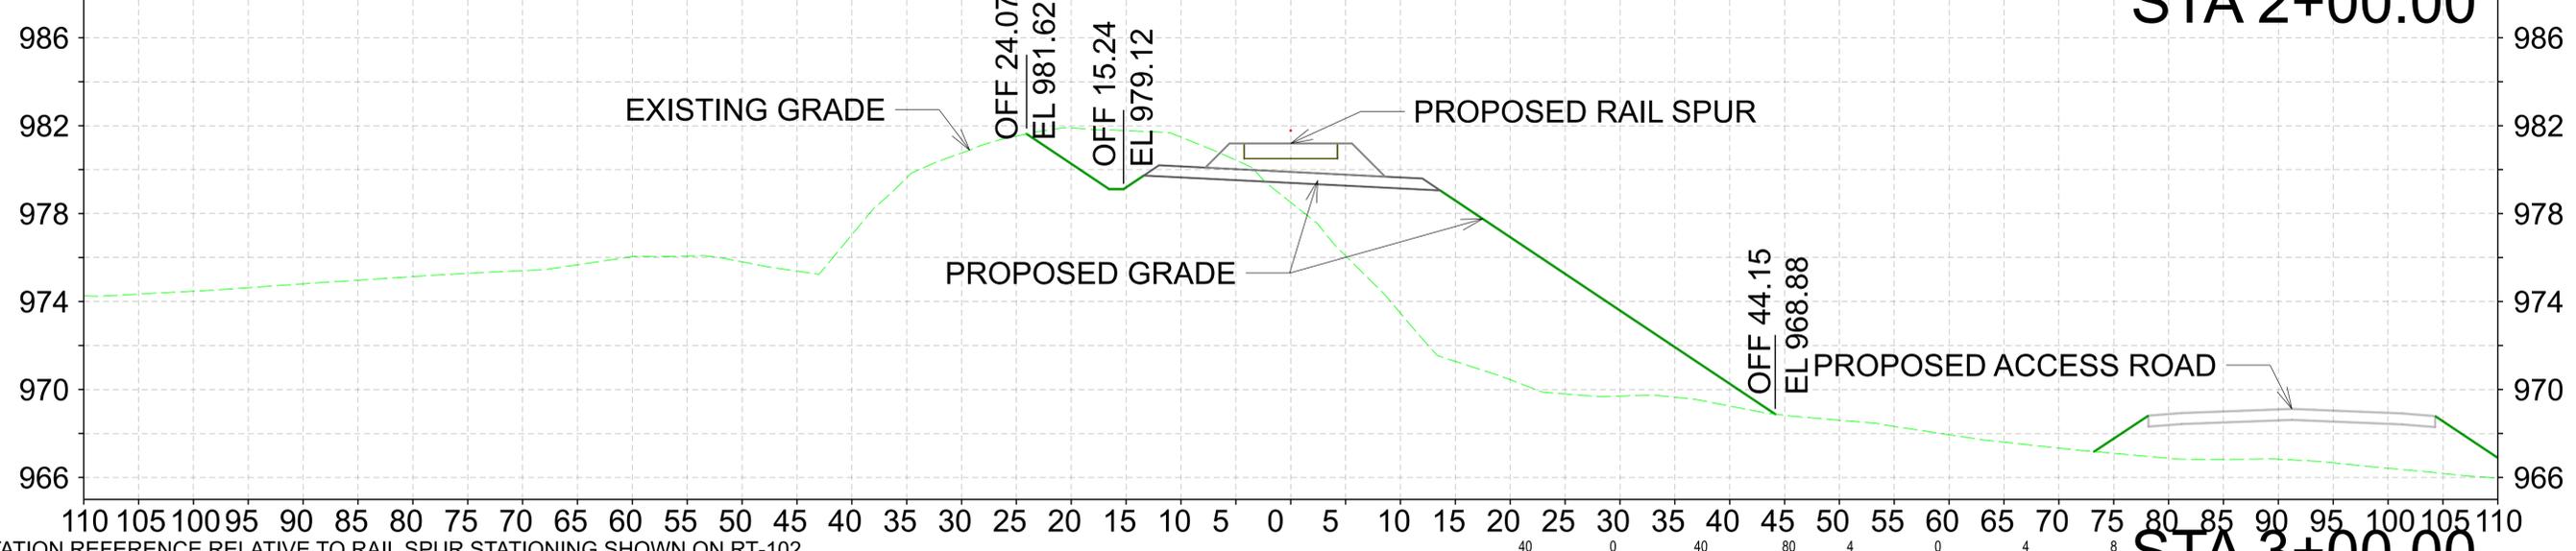
RT-103

NOTE: STATION REFERENCE RELATIVE TO RAIL SPUR STATIONING SHOWN ON RT-102.
HORIZONTAL SCALE RELATIVE TO PROPOSED TRACK CENTERLINE.

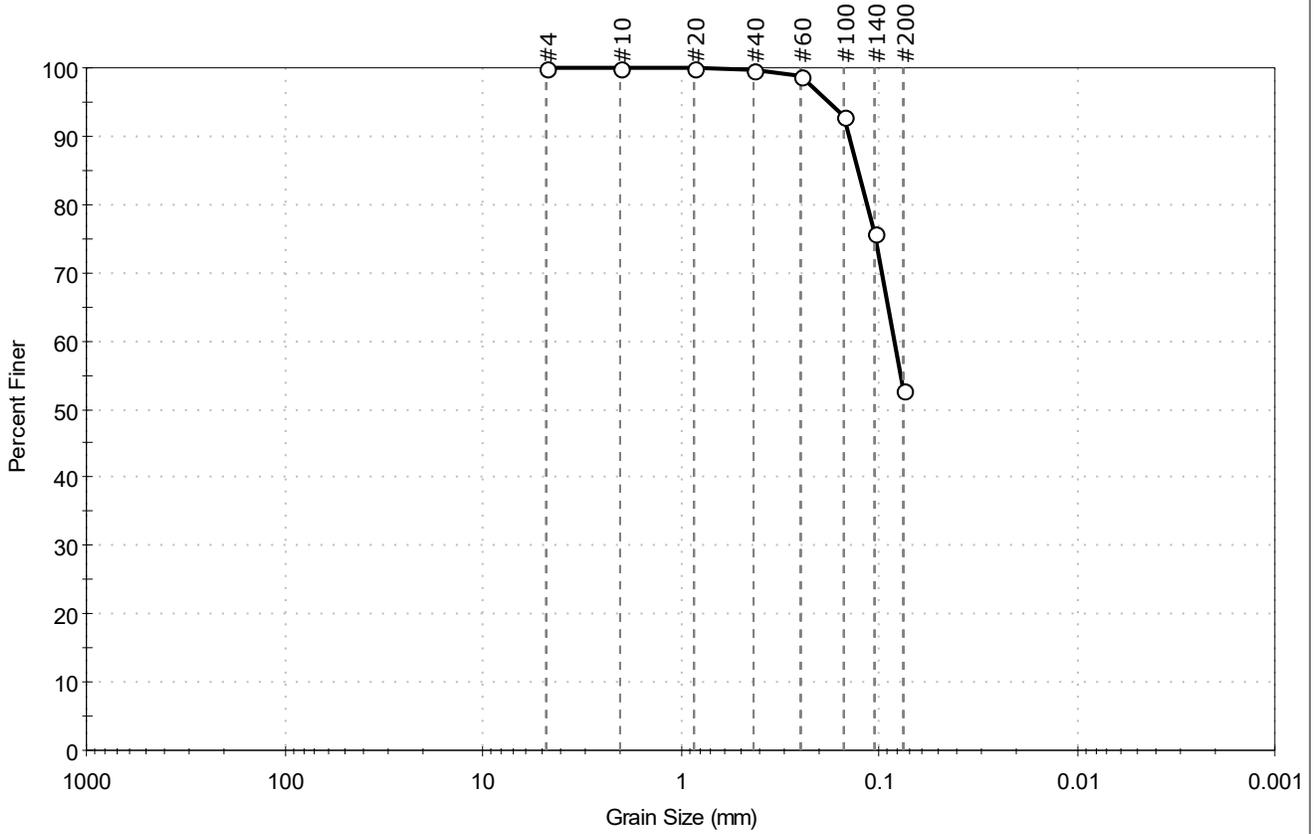
Particle Size Analysis - ASTM D6913

% Cobble	% Gravel	% Sand	% Silt & Clay Size
—	0.0	47.3	52.7

Sieve Name	Sieve Size, mm	Percent Finer	Spec. Percent	Complies
#4	4.75	100		
#10	2.00	100		
#20	0.85	100		
#40	0.42	100		
#60	0.25	99		
#100	0.15	93		
#140	0.11	76		
#200	0.075	53

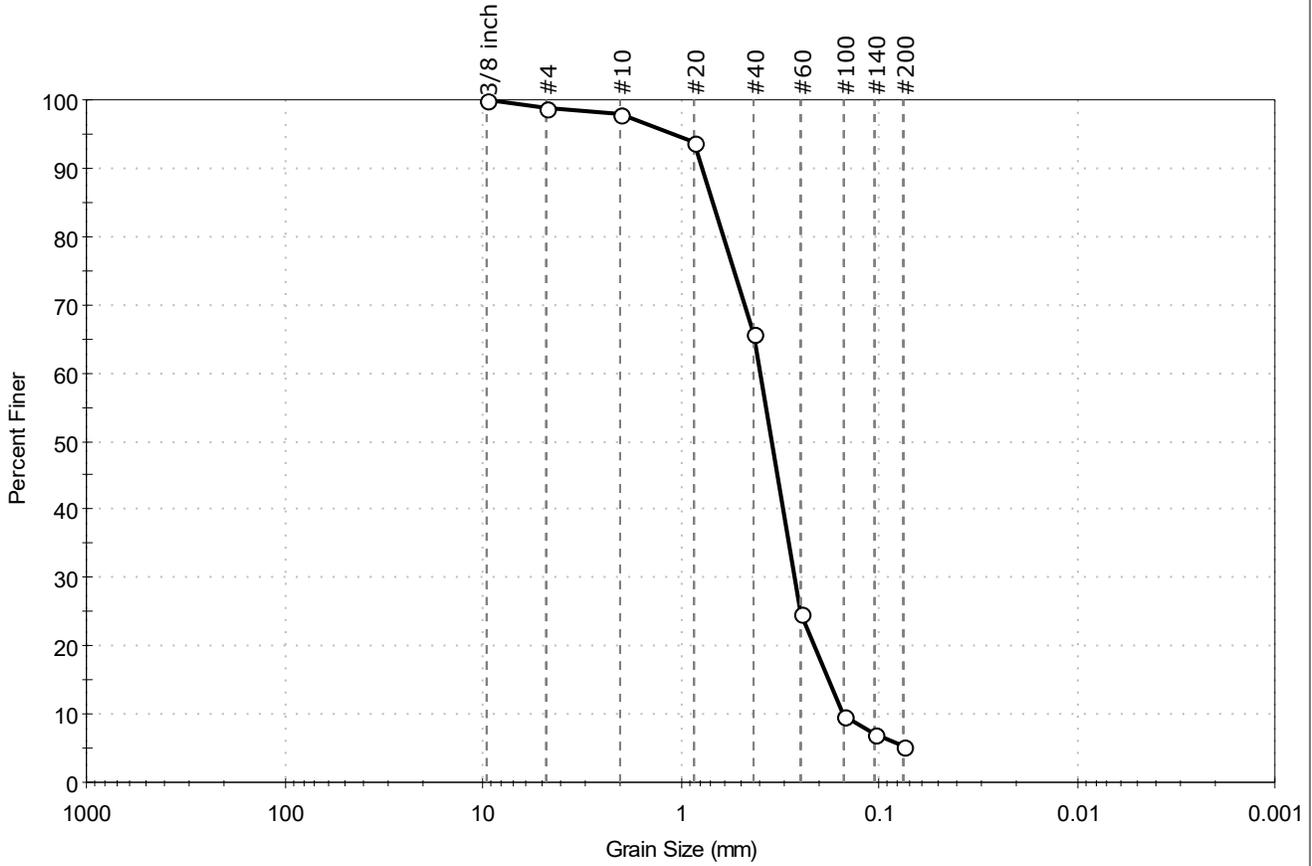
Particle Size Analysis - ASTM D6913

% Cobble	% Gravel	% Sand	% Silt & Clay Size
—	1.1	93.6	5.3

Sieve Name	Sieve Size, mm	Percent Finer	Spec. Percent	Complies
3/8 inch	9.50	100		
#4	4.75	99		
#10	2.00	98		
#20	0.85	94		
#40	0.42	66		
#60	0.25	25		
#100	0.15	10		
#140	0.11	7		
#200	0.075	5.3

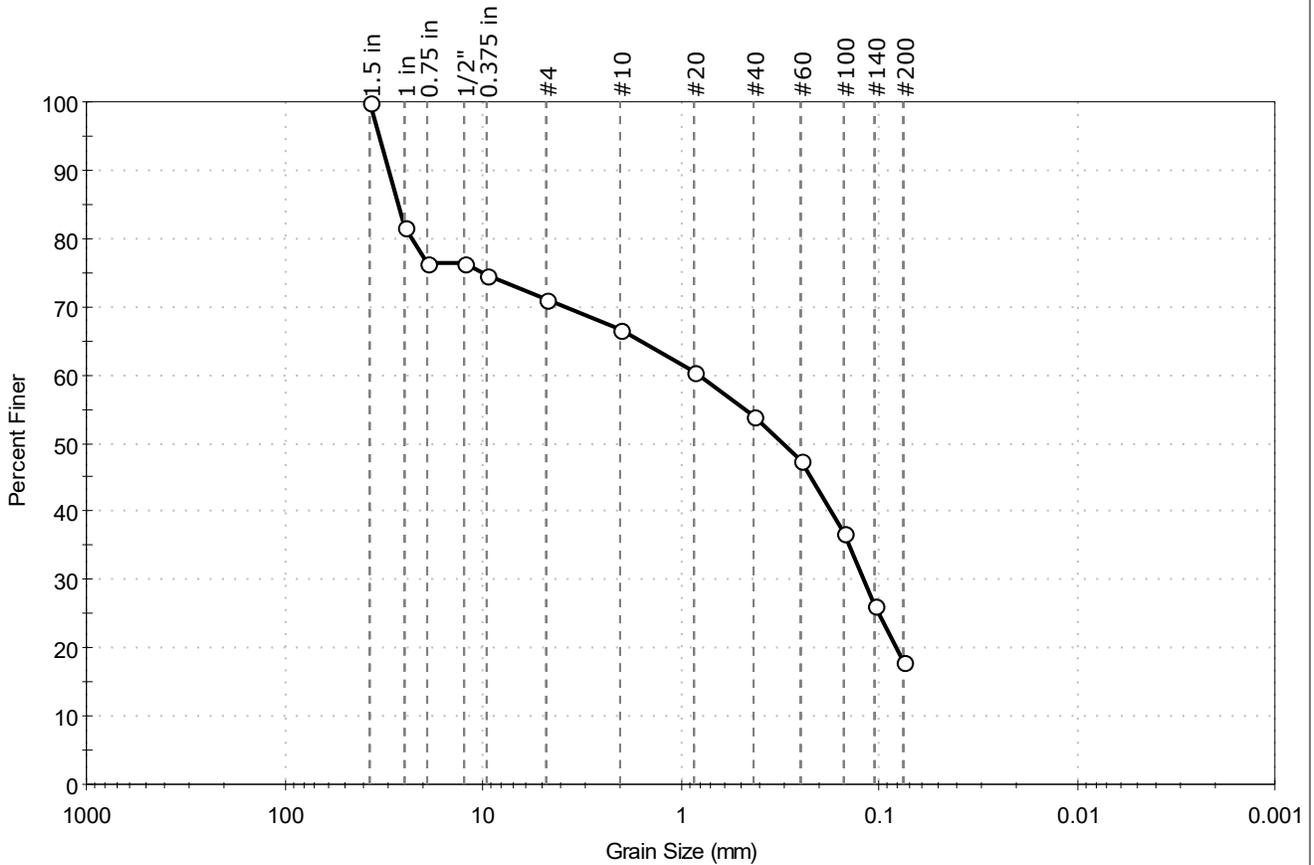
Particle Size Analysis - ASTM D6913

% Cobble	% Gravel	% Sand	% Silt & Clay Size
—	28.8	53.3	17.9

Sieve Name	Sieve Size, mm	Percent Finer	Spec. Percent	Complies
1.5 in	37.50	100		
1 in	25.00	82		
0.75 in	19.00	76		
1/2"	12.50	76		
0.375 in	9.50	75		
#4	4.75	71		
#10	2.00	67		
#20	0.85	61		
#40	0.42	54		
#60	0.25	47		
#100	0.15	37		
#140	0.11	26		
#200	0.075	18

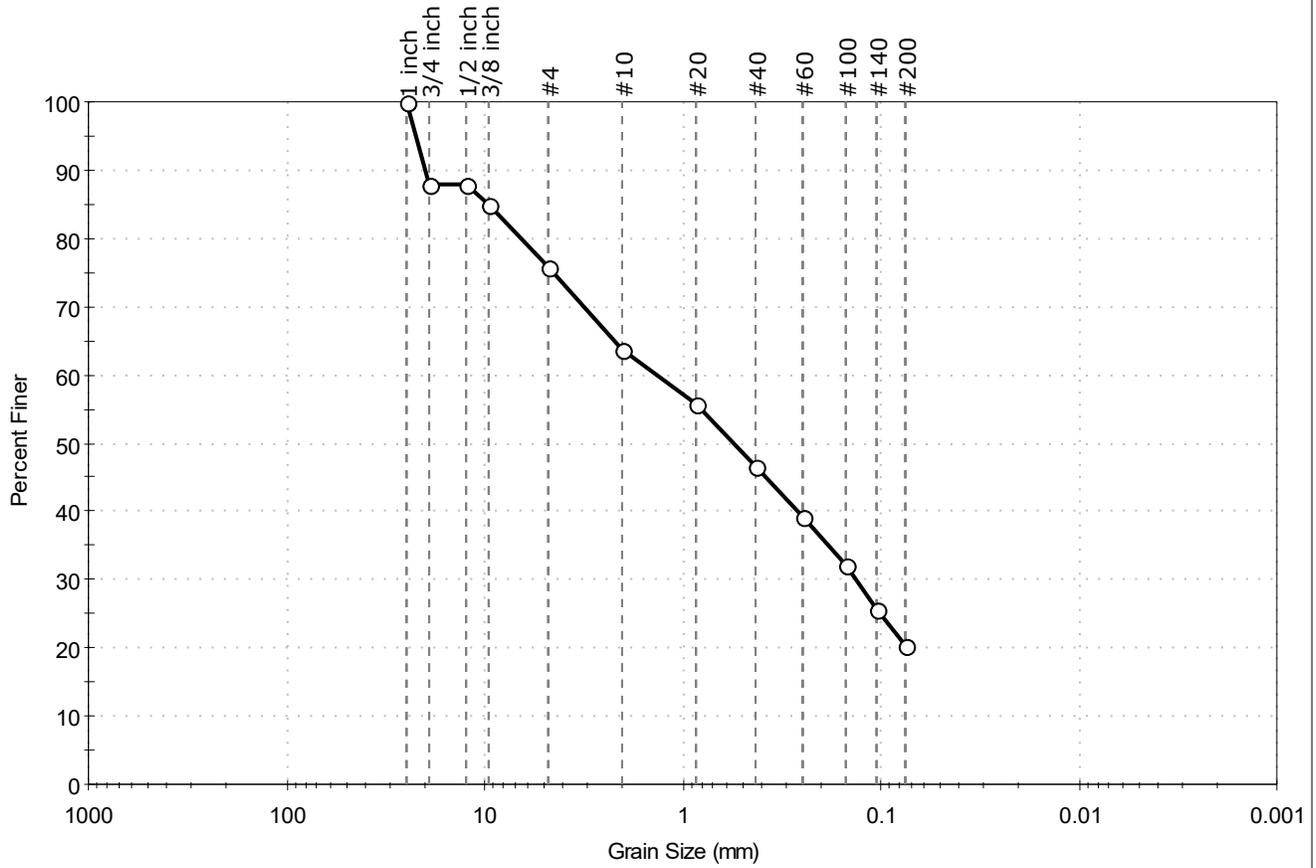
Particle Size Analysis - ASTM D6913

% Cobble	% Gravel	% Sand	% Silt & Clay Size
—	24.3	55.4	20.3

Sieve Name	Sieve Size, mm	Percent Finer	Spec. Percent	Complies
1 inch	25.00	100		
3/4 inch	19.00	88		
1/2 inch	12.50	88		
3/8 inch	9.50	85		
#4	4.75	76		
#10	2.00	64		
#20	0.85	56		
#40	0.42	47		
#60	0.25	39		
#100	0.15	32		
#140	0.11	26		
#200	0.075	20

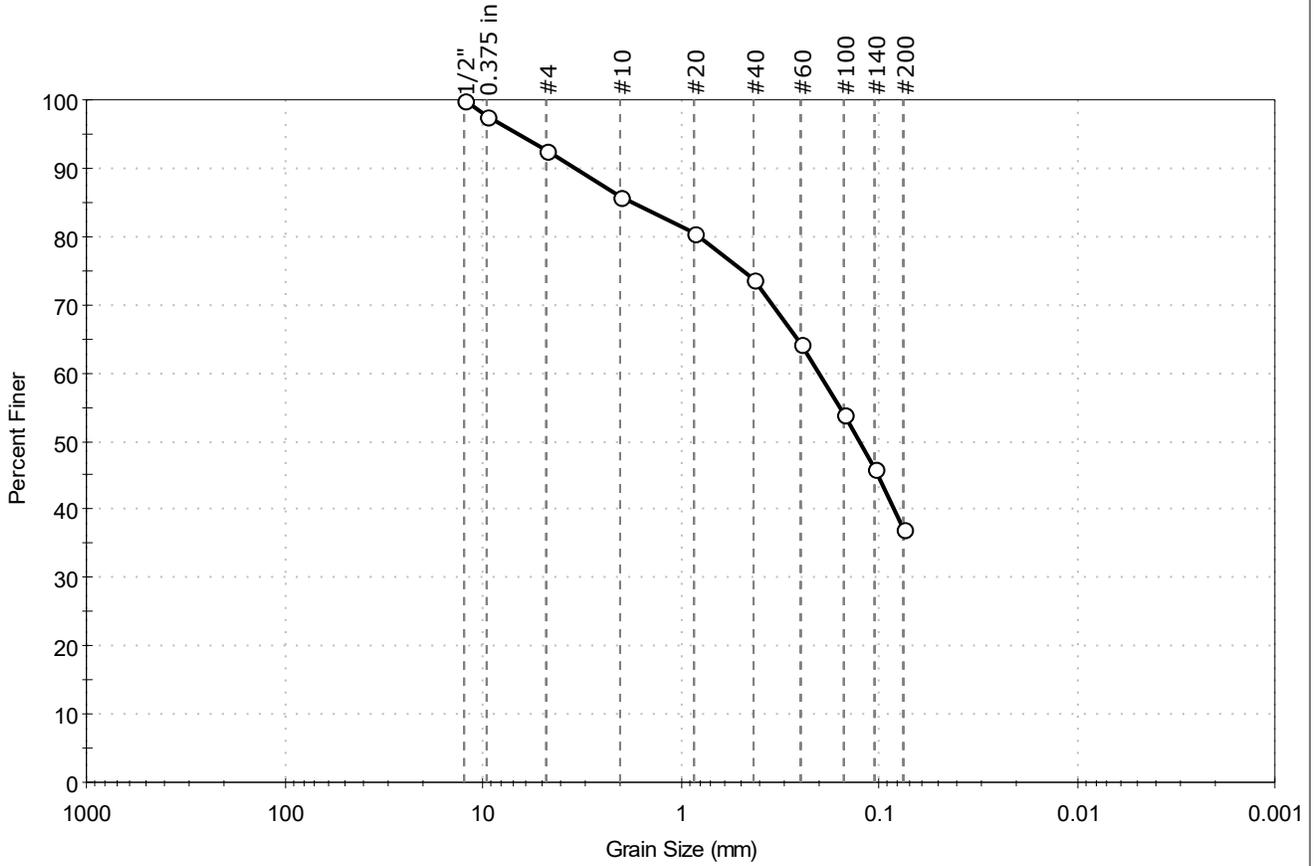
Particle Size Analysis - ASTM D6913

% Cobble	% Gravel	% Sand	% Silt & Clay Size
—	7.4	55.5	37.1

Sieve Name	Sieve Size, mm	Percent Finer	Spec. Percent	Complies
1/2"	12.50	100		
0.375 in	9.50	98		
#4	4.75	93		
#10	2.00	86		
#20	0.85	81		
#40	0.42	74		
#60	0.25	64		
#100	0.15	54		
#140	0.11	46		
#200	0.075	37

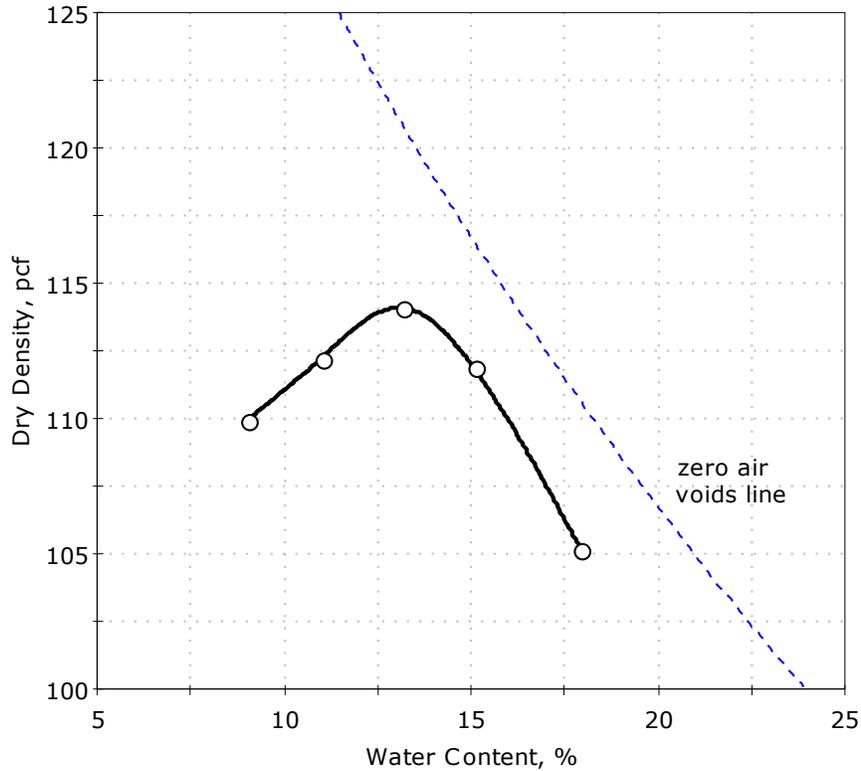
Compaction Report - ASTM D1557

Data Points	Point 1	Point 2	Point 3	Point 4	Point 5
Dry density, pcf	109.9	112.2	114.1	111.9	105.2
Moisture Content, %	9.0	11.0	13.2	15.1	17.9

Method : A

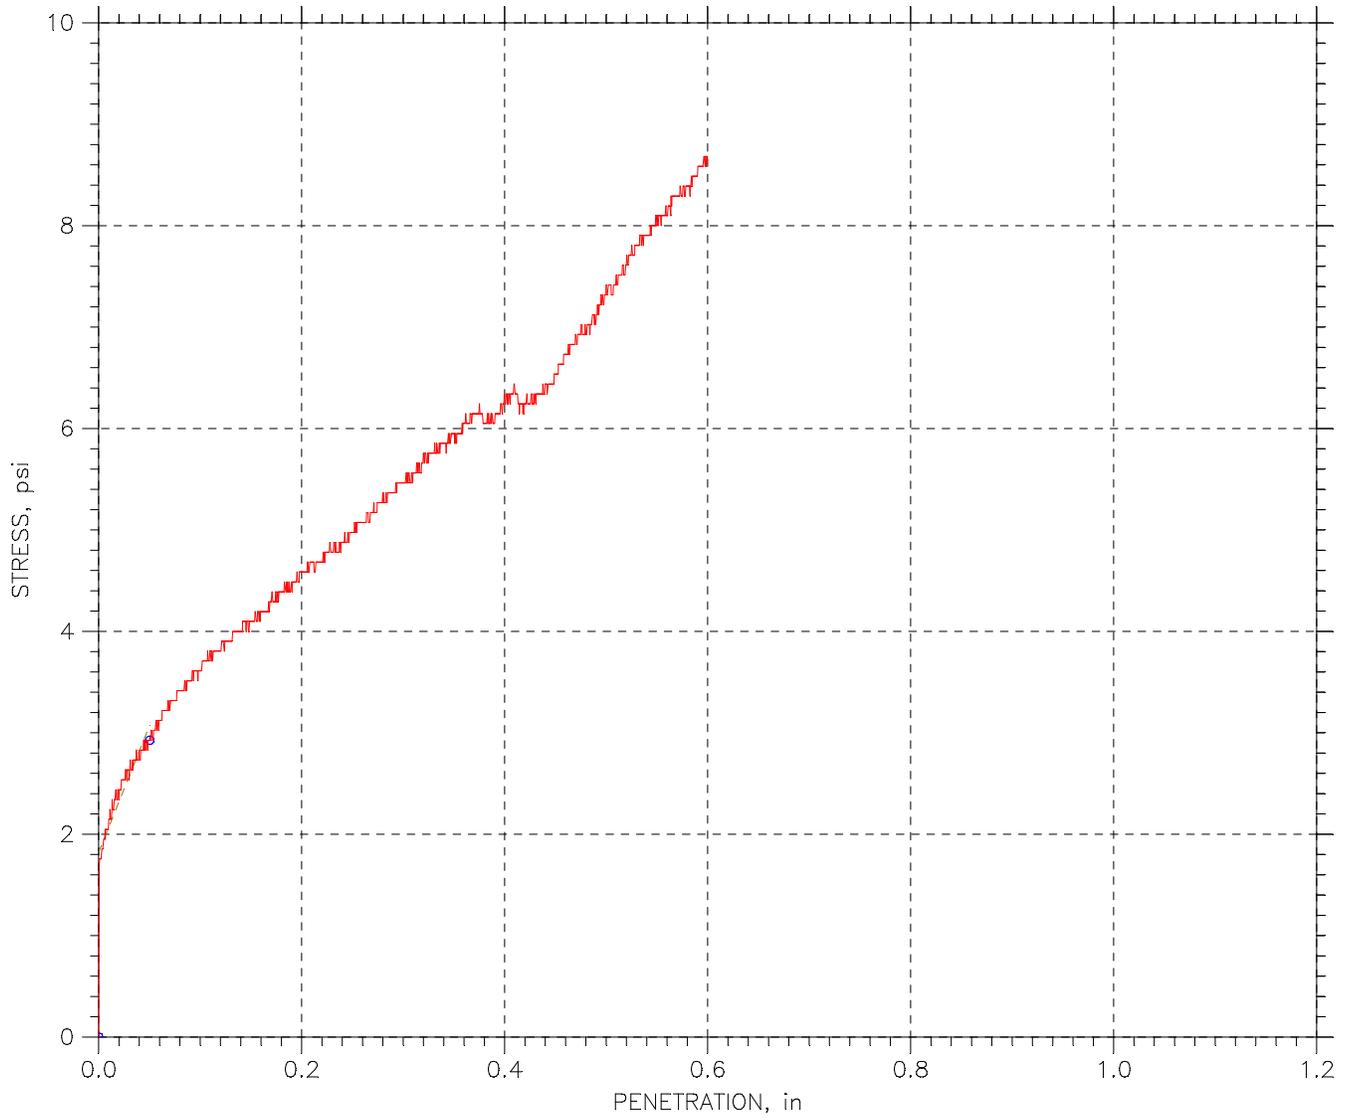
ASTM D1883

Sample Height: 4.58 in	California Bearing Ratio			
Sample Area: 28.274 in ²	at 0.1 in: 0	at 0.3 in: 0	at 0.5 in: 0	
Sample Volume: 0.07494 ft ³	at 0.2 in: 0	at 0.4 in: 0		
Sample Mass: 3736 gm				
Sample Condition: Soaked	Water Content	Before	Top	Average
Swell: -1.35 %	Tare ID	E14824	E15067	E15097
Surcharge: 4540 gm	Tare Mass, gm	8.25	8.27	8.37
Void Ratio: 0.70	Mass Tare + Wet Soil, gm	310.77	215.9	274.15
Wet Unit Weight: 109.91 pcf	Mass Tare + Dry Soil, gm	275.42	184.61	232.76
Dry Unit Weight: 97.065 pcf	Water Content, %	13.23	17.74	18.45
