**Re: GE-Pittsfield/Housatonic River Site
Rest of River (GECD850)
Conceptual Design Plan for Rail Transload Areas in Reaches 5 and 6**

Conceptual Design Plan for Rail Transload Areas in Reaches 5 and 6

**Housatonic River – Rest of River
Pittsfield, Massachusetts**

February 2026

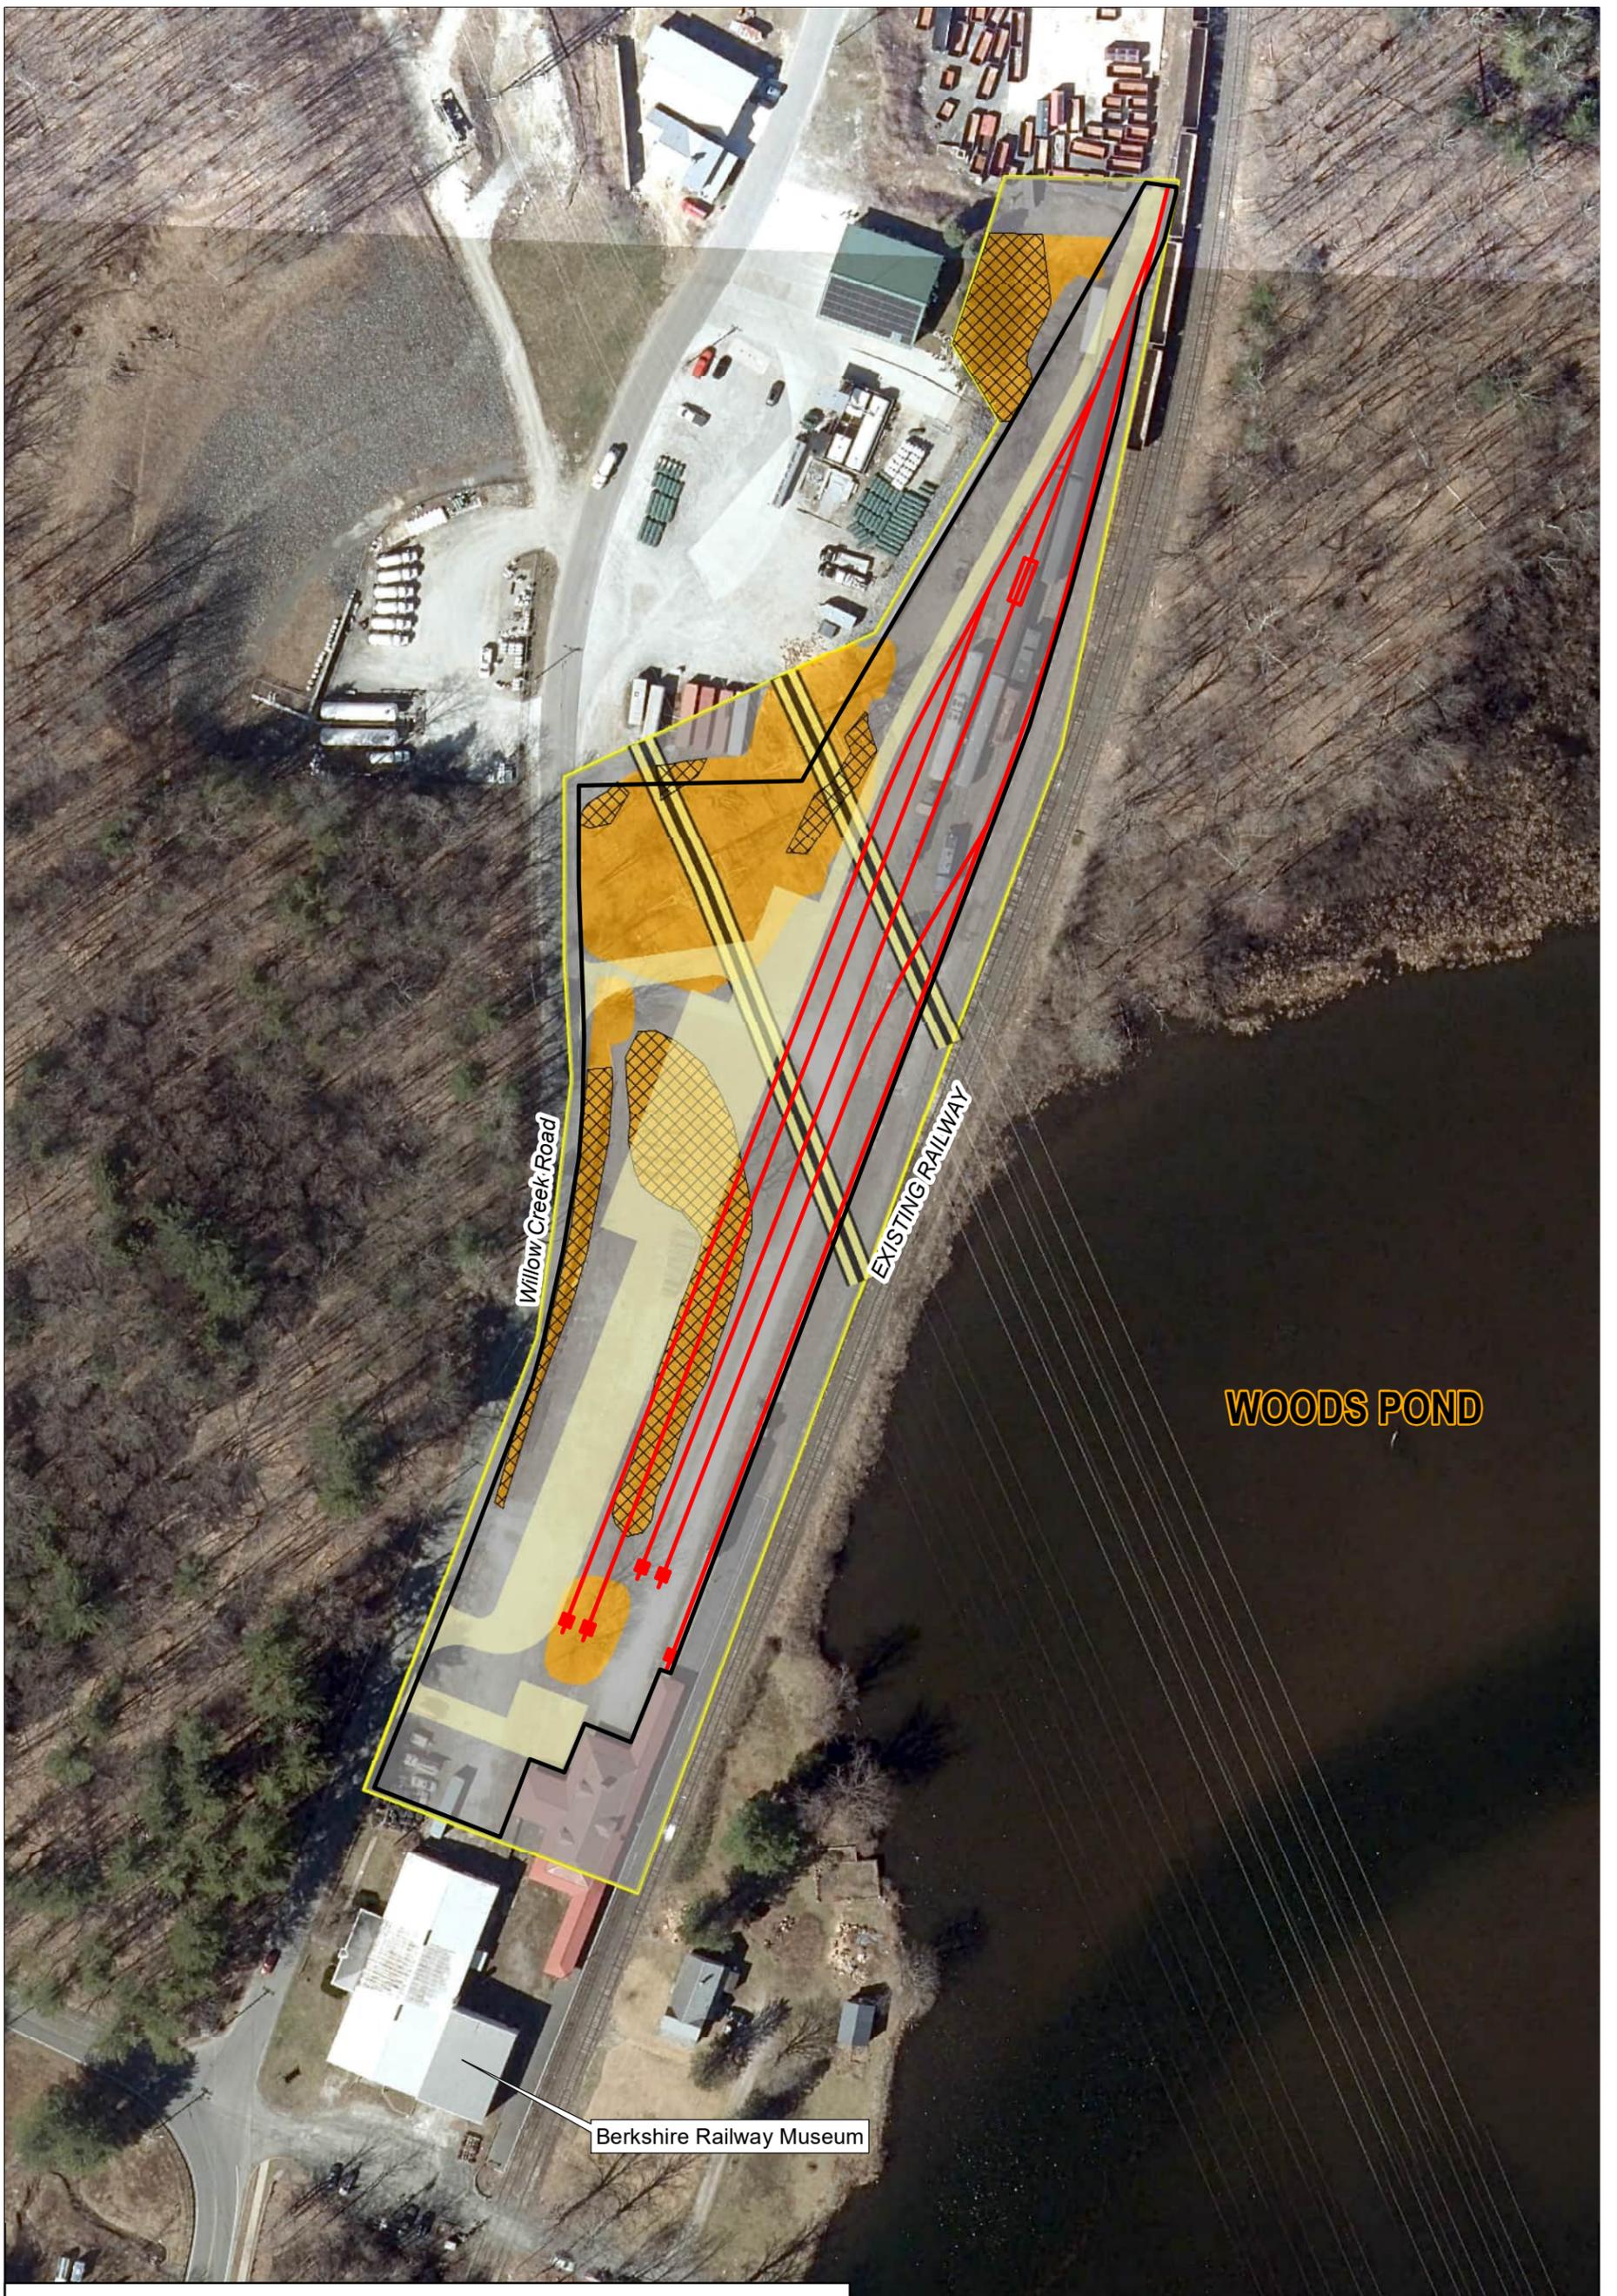
The resulting plant community cover maps are presented on **Figures 2 and 3** for the Utility Drive and Woods Pond Spur transload properties, respectively.

A total of eight different habitat cover types were mapped at the Utility Drive property following the DeGraaf and Yamasaki (2001) habitat classification system. The cover types identified are summarized in **Table 2** and shown on **Figure 2**.

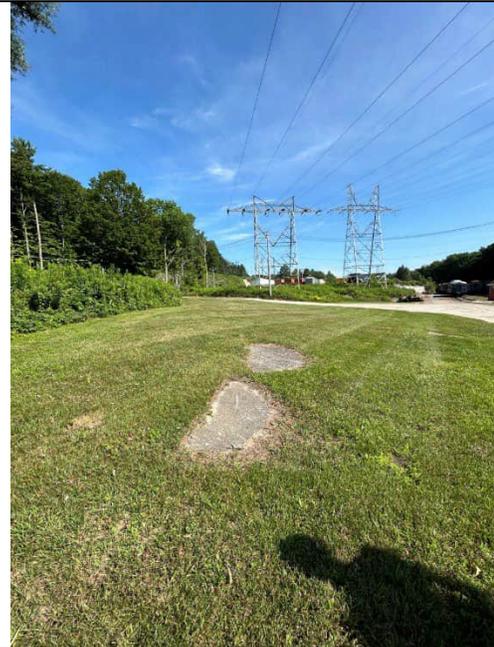
Photo No. 29	Date: 7/30/2025	Photo No. 30	Date: 7/30/2025
Description: Woods Pond Transload Site southern portion view north.		Description: Woods Pond Transload Site photo taken from the central portion viewing north of utility structures and overhead line located in the northern portion of the site.

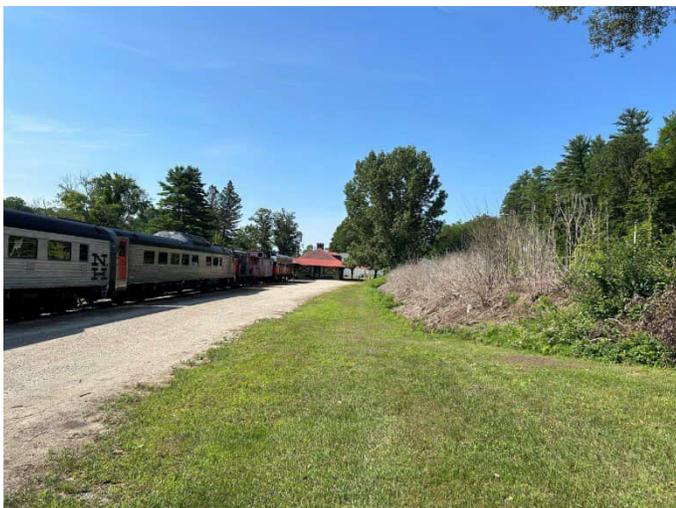
Photo No. 31	Date: 7/30/2025	Photo No. 32	Date: 7/30/2025
Description: Woods Pond Transload Site central portion view south of non-vegetated cover type (gravel access road and hardpacked low groundcover with herbaceous, Upland Field cover type at the right of photo.		Description: Woods Pond Transload Site northern portion view north of non-vegetated gravel access adjacent to railroad tracks.

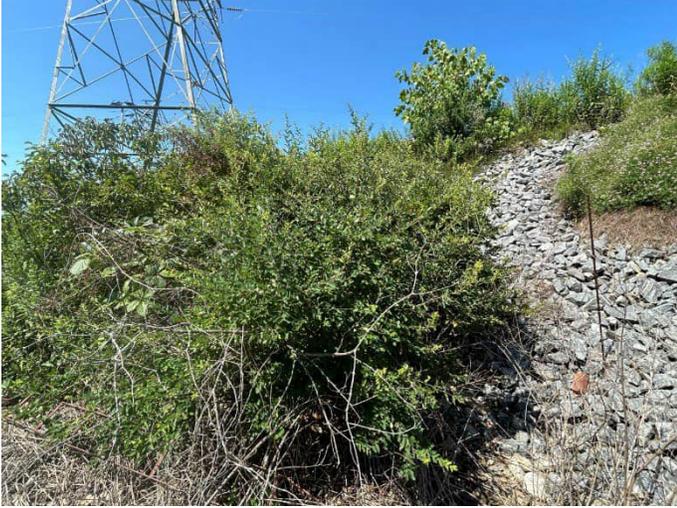
Photo No. 33	Date: 7/30/2025	Photo No. 34	Date: 7/30/2025
Description: Woods Pond Transload Site northern portion view southwest of steep slope transition between railroad tracks gravel access road and utility structures. Invasive honeysuckle (<i>Lonicera morrowii</i>) patch.		Description: Woods Pond Transload Site central portion view east of shrub hedgerow, at the site’s western border and adjacent to Willow Creek Road. Weeping willow (<i>Salix babylonica</i>).

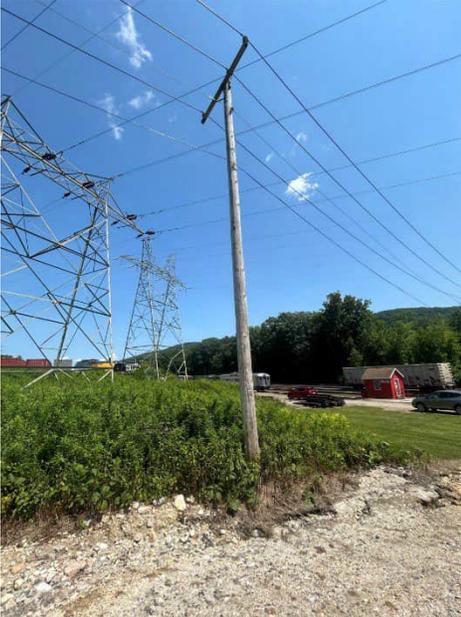
Photo No. 35	Date: 7/30/2025	Photo No. 36	Date: 7/30/2025
Description: Woods Pond Transload Site central portion view west. Patch of milkweed (<i>Asclepias</i> sp.).		Description: Woods Pond Transload Site northern portion, new north of utility ROW and hardpack gravel access road in the northern portion of the site.

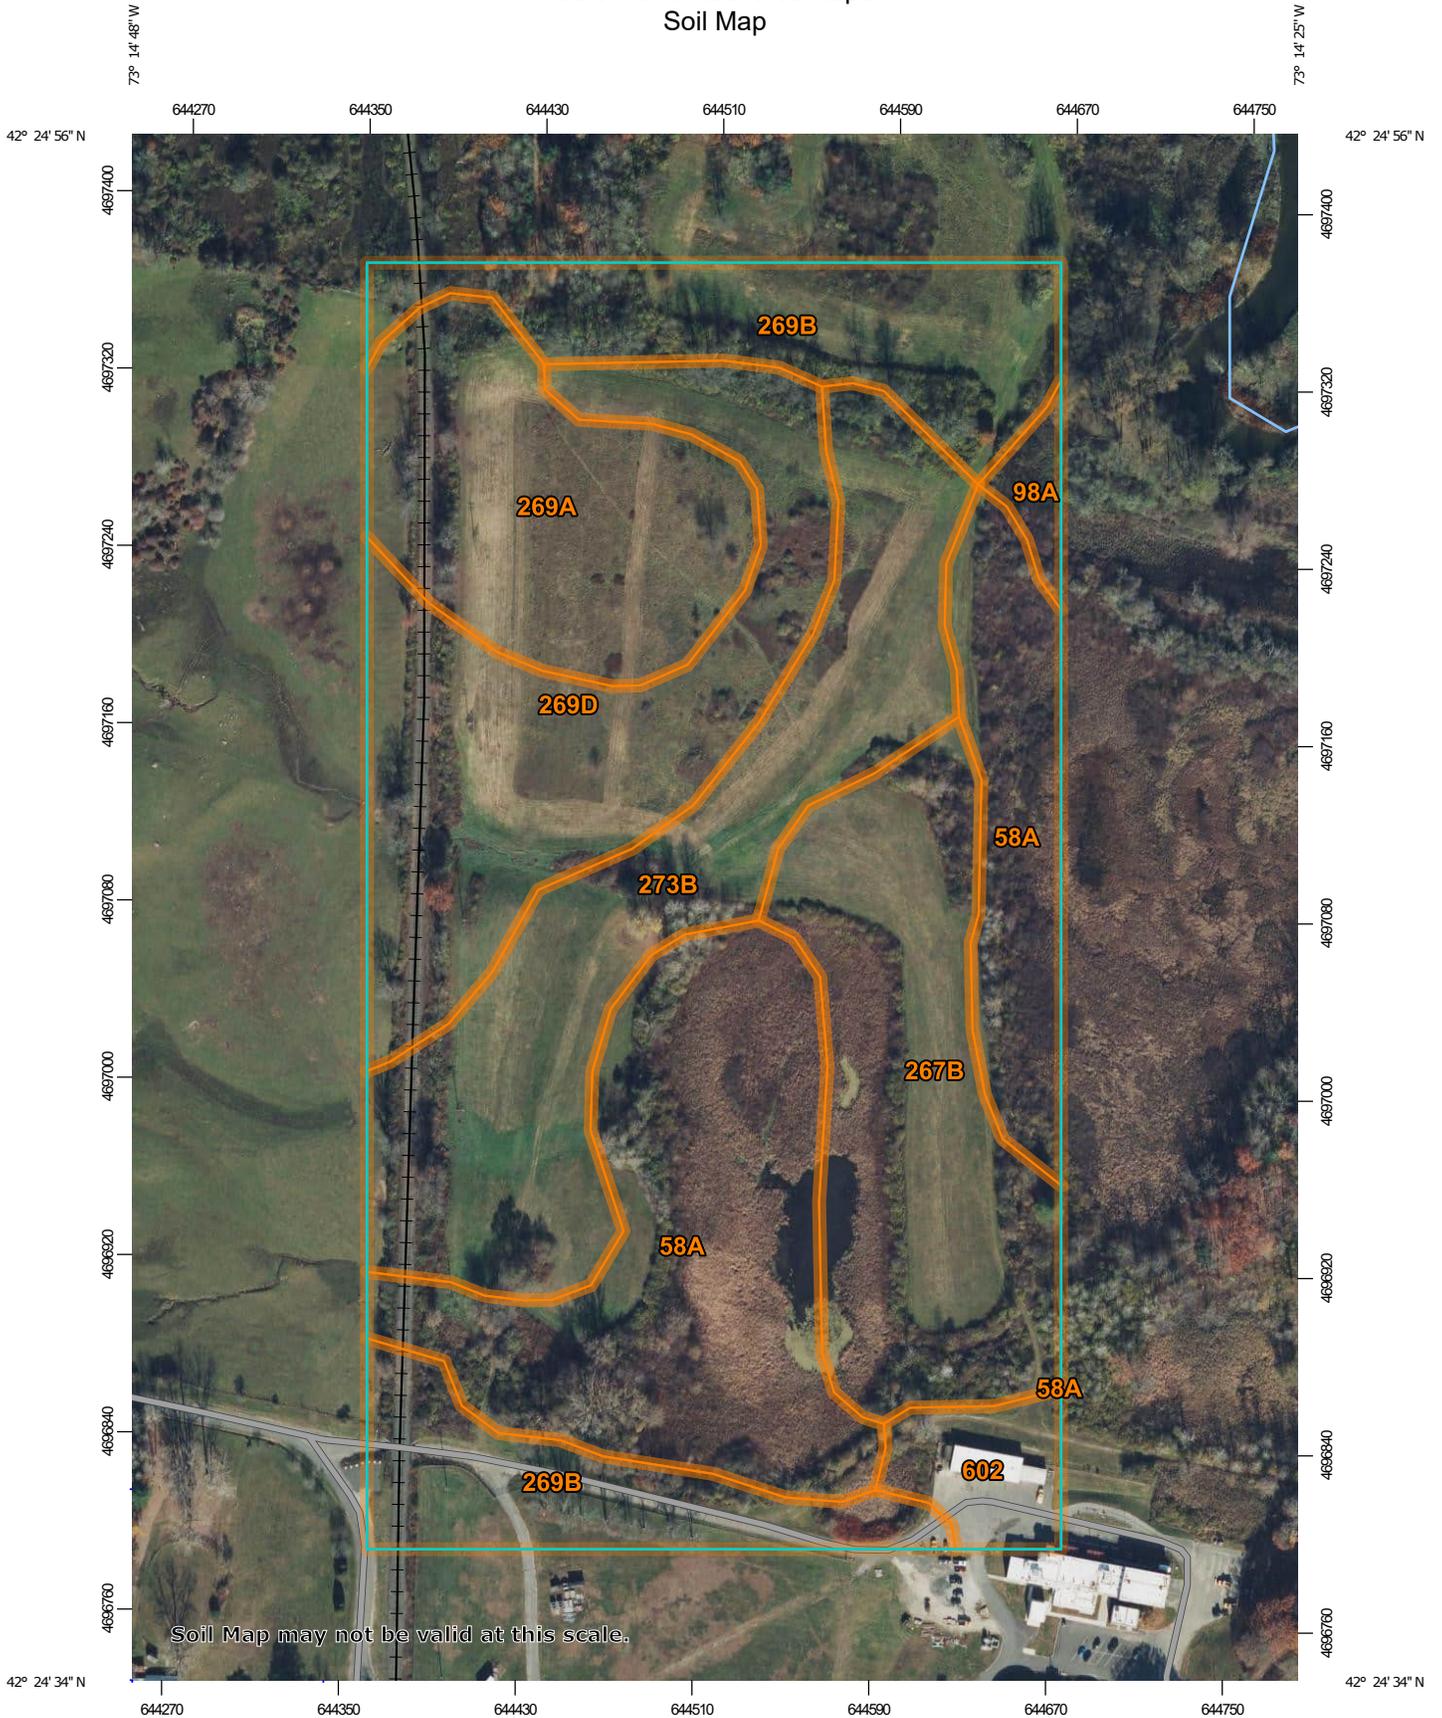
Custom Soil Resource Report Soil Map

The soil map section includes the soil map for the defined area of interest, a list of soil map units on the map and extent of each map unit, and cartographic symbols displayed on the map. Also presented are various metadata about data used to produce the map, and a description of each soil map unit.

Map Scale: 1:3,400 if printed on A portrait (8.5" x 11") sheet.

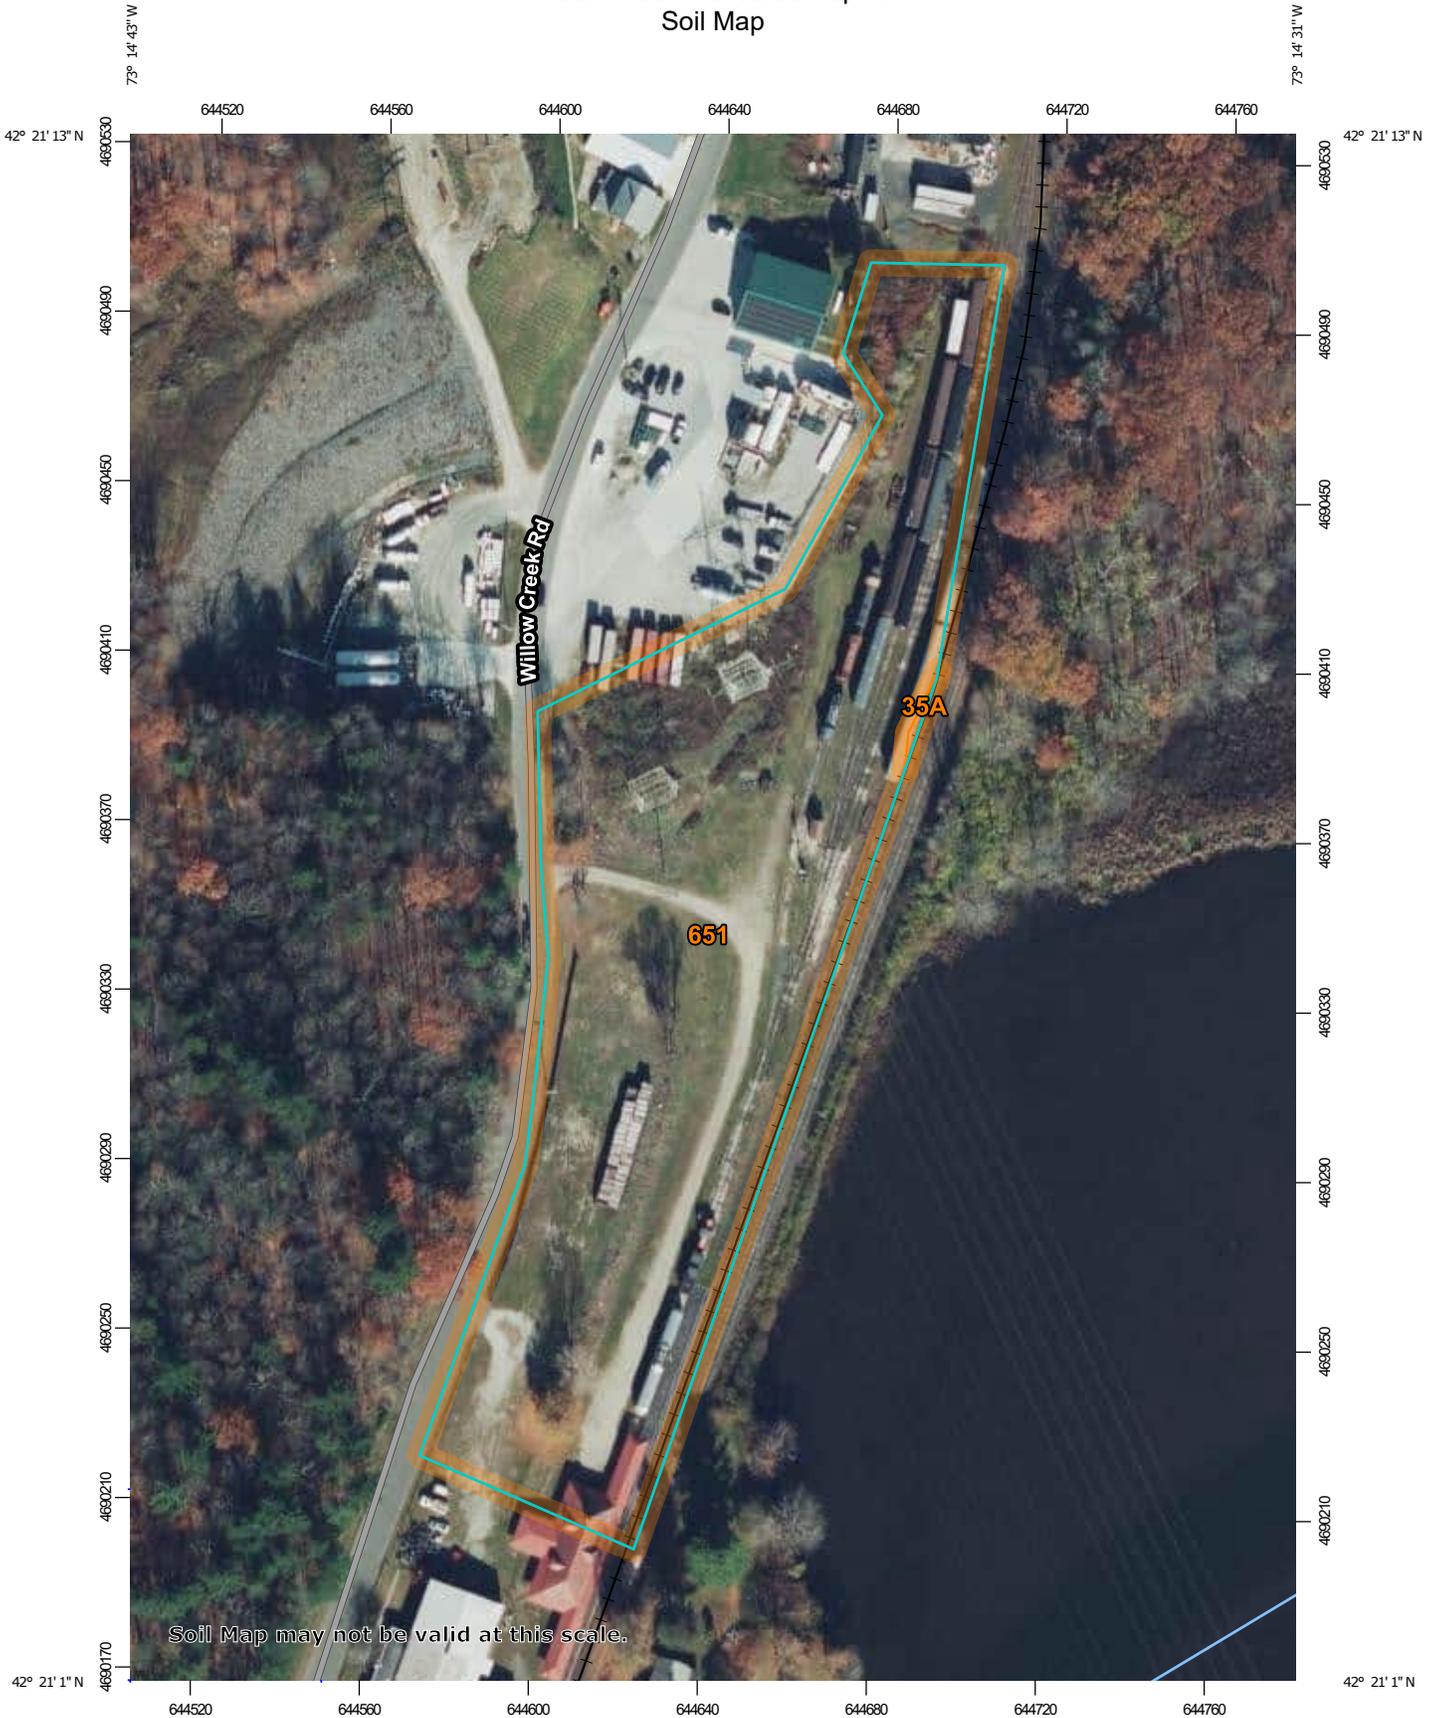
Custom Soil Resource Report Soil Map

The soil map section includes the soil map for the defined area of interest, a list of soil map units on the map and extent of each map unit, and cartographic symbols displayed on the map. Also presented are various metadata about data used to produce the map, and a description of each soil map unit.

Map Scale: 1:1,780 if printed on A portrait (8.5" x 11") sheet.

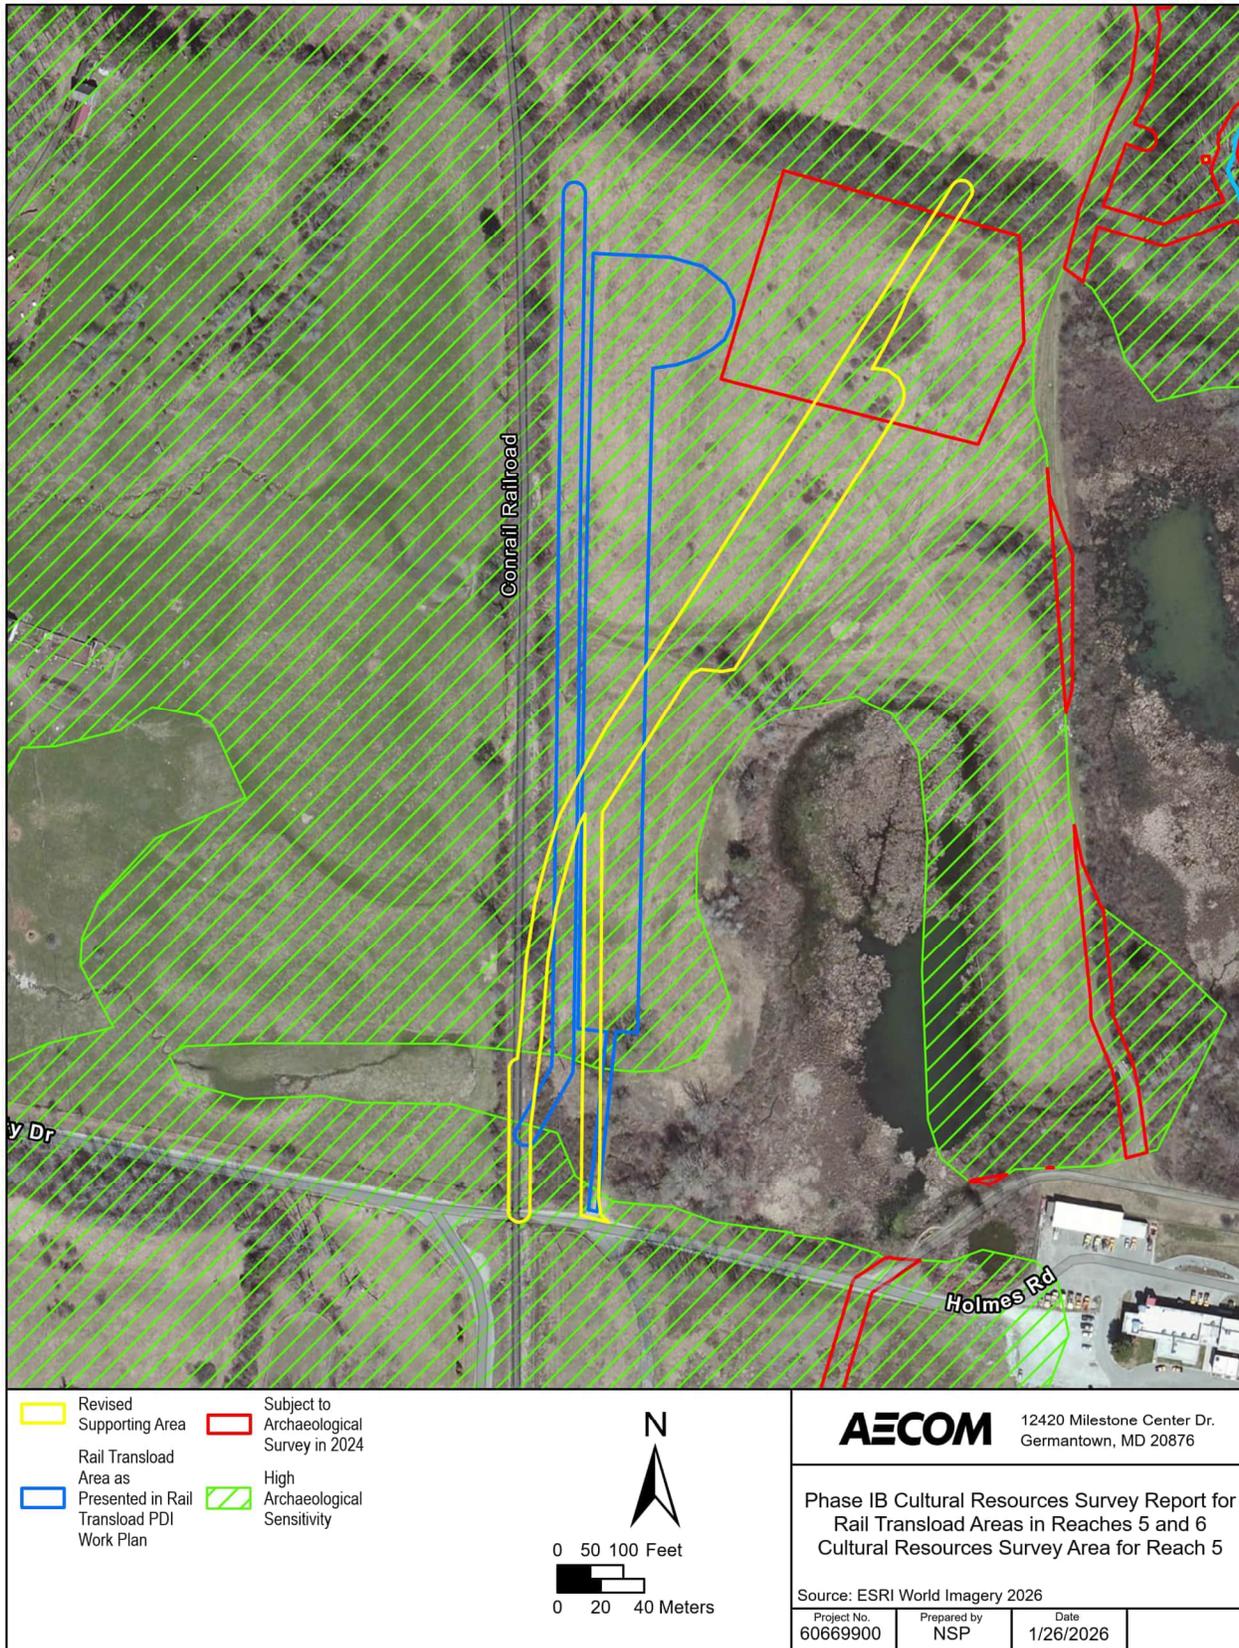
Figure 1.1: Utility Drive Transload Area for Cultural Resource Survey.

On GE's behalf, AECOM conducted the Phase IB CRS activities at the Utility Drive and Woods Pond Spur rail transload areas (as shown in Figures 1.1. and 1.2) in July 2025. This report presents the results of the Utility Drive area survey, and it summarizes the results of the Woods Pond Spur area survey, which have already been presented in more detail in the Reach 6 CRS Report, which was submitted on January 22, 2026. In the meantime, the configuration of both of these rail transload areas has been revised and expanded and will require additional survey activities for potential cultural resources. A proposal for such additional CRS activities in the expanded portions of these rail transload areas is presented in Section 6 of this report.

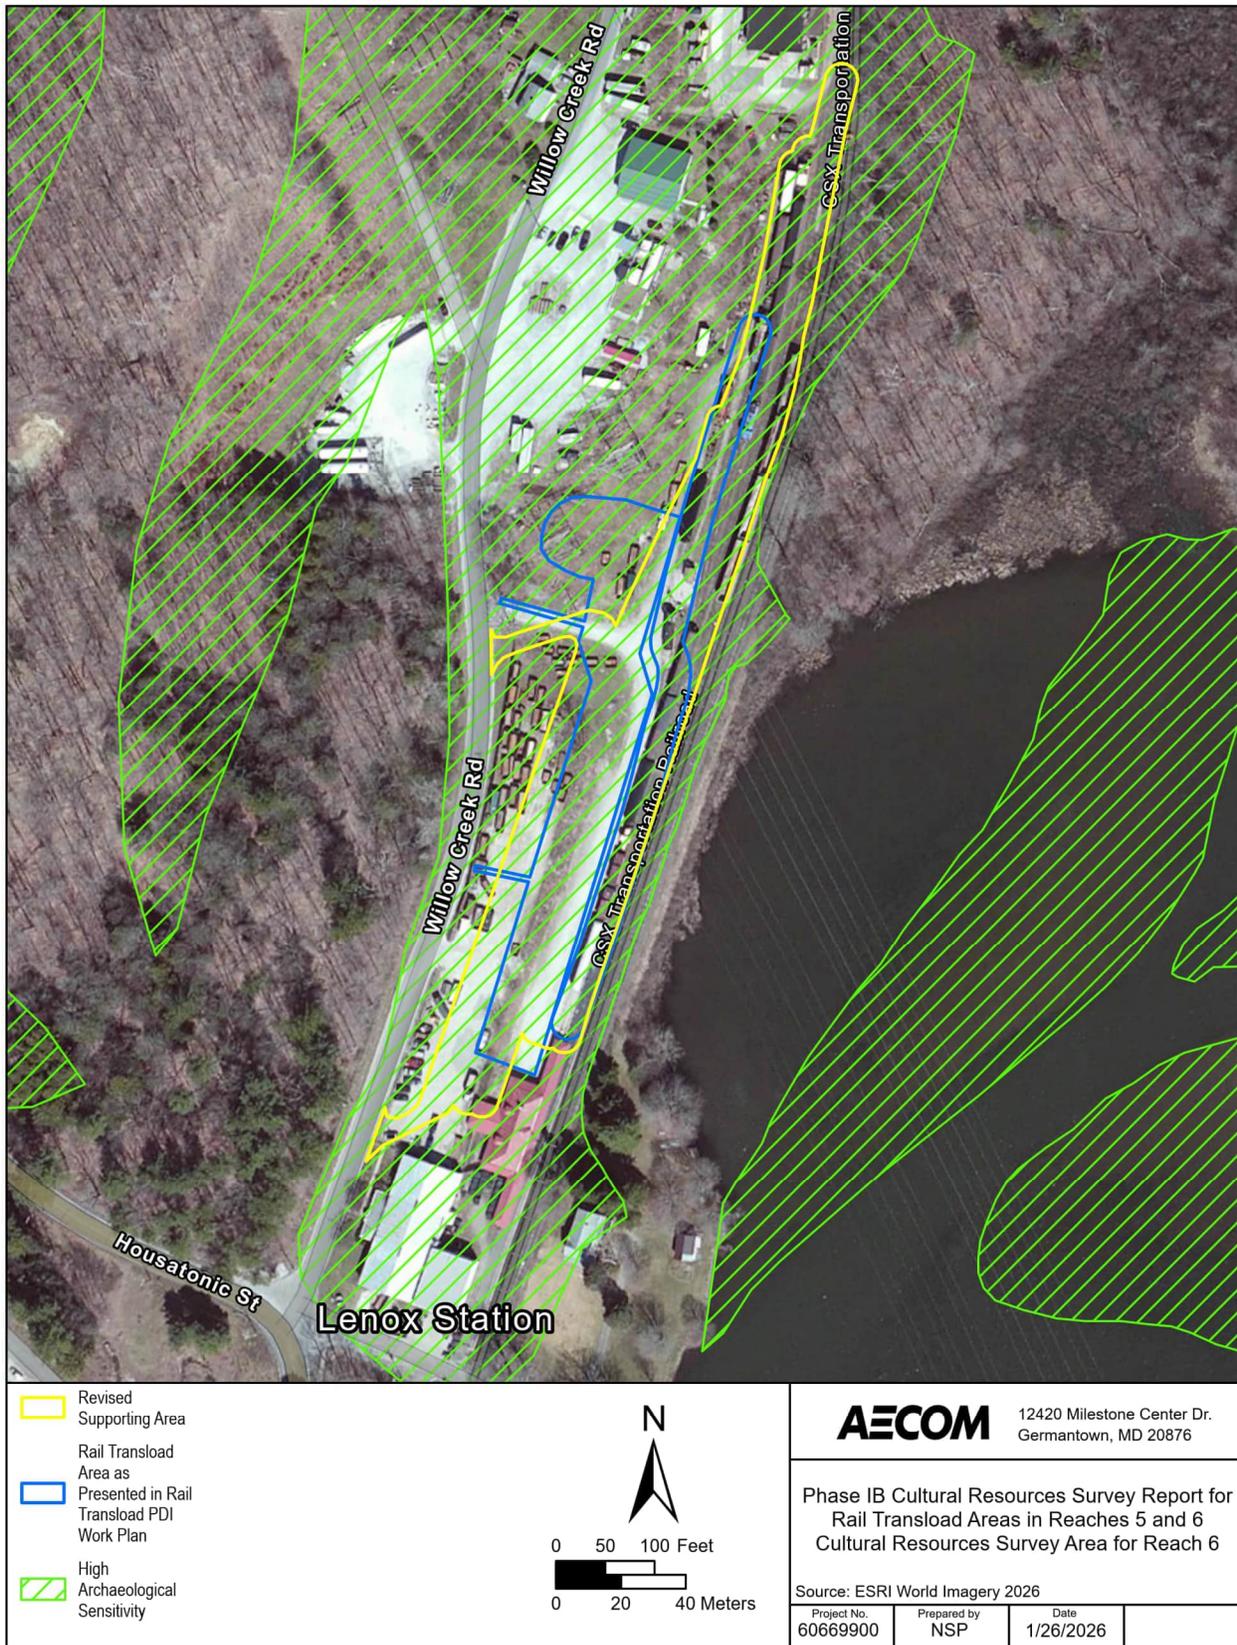
Figure 1.2: Woods Pond Spur Transload Area for Cultural Resource Survey.

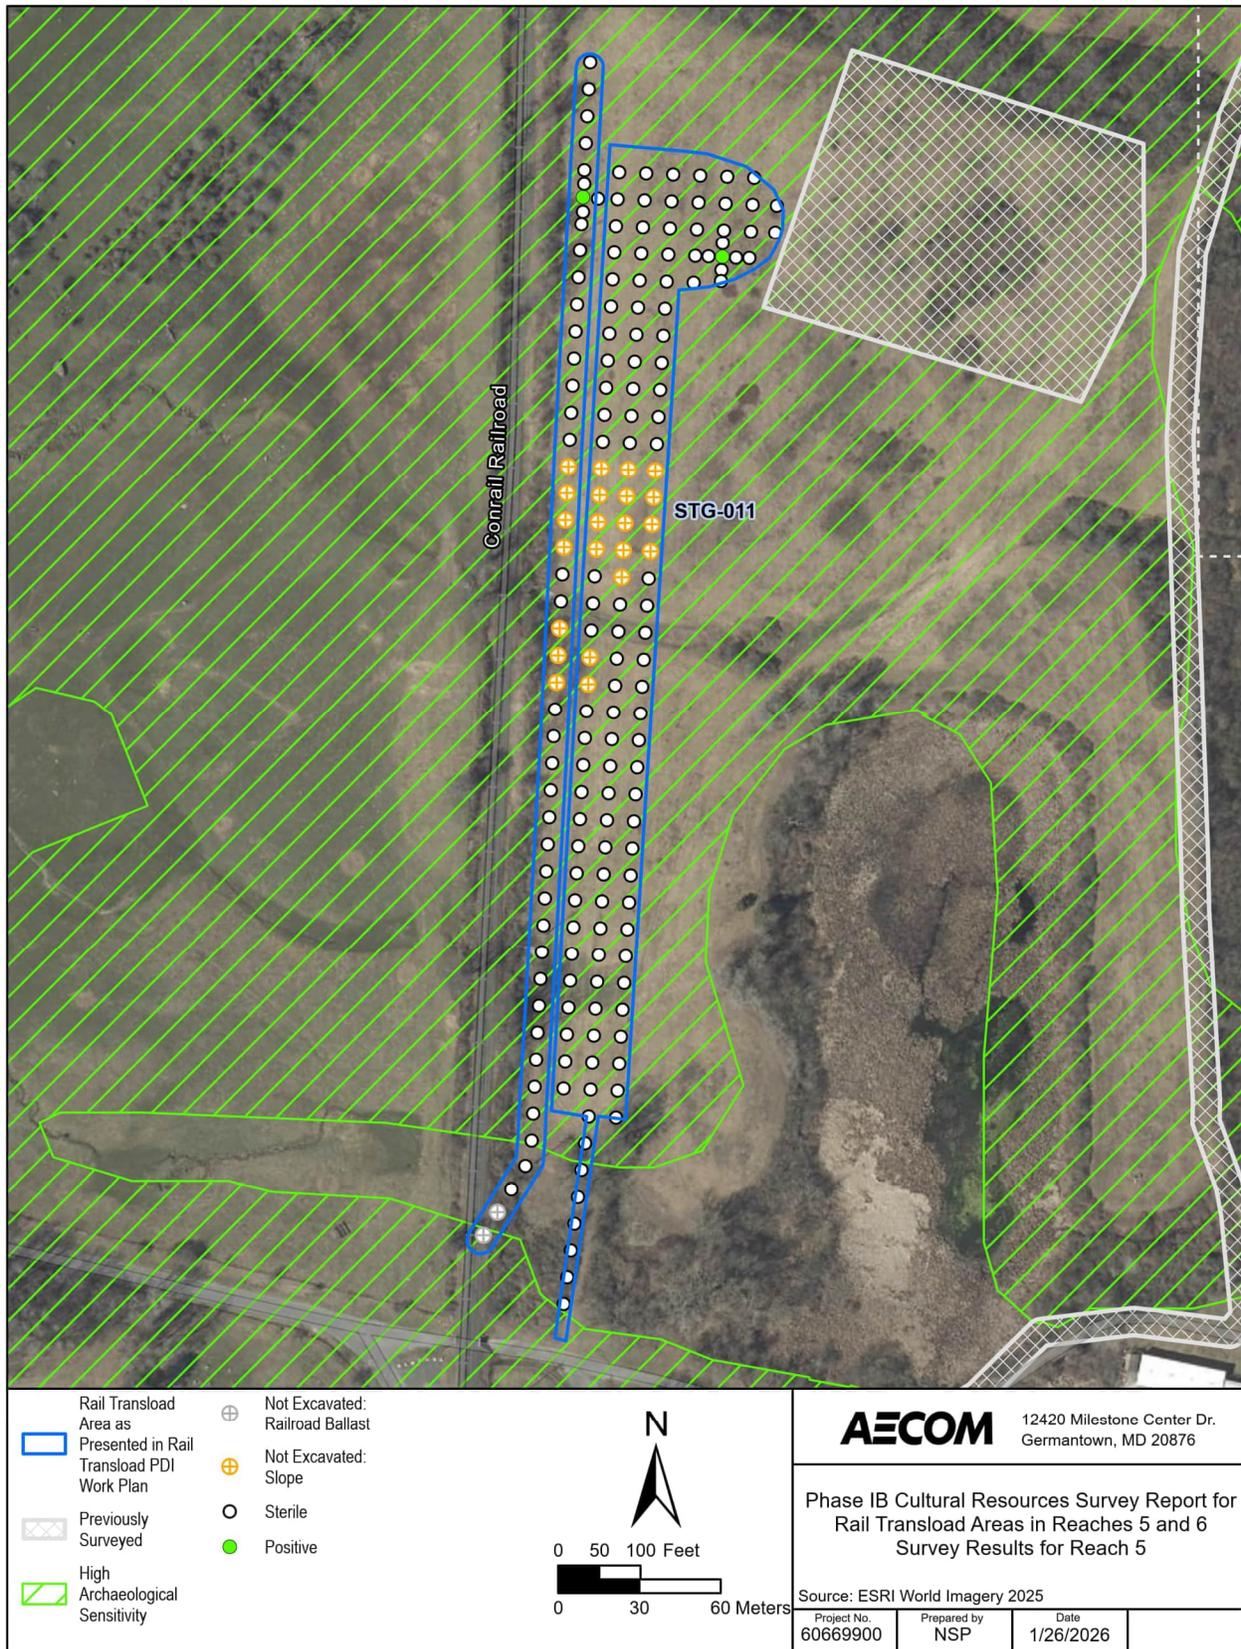
Figure 3.1: Survey Coverage Map for Utility Drive Rail Transload Area.

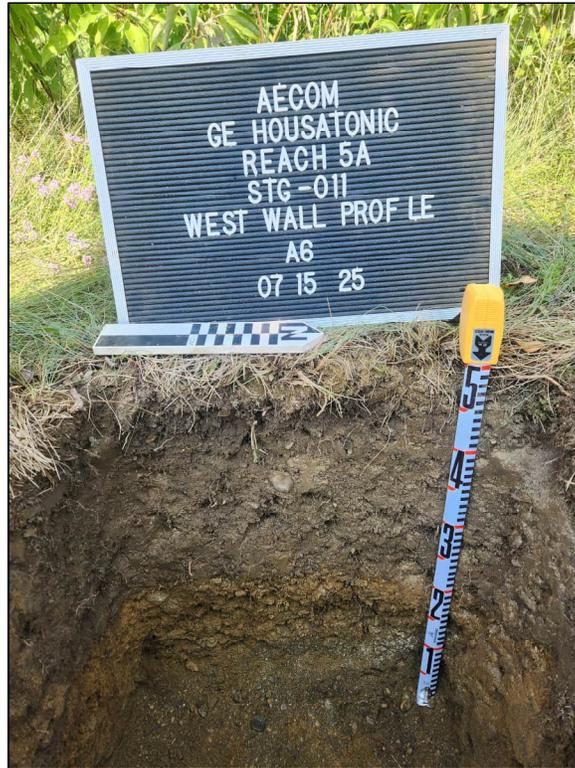
Photograph 3.5: STG-011 west profile of STP A6.

STPs exhibited variable stratigraphy and included areas of deflated Ap horizons, relatively shallow stratified soil sequences, colluvial deposits, and deep A horizons overlying a poorly drained or scoured subsoil. STPs that exhibited a deflated Ap horizon typically consisted of a 0.25-meter (0.82-foot) thick brown (10YR 4/3) sandy loam Ap horizon overlying an olive brown (2.5Y 4/3) coarse sand C horizon (Photograph 3.5). STPs revealing a shallow stratified soil sequence typically consisted of 0.3-meter (0.98-foot) thick brown (10YR 4/3) sandy loam Ap horizon overlying a dark yellowish brown (10YR 4/6) sandy loam Bw horizon and terminating at a light olive brown (2.5Y 5/4) coarse sand C horizon (Photograph 3.6, Figure 3.2). Colluvial deposits are typified by STP A21, which included three strata. Stratum I extended to 0.40 meters (1.31 feet) below ground surface (bgs) and was a very dark gray (10YR 3/1) sandy loam A1 horizon with 20 percent subangular gravel. Stratum II extended to 0.65 meters (2.13 feet) bgs and was a dark brown (10YR 3/3) sandy loam A2 horizon with 20 percent subangular gravel. Stratum III was excavated to 1.02 meters (3.34 feet) bgs and was a very dark brown (10YR 2/2) mixed with a brown (10YR 4/3) sandy loam A3 horizon with 20 percent subangular gravel (Photograph 3.7, Figure 3.2). STPs with deep A horizons overlying a poorly drained and or scoured subsoil typically consisted of 0.15-meter (0.49-foot) thick brown (10YR 4/3) sandy loam A1 horizon overlying a brown (10YR 3/2) mixed with an olive brown (2.5Y 4/3) A2 horizon with minor scouring terminating at an olive brown (2.5Y 4/3) mixed with a gray (2.5Y 5/1) C horizon with coarse sand inclusions (Photograph 3.8).

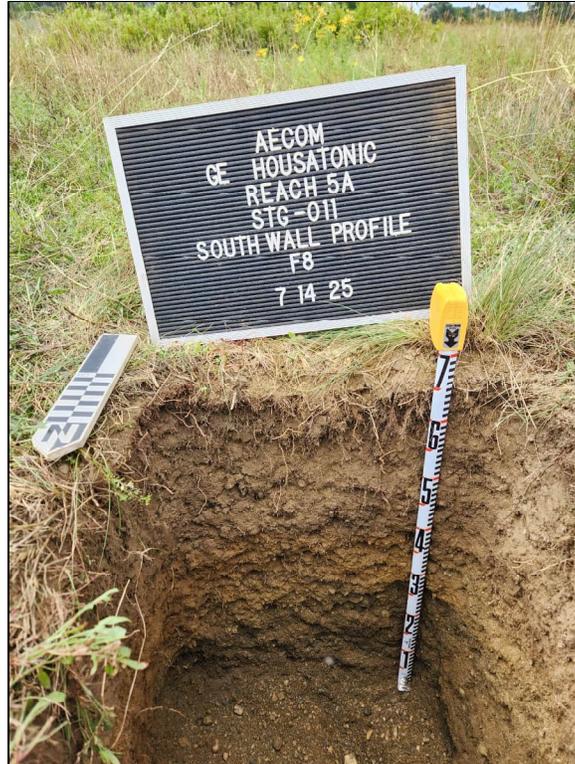
Photograph 3.6: STG-011 south profile of STP F8.

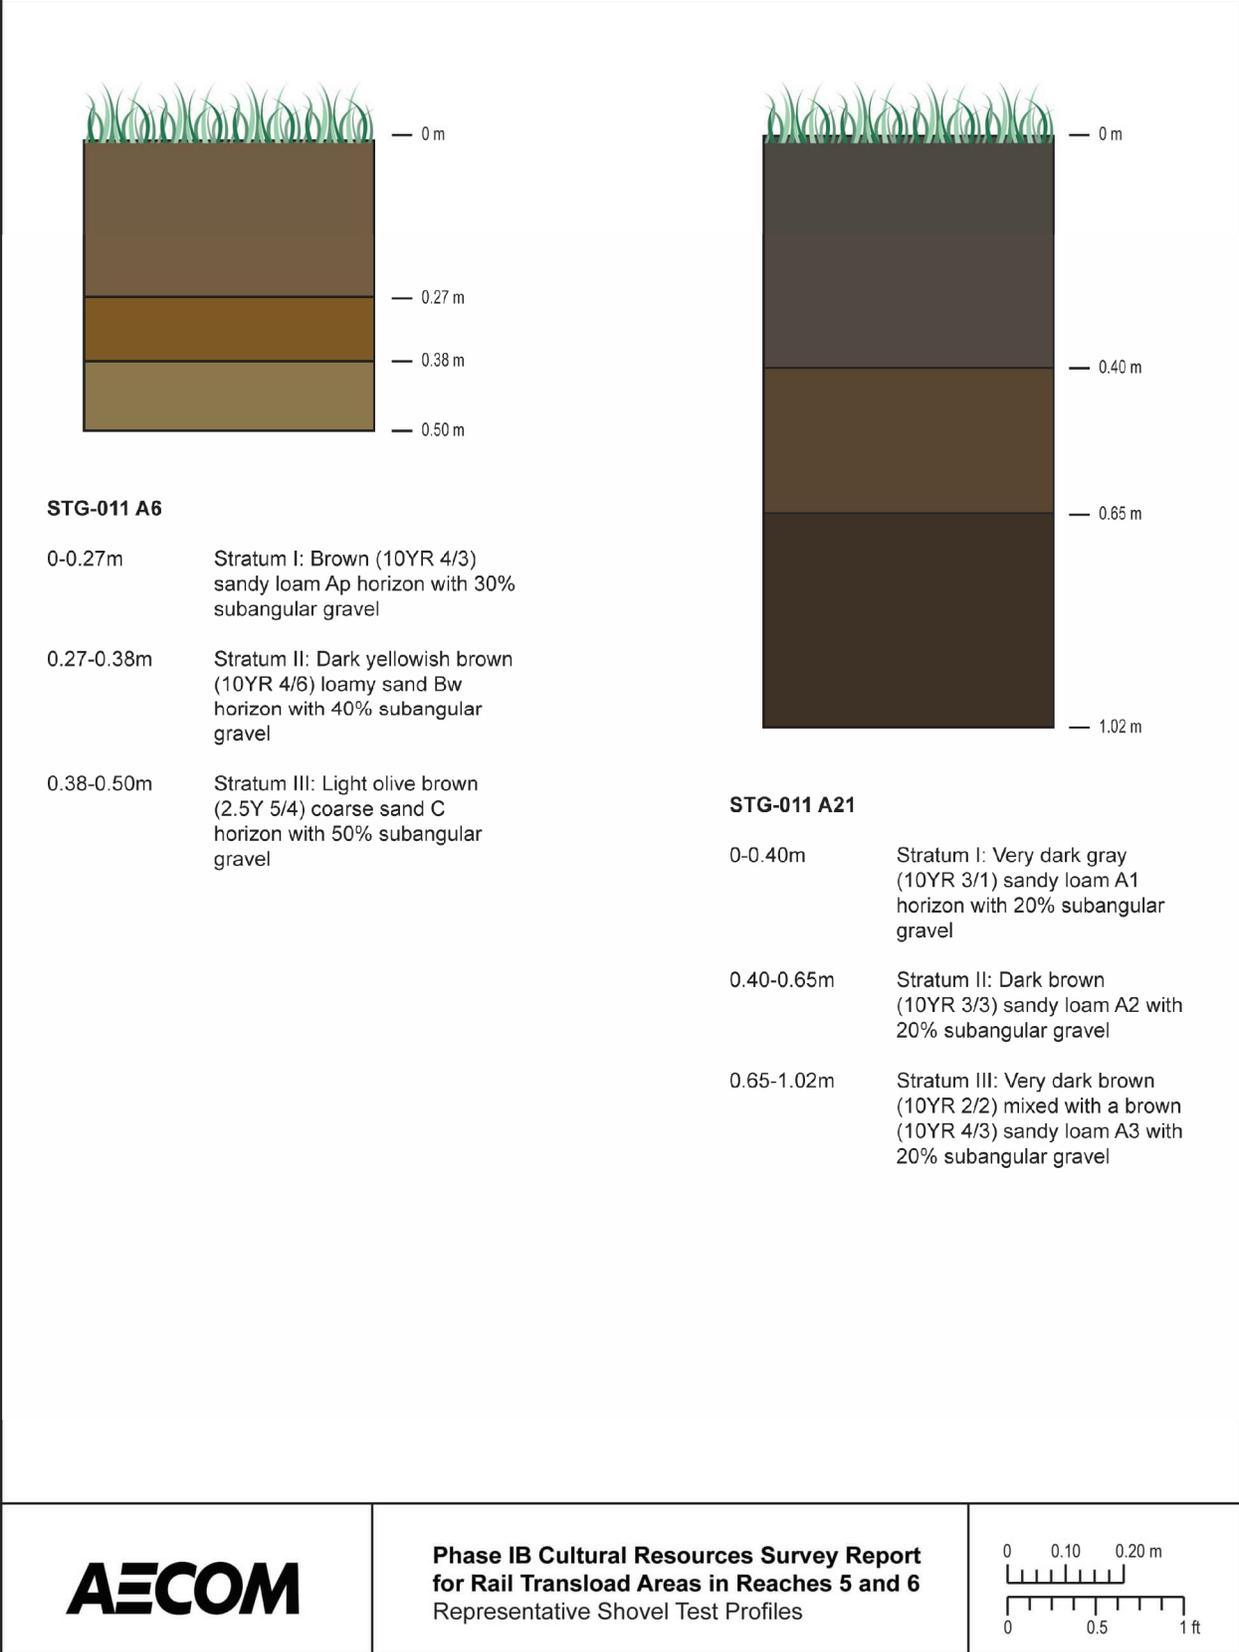
Figure 3.2: Representative Profiles, STPs A6 and A21 in survey area STG-011.

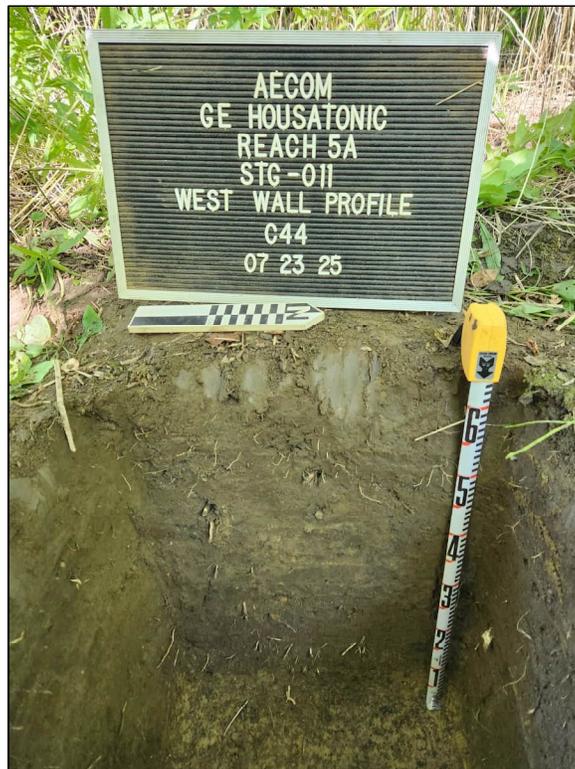
Photograph 3.8: STG-011 west wall profile of STP C44.

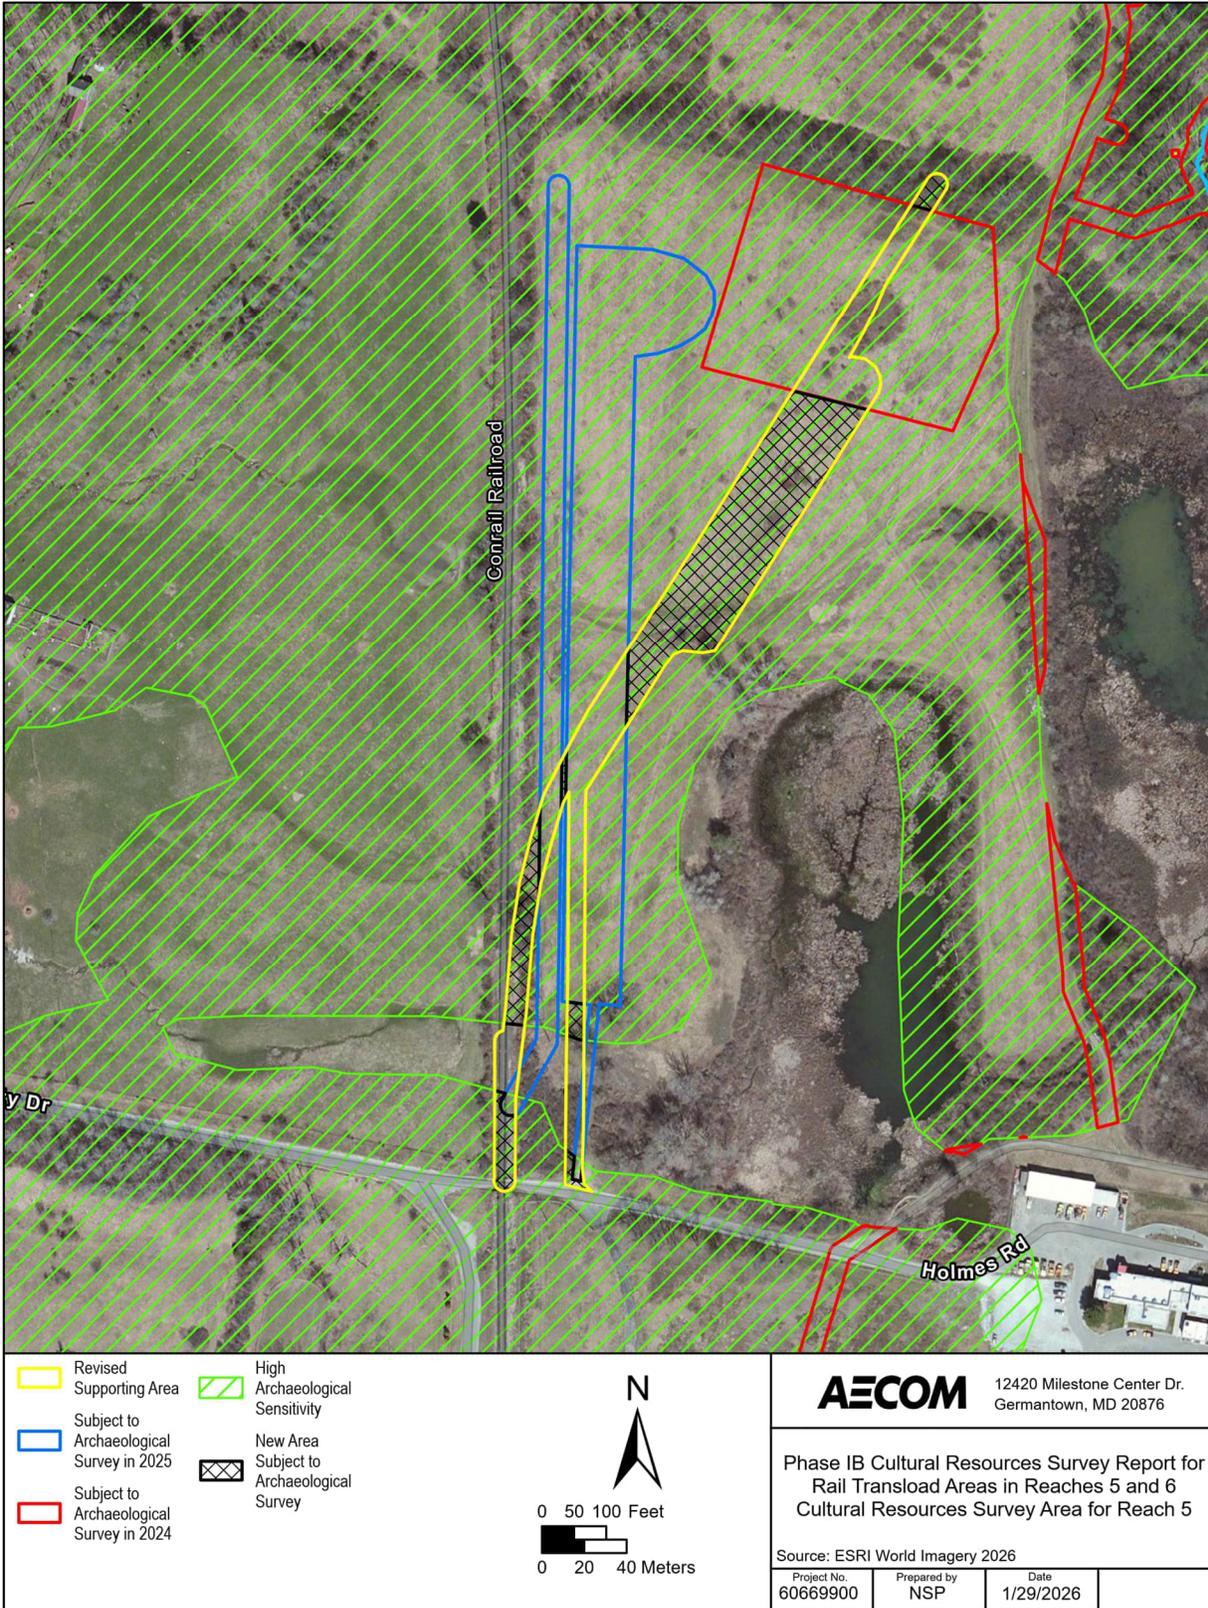
Figure 6.1: Proposed 2026 survey coverage map for Utility Drive Rail Transload Area.
