TECHNICAL MEMORANDUM No. 2

**Results from the 2009 Field Sampling
Program to Support the Ecological Risk
Assessment of Koppers Pond Kentucky
Avenue Wellfield Superfund Site
Operable Unit 4
Horseheads, New York**

Prepared for
Koppers Pond RI/FS Group

June 10, 2010

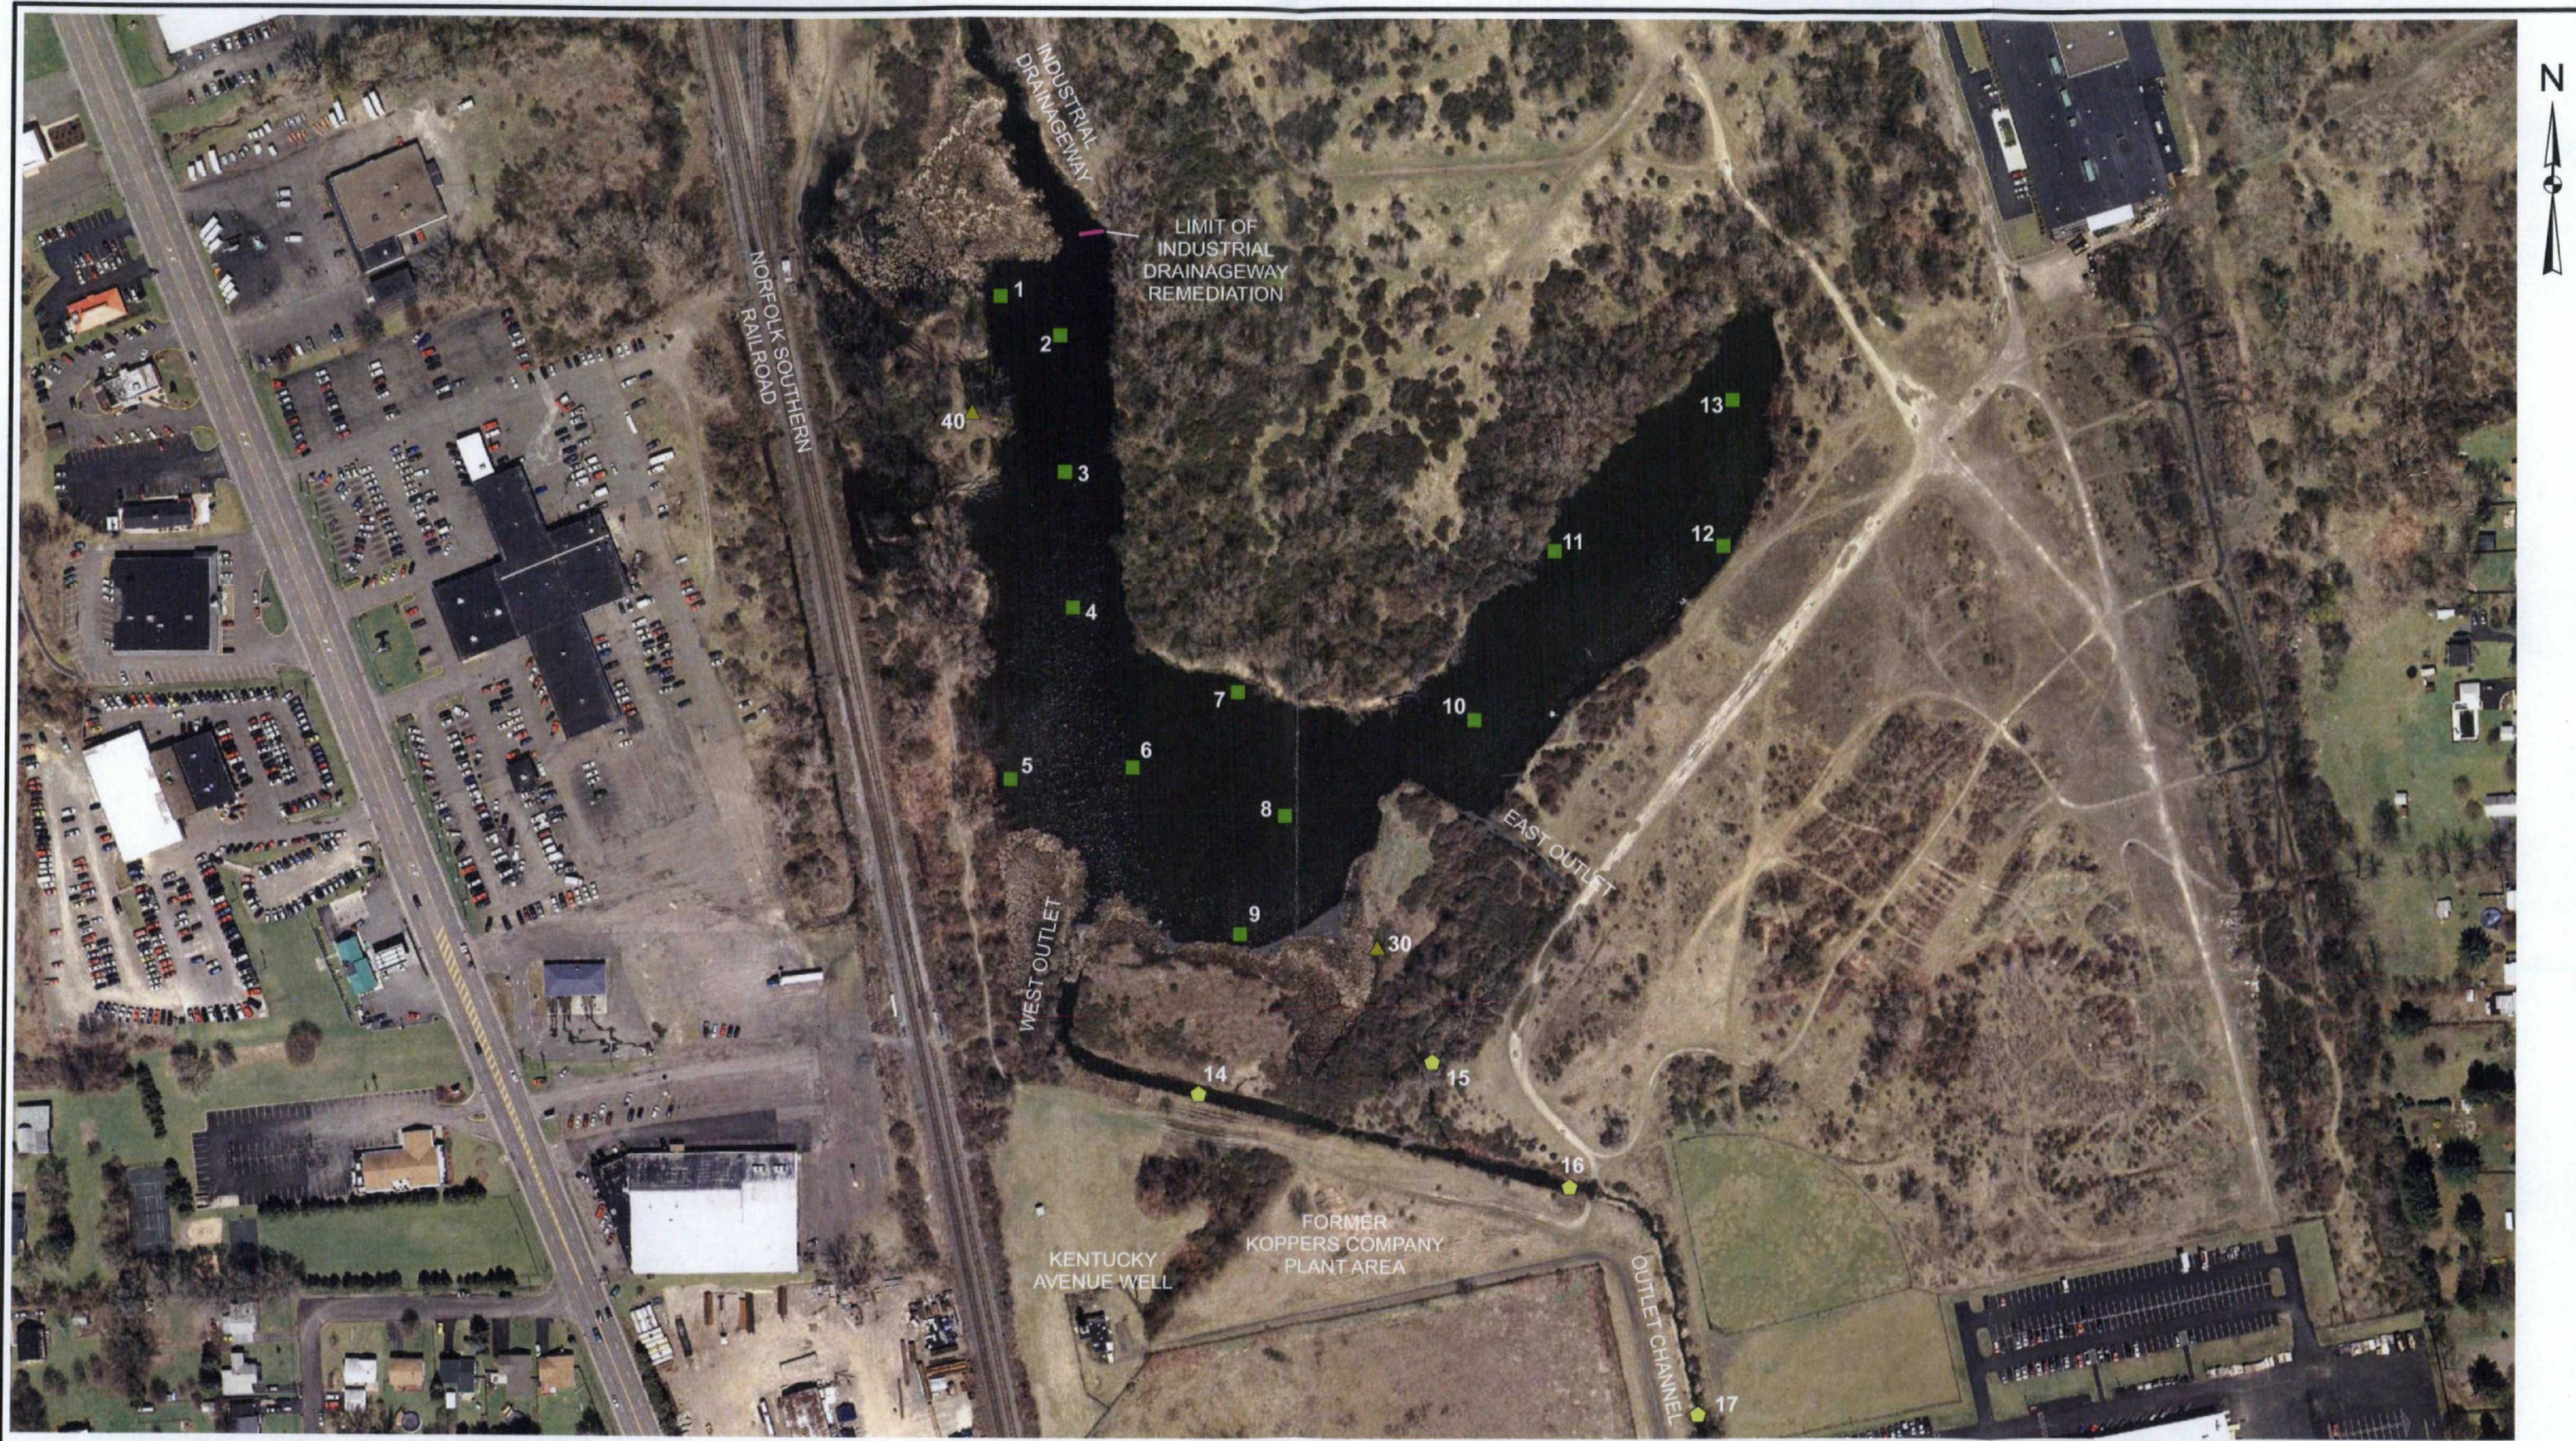
**Figure 1-1. Sampling Locations from Koppers
Pond and Outlets
Kentucky Avenue Wellfield Site - OU4
Horseheads, New York**

- Pond Sample Location
- ◆ Outlet Channel Sample Location
- ▲ Mud Flat Sample Location

Koppers Pond is a man-made, V-shaped pond located in the Village of Horseheads, New York (Figure 1-1). At the northern end of its western leg, the pond receives inflow from the Industrial Drainageway, the watershed for which is a largely a commercial and industrial area. The drainageway receives much of its base flow from discharges originating at the former Westinghouse Horseheads plant site. The overflow from Koppers Pond discharges to two outlet streams located at the southern end of the pond, and these combine about 400 feet southeast of the pond to form a single outlet channel.

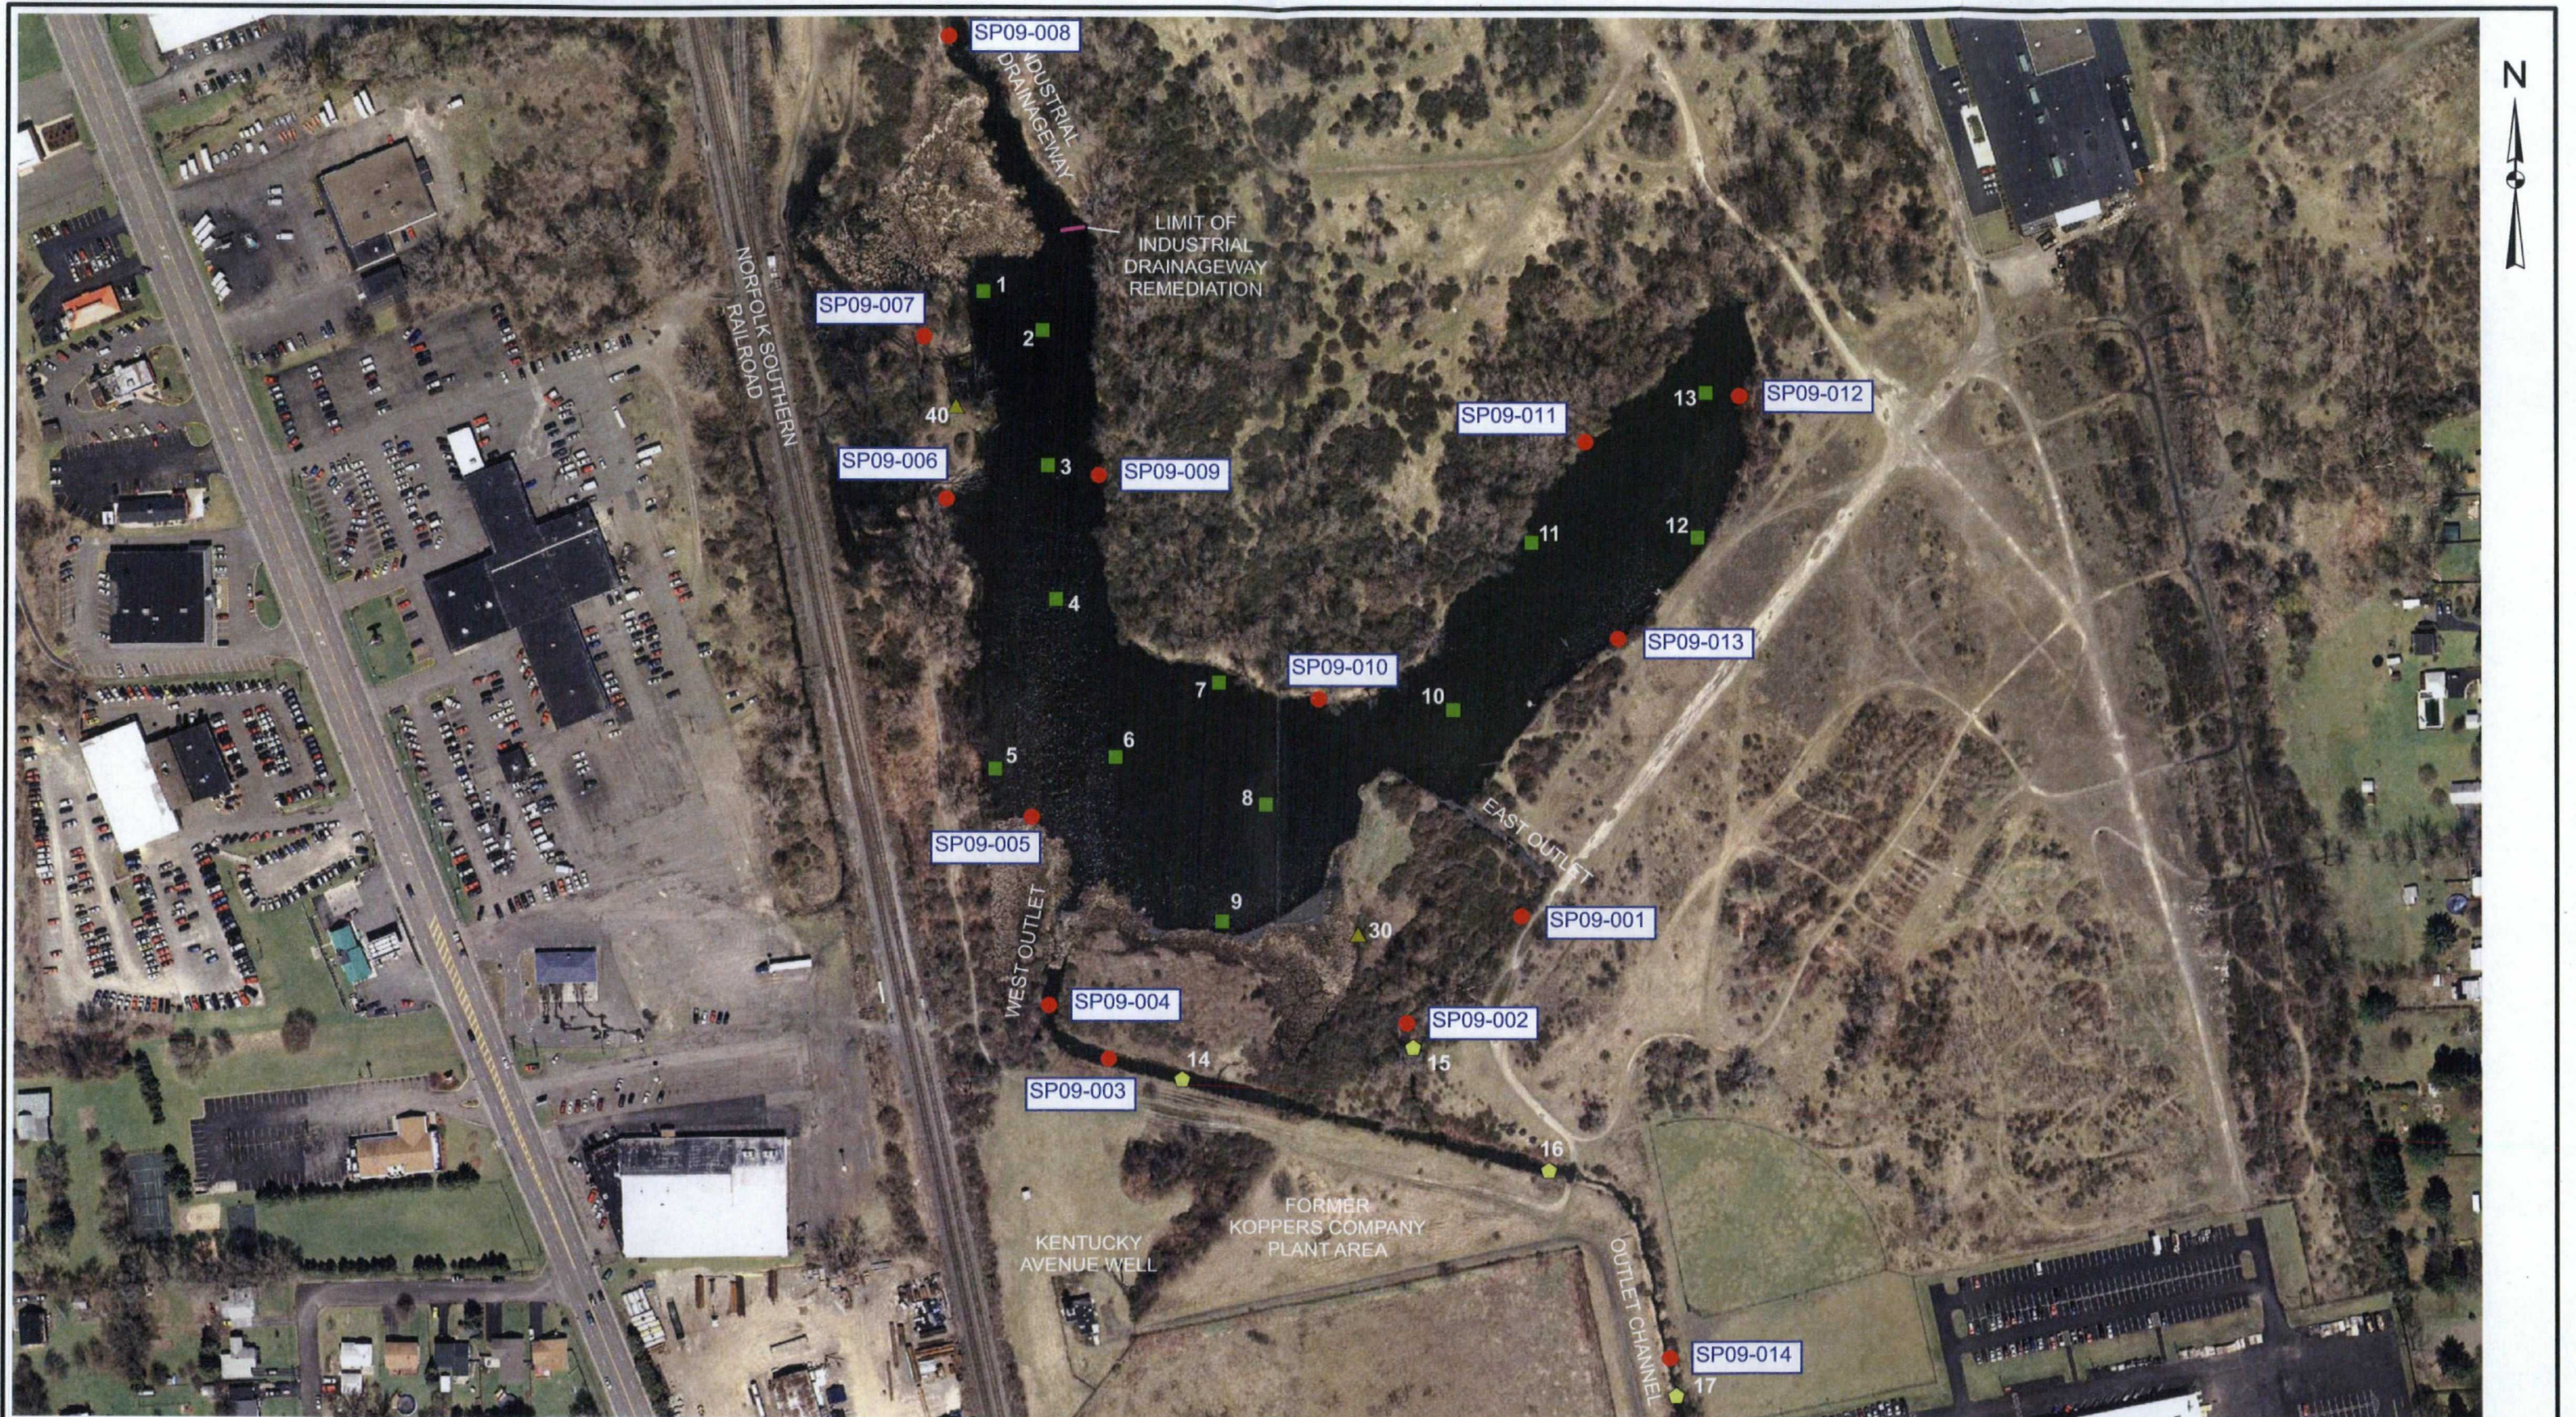
Figure 2-1. Slender Pondweed Survey Locations for Koppers Pond and Outlet Channels Kentucky Avenue Wellfield Site - OU4 Horseheads, New York

- Pond Sample Location
- ◆ Outlet Channel Sample Location
- ▲ Mud Flat Sample Location

Five survey point locations along the east (SP09-001, SP09-002), west (SP09-003, SP09-004), and main outlet channels (SP09-14) of Koppers Pond, were examined. The latter extended as far downstream as sediment sample location SD017. The sample log sheet for the outlet channel survey is provided in Attachment 2 (Table A2-2).

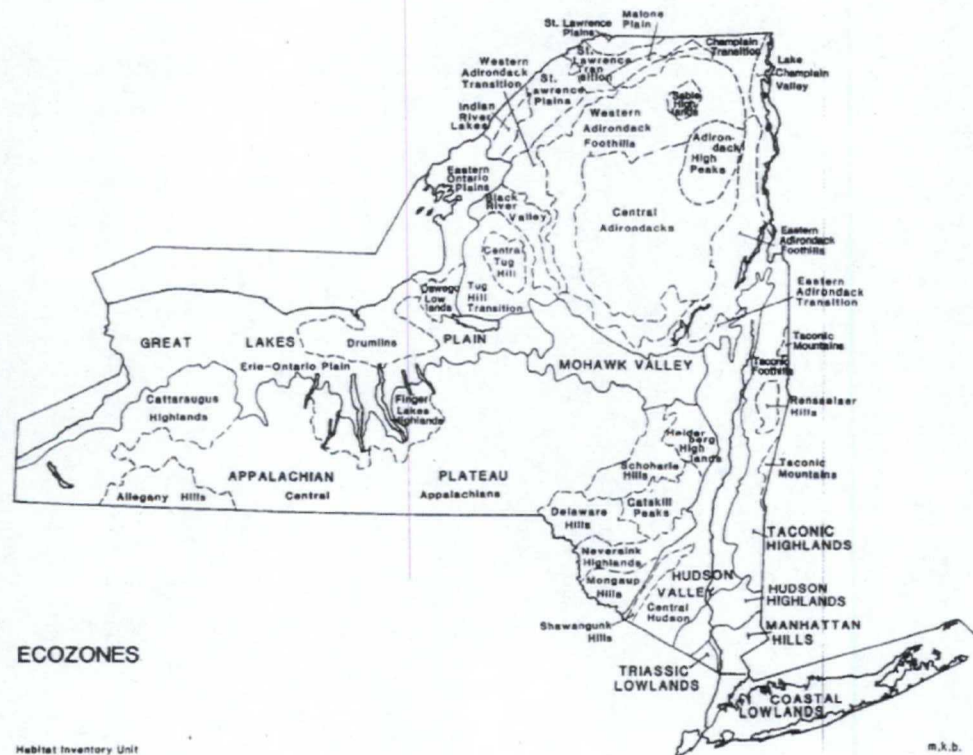
Figure 2-2. County Map Showing Reported Locations of Slender Pondweed in New York State, and Ecozone Map

(a) USDA Plants Profile map showing reported locations of slender pondweed in New York

(b) Ecozones of New York State as reported by Reschke (1990)

The Maine Department of Conservation [MDOC] (2004) reported that the slender pondweed has been observed in marl ponds with water column pH ranging from 7.3 to 9.1 (an average pH was not reported). Reschke (1990) defines a marl pond as "small, shallow spring-fed pond in which the water column has a high concentration of calcium" and in which the calcium precipitates out of the water column on to the sediment surface as calcium carbonate. These ponds have low primary productivity and sparse growth of aquatic macrophytes. Reschke (1990) also states that the marl ponds are known only in a portion of the Finger Lakes highlands subzone of the Appalachian Plateau ecozone. This is consistent with the information reported from the USDA Plants Profile website.

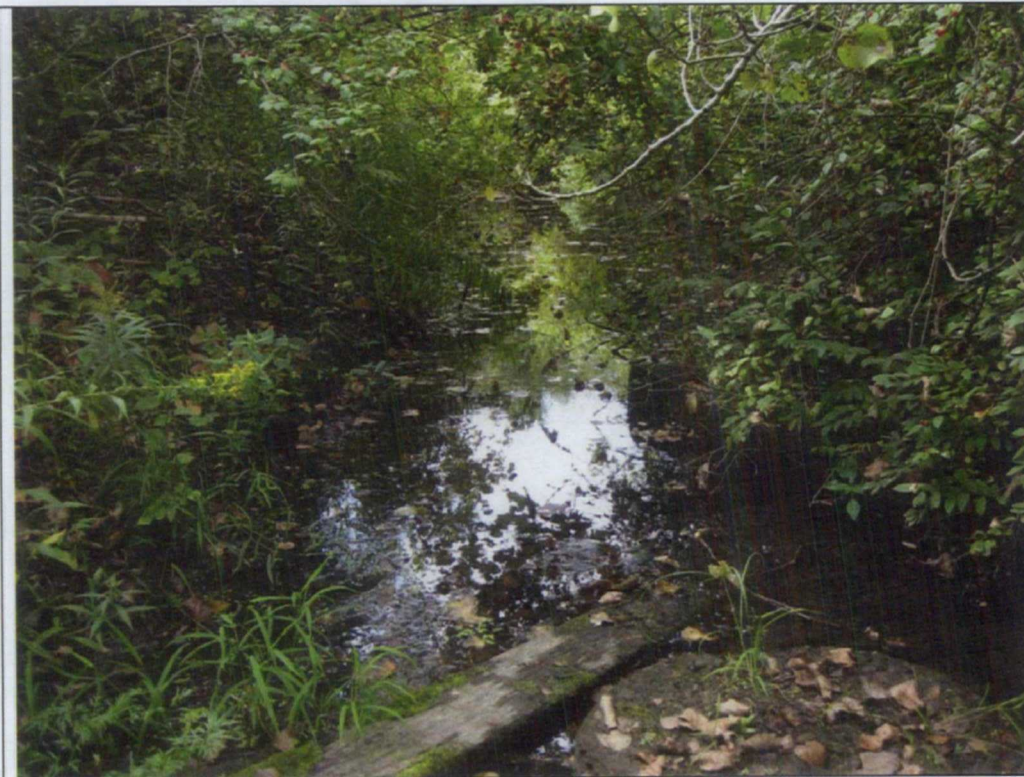
Photo A1-3

East outlet
(SP09-002)
N42.14760
W76.82799

The slender pondweed was not observed at any of these locations. There were also no apparent SAV at any of these locations. Many of the outlet channels had terrestrial vegetation overgrowing their surfaces.
