Project Activities

Arconic Inc. (formerly Alcoa) will be working through the summer to continue to reconstruct habitat areas impacted by the dredging and capping required by the U.S. Environmental Protection Agency (EPA) at the Grasse River Superfund site (aka Alcoa Aggregation) in Massena, New York. Nearly a quarter million cubic yards of sediment contaminated with polychlorinated biphenyls (PCBs) were removed from a 7.2-mile stretch of the lower Grasse River and about 250 acres of river bottom were capped.

Ice Jam Investigation

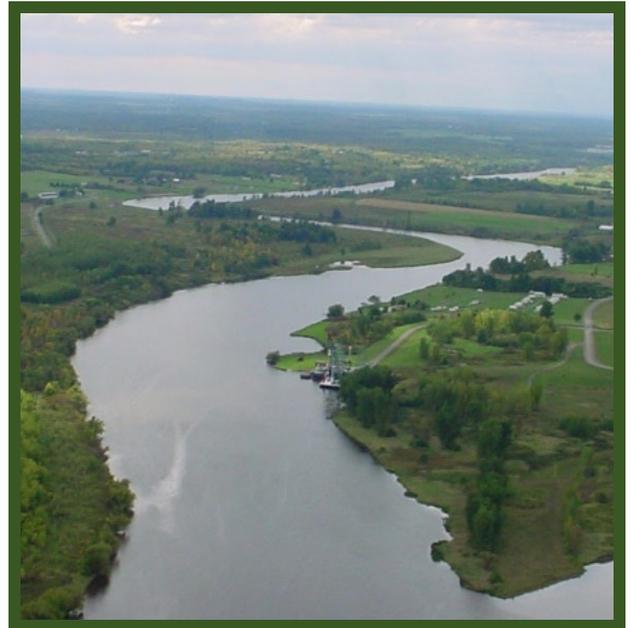
An ice jam event occurred in March 2022 which resulted in limited scouring of the cap and sediment immediately upstream of the Route 131 Bridge in Massena. In order to repair the damaged cap in this section of the river, additional work in the river will be necessary this year. River sections downstream of the damaged section will also be tested and addressed, as necessary.

Historically, ice jams have not occurred this far down river and the construction of the cap in the damaged area was not designed for the forces resulting from the jam. The armored cap constructed in the river upstream of the area, which was designed to withstand ice jam forces, was not damaged.

An ice jam is an accumulation of ice in the river channel that causes an ice jam toe to form, creating a very high-water flow rate and turbulence under the ice jam toe.

Consistent with plans that were developed to monitor the site after cleanup, water sampling and bathymetric surveys (measurements of the river bottom) were conducted to identify areas that have eroded or where the eroded capping material and sediment deposited, and to evaluate the extent of impact.

Arconic began additional investigations in mid-June, which will result in the development of a workplan to address next steps, including repairs to the cap and/or modification to cap design in the area where erosion has occurred. It is anticipated that any necessary repairs will begin in late summer and be completed this year.

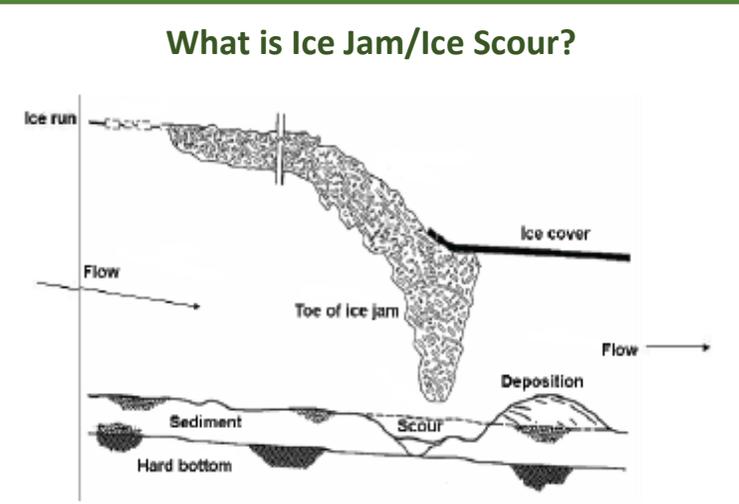
What is Ice Jam/Ice Scour?

The higher water flow rates are created by the same amount of water being pushed through a smaller portion of the river channel. The high-water flow rate and turbulence under the ice jam toe can result in localized scour along the river bottom sediment and redistribution of sediment.

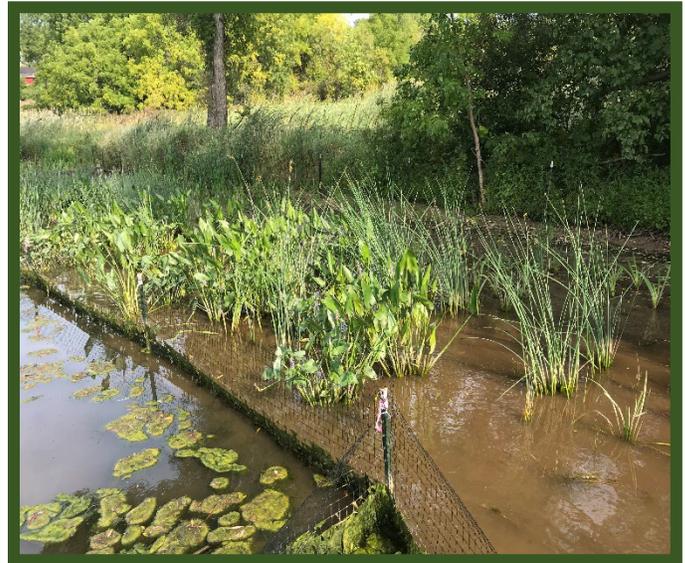
Vegetation that has been planted in the river as part of habitat reconstruction activities.

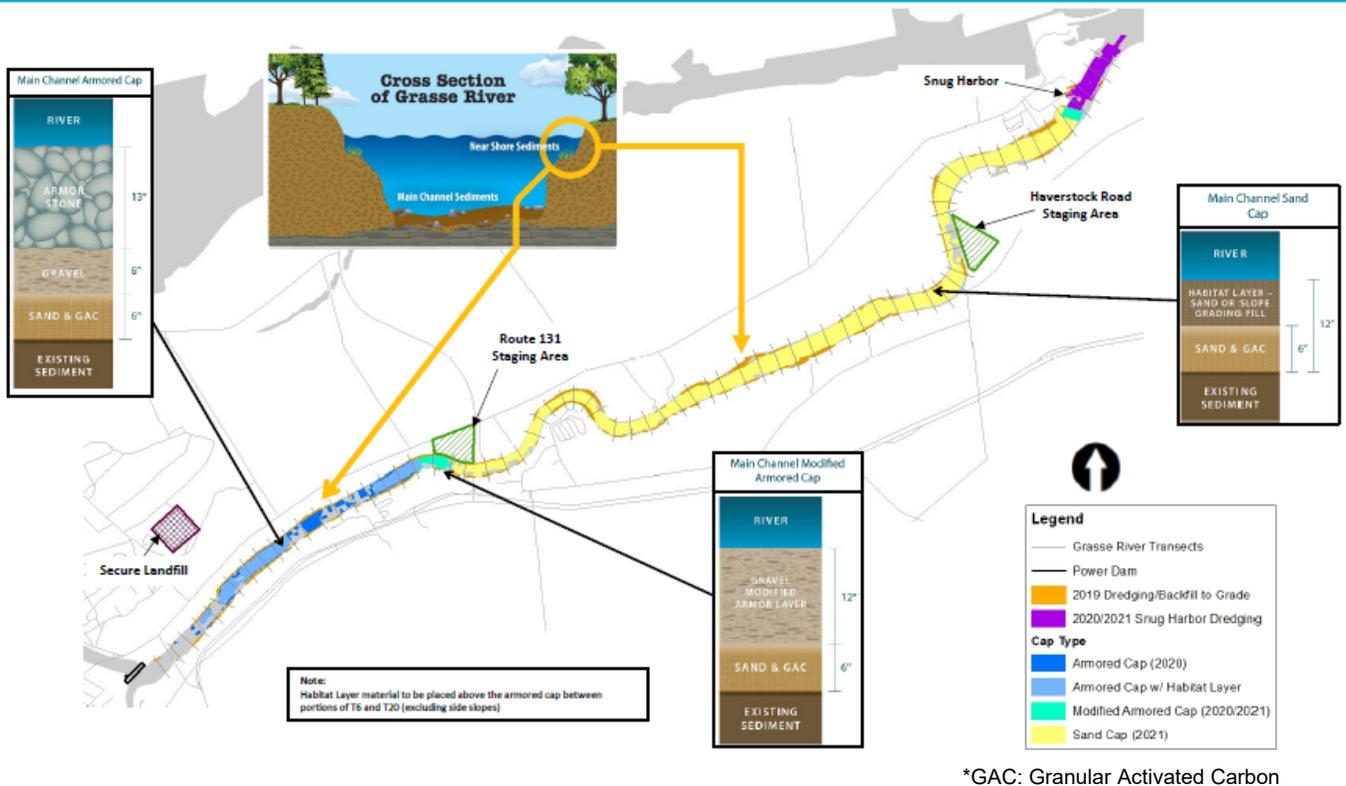
Figure 1

The capping material includes sand and powdered carbon, which works to capture and chemically bind pollutants in place, as well as some stone and gravel. Three different types of caps were installed, depending on river location (see Figure 1: *Grasse River Remedy Overview* which shows dredged areas, capped areas and type of cap installed).

Grasse River Remedy Overview
