*The*  
**BORIT ASBESTOS  
SUPERFUND SITE**

Ambler, PA **January 2016**

*A Story of*  
**PROGRESS**  
*and*  
**PROMISE**

A detailed look at the work of EPA's Superfund Removal Program

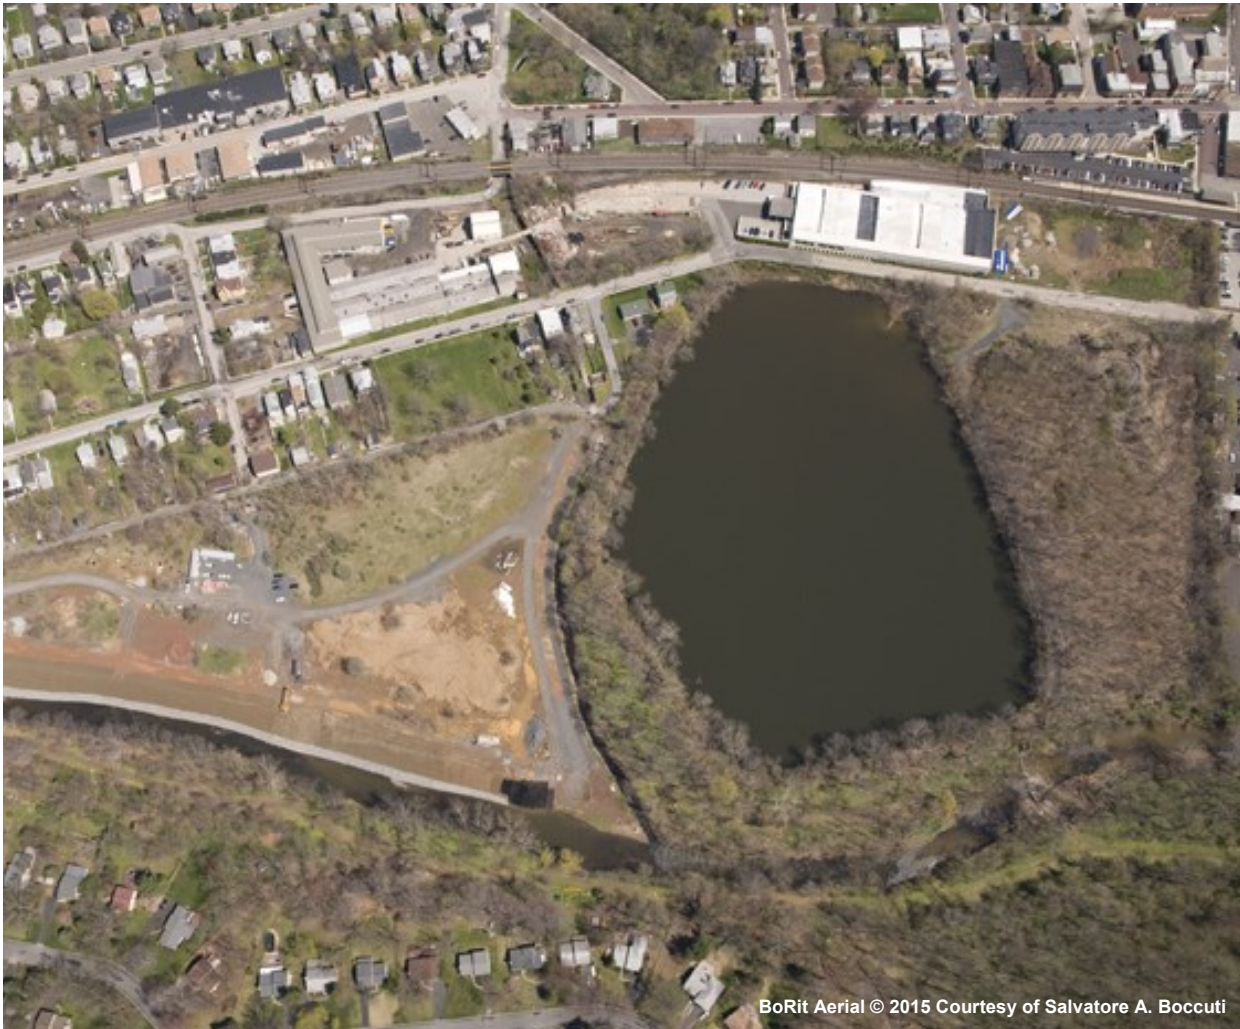
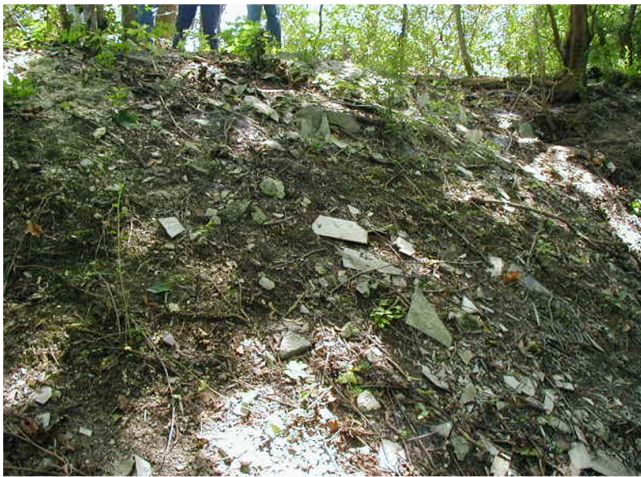
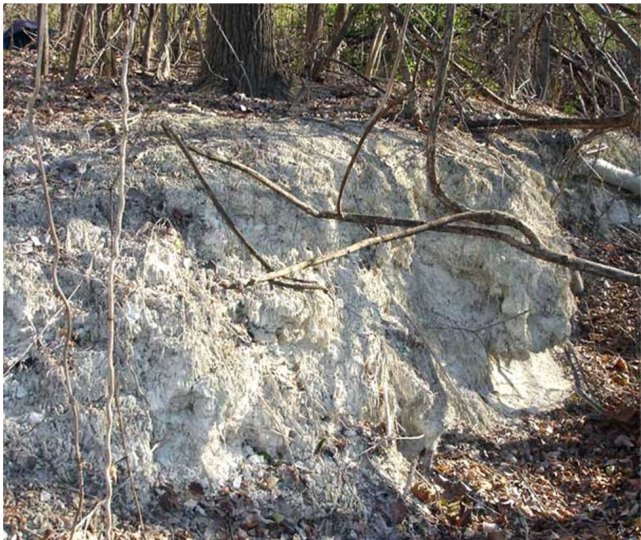
**Above:** Aerial photograph of the BoRit site taken in 2009. **Top Right:** Before EPA began work at the site in 2008, visible asbestos-containing debris littered the site surface. **Bottom Right:** Slurry containing asbestos was also present in some areas of the site.

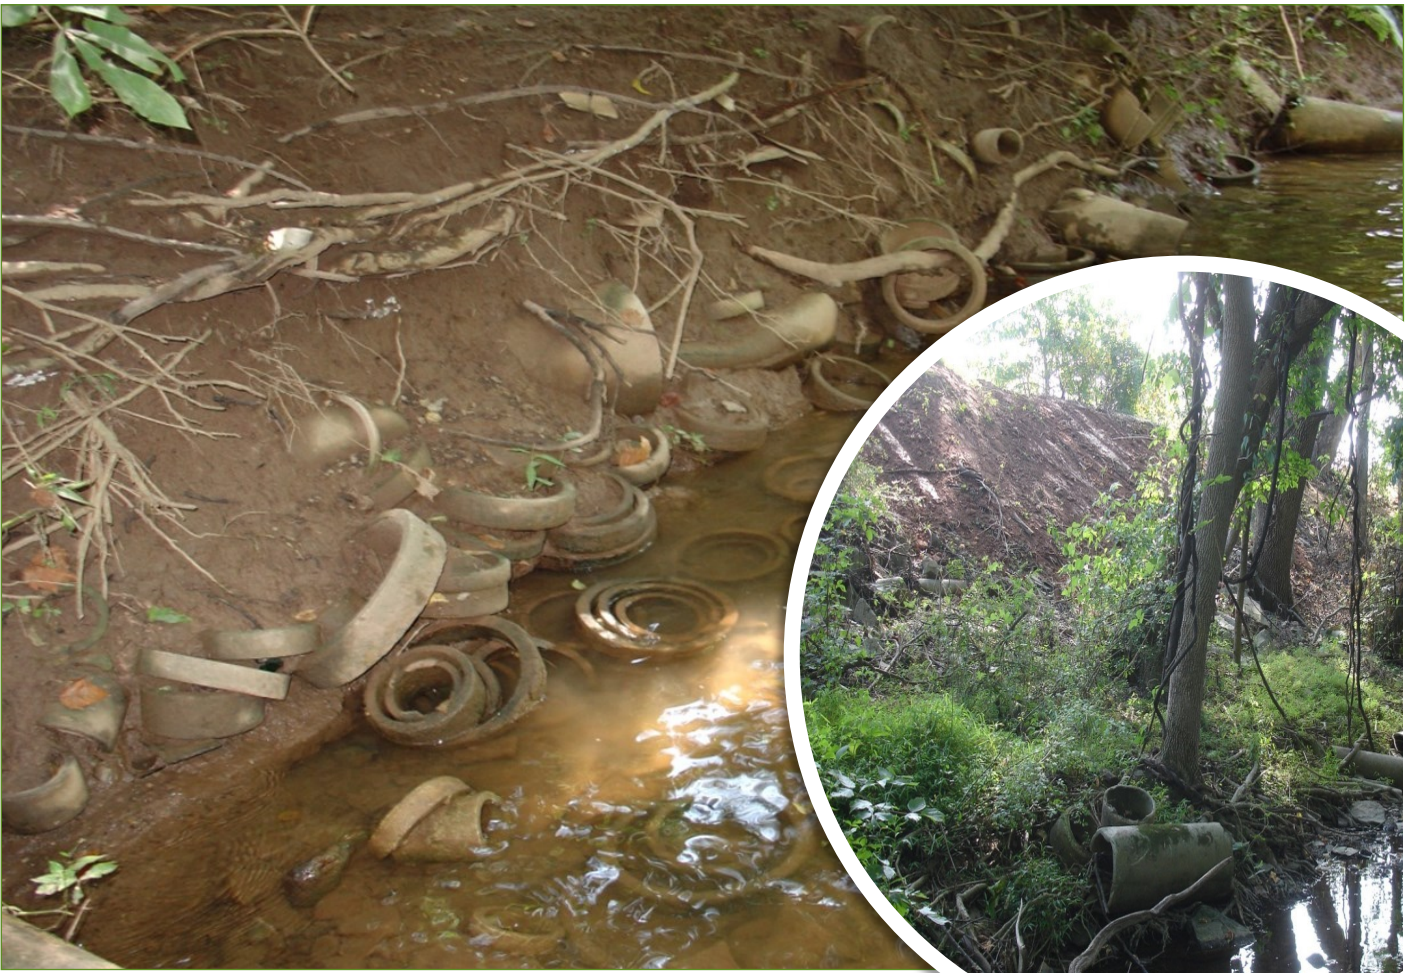
*When EPA reassessed the site in 2006, discarded and broken asbestos-containing materials (ACM) littered the creeks surrounding the BoRit site and the slopes of the waste piles. These pictures show portions of Wissahickon Creek and an adjacent slope of the former West Ambler community park which was closed in the 1980s because of asbestos concerns.*

portions of the slopes. By 2006, when EPA reassessed the site, asbestos-containing materials (ACM) were visible in Wissahickon Creek, Tannery Run, and Rose Valley Creek which border or intersect the BoRit site and run along the edge of the waste piles. Broken products were also exposed on some of the steeply sloped sides of the piles. In the portion of the site located in Ambler, contaminated sludge was also present.

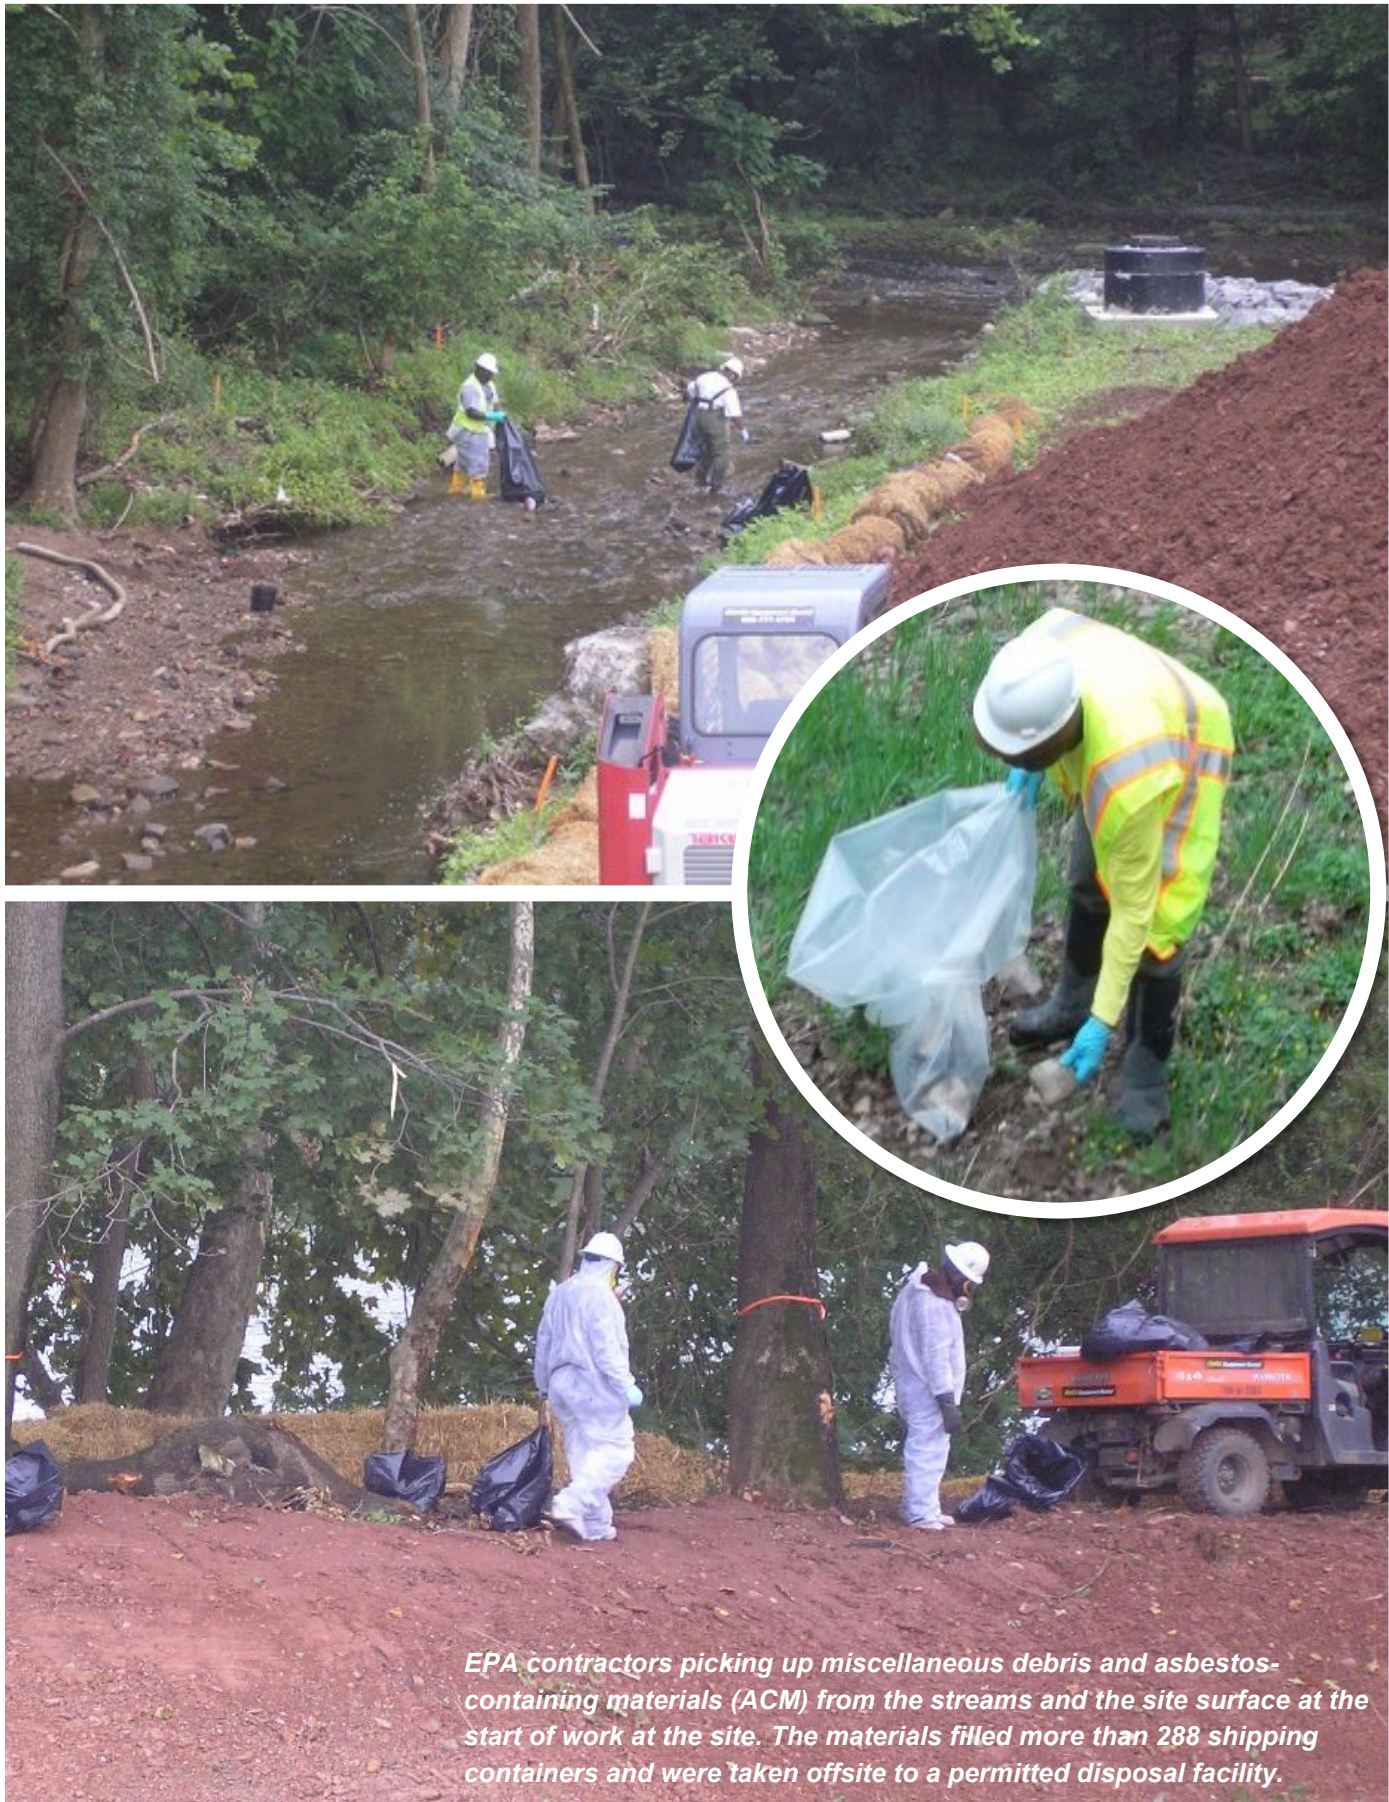
EPA contractors picking up miscellaneous debris and asbestos-containing materials (ACM) from the streams and the site surface at the start of work at the site. The materials filled more than 288 shipping containers and were taken offsite to a permitted disposal facility.

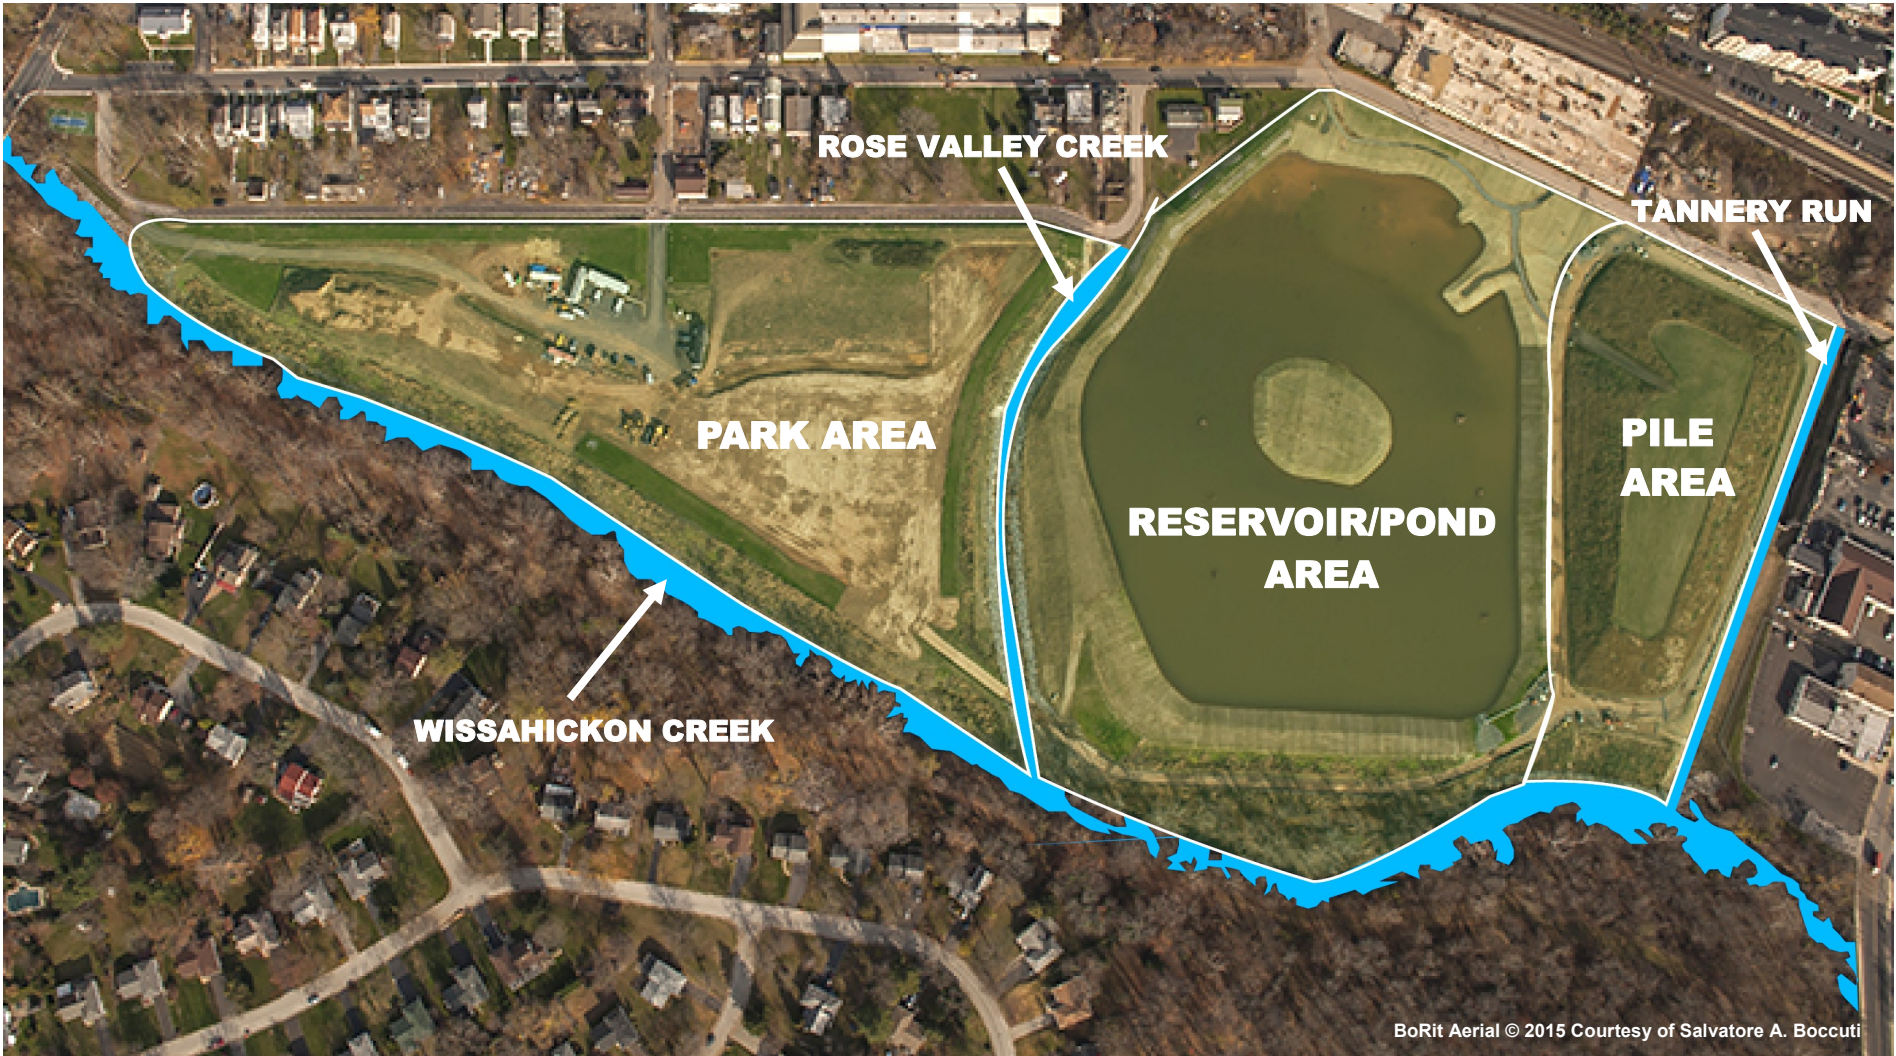
Aerial view of site, taken in November 2015, shows work in progress on the park parcel and work completed on the pile parcel and the former reservoir now called the pond. Improvements made to the pond include a 1/2-acre island for nesting migratory birds and a viewing area and trails along Maple Avenue.

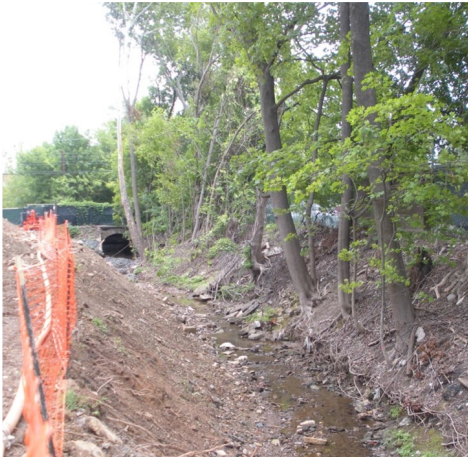
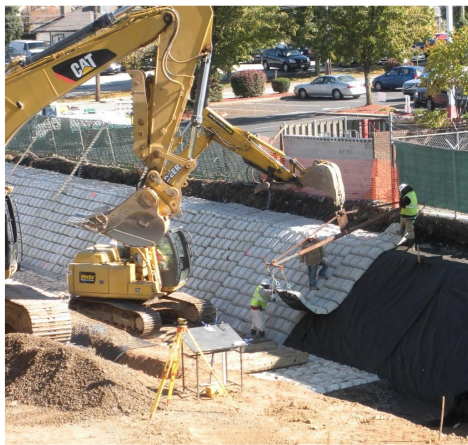
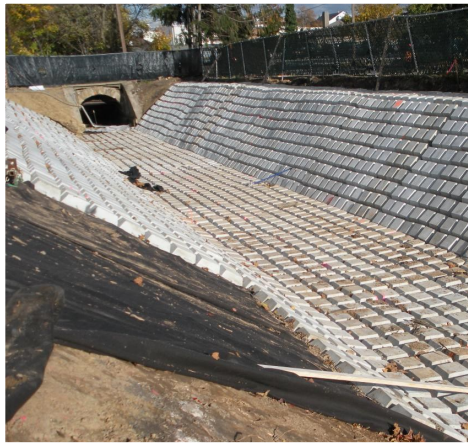
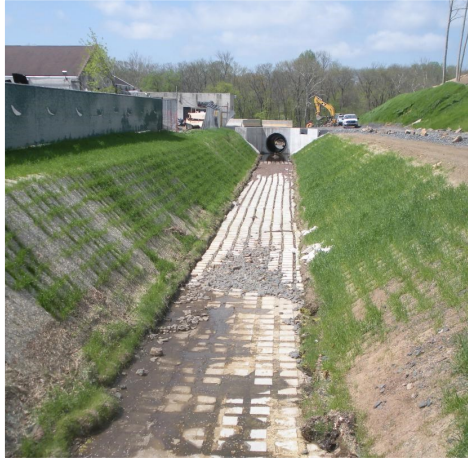
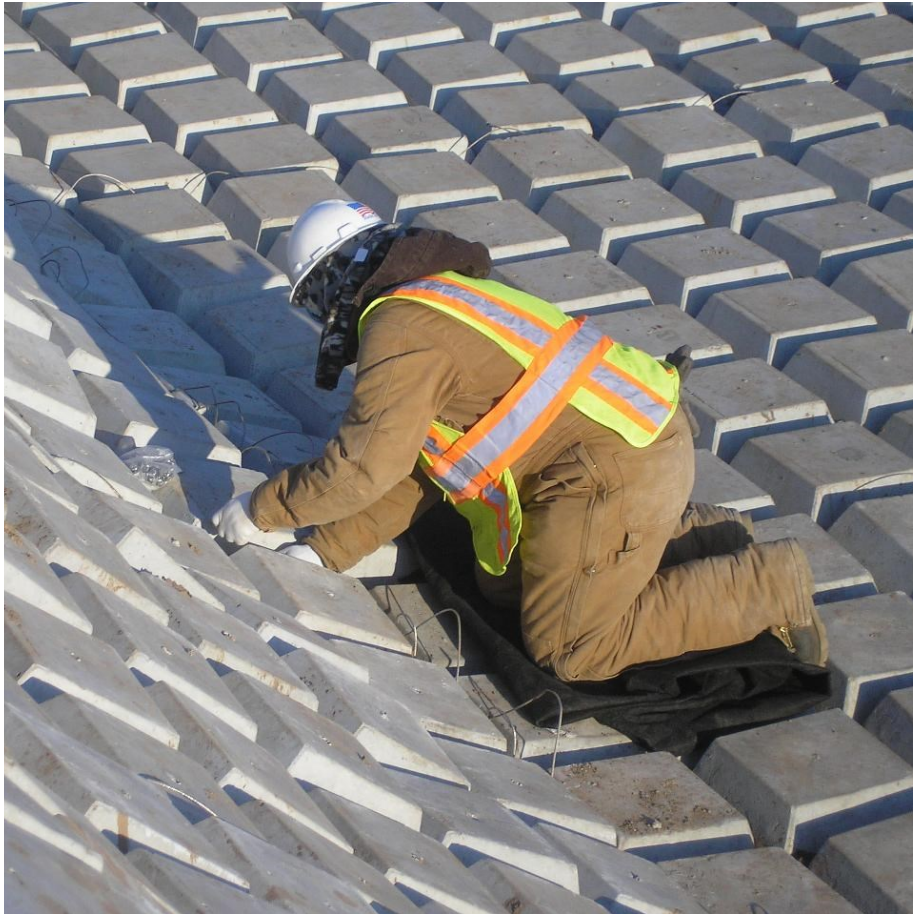
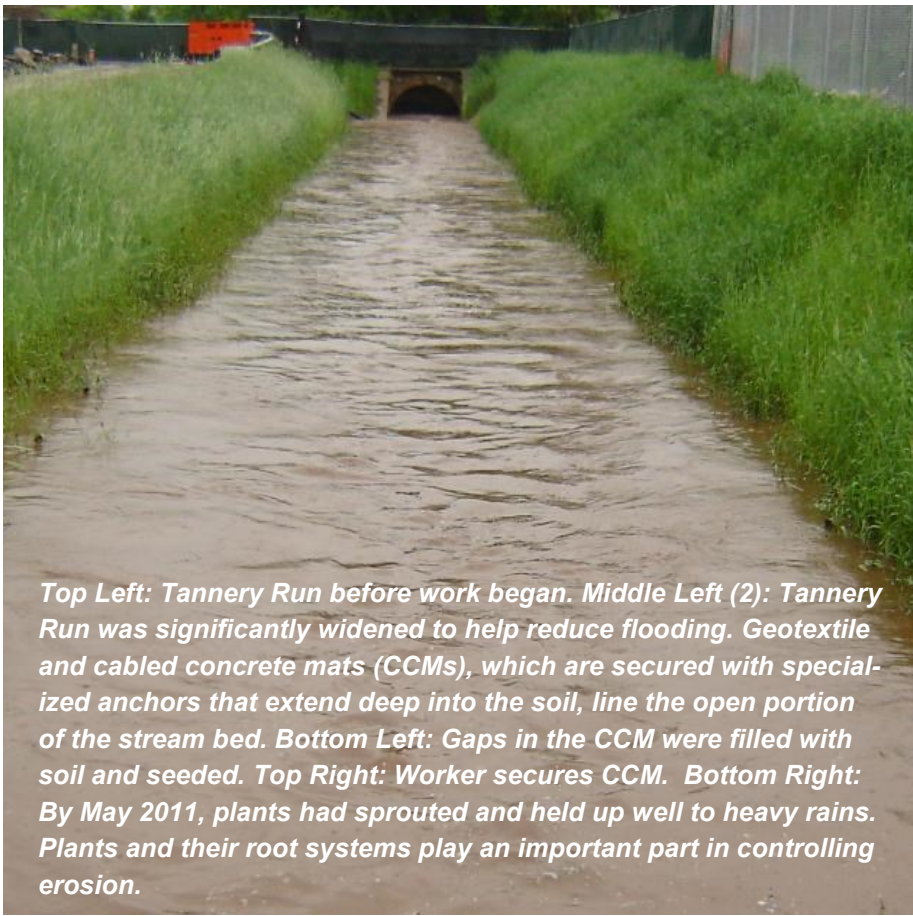
Top Left: Tannery Run before work began. Middle Left (2): Tannery Run was significantly widened to help reduce flooding. Geotextile and cabled concrete mats (CCMs), which are secured with specialized anchors that extend deep into the soil, line the open portion of the stream bed. Bottom Left: Gaps in the CCM were filled with soil and seeded. Top Right: Worker secures CCM. Bottom Right: By May 2011, plants had sprouted and held up well to heavy rains. Plants and their root systems play an important part in controlling erosion.

There are several components to the cap. A heavy geotextile was placed over the entire 32-acre site. Next, the geotextile was covered by a minimum of two feet of clean soil. Because the site is bordered by Wissahickon Creek and Tannery Run and dissected by Rose Valley Creek -- three waterways which are prone to flooding -- it is important to protect the cap from the daily water flow, as well as from storm surges. So, the stream beds were widened to accommodate heavier storm-water flows. Then, they were lined with geotextile and cabled-concrete mats which were anchored to the soil with specialized construction anchors that were driven deep into the earth. When they are opened, the anchors function much like toggle bolts and can hold great weight. The cabled-concrete mats line the creek bottoms and extend up the stream banks to above the historic flood lines.

Large, heavy rocks, commonly called rip rap, are layered over the cabled concrete mats to help ensure that heavy storms, do not lift the mats or erode the stream banks.

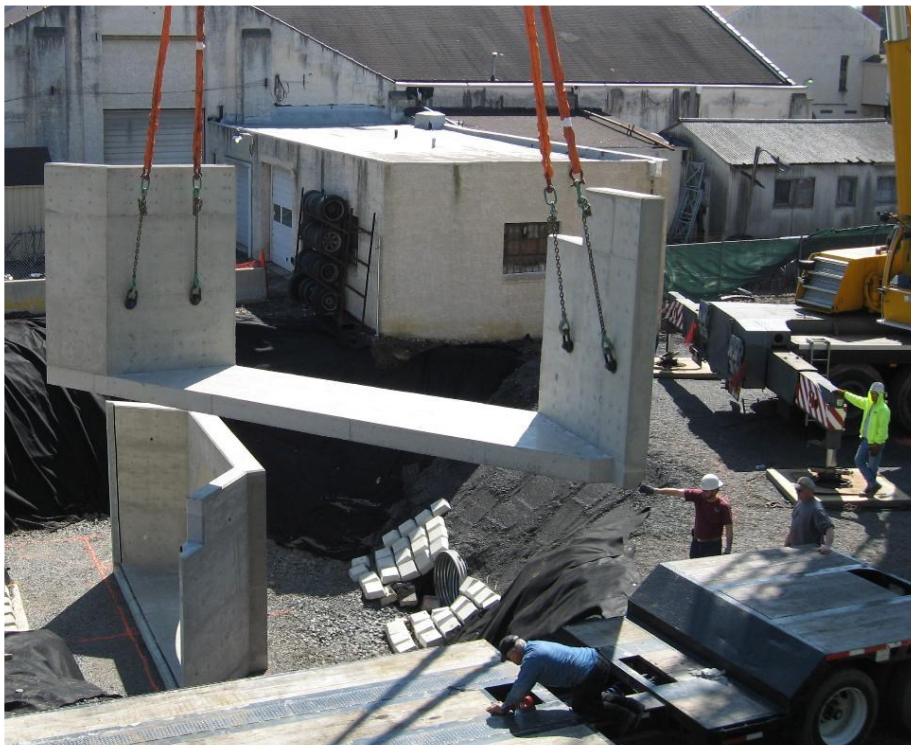
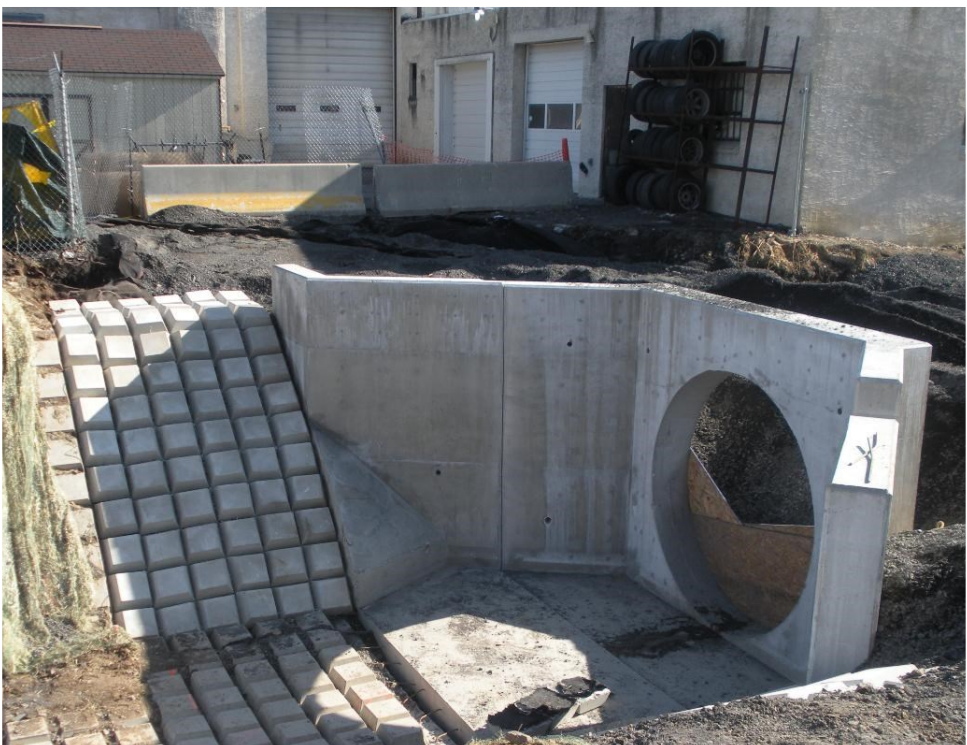
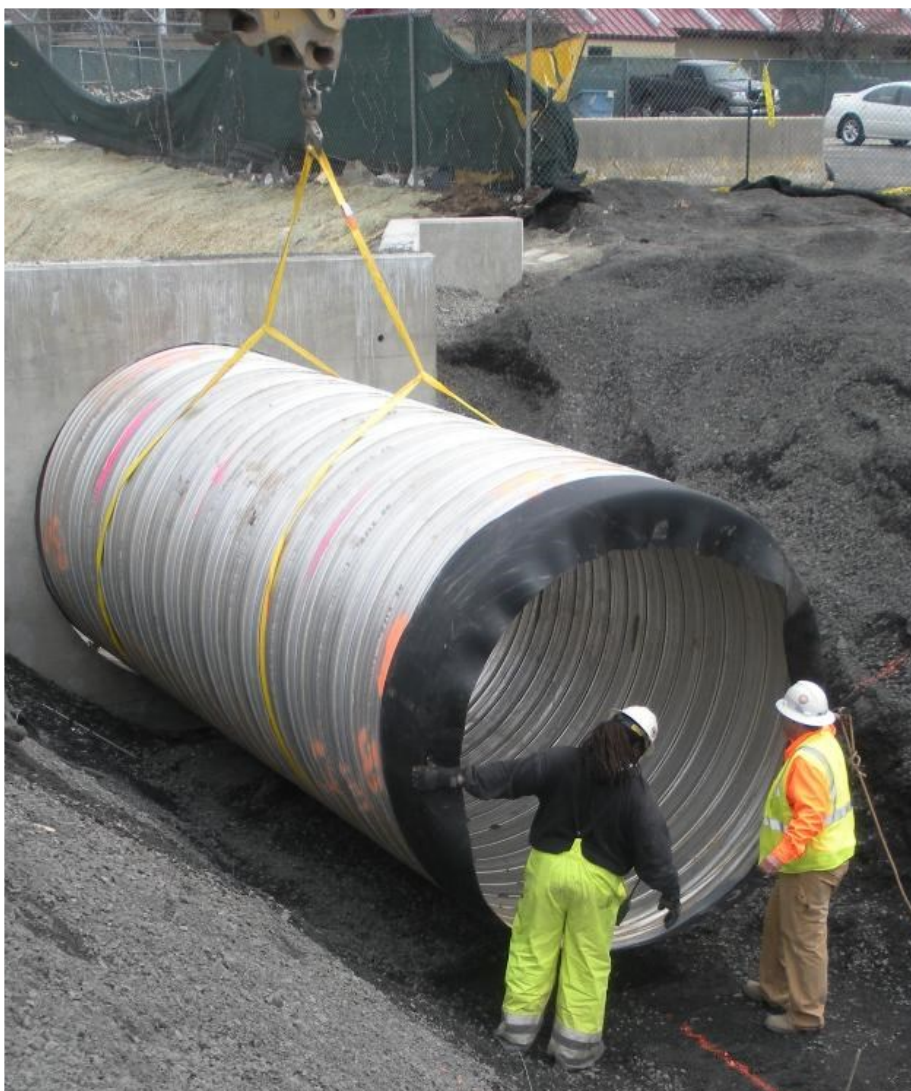
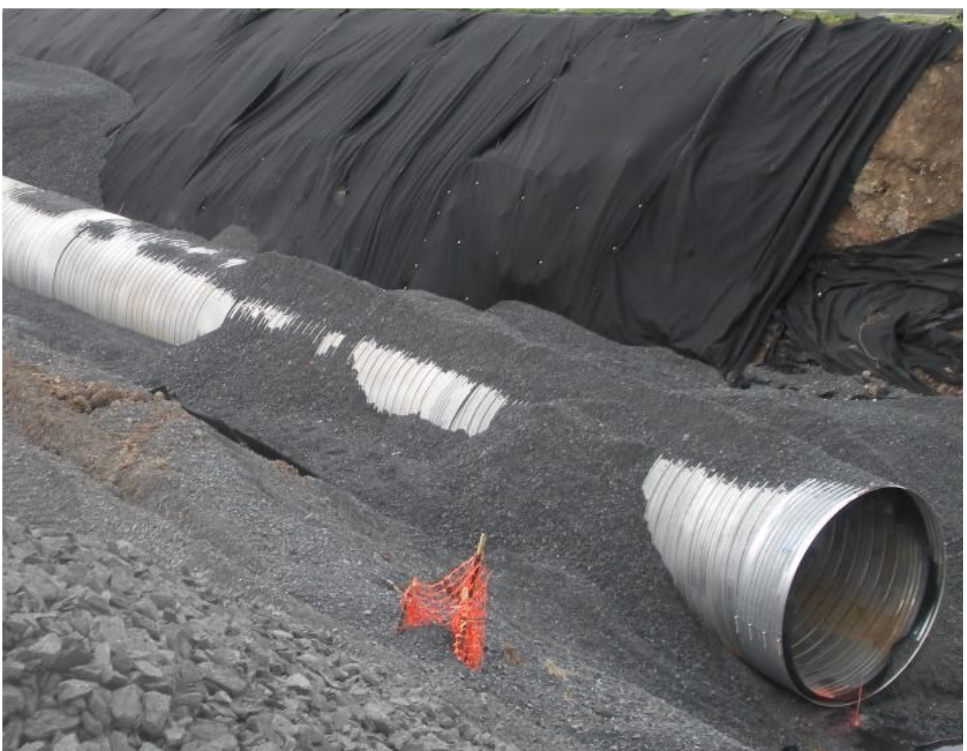
The 25-ft.-high embankment of Tannery Run, behind Butler Street businesses, was eroding and destabilizing parking lots. EPA enclosed a 325-foot portion of the stream to prevent collapse. **Top Left:** Crew installs the headwall to anchor the 8-ft-diameter pipe through which the stream will flow. **Top Right:** Water will flow from the lined open channel into the 8-ft. diameter pipe at the headwall. **Bottom Left:** Workers install first section of 8-ft-diameter pipe. **Bottom Right:** Liner and pipe were covered with 2,640 cubic yards of stone; the enclosed area was finished with soil and seeded.

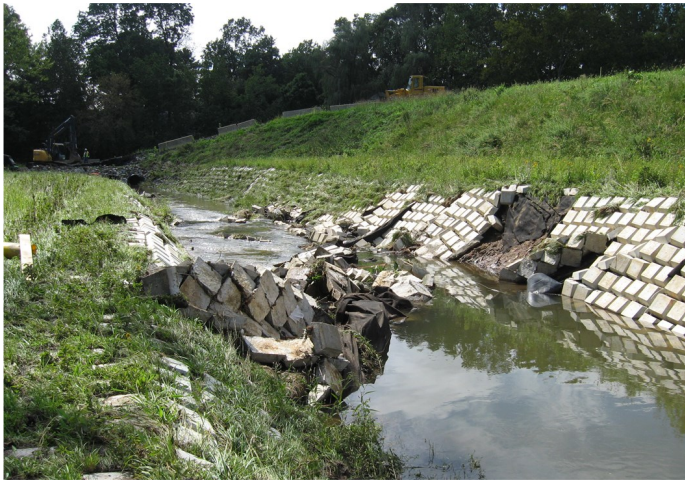
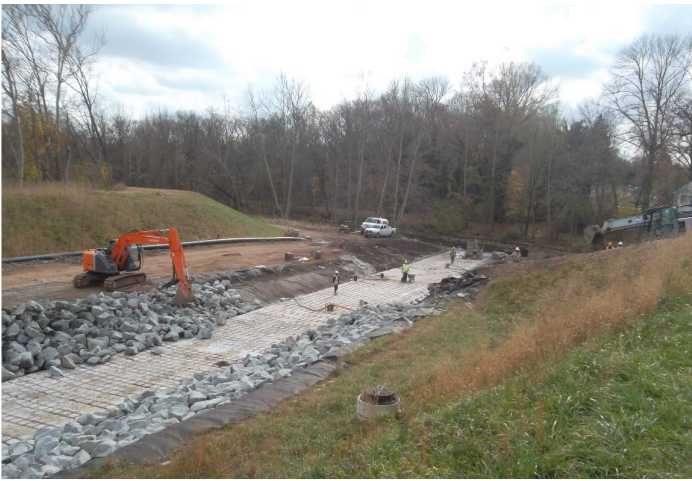
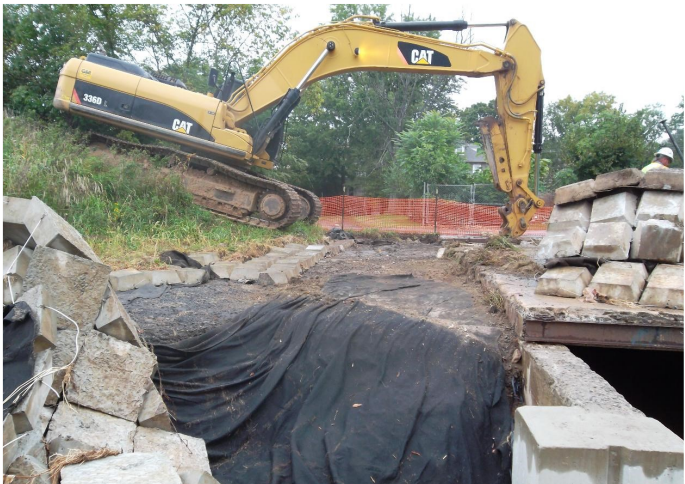
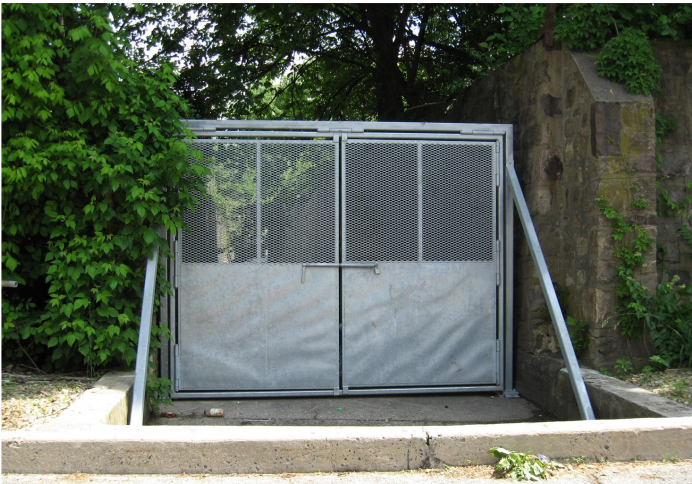
**Upper Left:** During Tropical Storm Lee, water and debris burst through the old sluice gate at Maple Ave., sweeping down Rose Valley Creek and destroying the recently installed cabled concrete mats (CCM). Although a setback, the experience helped EPA and the US Army Corps of Engineers to improve and strengthen the stream liner system. **Lower Left:** Contractor conducting CCM repair after the storm. **Upper Right:** Restored and strengthened stream liner at Rose Valley Creek headwall. **Lower Right:** A new swing-gate was installed at Maple Avenue/Rose Valley Creek sluiceway. The gate is designed to release water slowly during future storm events.

In September 2011, Tropical Storm Lee did cause damage to earlier work that had been done at BoRit. But it also provided lessons for how to protect the site against future severe weather events. For example, storm water carried debris down Rose Valley Creek during the storm. When the debris reached the sluiceway under Maple Street in West Ambler, it collected until mounting water pressure caused an explosive release that endangered residents and damaged work done downstream at the Borit site. In addition to repairing the damage at the site, EPA made improvements to the Rose Valley Creek channel at Maple Street by adding a swing gate to gradually release water during future storms. EPA also added a guard rail upstream to prevent cars and large debris from entering the

channel. Although the storm caused a set-back to the Removal Action, EPA and the U.S. Army Corps of Engineers (USACE) used the experience to fortify the repair work at the site and to strengthen the remaining work in the stream beds and the pond. USACE frequently is contracted by EPA to provide construction expertise on projects. Along the Wissahickon Creek, a honeycomb

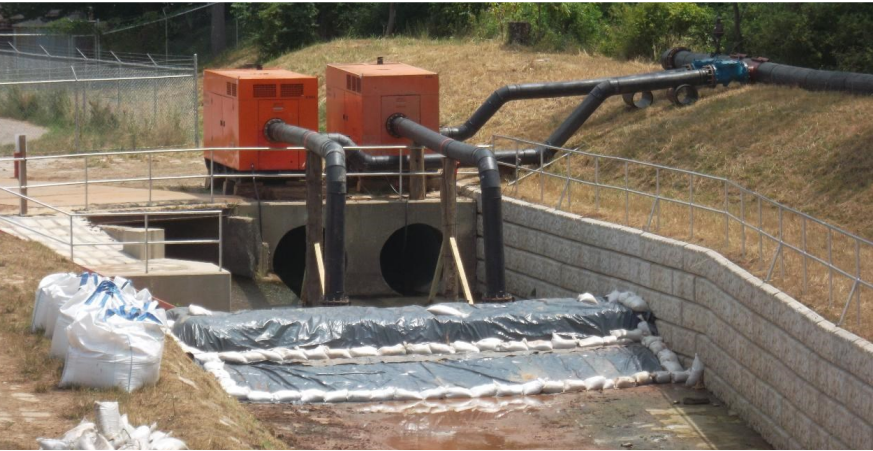
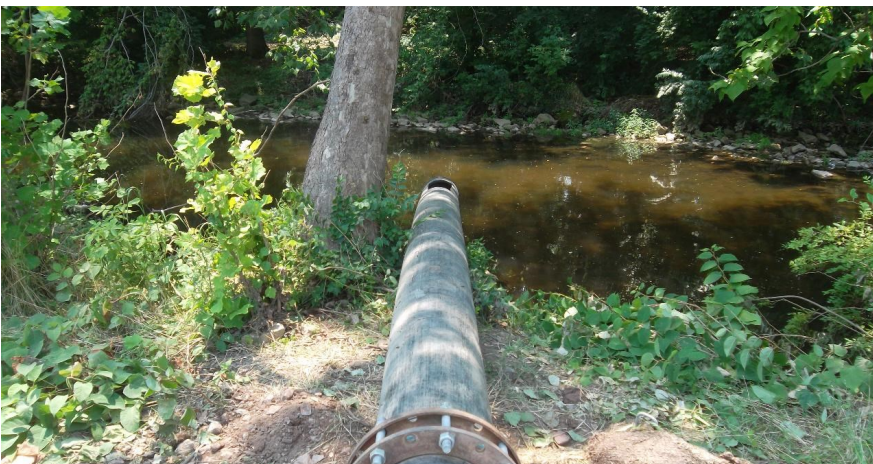
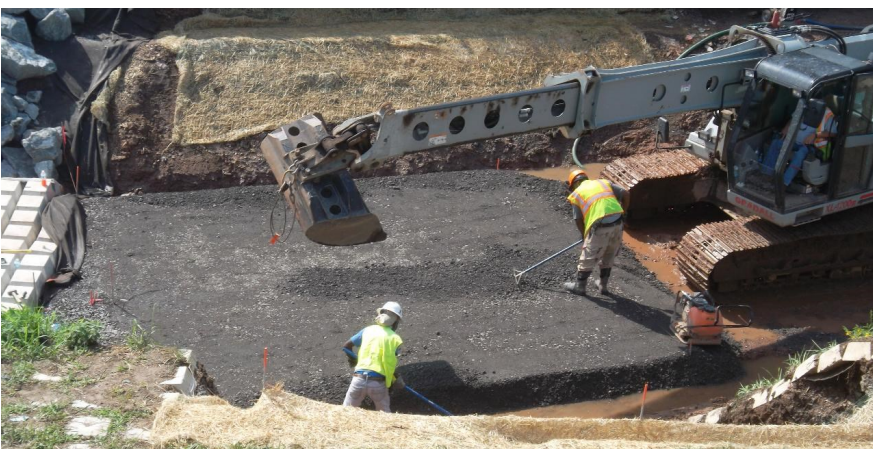
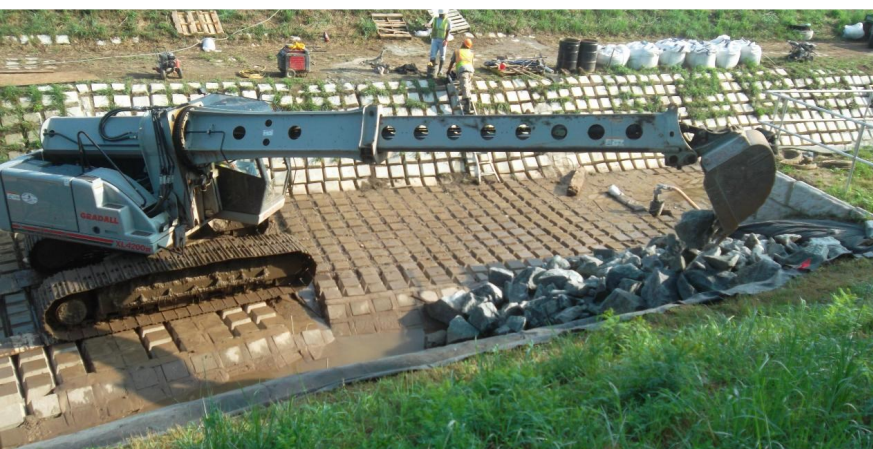
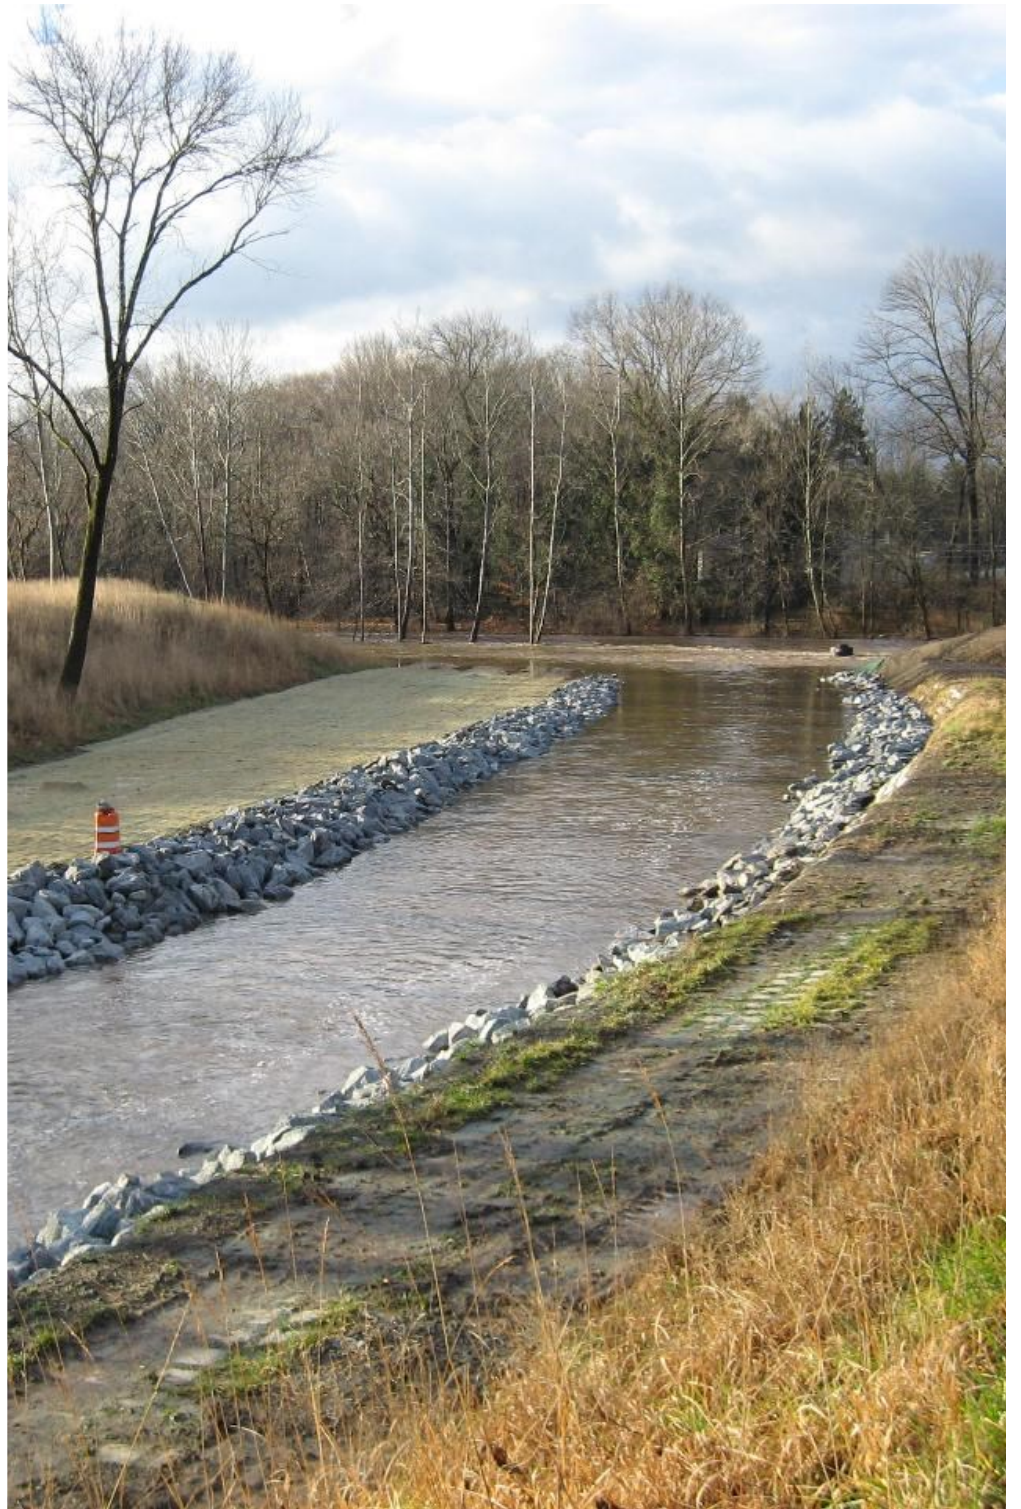
**Top Left:** Temporary pumps and a sandbag dam were installed to create a dry work area for rebuilding Rose Valley Creek. **Upper Middle:** Stream water was re-routed through 700 feet of piping and discharged into Wissahickon Creek while Rose Valley was being widened and lined. **Lower Middle:** Before geotextile and cabled concrete mats (CCM) were laid, workers placed a layer of stone on the floor of Rose Valley Creek. **Bottom Left:** For added security, rip rap was placed over the CCM on the stream embankment. **Top Right:** Rose Valley Creek after being repaired and widened to reduce future flooding.

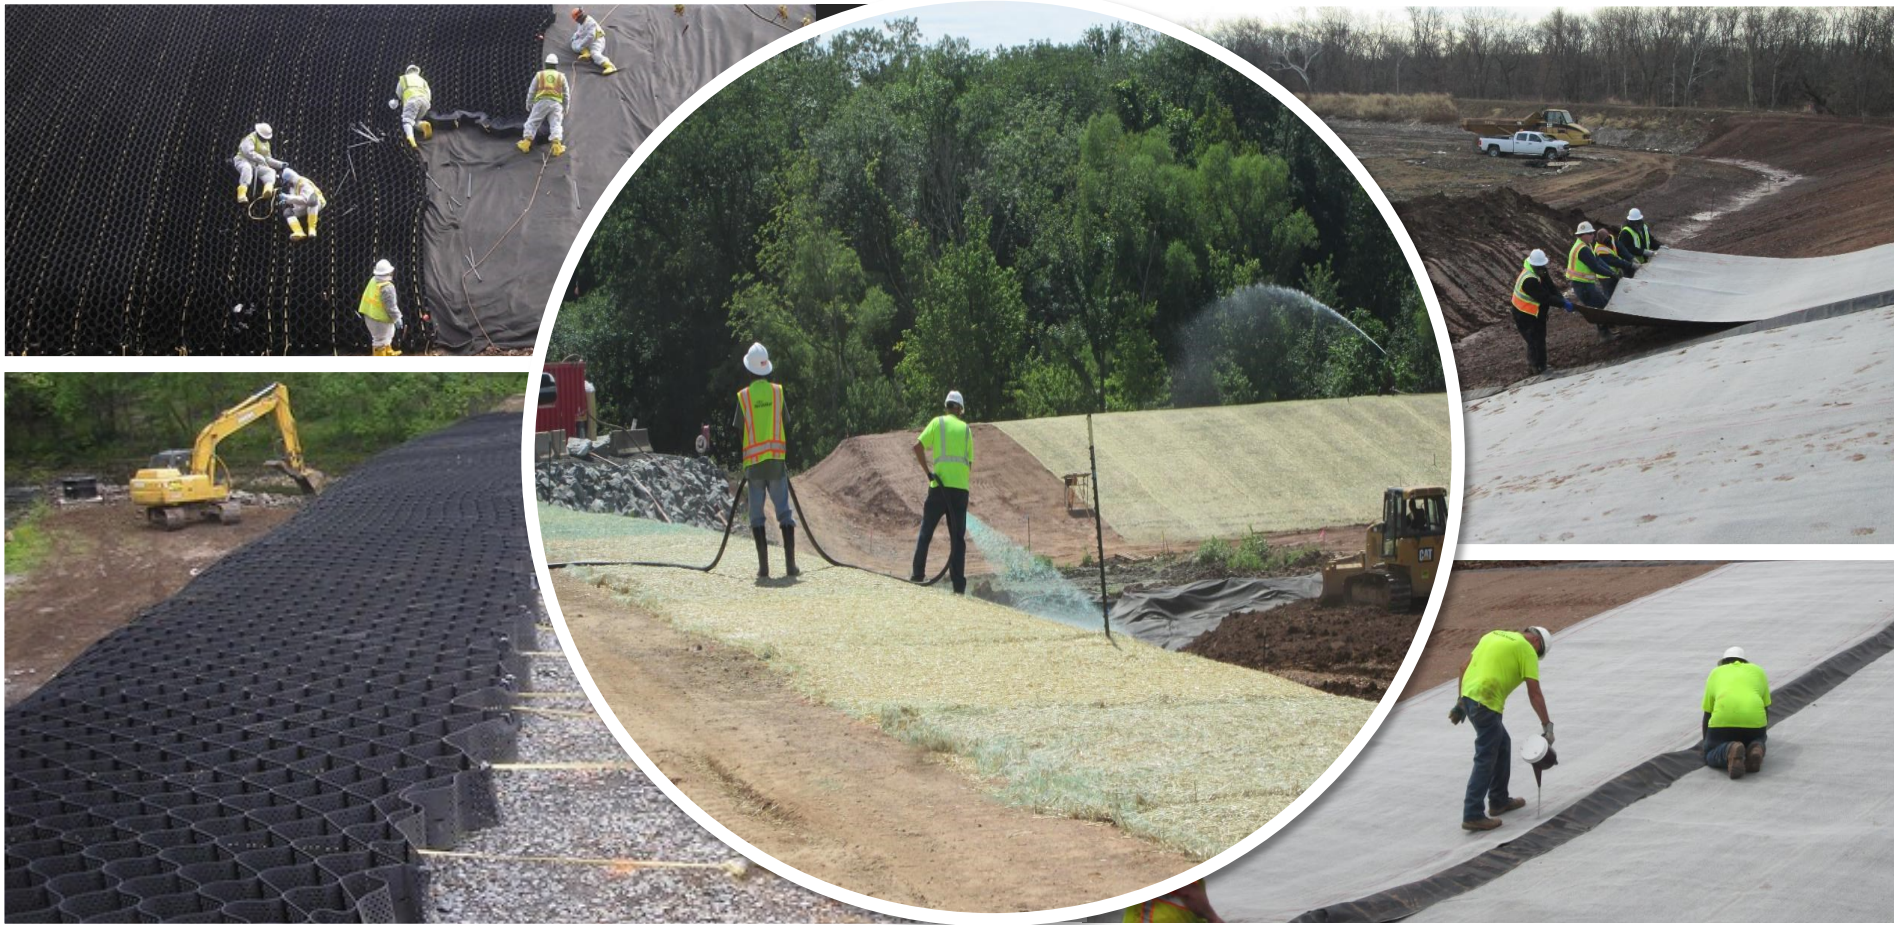
Geotextile was laid over the entire 32-acre site. Additional components of the cap were layered over the textile. **Top Left:** Workers secure high-density polyethylene geocells resembling a honeycomb over geotextile on a steep embankment of the Wissahickon. **Bottom Left:** A crane was used to fill geocells with stone. Soil was later placed over the geotextile and geocells and seeded. **Top Right:** Workers place geosynthetic clay-impregnated liner (GCL) on an inside section of the pond berm to increase structural stability. **Bottom Right:** Workers pore bentonite along the seams of the clay liner. **Center:** Workers hydro-seeding berm. Straw mats prevent erosion and help seeds to sprout.

made of high-density polyethylene was anchored to the slopes of the waste piles and the outer walls of the onsite pond. The compartments of the honeycomb were filled and then covered with soil on the upper slopes and with rocks on the lower slopes. The honeycomb structure increases the stability of the site slopes and helps plants to take root. As sections of the cap were completed, workers

hydro-seeded the soil with native grasses and wildflowers. Finally, the seeded areas were covered with erosion mats made of straw or, on steep slopes, woven, high-performance, turf mats, which allowed the seeds time to sprout. The seed mixture was selected for its suitability to the local climate and the terrain, and the stabilizing growth habits of the plants.
