*The*  
**BORIT ASBESTOS  
SUPERFUND SITE**

Ambler, PA **January 2016**

*A Story of*  
**PROGRESS**  
*and*  
**PROMISE**

A detailed look at the work of EPA's Superfund Removal Program

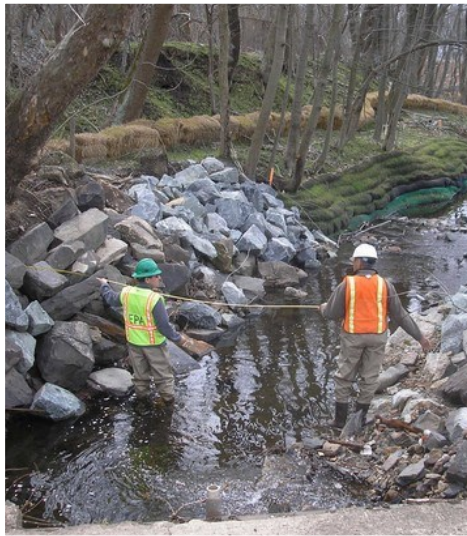
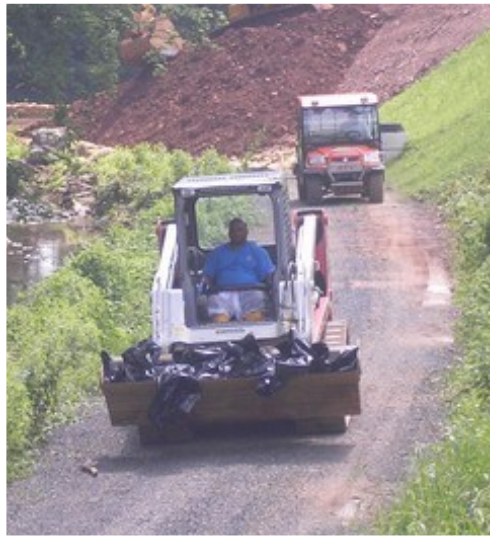
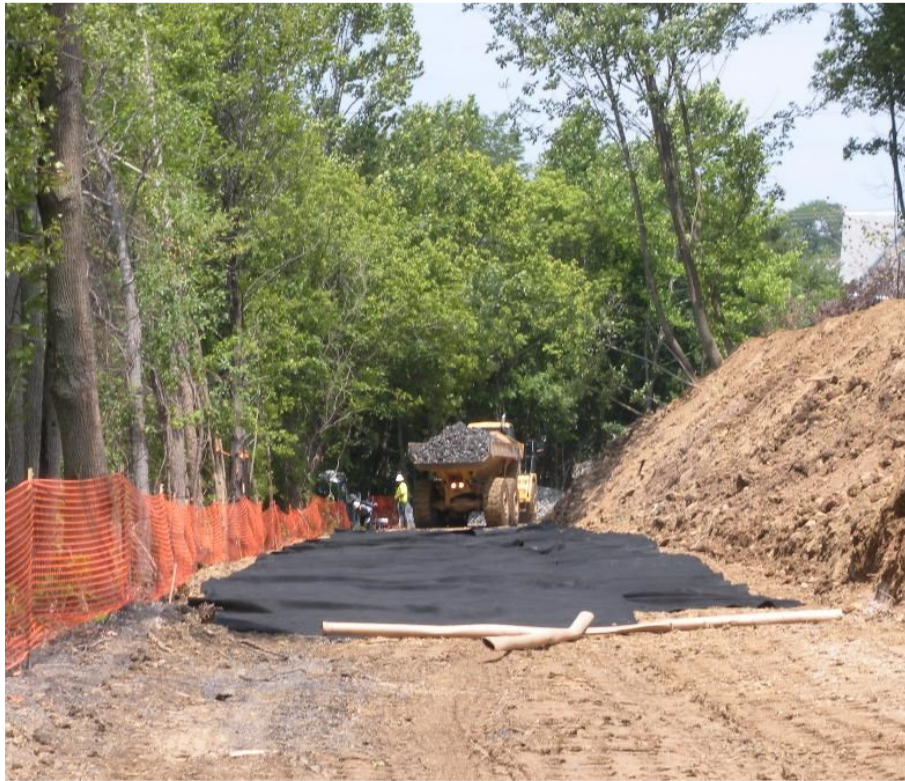
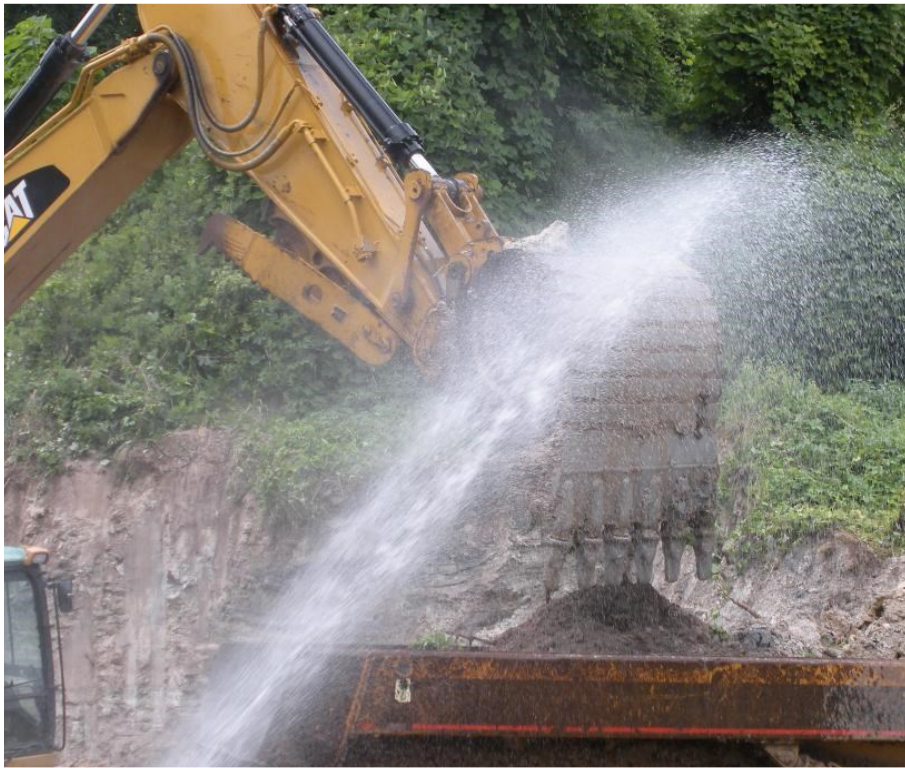
**Top Left:** Workers measure a section of Rose Valley Creek to prepare stream-bank stabilization plans. **Middle Left:** ACM, wetted, bagged and wrapped in plastic, is transported to Roll-Off shipping containers for disposal off-site. **Top Right:** Onsite access roads were built to ensure vehicles drove only on clean surfaces. Here, workers are placing geotextile and covering it with gravel. **Lower Right:** To suppress dust, water was used whenever contaminated materials were disturbed.

Throughout the work at the BoRit site, protecting the health of site workers and community members was, and continues to be, EPA's top priority. Whenever site work involved disturbing contaminated soil, water cannons were used to deeply saturate the soil to prevent the contaminants from becoming airborne. If a release of asbestos fibers were to occur, EPA personnel and contractors working on the site would be the first and most directly affected population. So, protecting onsite workers' health is of paramount importance, and it also ensures the protection of the surrounding communities. In addition to personal air monitors worn by site personnel, monitors were located along the fence-line to monitor ambient air for the presence of contaminants.

The construction of access roads throughout the site is another example of a protective measure taken by EPA to protect workers and community members. In order for trucks and heavy equipment to move about the site, gravel and clean fill were brought in to build roadways, all of which were underlain with geotextile like the rest of the cap. This ensured that trucks and other equipment did not drive through contaminated soils. Additionally, even though vehicles drive only on clean soil, equipment leaving the site is washed down to help limit the amount of nuisance dirt tracked through the neighborhood. While some dirt is still tracked onto local streets, EPA wants residents to know that when soil is tracked into the streets from the site it is clean fill.

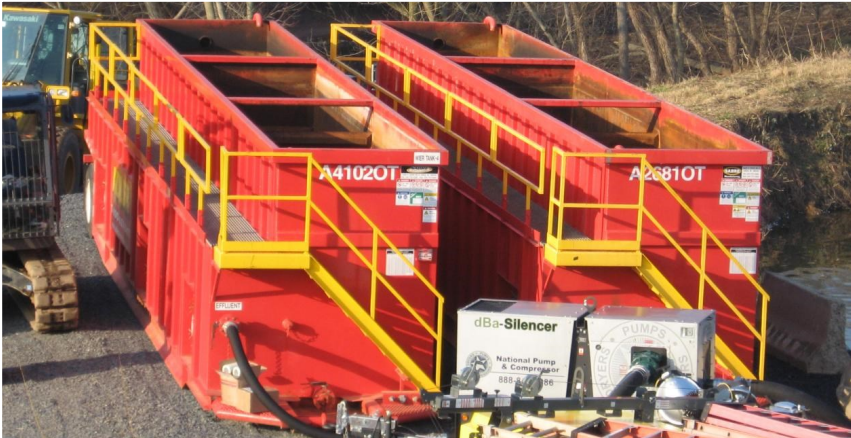
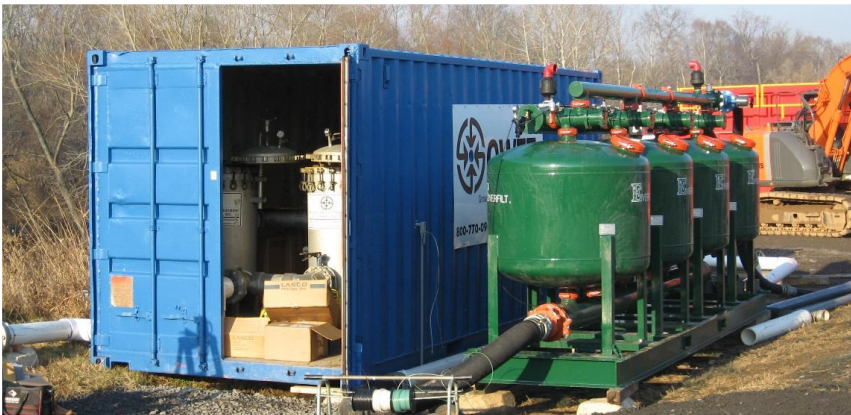
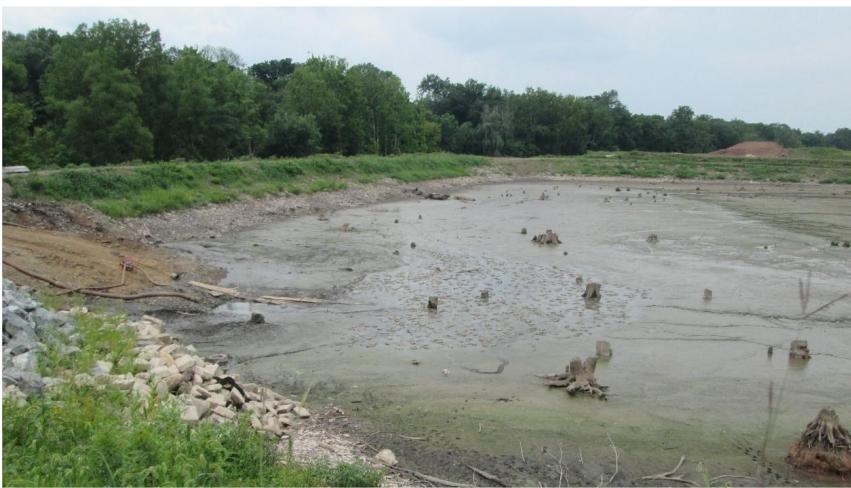
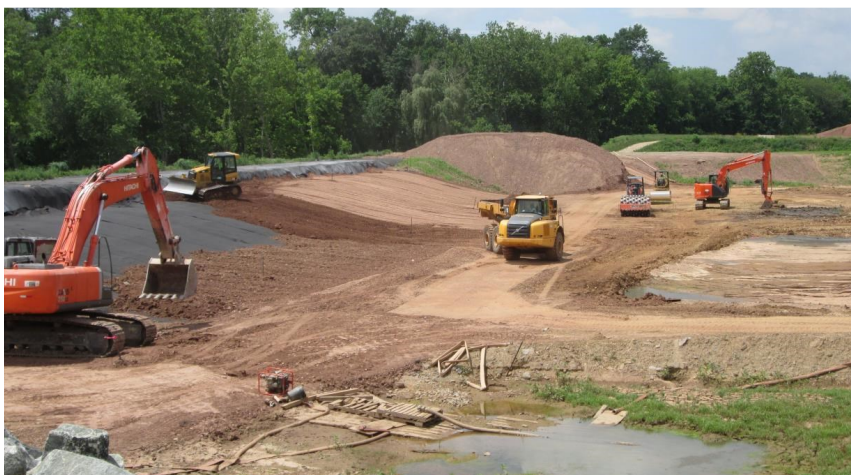
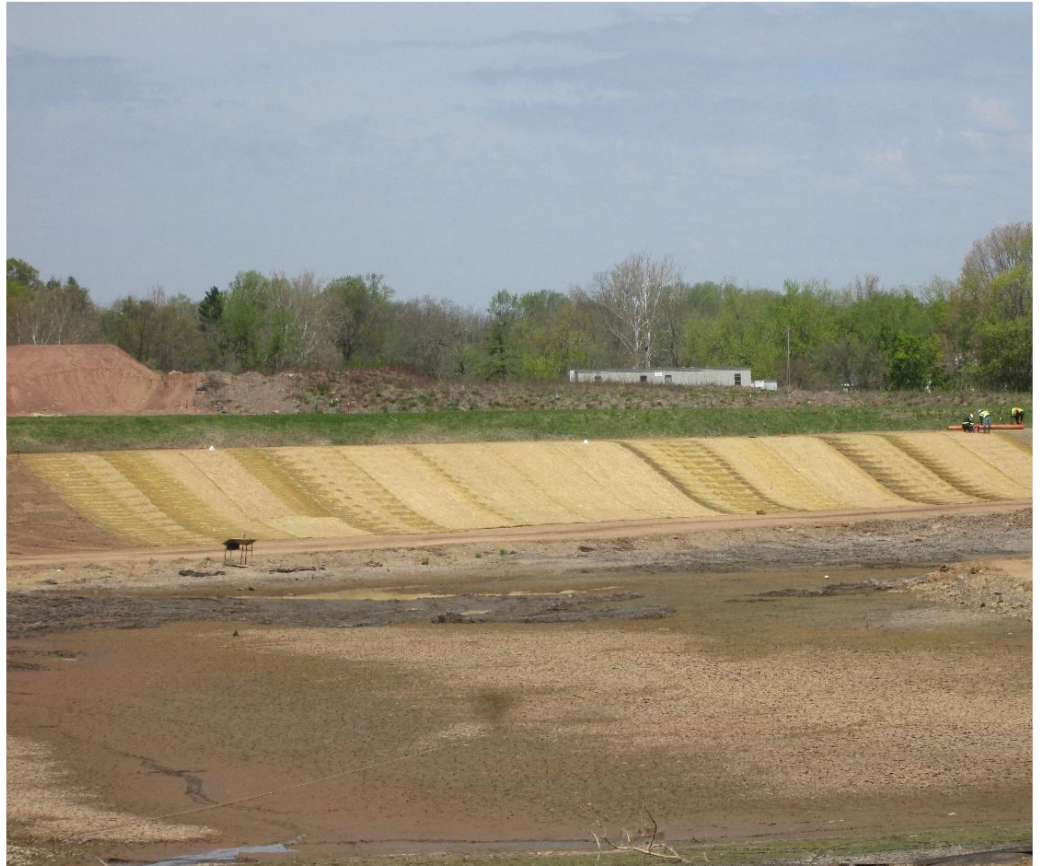
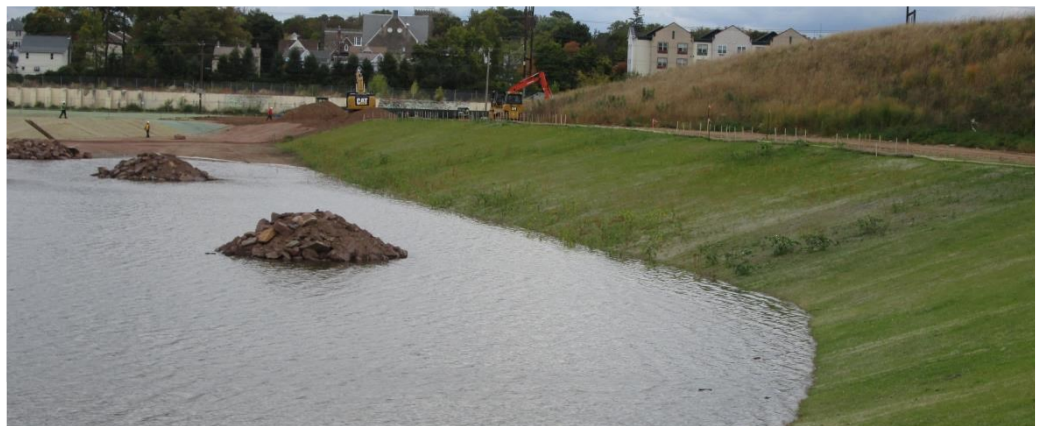
**Top Left:** Thirty-one million gallons of water were drained from the old reservoir through these holding tanks so that work on the pond could begin. Additional pumping was needed after each rain. **Upper Middle:** From the holding tanks, water went into these filtration units to be treated and sampled before being released into Wissahickon Creek. Throughout the project, more than 37 million gallons of water were treated. **Lower Middle:** When the water was drained, trunks of trees cut down decades ago were revealed and had to be removed. **Bottom Left:** Contractors work on the liner for the former reservoir which includes geotextile, GCL, and at least two feet of soil. **Top Right:** After the final soil cover was placed on the berm and seeded, straw mats were laid to ensure seeds had time to take root. **Bottom Right:** Water from the Wissahickon was pumped into the finished pond at 300 gallons/minute, 12 hours/day, 7 days/week. When the pond is filled, the stone piles will be submerged and will provide protection for fish and turtles.

The 10-acre impoundment, now referred to as ‘the pond’, was also stabilized and improved. Its walls (aka berms), which were built of the same materials as the waste piles, were unstable in some areas when work began, especially along portions of the Wissahickon and Rose Valley Creeks. Working with the Army

Corps of Engineers, EPA drained the pond of 31 million gallons of standing water and treated the water before releasing it into Wissahickon Creek. The pond bottom contained the remains of trees cut down and left in place when the impoundment was originally constructed. The tree stumps were removed, and the geotextile was laid. Then it was covered with a minimum of two feet of soil. In unstable areas of the berm and the pond bottom, lime was mixed into the soggy base materials

and a clay-impregnated liner was laid on the inner surface of the berm to add stability. The outer walls of the berms were treated in the same manner as other areas of the site with various combinations of geotextile, soil, polyethylene honeycomb fabric or cabled

concrete mats, and rip rap, as appropriate for each area. Additionally, an island was constructed in the pond to provide habitat for migratory birds.

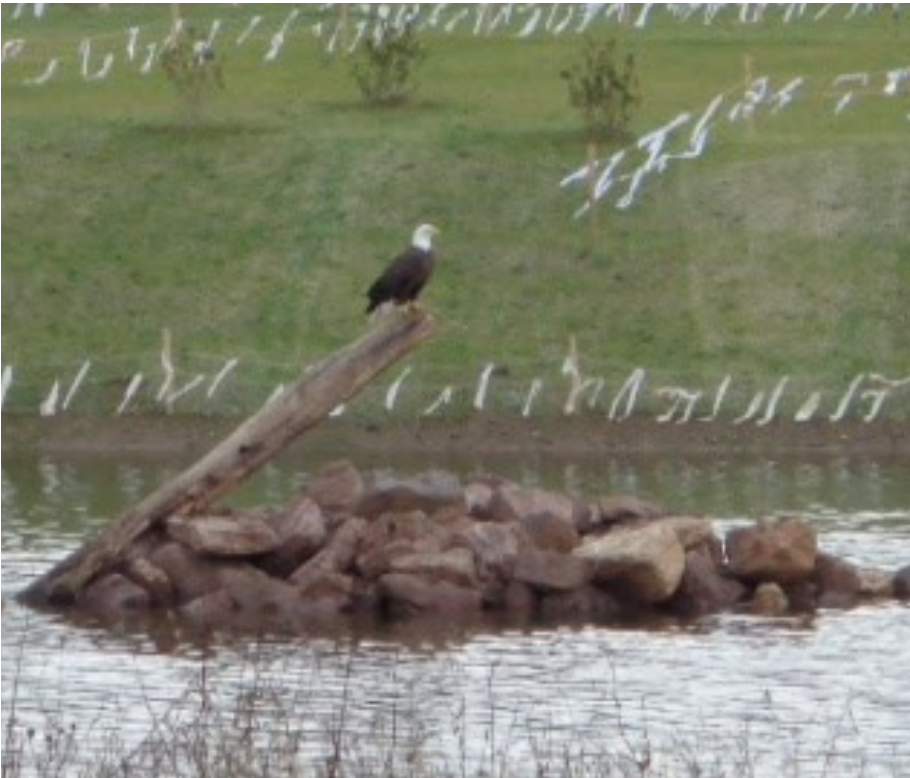
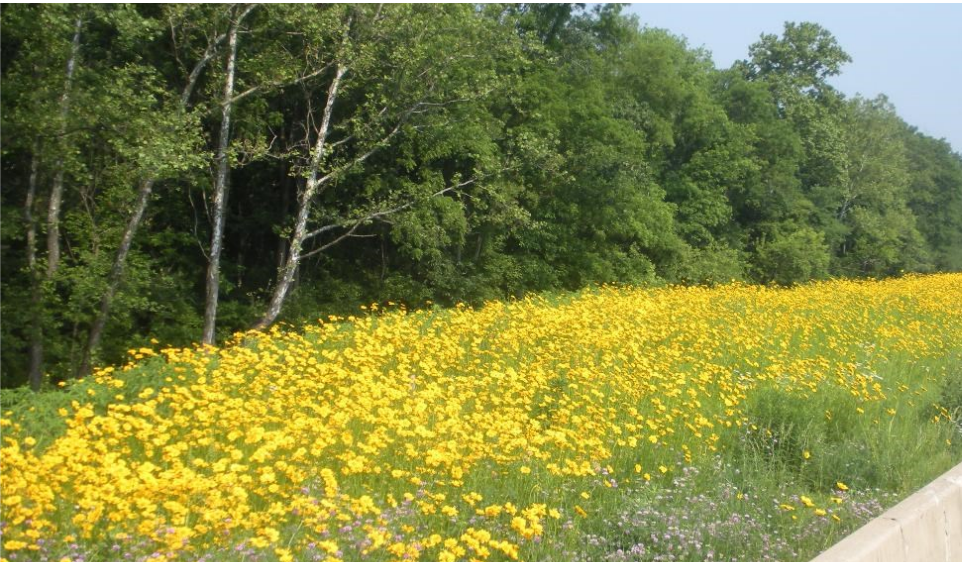
**Left:** An eagle perches on one of several tree branches anchored in the pond to provide sanctuary for birds. The rock pile is one of many built to shelter fish and other aquatic animals. Temporary white flags help to keep birds from disturbing young plants before roots have matured. **Right:** Wildflowers covered finished areas of the site in Spring 2015.

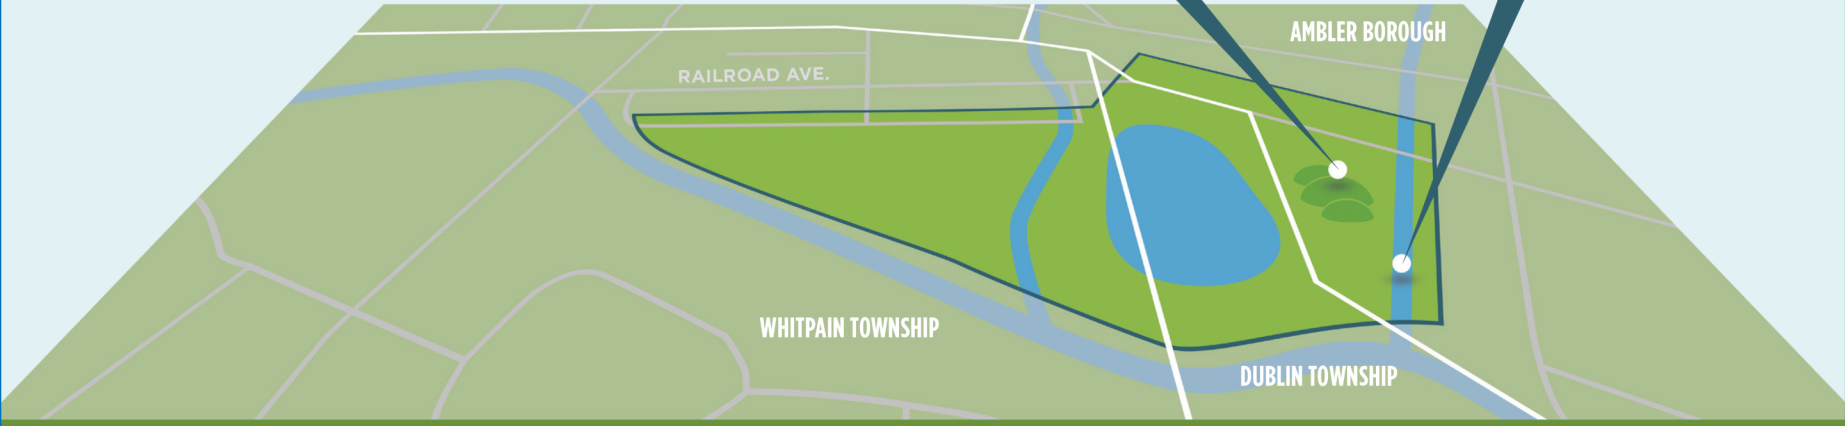
### RE-ENGINEERED CREEKS

Rose Valley Creek and Tannery Run were widened to accommodate storm flows. Then the bottoms and sides were lined with cabled concrete mats and large rocks called rip rap.

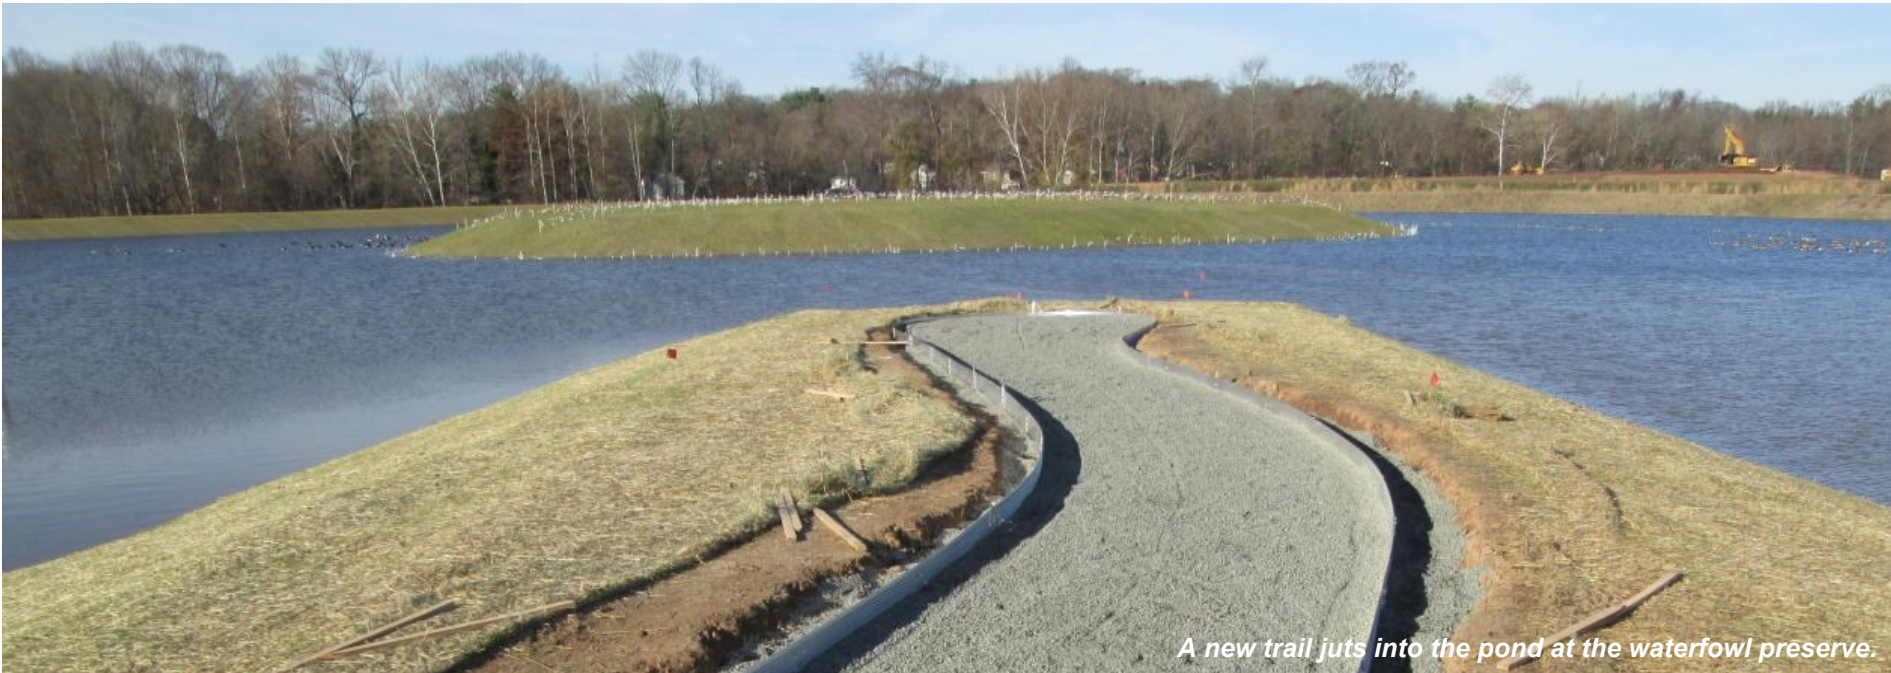
A new trail juts into the pond at the waterfowl preserve.
