**FEDERAL ON-SCENE COORDINATOR'S
AFTER ACTION REPORT
for the
FOURCO GLASS SITE
CLARKSBURG, HARRISON COUNTY, WEST VIRGINIA
October 11, 2010 to October 25, 2010**

**UNITED STATES
ENVIRONMENTAL PROTECTION AGENCY
REGION III
WHEELING, WEST VIRGINIA**

**Federal On-Scene Coordinator's Report
Fourco Glass Site**

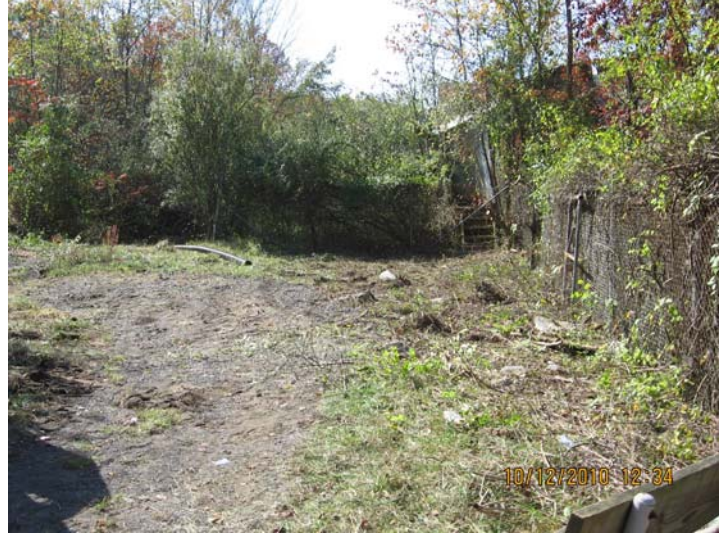
10/12/2010
Rails to Trails trail upon initial ERRS entry and work (North)
IMG_5435.jpg

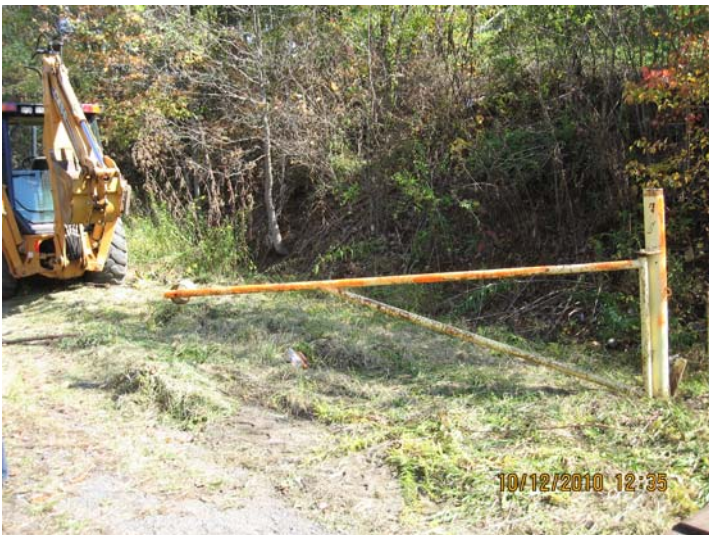
10/12/2010
Area at head of RTT trail where ERRS will stage materials (S)
IMG_5436.jpg

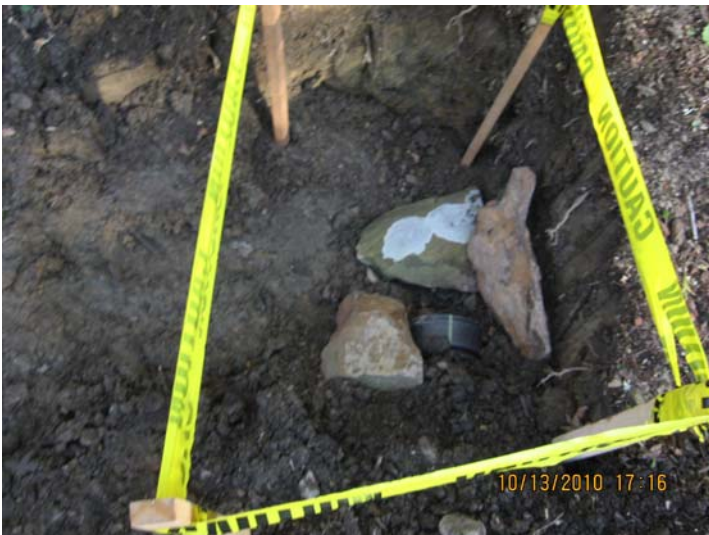
10/13/2010
Area along RTT trail where underflow drain pipe was installed
IMG_5478.jpg

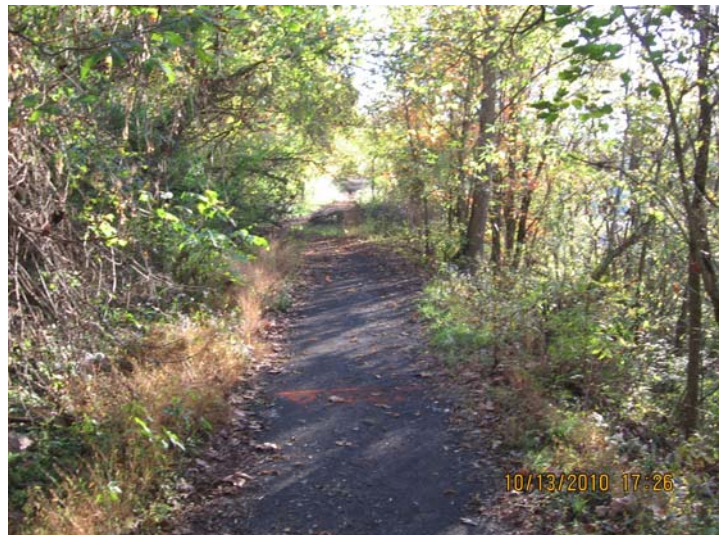
10/13/2010
Head of installed drain pipe - water will cross from (E) to (W)
IMG_5482.jpg

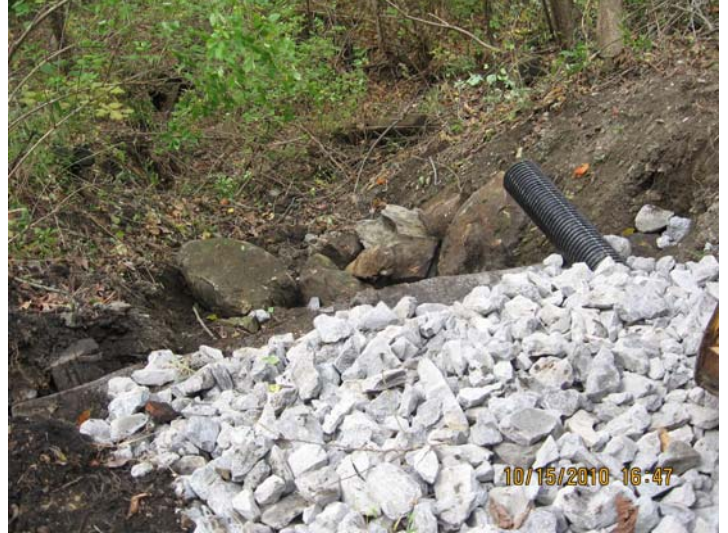
10/15/2010
Slag pile boundary with riprap installed in buttress system (N)
IMG_5536.jpg

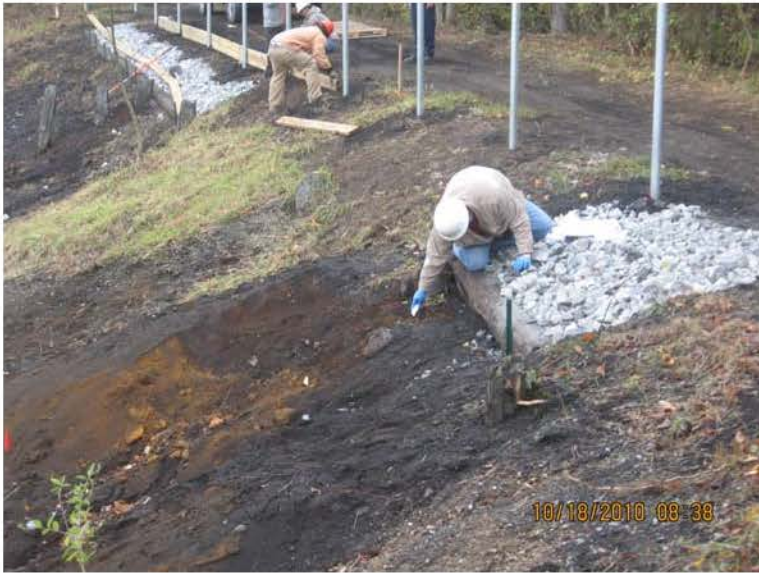
10/18/2010
START Hpreparing to collect a waste sample from the slag pile. AG-PL
IMG_5567.JPG

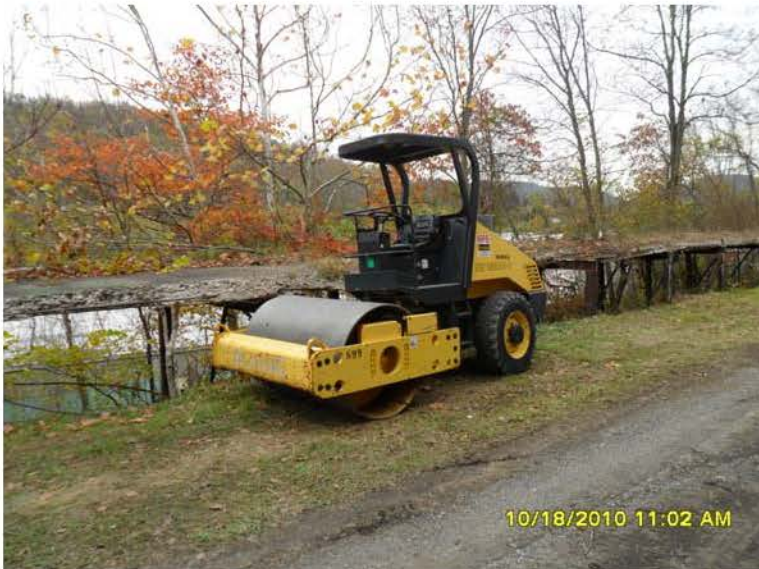
10/18/2010
View of gravel base compacted on trail.
SAM_0001.JPG

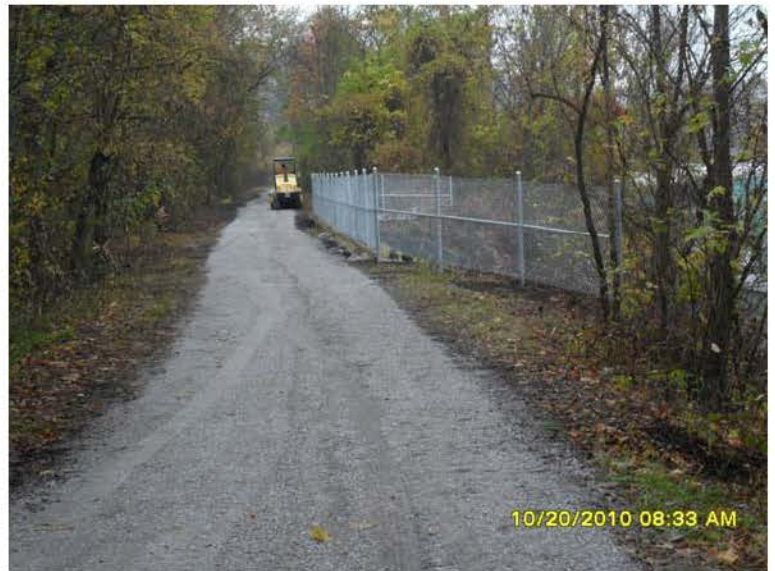
10/20/2010
Extent of the trail which will be capped. Note the 2 orange stakes on the hillside.
SAM_0015.JPG

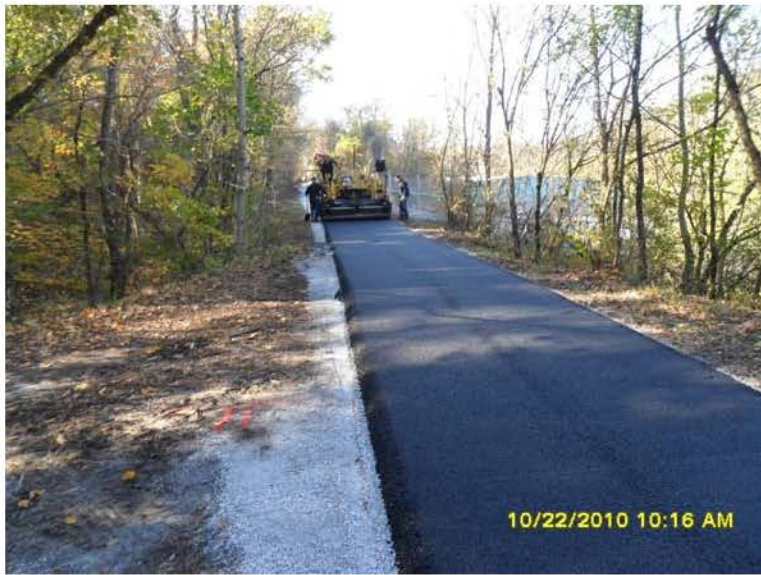
10/22/2010
Paving of the trail. Started at North end and worked south ...
SAM_0036.JPG

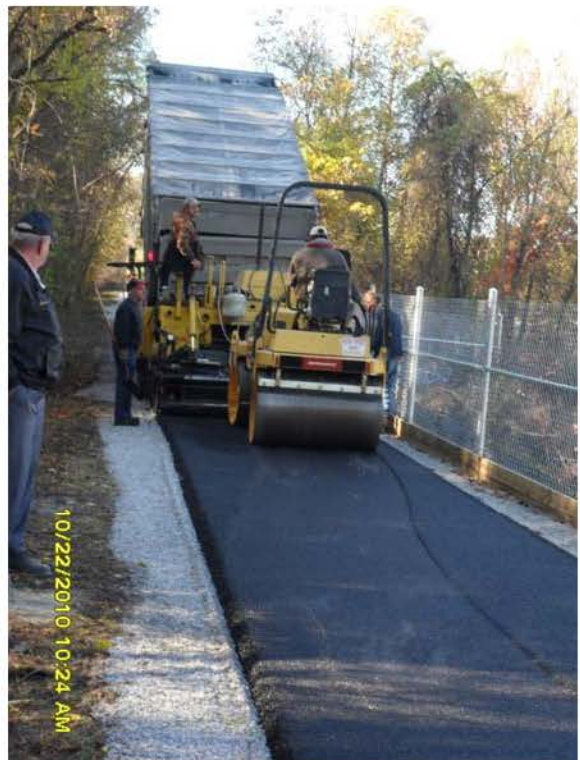
10/22/2010
Compaction on trail after asphalt was laid.
SAM_0039.JPG
