**FOURTH FIVE-YEAR REVIEW REPORT FOR
CROYDON TCE SUPERFUND SITE
BUCKS COUNTY, PENNSYLVANIA**

DECEMBER 2016

**United States Environmental Protection Agency
Region 3
Philadelphia, Pennsylvania**

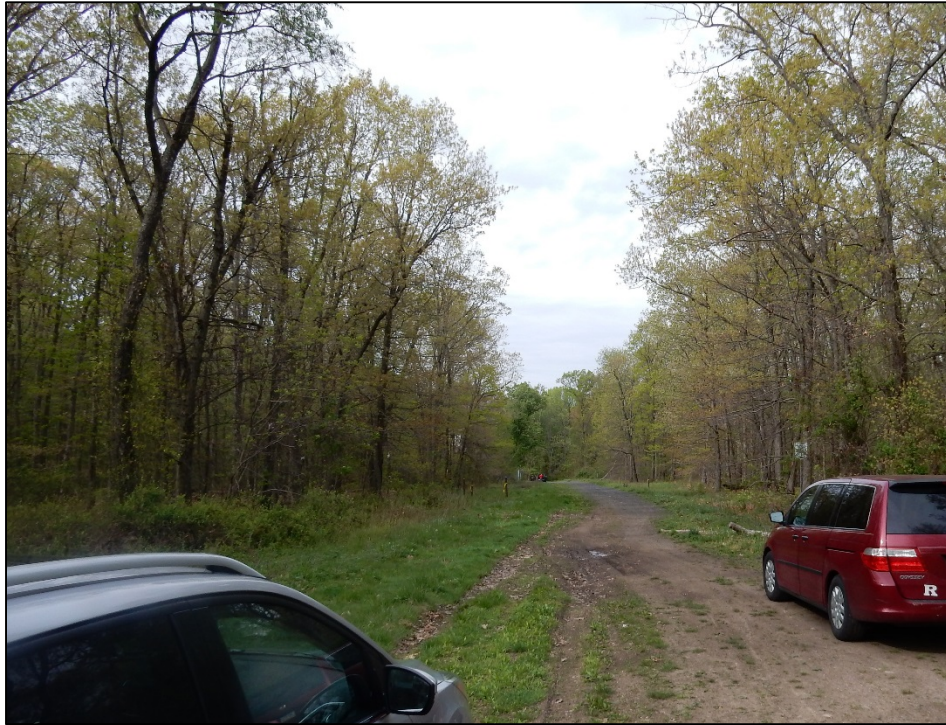
Site inspection participants met at the access road to the treatment plant building, along Stella Avenue. The access gate leading onto the Heritage Conservancy property was unsecured. The Heritage Conservancy representative indicated that the local fire department had recently cut the gate's lock to gain access to the Site for a reported fire caused by trespassers. Trespassing and vandalism are an ongoing nuisance. Evidence of trespassing (trash, evidence of campfires, vehicle tracks) were observed across the property during the site inspection.

Access road to the groundwater treatment system building

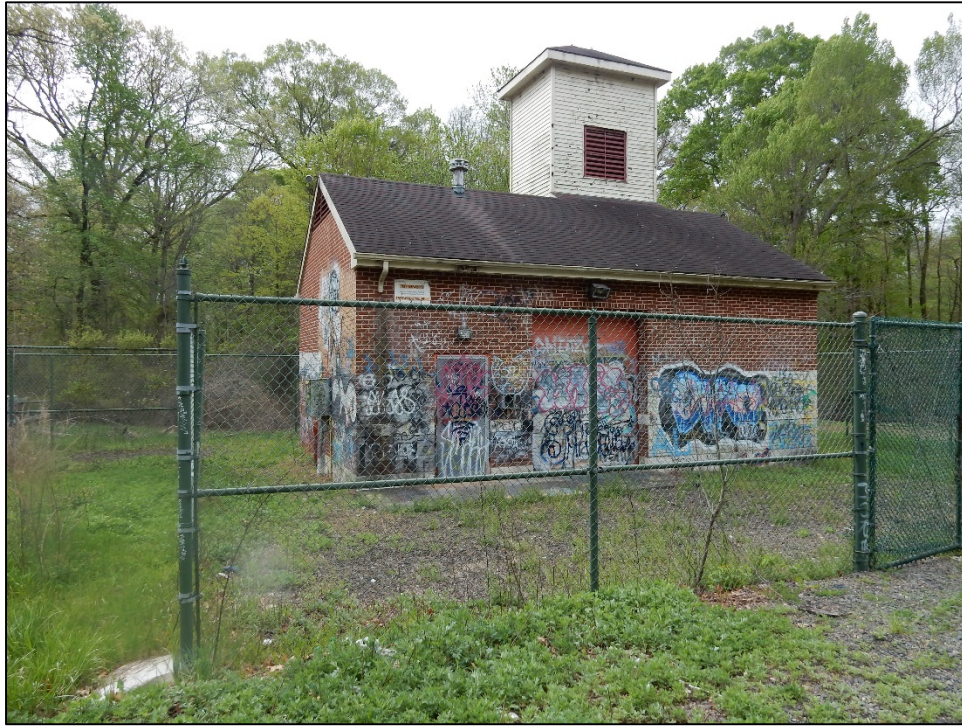
The groundwater extraction and treatment system is no longer in operation, but the treatment system building remains. The treatment system building, although covered in graffiti, is in relatively good condition and is enclosed with chain-link fencing. The building is currently bolted shut to deter unauthorized access. The interior of the building was not observed during the site inspection. PADEP representatives indicated that electricity and water have been shut off to the treatment system building. It is anticipated that remaining system components, including the chain-link fence, will be dismantled and removed within the next year.

Trespassing and vandalism of the treatment system building are ongoing issues at the Site. During this FYR period, fencing has been cut on multiple occasions, door locks and alarms to the treatment system building have been damaged, and various system components have been found missing or damaged. PADEP's contractor has contacted the Bristol Township Police Department on several occasions to report the damage.

Fenced groundwater treatment system building

- Trespassing and vandalism are an ongoing nuisance for the property where the groundwater treatment system building is located. PADEP plans to dismantle the treatment system building in the near future. Wells found unlocked during the site visit should be secured. The lock on the access gate cut by the fire department should be replaced. PADEP and the property owner should explore additional security measures to ensure the integrity of any remaining remedy components, such as monitoring wells and extraction wells.
- The site repository did not include the complete administrative record for the Site. The site repository will be updated with OU1 and OU2 site documents.
- A risk assessment will be performed once groundwater cleanup goals are achieved to evaluate cumulative risk from multiple contaminants.

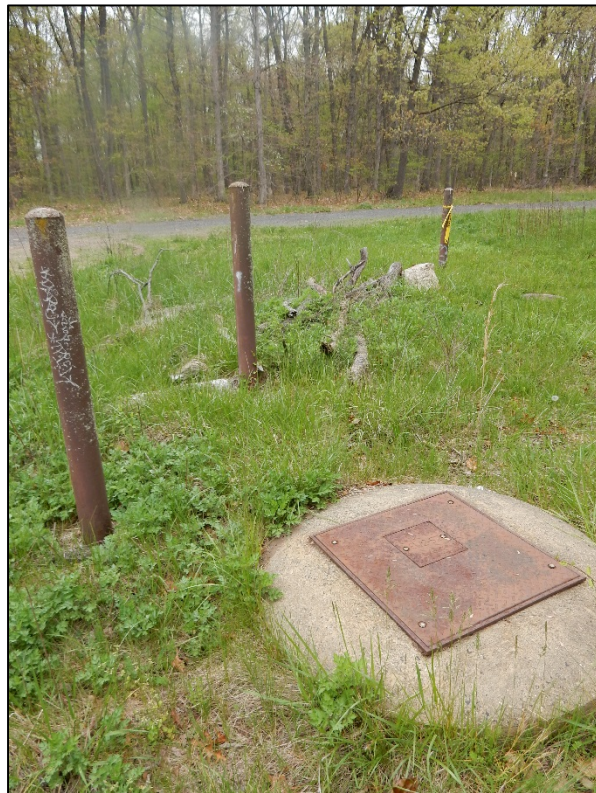
Former extraction well EW-1

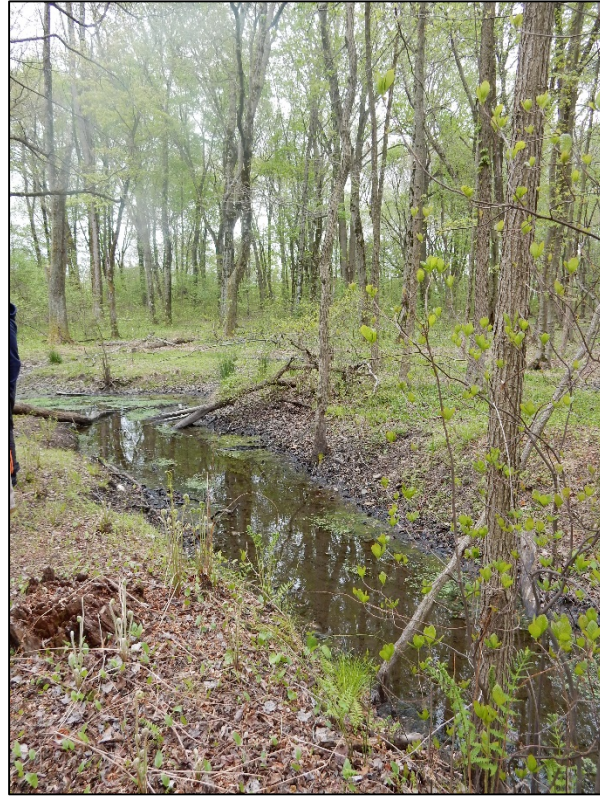
Site inspection participants observed the West Branch of Hog Run Creek, which is included in the semi-annual sampling program for the Site. Low-flow conditions were observed at the time of the inspection.

West Branch of Hog Run Creek

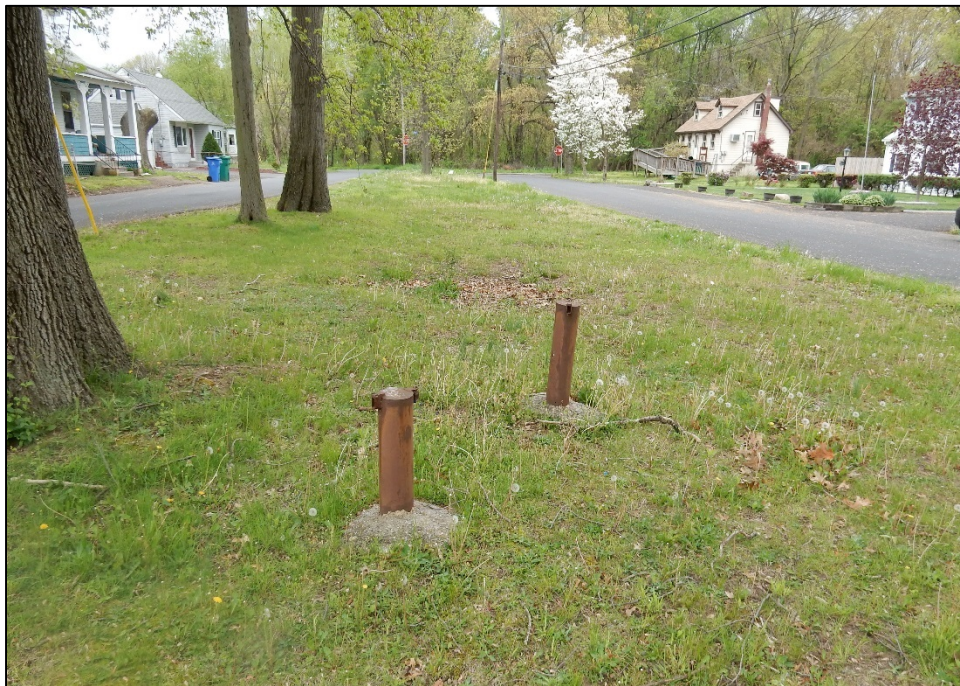
Site inspection participants inspected several of the monitoring wells included in the current monitoring program, which included wells in the residential area of the Site. Most wells were found locked and in generally good condition; one of the wells was found to be unsecured due to a rusted lock.

Monitoring wells

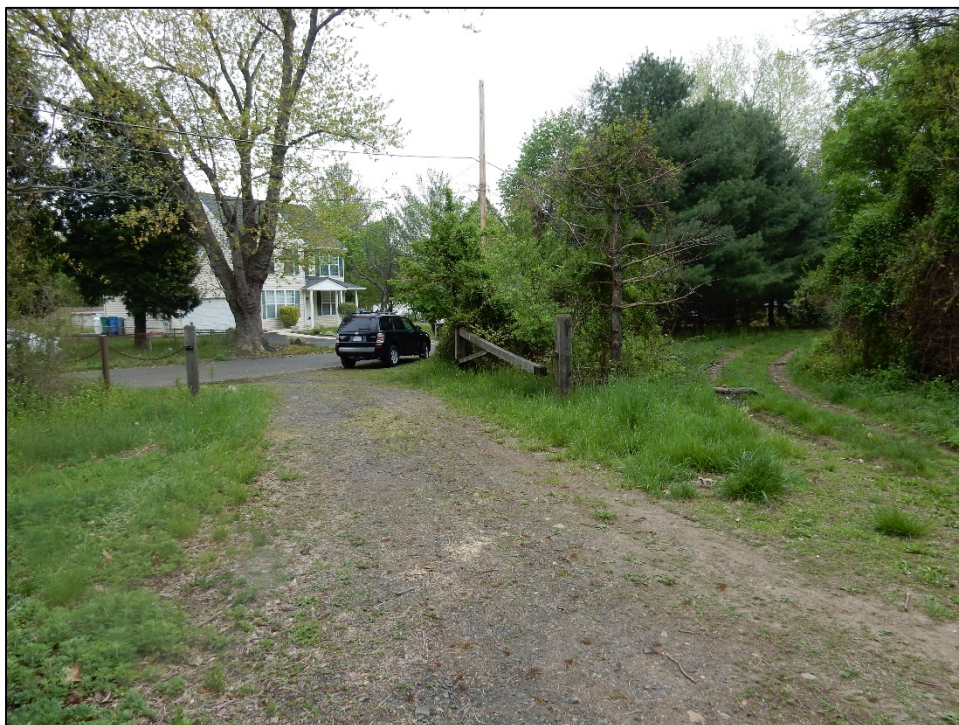
View of access road looking toward gate at Stella Avenue
