**FOURTH FIVE-YEAR REVIEW REPORT FOR  
RENTOKIL, INC. (VIRGINIA WOOD PRESERVING DIVISION) SUPERFUND SITE  
HENRICO COUNTY, VIRGINIA**

**JULY 2018**

**U.S. Environmental Protection Agency  
Region 3  
Philadelphia, Pennsylvania**

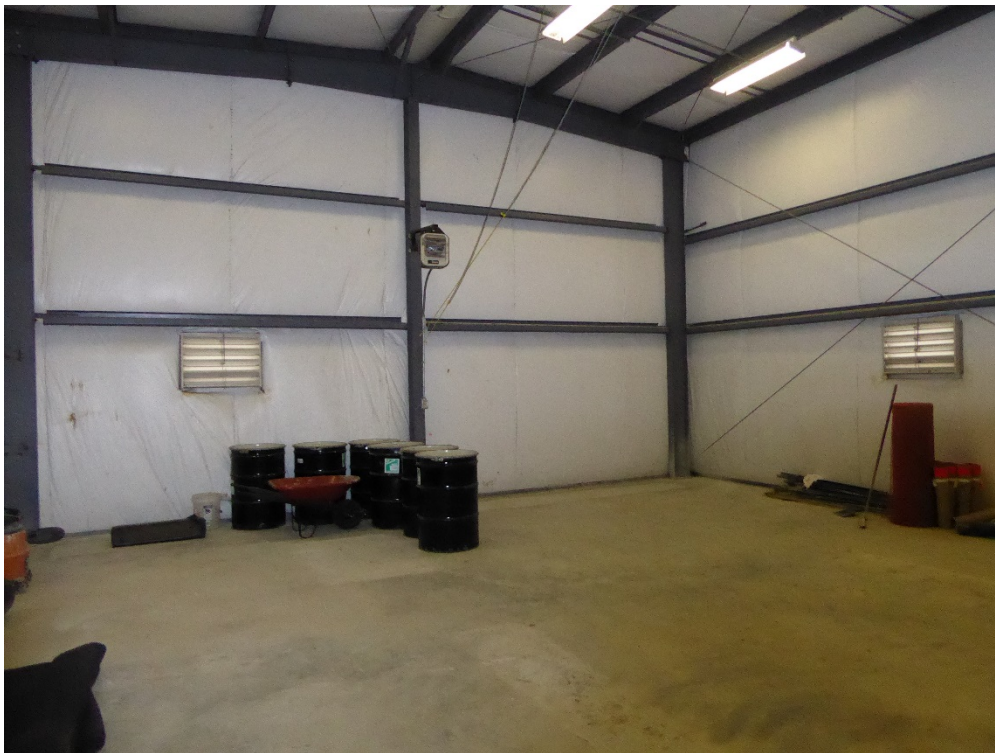
A 2008 groundwater extraction test determined that site groundwater conditions, from a contaminant concentration and flow velocity/direction standpoint, are similar under extraction conditions and under the natural conditions observed since the shut-down of the extraction system. Based on the results, EPA and VDEQ agreed to the indefinite suspension of groundwater extraction system operation. In April 2015, with EPA approval, the PRP removed the groundwater extraction pumps and abandoned the groundwater extraction laterals per VDEQ requirements. The remainder of the groundwater extraction system, including the above-ground pumps, piping and tanks, was removed from the site in 2016. In January 2017, the PRP removed components of the containment area dewatering system from the water facility building. The building remains in place, but is no longer in use.

Inside water facility building formerly used to house cap dewatering system

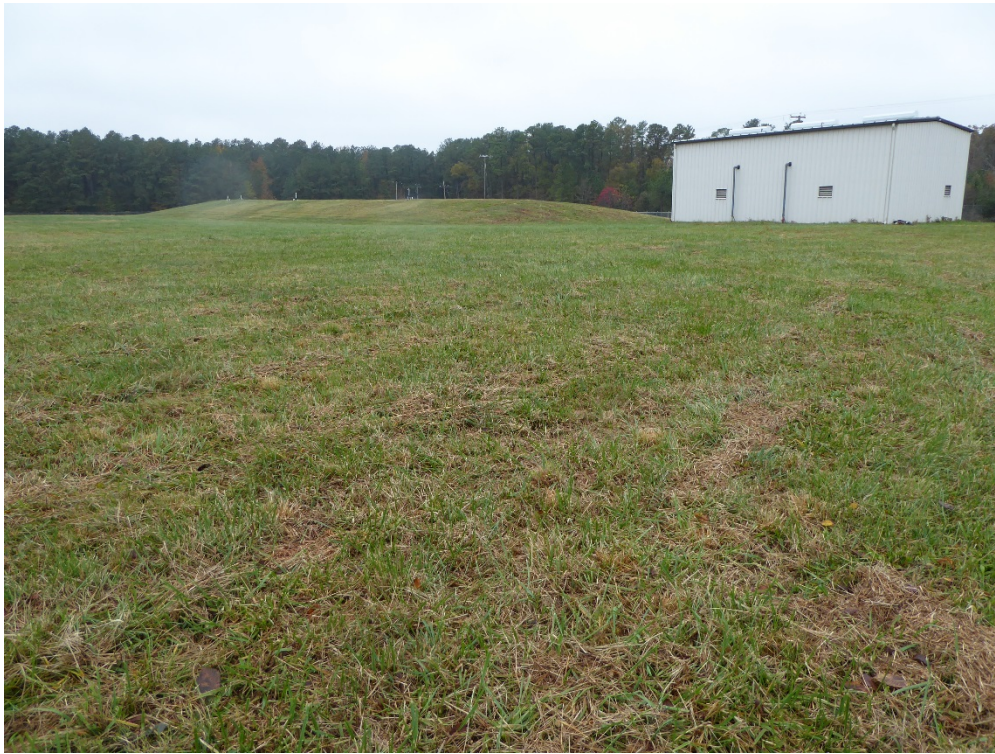
Site inspection participants inspected the cap and slurry wall areas. No damaged fencing was noted. The original cap was in good condition and vegetation is well established. No erosion was evident. Participants noted that one of the sanitary sewer tie-ins along the Peyton Street cap edge was damaged. The newly capped area was recently seeded; the vegetation was thin and absent in some areas. Arcadis and EPA will evaluate whether additional seeding is needed in 2018. Site inspection participants then left the fenced cap and slurry wall area to inspect the monitoring wells and observe Wetland Area A and North Run Creek. All monitoring wells were locked. Arcadis installed three new monitoring wells to replace the wells abandoned during the cap and slurry wall extension. Two of the new wells, VPDW-04R and VPDW-05R, were observed during the site inspection and found to be labelled inside the well casing, but not outside. EPA suggested that Arcadis ensure that all wells are labelled both inside and outside the well casing. VPMW-4 was not labeled and the concrete well base was cracked. Participants noted that VPMW-5 and VPMW-6 had standing water between the inner and outer (protective) well casings. EPA discussed these items with Arcadis, and Arcadis agreed to address the well issues noted. Site inspection participants observed the Wetland Area A, North Run Creek and the stormwater basin. No issues were noted in these areas. Site inspection participants left the fenced cap and slurry wall area and observed former Wetland Area B, which is fenced and supports well-established vegetation.

Looking northwest across original capped area

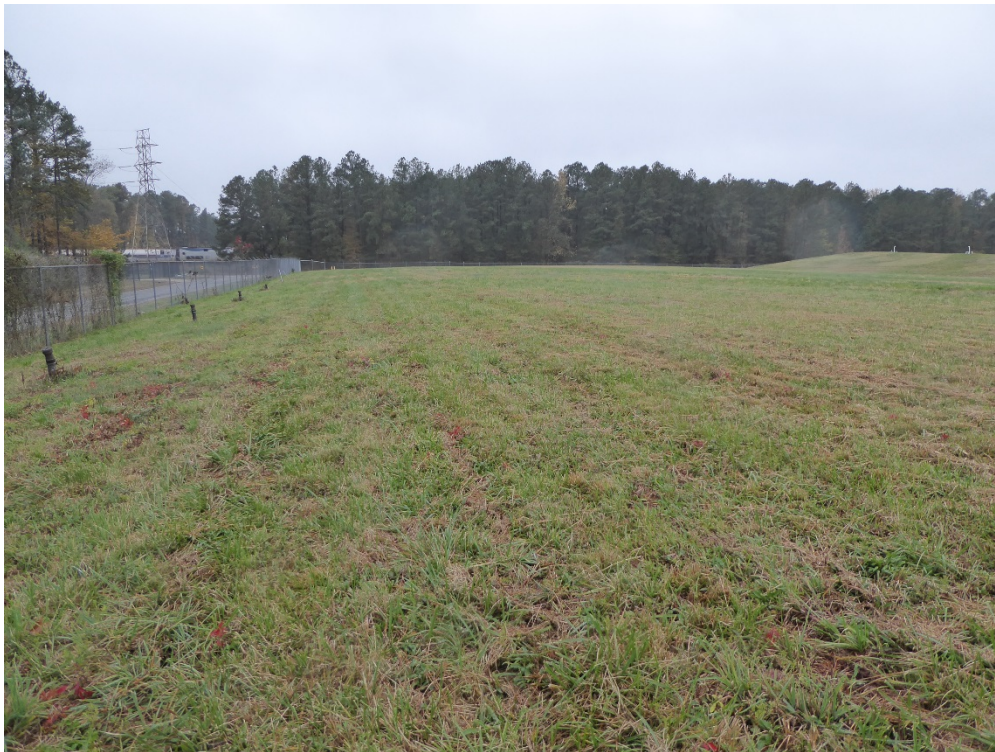
Looking southwest across original capped area (sanitary sewer tie-ins visible along Peyton Street side of the cap)

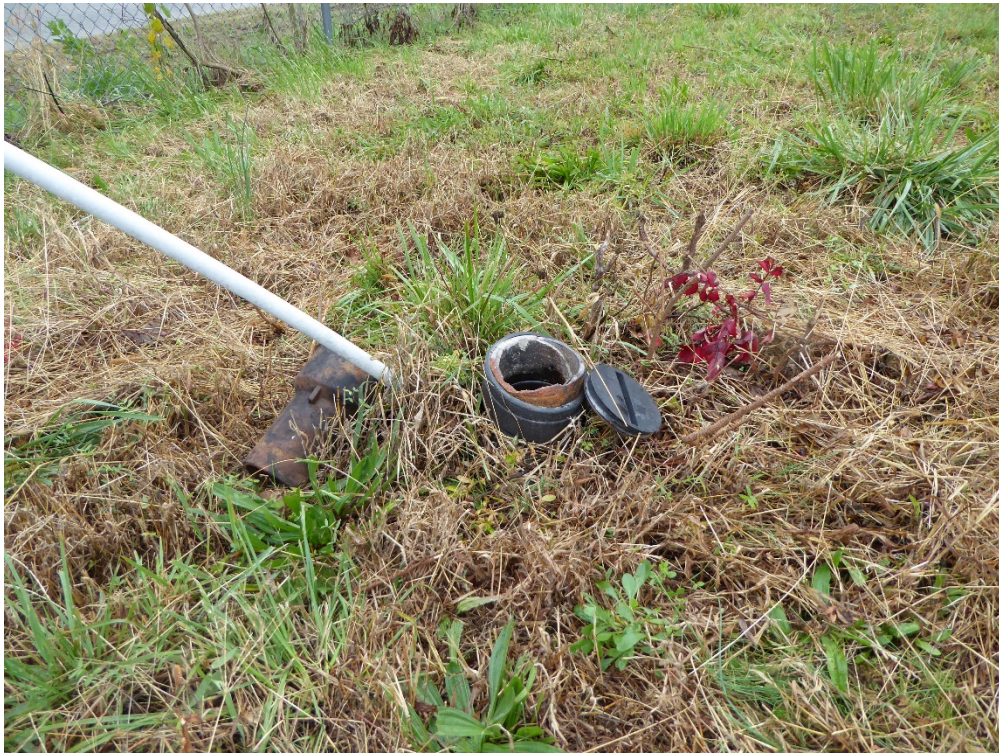
Damaged sanitary sewer tie-in along Peyton Street cap edge

Site O&M is adequate. Based on a review of the available O&M reports and the site inspection, no significant issues have been noted since the previous FYR regarding the condition or functionality of the cap, slurry wall or stormwater controls. A few minor O&M issues were noted during the FYR site inspection and were addressed by the PRP in January 2018.

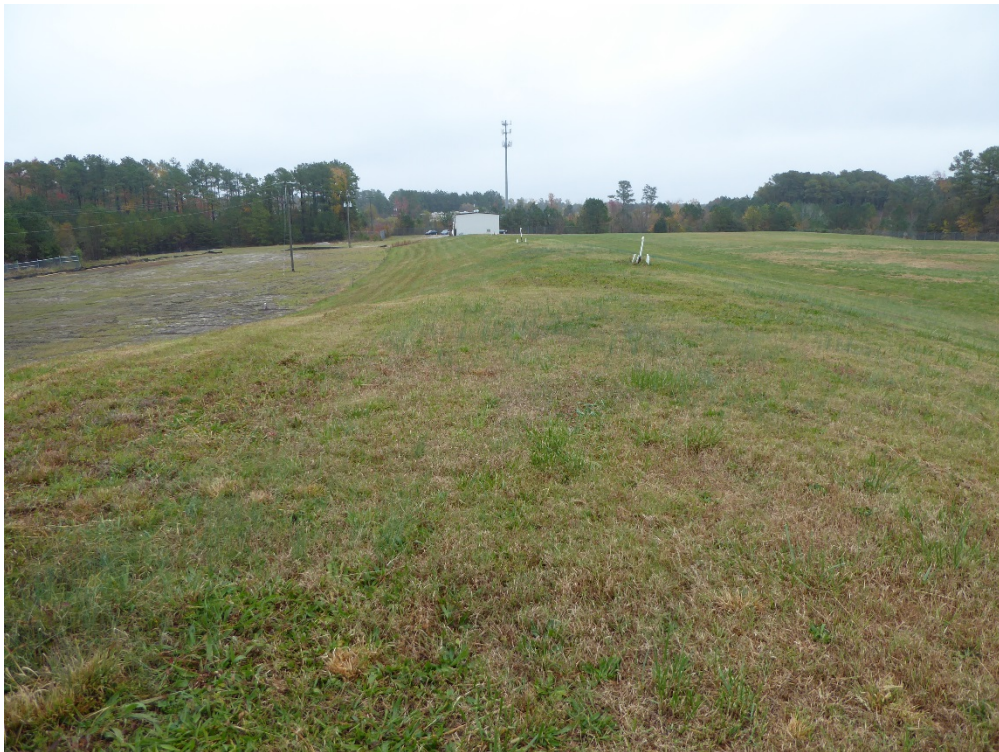
Looking northeast along newly capped area (left) and original capped area (right)

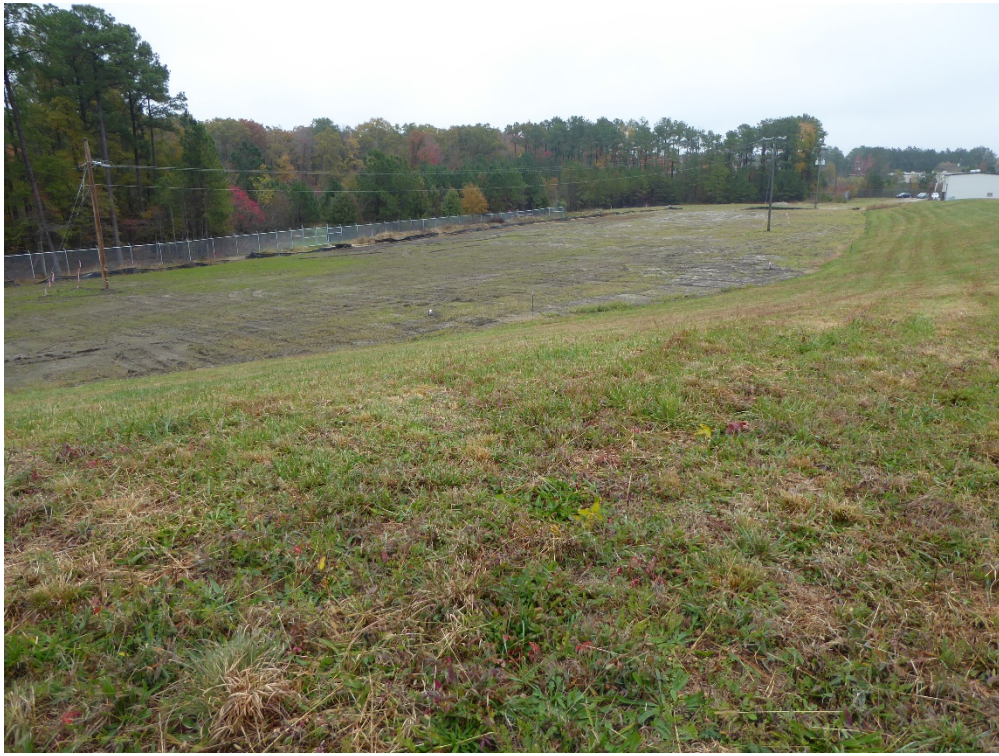
5.	<b>Vegetative Cover</b> <input checked="" type="checkbox"/> No signs of stress Remarks: <u>Vegetative cover is properly established over the original capped area. Vegetative cover over the newly extended capped area is thin; site inspection participants observed bare spots.</u>	<input checked="" type="checkbox"/> Grass <input type="checkbox"/> Trees/shrubs (indicate size and locations on a diagram)	<input type="checkbox"/> Cover properly established

Looking northeast at newly capped area

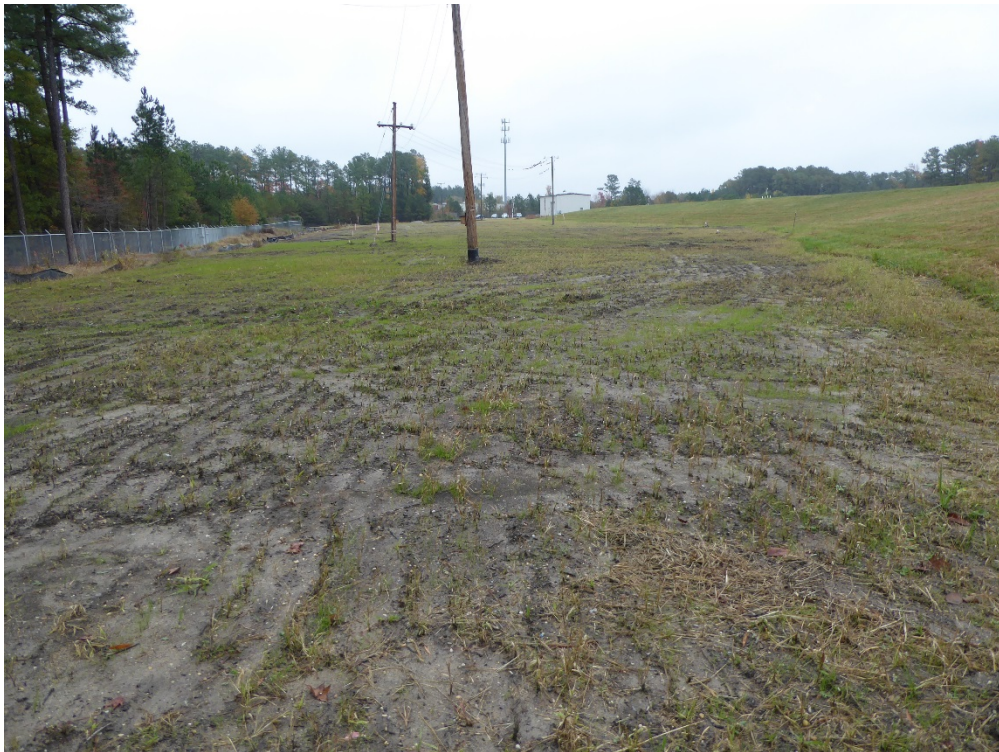
Looking northeast across newly capped area

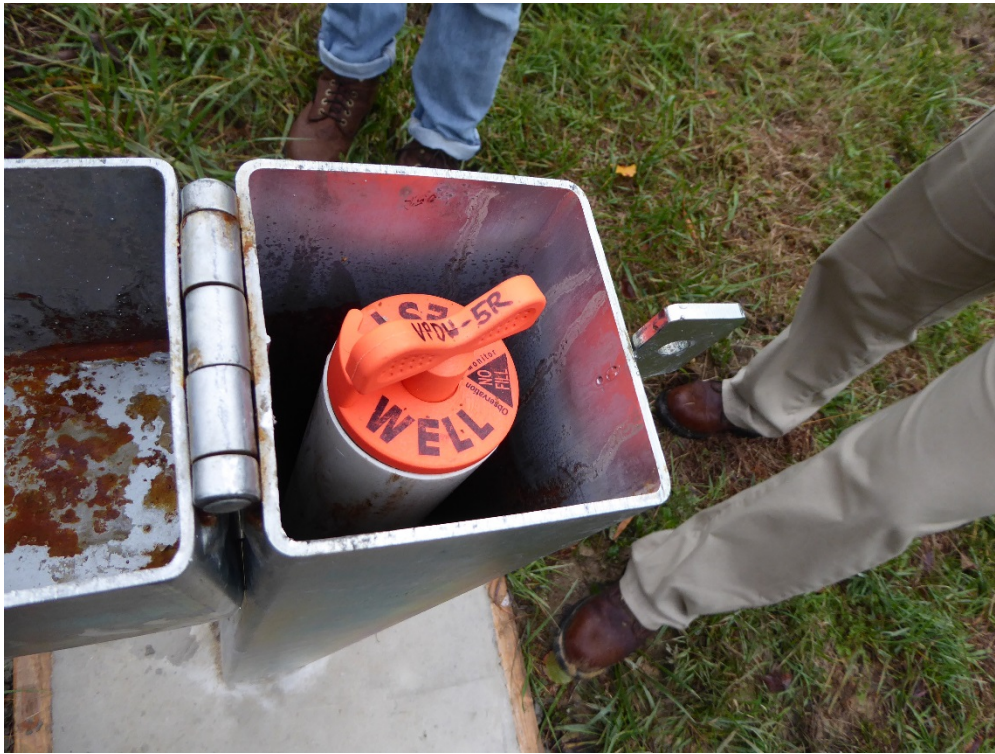
New monitoring well VPDW-5R

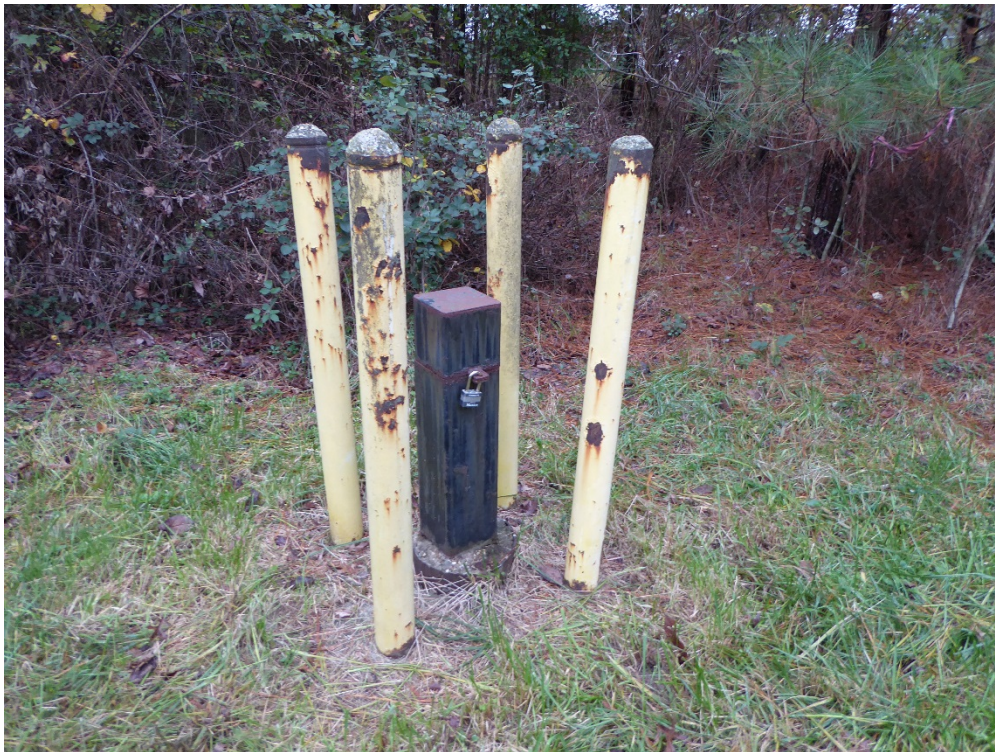
6. <b>Monitoring Wells</b> (pump and treatment remedy) <input checked="" type="checkbox"/> Properly secured/locked <input checked="" type="checkbox"/> Functioning <input checked="" type="checkbox"/> Routinely sampled <input type="checkbox"/> Good condition <input checked="" type="checkbox"/> All required wells located <input checked="" type="checkbox"/> Needs maintenance <input type="checkbox"/> N/A Remarks: <u>Monitoring wells on site are used to assess the performance of the slurry wall and cap (they are not part of a pump and treat remedy). All monitoring wells are secured with locks. At the time of the site inspection, monitoring well VPMW-4 was not labeled and the concrete base of the well was cracked. Recently installed monitoring wells VPDW-04R and VPDW-05R were not labeled outside the well casing, and standing water was observed inside the casing of wells VPMW-5 and VPMW-6. A weight was also observed stuck in the well casing of well VPMW-5.</u>

VPMW-4 (not labelled and has cracked concrete base)

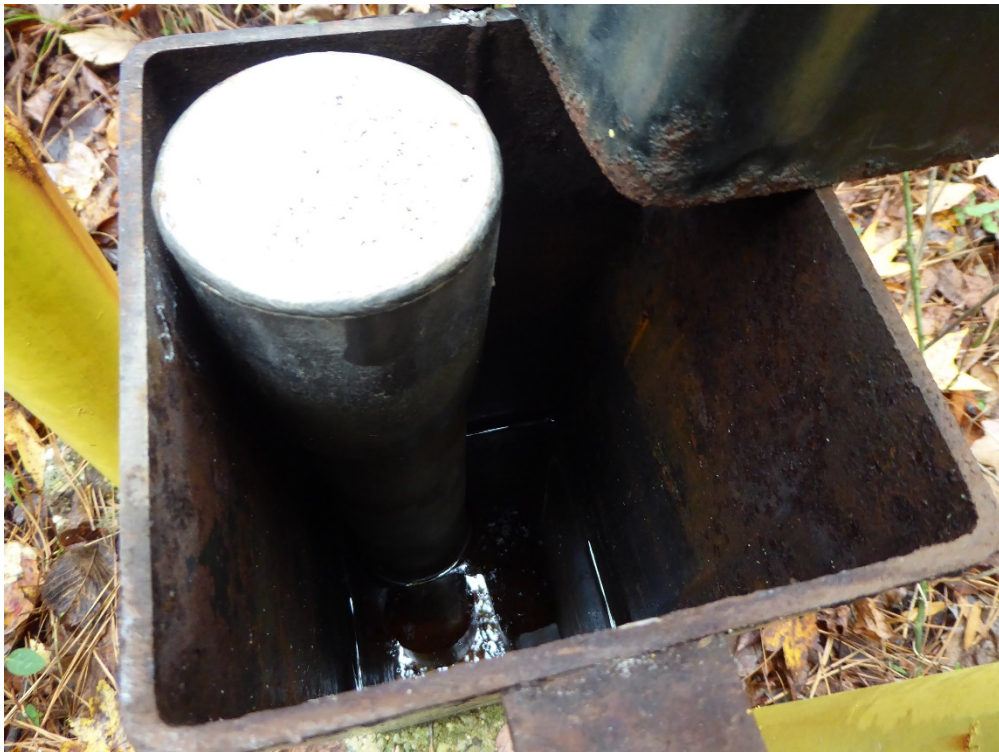
VPMW-5 (standing water outside inner well casing)

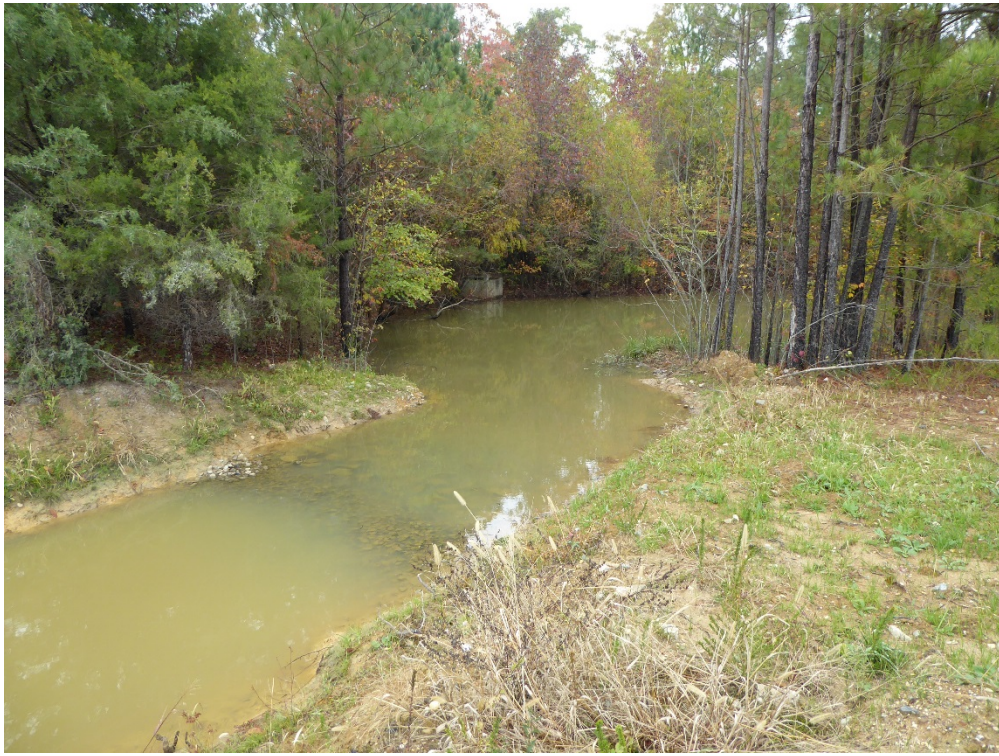
Looking north toward on-site stormwater basin
