**FIRST FIVE-YEAR REVIEW REPORT FOR  
BRESLUBE-PENN, INC. SUPERFUND SITE  
ALLEGHENY COUNTY, PENNSYLVANIA**

**APRIL 2019**

**U.S. Environmental Protection Agency  
Region 3  
Philadelphia, Pennsylvania**

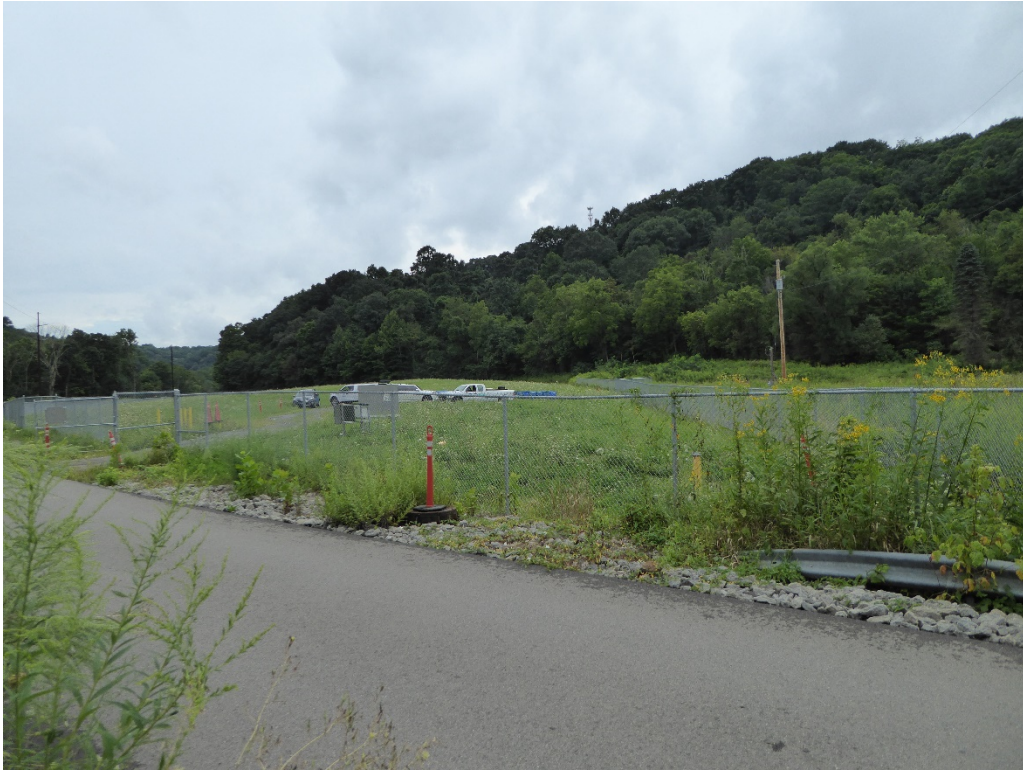
Fenced Waste Management Area (contractor vehicles on site to perform sampling), private road in foreground

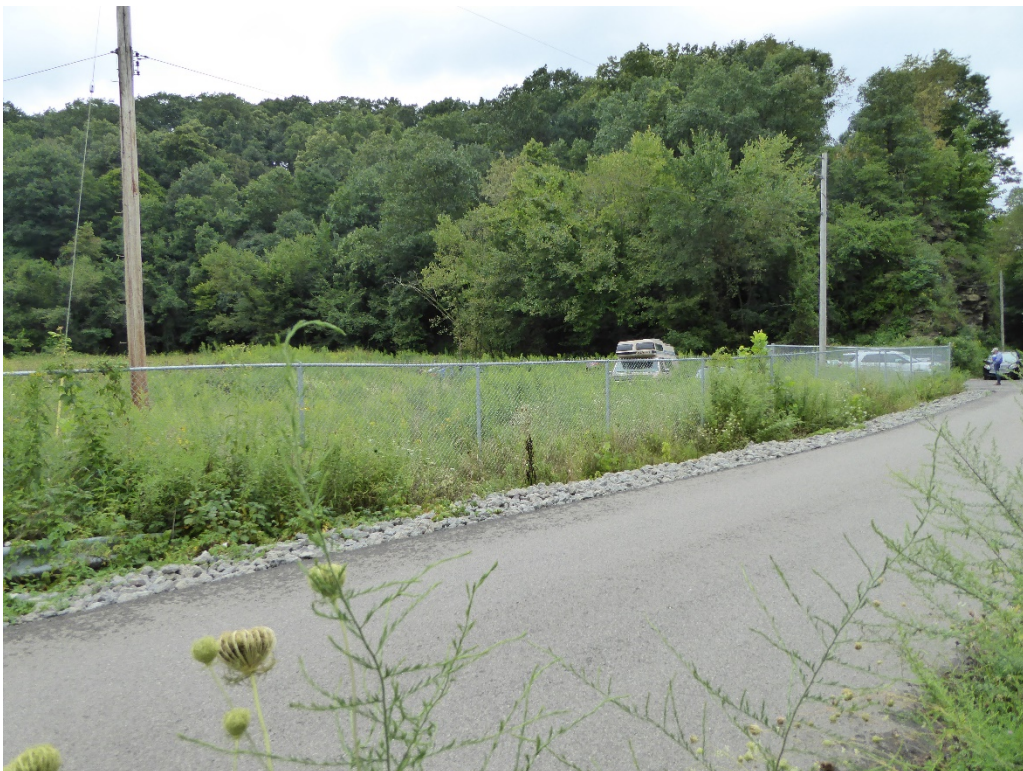
Fenced wetland area with junk vehicles stored on site

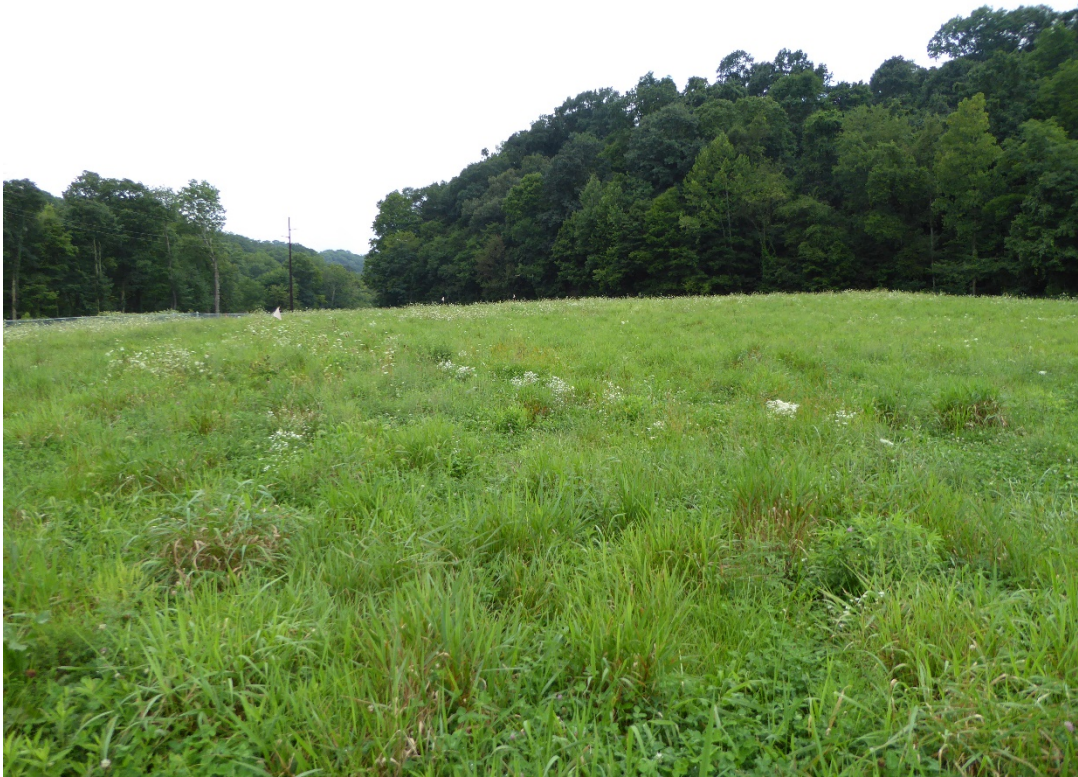
Site inspection participants walked around the WMA. The vegetated cover is well established. No animal burrows were observed. There were a few wheel ruts in the vegetated cover of the WMA, in the area where PRP contractors park their trucks. Site inspection participants opened the cover of TC-1 and observed the activated carbon treatment system.

Waste Management Area

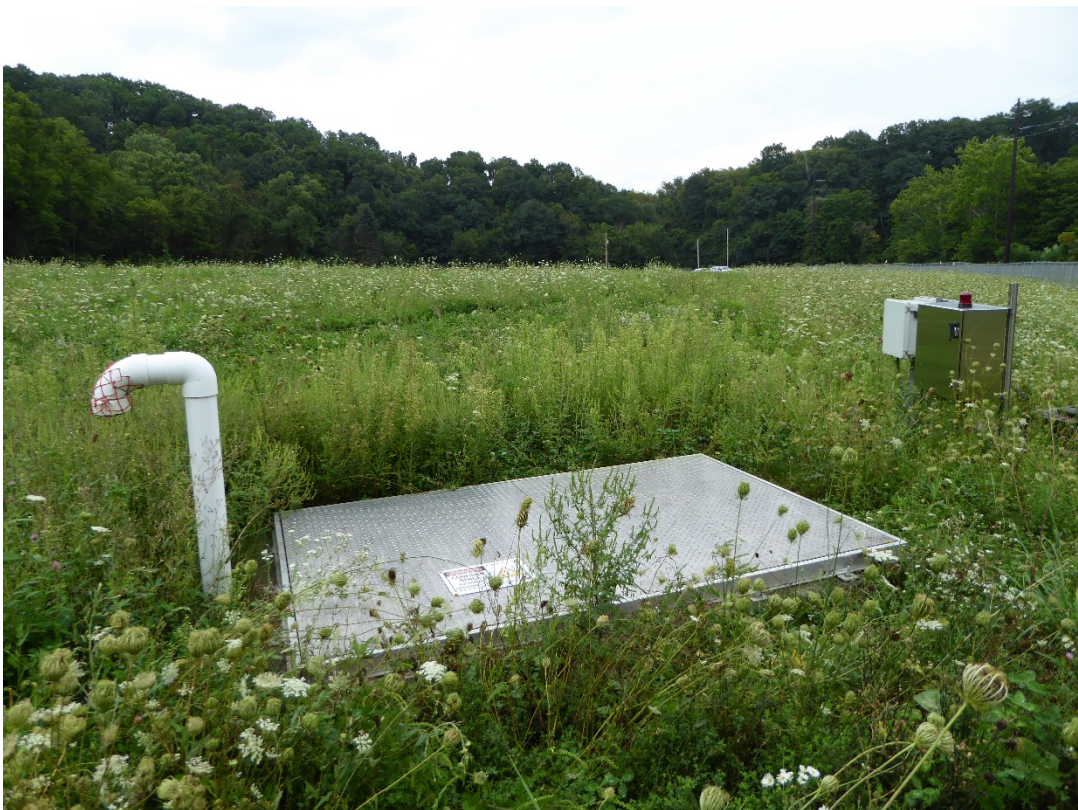
Treatment Cell TC-2

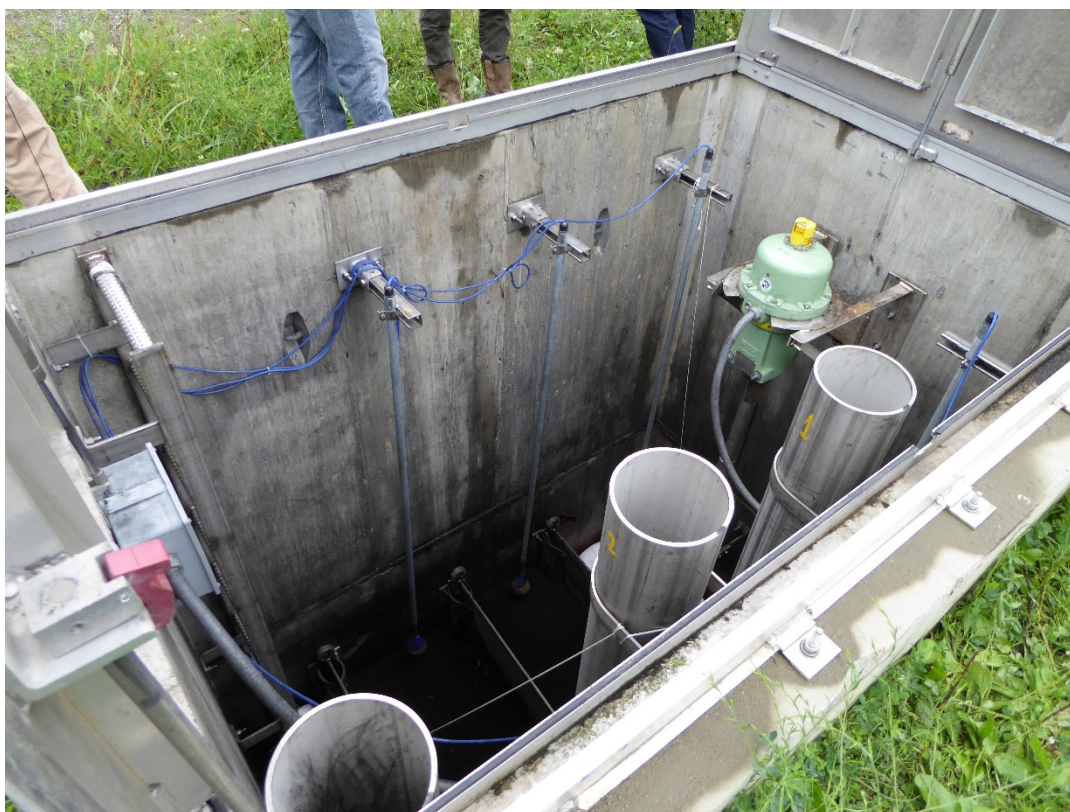
Treatment cell 1 (TC-1) has experienced various periods of operational downtime since it began operating in August 2015. These problems occur when the groundwater level in the discharge infiltration gallery is high, causing an inadequate hydraulic gradient between the treatment cell and the discharge gallery. At EPA's request, the PRP group submitted a work plan in May 2018 for modifications to TC-1 to address this performance issue. In July 2018, EPA notified the PRP group that it may proceed with implementing the modifications as presented in the work plan. The PRP group mobilized at the Site in September 2018 and completed the modifications by November. The modifications included installing an injection well for discharging effluent from TC-1 when the groundwater level is too high to discharge to the TC-1 discharge gallery. In addition, the PRP group conducted maintenance activities for both treatment cells, including sealing leaks, installing check valves to prevent backflow from the discharge galleries, and cleaning effluent discharge lines.

Treatment Cell TC-1

| | <b>Recommendation:</b> Determine whether the PRP group's modifications to treatment cell TC-1 have resulted in satisfactory performance of the WMA. If not, determine whether additional modifications can achieve the performance standards or if the ROD's Contingency 1 remedy (extraction and treatment of groundwater within the WMA) needs to be implemented. | | | |

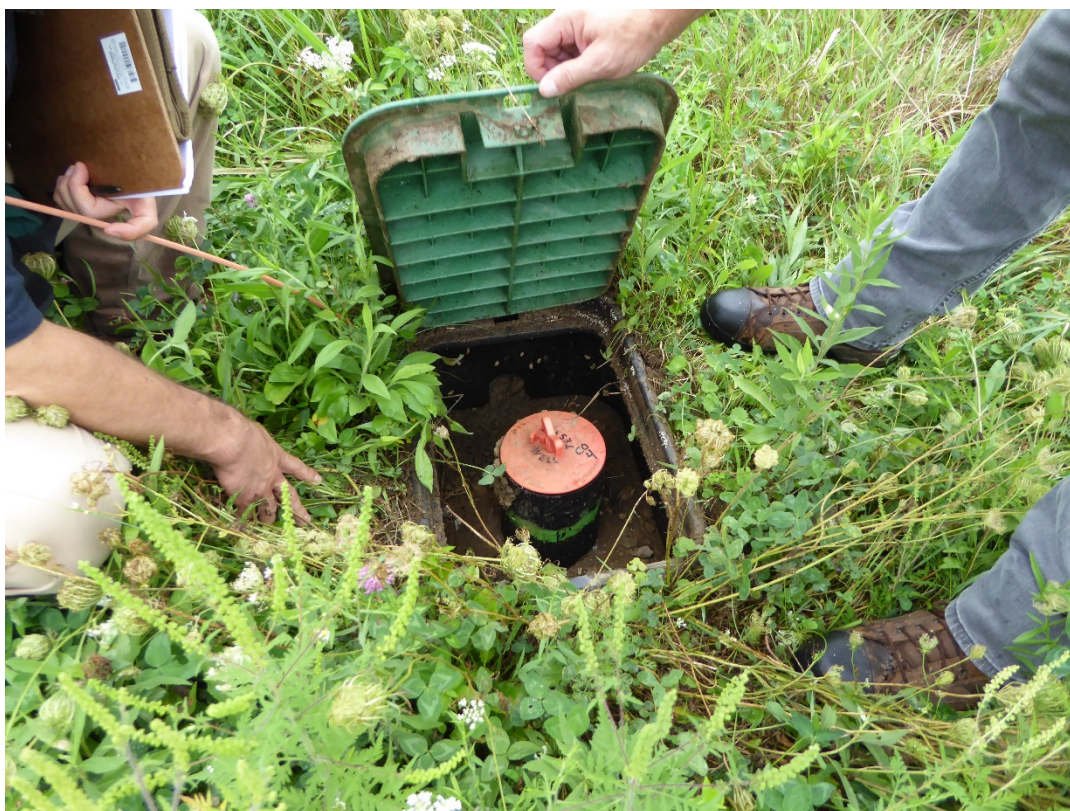
Cleanout access point for lateral groundwater recovery line

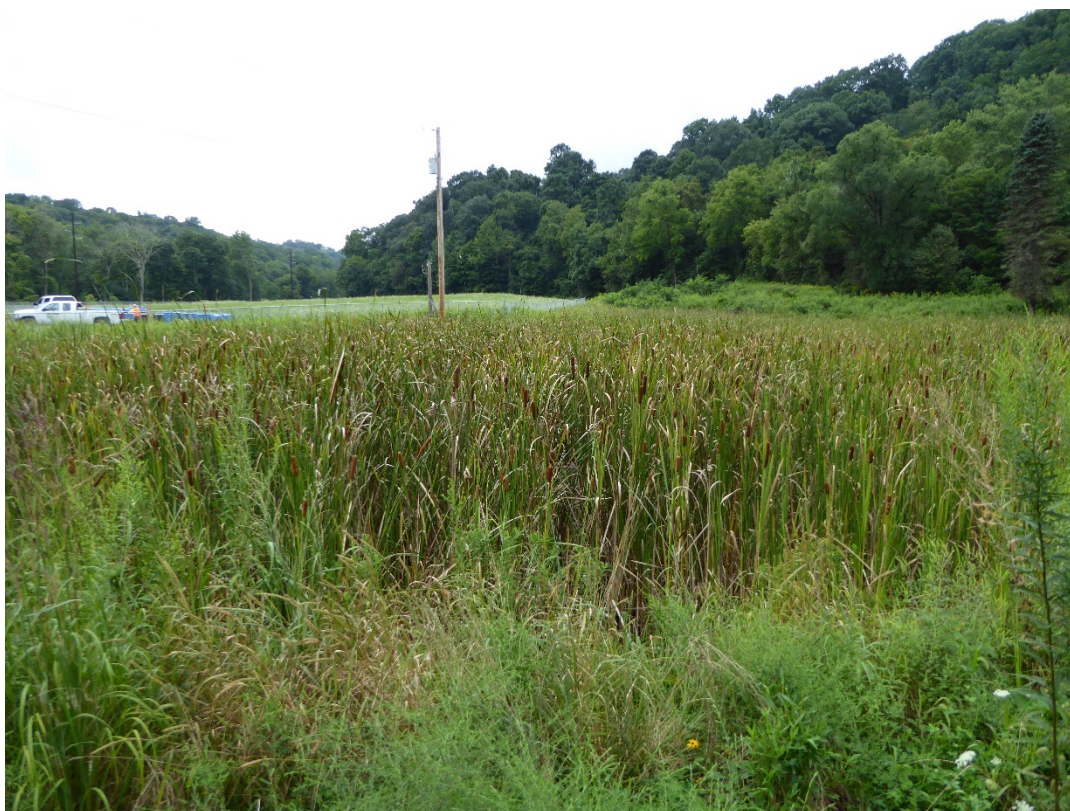
Wetland area

- The wetland appears to be well established with cattails. A vegetation survey should be performed for the wetland to demonstrate that the native plant community meets the design specifications.
- The reported detection limits for pentachlorophenol and Aroclor 1254 in groundwater and treated effluent are higher than their groundwater cleanup levels. EPA recommends that the PRP group report the more stringent Method Detection Limits for pentachlorophenol and Aroclor 1254, as specified in the Site's 2016 Quality Assurance Project Plan, Worksheet #15.

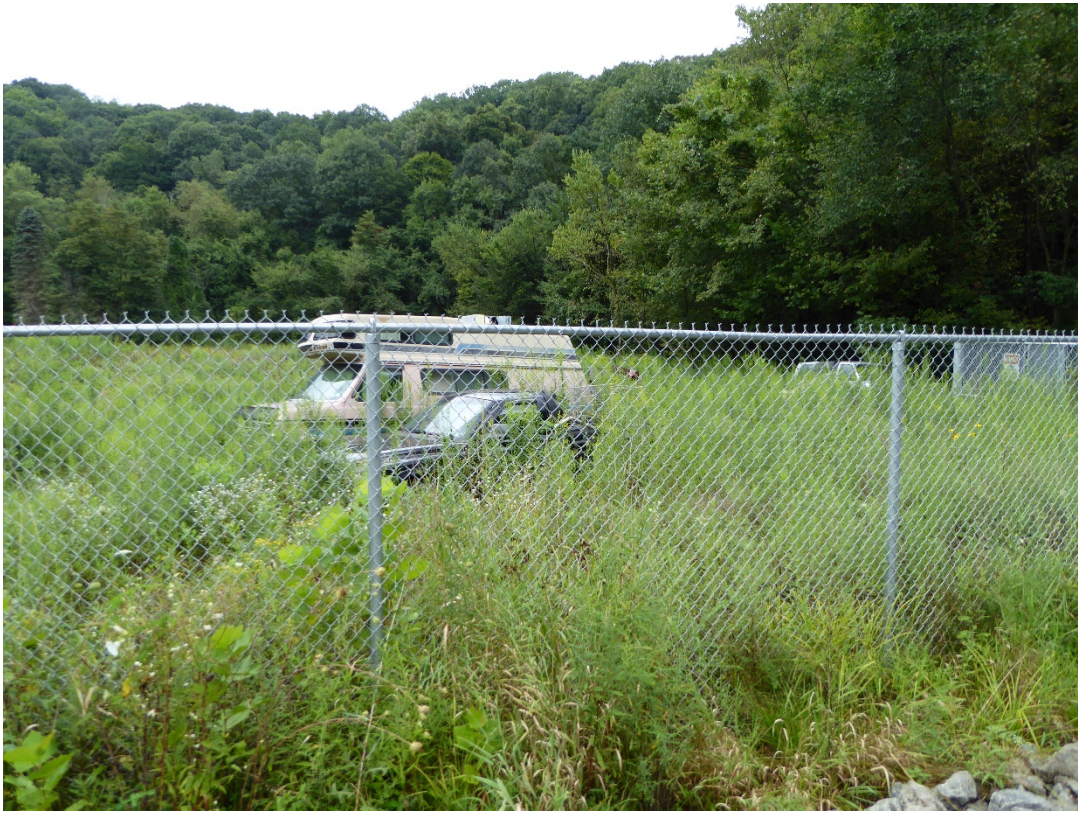
Fenced wetland area with vehicles stored on site
