**FIFTH FIVE-YEAR REVIEW REPORT FOR  
FIRST PIEDMONT ROCK QUARRY (Route 719) SUPERFUND SITE  
PITTSYLVANIA COUNTY, VIRGINIA  
EPA ID No. VAD980554984**

**January 2020**

**U.S. Environmental Protection Agency  
Region 3  
Philadelphia, Pennsylvania**

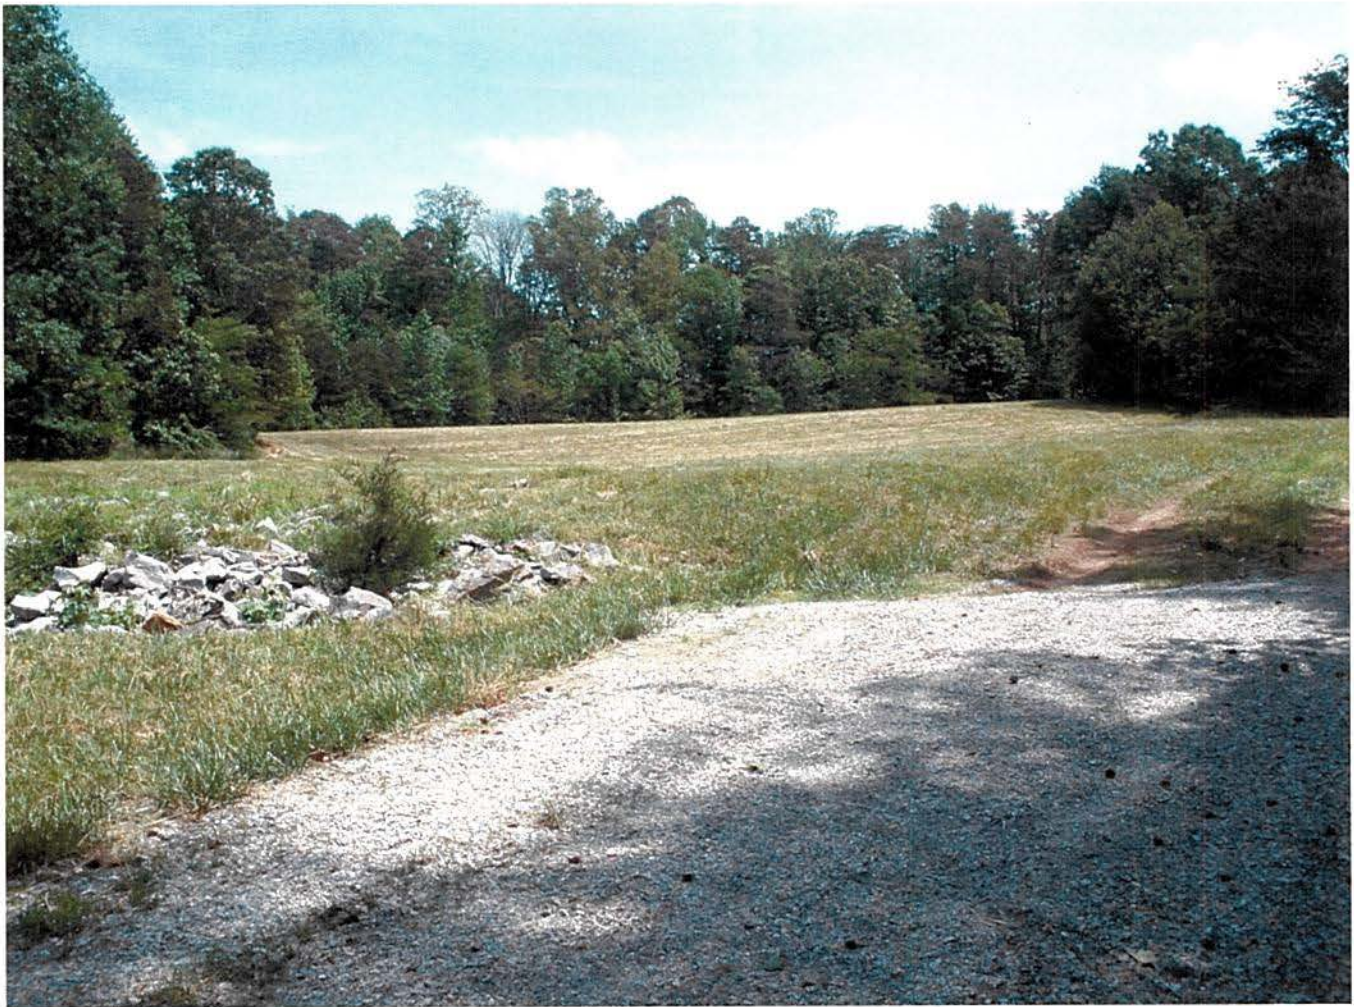
migration of contaminants to the groundwater, and reduces the generation of leachate. There is no evidence of erosion or breach of the RCRA cap on the landfill. The collection and off-site disposal of leachate reduces the potential for direct contact with the leachate. The Carbon Black Pile, the Waste Pile, debris and drums have been removed and treated off-site, which eliminates the potential of direct contact with contaminated material from these sources. The chain link security fence restricts access to the portion of the Site where waste within the landfill has been left in place.

Photo 1: Northward View of Landfill from Southern Toe

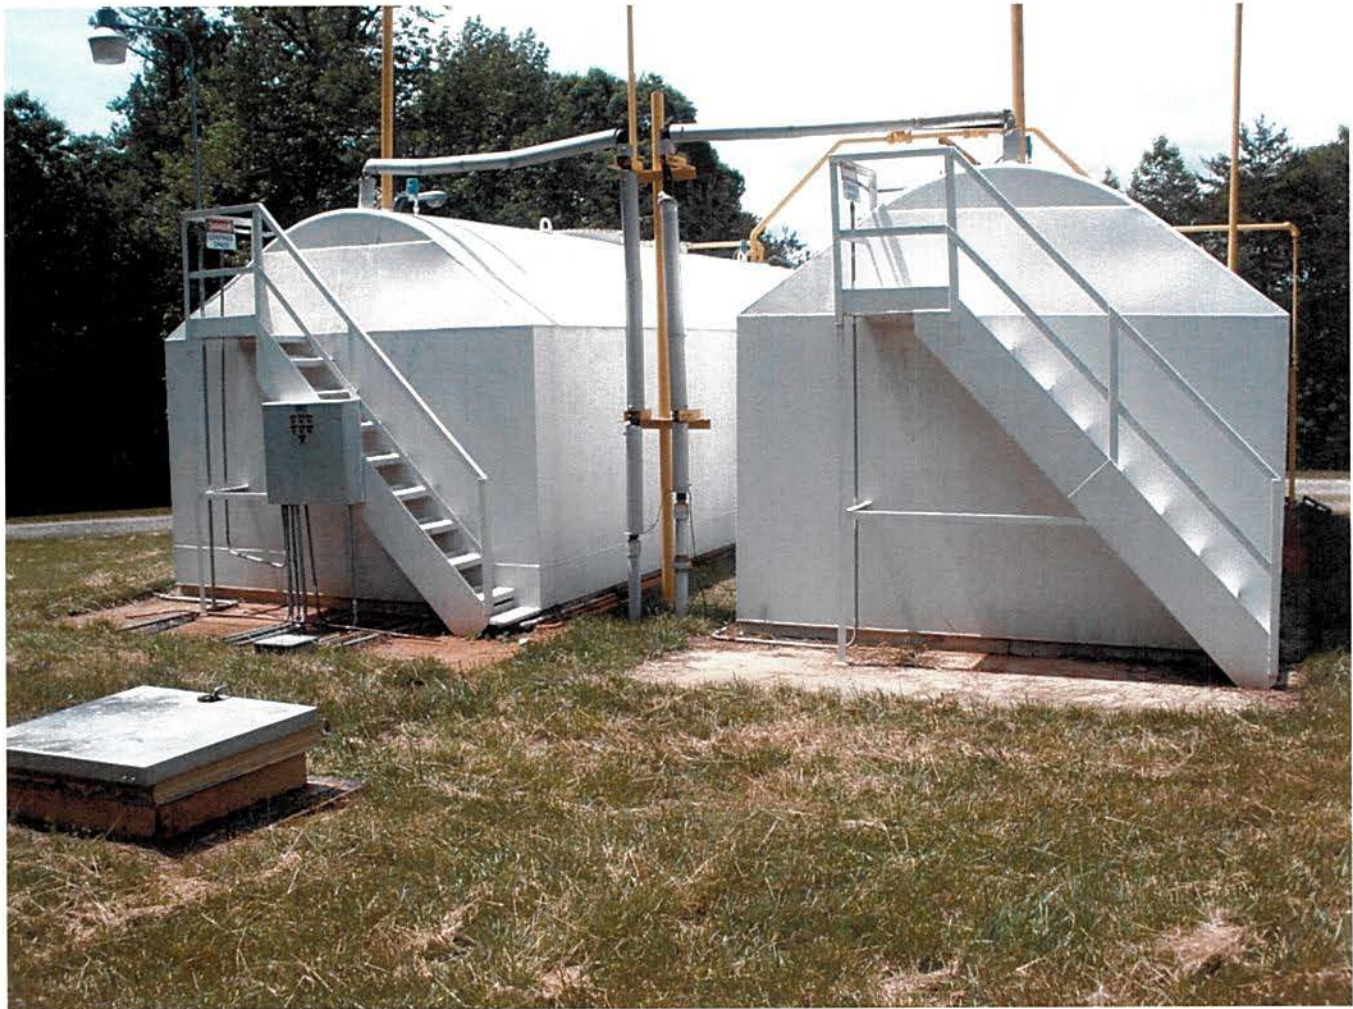
- Leachate Collection System: Leachate collection system construction was completed in October 1995. The system collects leachate in a trench excavated below the top of bedrock at the western

edge of the landfill. The leachate in the trench collects in a 4-inch slotted polyvinyl chloride (PVC) pipe, which is surrounded by fill material. Leachate flows into the collection sump at the southern end of the trench and is then pumped to primary and secondary 20,000-gallon storage tanks. Leachate is sampled quarterly and disposed at Danville's publicly owned treatment works (POTW).

Photo 2: Leachate Collection System

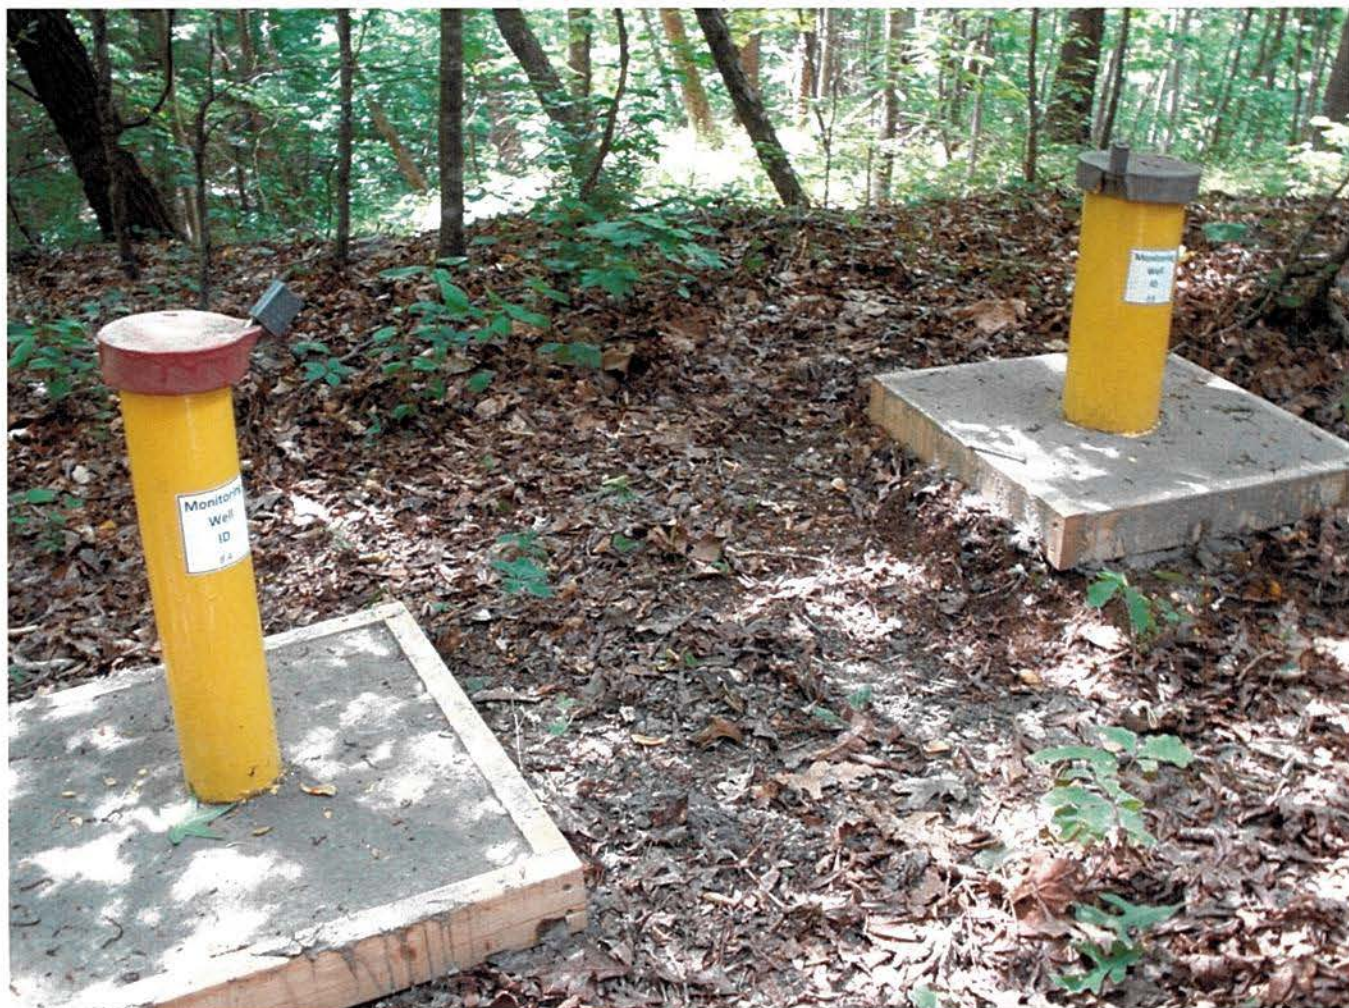
- Groundwater Monitoring: Groundwater monitoring is conducted at existing wells up and down-gradient of the landfill to determine whether the remedy is protective of human health and the environment. Groundwater monitoring will continue as long as leachate is collected and treated at the Site, or for 30 years, whichever is longer.

Photo 3: Monitoring Wells

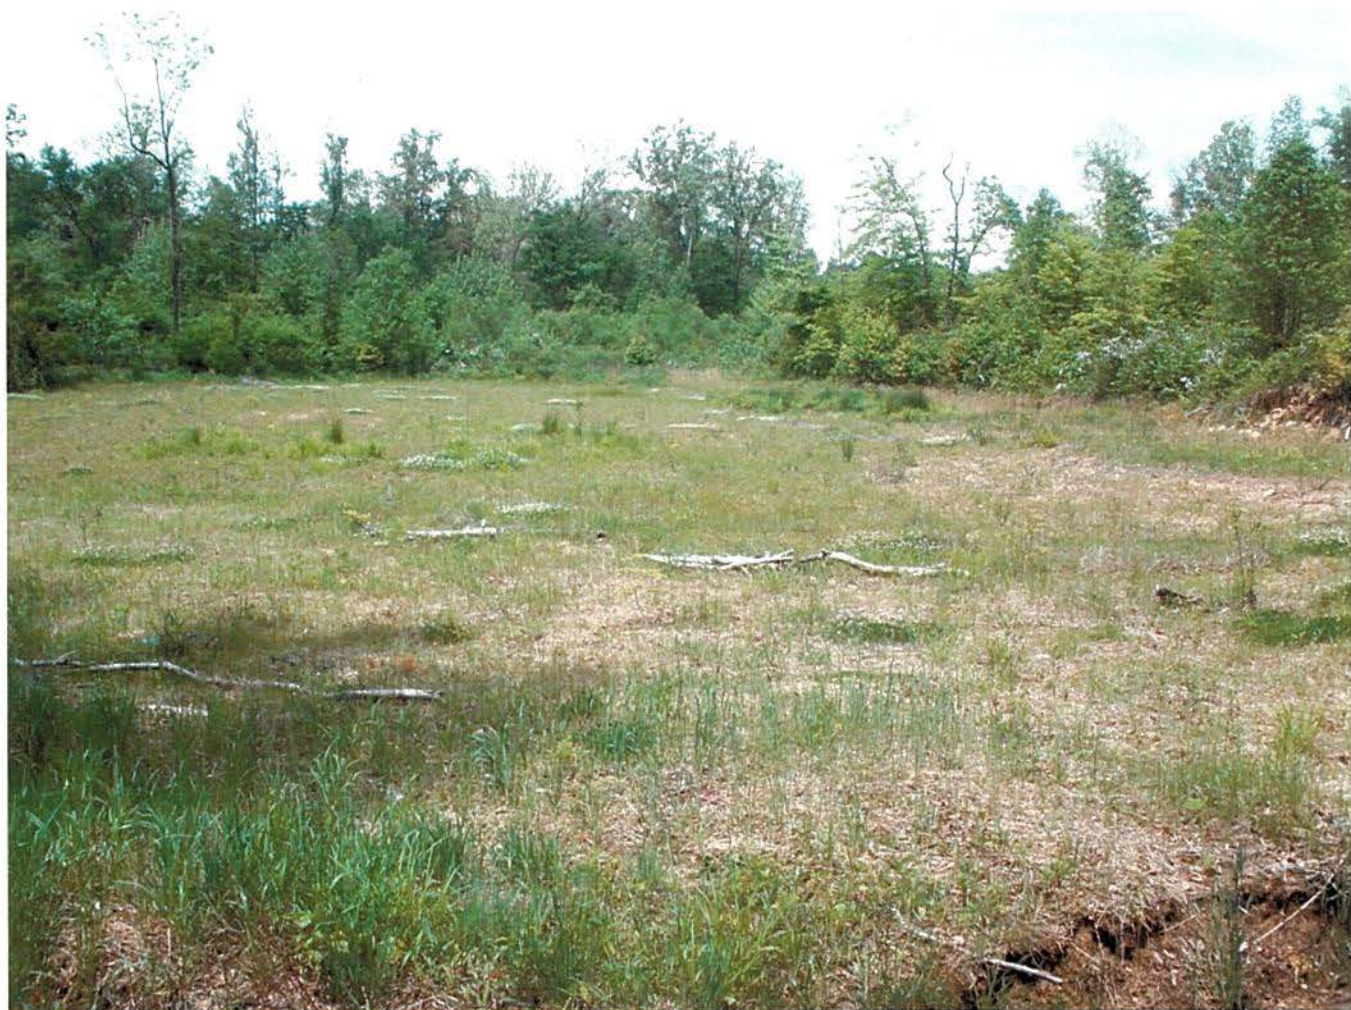
The excavation at the Southern Drainage area and Lawless Creek Floodplain was performed from August to November 2017. The work plan called for the removal of soils with zinc concentrations exceeding the cleanup goal of 148.6 mg/kg in the upper 24 inches. It was decided during field operations to continue the contaminated soil excavation deeper than 24 inches where necessary to achieve the performance standard. No soil exceeding zinc concentrations of 148.6 mg/kg was left in place. The excavation resulted in the removal of 420 cubic yards (62.2 tons) of vegetative debris, 2,655 cubic yards (3,188 tons) of impacted soils, 200 gallons of wastewater, and 13.85 tons of general trash. The area was then backfilled with clean soil and planted. The PRPs also purchased 1.42 wetland credits to offset the temporary impacts to the 0.71-acre of delineated wetlands in the floodplain removal area. No land use restrictions were needed in the wetland area, because all soil/sediments above the cleanup goal were removed.

Photo 4: Restored Zinc Sediment Excavation Area, Looking North
