**SIXTH FIVE-YEAR REVIEW REPORT FOR
LEHIGH ELECTRIC & ENGINEERING CO. SUPERFUND SITE
LACKAWANNA COUNTY, PENNSYLVANIA**

February 2020

**Prepared By:
United States Environmental Protection Agency
Region 3
Philadelphia, Pennsylvania**

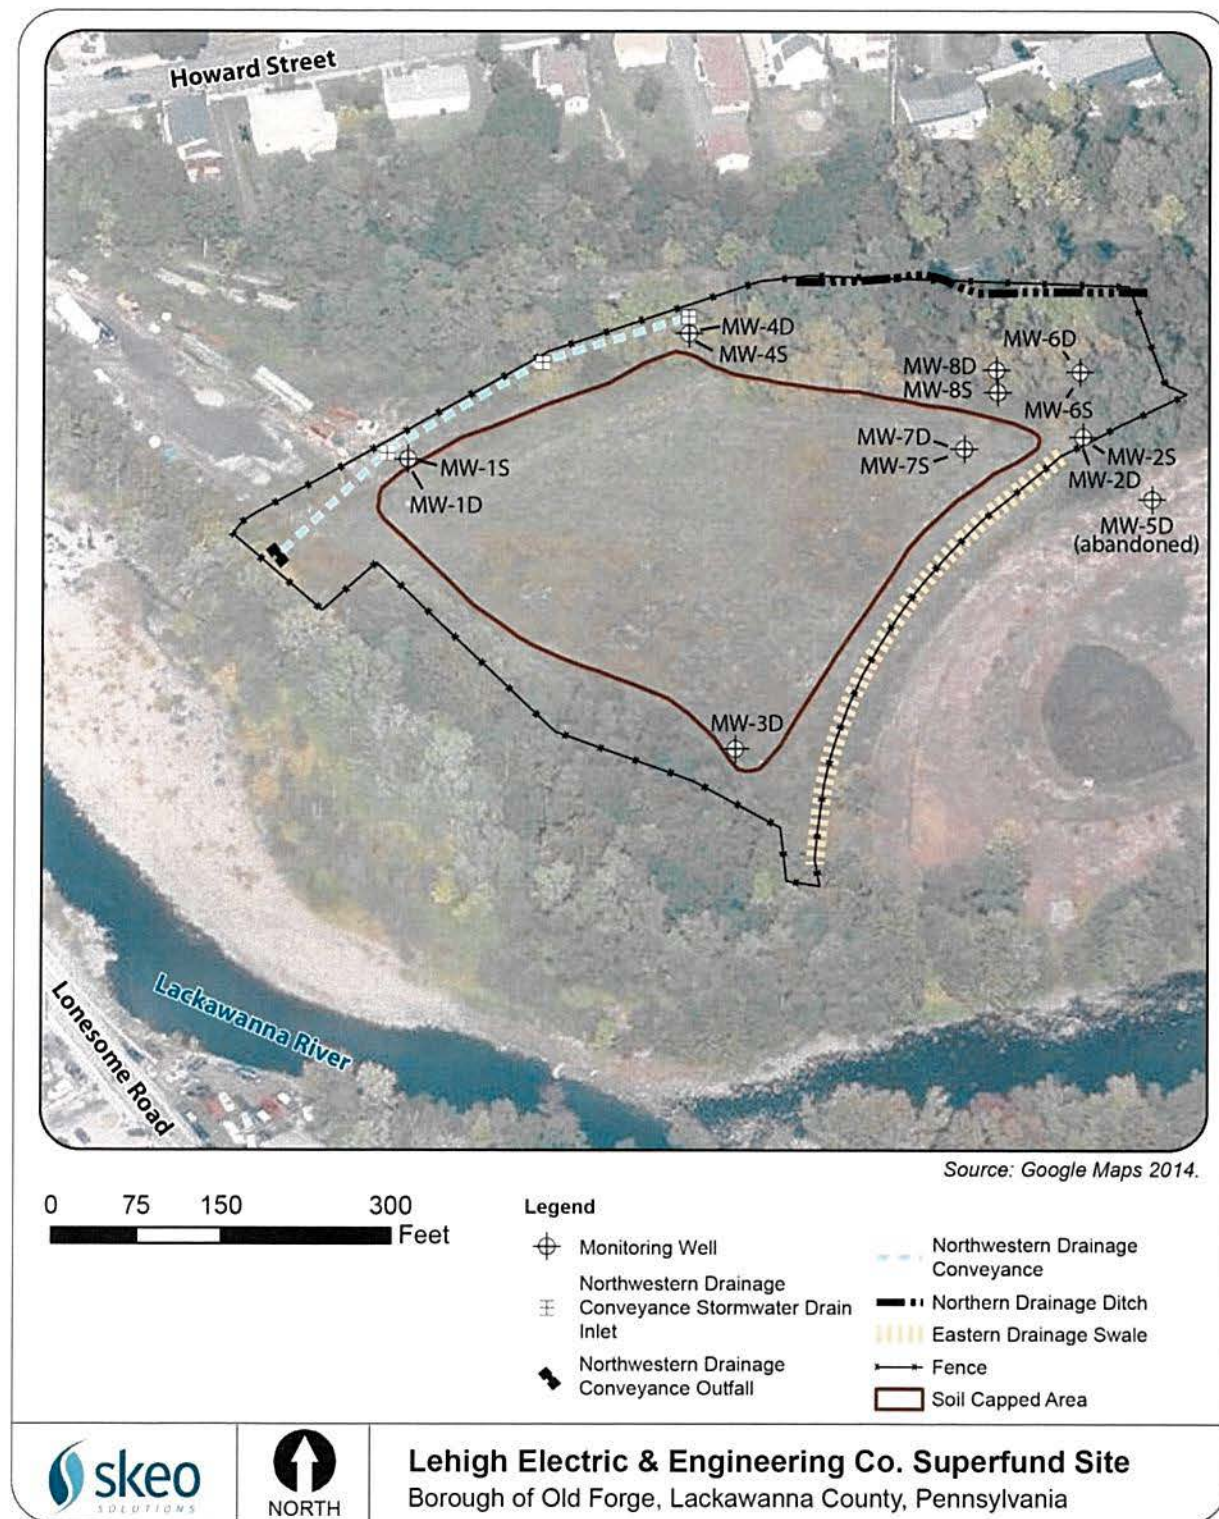
Figure B-2: Detailed Site Map

No additional groundwater data was collected for this FYR. The Site has 13 monitoring wells screened in saturated fracture zones (Figure B-2). Although the ROD did not select a remedial action for groundwater, groundwater monitoring has been conducted periodically. For reference, EPA's maximum contaminant level (MCL) for PCBs in drinking water is 0.5 micrograms per liter ($\mu\text{g/l}$).

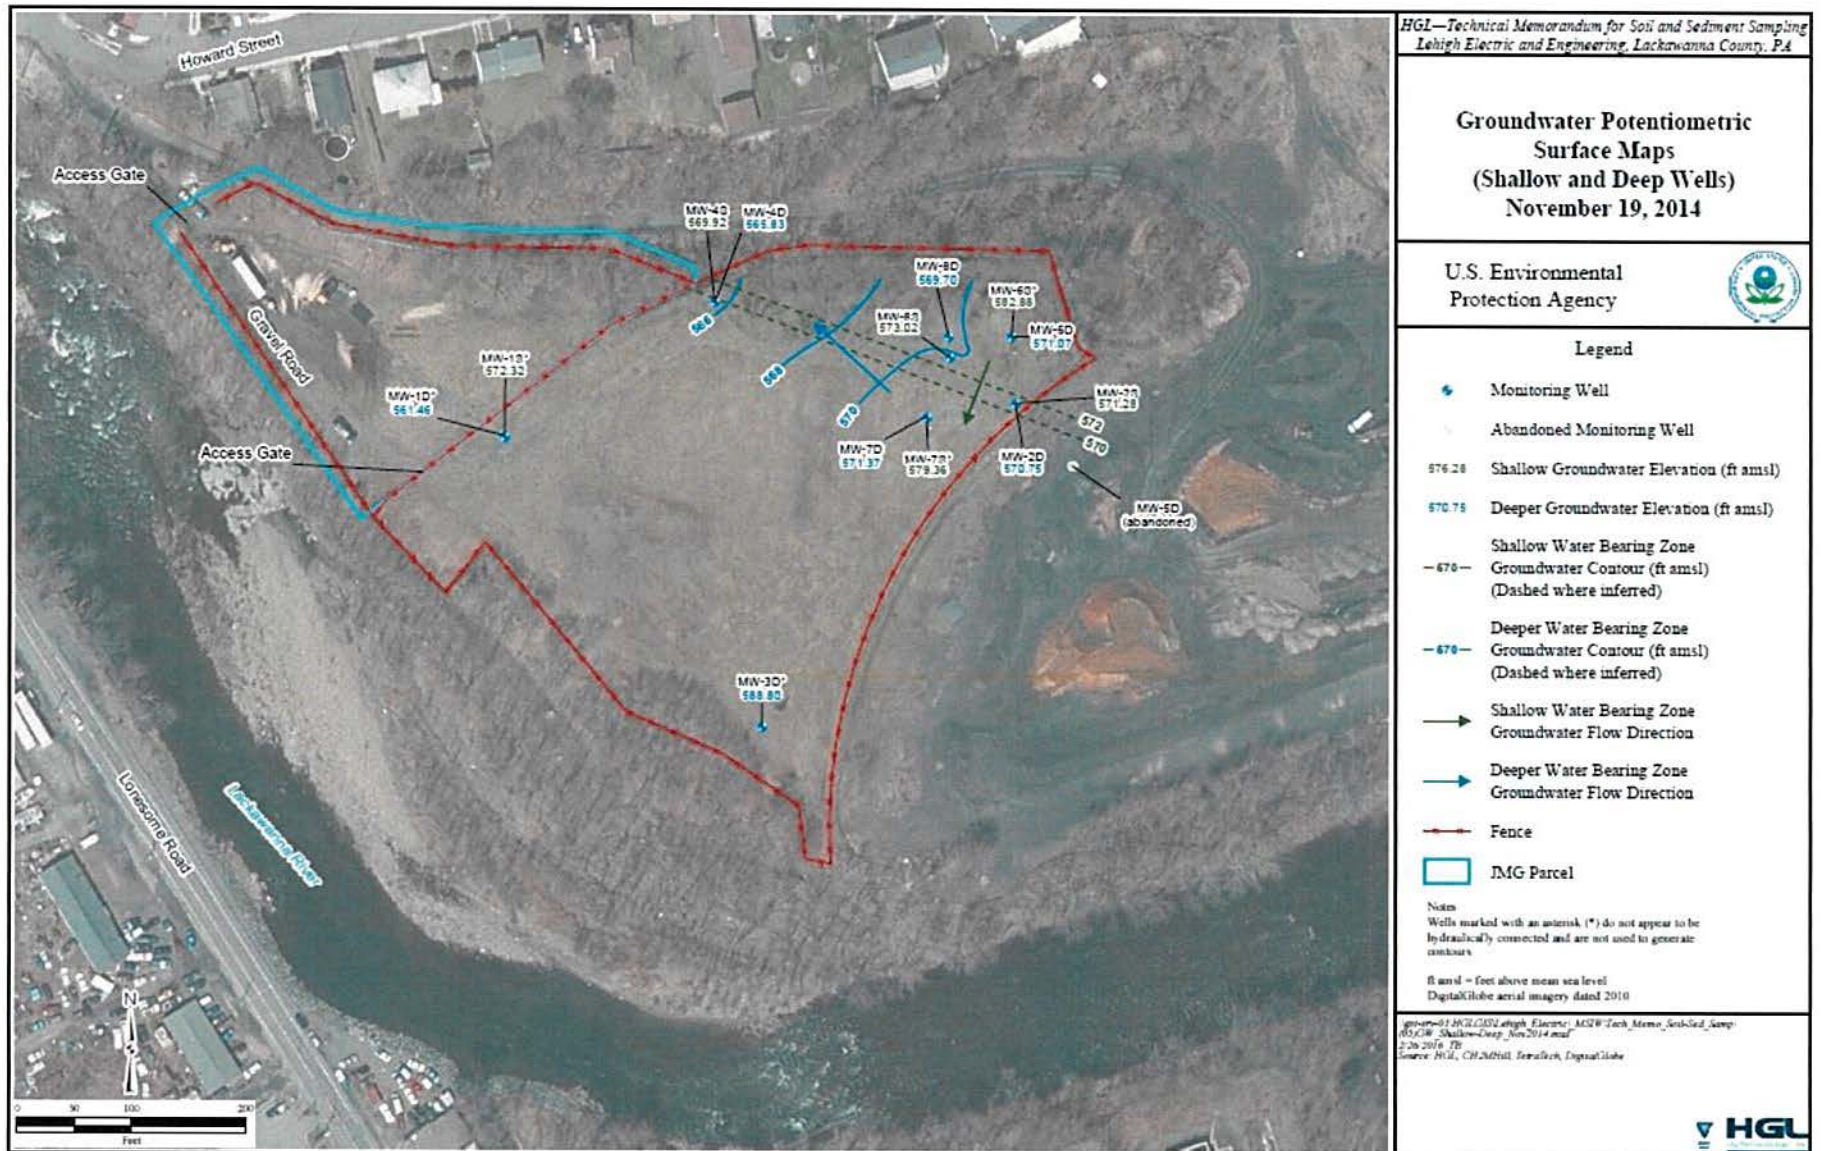
Figure B-4: Groundwater Potentiometric Surface Map – Shallow & Deep Wells, November 19, 2014

All measured groundwater elevations are below the surface elevation of the Lackawanna River, and downward vertical groundwater gradients have been observed between all co-located well pairs at the Site. Groundwater potentiometric surface contours for the shallow and deep wells are presented on Figure B-4, showing apparent flow directions to the southwest towards the Lackawanna River in the shallow wells and toward the north or northwest in the deeper wells. Based on the groundwater analytical data collected up to 2011¹, groundwater contamination at the Site appears to be isolated in the vicinity of the MW-2 monitoring well cluster and, in conjunction with groundwater level elevation measurements, does not appear to be migrating off of the property.

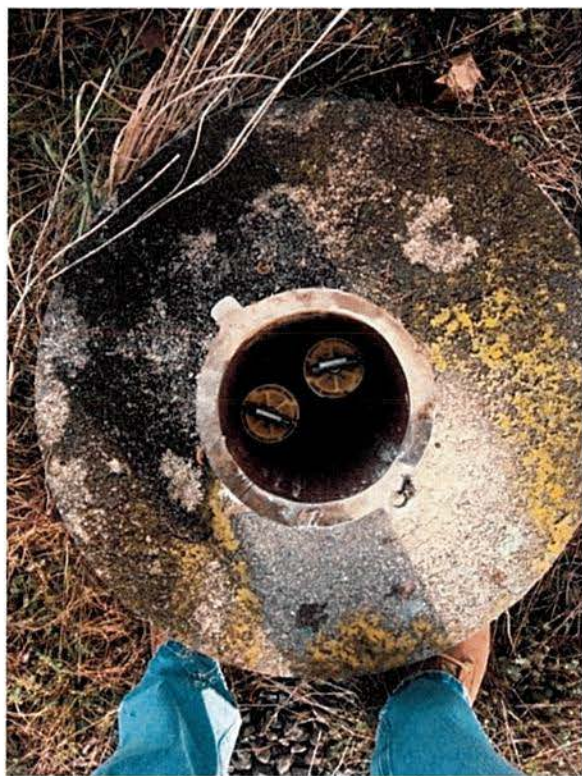
Monitoring Wells 1S and 1D

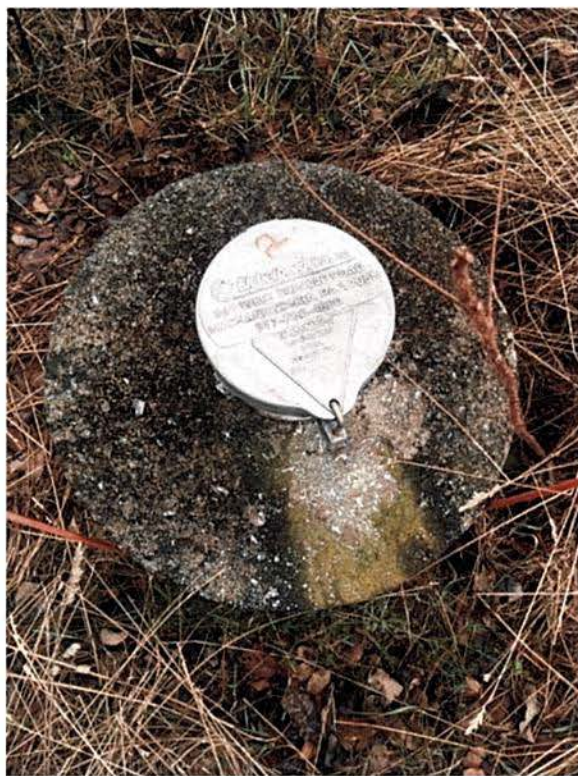
Monitoring Wells 2S and 2D

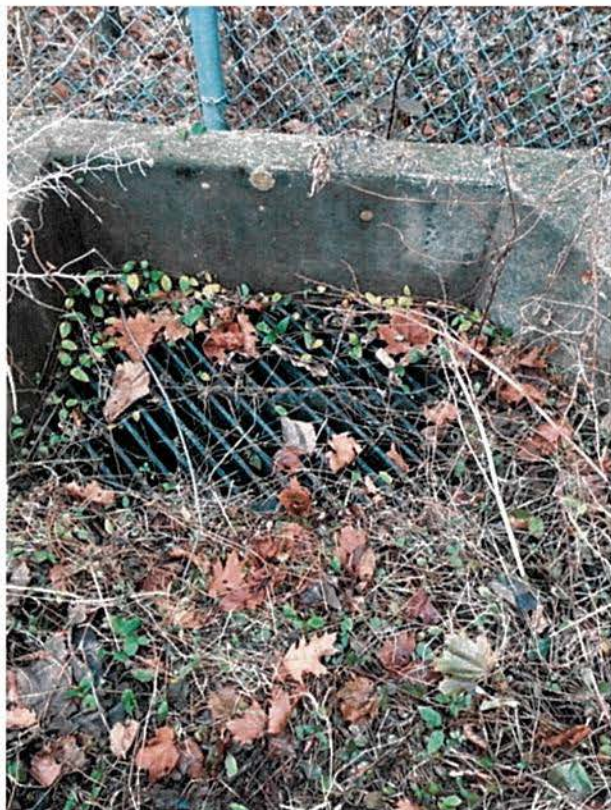
No sediment buildup was observed adjacent to the northwest drainage conveyance system inlets and a small amount of water flow was observed in the stormwater conveyance drainpipe. The drain inlets are covered with metal grates and surrounded on three sides by concrete curbing. The drain inlets were surrounded by grass and no erosion was observed. The eastern drainage swale was grass-covered with no evidence of standing water or sediment erosion. The northern drainage ditch, which lies outside the northern fence-line, is well defined and moderately vegetated with trees and shrubs. Some debris was observed in the northern drainage ditch consisting of felled vegetation and abandoned tires.

Top of Northwest Conveyance Drainage

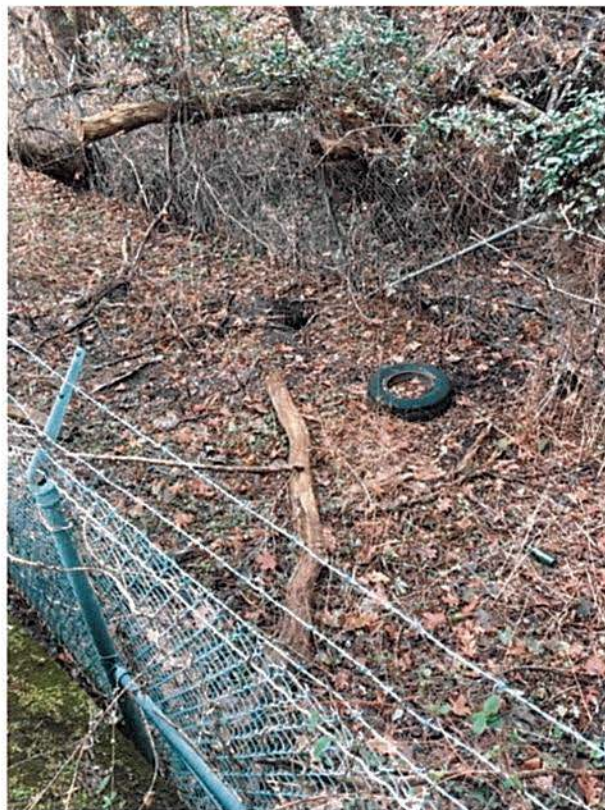
Northern Drainage Ditch

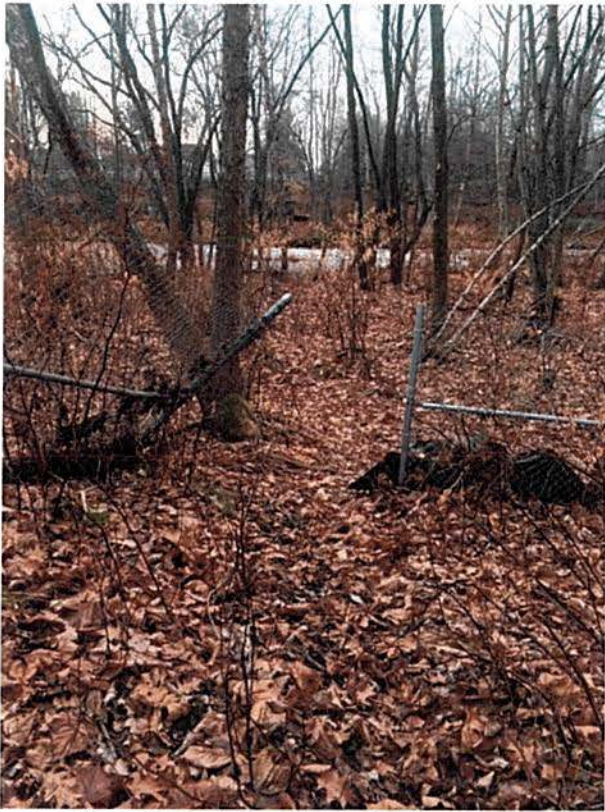
Site inspection attendees walked the Site and inspected all monitoring wells. All monitoring wells were in good condition and properly locked. The chain-link fence surrounding the Site was in good condition across most of the Site. However, a portion of fence was down near the far southeastern corner of the Site potentially allowing unauthorized access to occur. A smaller breach in the fence on the northern perimeter was also noted. The front gate was locked. There were no signs of trespassing or vandalism. Vegetation on the cap was well-established. The cap had no erosion or visible damage. No significant surface water ponding was observed on the cap, although some wet areas were observed along the eastern and southeastern perimeters.

Fence Breach Southeast Corner of Site

Issues and Recommendations Identified in the FYR:				
OU(s): OU2	Issue Category: Site Access/Security			
	Issue: A portion of the Site's fence is down in southeastern corner of the Site and a hole exists in the fence along the northern Site perimeter			
	Recommendation: Repair the Site fence, where necessary.			
Affect Current Protectiveness	Affect Future Protectiveness	Party Responsible	Oversight Party	Milestone Date
No	Yes	State	EPA/State	2/3/2021

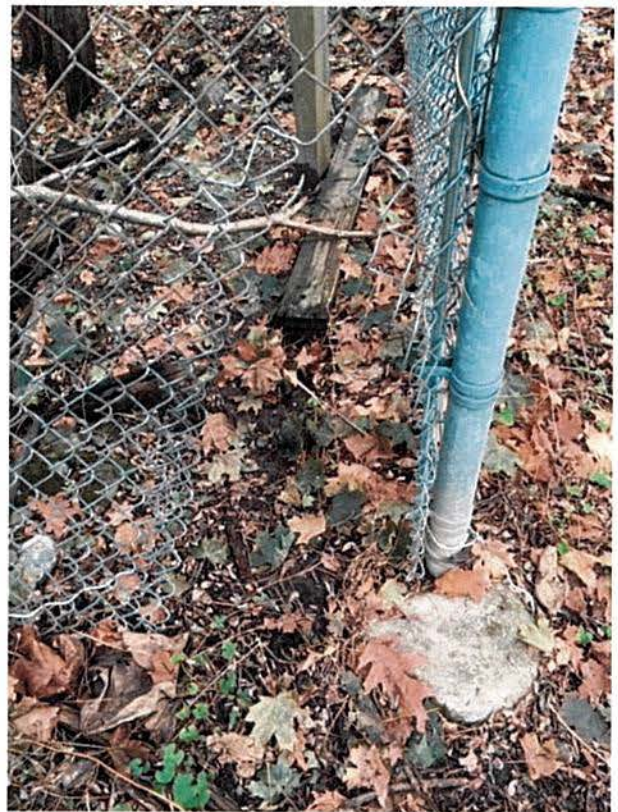
Fence Breach Northern Site Fence

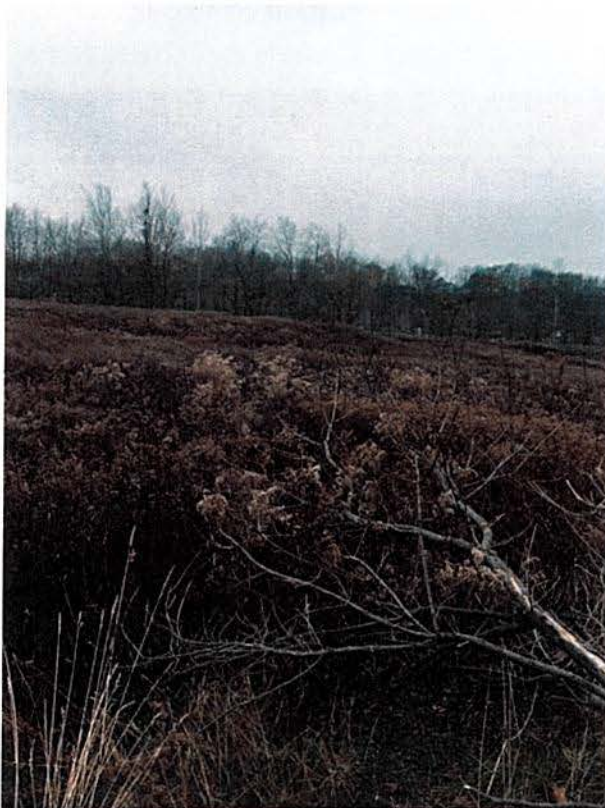
The remedy is functioning as intended by the ROD. EPA removed PCB-contaminated soil, debris, transformers, capacitors and other material, and disposed of them off-site. The soil cap is in good condition. Vegetation on the cap is well-established. There was no evidence of visible damage, erosion, or significant surface water ponding on the cap. The chain-link fence surrounding the Site was in good condition across most of the Site. However, a portion of fence was down near the far southeastern corner of the Site potentially allowing unauthorized access to occur. A smaller breach in the fence on the northern perimeter was also noted. The front gate was locked. During the 2019 FYR Site inspection, there were no signs of trespassing or vandalism.

Site Cap Looking Southeast

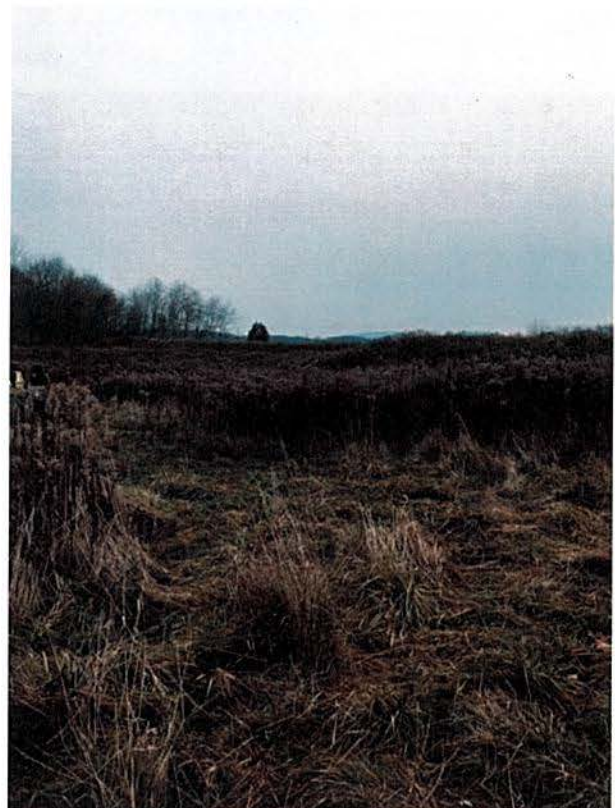
Site Cap Looking Northeast
