**SIXTH FIVE-YEAR REVIEW REPORT FOR
STRASBURG LANDFILL SUPERFUND SITE
CHESTER COUNTY, PENNSYLVANIA**

April 2020

**U.S. Environmental Protection Agency
Region 3
Philadelphia, Pennsylvania**

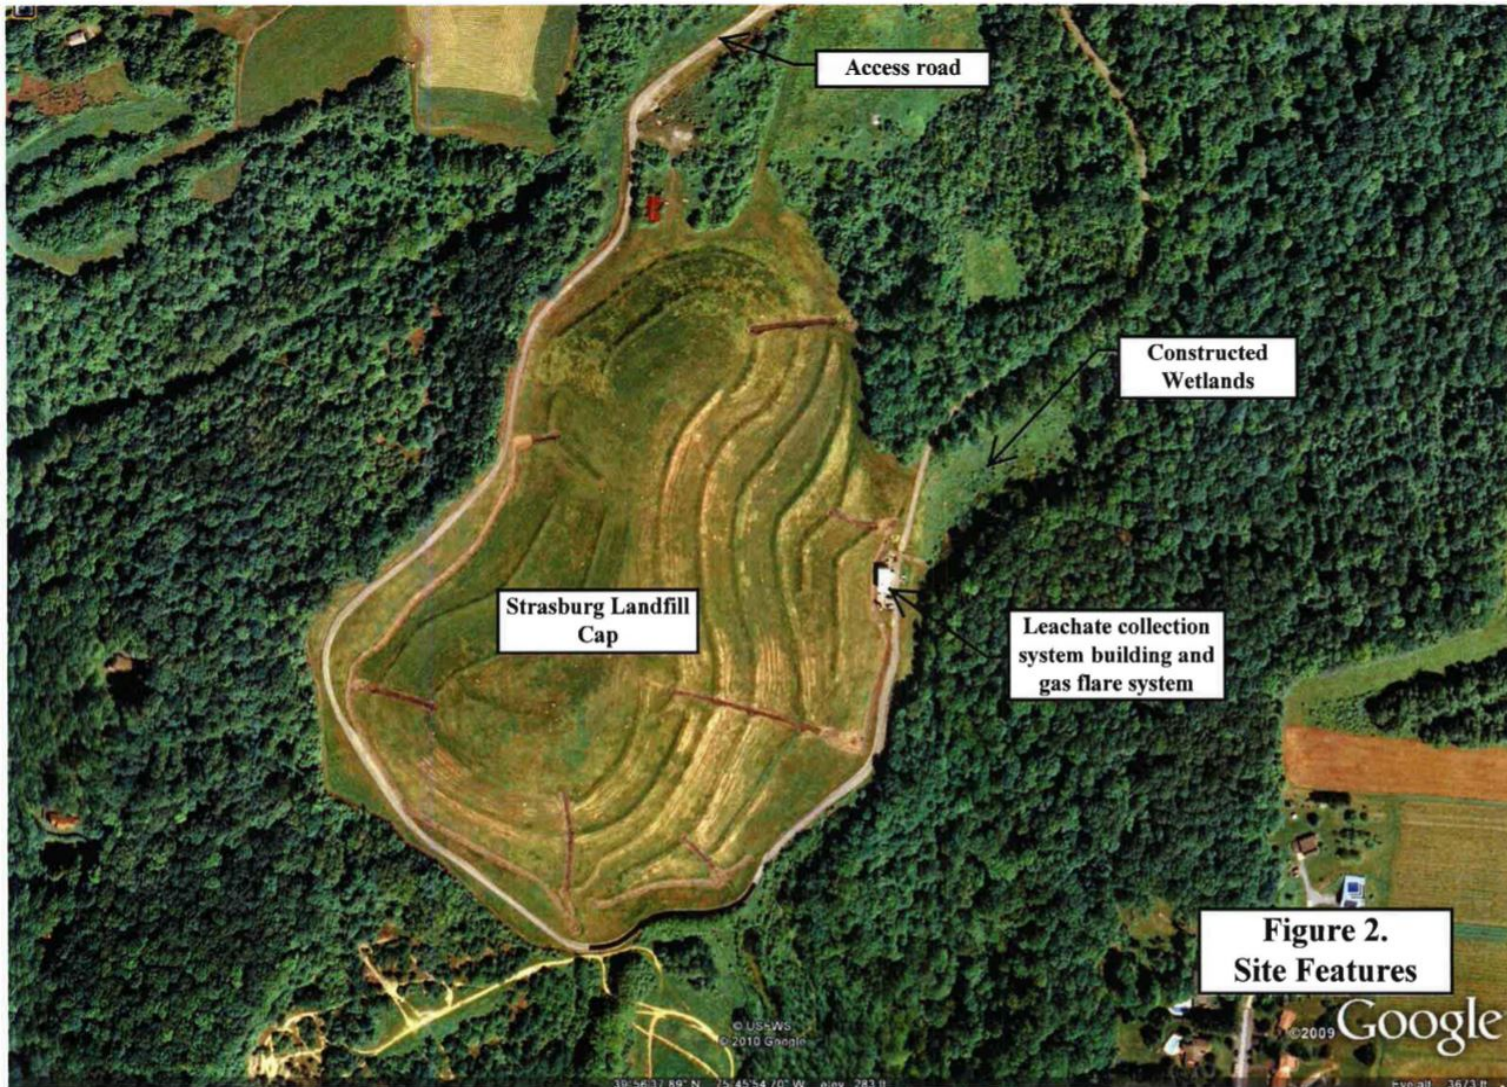
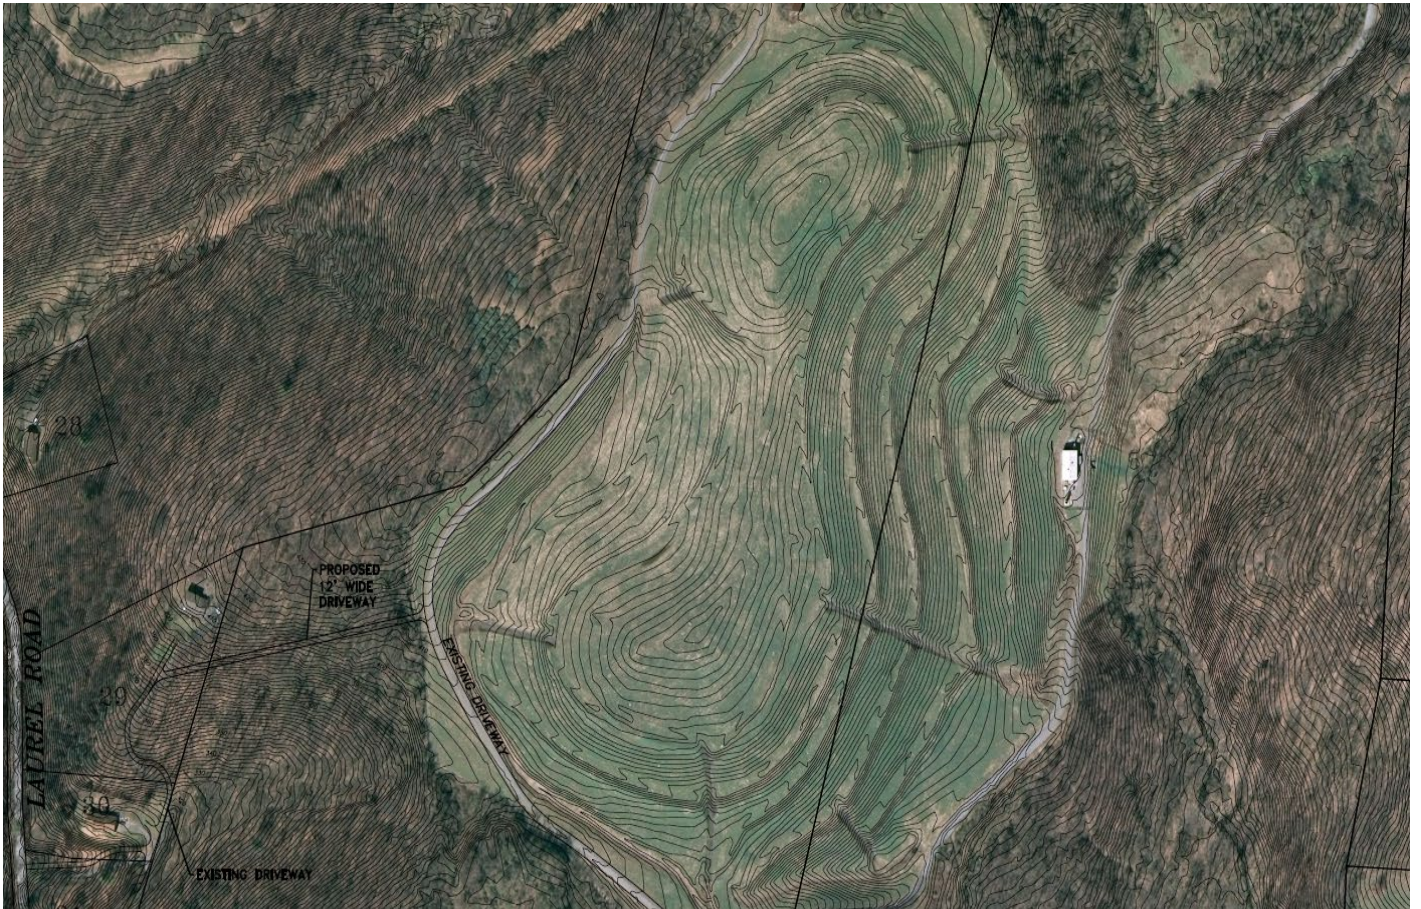
New Proposed Road around Strasburg Landfill

A new road is proposed to run through the Site and an adjacent property to replace a portion of Laurel Road which was damaged by flash flooding on the West Branch of the Brandywine Creek. The proposed public road will connect Laurel Road to Strasburg Road.

The detailed design work and the required approvals for the proposed public road and associated driveways, through the Site and adjacent Michael Rosen Property will tentatively be completed in 2020 and construction will occur in 2021. A draft plan of the new road can be found in the Appendix E.

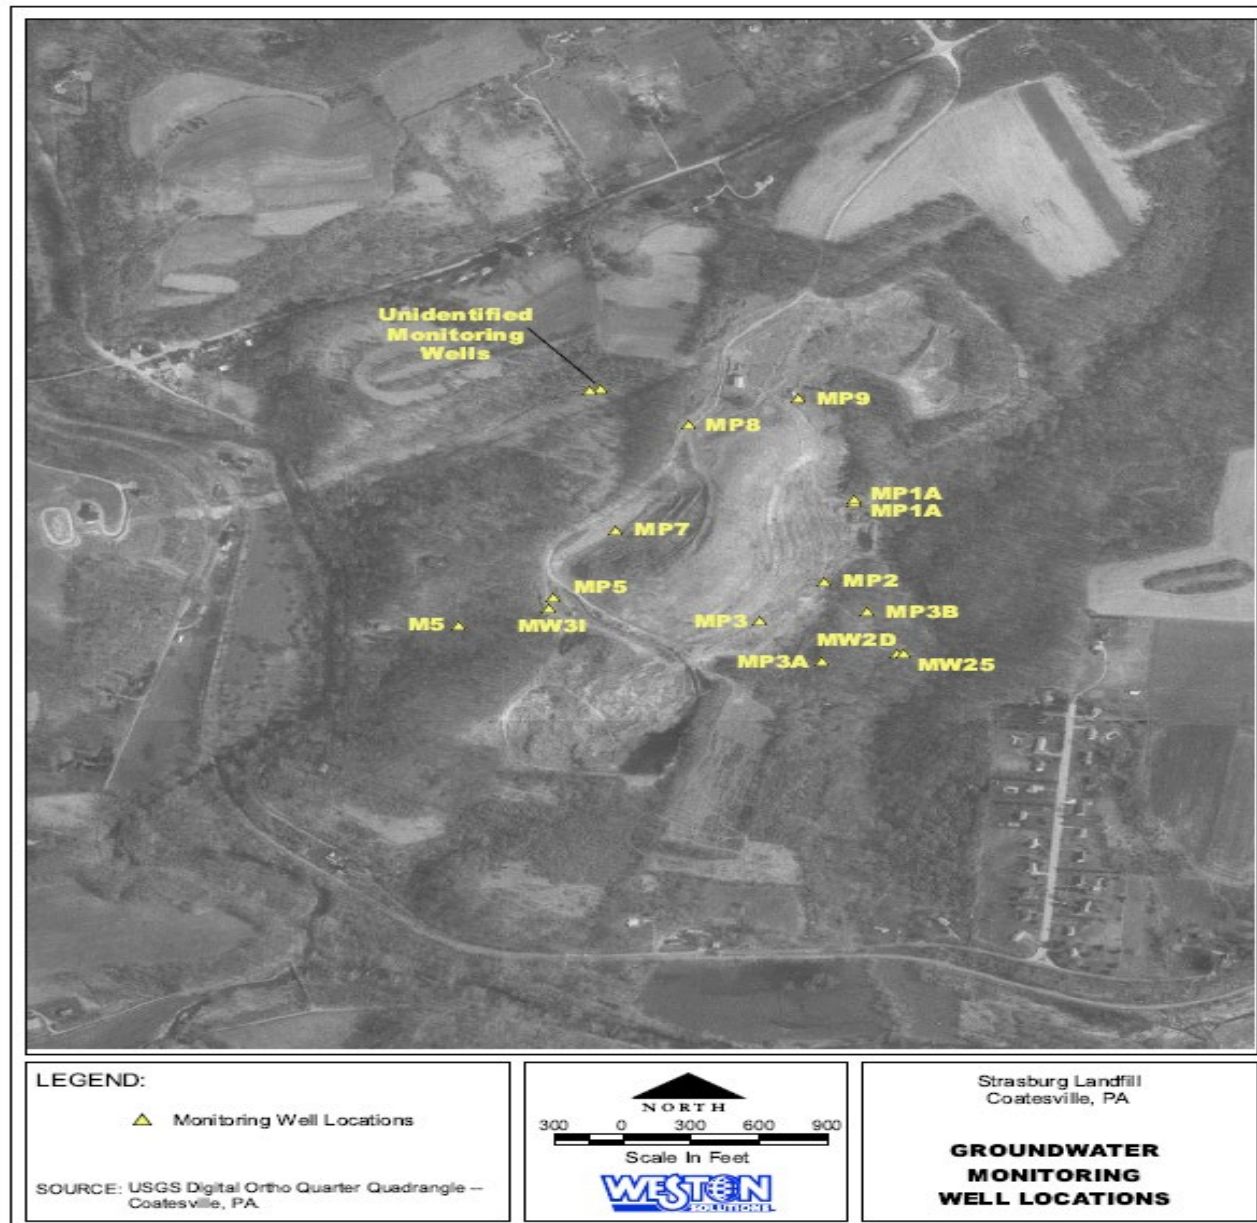
APPENDIX F – Groundwater Monitoring Well Locations

<p>B- This flag is used when the analyte is found in the associated blank as well as the sample. -All results reported in ug/L</p>	<p>Map in Appendix F details the monitoring well network at the Site</p>	
--	--	--
