**SECOND FIVE-YEAR REVIEW REPORT FOR
UGI COLUMBIA GAS PLANT SUPERFUND SITE
LANCASTER COUNTY, PENNSYLVANIA**

MAY 2021

**U.S. Environmental Protection Agency
Region 3
Philadelphia, Pennsylvania**

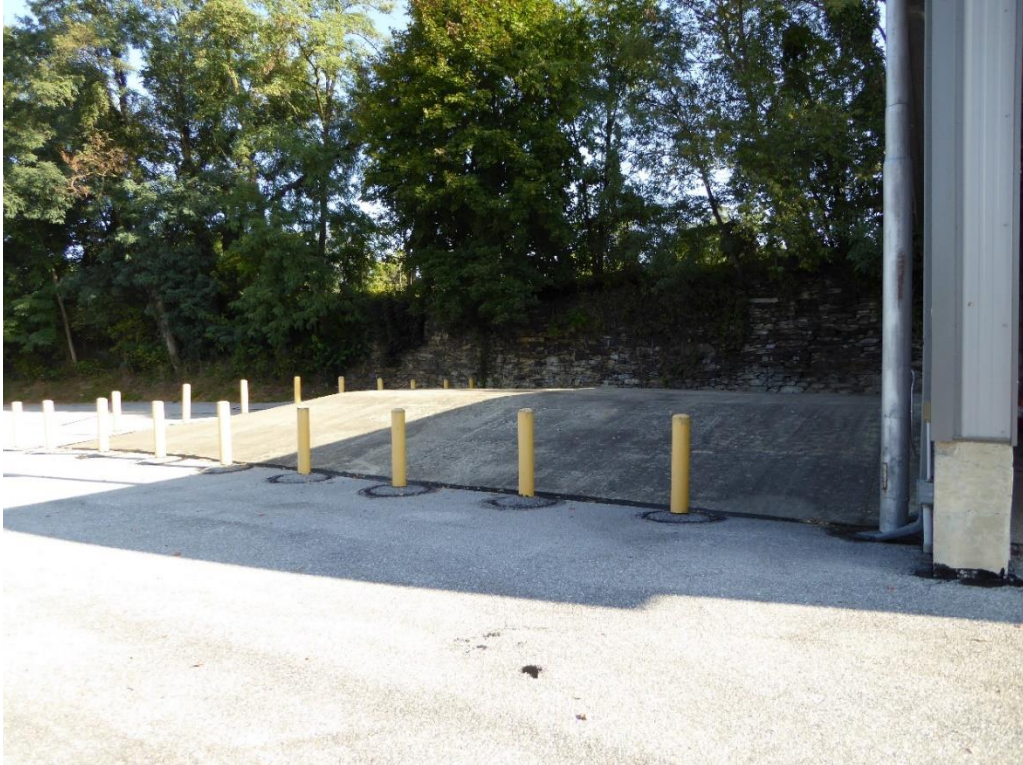
6.	Alternative Cover (e.g., armored rock, concrete) Remarks: <u>Concrete and asphalt are in good condition (recently sealed) at manufactured gas plant area.</u>

Western concrete cap at MGP area

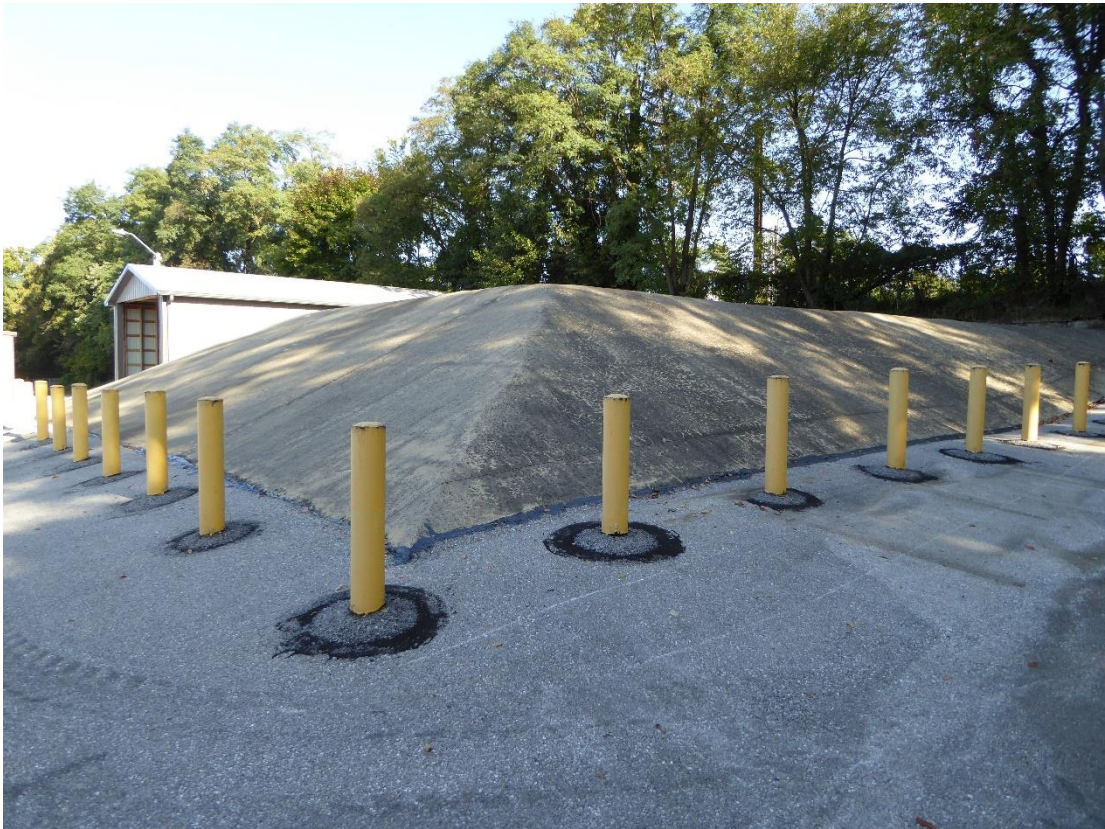
Eastern concrete cap at MGP area

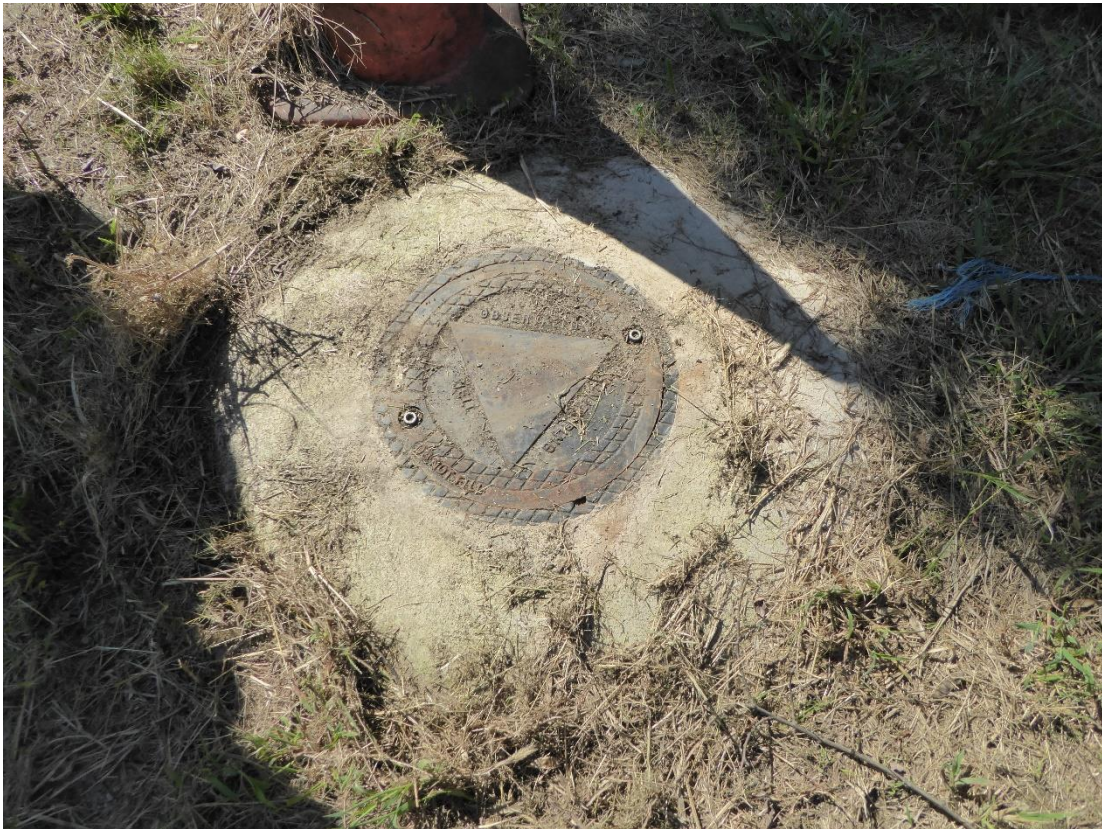
Site inspection participants observed the former MGP facility, the area of sediment remediation in the Susquehanna River, the former Columbia WWTP, the borough municipal garage southwest of Front Street and the LWA drinking water pumping station. At the former MGP facility, the concrete and asphalt covers are in good condition with no significant cracks; they appear to have been sealed recently. The two concrete-capped former MGP holders are surrounded by bollards for protection. A locked fence surrounds the former MGP facility. Monitoring well CWW01 was locked but the lid was not secured to the well casing. The PRPs have since fixed the locking cap and the well is secured. Other monitoring wells appeared to be in good condition but were not labeled.

Monitoring well MW-4

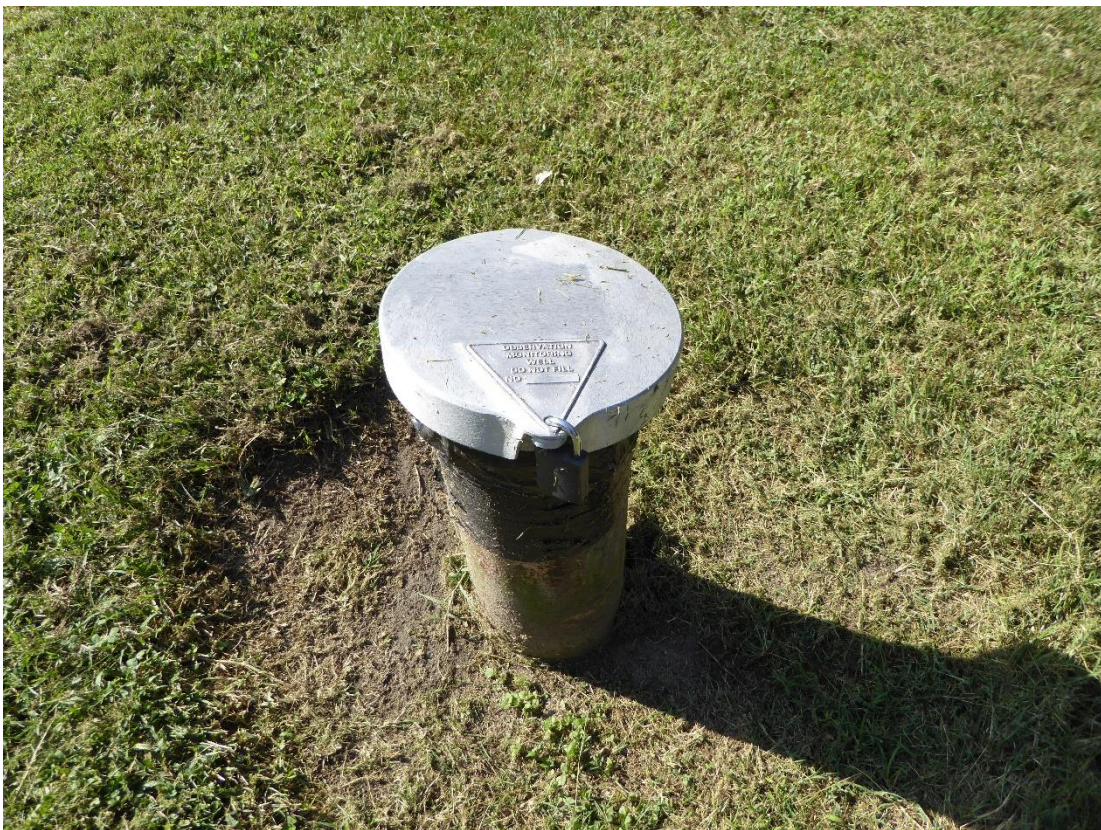
E. Monitored Natural Attenuation		
1.	Monitoring Wells (natural attenuation remedy)	
	<input type="checkbox"/> Properly secured/locked <input checked="" type="checkbox"/> Functioning <input checked="" type="checkbox"/> Routinely sampled <input checked="" type="checkbox"/> Good condition	
	<input type="checkbox"/> All required wells located <input checked="" type="checkbox"/> Needs maintenance <input type="checkbox"/> N/A	
	Remarks: <u>Monitoring well CWW01 was locked but the lid was not attached to the casing.</u>

Monitoring well CWW01 (lid locked but not attached to casing)

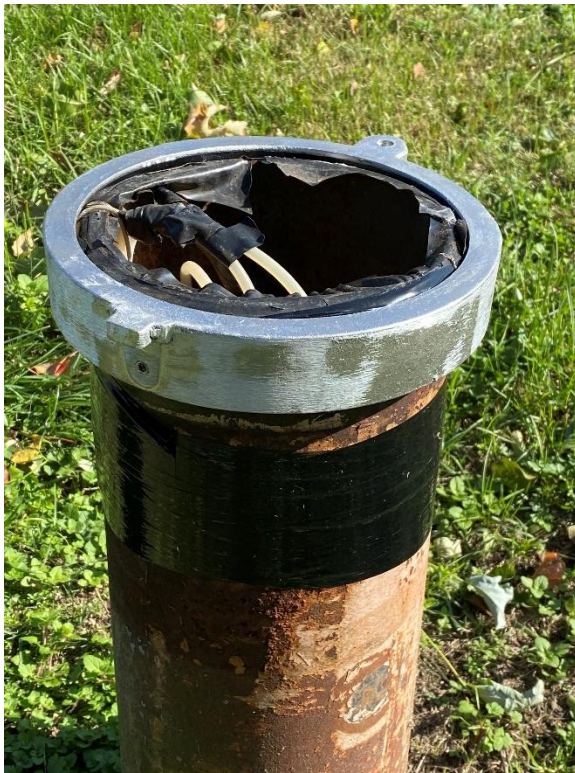
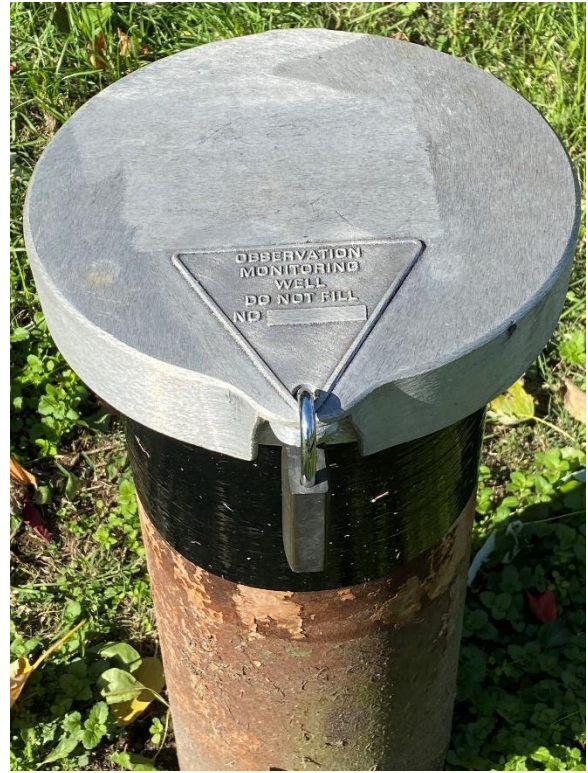
New collar and lockable lid installed on CWW01 after FYR site inspection
