SECOND FIVE-YEAR REVIEW REPORT FOR BELTSVILLE AGRICULTURAL RESEARCH CENTER SUPERFUND SITE

BEAVERDAM ROAD LANDFILL (BARC 27) – OPERABLE UNIT 5

Beltsville, Prince Georges County, Maryland

July 2023

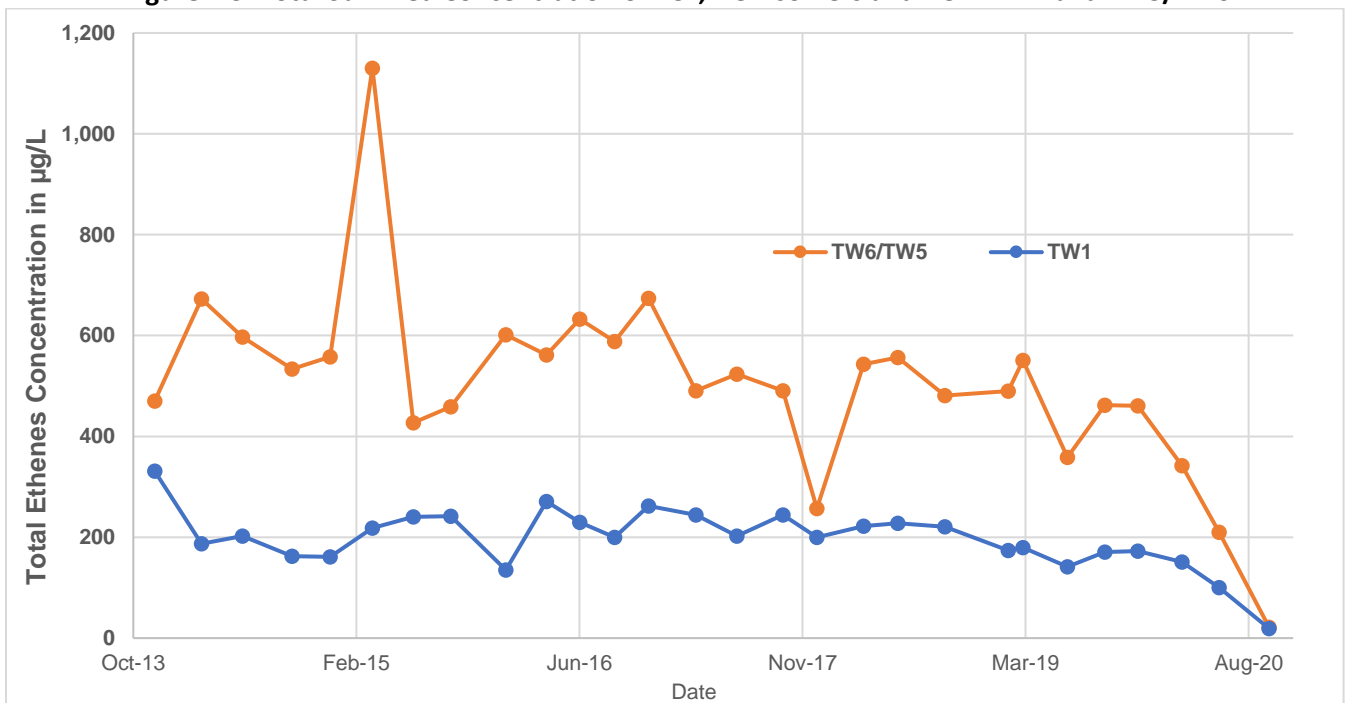
Figure 4.3. Total Summed Concentration of TCE, DCE isomers and VC in TW1 and TW5/TW6

The total molar mass of chlorinated ethenes detected in TW1 during the first six-years of monitoring was consistently lower than the molar mass of ethenes detected in TW5/TW6 during that same time span. This suggests that either abiotic processes were contributing to the reduction in CAH concentrations, or some degree of sorption was occurring. However, this does not provide any indication as to which abiotic process is predominant (e.g., adsorption or biogeochemical transformation). Adsorption to the organic substrate of the biowall, and the degradation products of the β -elimination (dichloroacetylene, chloroacetylene, and acetylene) may account for this discrepancy. Furthermore, degradation of VC may be underestimated due to the short half-life of ethene in groundwater (AFCEE et al., 2008).

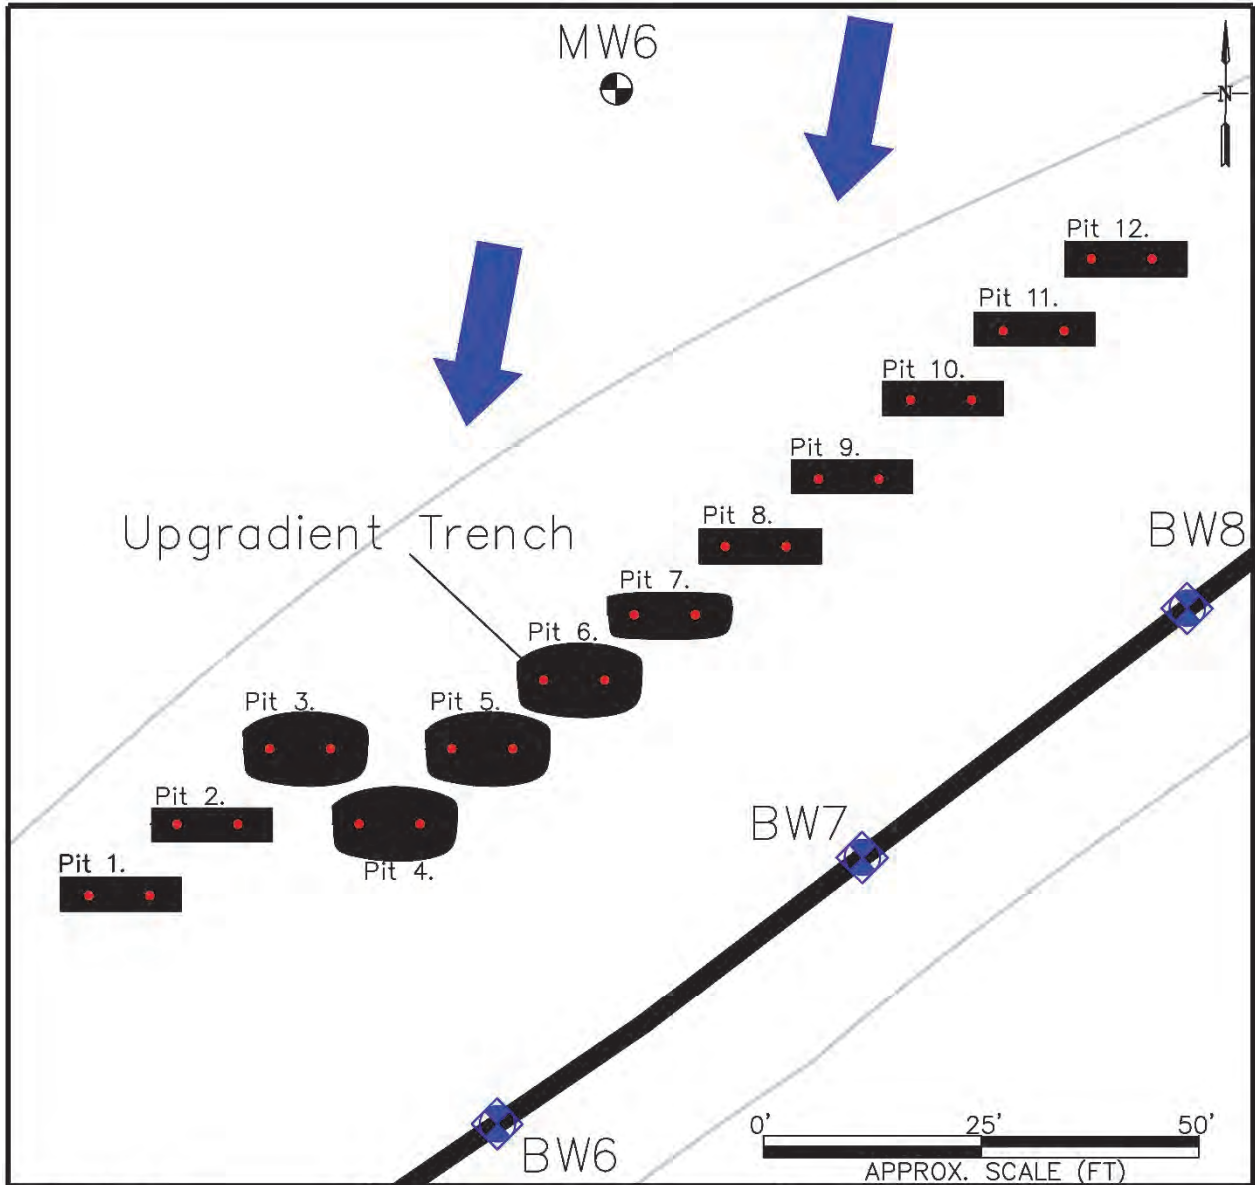
FIGURE 5
 BARC 27:
 Beaverdam Road Landfill
 Microbial Injection
 Piezometer Well Locations

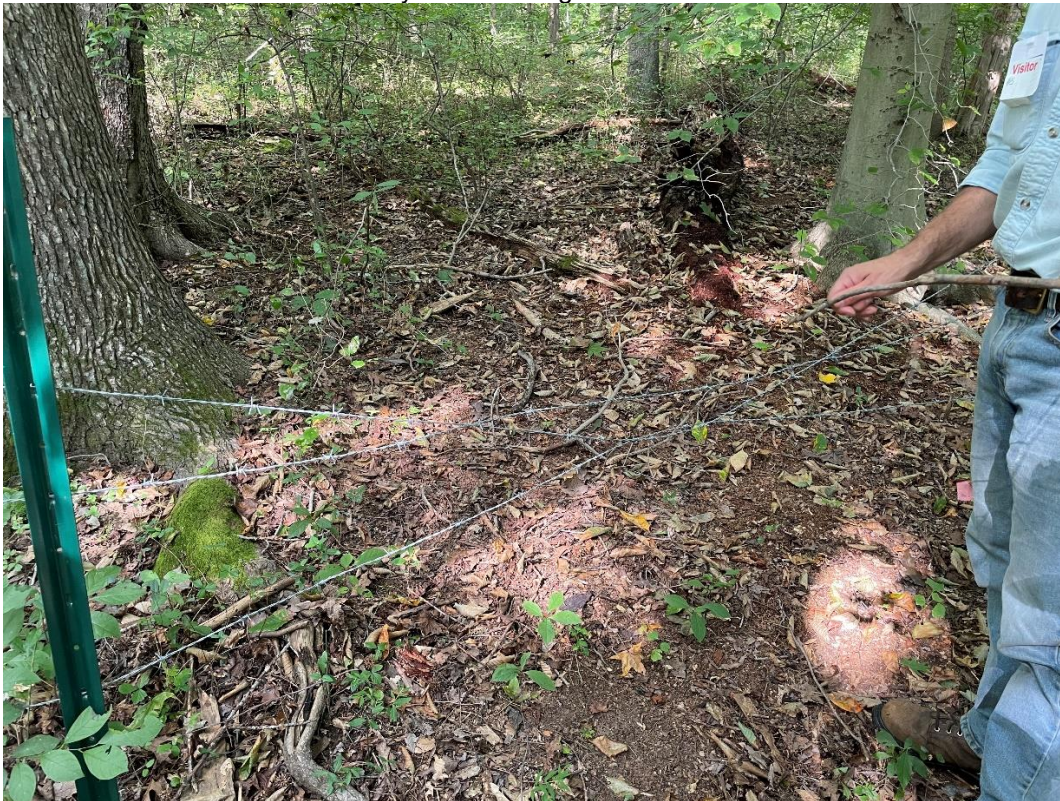
PHOTOGRAPH 01: Strands of barbed wire were twisted to allow easier site access past the BDRLF fence line on the western site boundary. No other signs of unauthorized site access were observed.

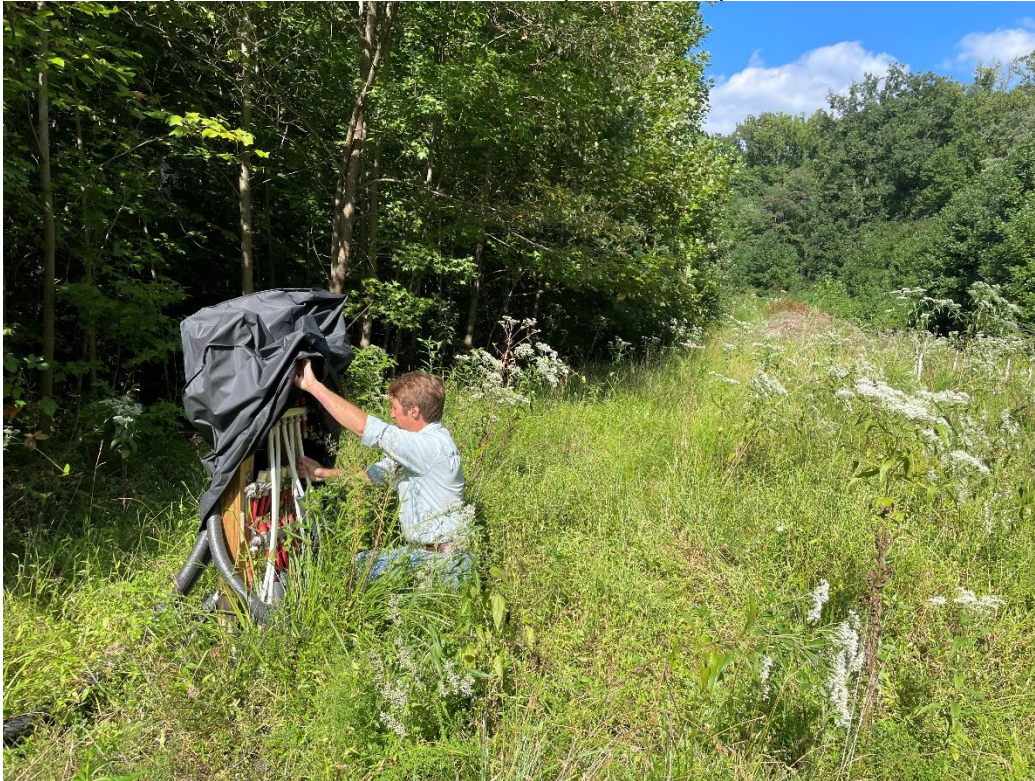
PHOTOGRAPH 03: BDRLF Solar water heating system distribution manifold is located north of the upgradient trench pits that were installed in 2020. There was no evidence of tampering or damage to this system at the site of the LUCIP inspection in September 2020.

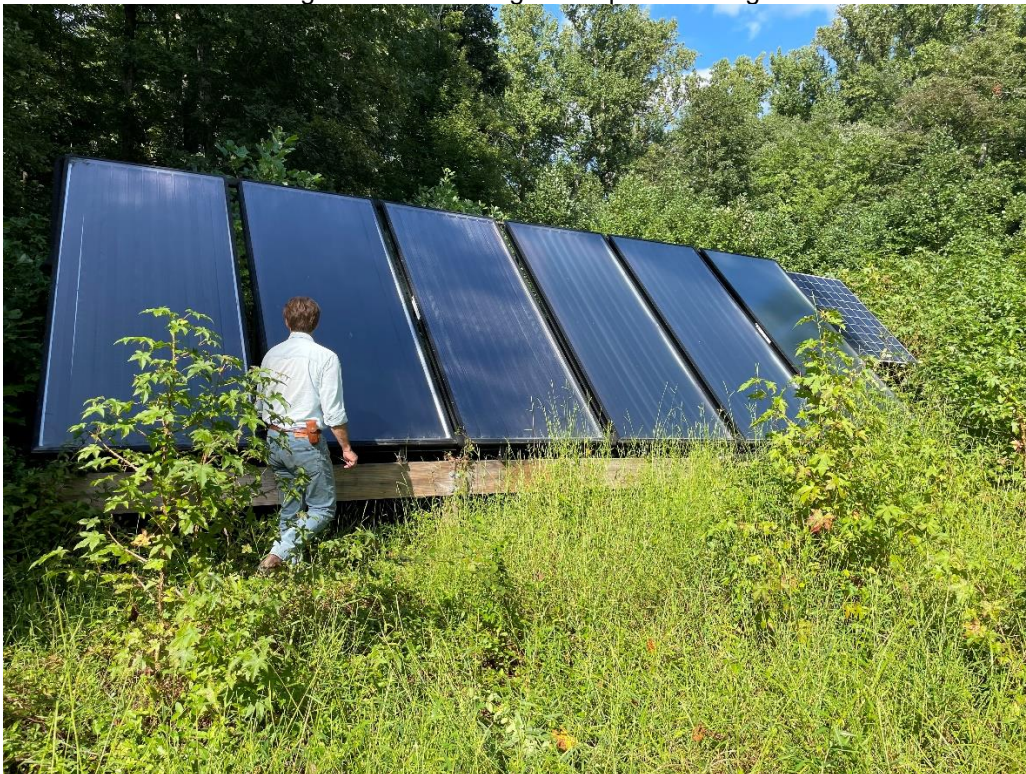
PHOTOGRAPH 04: Solar panels to heat water for circulation through selected upgradient trench pits (See Figure 1). There were no signs of damage or tampering on this system at time of inspection. Vegetation in clearing will require clearing.

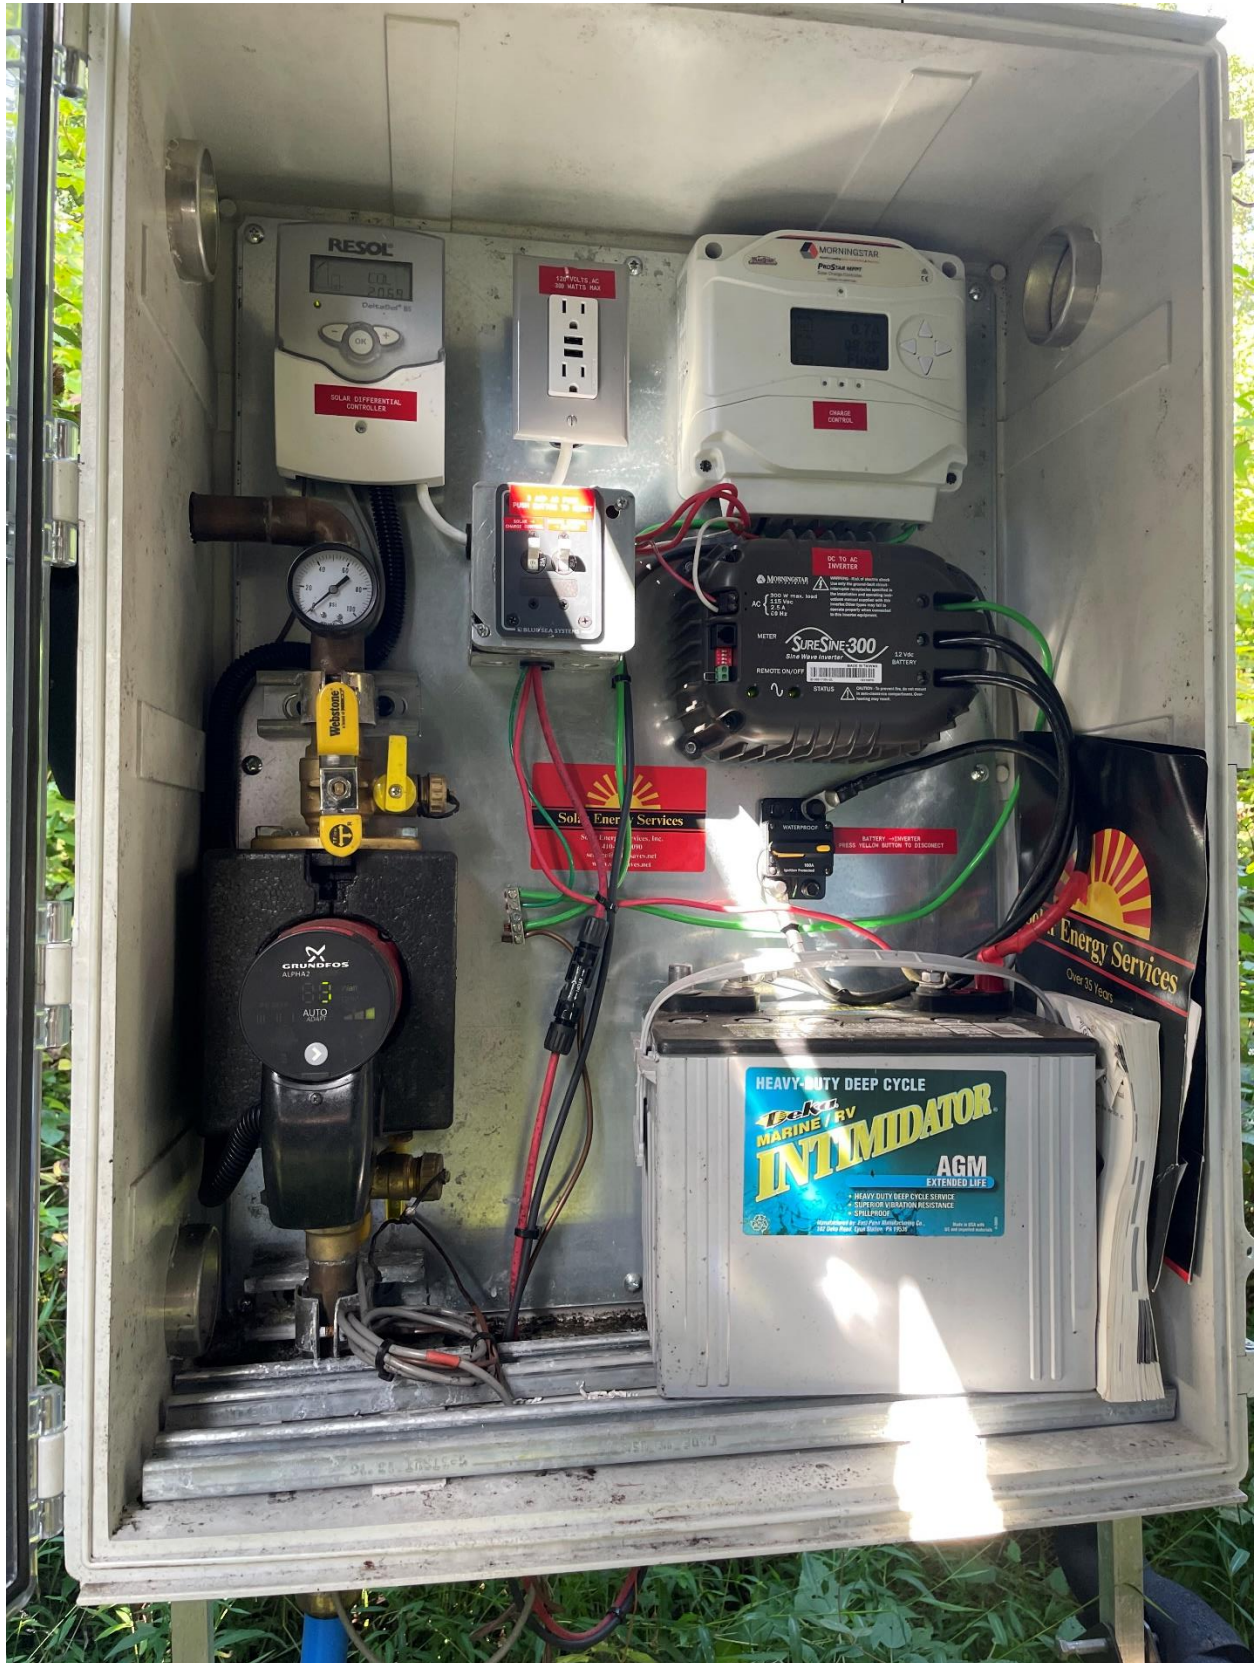
PHOTOGRAPH 05: Solar hot water circulation system main control panel. No signs of tampering or unauthorized access were observed at time of site inspection.

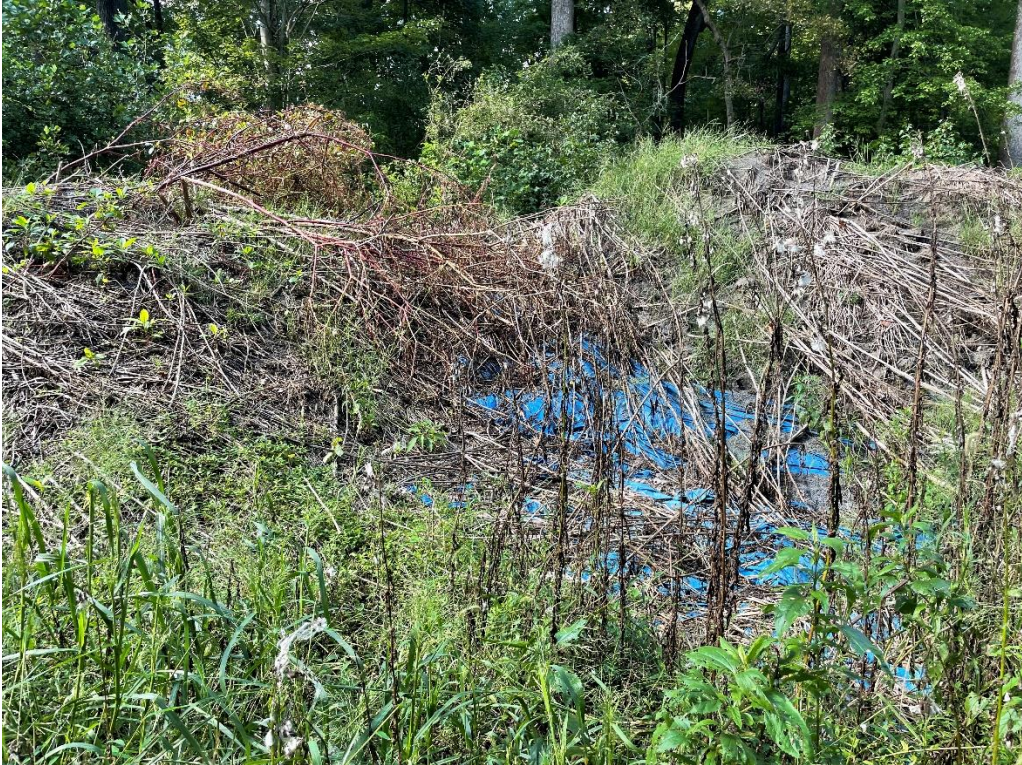
PHOTOGRAPH 06: Excess fill material for upgradient trench pits was stockpiled at the eastern extents of the biowall and covered with a tarp in 2020 to be available for potential system repairs. Tarp should be removed.

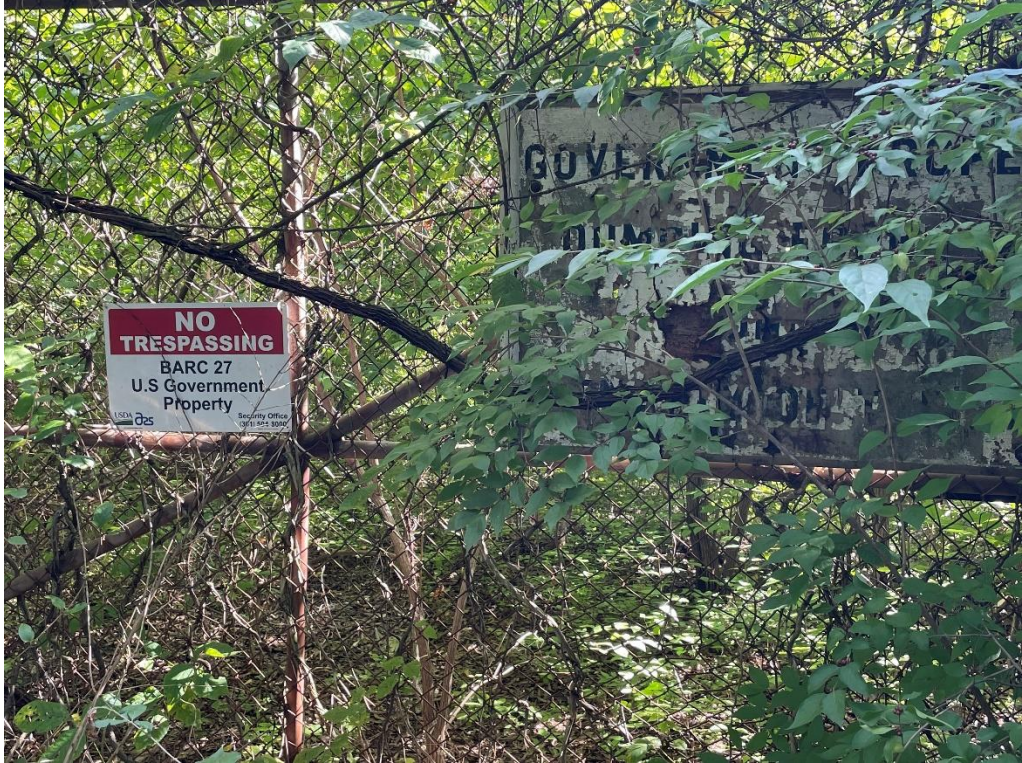
PHOTOGRAPH 07: Signage on site fencing on Beaverdam Road.

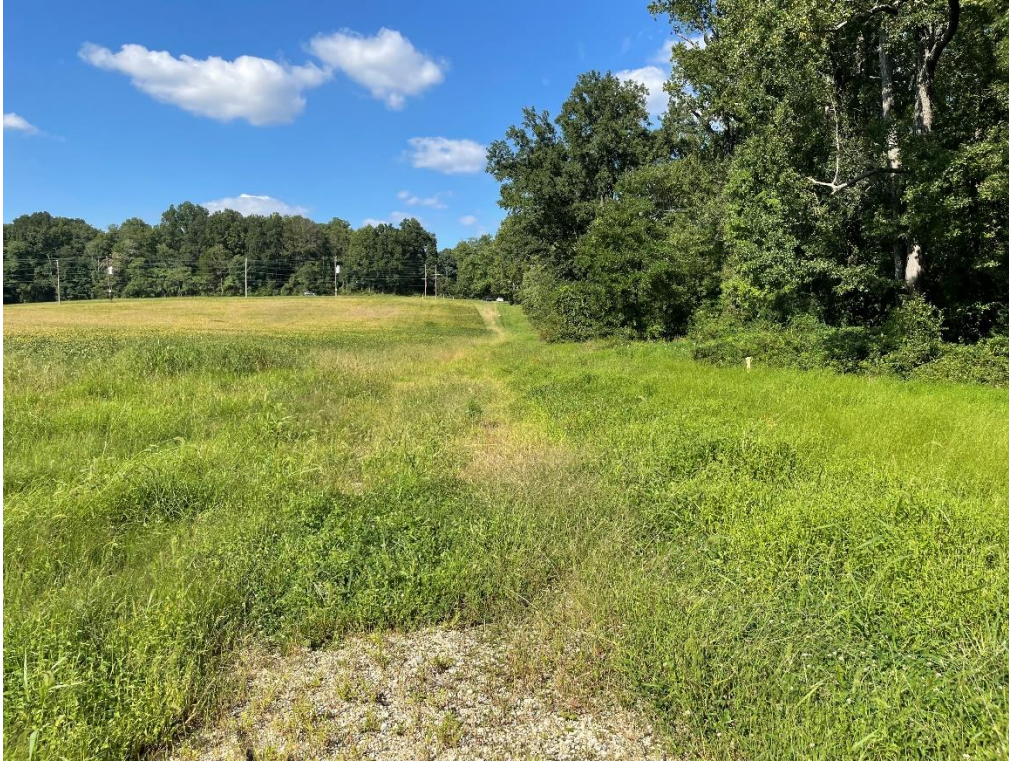
PHOTOGRAPH 08: BDRLF Gravel access road, facing north towards Beaverdam Road from main access gate. Gravel road was in good condition at time of site inspection.

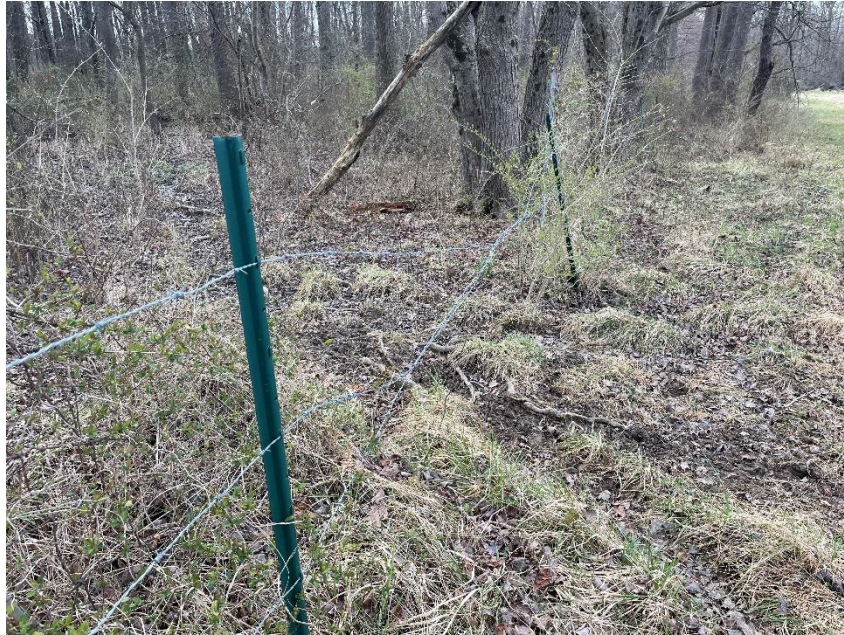
PHOTOGRAPH 01: Strands of barbed wire were twisted to allow easier site access past the BDRLF fence line on the western site boundary. No other signs of unauthorized site access were observed.

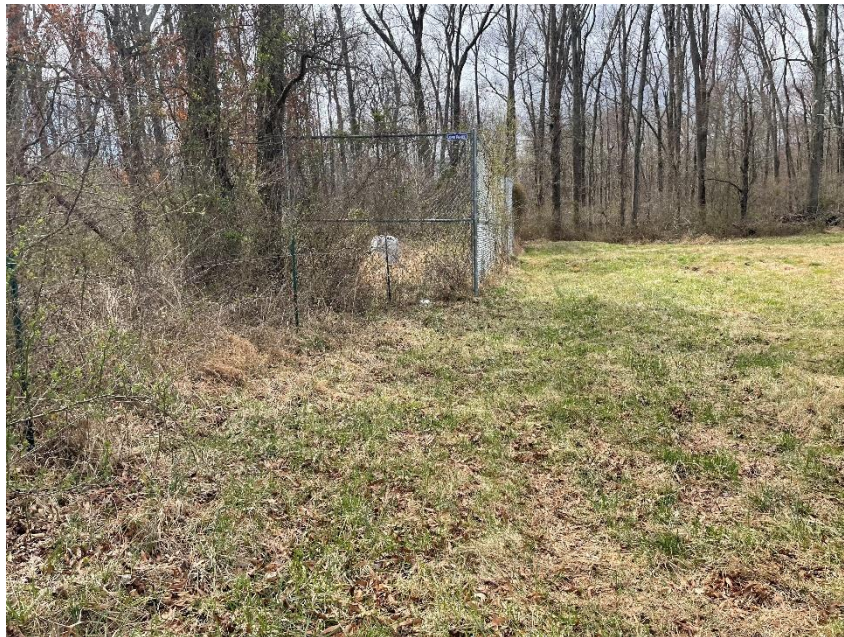
PHOTOGRAPH 02: BDRLF Gate. Good condition, lock present. No evidence of trespassing.

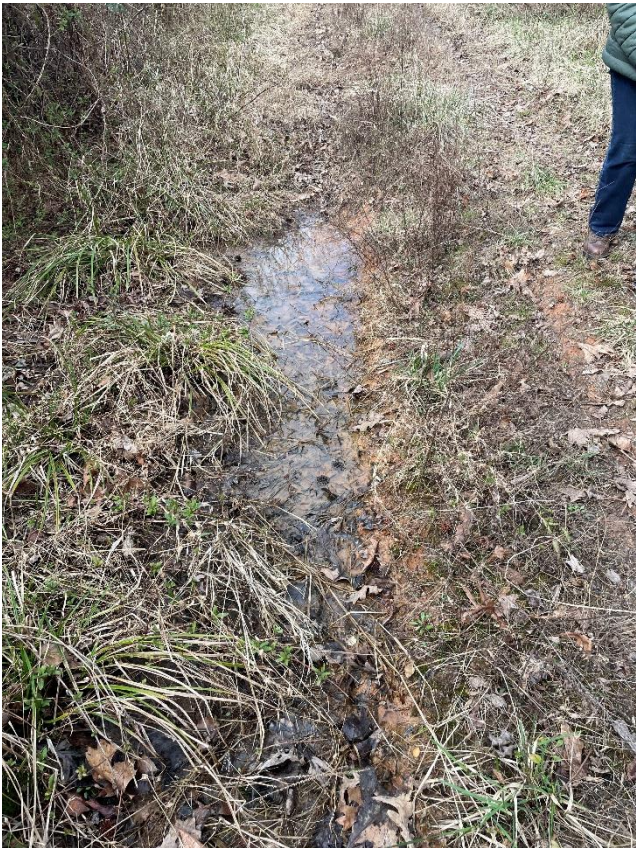
PHOTOGRAPH 03: Ponded water on the north of Biowall access path. Becomes a swale and enters a culvert to the tributary creek. The swale has a gravel check dam with vegetation growing on it. Vegetation to be removed.

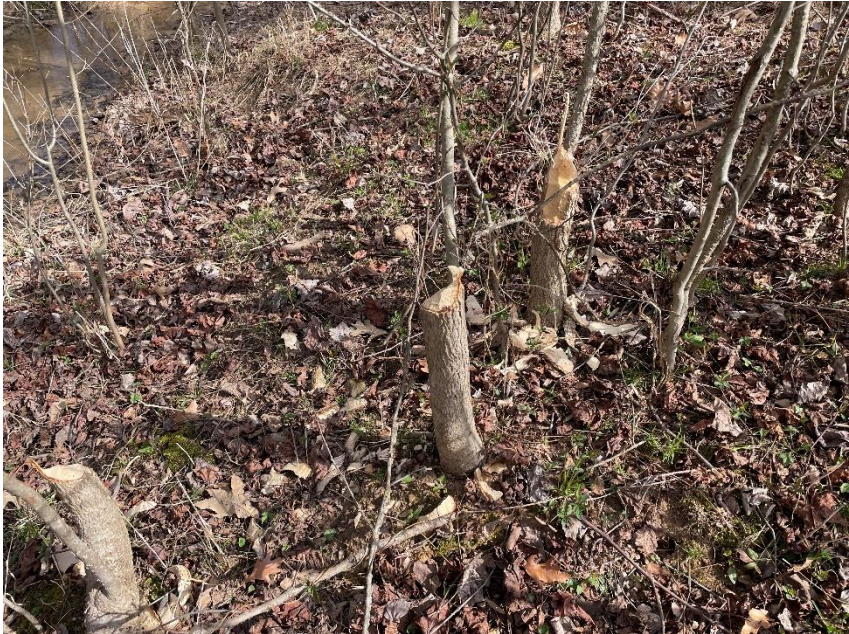
PHOTOGRAPH 04: Evidence of beavers near the swale and check dam, north of the biowall.

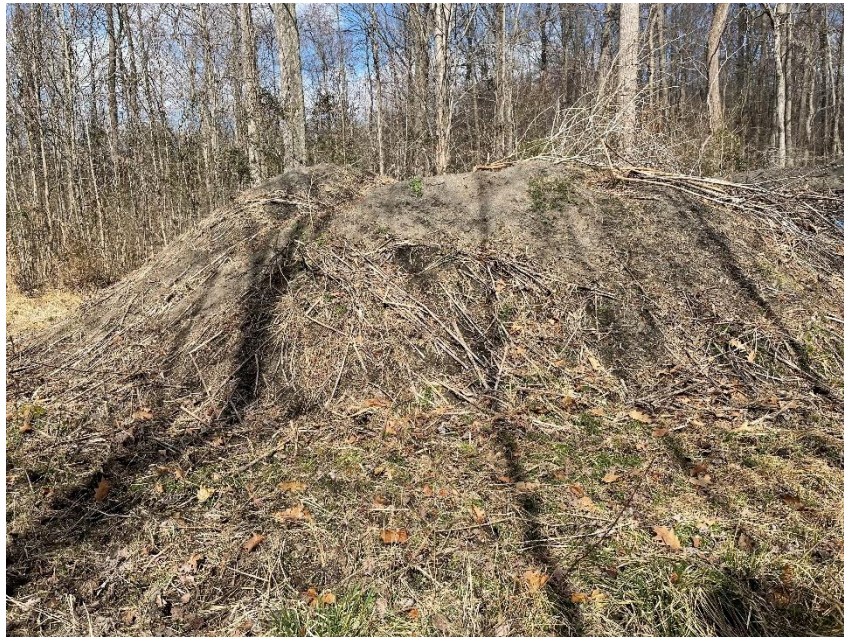
PHOTOGRAPH 05: Stockpiles of mixed crushed limestone and biosolids. Old silt fencing around piles, as well as a tarp (not pictured). Silt fencing and tarp to be removed. Stockpiles to be removed and used elsewhere.

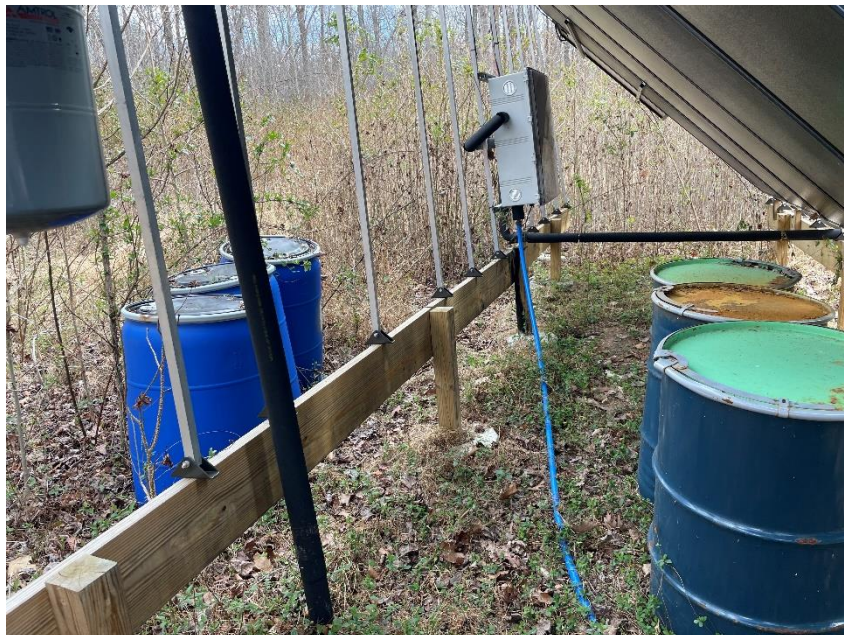
PHOTOGRAPH 06: Empty drums at the solar water heating area. Initial inspection identified the drums as containing some liquid. Subsequent review determined they were empty, but sunk into the ground. Drum to be removed, all liquids handled as per the BARC Master IDW Plan.
