**SIXTH FIVE-YEAR REVIEW REPORT FOR  
C&R BATTERY CO., INC. SUPERFUND SITE  
CHESTERFIELD COUNTY, VA**

**August 2023**

**U.S. Environmental Protection Agency  
Region 3  
Philadelphia, Pennsylvania**

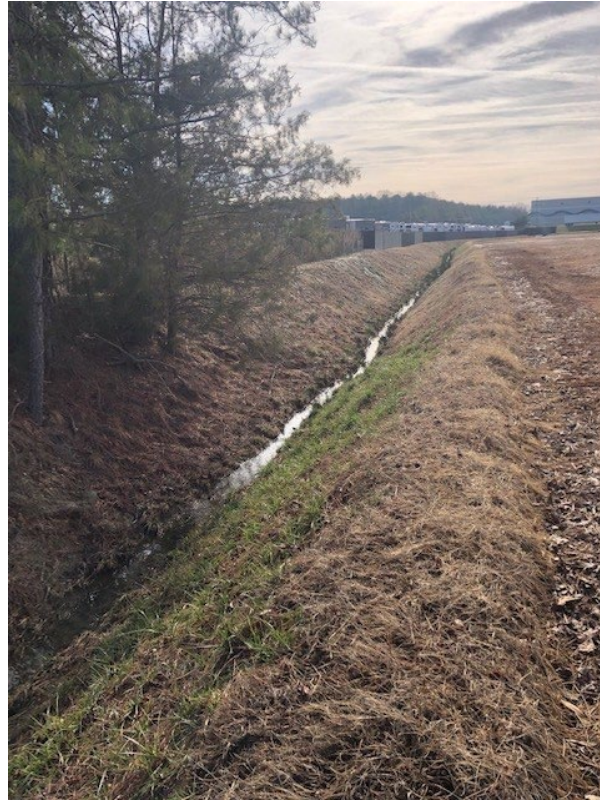
View of drainage ditch located on eastern boundary of 1320 Bellwood Road, facing south.

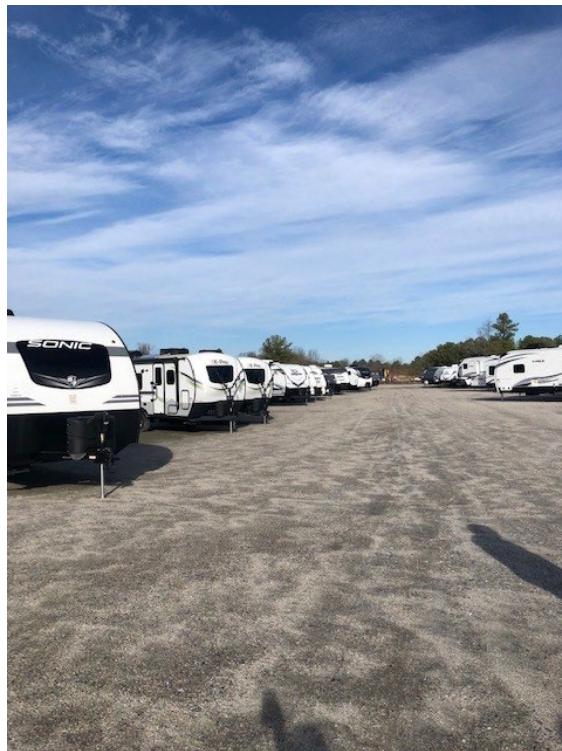
Next, participants toured 1360 Bellwood Road (parcel 7986773046). The property was in good condition and includes a gravel surface and fencing around the perimeter. The property is currently being leased by an RV company and is used for storage of RV vehicles. A small building (former Capitol Oil building) was observed on the property and is utilized by the tenant. The parcel includes a fence around the perimeter which appeared to be in good condition. The property owner noted that both parcels are secure, and trespassing has not been an issue.

View of RV parking area and gravel surface at 1306 Bellwood Road, facing north.

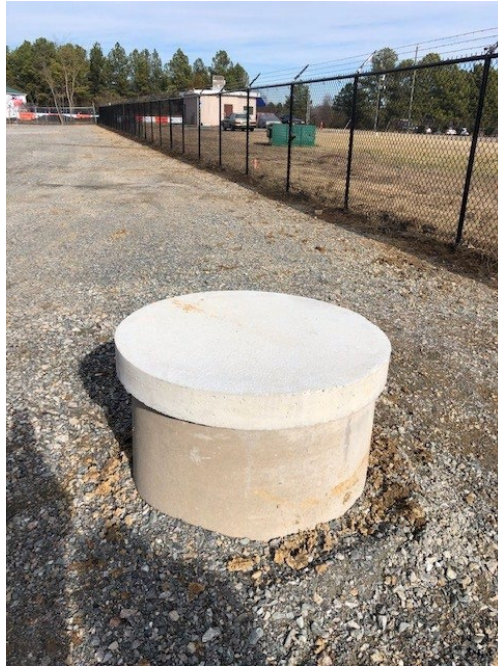
Well located near fencing on eastern side of the 1306 Bellwood Road property. This well is not used for drinking water.

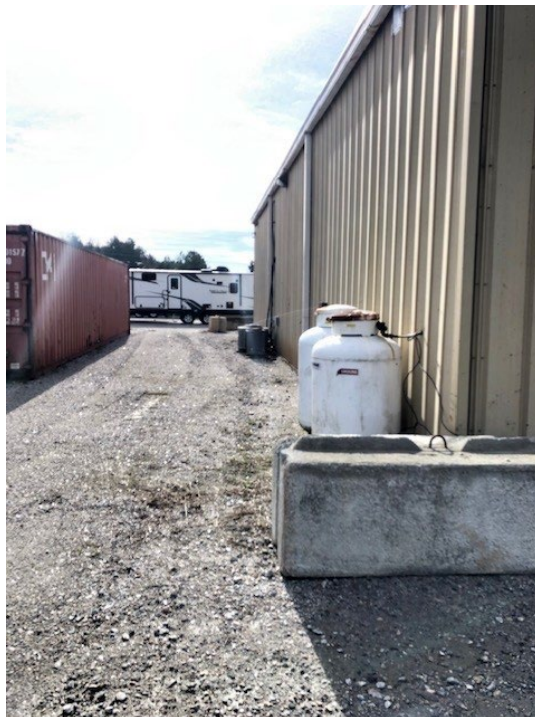
View of storage building, two propane tanks and gravel surface at 1306 Bellwood Road.
