HAZARD RANKING SYSTEM (HRS) DOCUMENTATION RECORD COVER SHEET

Name of Site: Post and Lumber Preserving Co. Inc.

EPA ID No.: FLD004061925

HAZARD RANKING SYSTEM (HRS) DOCUMENTATION RECORD

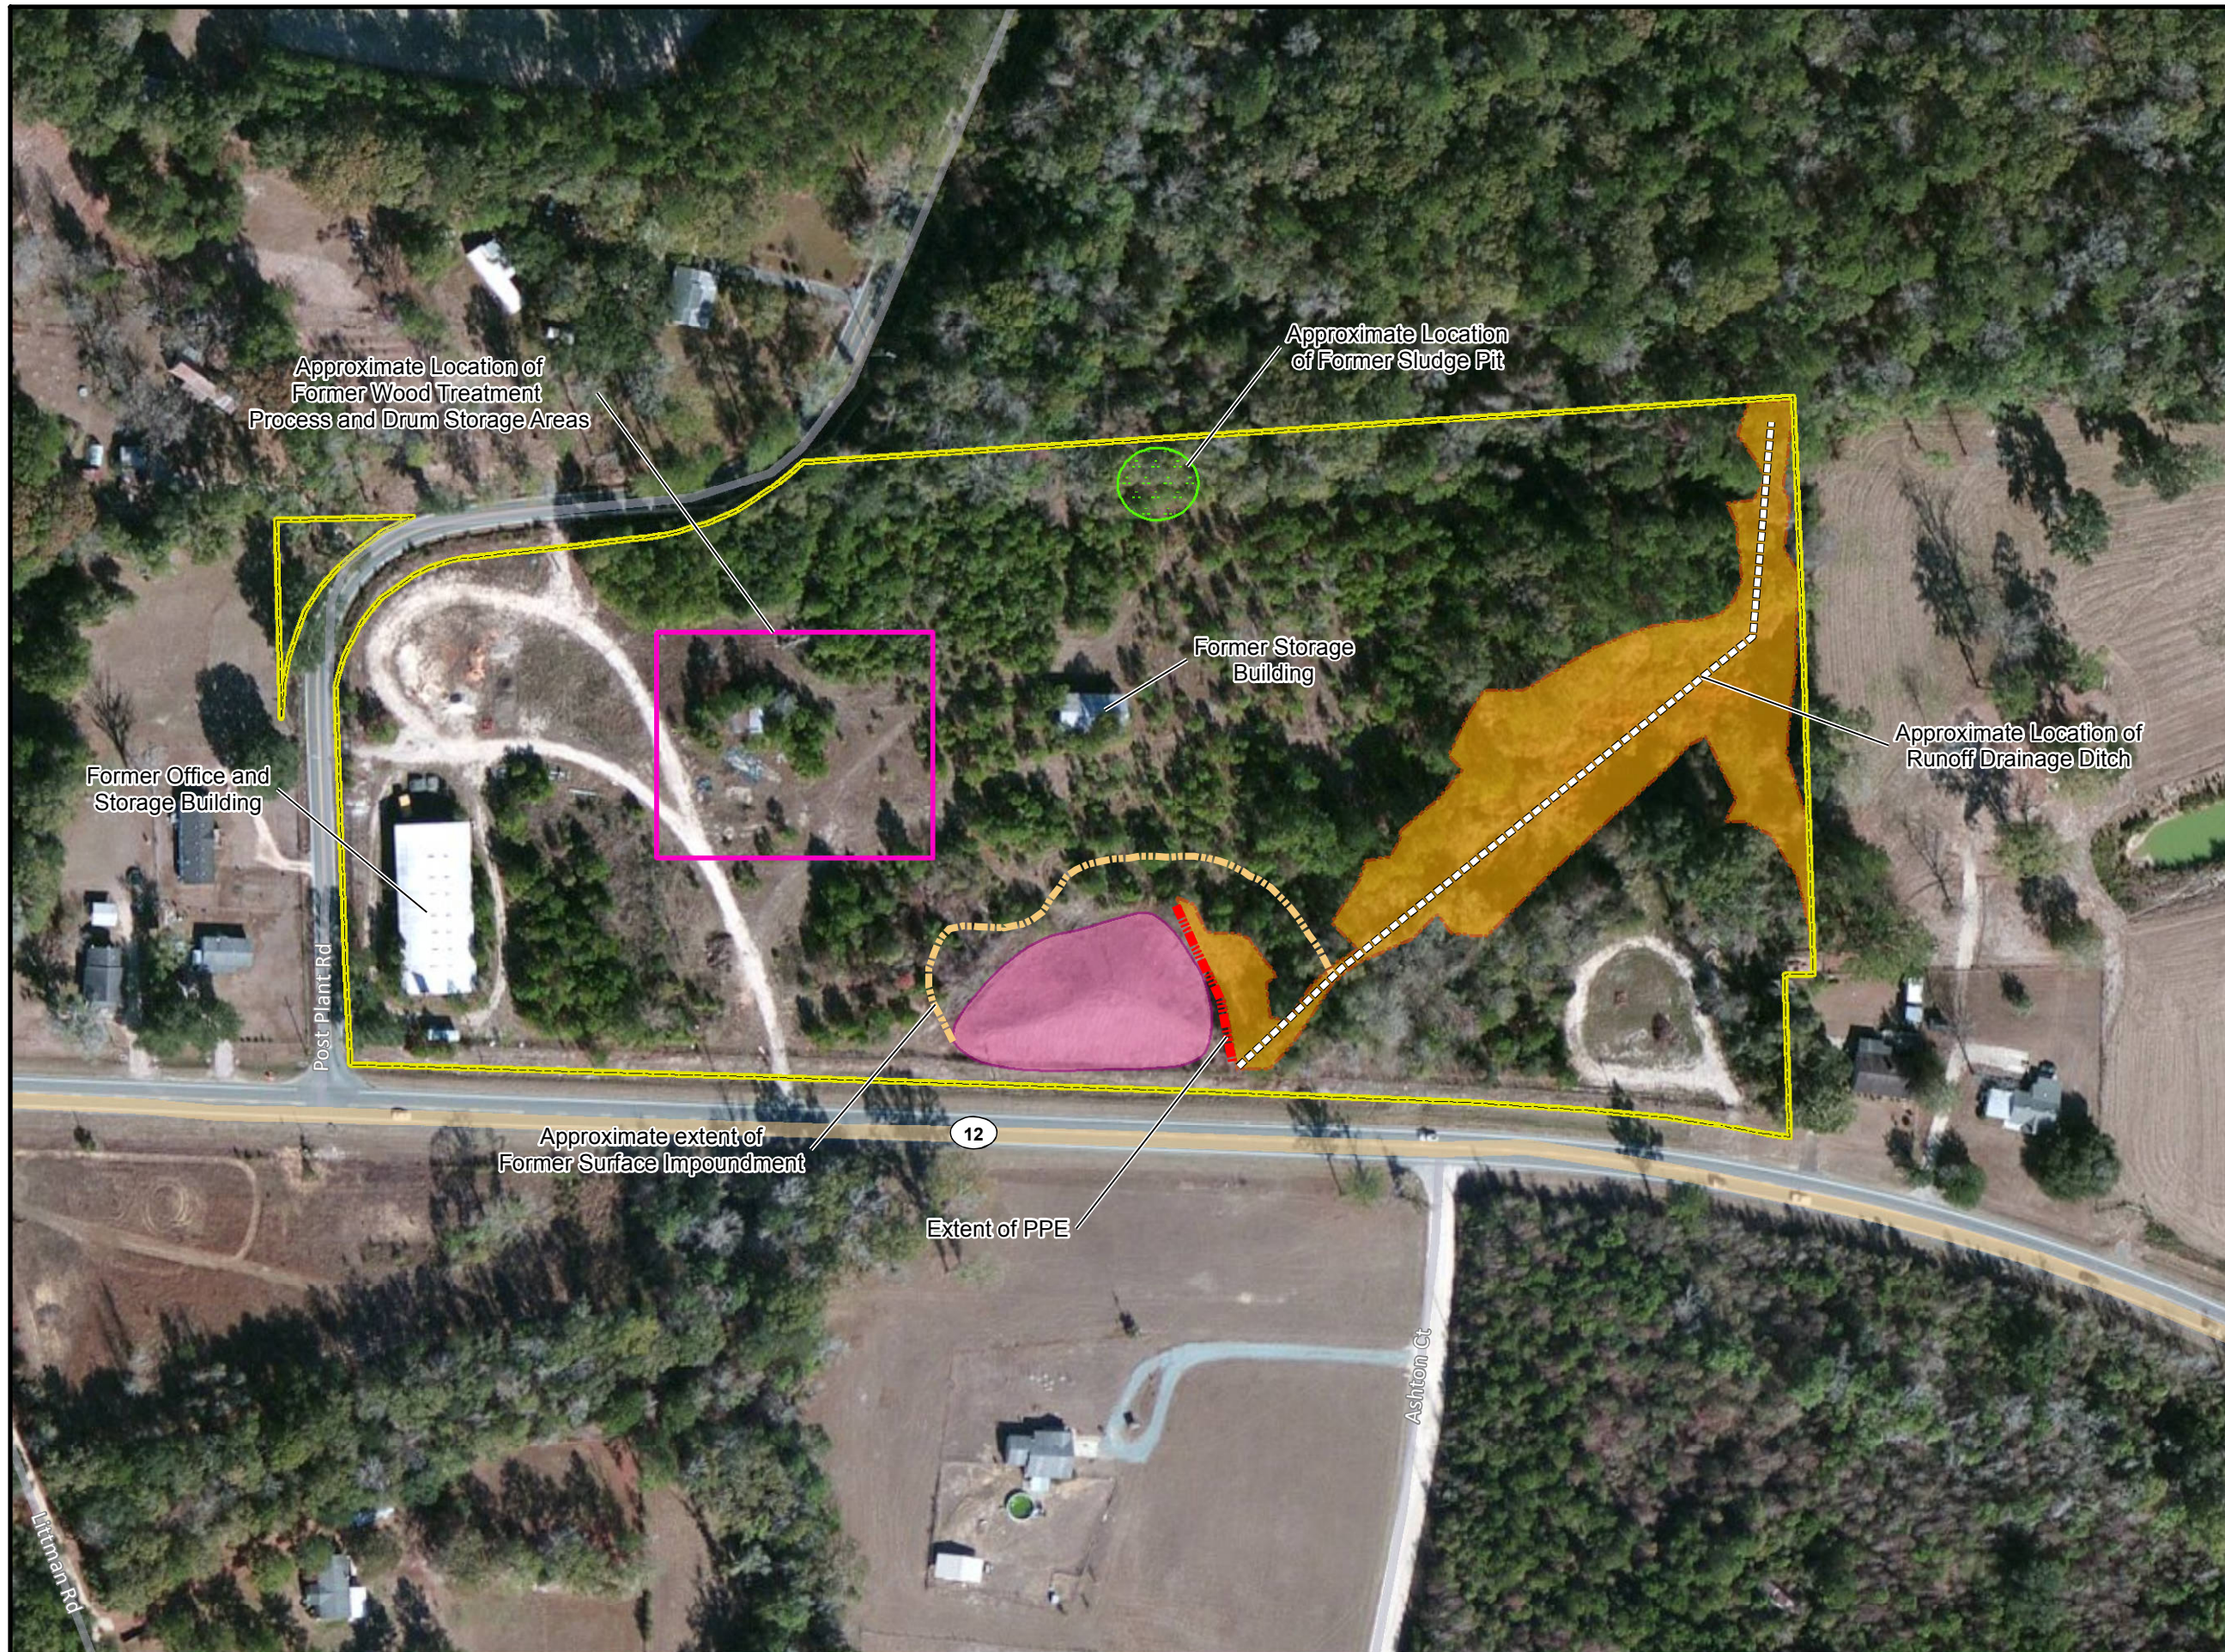
- Legend**
- Approximate Extent of Former Surface Impoundment
 - Approximate Location of Runoff Drainage Ditch
 - Extent of PPE
 - Approximate Location of Former Sludge Pit
 - Approximate Location of Former Wood Treatment Process and Drum Storage Areas
 - Property Boundary
 - Source No. 1
- FDEP Delineated Wetlands**
- HRS Eligible Palustrine Forested Wetlands

Insufficient information exists to evaluate hazardous constituent quantity, hazardous wastestream quantity, and volume. Therefore, the Hazardous Waste Quantity (HWQ) value will be calculated using Tier C, for the volume of bottom sludge/sediments and contaminated soil contained in the pile located in the southern portion of the Post & Lumber property (Ref. 1, pp. 51590, 51591) (see Figure 2 of this HRS documentation record).

During Post & Lumber operations, the former surface impoundment received process wastewater and rainwater runoff from the treatment process area during operations (Ref. 7, p. 49) (see Figure 2 of this HRS documentation record). Between 1982 and 1989, Post & Lumber received several Warning Notices, Notices of Violations, and Notices of Deficiencies, including a Warning Notice on July 1, 1985, to correct inadequate and eroded dikes surrounding the former surface impoundment (Ref. 7, pp. 30, 31). During periods of heavy rainfall, the former surface impoundment overflowed into the eastern runoff drainage ditch, which becomes an intermittent stream northeast of Post & Lumber and flows into the Little River (Ref. 7, pp. 25, 39). The eastern drainage ditch is located in an area that FDEP delineated as wetland forested mixed (630), which is equivalent to palustrine forested wetlands (Refs. 7, pp. 25, 39; 12, pp. 321, 322, 323; 21, p. 57; 22, pp. 6, 8, 16). Continuous wetlands are located along the unnamed tributary referred in the RCRA Facility Assessment as an intermittent stream (Ref. 20, pp. 1, 2, 5). Also, surface water runoff from Source No. 1 enters palustrine forested wetlands located adjacent to Source No. 1 (Refs. 12, pp. 321, 322, 323; 18, pp. 15, 116; 22, pp. 6, 8, 16). Analytical data to document an observed release by direct observation are not available.

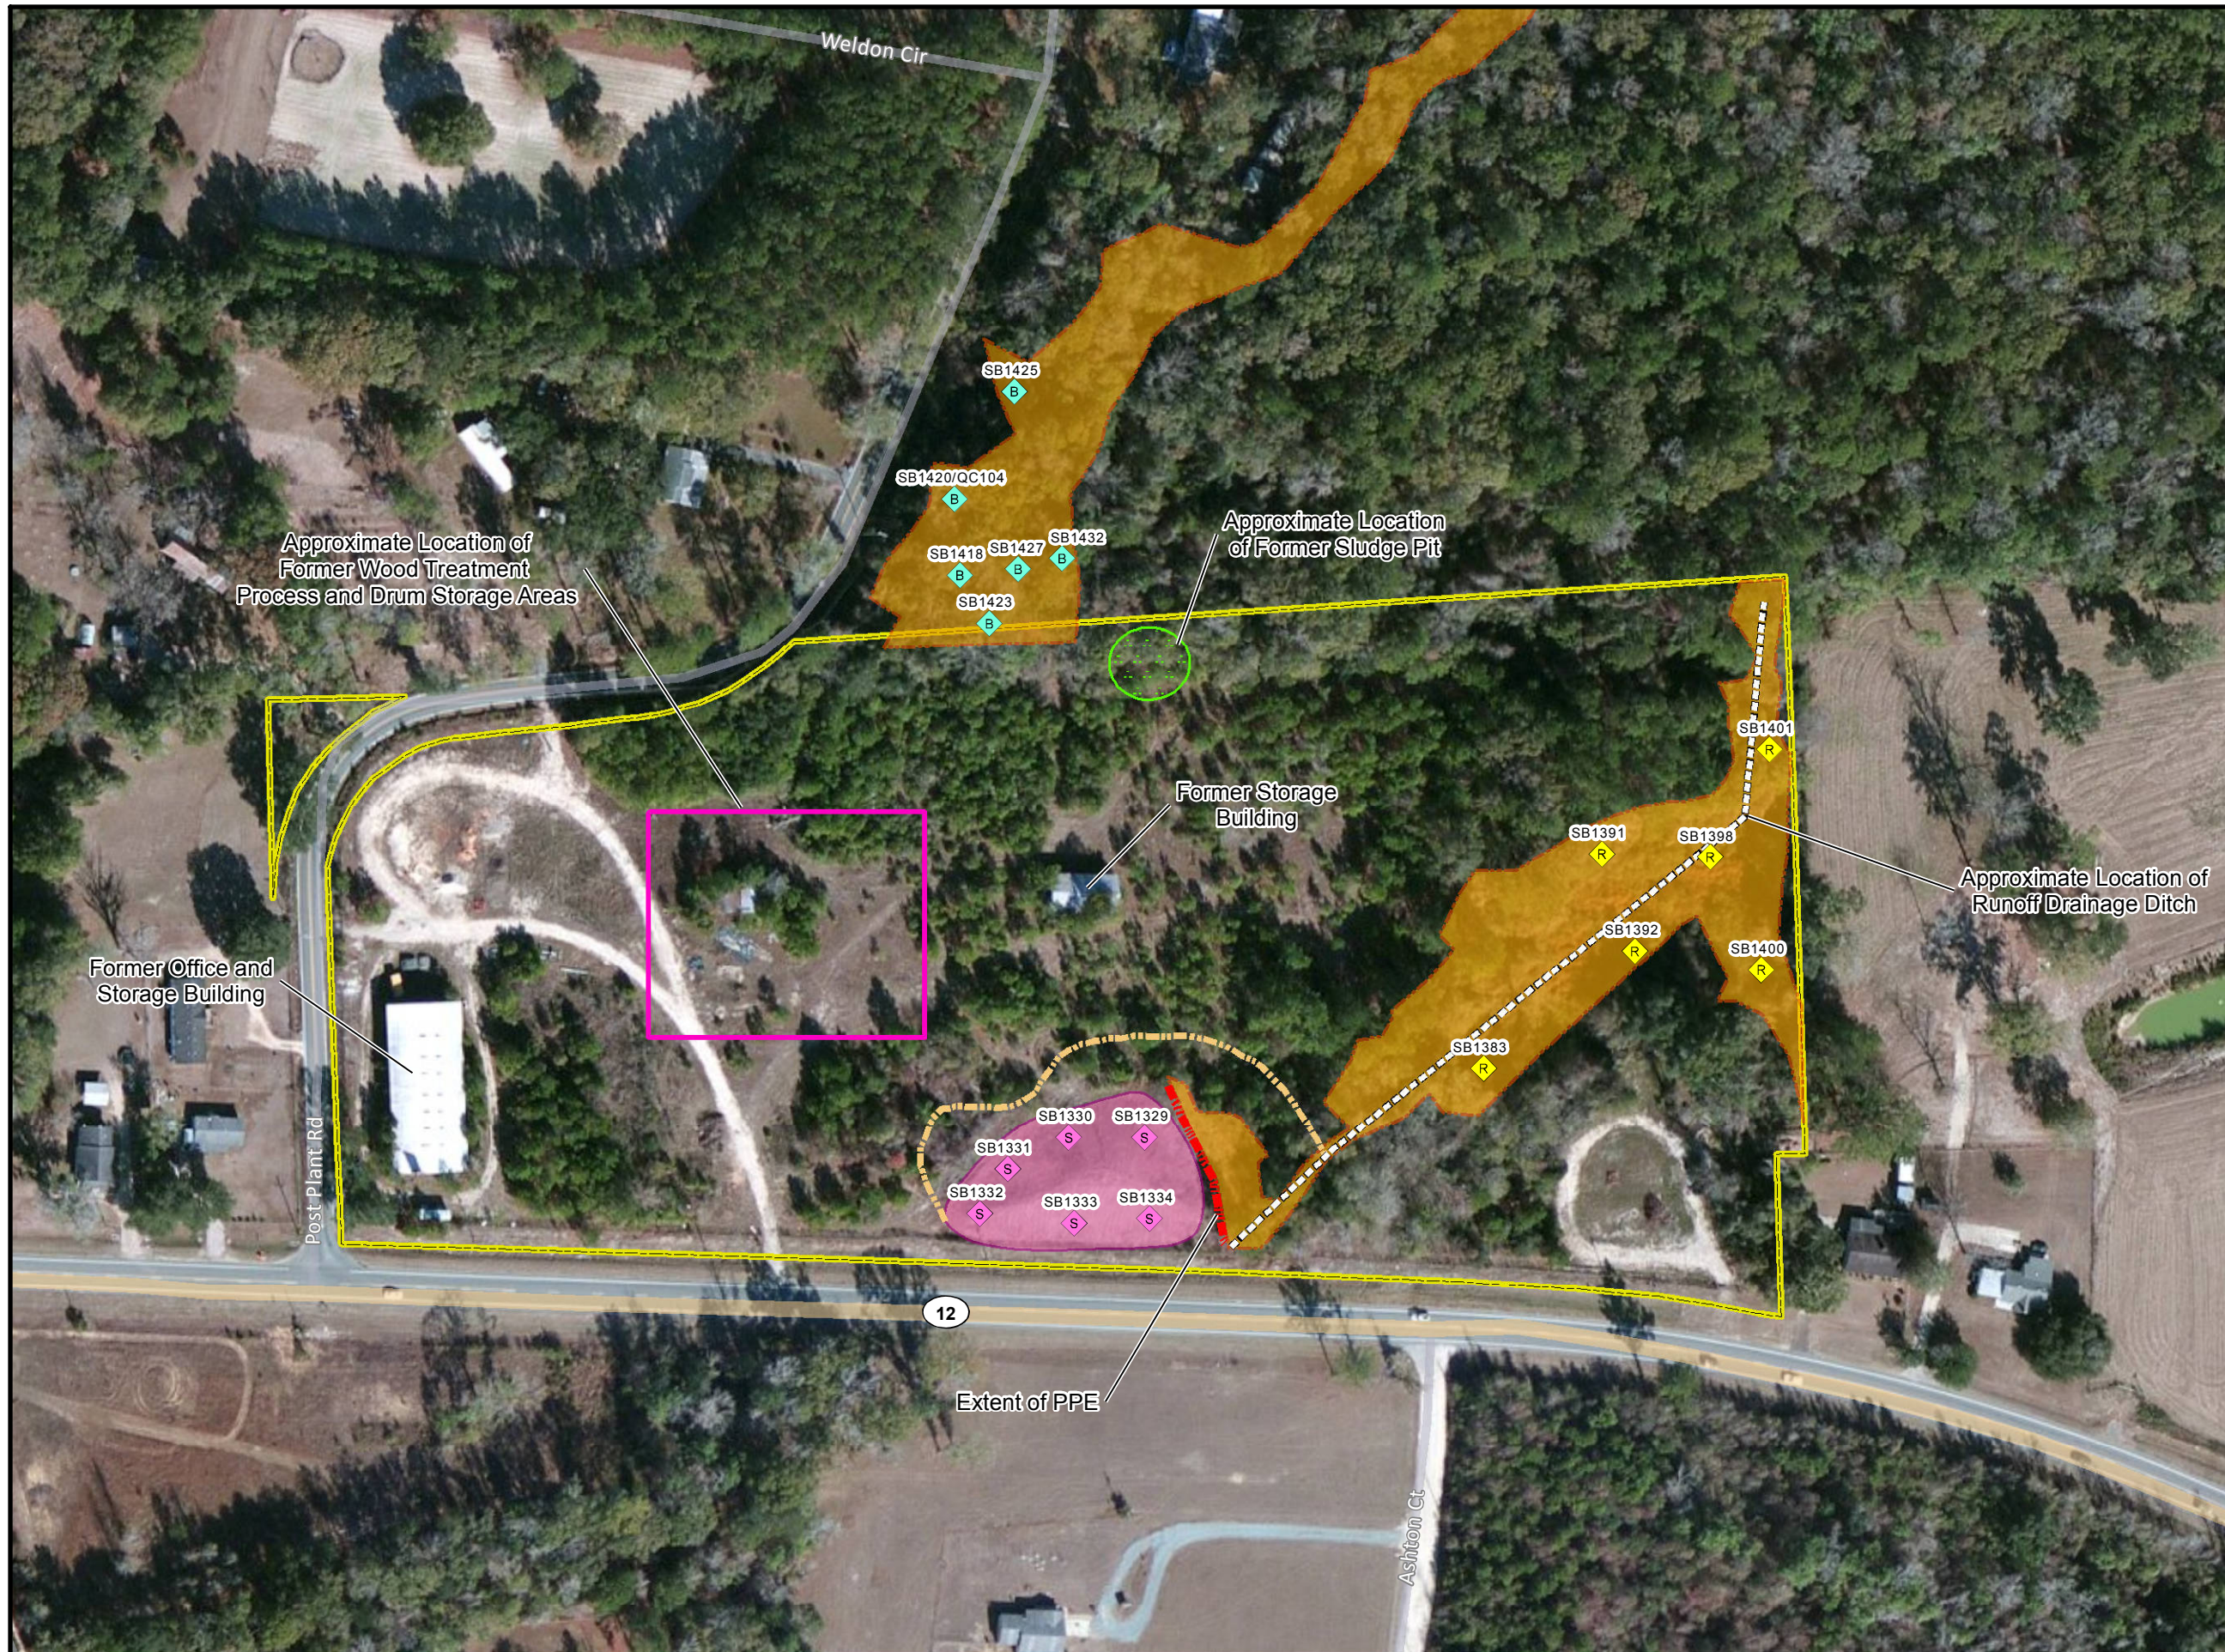
FIGURE 3
 Source and Observed Release Sampling Locations

- Legend**
- ◆ Observed Release Wetland Sample
 - ◆ Background Wetland Sample
 - ◆ Source Sample
 - Approximate Extent of Former Surface Impoundment
 - Approximate Location of Runoff Drainage Ditch
 - Extent of PPE
 - Approximate Location of Former Sludge Pit
 - Approximate Location of Former Wood Treatment Process and Drum Storage Areas
 - Property Boundary
 - Source No. 1
- FDEP Delineated Wetlands**
- HRS Eligible Palustrine Forested Wetlands

Coordinates listed above for the Post and Lumber Preserving Co. Inc. were measured at the approximate center of Source No. 1 (Ref. 4) (see Figure 3 of this HRS documentation record).
