**THIRD FIVE-YEAR REVIEW REPORT FOR  
MACALLOY CORPORATION SUPERFUND SITE  
NORTH CHARLESTON, CHARLESTON COUNTY, SOUTH CAROLINA**

**August 2020**

**Superfund & Emergency Management Division  
U.S. Environmental Protection Agency  
Region 4  
Atlanta, Georgia**

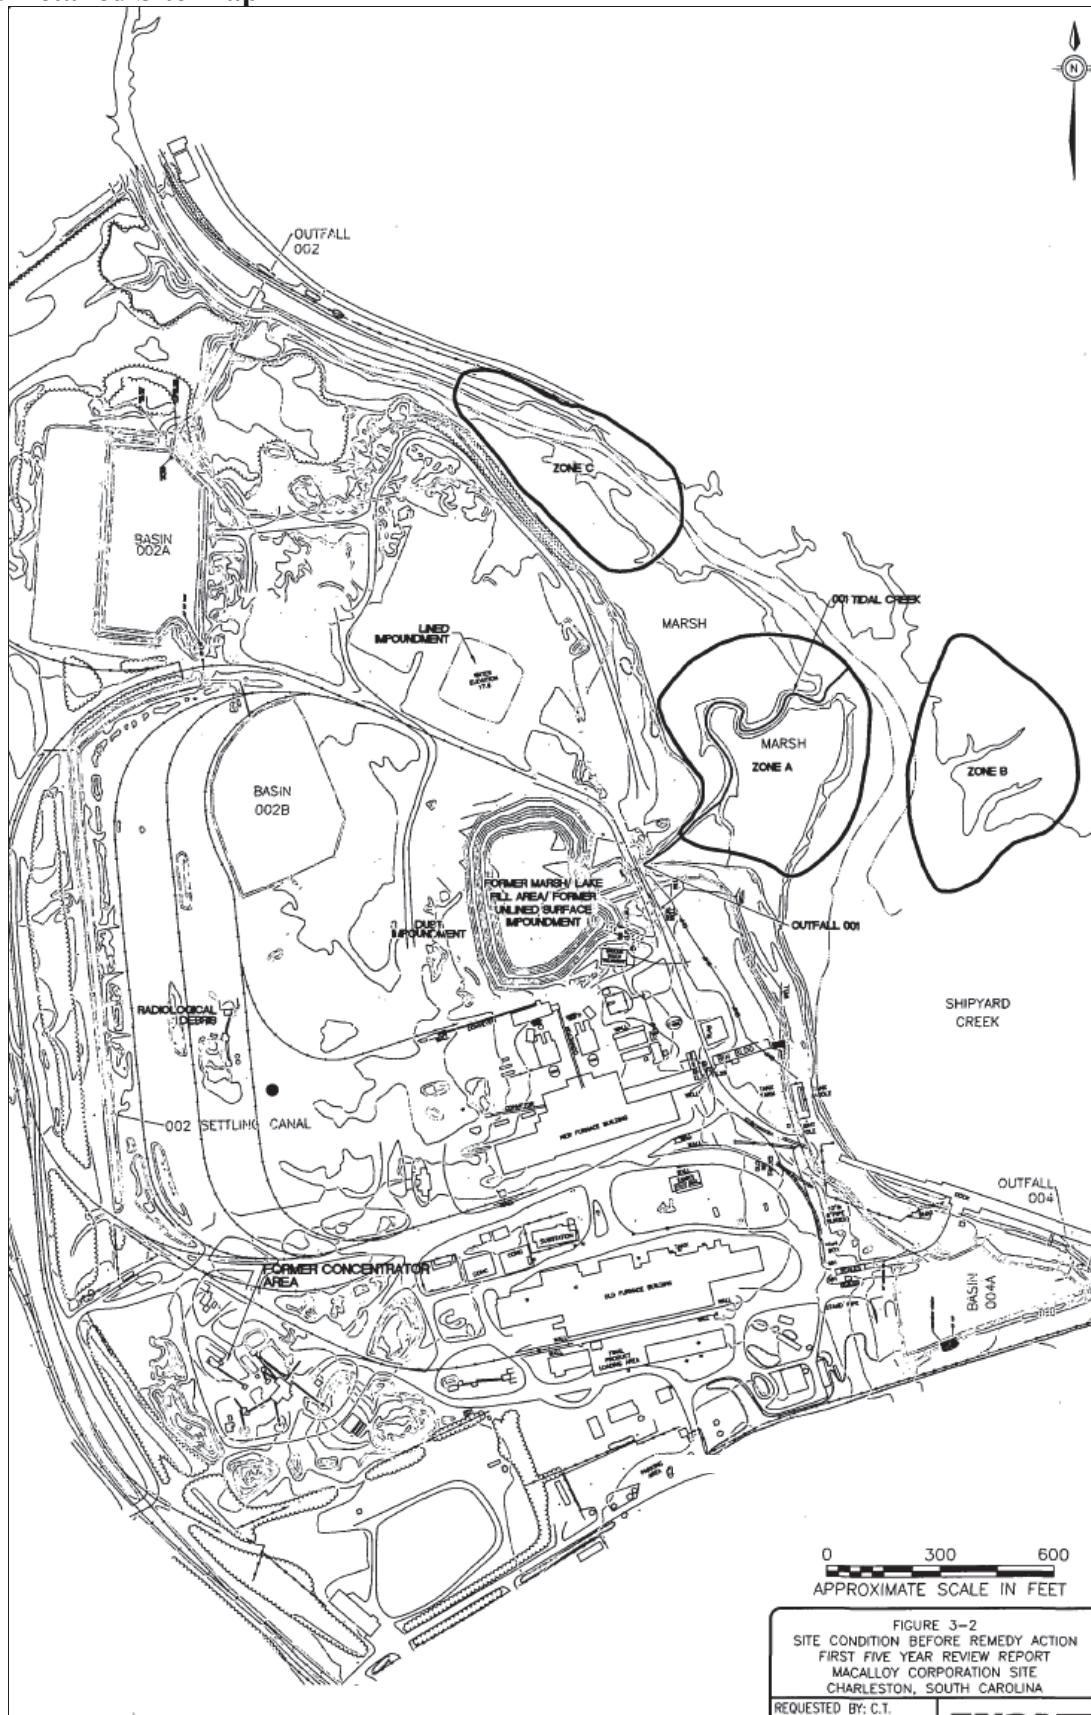
Figure 2: Detailed Site Map

produce more hexavalent chromium by-product than submerged arc furnaces. The submerged arc furnace yielded approximately 180 tons of finished ferrochromium per day. Waste materials generated during furnace operations included wastewater, airborne waste gases, and particulate matter. Water was used for cooling the furnace and as the contact cooling medium for airborne discharges from the furnace. Air emissions control equipment at the facility included three baghouses, two gas conditioning towers, and two electrostatic precipitators (ESPs). These systems generated various solid wastes, including dust collected in the ESPs and baghouses, sludge from the gas conditioning towers, and bottom sludge from an on-site NPDES permitted settling pond (former Outfall 001). From 1988 until 1997, Macalloy operated an unlined surface impoundment (USI) for treated ESP dust just north of the ferrochromium process area. Figure 2 presents a detailed map of the Site.

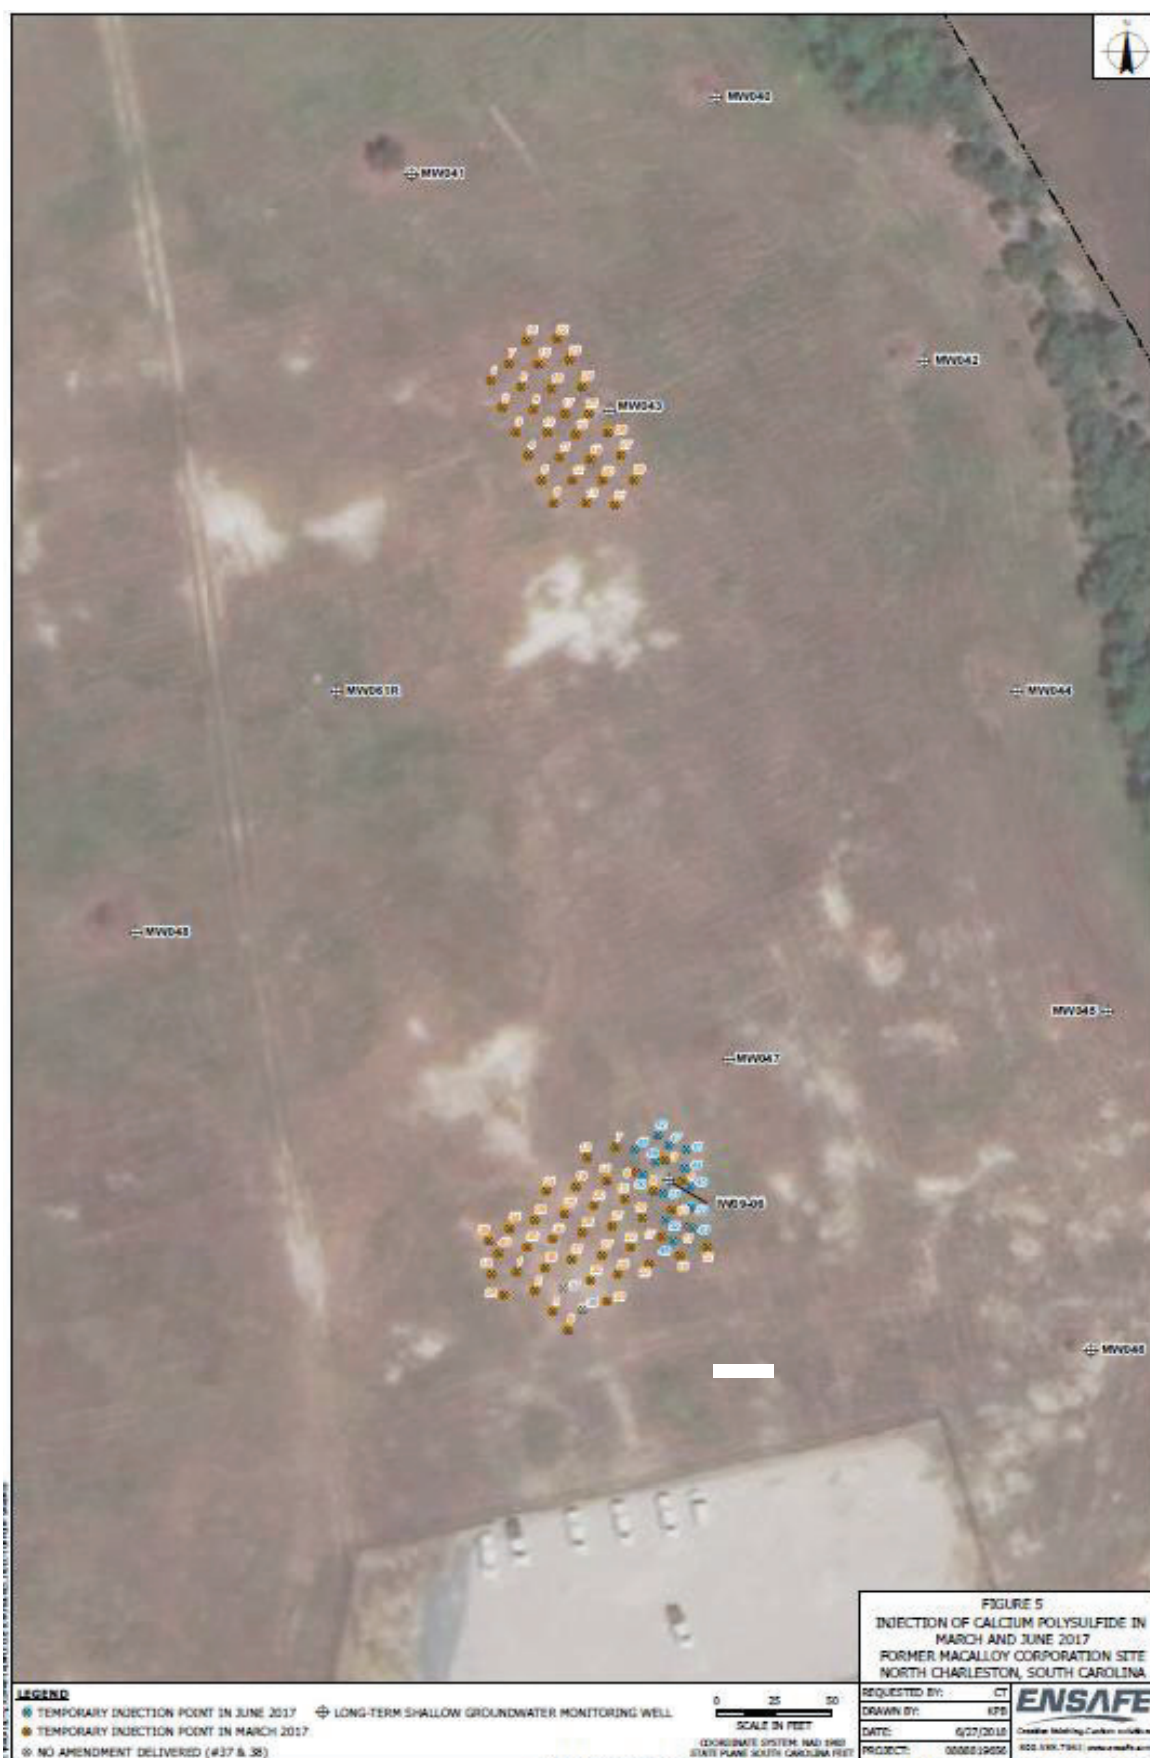
**Figure 3: Injection Points from March and June 2017 Supplemental Injection**

Supplemental injections of the chemical reductant CPS were completed in the vicinity of MW043 and IW09-06 in March and June 2017. The goal was to establish highly reducing conditions in the aquifer matrix to elicit conversion of Cr(VI) to Cr(III), which does not pose the same ecological and health threat as Cr(VI), as in previous remedial actions.

A map of the injection points from both 2017 events is pictured in Figure 3:

The pre-injection Cr(VI) concentration at IW09-06 in December 2016 was 3,300 µg/L, significantly above the cleanup goal of 100 µg/L. Subsequent to the March 2017 injection, Cr(VI) concentrations remained above the cleanup goal, ranging from 490 to 4,100 µg/L through May 2017. Additionally, positive oxidation reduction potential (ORP) levels indicated the injection did not establish optimum reducing conditions in the subsurface sufficient to convert Cr(VI) to Cr(III), or extend over a large enough area to be present at IW09-06. Following the second injection in June 2017, ORP reduced significantly indicating sufficient CPS was delivered to the subsurface, Cr(VI) concentrations in IW09-06 immediately declined by an order of magnitude to 480 µg/L in July 2017, and then were non-detect for eight monthly events from September 2017 through May 2018.

The pre-injection Cr(VI) concentration at MW043 in October 2016 was 730 µg/L. Subsequent to the March 2017 injections, Cr(VI) was not detected at MW043 for six months from March through August 2017; however, higher ORP and dissolved oxygen levels suggested insufficient CPS was delivered to the subsurface to establish optimum long-term reducing conditions. In September 2017, the sample collected from MW043 contained elevated Cr(VI) at 3,800 µg/L. A second sample collected later in the month confirmed the elevated Cr(VI), with a concentration of 8,200 µg/L. Both detections were historic highs at MW043 above the cleanup goal. Unusual hydrological conditions caused by tropical rainfall from Hurricane Irma (5.51 inches on September 11, 2017) likely contributed to the elevated Cr(VI) concentrations during the two September sampling events. Following the September hurricane rainfall event, Cr(VI) concentrations returned to non-detect at MW043 for four months, and then elevated Cr(VI) at 2,500 µg/L was reported in February 2018. Subsequently from March through June, 2018, Cr(VI) was non-detect. Eight consecutive monthly samples for Cr(VI) below the cleanup goal are necessary to document that groundwater restoration is complete and the Site can proceed with NPL deletion.

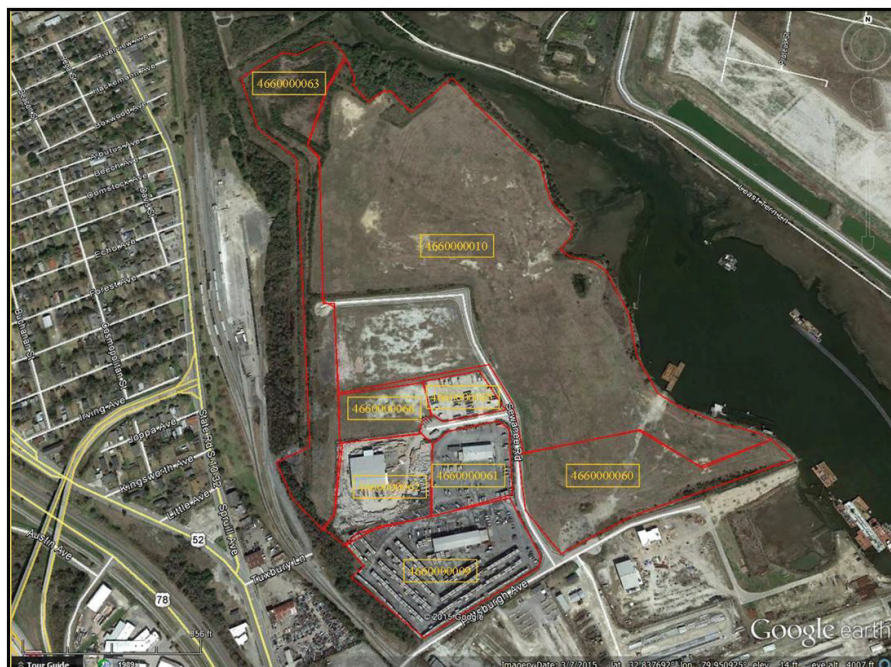
**Figure 4: Institutional Control Base Map**

Charleston County identifier numbers for the parcels associated with the Site are: 4660000010, 4660000063, 4660000060, 4660000009, 4660000061, 4660000065, and 4660000066 which are owned by Shipyard Creek Associates; and parcel 4660000062, which is owned by Sonoco Recycling LLC. As a part of the site-wide remedy, institutional controls and restrictive covenants were executed for the Site that limit future use to commercial/industrial purposes and prohibit the use of groundwater underlying the property. These institutional controls were approved by the EPA and SCDHEC in May 2006, and have been officially recorded with the Charleston County Register of Deeds. A copy of the restrictive covenants is provided in Appendix H. Current and future land use for the Site is industrial and commercial use only. Table 2 lists the institutional controls associated with areas of interest at the Site. Figure 4 shows the location of the parcel boundaries associated with the Site.

*Parcel 4660000062 owned by Sonoco Recycling LLC. The rest are owned by Shipyard Creek Associates.  
All parcels shown are subject to limiting future use to commercial/industrial purposes,  
and prohibiting the use of groundwater underlying the property.*

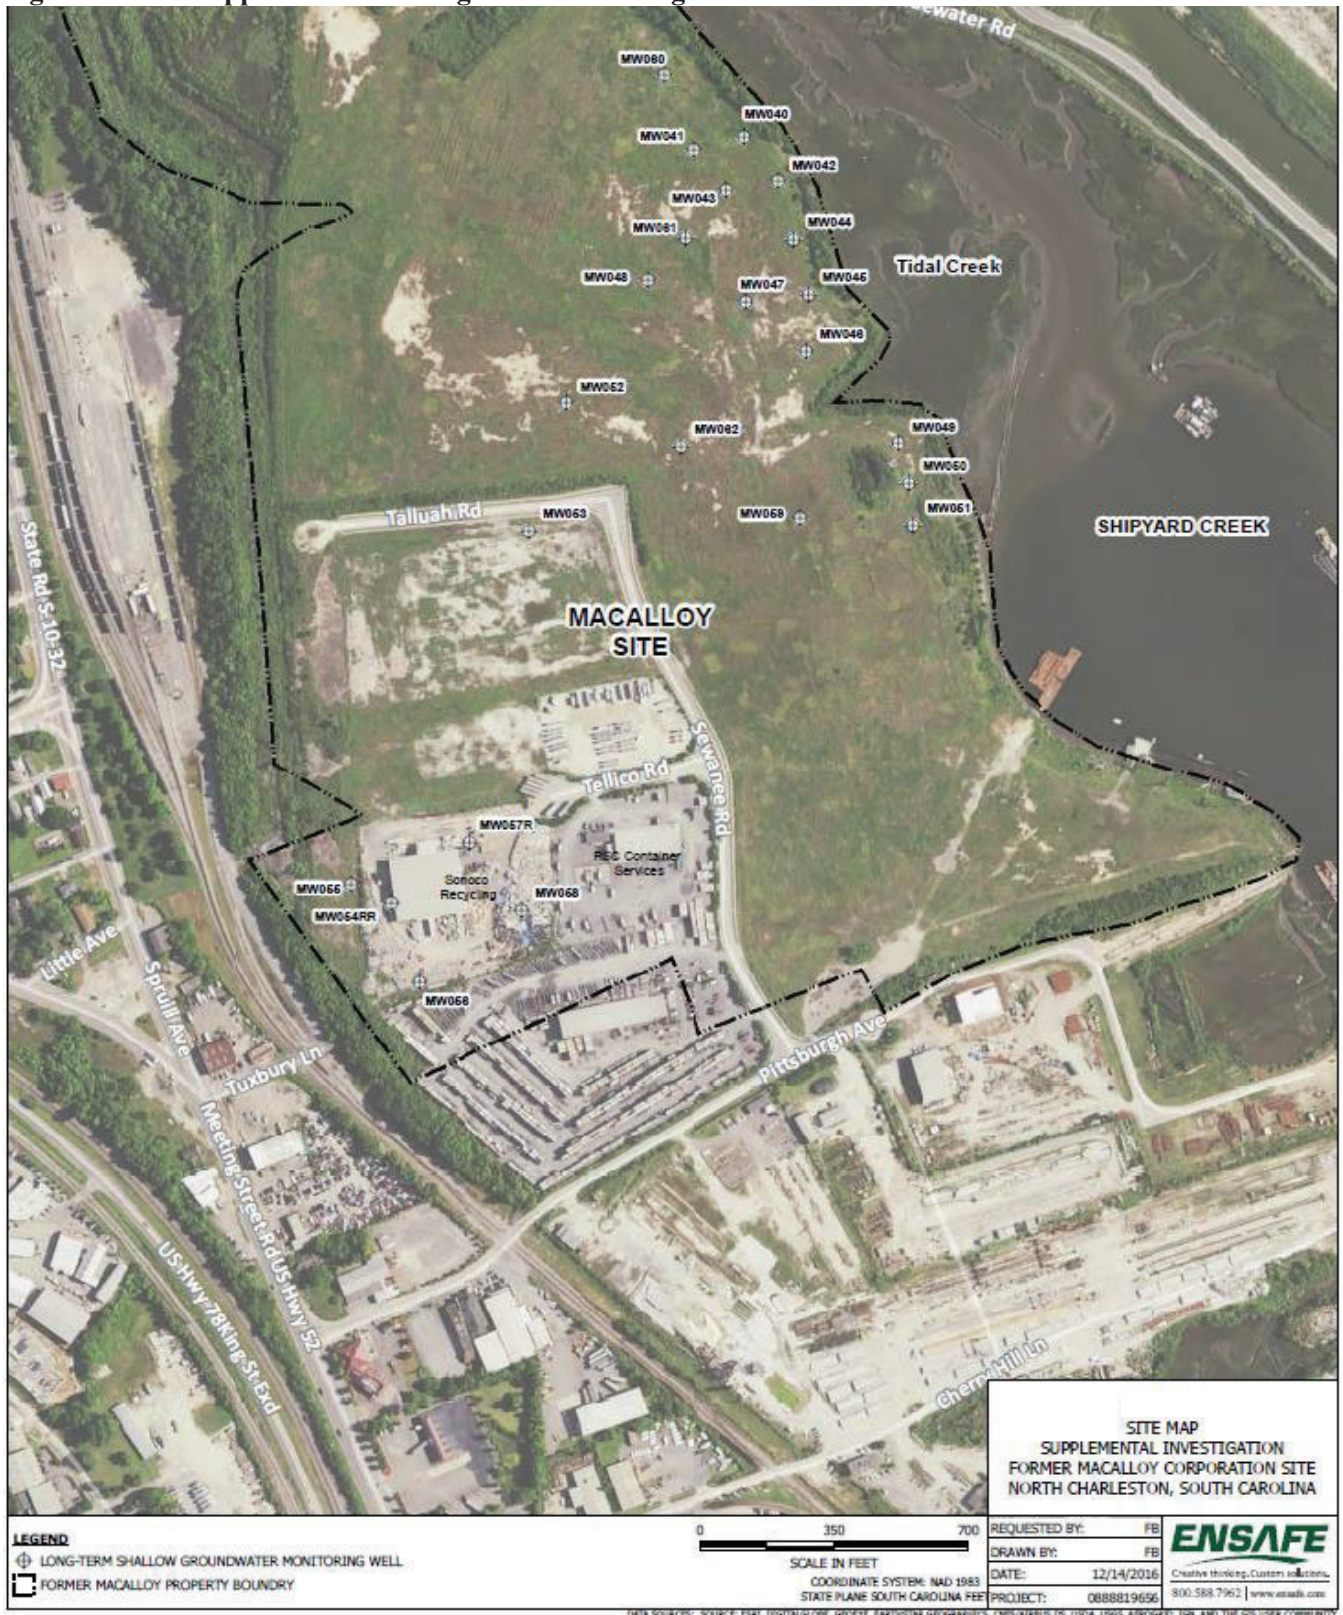
Figure 5: 2016 Supplemental Investigation Monitoring Locations

More than a decade of groundwater monitoring from 2006 through July 2016 indicated total chromium concentrations were below the cleanup goal in Site monitoring wells, with the exception of a few acres of elevated total Cr at MW041, MW043, MW047, MW060, and MW061R. A 2016 Supplemental Investigation recommend additional injections of CPS in these areas where chromium (VI) contamination above cleanup goals persists. Supplemental injections were carried out in March and June of 2017 at two locations: MW043 and IW09-06. Groundwater monitoring results and sampling locations from the Supplemental Investigation can be found below in Table 5 and Figure 5, respectively.
