**HAMILTON COUNTY
GENERAL HEALTH DISTRICT**

**Re: 8200 Broadwell Road, Anderson Township, Hamilton County/Completion of Cleanup and
Cover Activities**

Re: BWAY Facility, 8200 Broadwell Road

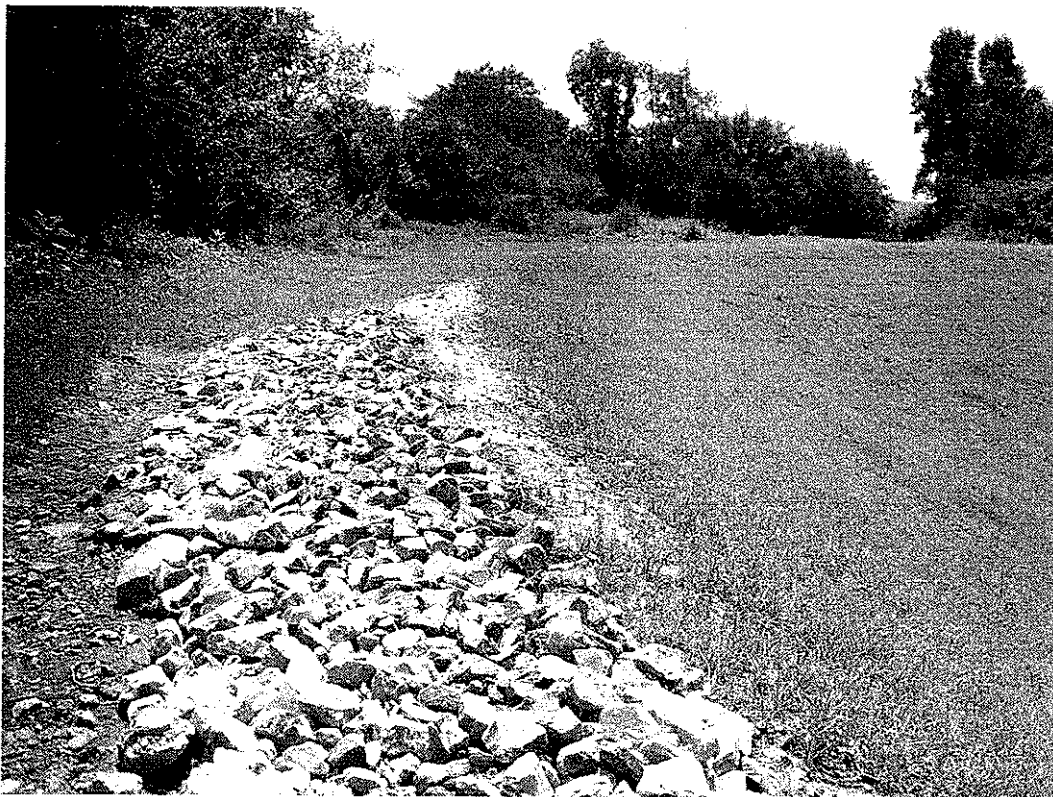
Photo 15: View of rearranged rip-rap from the east facing west.

Photo 16: View of area where crack was repaired and reseeded from the east facing west.

AST returned to the site on July 30, 2003 to correct the issues discussed above. AST rearranged the rip-rap to keep water in the rip-rap channel and off of the slope (Photograph 15). Soil was placed in the eroded areas and the areas were reseeded. AST also placed and compacted bentonite into the crack noted along the aforementioned portion of the east slope. Additional clay was placed in this area and the area was recompact and reseeded (Photograph 16).

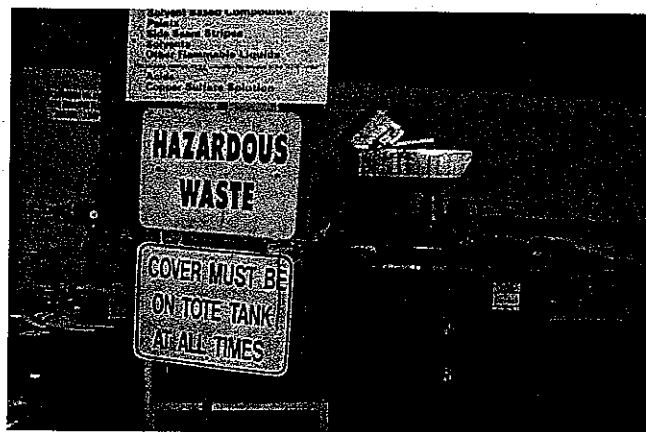
Photo #32: Hazardous waste storage
