**FIFTH FIVE-YEAR REVIEW REPORT FOR
WHEELER PIT SUPERFUND SITE
LAPRAIRIE COUNTY, WISCONSIN**

**U.S. Environmental Protection Agency
Region 5
Janesville, Wisconsin**

9/15/2017

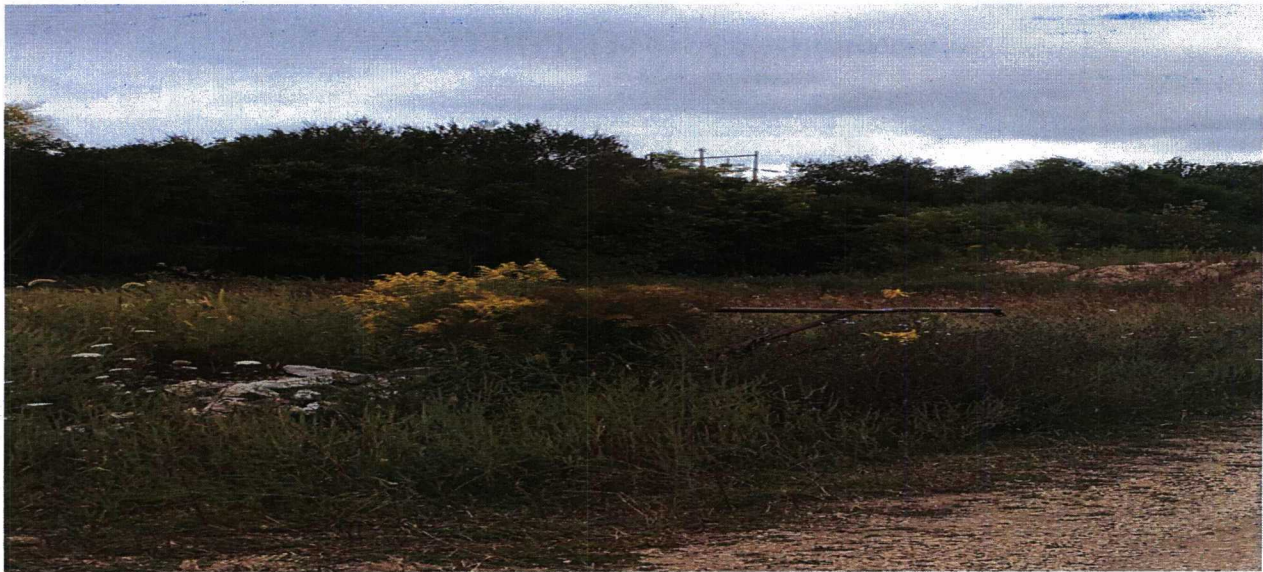
Photograph #1 – Access gate and road off County Highway O to Wheeler Pit (Photographer: Karen Mason-Smith, EPA Region 5 RPM, September 8, 2017).

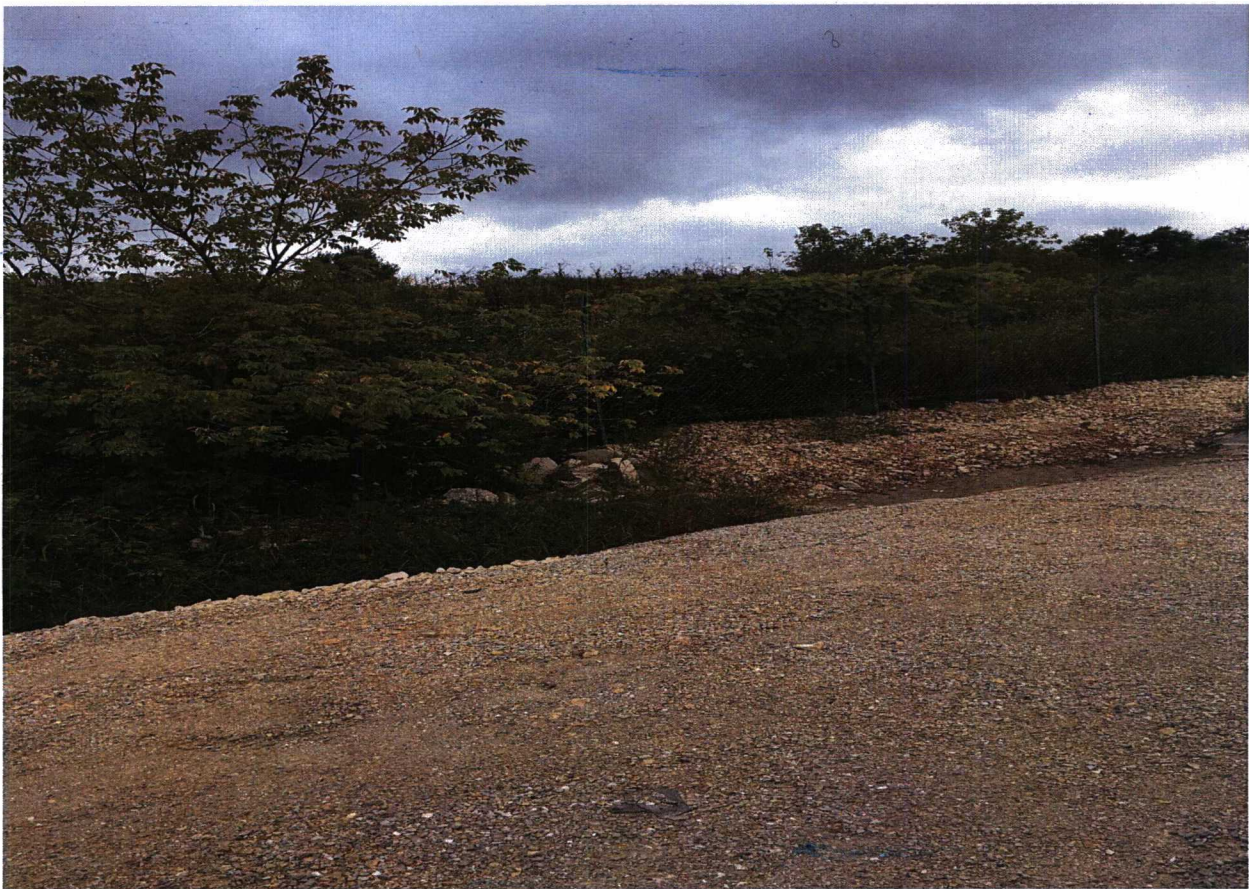
Photograph #2 – Wheeler Pit fence and access road (Photographer: Karen Mason-Smith, EPA Region 5 RPM, September 8, 2017).

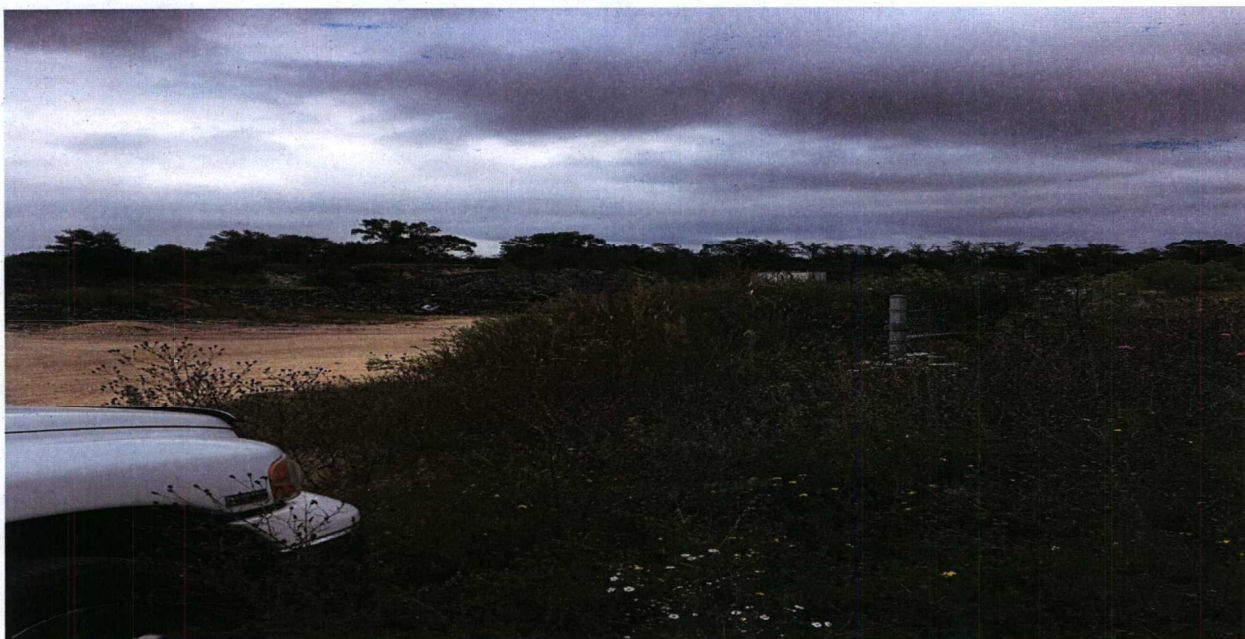
The gate and part of the fence had been removed and barbed wire was used to replace one section of the top of the fence that looked damaged on the Frank Brothers property. As stated above in the ICs section, the Frank Brothers property is currently part of the area surrounding the Site that is not required to be fenced. Another part of the fence had been moved back approximately 50-100 feet by Roger Frank (Frank Brothers property owner) off Frank Brother's property to be included on the Site. The landfill cap is in need of mowing, parts of the the fence need to be repaired, and the Site needs routine maintenance. Tree growth and other vegetation was also observed growing at the Site, and need to be removed. Security of the Site has been compromised by the unauthorized removal of the entrance gate and part of the fence. Vegetation is so overgrown on the fence that you cannot see the Superfund Site sign. There have been no updated O&M activities at the Site; however, the landowner plans to conduct O&M activities in the near future. The inspection concluded that the site remedy remains protective in the short-term; however routine O&M is recommended to maintain the integrity of the landfill.

Frank Brother's Asphalt Shingle Company's large dump trucks currently serve as a barrier where the front gate and additional fencing was taken down, preventing access to the Site. Maintenance of the cap, fencing and other areas at the Site have been neglected after GM went bankrupt and abandoned O&M activities in 2009. However, the landfill did not appear to be breached during the 2017 site visit. The landowner also plans to add new warning signs and conduct O&M activities at the Site in the near future. The fence and gate at the Site's entrance should be replaced. EPA plans to discuss this O&M issue with WDNR and Roger Frank, such as mowing grass on landfill cap, clearing vegetation, repairing the fence, and posting no trespassing signs by 09/30/2018.

Photograph #3 – Missing fence and entrance gate at Wheeler Pit (Photographer: Karen Mason-Smith, EPA Region 5 RPM, September 8, 2017).

OU(s): 1/Sitewide	Issue Category: Operations and Maintenance.			
	Issue: O&M activities lapsed in 2013, after Wisconsin conducted O&M activities in August and October 2012.			
	Recommendation: Develop an O&M Plan and implement O&M activities.			
Affect Current Protectiveness	Affect Future Protectiveness	Party Responsible	Oversight Party	Milestone Date
No	Yes	EPA/State/ Landowner	EPA/State	09/30/2018

Remarks: Fencing needs to be repaired

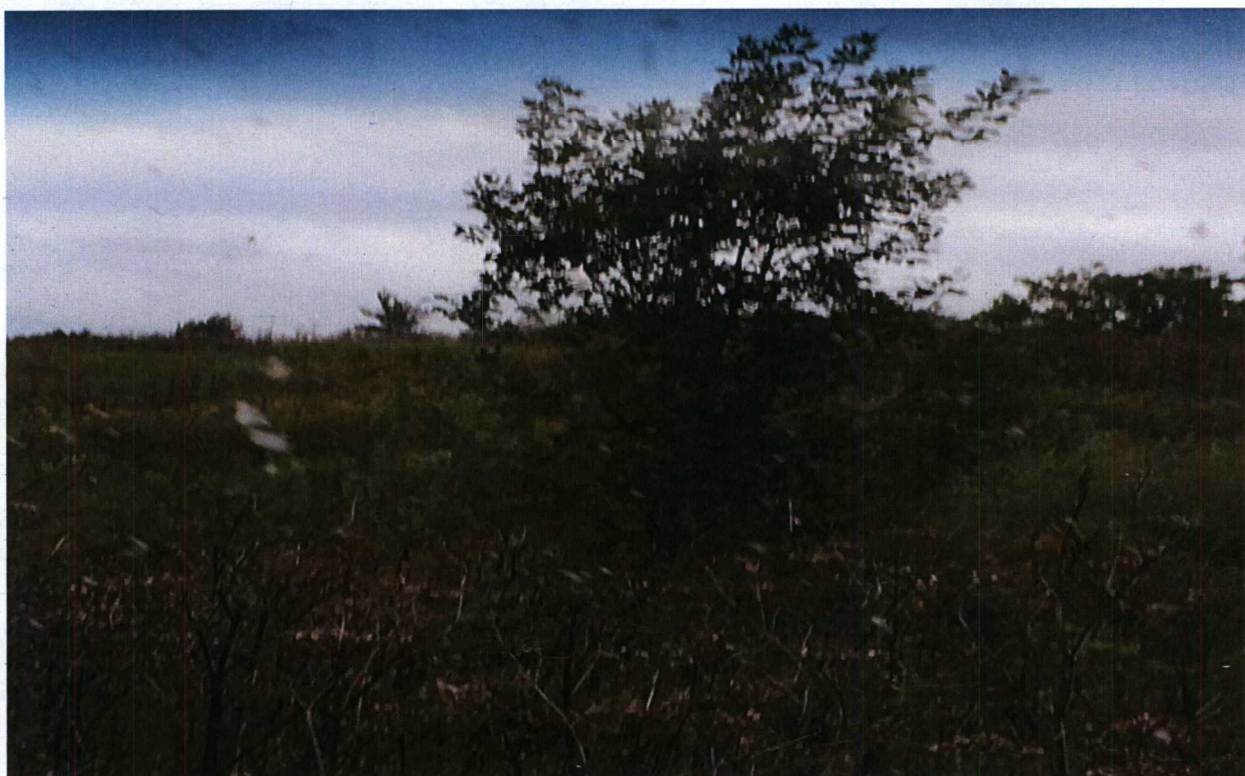
B. Other Site Conditions			
Remarks: <u>The fence needs repair, lawn needs mowing and trees are overgrown on parts of the landfill.</u>			
VII. LANDFILL COVERS <input checked="" type="checkbox"/> Applicable			
The lawn needs mowing and trees are overgrown on parts of the landfill.			
VIII. VERTICAL BARRIER WALLS <input type="checkbox"/> Applicable <input checked="" type="checkbox"/> N/A			
IX. GROUNDWATER/SURFACE WATER REMEDIES <input checked="" type="checkbox"/> Applicable

Photograph #4 – Wheeler Pit Landfill (Photographer: Karen Mason-Smith, EPA Region 5 RPM, September 8, 2017).
