**Subject: Final Removal Assessment Report
Layer Park
Miamisburg, Montgomery County, Ohio
Technical Direction Document No. S05-0001-16-04-001
SRS Contract No. EP-S5-16-01**

**REMOVAL ASSESSMENT REPORT
LAYER PARK - RS
MIAMISBURG, MONTGOMERY COUNTY, OHIO**

TDD No.:	S05-0001-16-04-001
Date Prepared:	July 6 th , 2016
Contract No.:	EP-S5-16-01
Prepared by:	SRS
START Project Manager:	Rich Baldino
Telephone No.:	(312) 220-7171
U.S. EPA On-Scene Coordinator:	Stephen Wolfe
Telephone No.:	(440) 250-1718

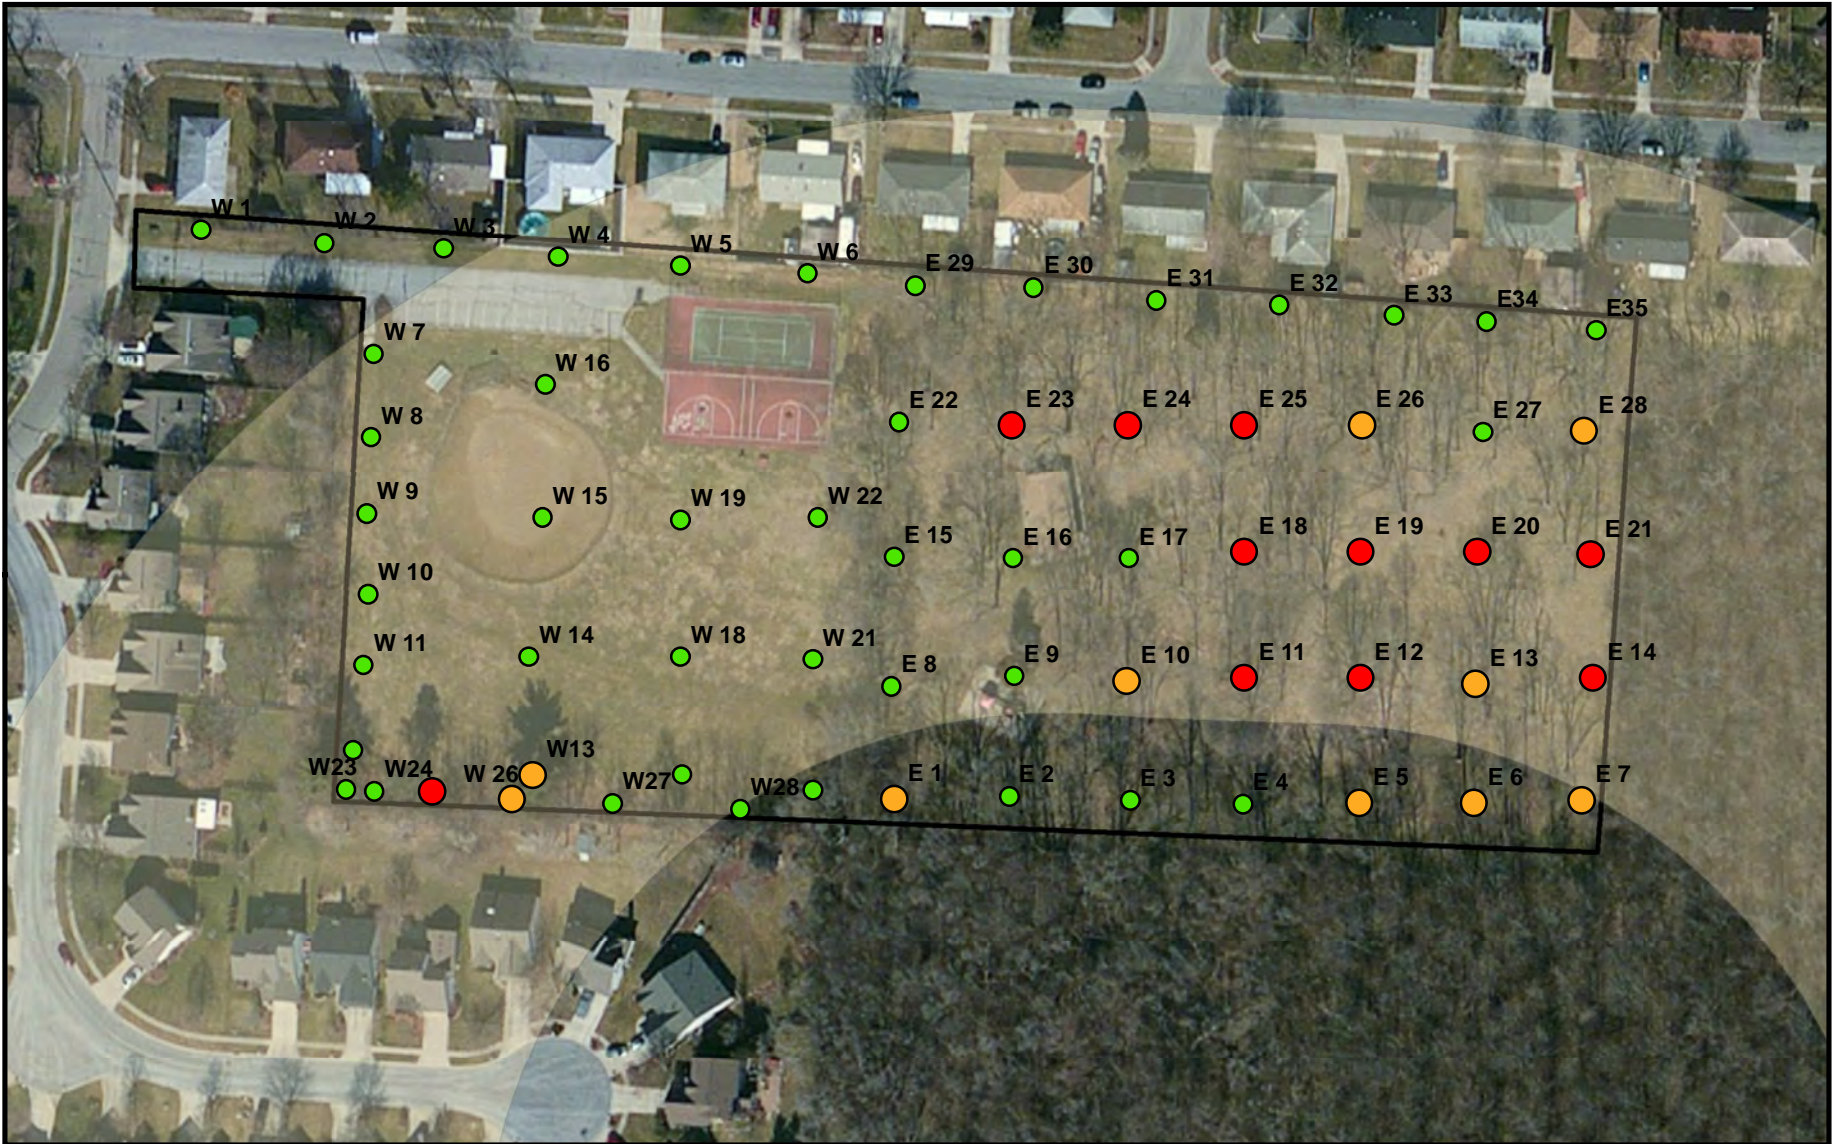
**Figure 3: XRF Lead Results in Parts Per Million
0 to 6 inches**

- Greater than 1000 ppm
- 400 to 1000 ppm
- Less than 400 ppm
- Primary Impact Zone
- Layer Park

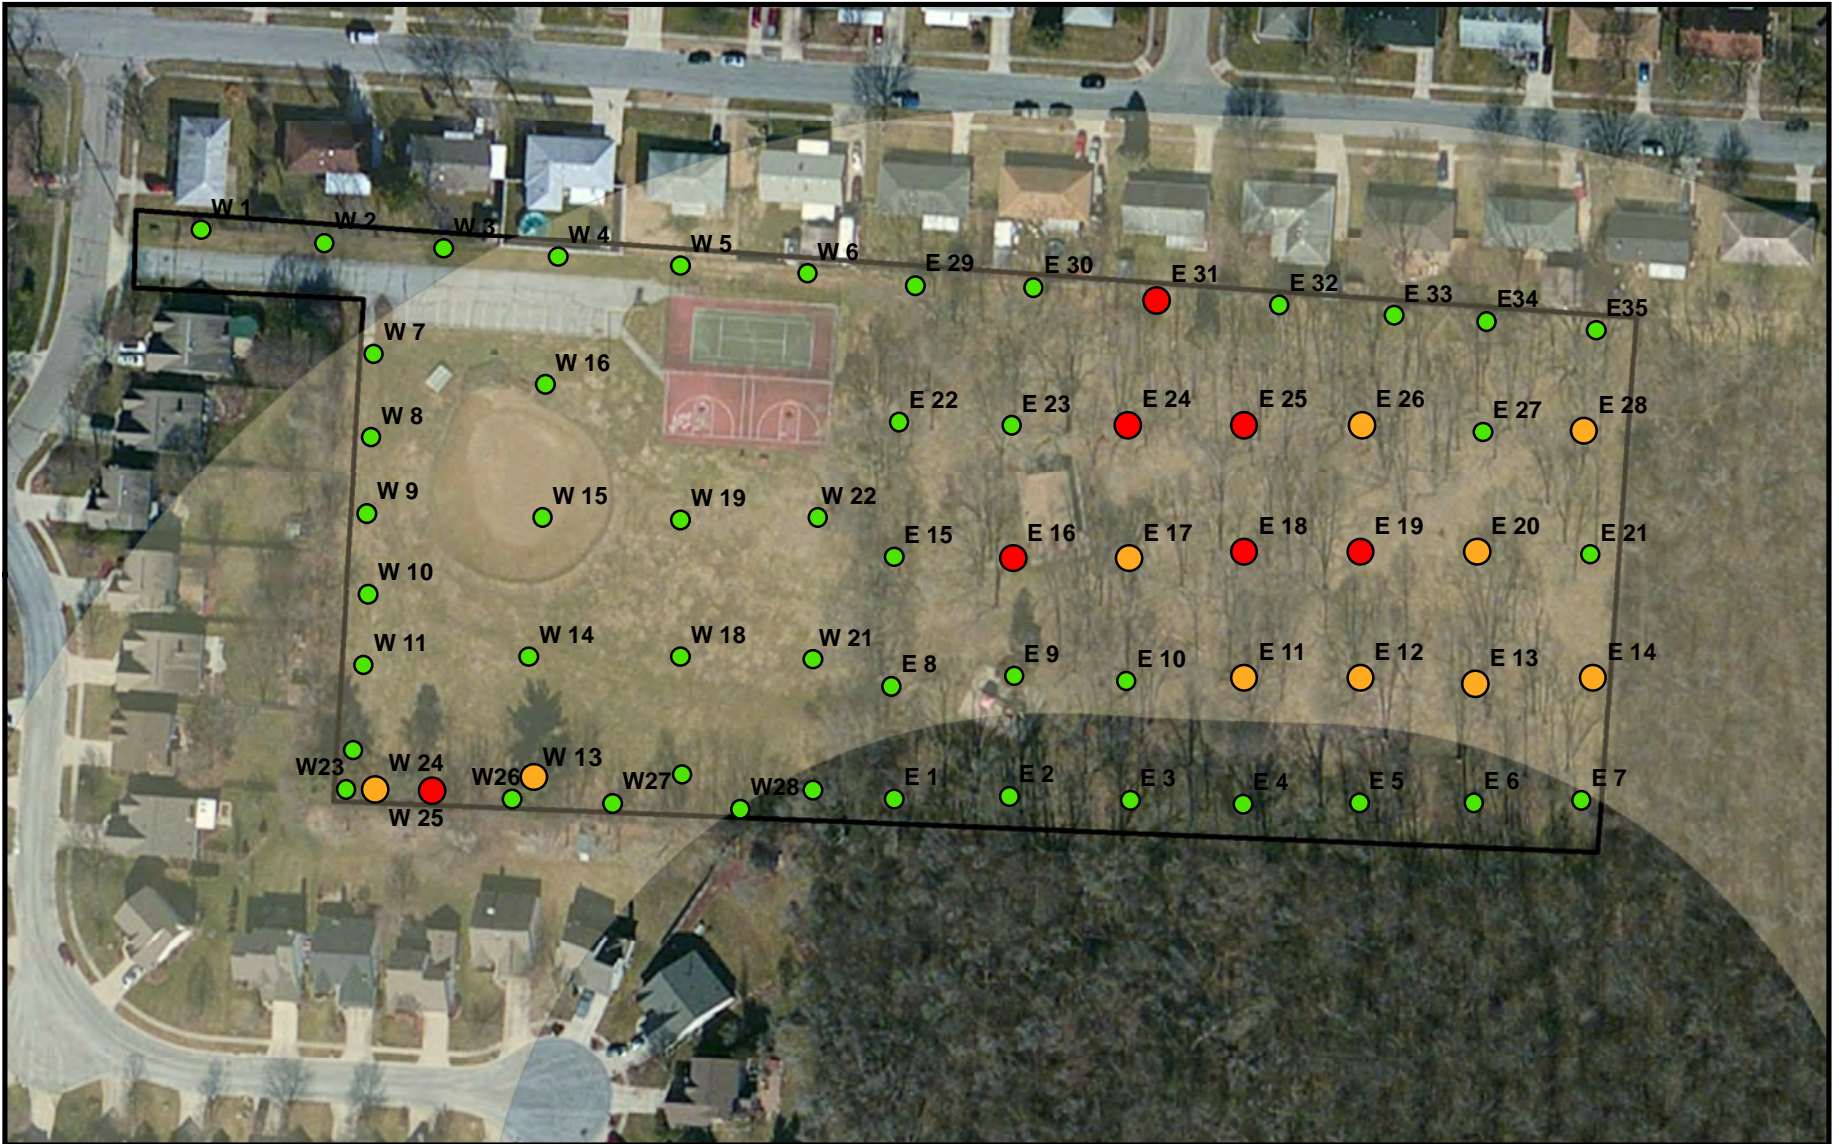
**Figure 4: XRF Lead Results in Parts Per Million
6 to 12 inches**

- Greater than 1000 ppm
- 400 to 1000 ppm
- Less than 400 ppm
- Primary Impact Zone
- Layer Park
