**Support Document for the
Revised National Priorities List
Final Rule
SBA Shipyard
September 2016**

**Site Assessment and Remedy Decisions Branch
Office of Superfund Remediation and Technology Innovation
Office of Land and Emergency Management
U.S. Environmental Protection Agency
Washington, DC 20460**

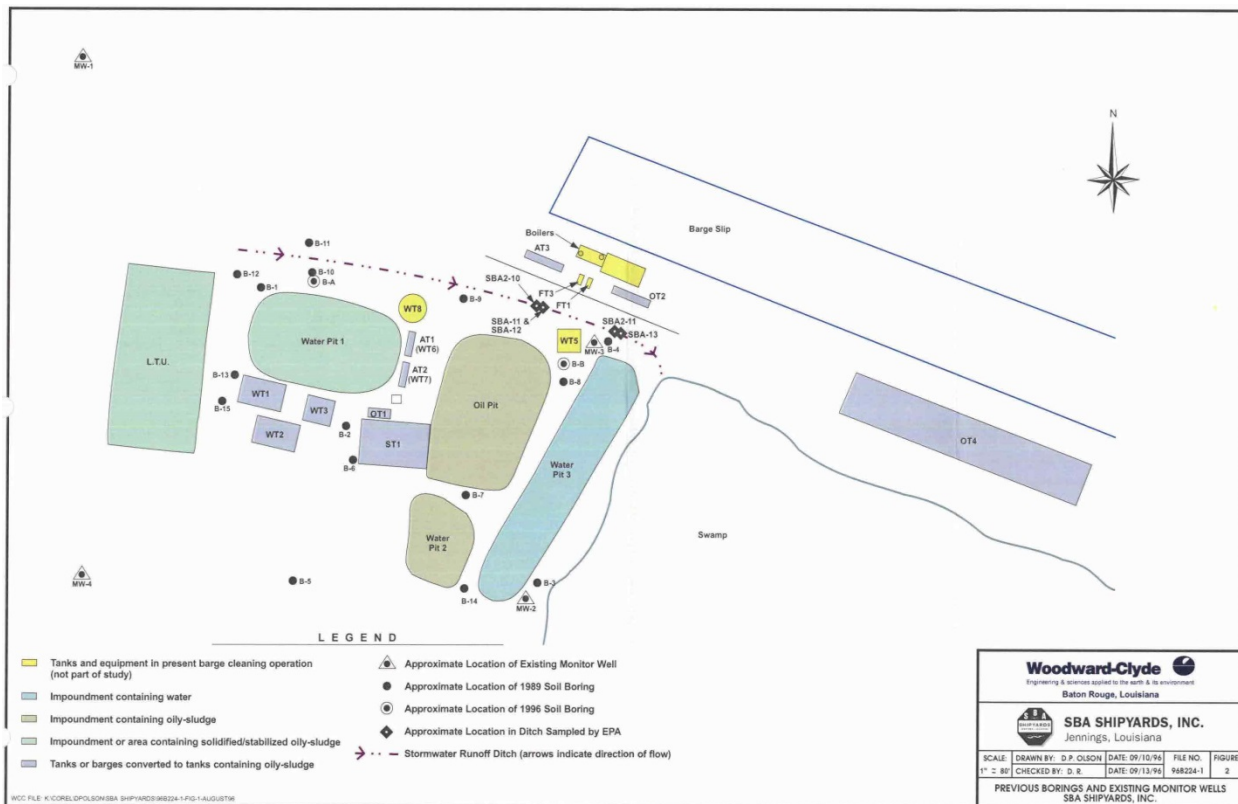
Figure 1: Approximate Source 4, the Former LTU, location as shown on page 2 of Reference 16 of the HRS documentation record at proposal.

Cited Reference 16 of the HRS documentation record at proposal contains the figures for the October 1996 RCRA Facility Investigation Work Plan, prepared for SBA Shipyards, Inc. by Woodward-Clyde Consultants (included as Reference 6 of the HRS documentation record at proposal). Page 2 of Reference 16 is a figure showing the location of the Former LTU as well as other components of the facility at the time. A cropped version of that page is shown in Figure 1 below:
