**Pre-CERCLIS Site Screening Assessment**

**Jefferson County Lead Site**

# PRE-CERCLIS SITE SCREENING ASSESSMENT REPORT JEFFERSON COUNTY LEAD SITE JEFFERSON COUNTY, MISSOURI

Superfund Technical Assessment and Response Team (START) 3 Contract No. EP-S7-06-01, Task Order No. 0002.012

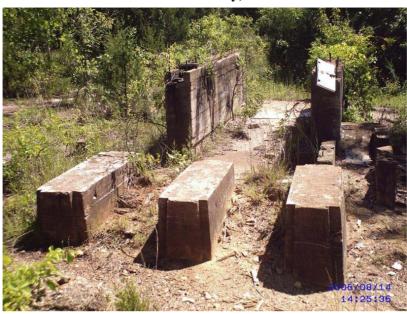
TETRA TECH PROJECT NO.	DESCRIPTION	This photograph shows lead mining mill remnants in Valles Mines, Missouri	1
X9004.L06.0002012	CLIENT	Environmental Protection Agency Region 7	Date
Direction: Southwest	PHOTOGRAPHER	Joe Parish	8/14/06

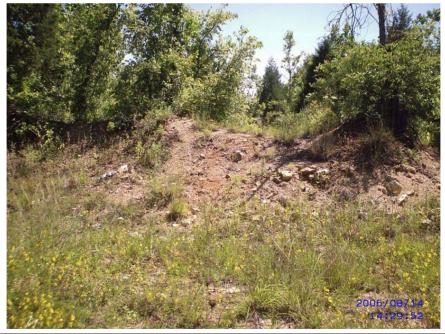
TETRA TECH PROJECT NO.	DESCRIPTION	This photograph shows tailings pile from milling operation in Valles Mines, Missouri	2
X9004.L06.0002.012	CLIENT	Environmental Protection Agency Region 7	Date
Direction: East	PHOTOGRAPHER	Joe Parish	8/15/06

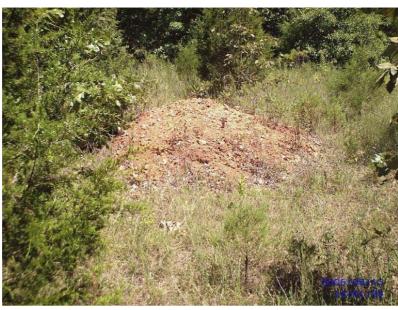
TETRA TECH PROJECT NO.	DESCRIPTION	This photograph shows chat piles from tiff mining at Engledow & Dickinson Roads, De Soto, Missouri.	3
X9004.L06.0002012	CLIENT	Environmental Protection Agency Region 7	Date
Direction: East	PHOTOGRAPHER	Joe Parish	8/15/06

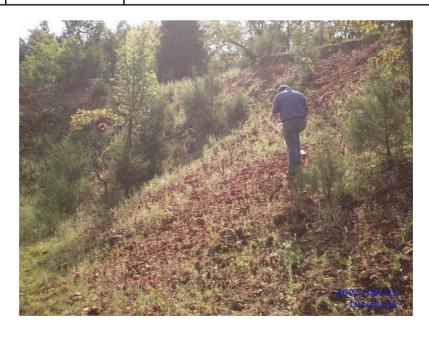
TETRA TECH PROJECT NO.	DESCRIPTION	This photograph shows workings at tiff mine site 990240 off of Engledow Road, De Soto, Missouri.	4
X9004.L06.0002.012	CLIENT	Environmental Protection Agency Region 7	Date
Direction: Southeast	PHOTOGRAPHER	Joe Parish	8/21/06

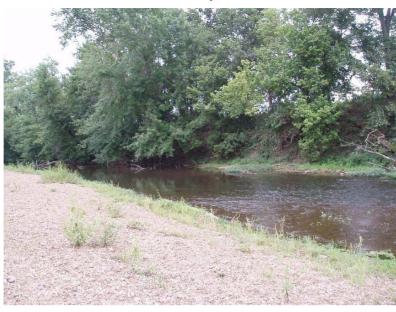
TETRA TECH PROJECT NO.	DESCRIPTION	This photograph shows the Big River south sample collection point.	5
X9004.L06.0002012	CLIENT	Environmental Protection Agency Region 7	Date
Direction: Southwest	PHOTOGRAPHER	Joe Parish	8/31/06

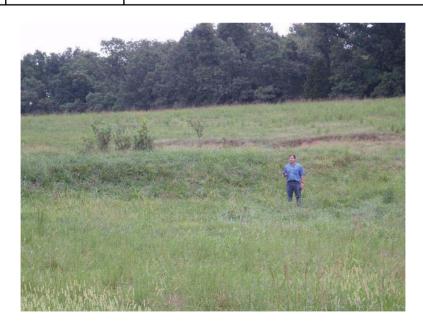
TETRA TECH PROJECT NO.	DESCRIPTION	This photograph shows apparent workings at mine site 990293 northwest of Valles Mines, Missouri.	6
X9004.L06.0002.012	CLIENT	Environmental Protection Agency Region 7	Date
Direction: North	PHOTOGRAPHER	Joe Parish	8/31/06

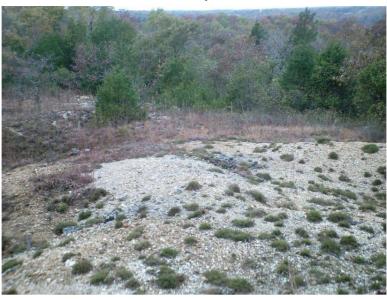
TETRA TECH PROJECT NO.	DESCRIPTION	This photograph shows mine tailings off of Hidden Valley Ranch Road in De Soto, Missouri.	7
X9004.L06.0002012	CLIENT	Environmental Protection Agency Region 7	Date
Direction: Northwest	PHOTOGRAPHER	Joe Parish	10/26/06

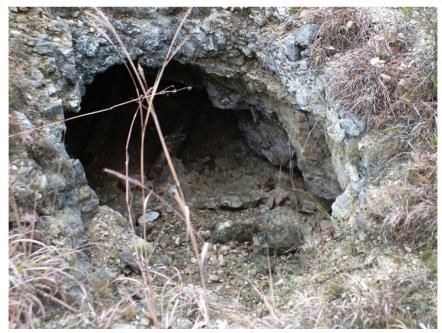
TETRA TECH PROJECT NO.	DESCRIPTION	This photograph shows a mine shaft off of Hidden Valley Ranch Road.	8
X9004.L06.0002.012	CLIENT	Environmental Protection Agency Region 7	Date
Direction: Southeast	PHOTOGRAPHER	Joe Parish	10/26/06
