**SITE INSPECTION REPORT  
FOR  
ELKHORN MINING DISTRICT**

**C & D MINE  
ELKHORN CREEK TAILINGS  
UNION ELKHORN MINE  
GREYBACK GULCH  
TRUMLEY HEAP LEACH  
ELKHORN SKYLINE MINE  
BOULAWAY MINE  
ELKHORN QUEEN MINE**

**JEFFERSON COUNTY, MONTANA**

Prepared by  
**WESTON SOLUTIONS, INC.**  
Region 8 Superfund Technical Assessment and Response Team

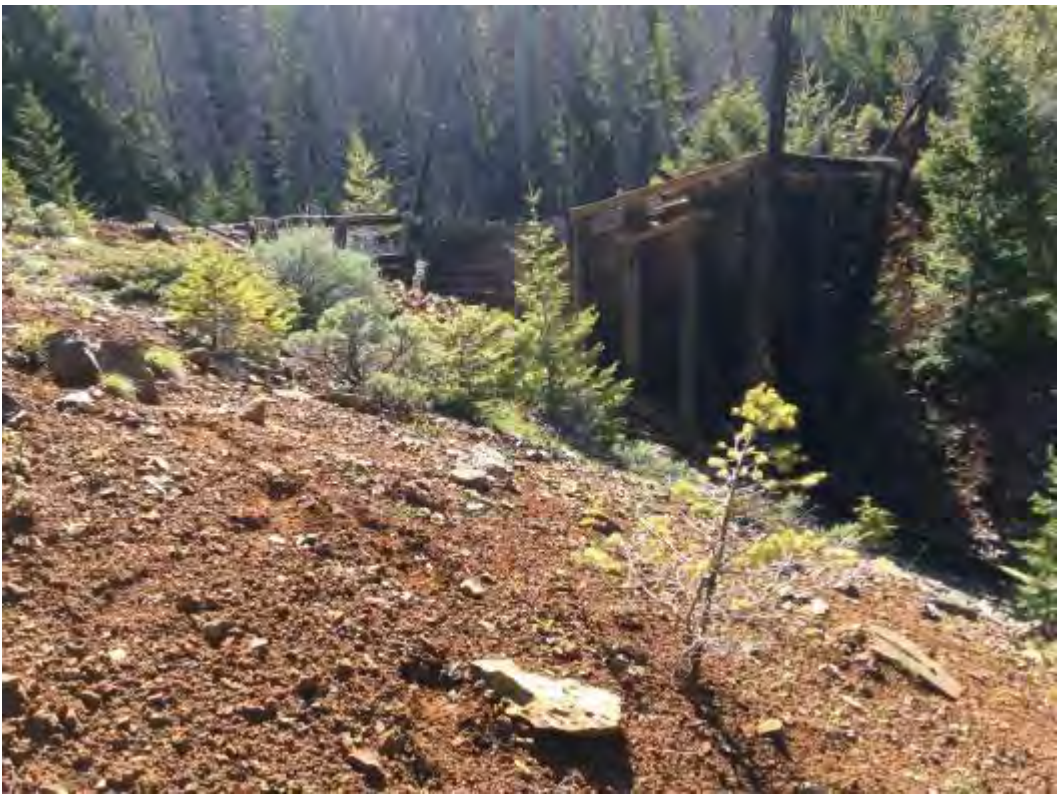
| <table> <tr> <td><b>Photo No.</b><br/><b>13</b></td><td><b>Date:</b><br/>06/05/2019</td></tr> <tr> <td colspan="2"><b>Photo Coordinates</b></td></tr> <tr> <td><b>Lat</b></td><td>46.288536</td></tr> <tr> <td><b>Long</b></td><td>-111.934578</td></tr> <tr> <td colspan="2"><b>Direction Photo Taken:</b><br/>107.636213311286</td></tr> <tr> <td colspan="2"> <b>Description:</b><br/><br/> Showing 5-point composite locations for sample CD-WR-07 </td></tr> </table> | <b>Photo No.</b><br><b>13</b> | <b>Date:</b><br>06/05/2019 | <b>Photo Coordinates</b> | | <b>Lat</b> | 46.288536 | <b>Long</b> | -111.934578 | <b>Direction Photo Taken:</b><br>107.636213311286 | | <b>Description:</b><br><br>Showing 5-point composite locations for sample CD-WR-07 | | |

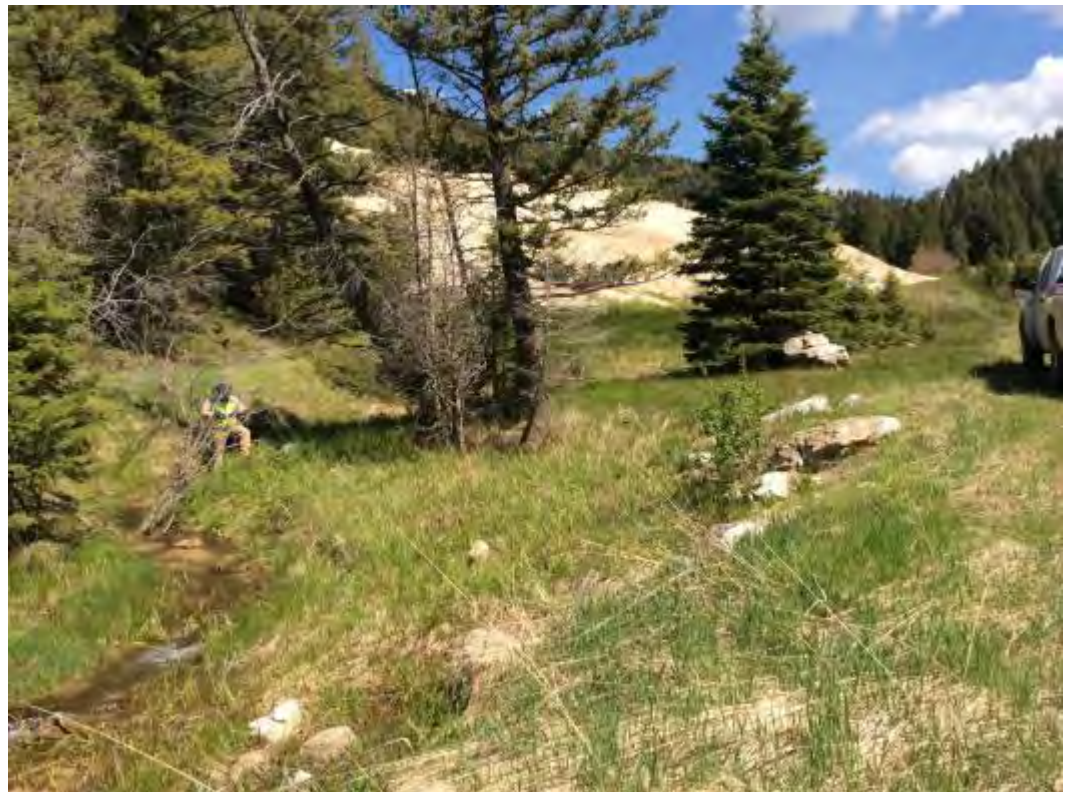
| <b>Description:</b><br><br>Location of sample ECT-SW/SD-03 in wetland below tailings pile and most downstream probably point of entry | |

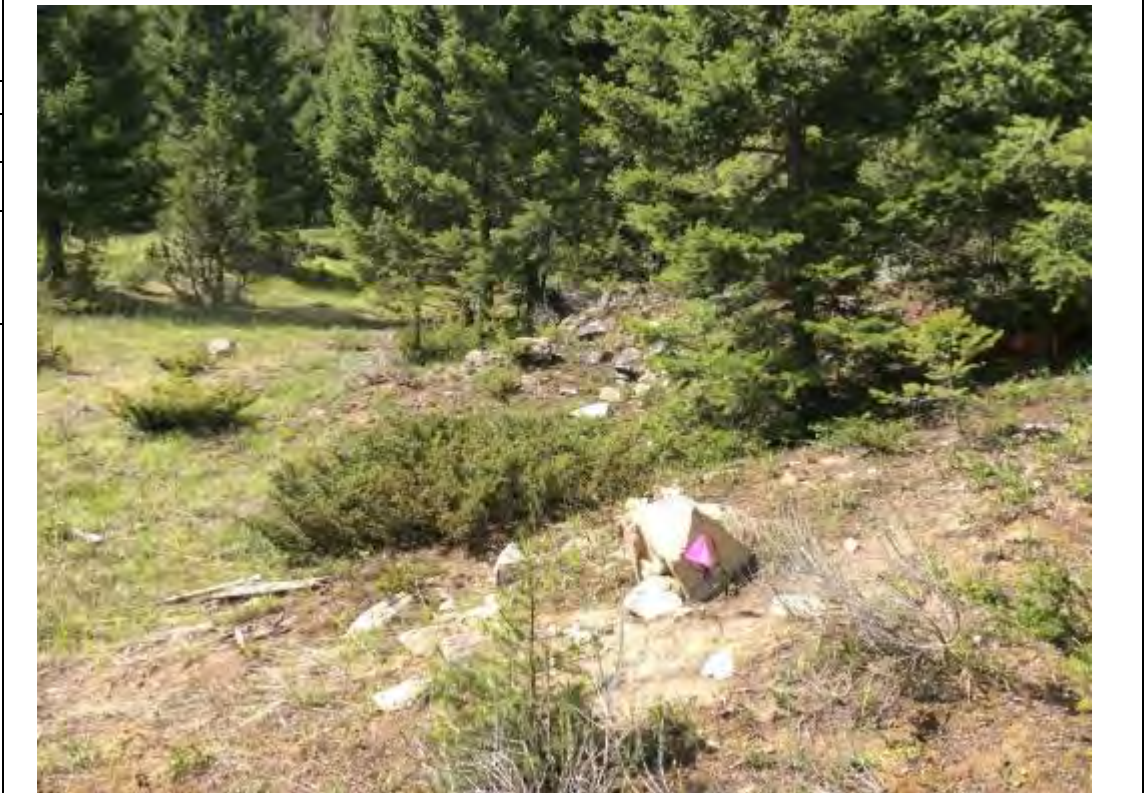
| <table border="1"> <tr> <td><b>Photo No.</b><br/><b>38</b></td><td><b>Date:</b><br/>06/03/2019</td></tr> <tr> <td colspan="2"><b>Photo Coordinates</b></td></tr> <tr> <td><b>Lat</b></td><td>46.266369</td></tr> <tr> <td><b>Long</b></td><td>-111.956069</td></tr> <tr> <td colspan="2"><b>Direction Photo Taken:</b><br/>332.837658017299</td></tr> <tr> <td colspan="2"> <b>Description:</b><br/><br/> Location of sample ECT-WR-04 in the Elkhorn Creek Tailings impoundment </td></tr> </table> | <b>Photo No.</b><br><b>38</b> | <b>Date:</b><br>06/03/2019 | <b>Photo Coordinates</b> | | <b>Lat</b> | 46.266369 | <b>Long</b> | -111.956069 | <b>Direction Photo Taken:</b><br>332.837658017299 | | <b>Description:</b><br><br>Location of sample ECT-WR-04 in the Elkhorn Creek Tailings impoundment | | |

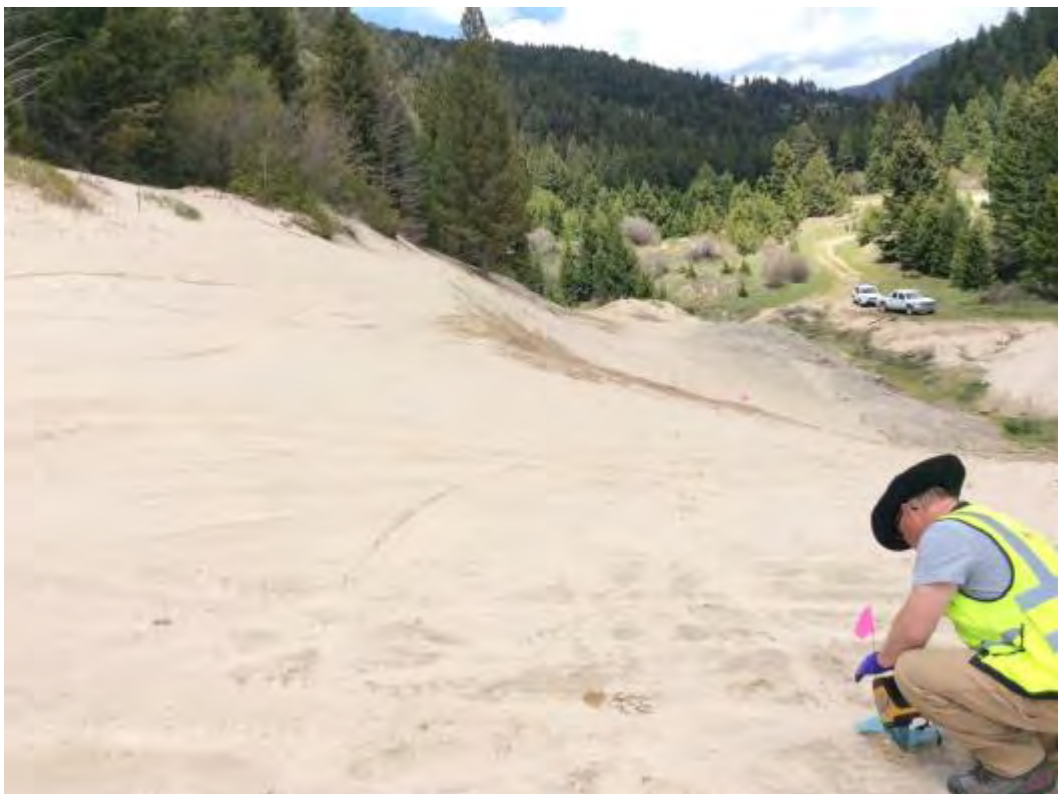
| <table> <tr> <td><b>Photo No.</b><br/><b>39</b></td><td><b>Date:</b><br/>06/03/2019</td></tr> <tr> <td colspan="2"><b>Photo Coordinates</b></td></tr> <tr> <td><b>Lat</b></td><td>46.264622</td></tr> <tr> <td><b>Long</b></td><td>-111.956628</td></tr> <tr> <td colspan="2"><b>Direction Photo Taken:</b><br/>353.141891476679</td></tr> <tr> <td colspan="2"> <b>Description:</b><br/><br/> Screening of 30-point composite location for sample ECT-WR-05 </td></tr> </table> | <b>Photo No.</b><br><b>39</b> | <b>Date:</b><br>06/03/2019 | <b>Photo Coordinates</b> | | <b>Lat</b> | 46.264622 | <b>Long</b> | -111.956628 | <b>Direction Photo Taken:</b><br>353.141891476679 | | <b>Description:</b><br><br>Screening of 30-point composite location for sample ECT-WR-05 | | |

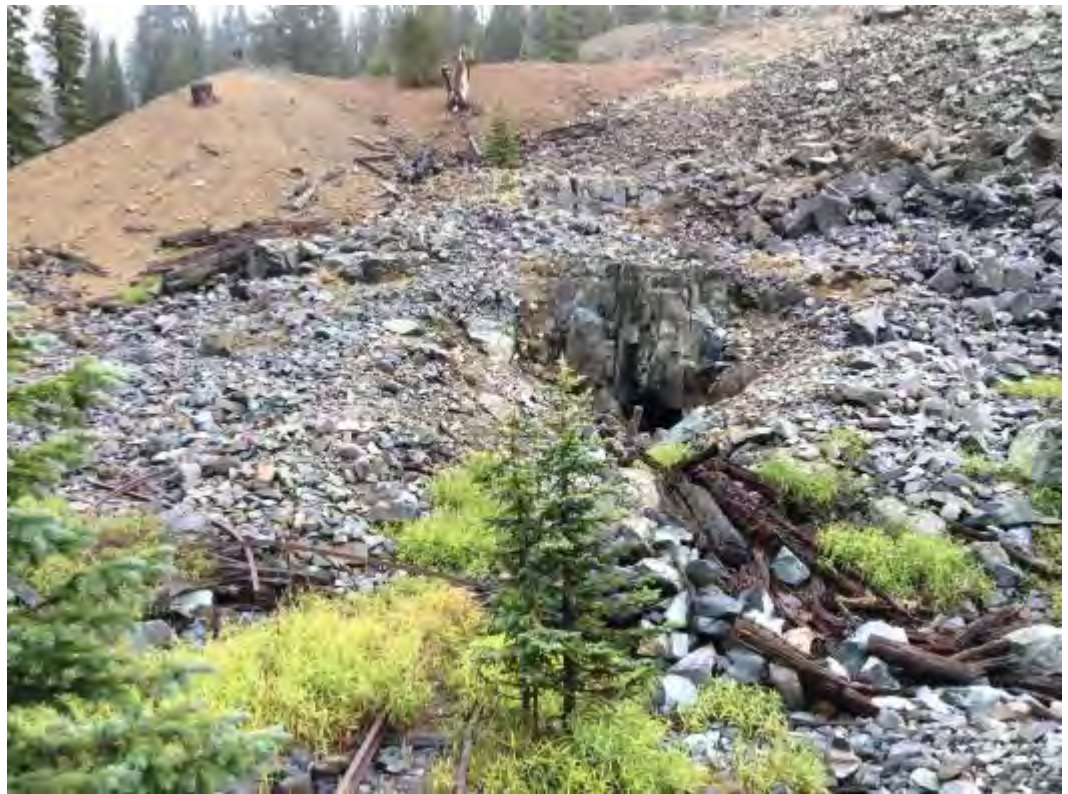
| <b>Description:</b><br><br>Skyline Mine adit and tailings pile | |

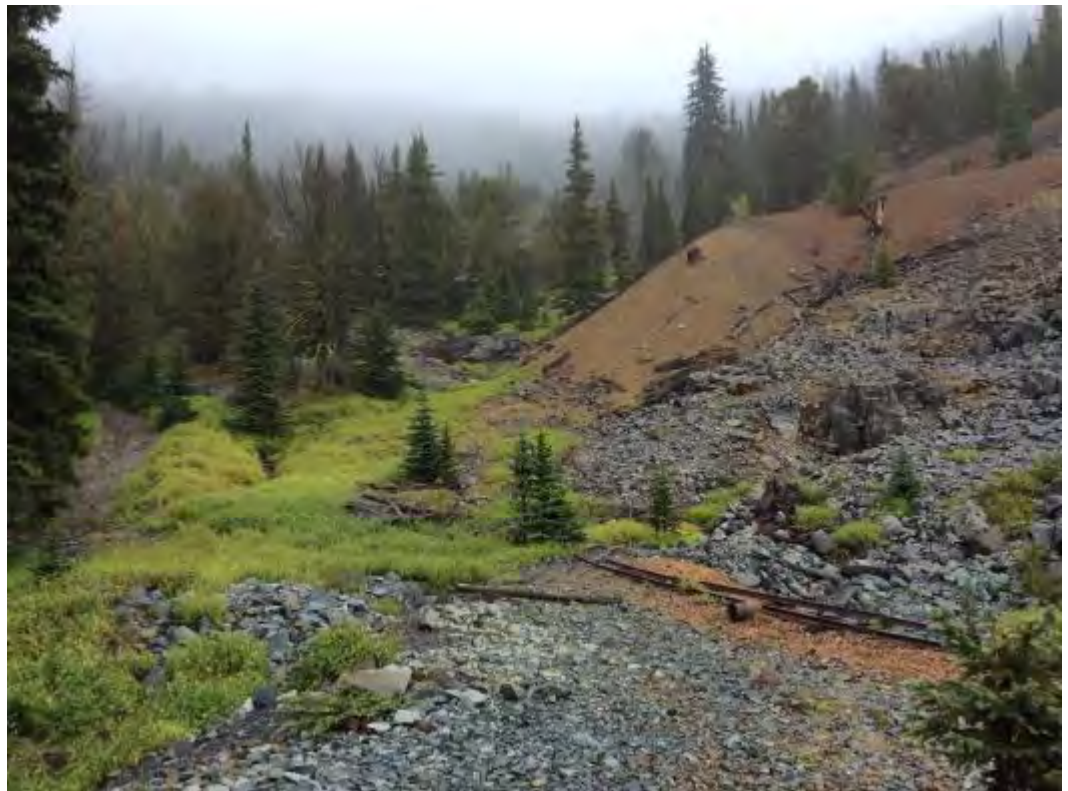
| <b>Description:</b><br><br>Skyline Mine adit, tailings pile, and the creek | |

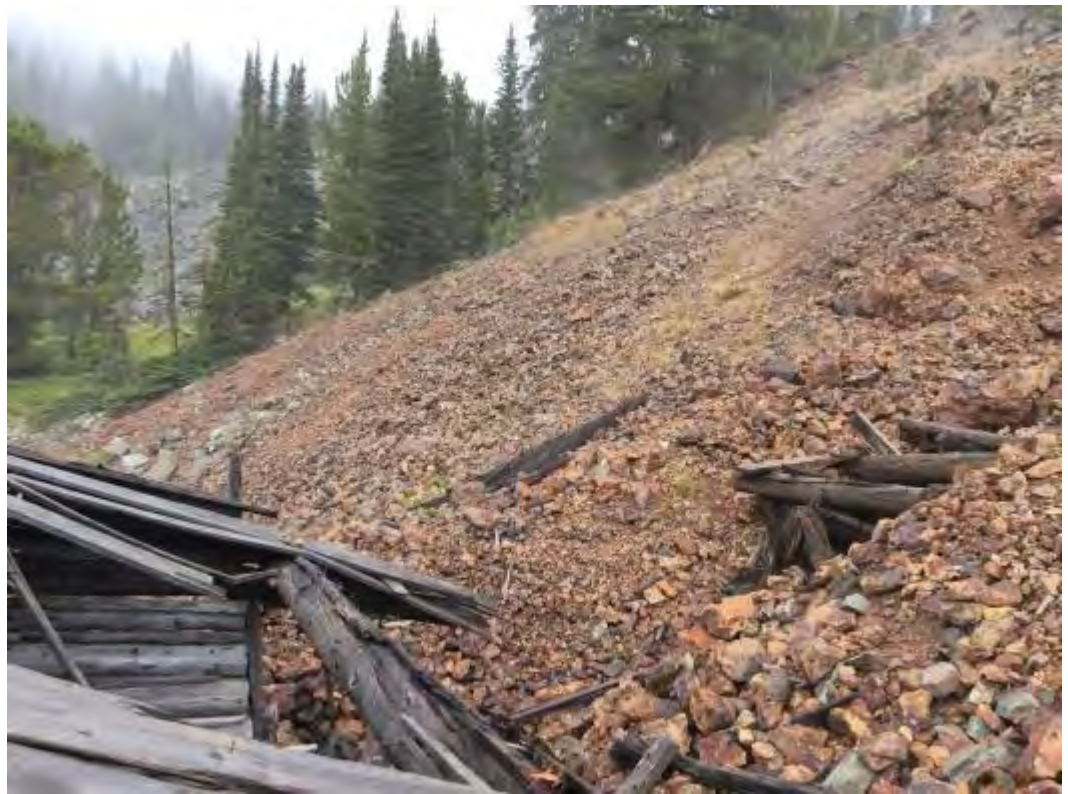
| <b>Description:</b><br><br>Skyline Mine upper adit | |

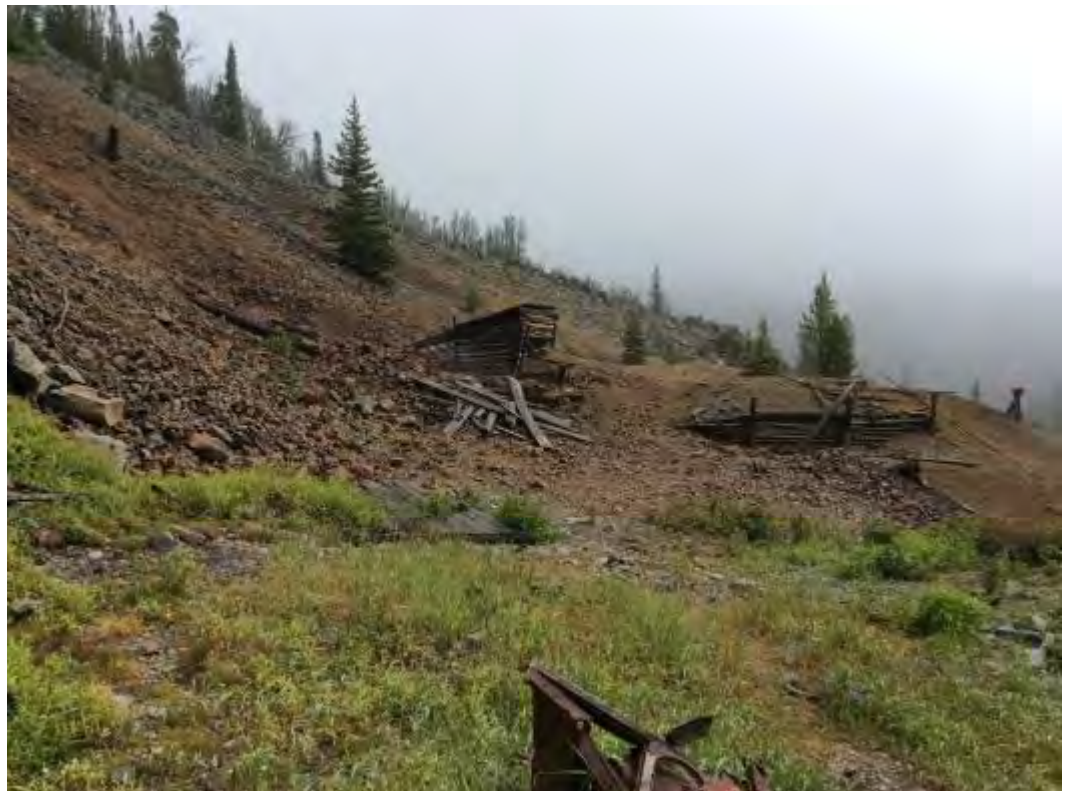
| <b>Description:</b><br><br>Skyline Mine upper tailings pile and mine adit | |

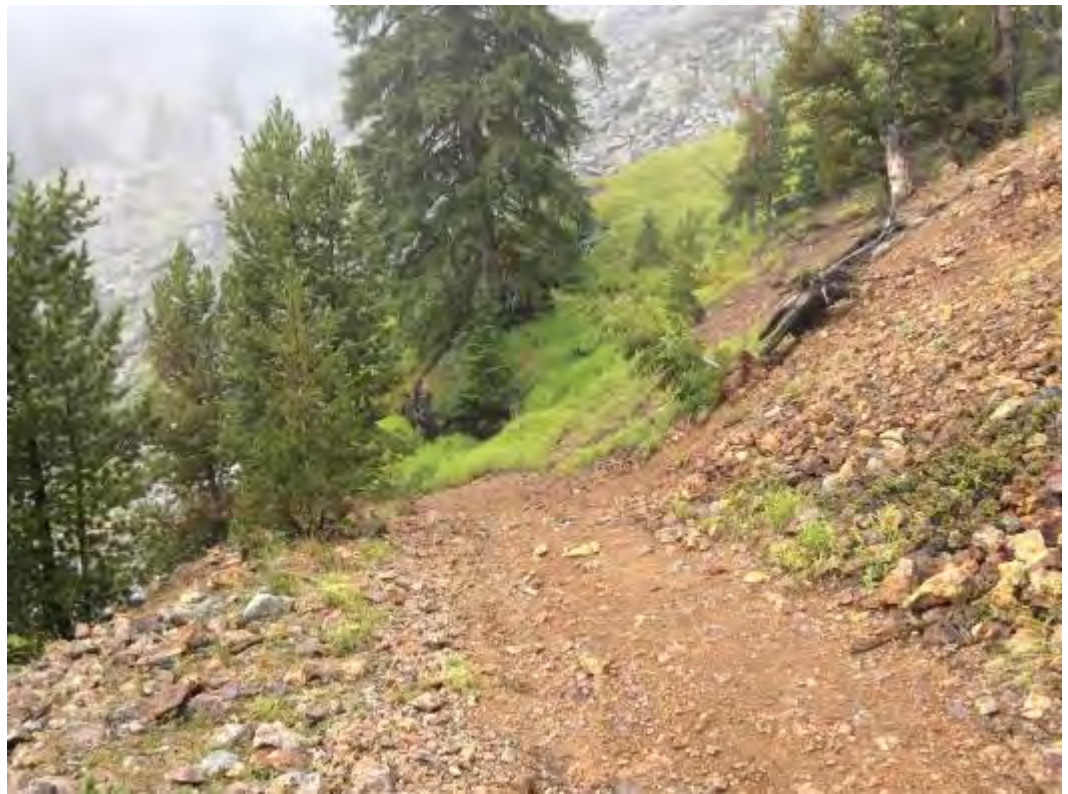
| <b>Description:</b><br><br>The road to Skyline Mine cut through the tailings pile | |

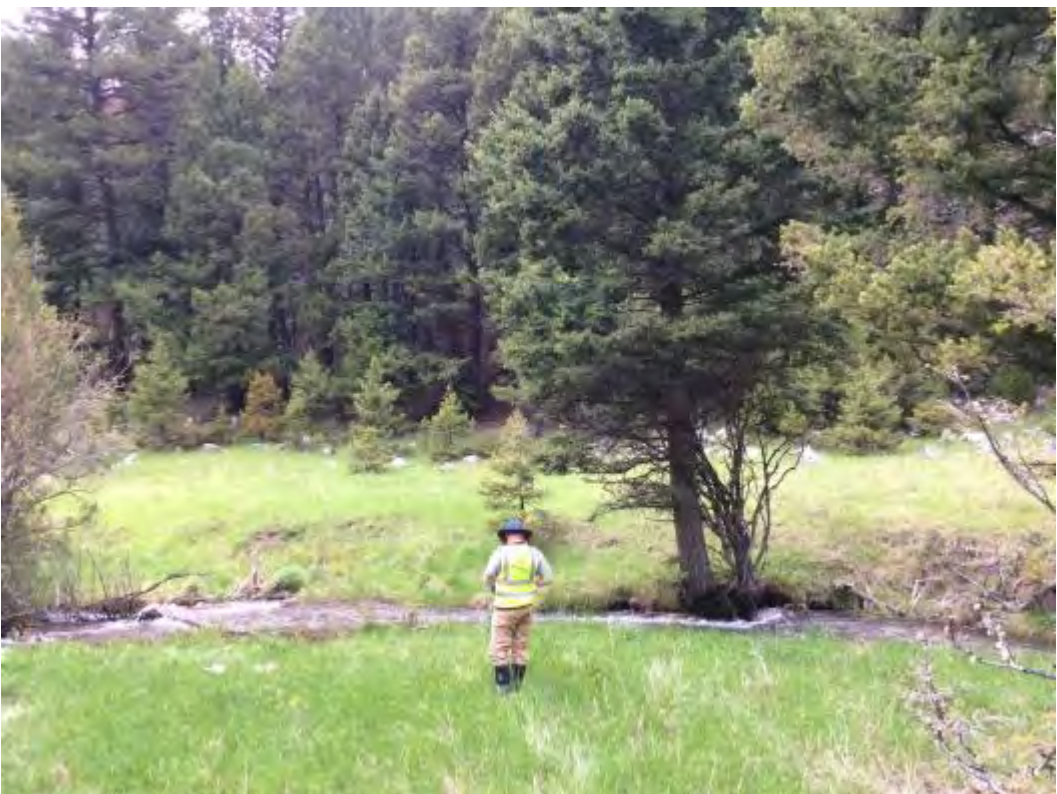
| <table> <tr> <td><b>Photo No.</b><br/><b>91</b></td><td><b>Date:</b><br/>06/04/2019</td></tr> <tr> <td colspan="2"><b>Photo Coordinates</b></td></tr> <tr> <td><b>Lat</b></td><td>46.257172</td></tr> <tr> <td><b>Long</b></td><td>-111.950583</td></tr> <tr> <td colspan="2"><b>Direction Photo Taken:</b><br/>291.154357950765</td></tr> <tr> <td colspan="2"><b>Description:</b><br/><br/>Location of sample<br/>BM-SW/SD-02</td></tr> </table> | <b>Photo No.</b><br><b>91</b> | <b>Date:</b><br>06/04/2019 | <b>Photo Coordinates</b> | | <b>Lat</b> | 46.257172 | <b>Long</b> | -111.950583 | <b>Direction Photo Taken:</b><br>291.154357950765 | | <b>Description:</b><br><br>Location of sample<br>BM-SW/SD-02 | | |

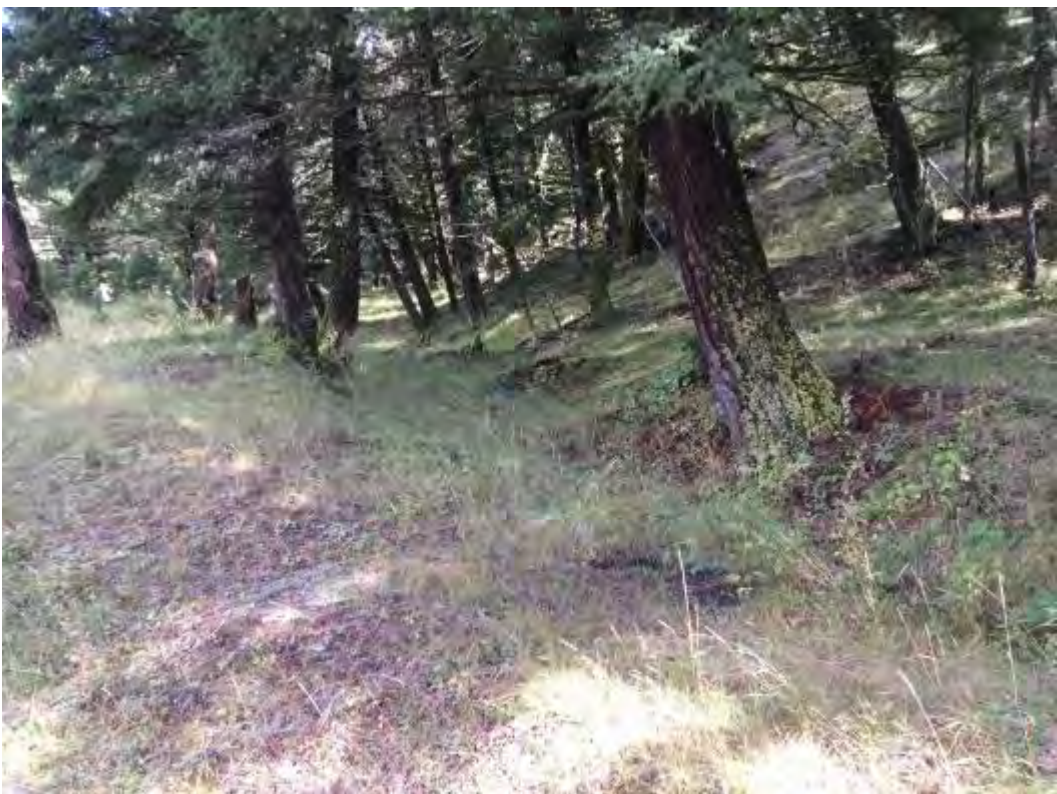
| <table border="1"> <tr> <td><b>Photo No.</b><br/><b>107</b></td> <td><b>Date:</b><br/>09/09/2019</td> </tr> <tr> <td colspan="2"><b>Photo Coordinates</b></td> </tr> <tr> <td><b>Lat</b></td> <td></td> </tr> <tr> <td><b>Long</b></td> <td></td> </tr> <tr> <td colspan="2"><b>Direction Photo Taken:</b></td> </tr> <tr> <td colspan="2"> <b>Description:</b><br/><br/> Dry creek bed of EQ-SW/SD-02; no sample was collected </td> </tr> </table> | <b>Photo No.</b><br><b>107</b> | <b>Date:</b><br>09/09/2019 | <b>Photo Coordinates</b> | | <b>Lat</b> | | <b>Long</b> | | <b>Direction Photo Taken:</b> | | <b>Description:</b><br><br>Dry creek bed of EQ-SW/SD-02; no sample was collected | | |

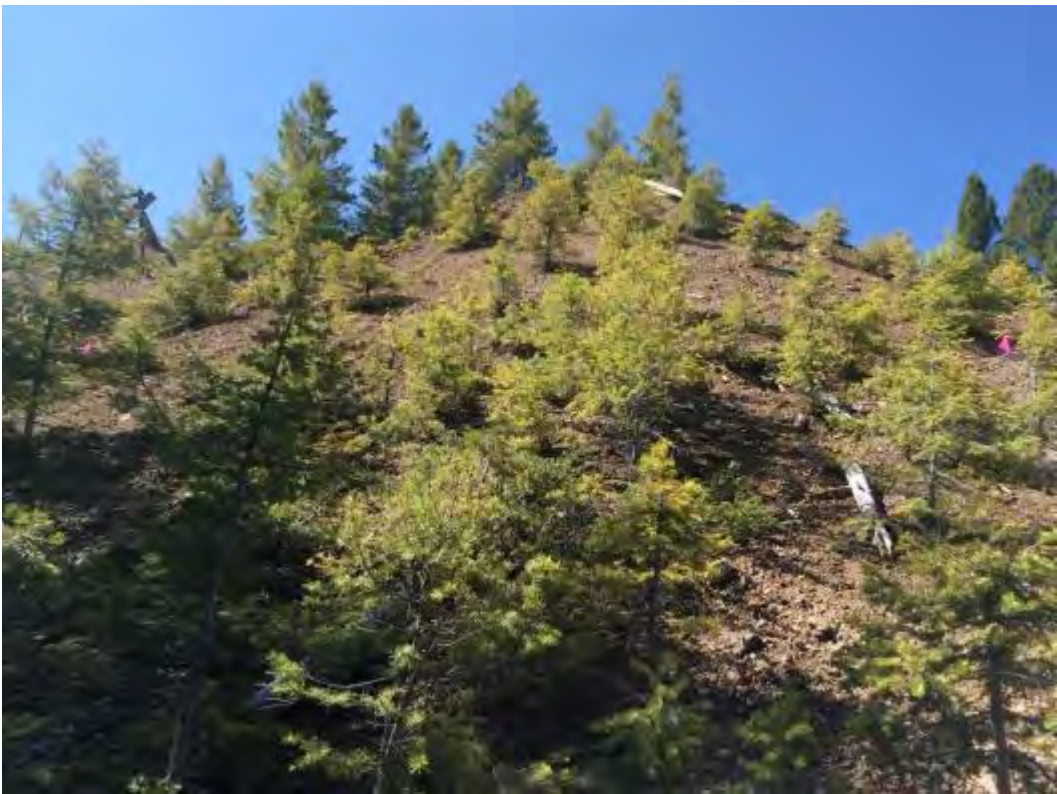
| <table> <tr> <td><b>Photo No.</b><br/><b>115</b></td><td><b>Date:</b><br/>06/03/2019</td></tr> <tr> <td colspan="2"><b>Photo Coordinates</b></td></tr> <tr> <td><b>Lat</b></td><td>46.246839</td></tr> <tr> <td><b>Long</b></td><td>-111.946564</td></tr> <tr> <td colspan="2"><b>Direction Photo Taken:</b><br/>201.195640616693</td></tr> <tr> <td colspan="2"> <b>Description:</b><br/><br/> Showing 5-point composite locations for sample EQ-WR-05 </td></tr> </table> | <b>Photo No.</b><br><b>115</b> | <b>Date:</b><br>06/03/2019 | <b>Photo Coordinates</b> | | <b>Lat</b> | 46.246839 | <b>Long</b> | -111.946564 | <b>Direction Photo Taken:</b><br>201.195640616693 | | <b>Description:</b><br><br>Showing 5-point composite locations for sample EQ-WR-05 | | |

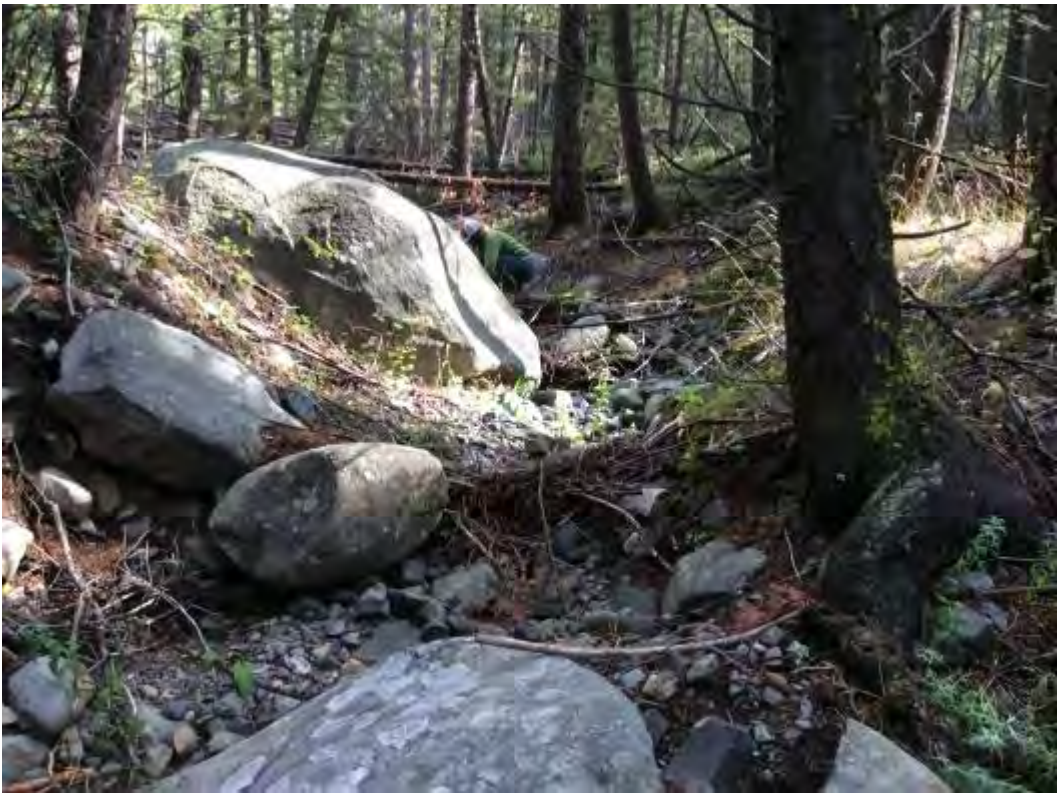
| <table> <tr> <td><b>Photo No.</b><br/><b>2</b></td><td><b>Date:</b><br/>09/10/2019</td></tr> <tr> <td colspan="2"><b>Photo Coordinates</b></td></tr> <tr> <td><b>Lat</b></td><td>46.278917</td></tr> <tr> <td><b>Long</b></td><td>-111.939614</td></tr> <tr> <td colspan="2"><b>Direction Photo Taken:</b><br/>42.45266723116</td></tr> <tr> <td colspan="2"><b>Description:</b><br/><br/>Location of sample<br/>CD-SD-BK01</td></tr> </table> | <b>Photo No.</b><br><b>2</b> | <b>Date:</b><br>09/10/2019 | <b>Photo Coordinates</b> | | <b>Lat</b> | 46.278917 | <b>Long</b> | -111.939614 | <b>Direction Photo Taken:</b><br>42.45266723116 | | <b>Description:</b><br><br>Location of sample<br>CD-SD-BK01 | | |

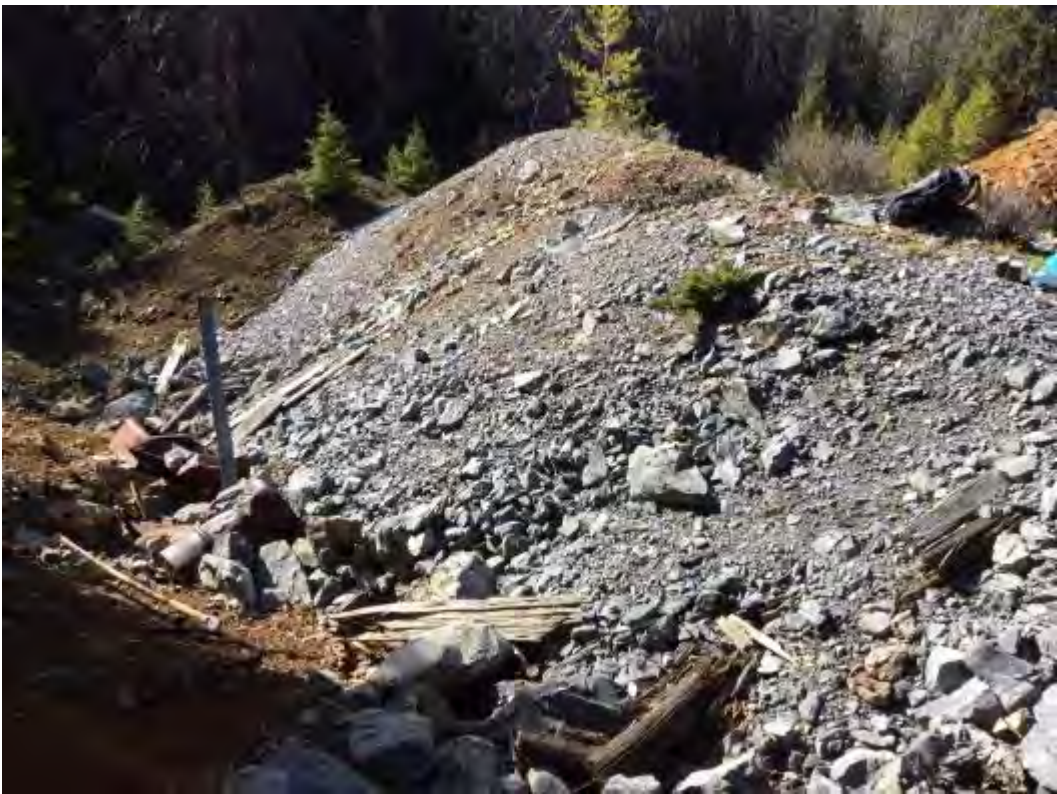
| <table> <tr> <td><b>Photo No.</b><br/><b>9</b></td><td><b>Date:</b><br/>06/05/2019</td></tr> <tr> <td colspan="2"><b>Photo Coordinates</b></td></tr> <tr> <td><b>Lat</b></td><td>46.288669</td></tr> <tr> <td><b>Long</b></td><td>-111.934364</td></tr> <tr> <td colspan="2"><b>Direction Photo Taken:</b><br/>153.148139946856</td></tr> <tr> <td colspan="2"> <b>Description:</b><br/><br/> Showing 5-point composite locations for sample CD-WR-03 </td></tr> </table> | <b>Photo No.</b><br><b>9</b> | <b>Date:</b><br>06/05/2019 | <b>Photo Coordinates</b> | | <b>Lat</b> | 46.288669 | <b>Long</b> | -111.934364 | <b>Direction Photo Taken:</b><br>153.148139946856 | | <b>Description:</b><br><br>Showing 5-point composite locations for sample CD-WR-03 | | |

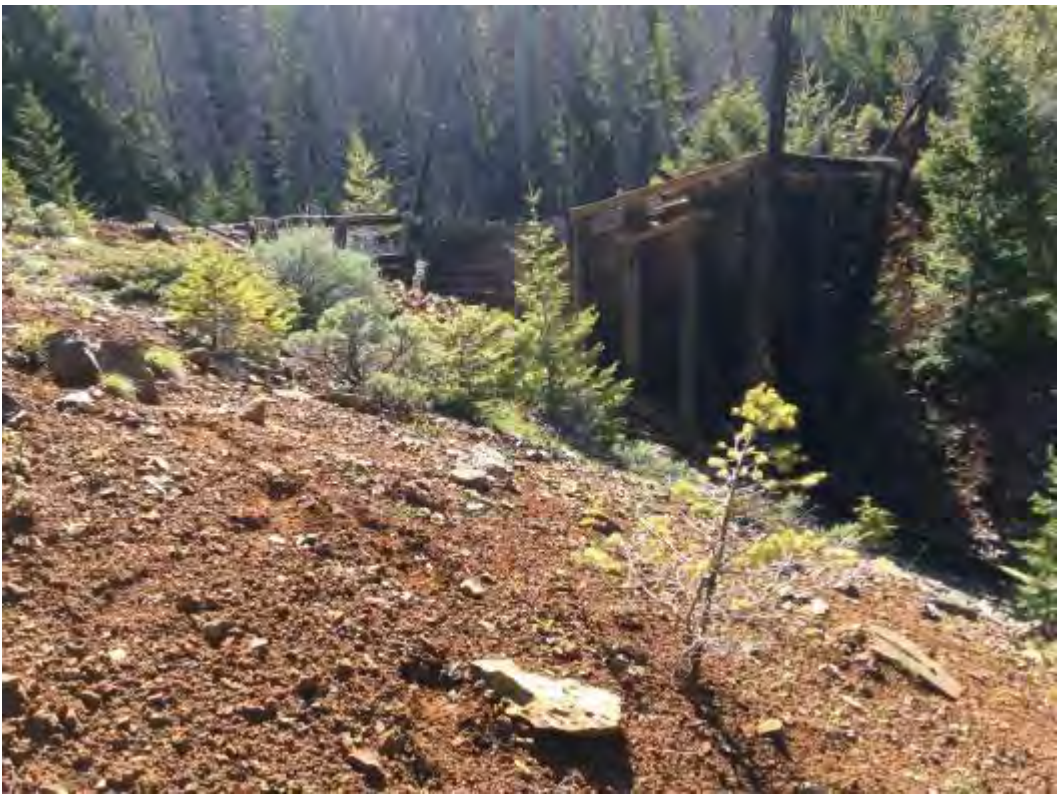
| <table> <tr> <td><b>Photo No.</b><br/><b>13</b></td><td><b>Date:</b><br/>06/05/2019</td></tr> <tr> <td colspan="2"><b>Photo Coordinates</b></td></tr> <tr> <td><b>Lat</b></td><td>46.288536</td></tr> <tr> <td><b>Long</b></td><td>-111.934578</td></tr> <tr> <td colspan="2"><b>Direction Photo Taken:</b><br/>107.636213311286</td></tr> <tr> <td colspan="2"> <b>Description:</b><br/><br/> Showing 5-point composite locations for sample CD-WR-07 </td></tr> </table> | <b>Photo No.</b><br><b>13</b> | <b>Date:</b><br>06/05/2019 | <b>Photo Coordinates</b> | | <b>Lat</b> | 46.288536 | <b>Long</b> | -111.934578 | <b>Direction Photo Taken:</b><br>107.636213311286 | | <b>Description:</b><br><br>Showing 5-point composite locations for sample CD-WR-07 | | |

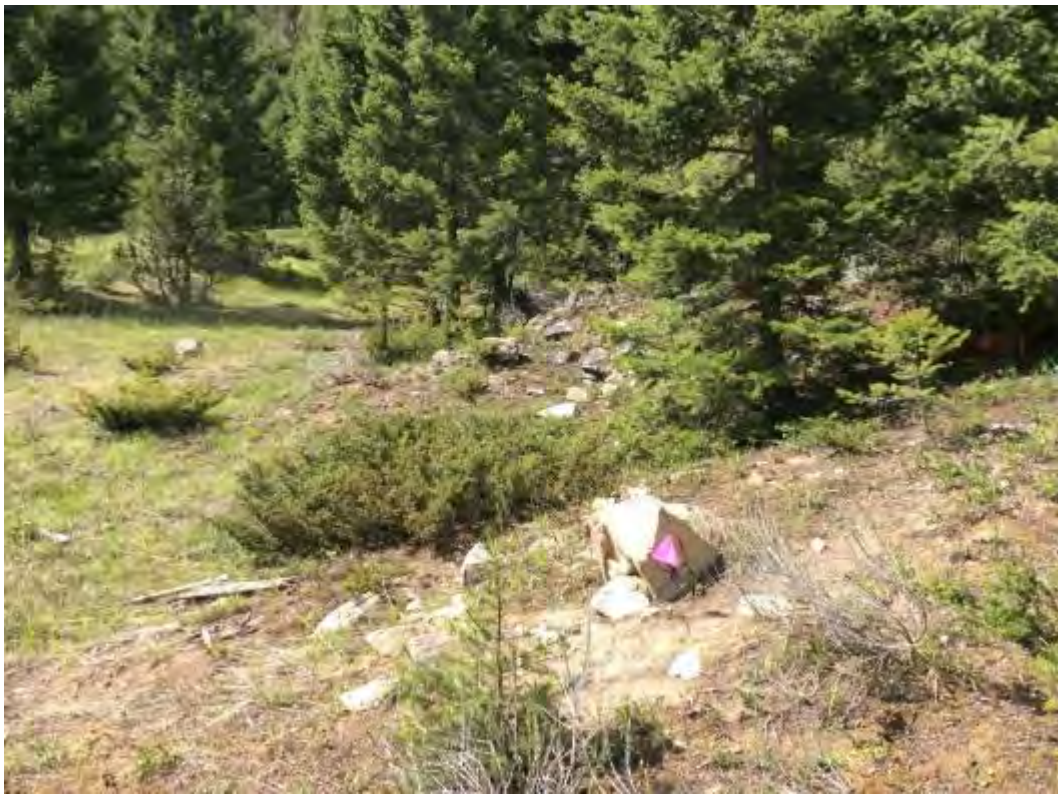
| <table border="1"> <tr> <td><b>Photo No.</b><br/><b>38</b></td><td><b>Date:</b><br/>06/03/2019</td></tr> <tr> <td colspan="2"><b>Photo Coordinates</b></td></tr> <tr> <td><b>Lat</b></td><td>46.266369</td></tr> <tr> <td><b>Long</b></td><td>-111.956069</td></tr> <tr> <td colspan="2"><b>Direction Photo Taken:</b><br/>332.837658017299</td></tr> <tr> <td colspan="2"> <b>Description:</b><br/><br/> Location of sample ECT-WR-04 in the Elkhorn Creek Tailings impoundment </td></tr> </table> | <b>Photo No.</b><br><b>38</b> | <b>Date:</b><br>06/03/2019 | <b>Photo Coordinates</b> | | <b>Lat</b> | 46.266369 | <b>Long</b> | -111.956069 | <b>Direction Photo Taken:</b><br>332.837658017299 | | <b>Description:</b><br><br>Location of sample ECT-WR-04 in the Elkhorn Creek Tailings impoundment | | |

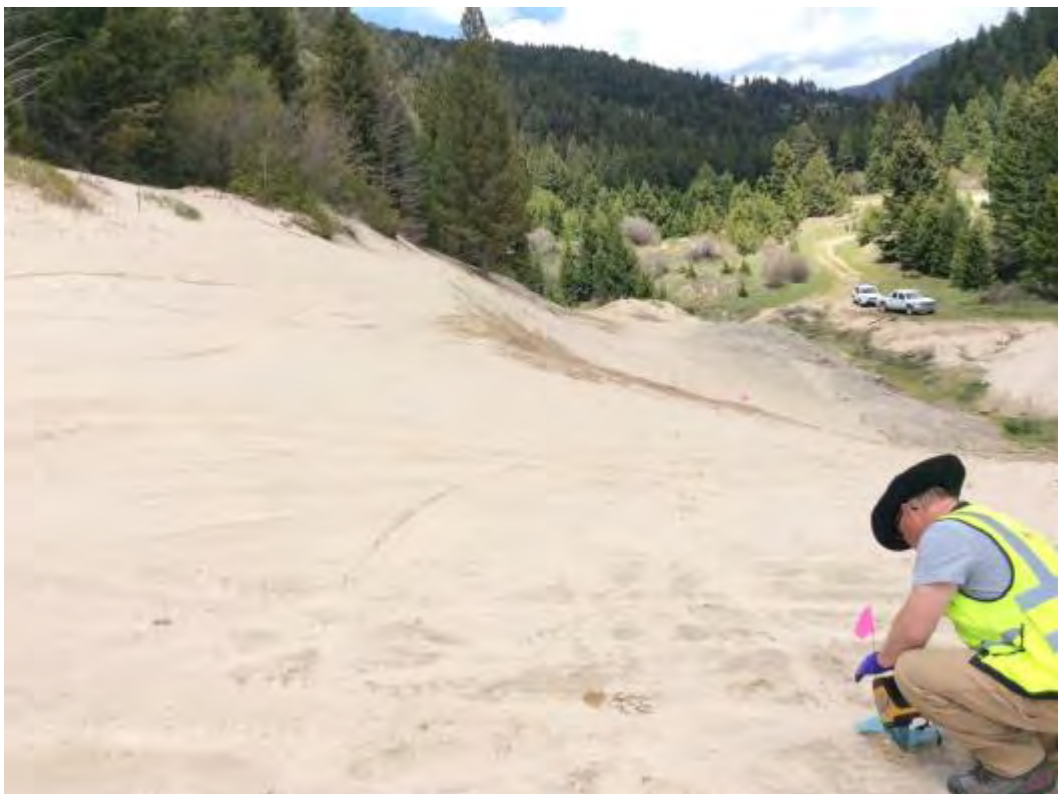
| <table> <tr> <td><b>Photo No.</b><br/><b>39</b></td><td><b>Date:</b><br/>06/03/2019</td></tr> <tr> <td colspan="2"><b>Photo Coordinates</b></td></tr> <tr> <td><b>Lat</b></td><td>46.264622</td></tr> <tr> <td><b>Long</b></td><td>-111.956628</td></tr> <tr> <td colspan="2"><b>Direction Photo Taken:</b><br/>353.141891476679</td></tr> <tr> <td colspan="2"> <b>Description:</b><br/><br/> Screening of 30-point composite location for sample ECT-WR-05 </td></tr> </table> | <b>Photo No.</b><br><b>39</b> | <b>Date:</b><br>06/03/2019 | <b>Photo Coordinates</b> | | <b>Lat</b> | 46.264622 | <b>Long</b> | -111.956628 | <b>Direction Photo Taken:</b><br>353.141891476679 | | <b>Description:</b><br><br>Screening of 30-point composite location for sample ECT-WR-05 | | |

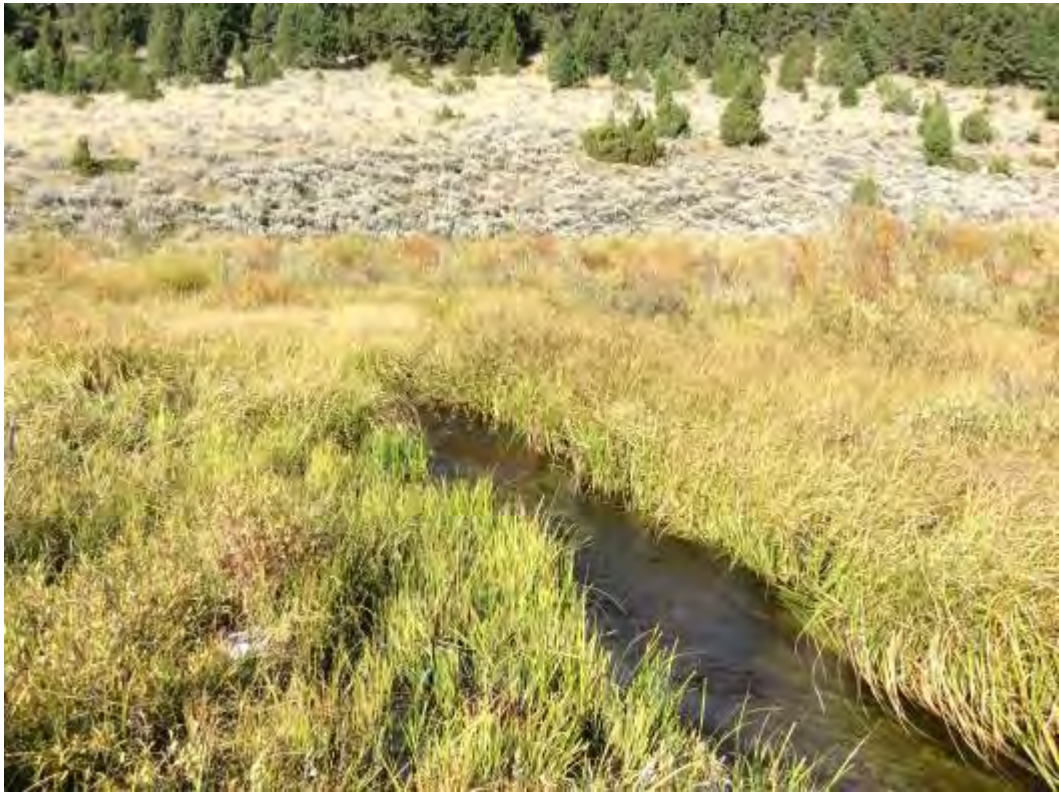
| <table> <tr> <td><b>Photo No.</b><br/><b>62</b></td><td><b>Date:</b><br/>09/09/2019</td></tr> <tr> <td colspan="2"><b>Photo Coordinates</b></td></tr> <tr> <td><b>Lat</b></td><td>46.270561</td></tr> <tr> <td><b>Long</b></td><td>-111.970397</td></tr> <tr> <td colspan="2"><b>Direction Photo Taken:</b><br/>43.8460388183594</td></tr> <tr> <td colspan="2"><b>Description:</b><br/><br/>Location of sample<br/>THL-SW/SD-01</td></tr> </table> | <b>Photo No.</b><br><b>62</b> | <b>Date:</b><br>09/09/2019 | <b>Photo Coordinates</b> | | <b>Lat</b> | 46.270561 | <b>Long</b> | -111.970397 | <b>Direction Photo Taken:</b><br>43.8460388183594 | | <b>Description:</b><br><br>Location of sample<br>THL-SW/SD-01 | | |

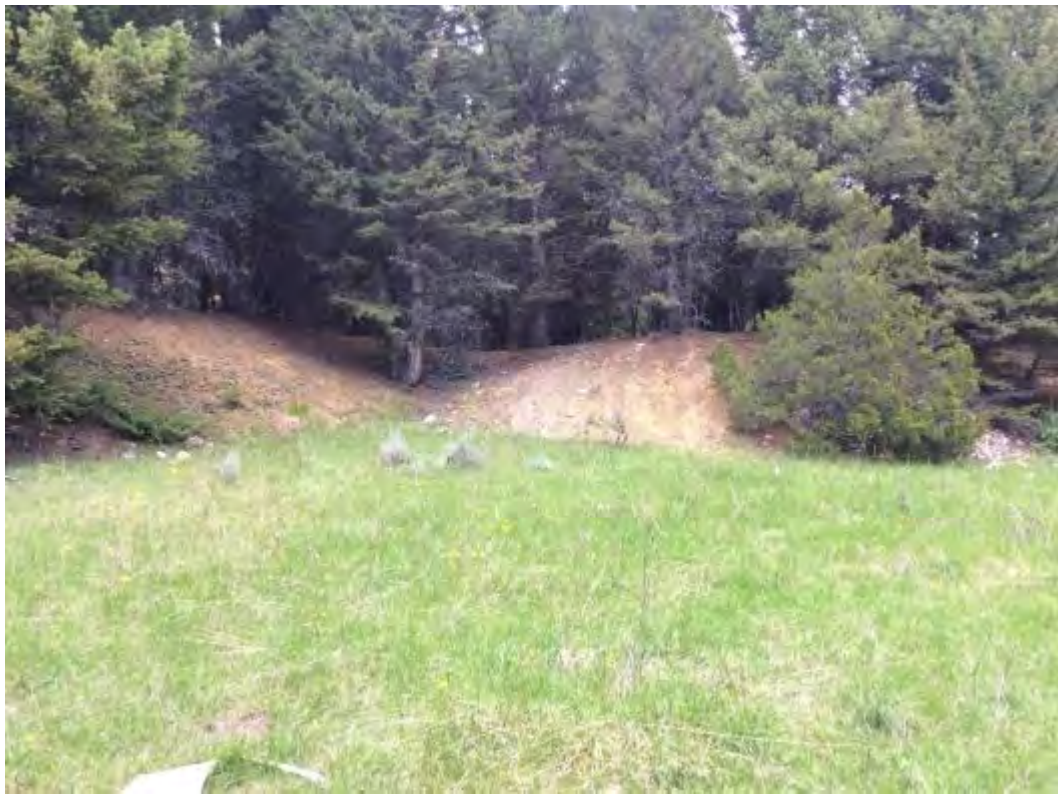
| <table border="1"> <tr> <td><b>Photo No.</b><br/><b>100</b></td><td><b>Date:</b><br/>06/04/2019</td></tr> <tr> <td colspan="2"><b>Photo Coordinates</b></td></tr> <tr> <td><b>Lat</b></td><td>46.25965</td></tr> <tr> <td><b>Long</b></td><td>-111.948394</td></tr> <tr> <td colspan="2"><b>Direction Photo Taken:</b><br/>32.9329223543226</td></tr> <tr> <td colspan="2"> <b>Description:</b><br/><br/> Showing 15-point composite locations for sample BM-WR-17 and duplicate sample BM-WR-19 </td></tr> </table> | <b>Photo No.</b><br><b>100</b> | <b>Date:</b><br>06/04/2019 | <b>Photo Coordinates</b> | | <b>Lat</b> | 46.25965 | <b>Long</b> | -111.948394 | <b>Direction Photo Taken:</b><br>32.9329223543226 | | <b>Description:</b><br><br>Showing 15-point composite locations for sample BM-WR-17 and duplicate sample BM-WR-19 | | |
