**Third Five-Year Review Report for Silver
Bow Creek/Butte Area Site**

**Volume 2: Stream Side Tailings Operable
Unit**

June 2011

U.S. Environmental Protection Agency
Helena, Montana

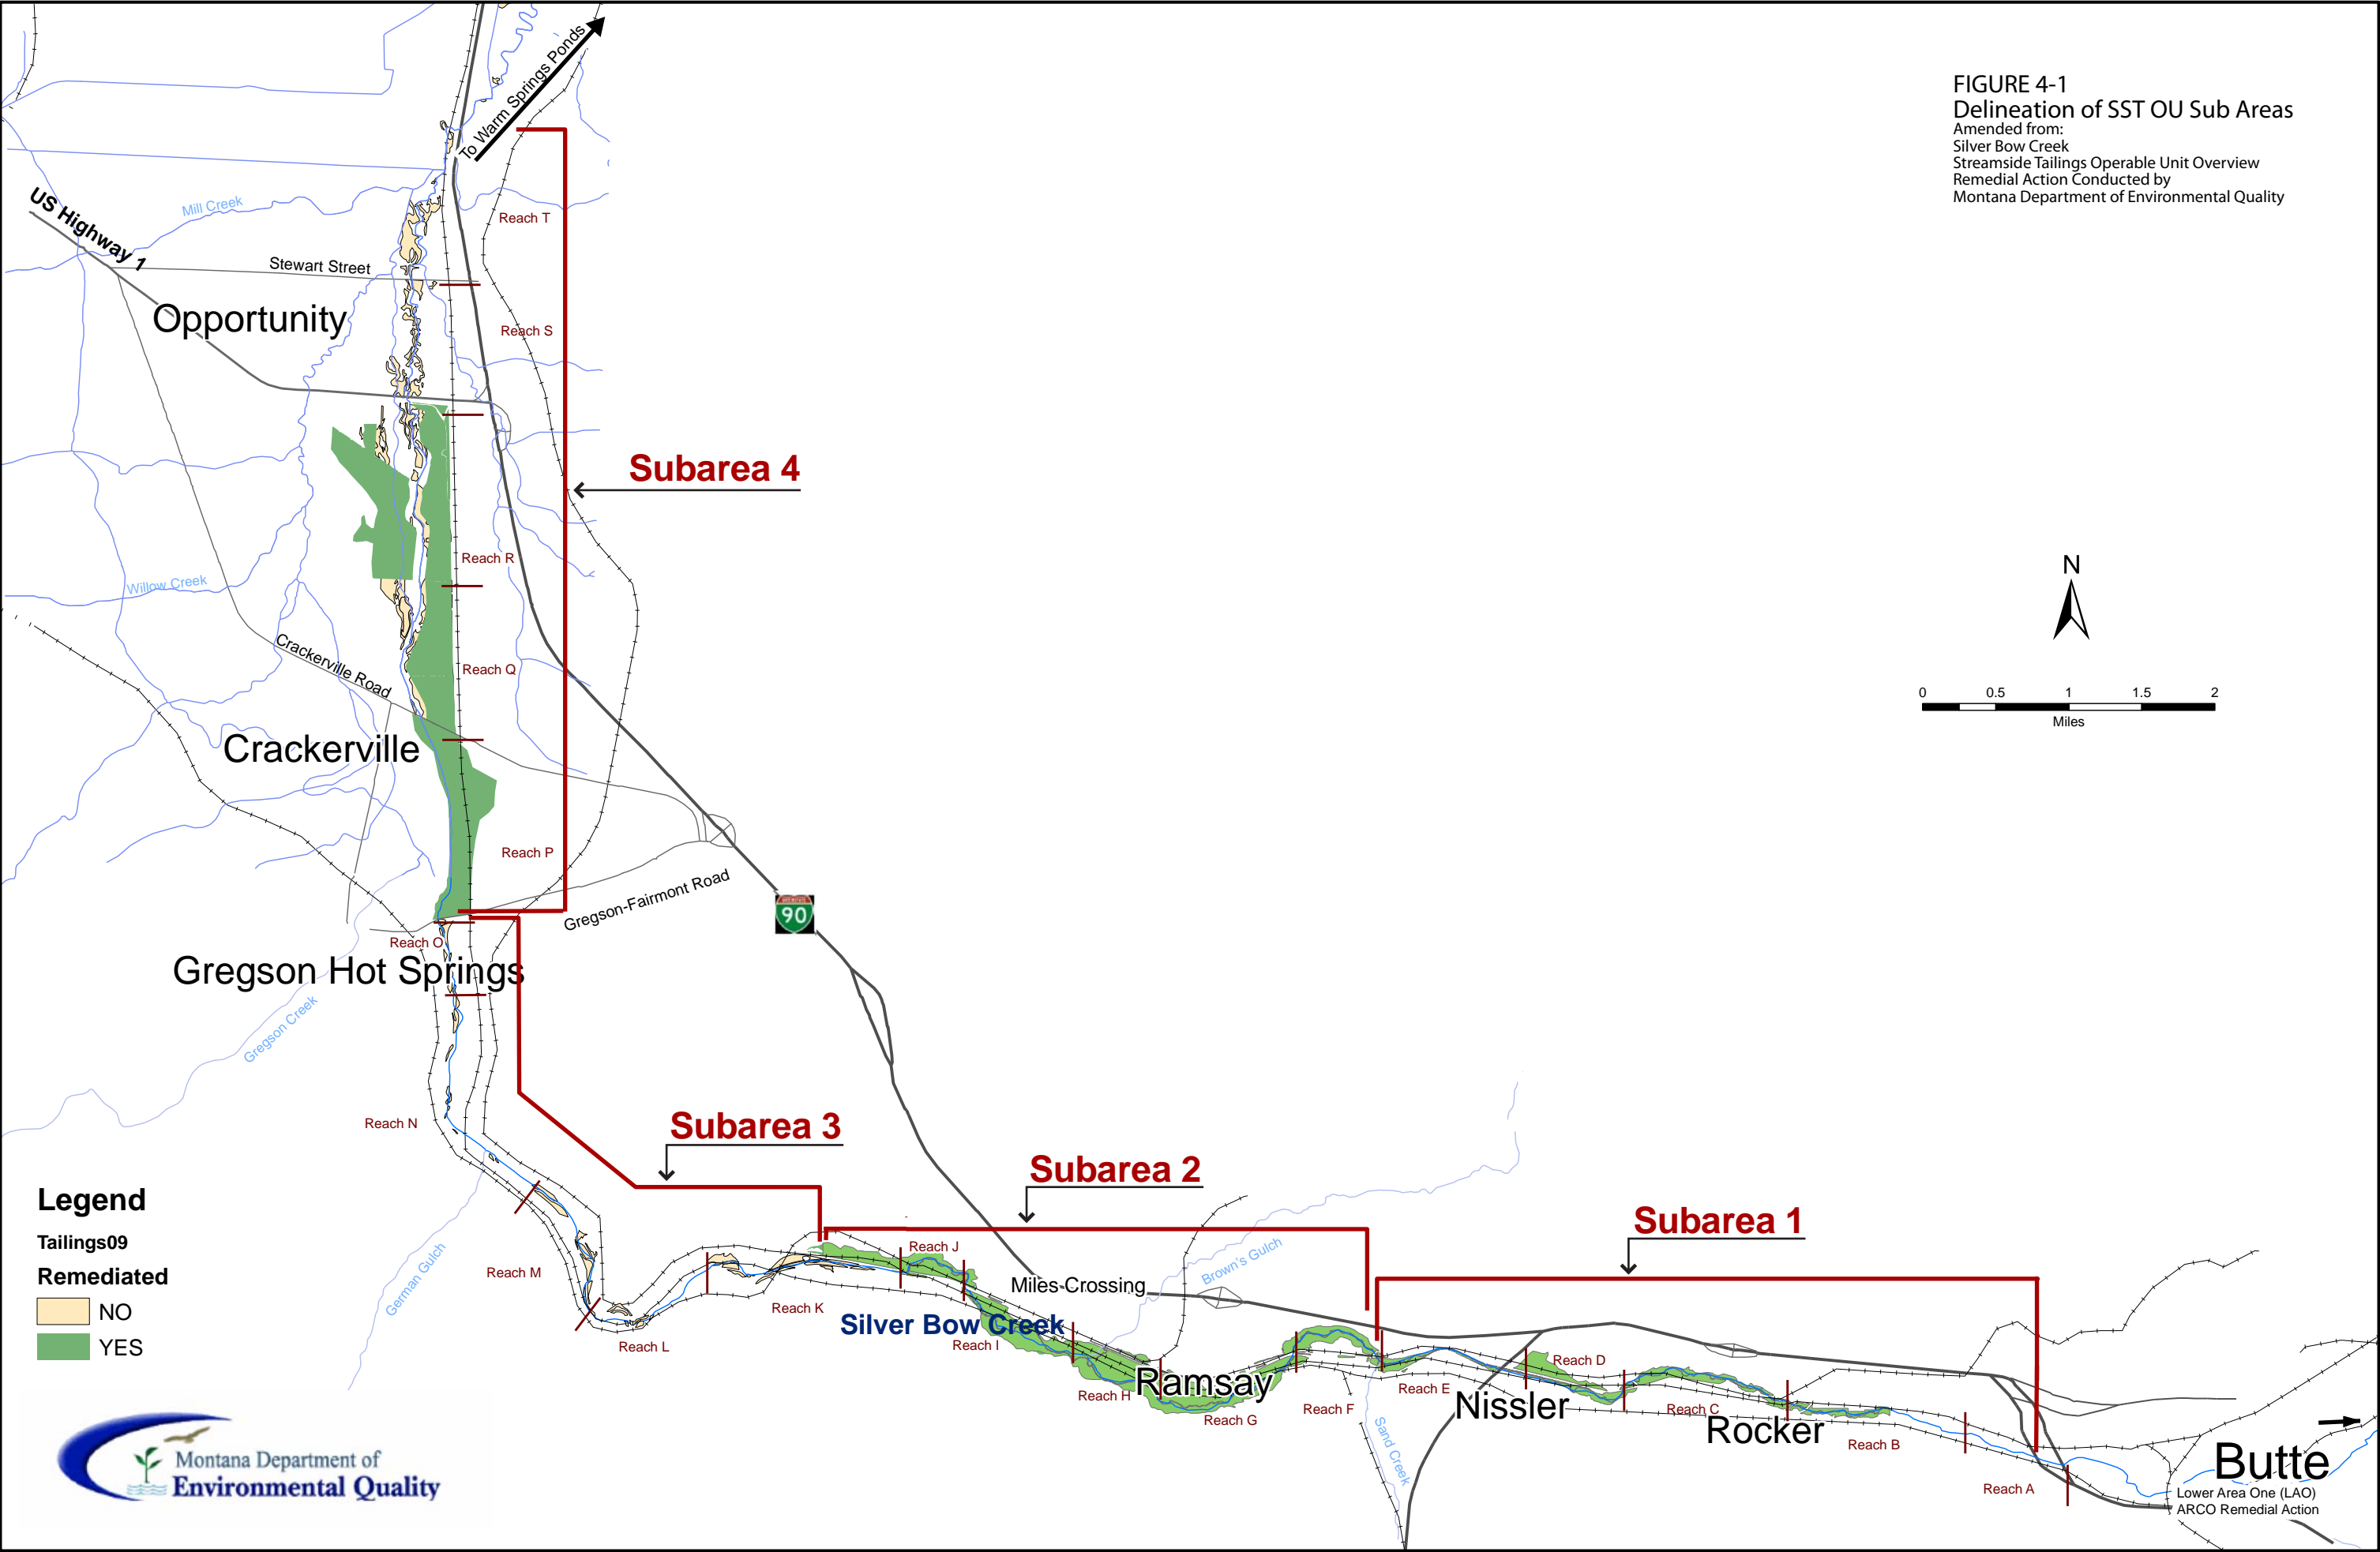
FIGURE 4-1
Delineation of SST OU Sub Areas
Amended from:
Silver Bow Creek
Streamside Tailings Operable Unit Overview
Remedial Action Conducted by
Montana Department of Environmental Quality

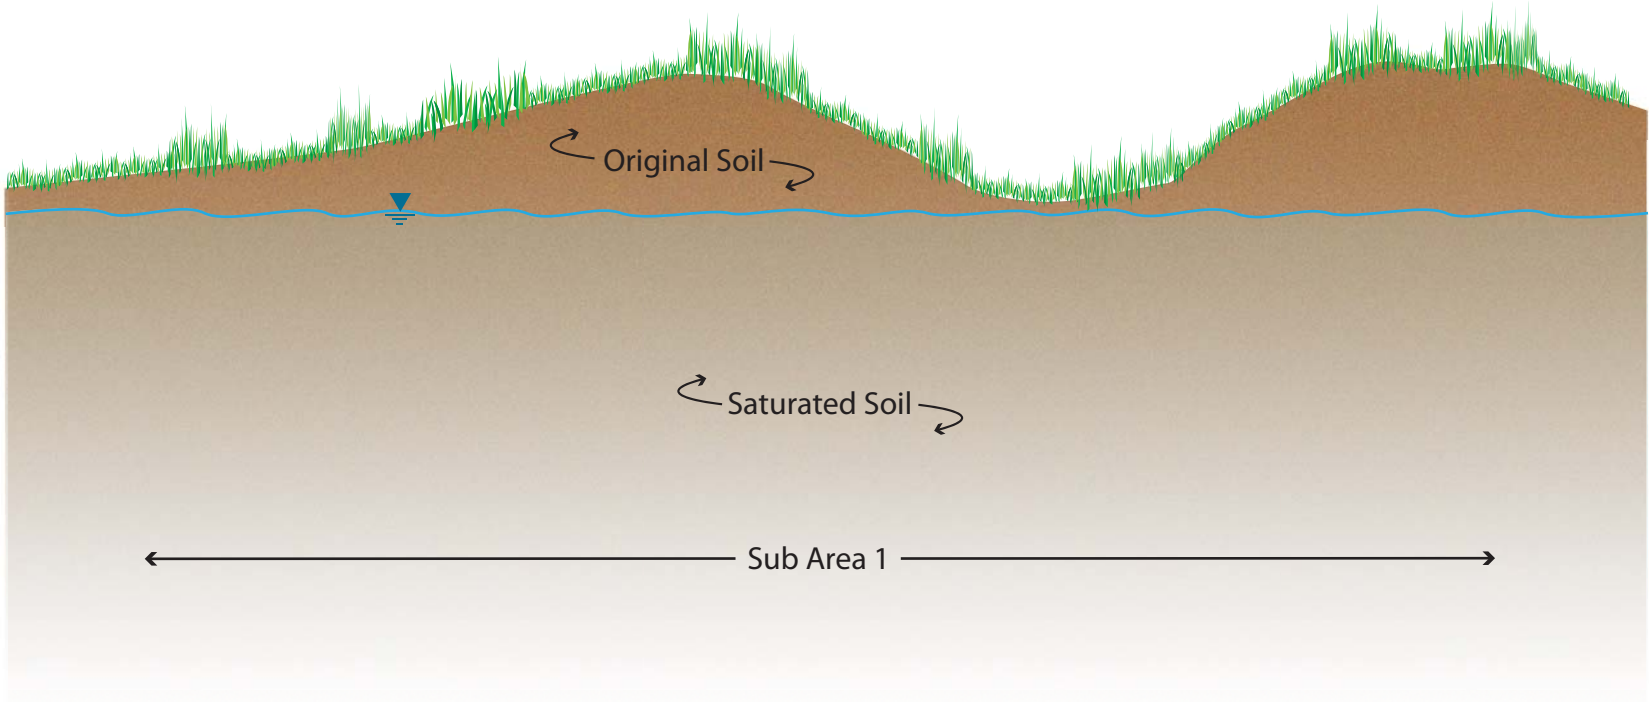
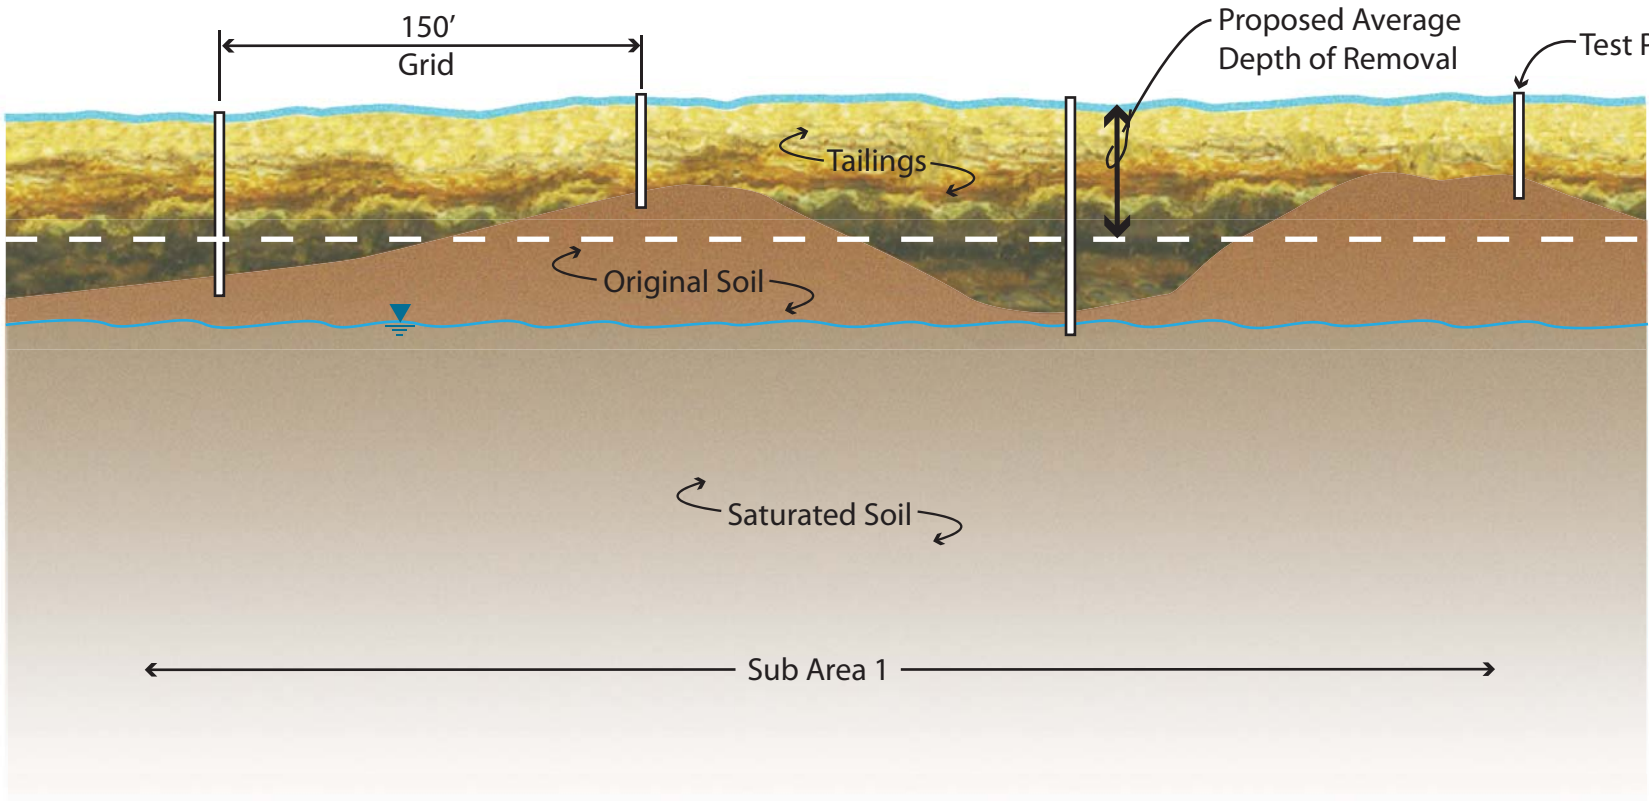
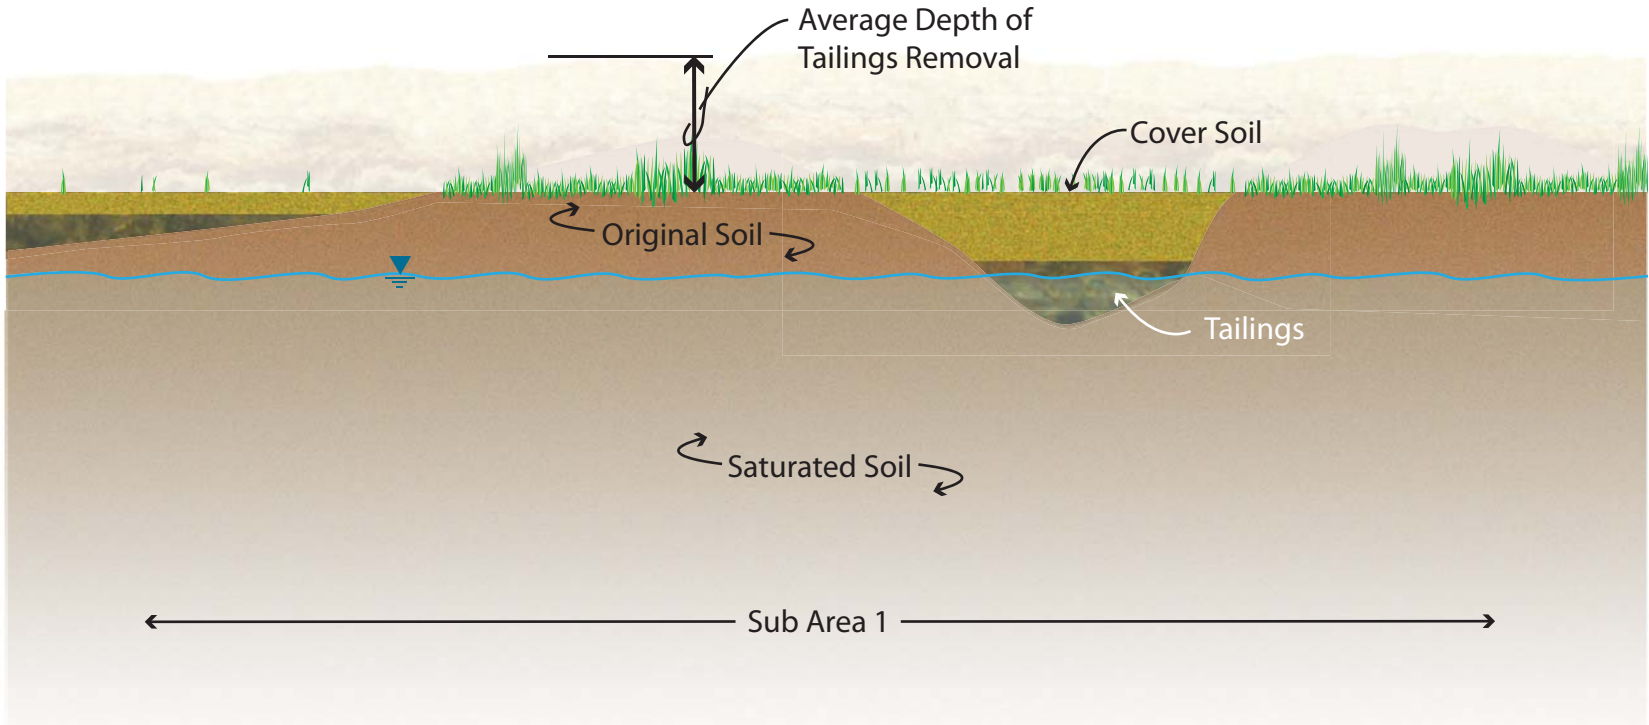
Before Tailing Deposition (Natural State)

After Tailing Deposition

After Remedial Action

FIGURE 4-2
Sub Area 1 - Remedial Excavation
Concept Diagram
Tails/Contaminated Soils Removal
Silverbow Creek OU 5 Year Review

remedial action goal (CQAPP, 1998) (see Figure 4-2 Concept Diagram). However, the removal process was periodically adjusted based on previous reach verification sampling data to help reduce the frequency of residual hot spots. Removal process adjustments consisted of over-excavation in 6- to 9-inch increments as the remedy moved down stream (Maxim, 2001 Final Design Report). The success of this method is reflected in a reduction of the sample percent failure rate as construction progressed downstream.

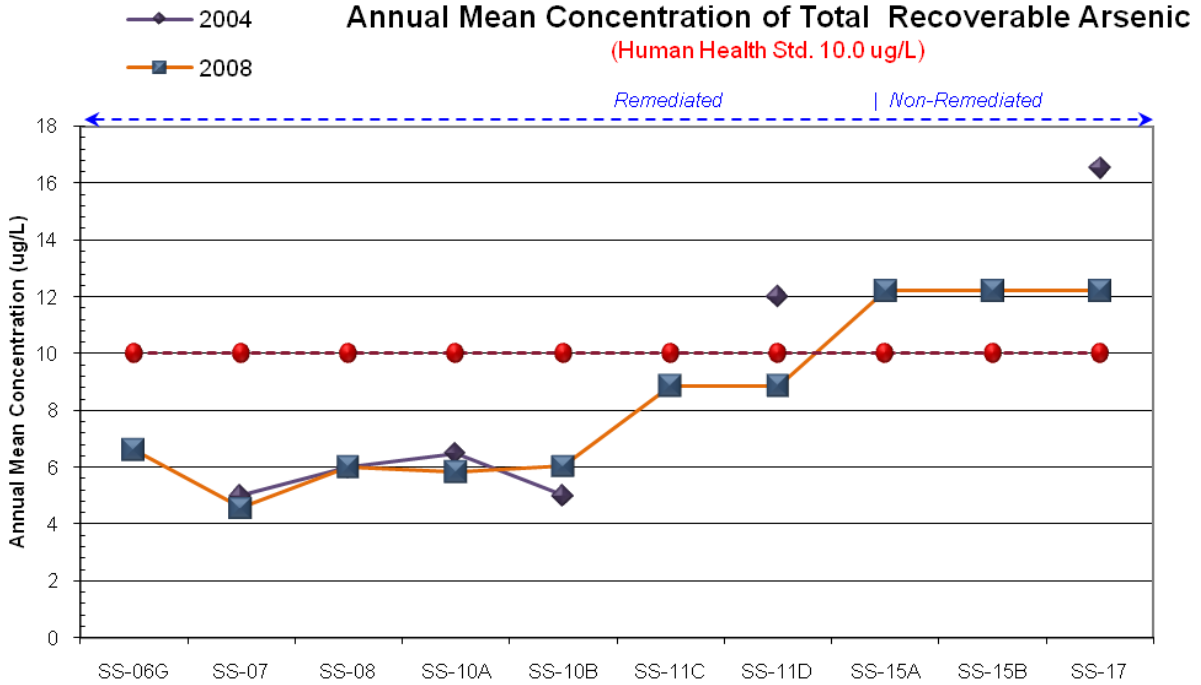
FIGURE 6-2

Annual Mean Concentration of Total Recoverable Arsenic

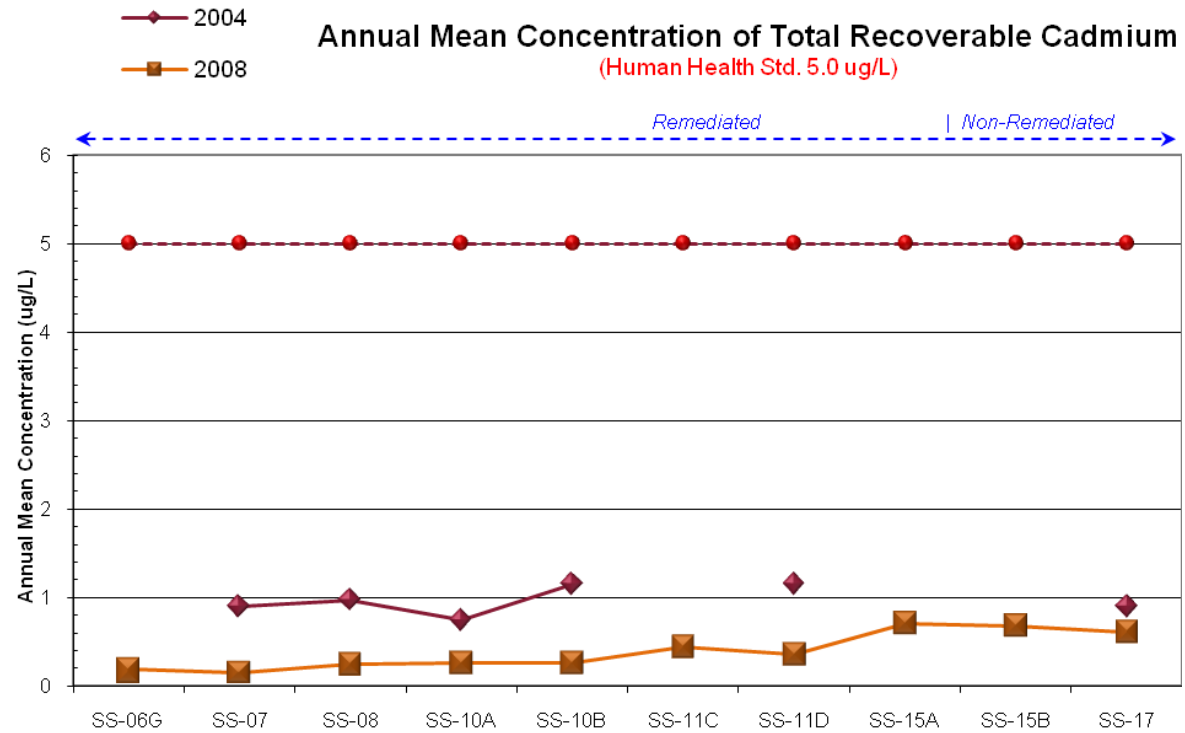
FIGURE 6-3

Annual Mean Concentration of Total Recoverable Cadmium

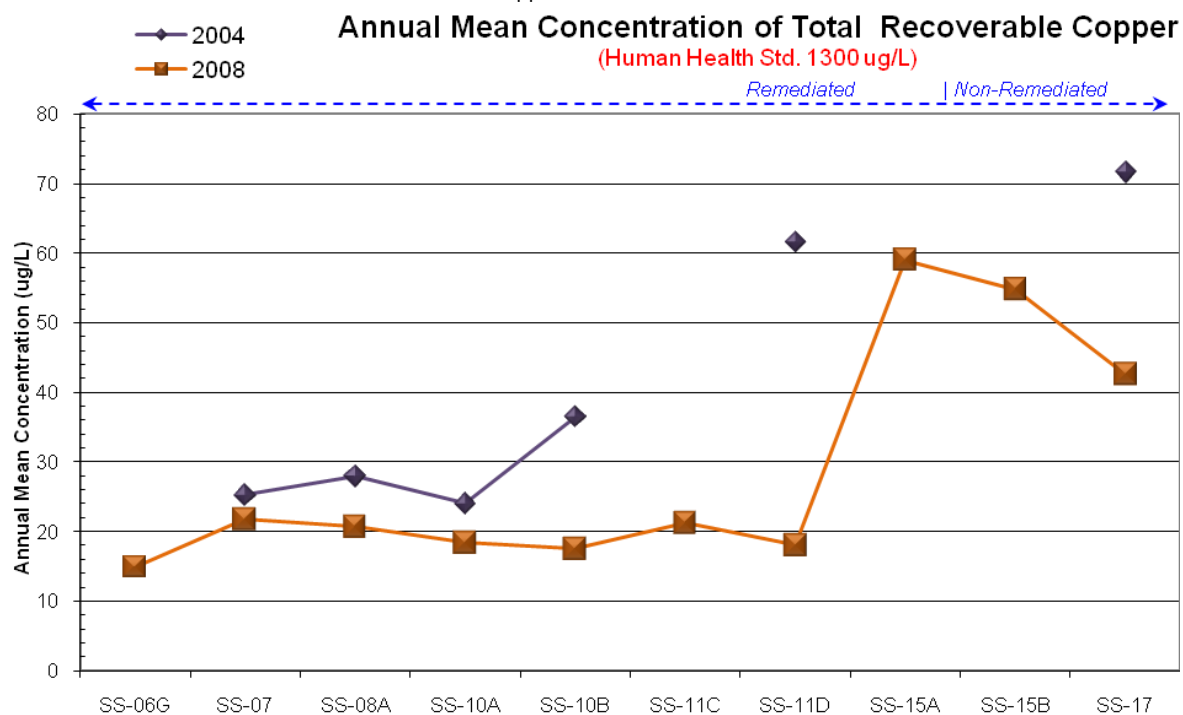
FIGURE 6-4

Annual Mean Concentration of Total Recoverable Copper

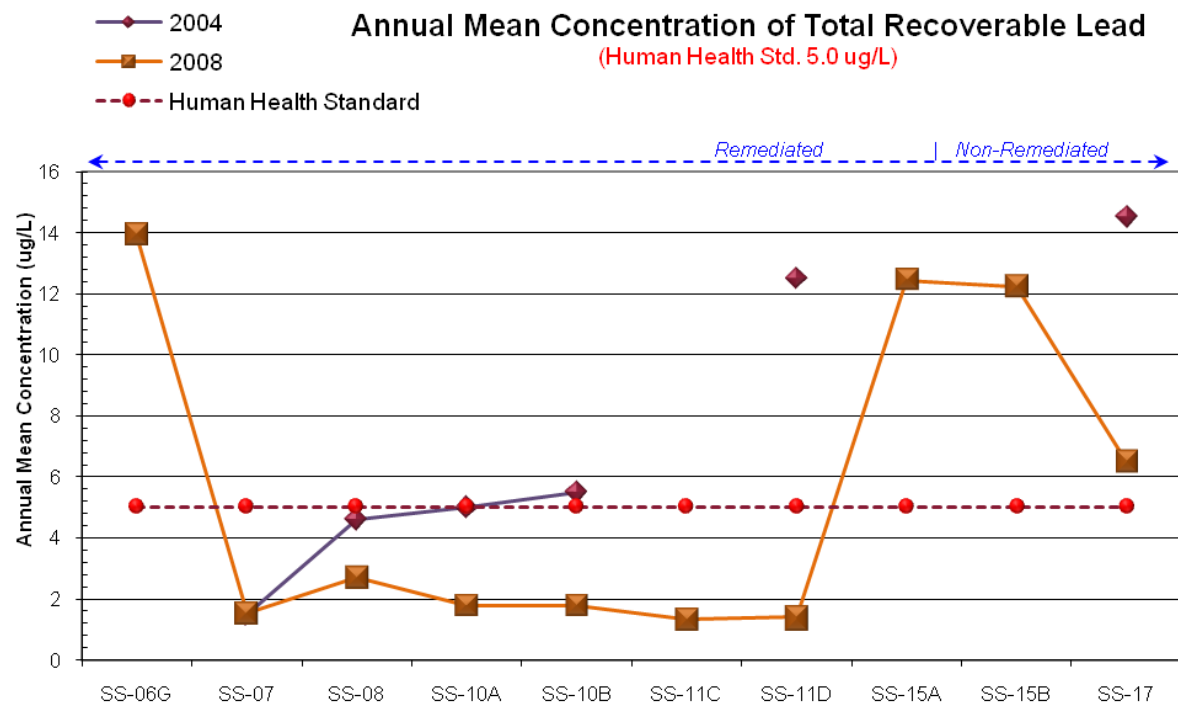
FIGURE 6-5

Annual Mean Concentration of Total Recoverable Lead

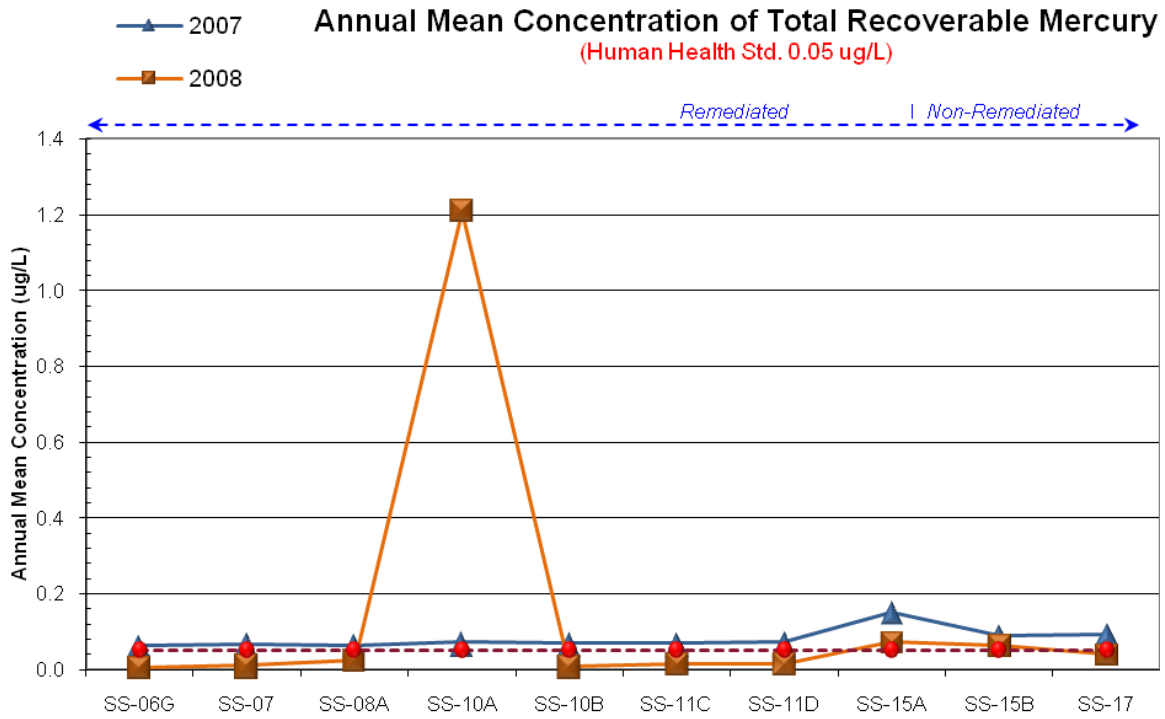
FIGURE 6-6

Annual Mean Concentration of Total Recoverable Mercury

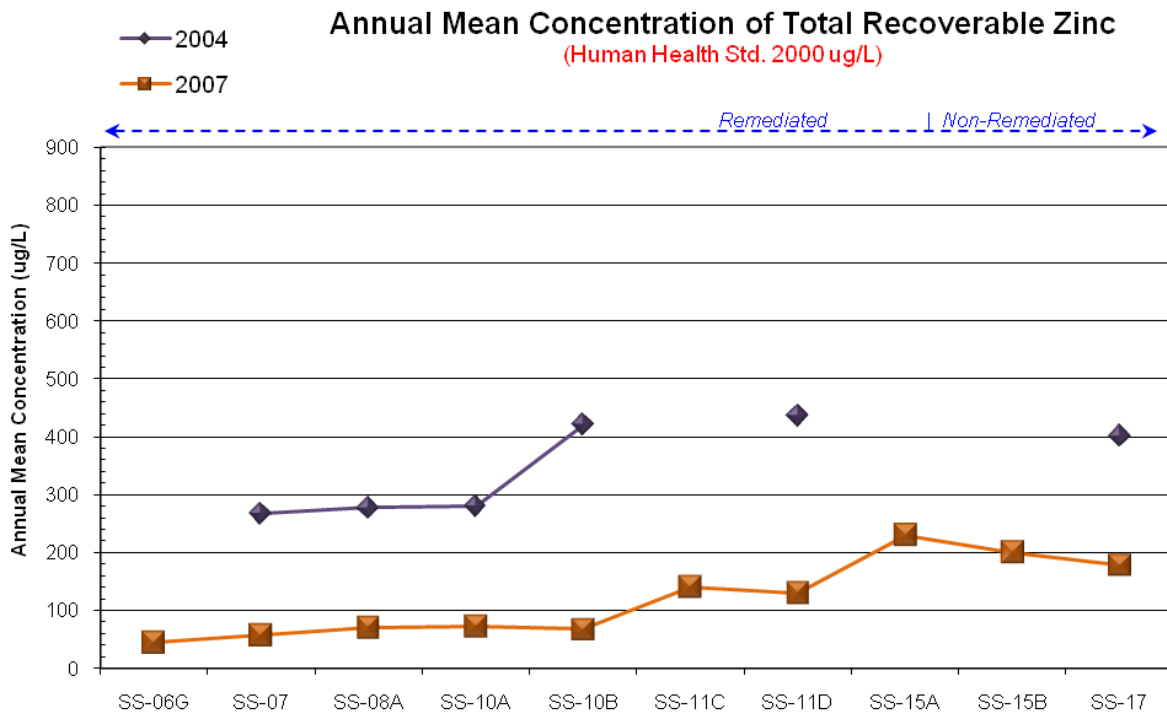
FIGURE 6-7

Annual Mean Concentration of Total Recoverable Zinc

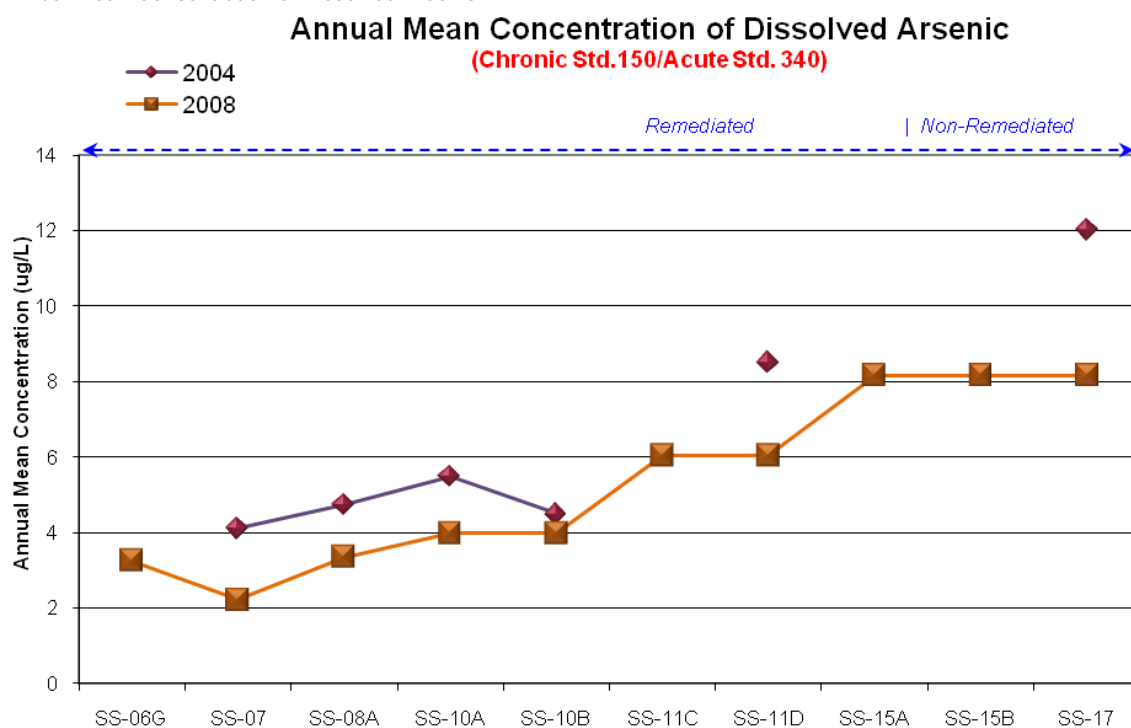
FIGURE 6-8
Annual Mean Concentration of Dissolved Arsenic

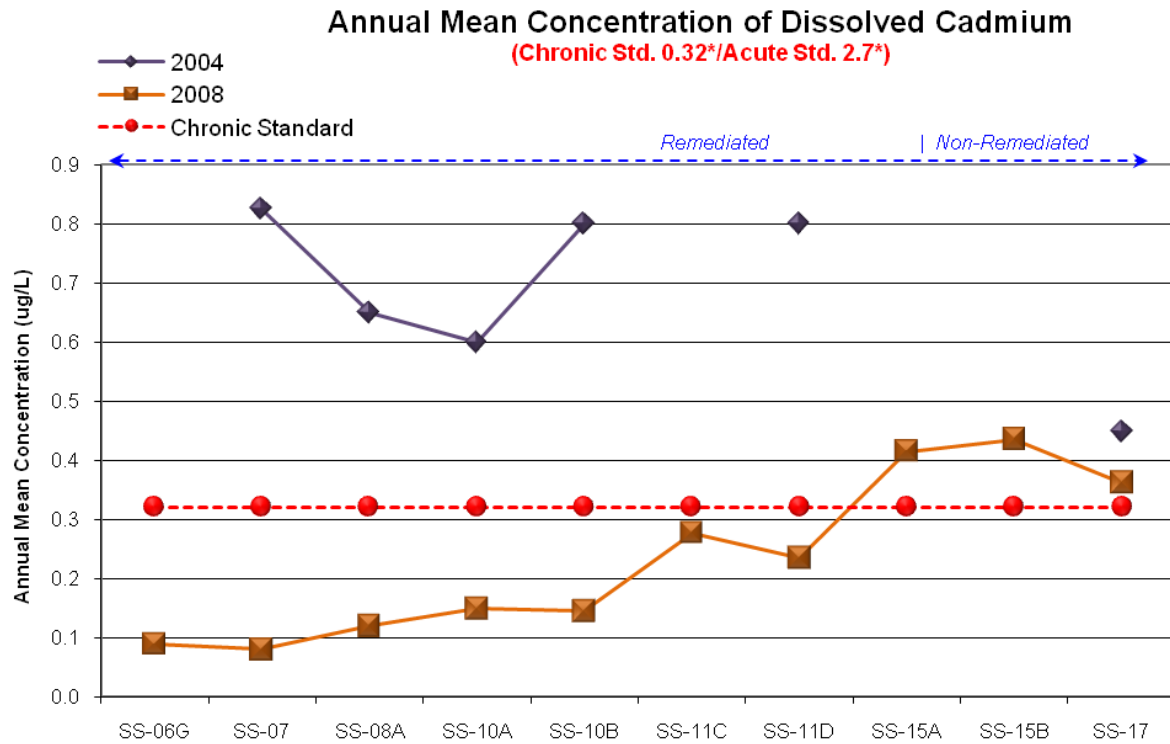
FIGURE 6-9

Annual Mean Concentration of Dissolved Cadmium

*Based on 125 mg/L hardness (typical Value for Silver Bow Creek in SSTOU)

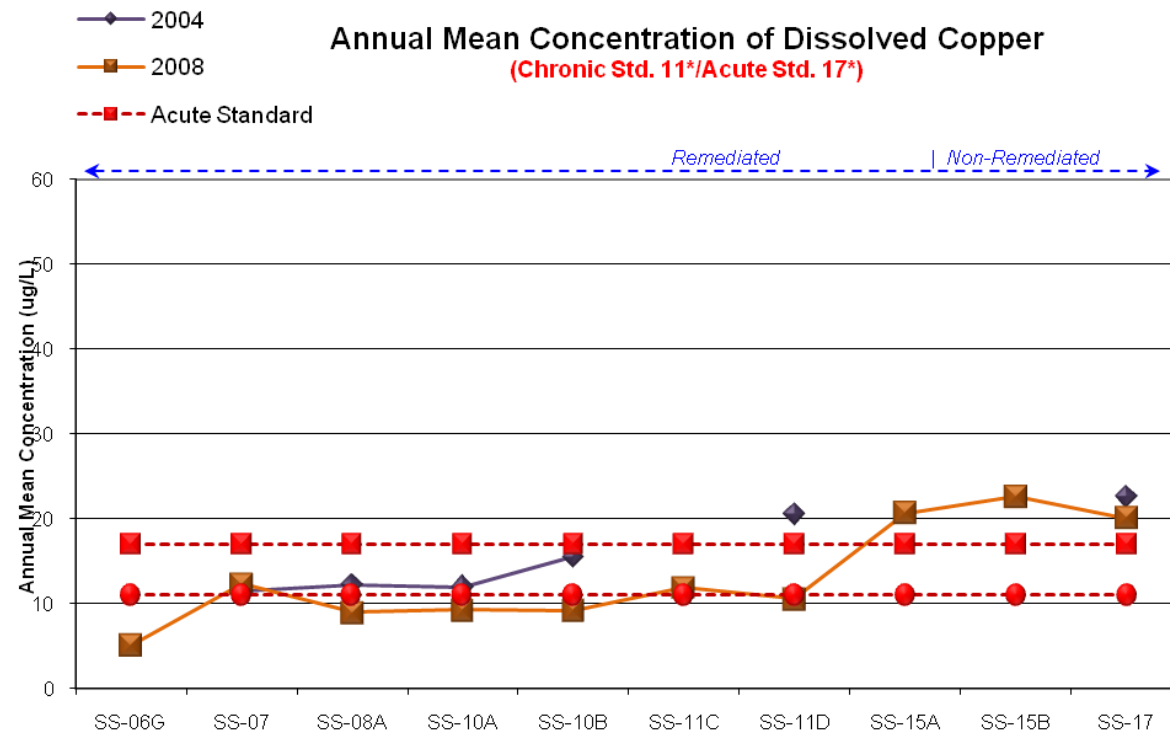
FIGURE 6-10

Annual Mean Concentration of Dissolved Copper

*Based on 125 mg/L hardness (typical Value for Silver Bow Creek in SSTOU)

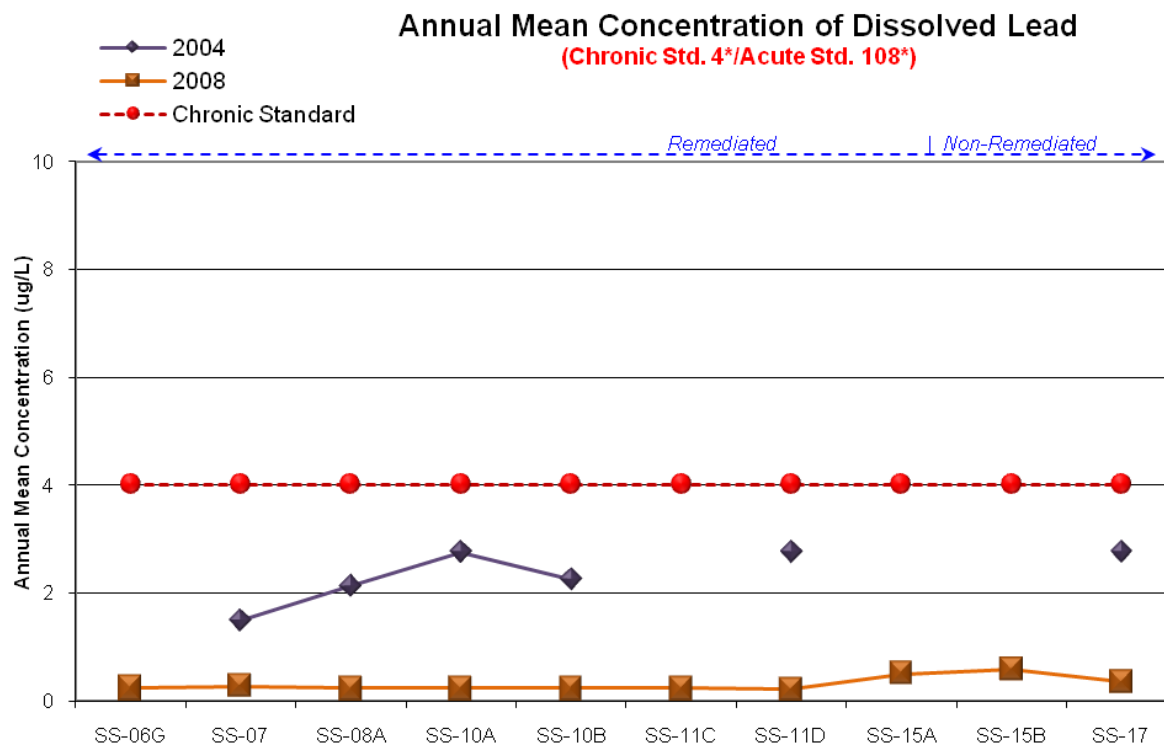
FIGURE 6-11

Annual Mean Concentration of Dissolved Lead

*Based on 125 mg/L hardness (typical Value for Silver Bow Creek in SSTOU)

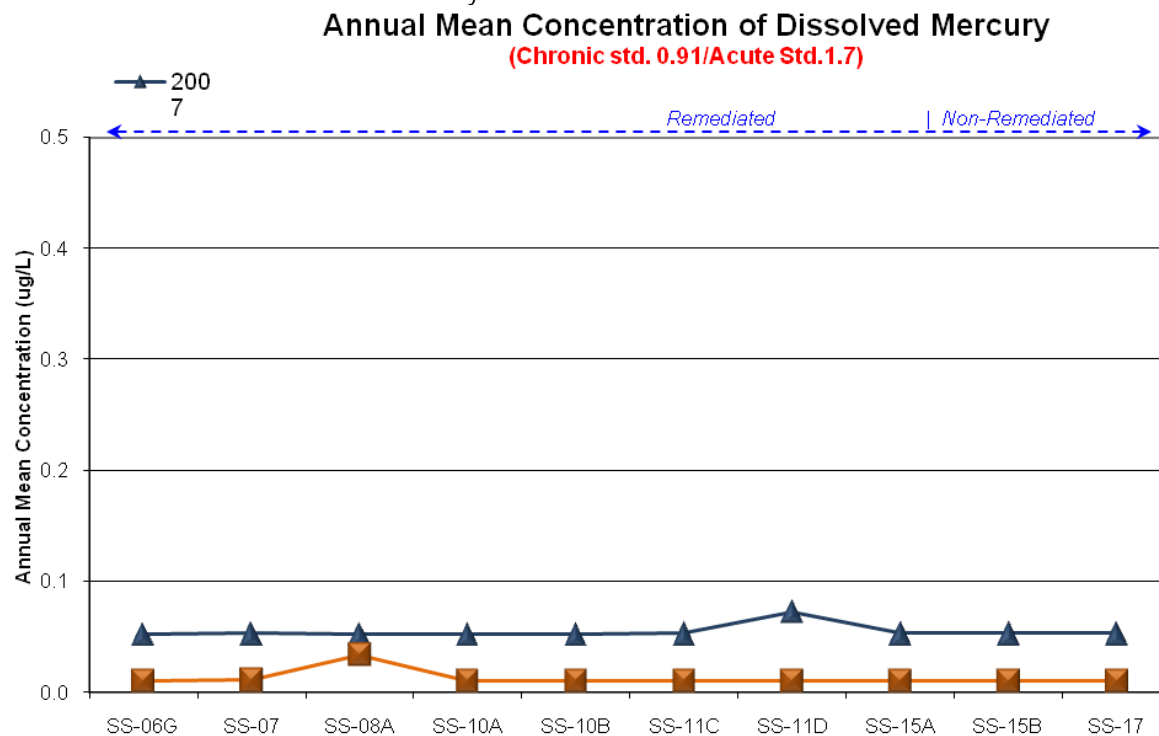
FIGURE 6-12

Annual Mean Concentration of Dissolved Mercury

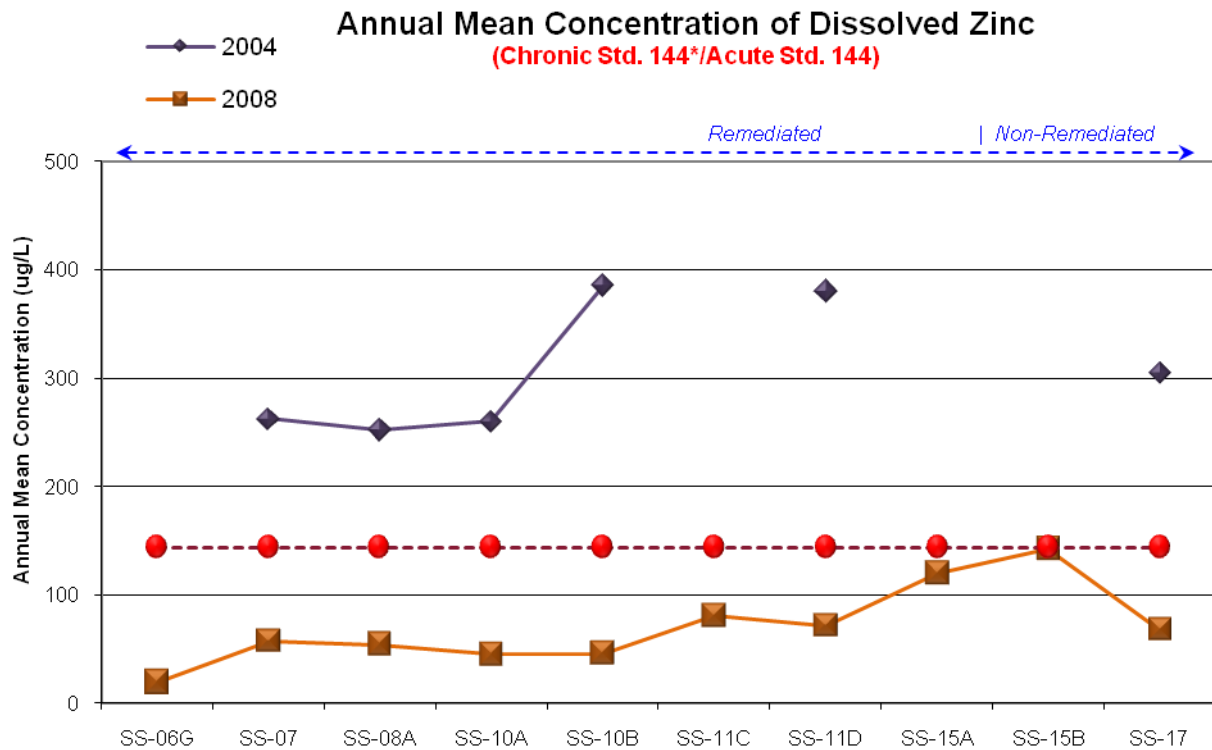
FIGURE 6-13
Annual Mean Concentration of Dissolved Zinc

*Based on 125 mg/L hardness (typical Value for Silver Bow Creek in SSTOU)

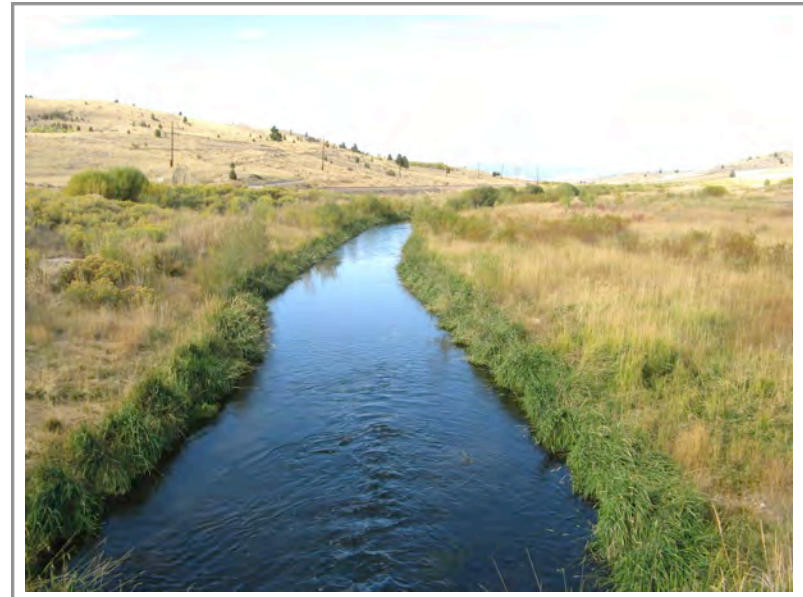
Photo 3: Upper section of Subarea 1—looking west toward Rocker from Santa Claus Road culvert showing sparsely vegetated streambanks

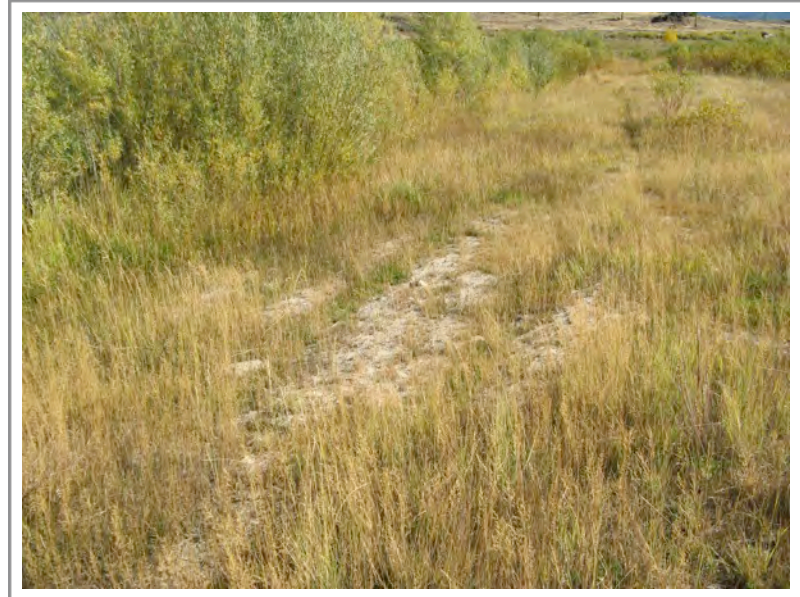
Photo 7: Upper section of Subarea 1—salts along with sparsely vegetated areas

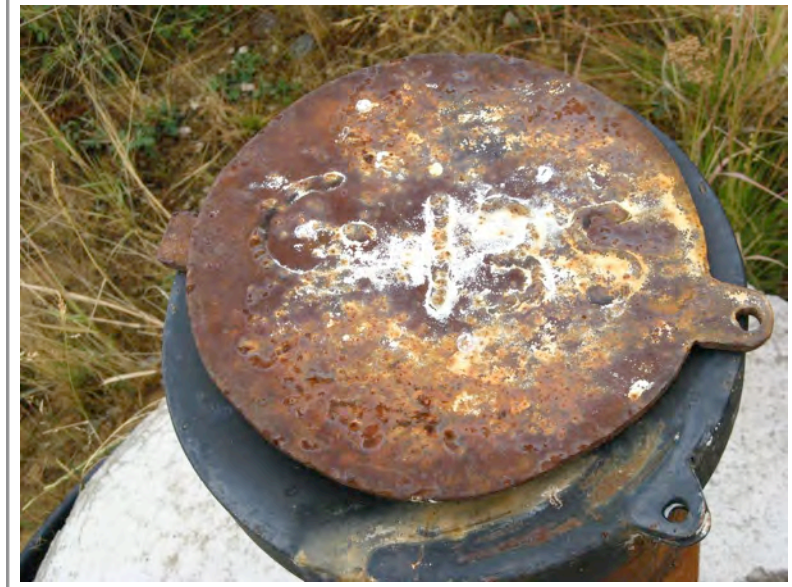
Photo 72: Ramsay Flats section of Subarea 2—unlocked well (G 135) with broken base at latitude 46.00032, longitude -112.68661 (WGS 84)

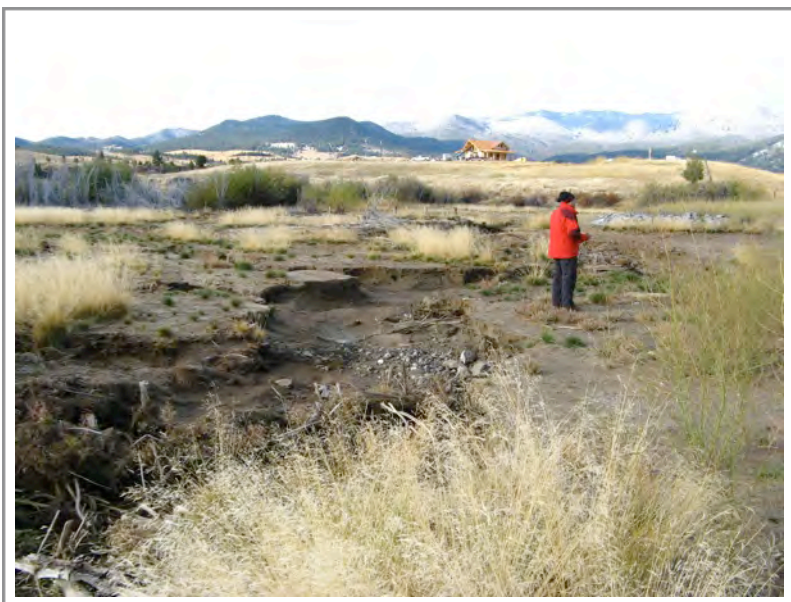
Photo 87: Lower section of Subarea 3—gully erosion of slickens/impacted site. Silver Bow Creek is to the right of the photo.

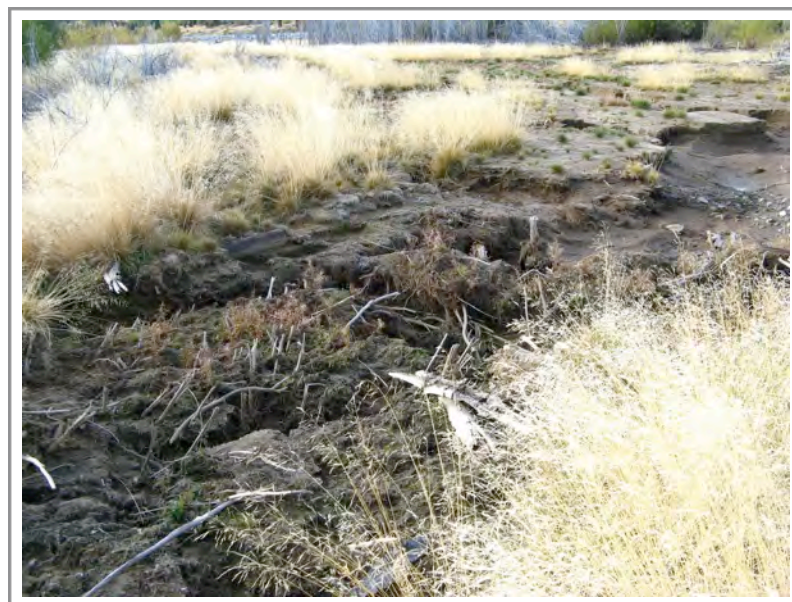
Photo 88: Lower section of Subarea 3—gully erosion of slickens/impacted site. Silver Bow Creek is to the right of the photo.

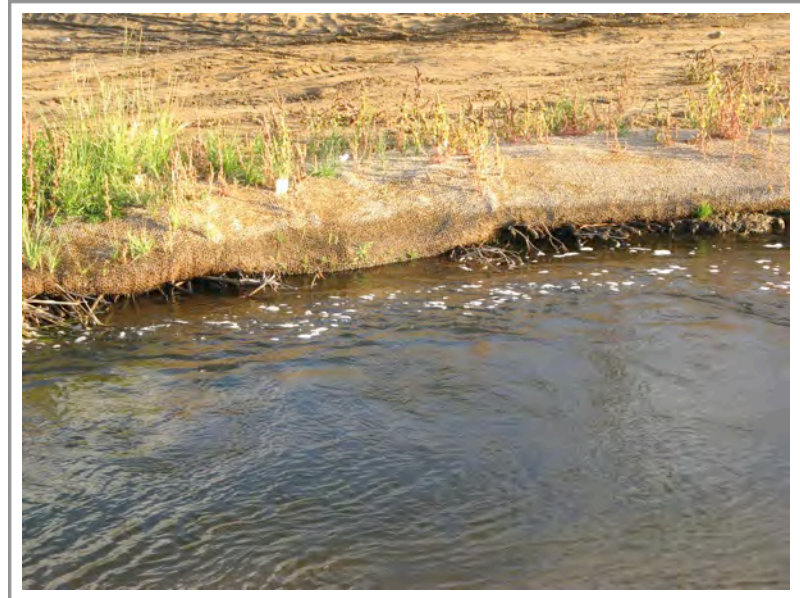
Photo 109: Upper section of Subarea 4—reconstructed Silver Bow Creek stream channel

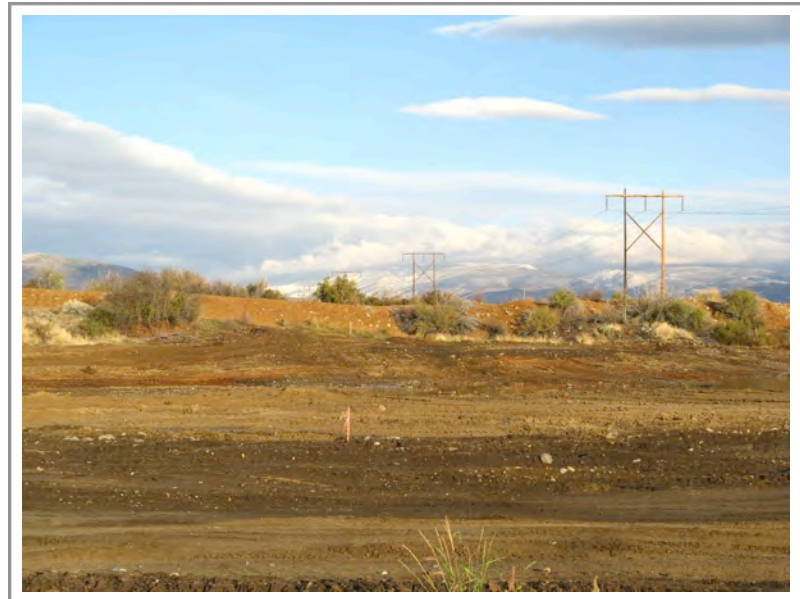
Photo 111: Upper section of Subarea 4—engineered riffle section in reconstructed Silver Bow Creek

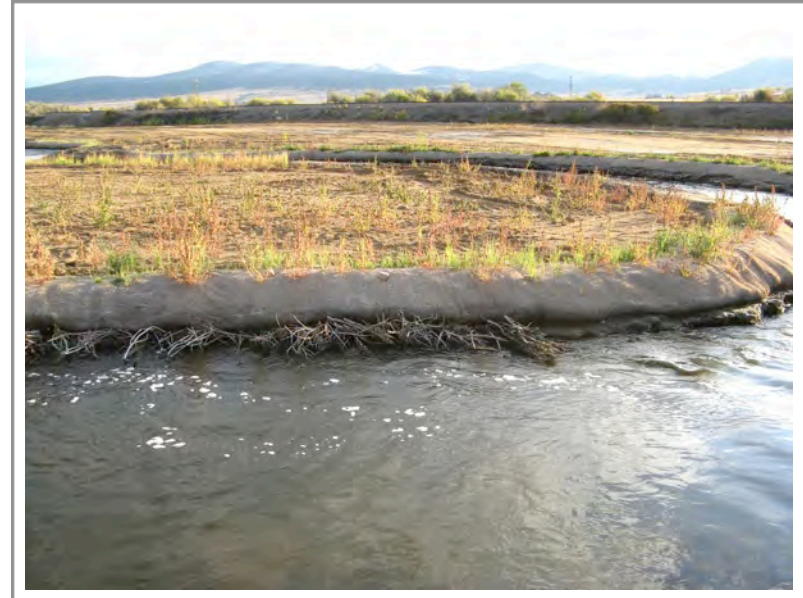
Photo 117: Upper section of Subarea 4—tight curve of newly engineered stream channel showing slight erosion

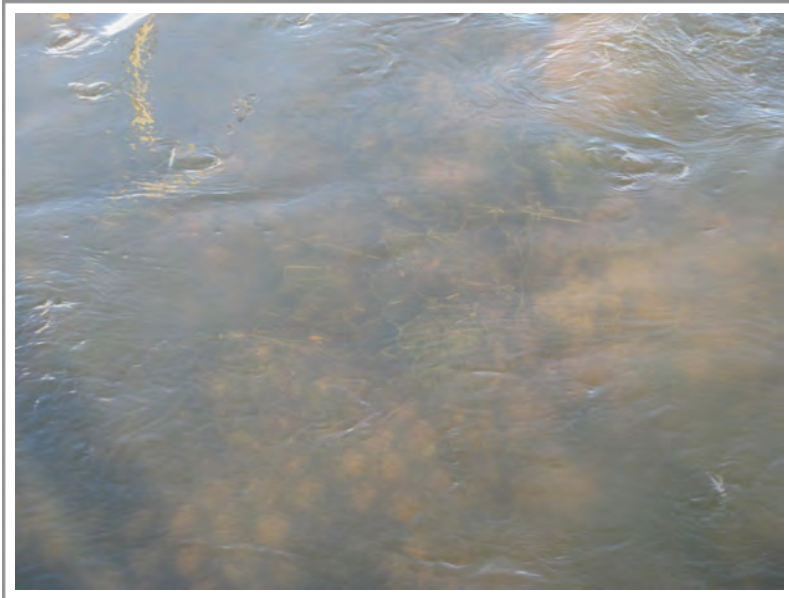
Photo 132: Upper section of Subarea 4—close-up of headcut downstream of pumping station (latitude 46.04443, longitude -112.79708 [WGS 84])

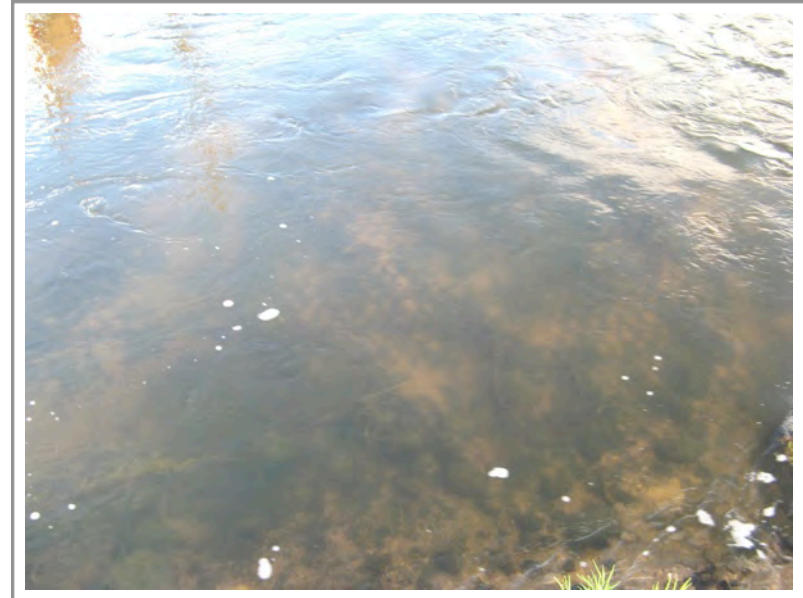
Photo 133: Upper section of Subarea 4—instream rock gabion (stainless steel cage) to control headcut just downstream of pumping station
