**Third Five-Year Review Report for Silver
Bow Creek/Butte Area Site**

**Volume 2: Stream Side Tailings Operable
Unit**

June 2011

U.S. Environmental Protection Agency
Helena, Montana

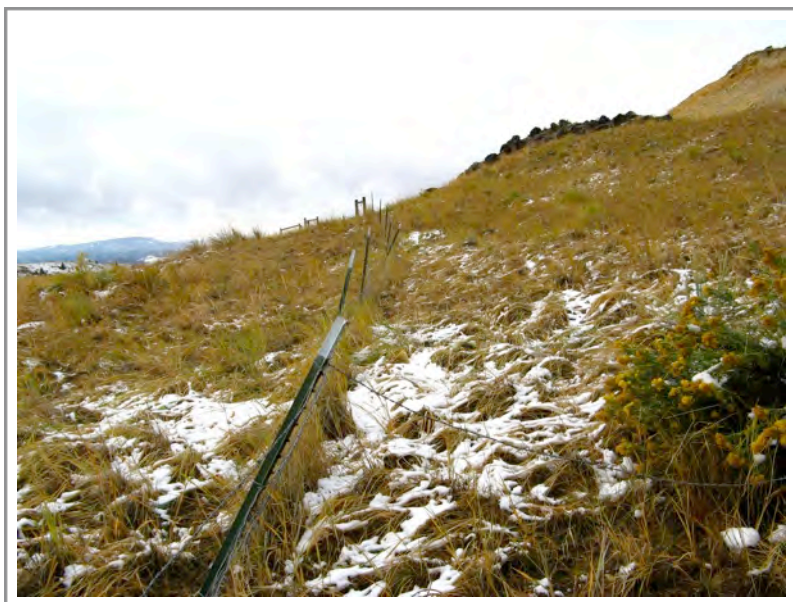
Photo 153: MWRR—fence along northeast portion of the repository. Sections of the fence are down in this area.
