**FOURTH FIVE-YEAR REVIEW REPORT FOR
MIDVALE SLAG SUPERFUND SITE
SALT LAKE COUNTY, UTAH**

**Utah Department of Environmental Quality
Division of Environmental Response and Remediation
For
U.S. Environmental Protection Agency
Region 8
DENVER, COLORADO**

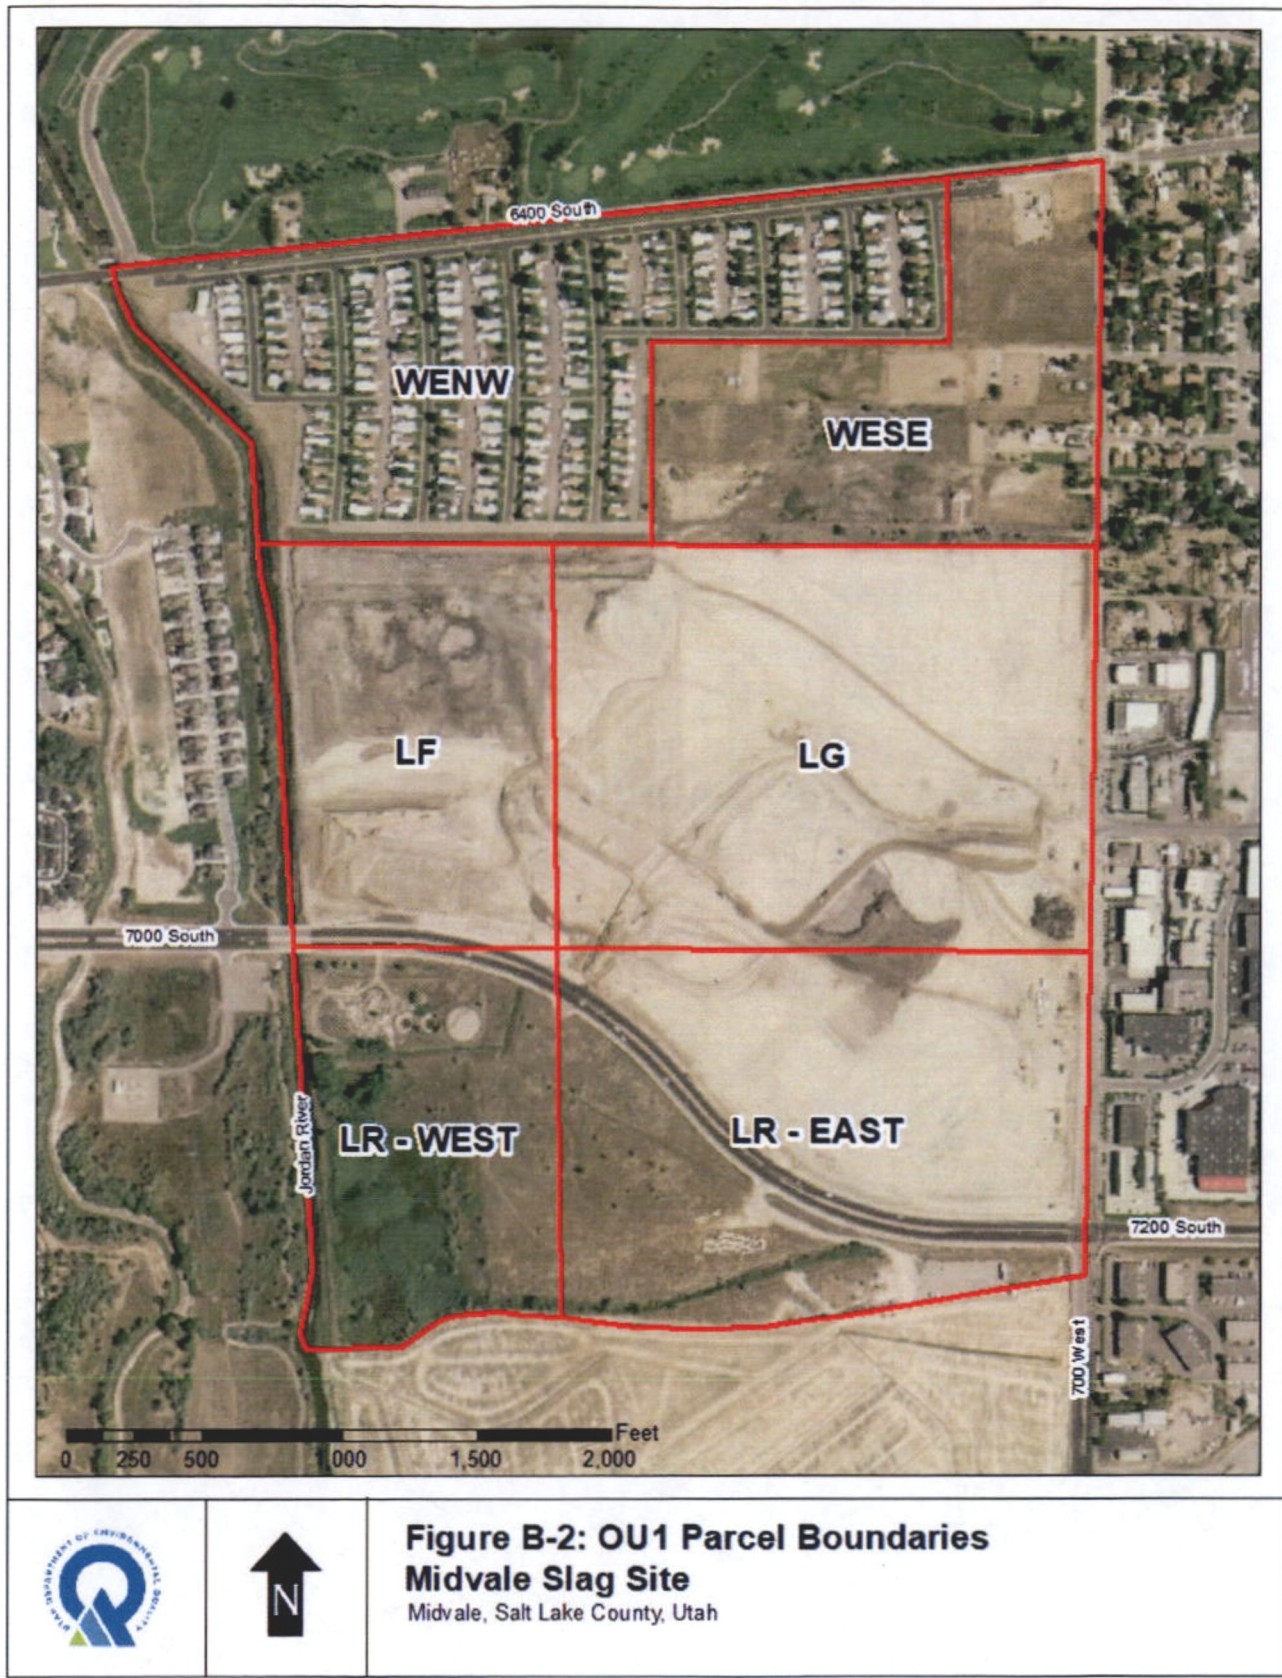
These parcels are depicted in Figure B-2.

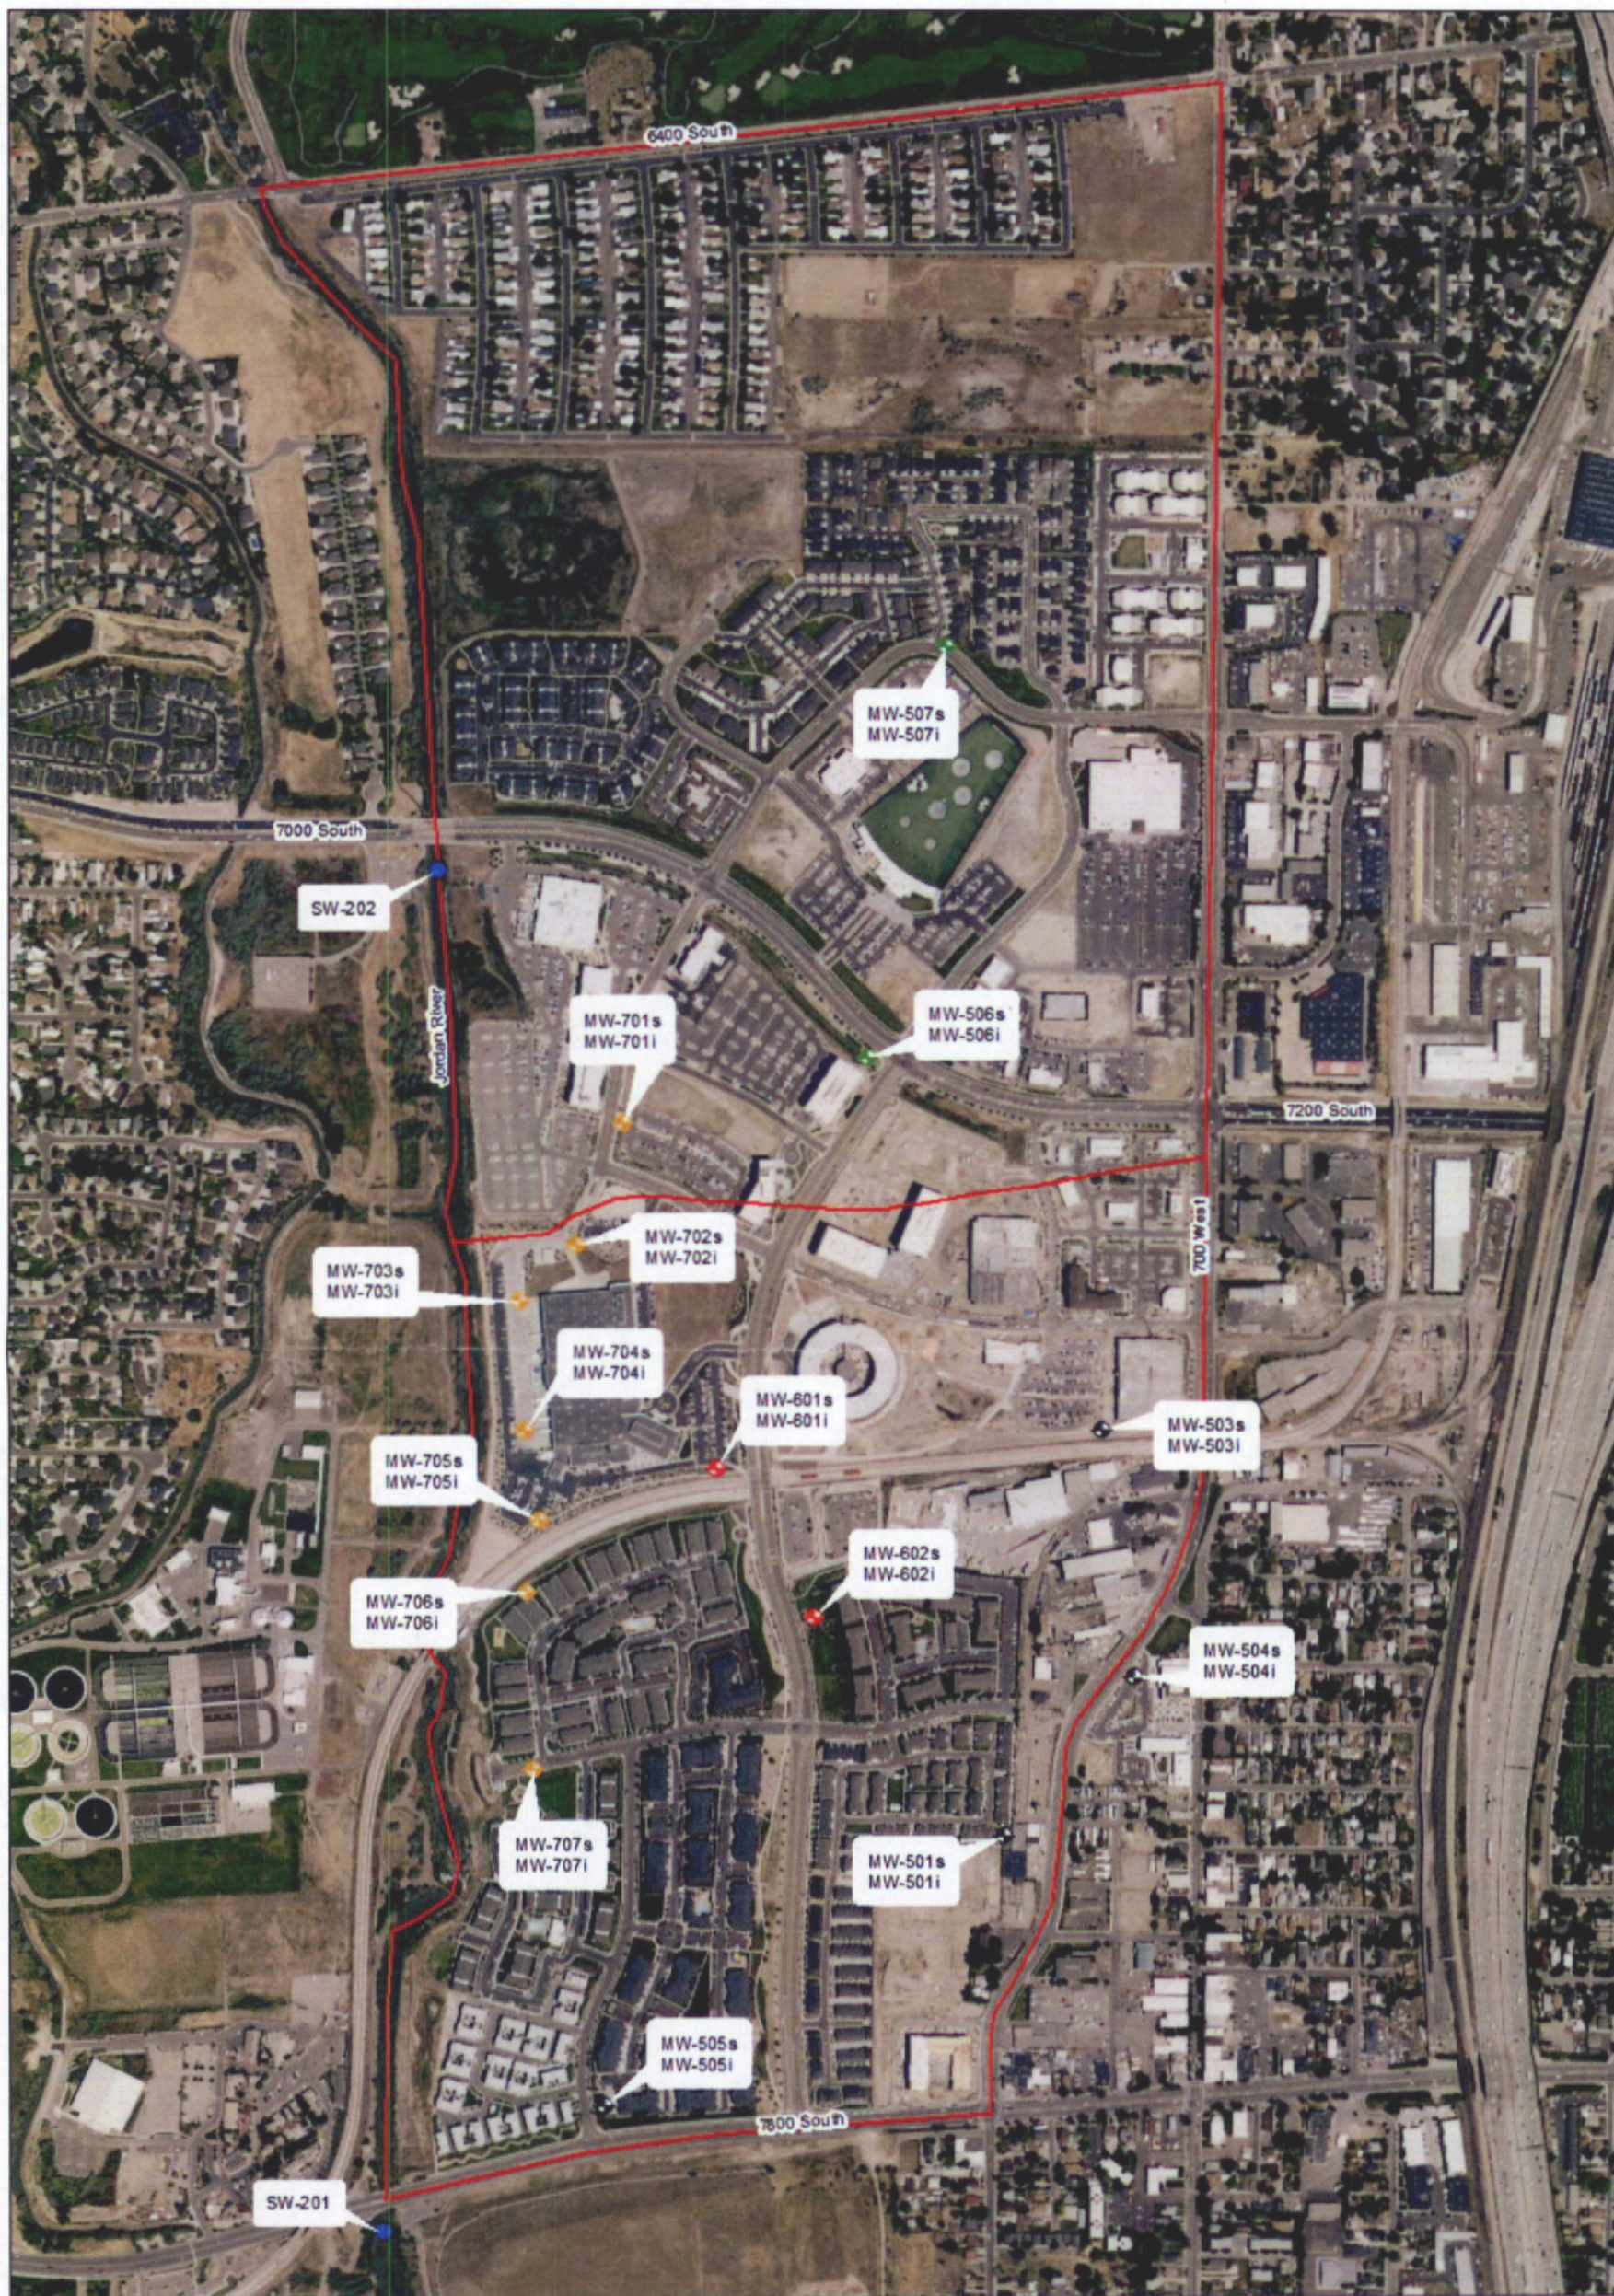
- Surface Water Sample Location
- ◆ Alternate Concentration Limit (ACL) Monitoring Well
- ◆ Plume Core Monitoring Well
- ◆ Downgradient Monitoring Well
- ◆ Upgradient Monitoring Well
