# Barton 3 (#220) Removal Site Evaluation Report

Final | October 9, 2018

Navajo Nation AUM Environmental Response Trust  
– First Phase

Stantec Consulting Services Inc.

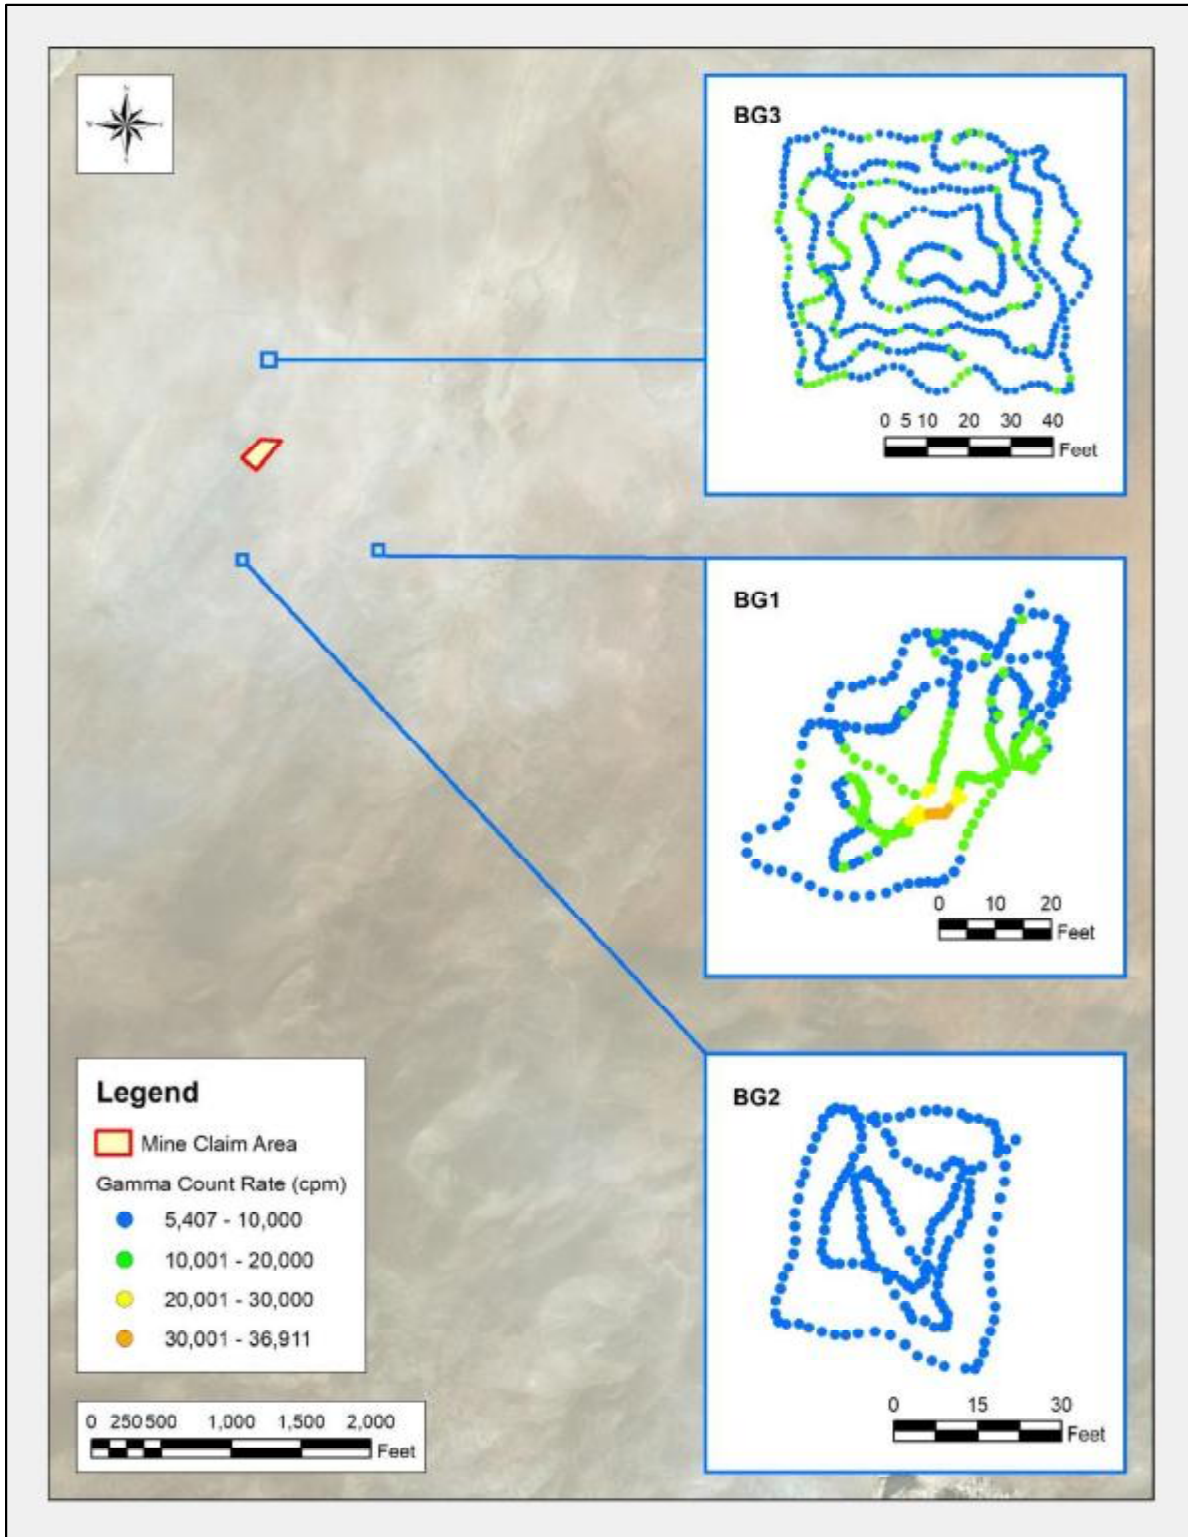
**Figure 2. Gamma count rates in the potential Background Reference Areas.**

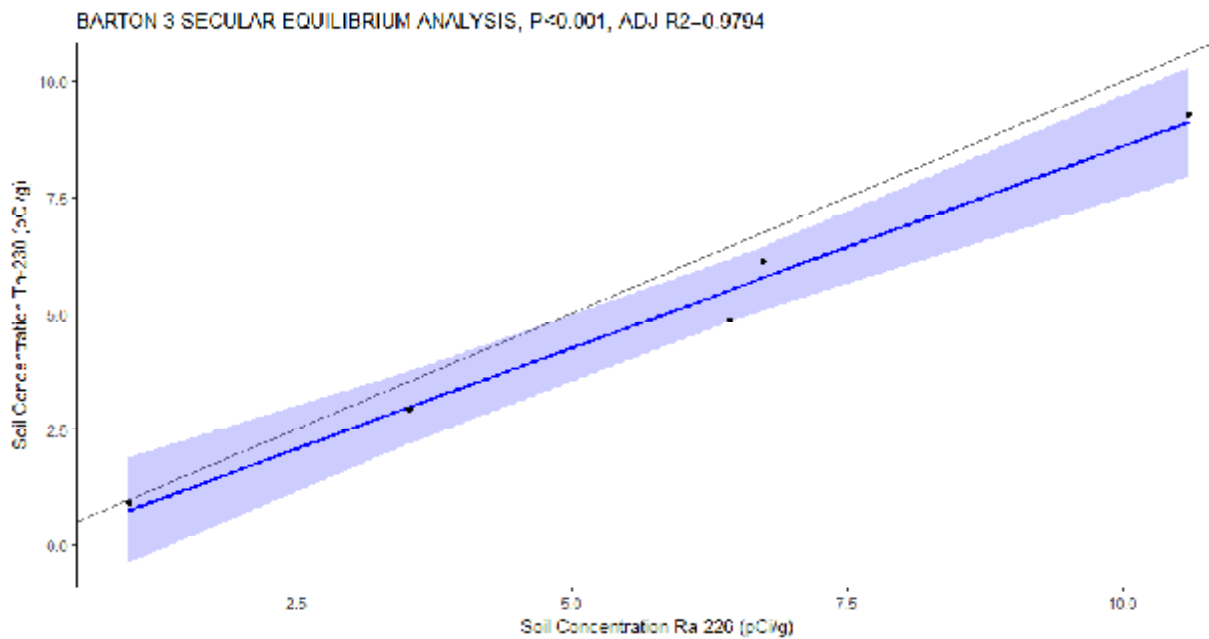
Based on this method, ERG concludes there is evidence that thorium-230 and radium-226 are in equilibrium, but not secular equilibrium (Figure 10).

**Figure 10. Evaluation of secular equilibrium in the uranium decay series.**

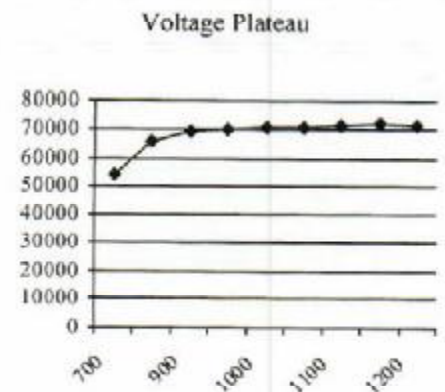
High Voltage	Source Counts	Background
700	53957	9925
800	65946	
900	69049	
950	69687	
1000	70240	
1050	70288	
1100	71224	
1150	71563	
1200	71161

Comments: HV Plateau Scaler Count Time = 1-min. Recommended HV = 1000

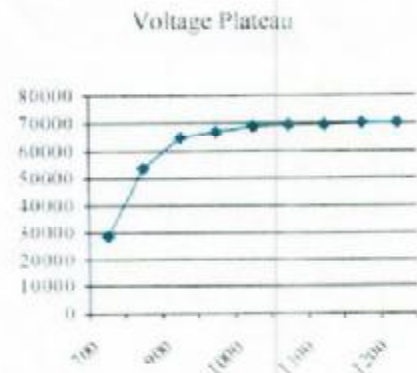
High Voltage	Source Counts	Background
700	28456	
800	53330	
900	64430	
950	66209	
1000	68333	
1050	69077	
1100	69121	8924
1150	69973	
1200	70155

Comments: HV Plateau Scaler Count Time = 1-min. Recommended HV = 1100

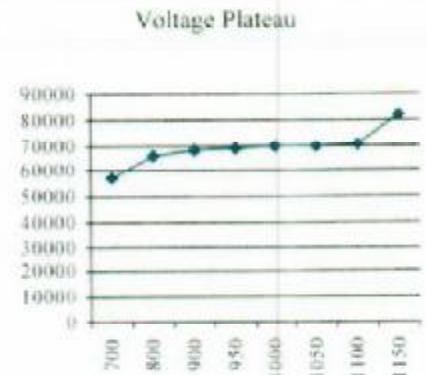
High Voltage	Source Counts	Background
700	57641	9773
800	65850	
900	68414	
950	68639	
1000	69410	
1050	69358	
1100	70301	
1150	81822

Comments: HV Plateau Scaler Count Time = 1-min. Recommended HV = 1000

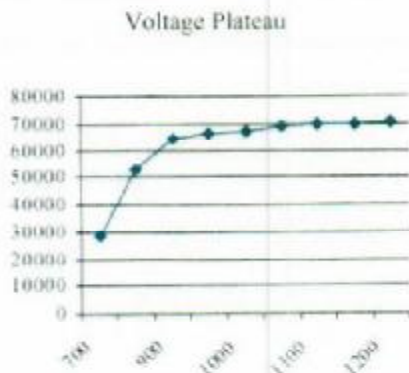
High Voltage	Source Counts	Background
700	28235	
800	52834	
900	64481	
950	66468	
1000	67321	
1050	69009	
1100	69981	9079
1150	69564	
1200	70538

Comments: HV Plateau Scaler Count Time = 1-min. Recommended HV = 1100

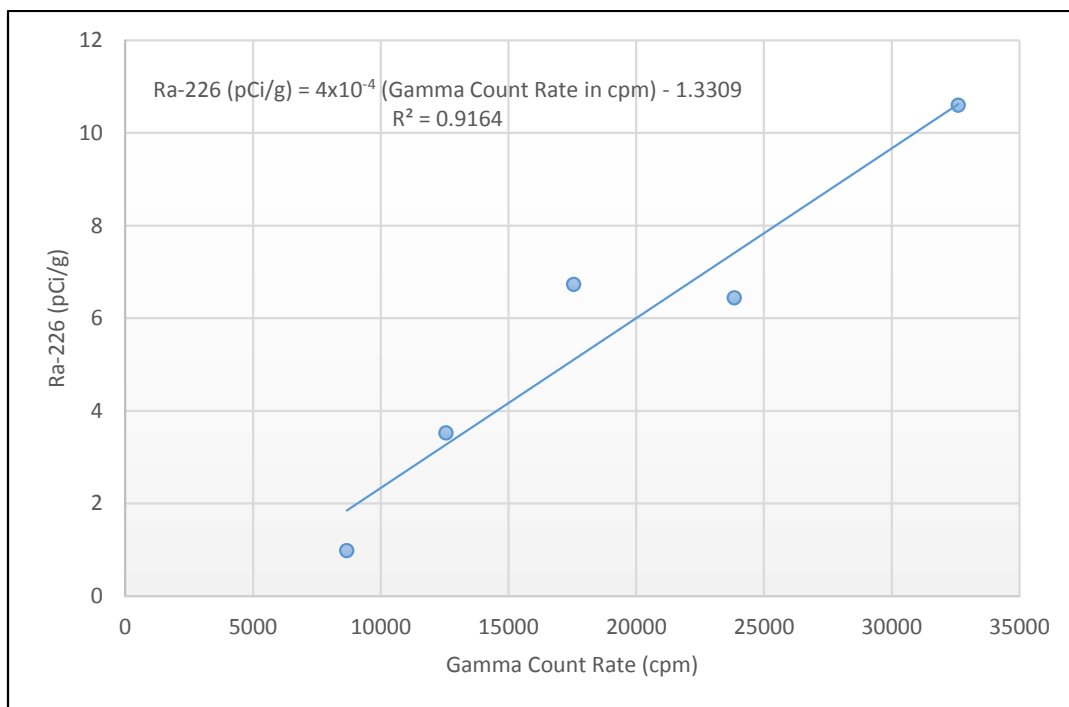
**Figure 8. Correlation of gamma count rates and concentrations of radium-226 in surface soils.**

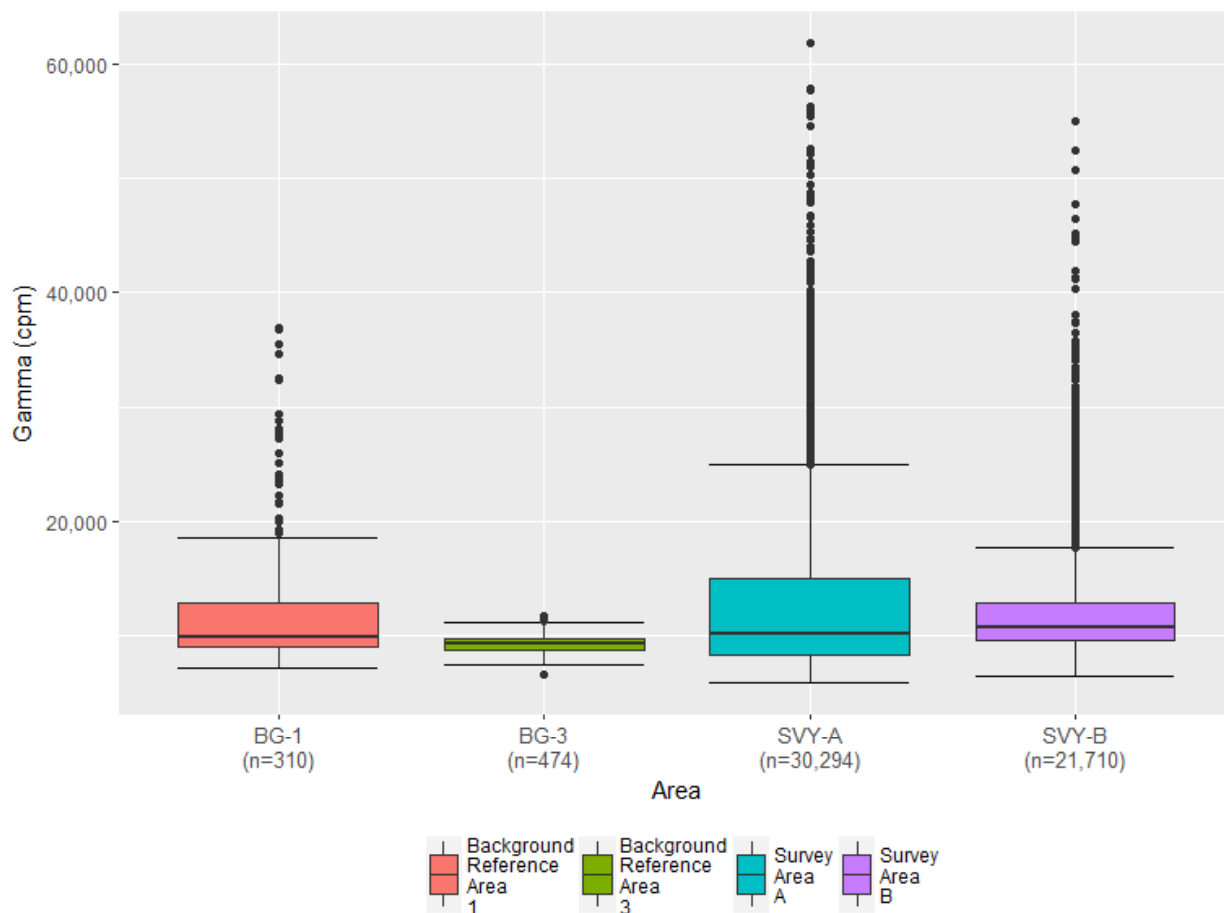
The gamma radiation survey results box plots shown on Figure 2A depict differences in the data distribution for gamma measurements between the background reference areas and Survey Areas. The large number of potential outlier values in the box plots for the Survey Areas indicates high skewness, or possibly non-normally distributed data, instead of outlier values. This is evaluated with the use of probability plots in Section 3.1.2 and further statistical outlier testing in Section 3.1.4. Based on Site geology, the potential gamma radiation outlier values observed for the Survey Area data on Figure 2A represent localized areas of higher gamma radiation with respect to other parts of the Survey Areas, as would be expected in areas with varying levels of mineralization, naturally occurring radioactive material (NORM), and potential TENORM.

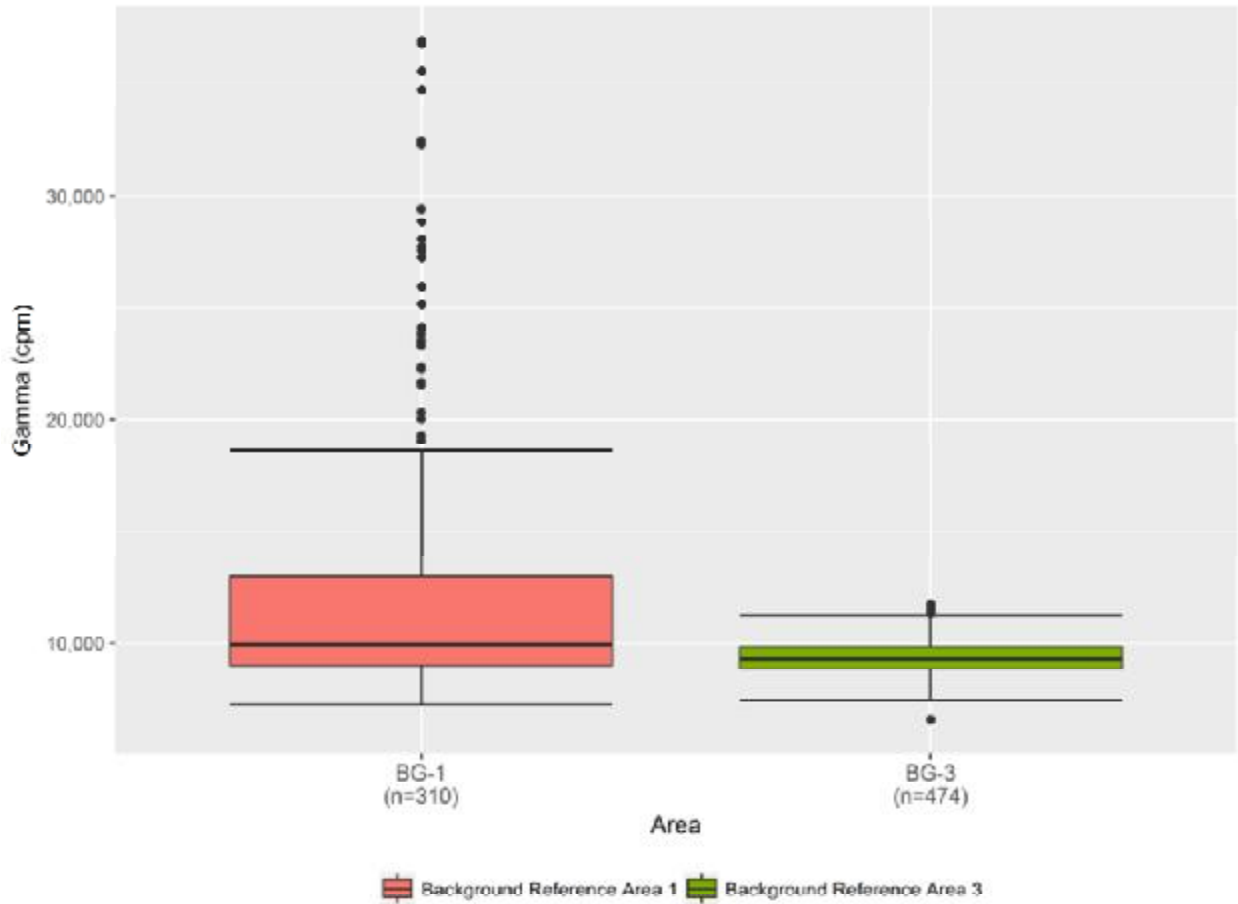
As shown in Figure 2B there are potential outlier values shown for the gamma data in the BG-1 dataset. These values are quite high, up to 37,000 counts per minute (cpm), and may represent heterogeneity within BG-1.
