Claim 28 (#78, 79) Removal Site Evaluation Report

Final | September 18, 2018

Navajo Nation AUM Environmental Response Trust
– First Phase

Stantec Consulting Services Inc.

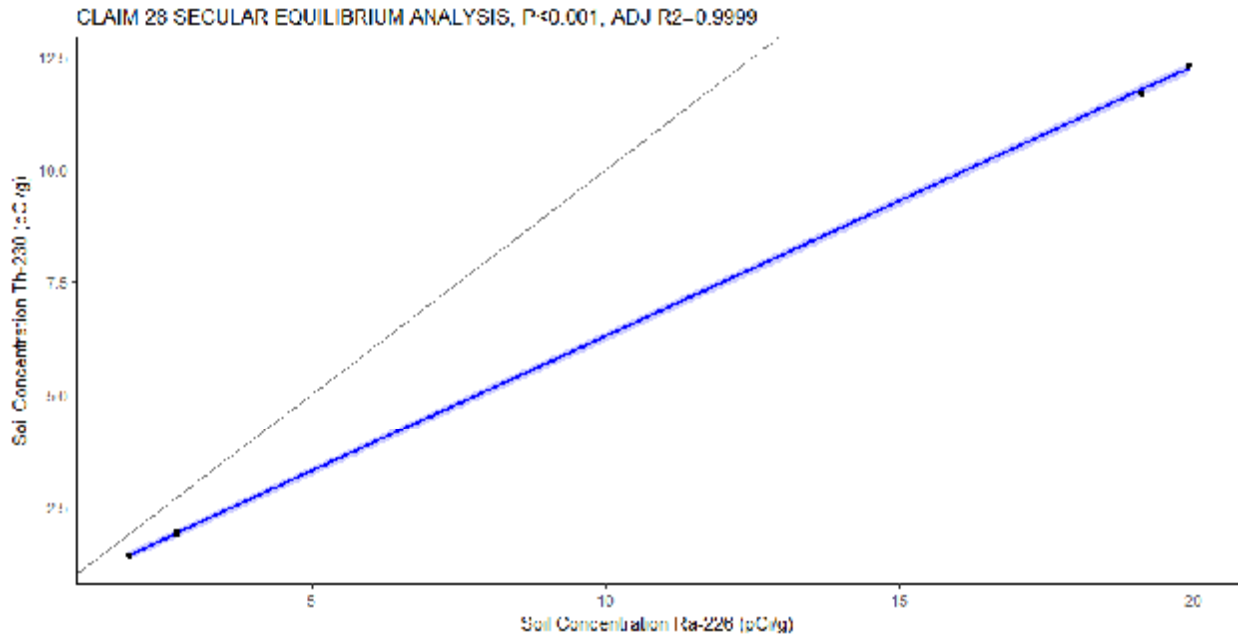
Figure 9. Evaluation of secular equilibrium in the uranium decay series.

Based on this method, ERG concludes there is evidence that thorium-230 and radium-226 are in equilibrium, but not secular equilibrium (Figure 9).
