# Mitten No. 3 (#260) Removal Site Evaluation Report

Final | October 7, 2018

Navajo Nation AUM Environmental Response Trust  
– First Phase

Stantec Consulting Services Inc.

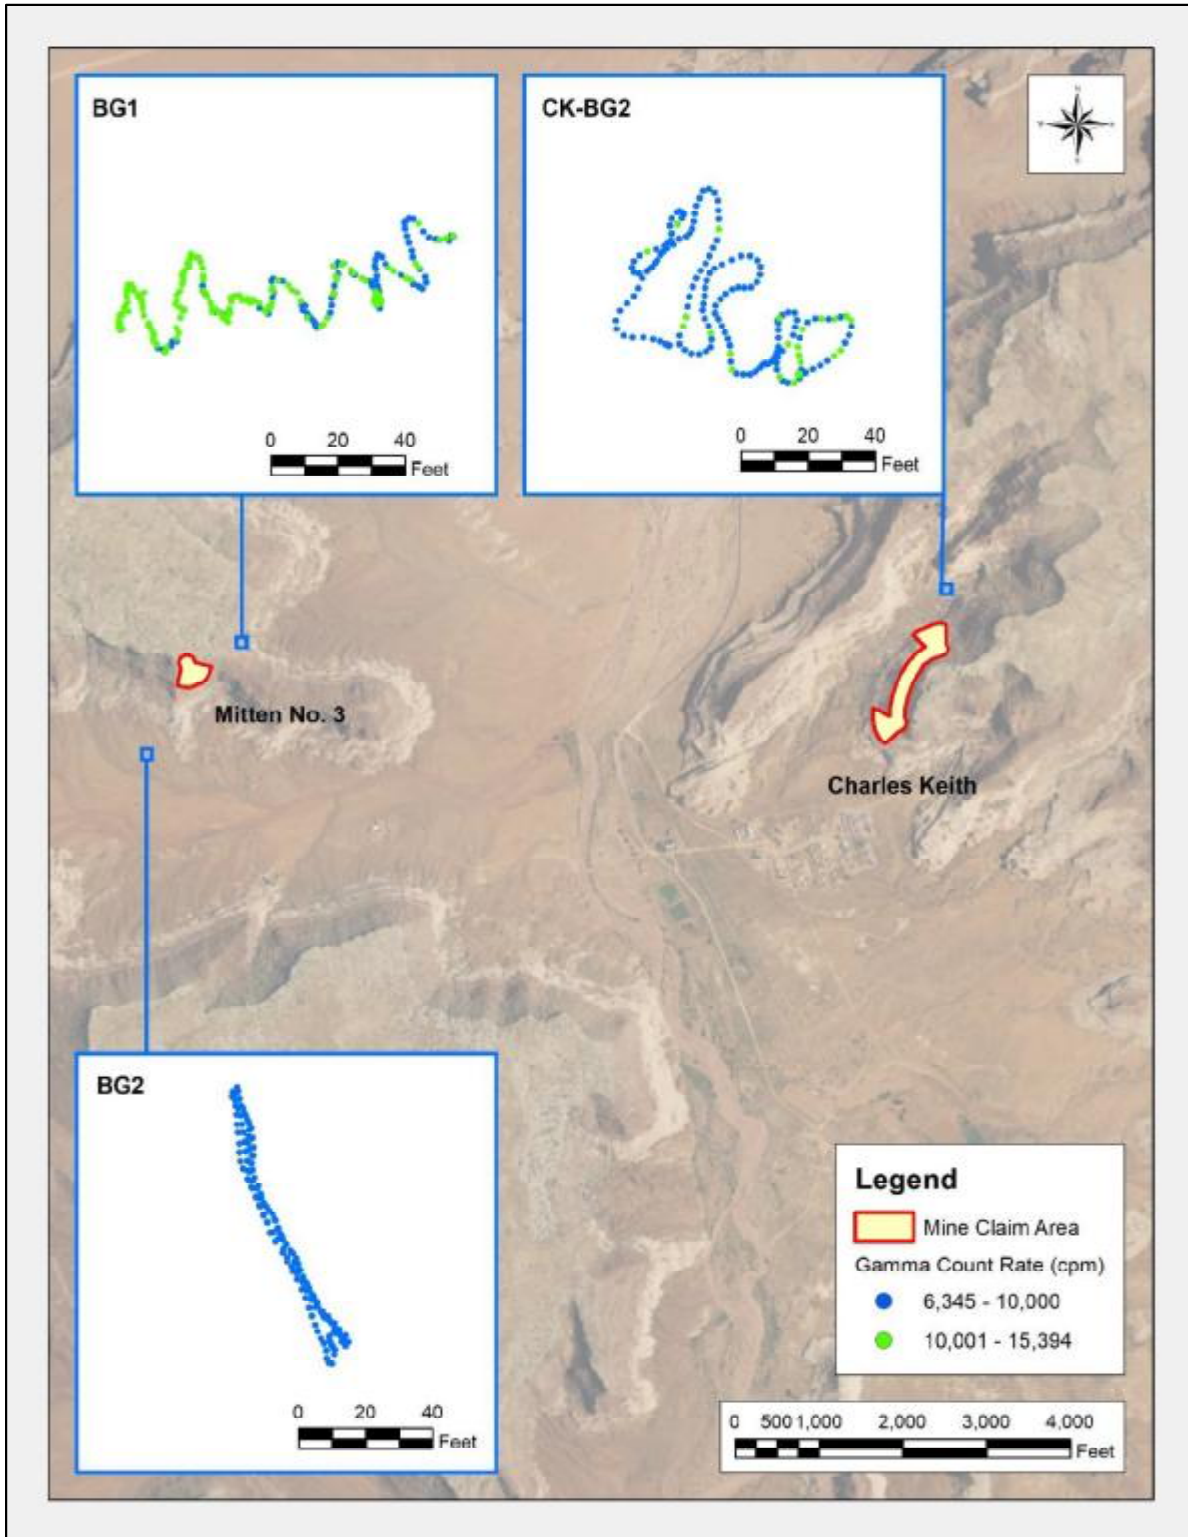
Figure 2. Gamma count rates in the potential Background Reference Areas.

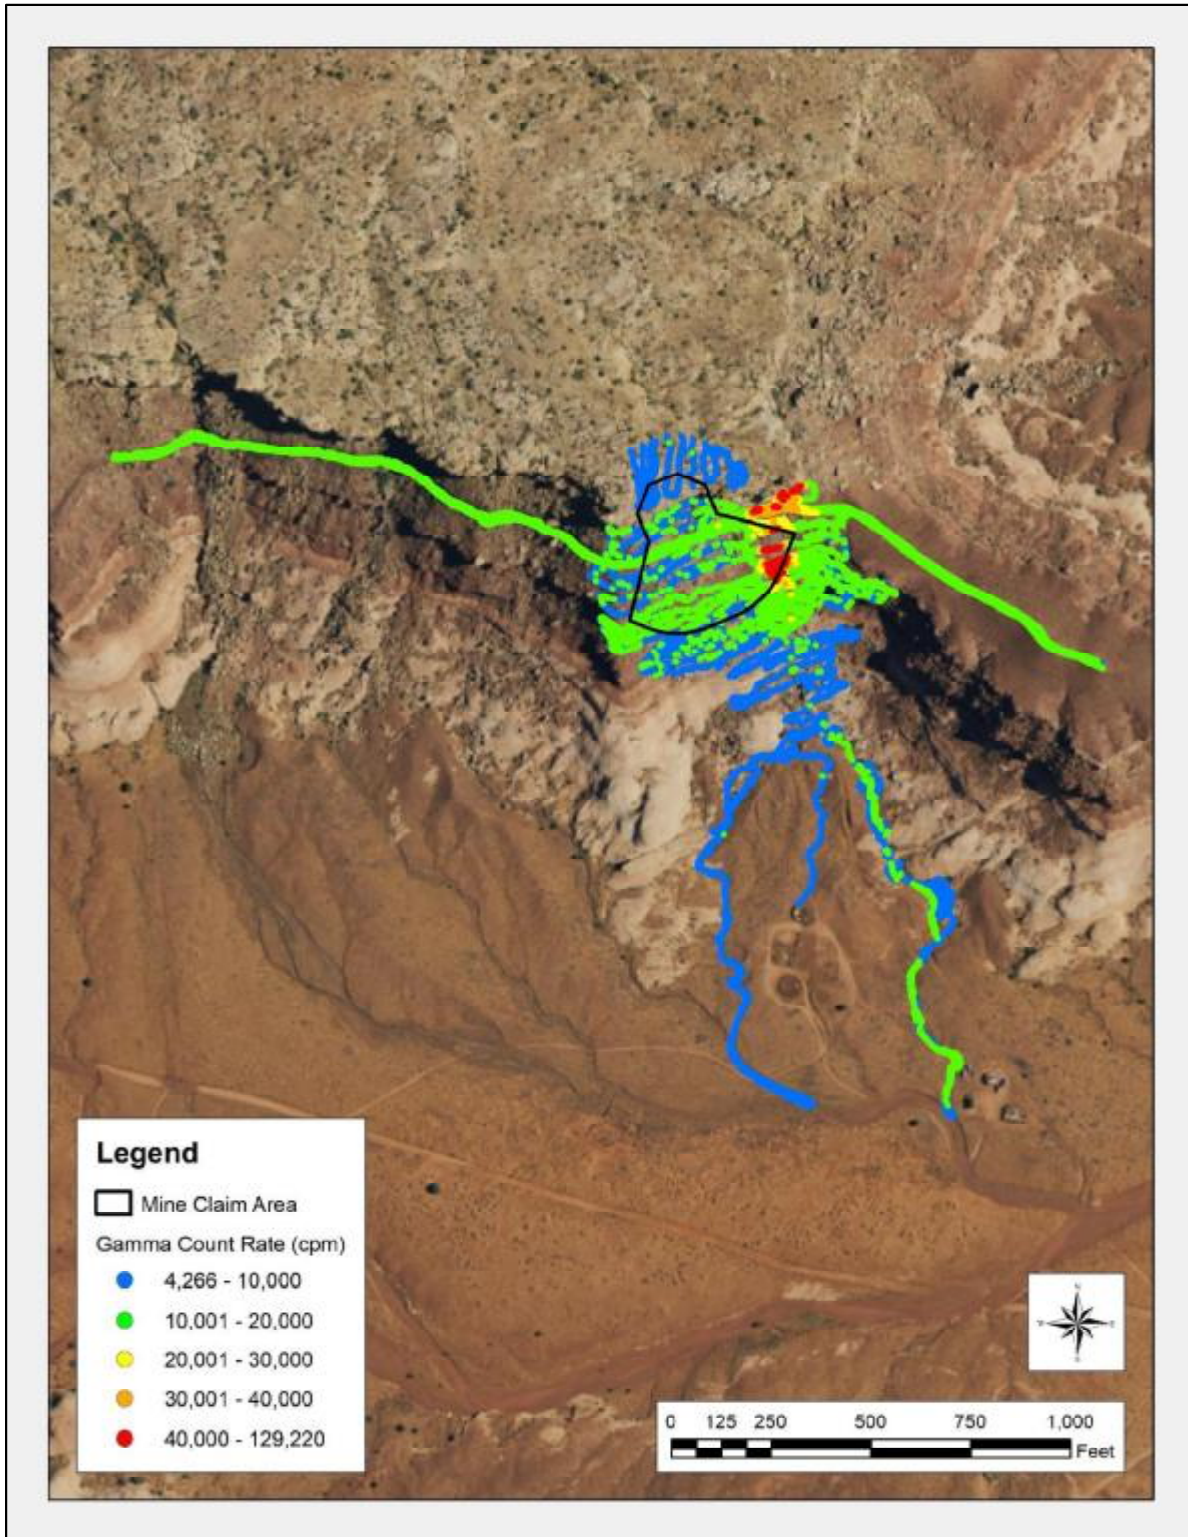
Figure 4. Gamma count rates in the Survey Area.

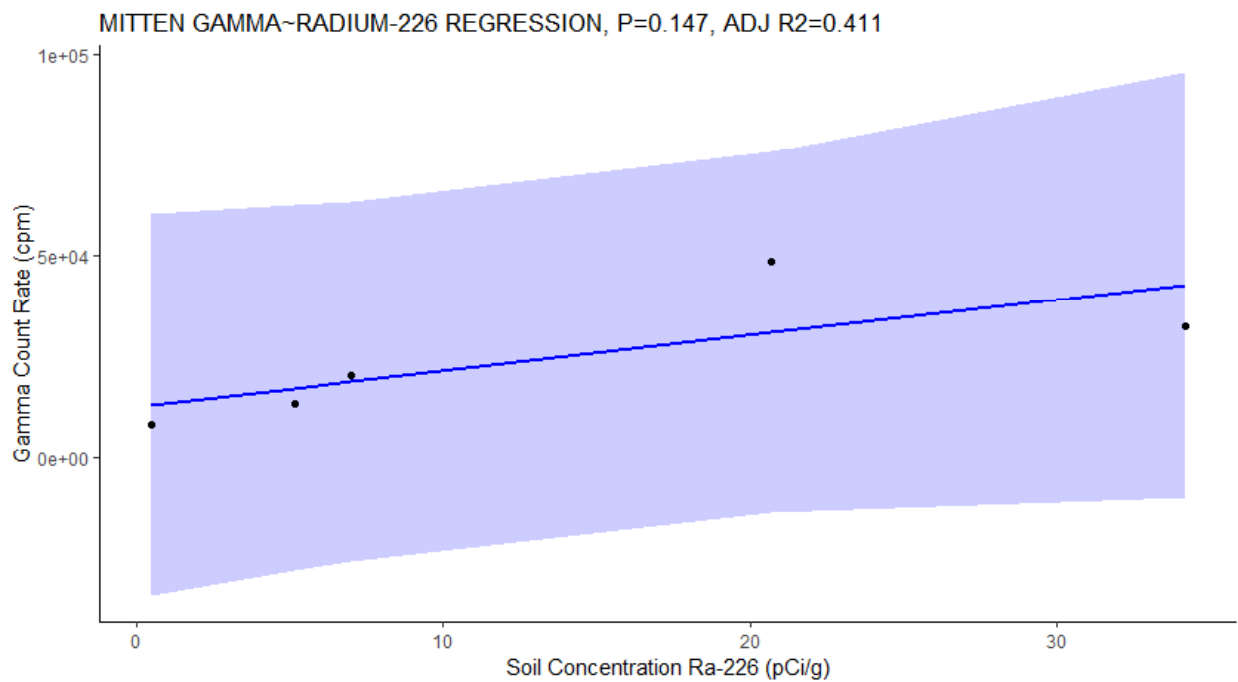
**Figure 8. Correlation of gamma count rates and concentrations of radium-226 in surface soils (blue line) and 95% prediction intervals plotted (shaded blue band).**

Figure 9 shows the predicted concentrations of radium-226, the spatial and numerical distribution of which mirror those depicted in Figure 4.

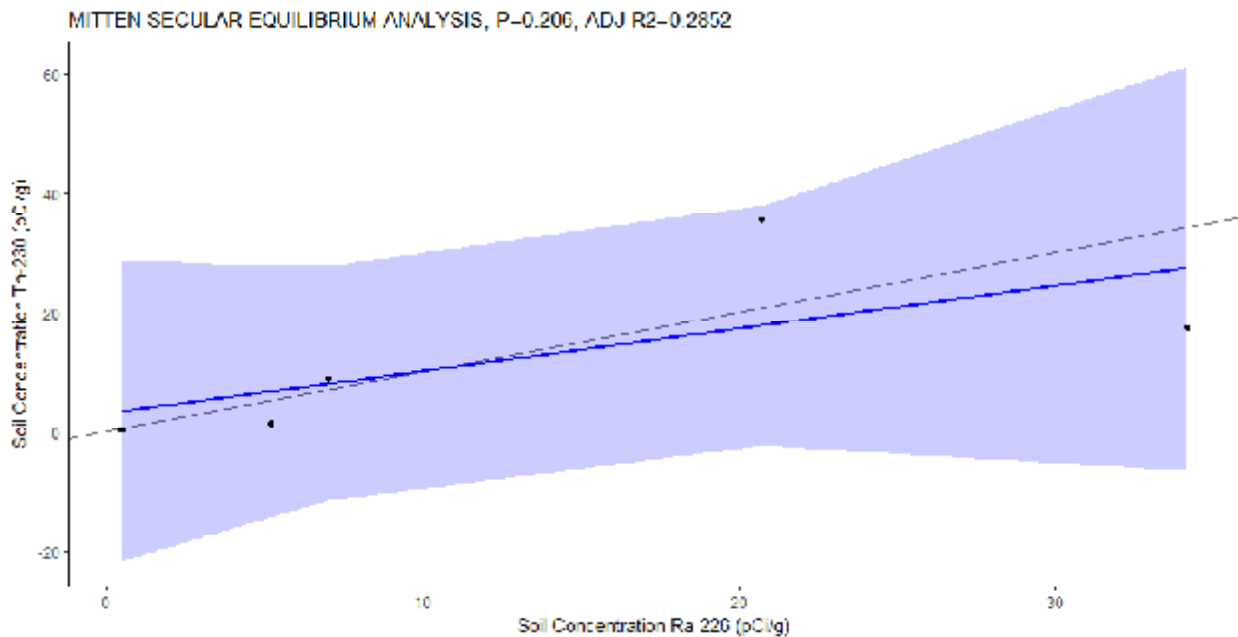
Based on this method, ERG concludes that there is no evidence of equilibrium (secular or otherwise) among the uranium decay series radionuclides (Figure 10).

**Figure 10. Evaluation of secular equilibrium in the uranium decay series.**

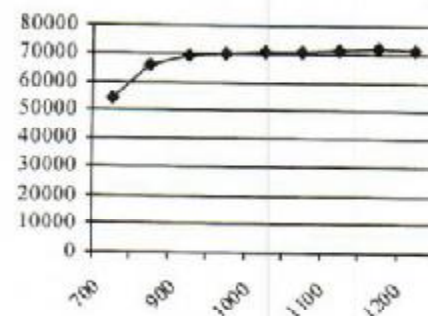
Comments: HV Plateau Scaler Count Time = 1-min. Recommended HV = 1000

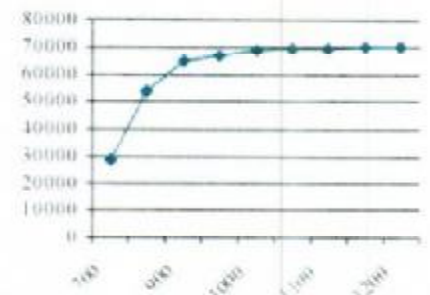
Comments: HV Plateau Scaler Count Time = 1-min. Recommended HV = 1100

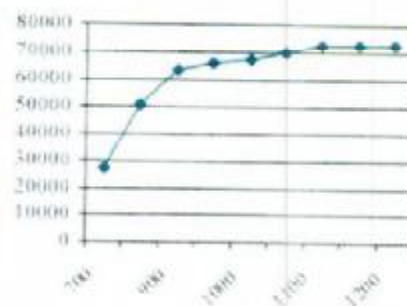
Comments: HV Plateau Sealer Count Time = 1-min. Recommended HV = 1150

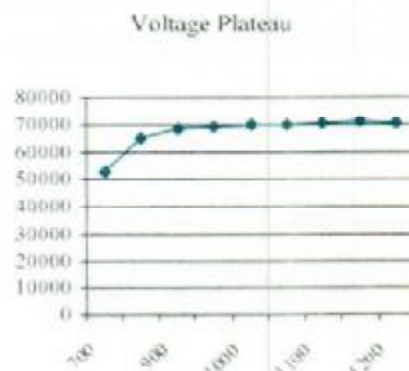
High Voltage	Source Counts	Background
700	52821	9111
800	65213	
900	68644	
950	69245	
1000	69492	
1050	69792	
1100	70472	
1150	71183	
1200	70571

Comments: HV Plateau Scaler Count Time = 1-min. Recommended HV = 1000

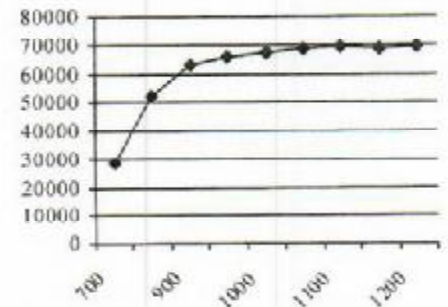
Comments: HV Plateau Scaler Count Time = 1-min. Recommended HV = 1100

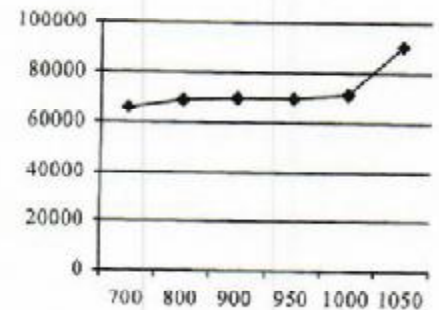
Comments: HV Plateau Scaler Count Time = 1-min. Recommended HV = 900

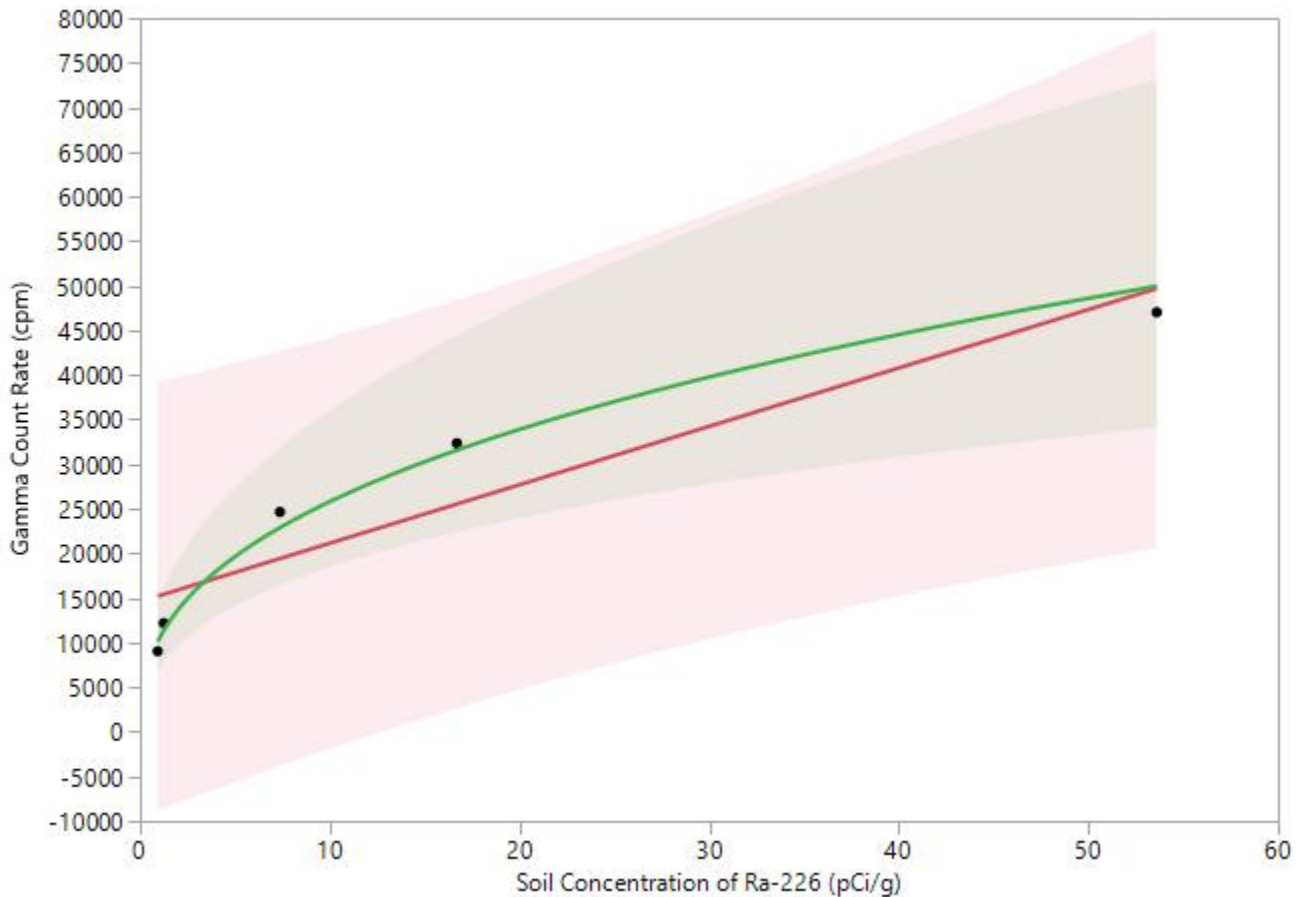
Note that while the statistical measures (i.e., conformance with the study DQO of  $R^2 > 0.8$ ) associated with these regressions can be improved by fitting a power curve to the data, and reporting unadjusted  $R^2$  values, with only five data points at each AUM, ERG does not believe that any statistical correlation model is sufficiently robust to make meaningful inferences concerning soil radium-226 concentration from the gamma scanning data. ERG believes that linear functions – not power curves – best mimic the conceptual model for the physical processes governing the observed data. Fitting any other function in an effort to achieve the study DQO for  $R^2$  is not a statistically rigorous approach, and improving  $R^2$  does not commensurately improve a statistical model's predictive ability. Figure 1 compares the result of fitting a linear versus a power function to the available correlation data for one AUM (Hoskie Tso); the other AUM results are similar.

Figure 1. Regression models (linear versus power curve) for gamma count rate regressed on radium-226 showing 95% UPLs (upper prediction limits). Both models meet the study DQO for adjusted  $R^2$  (greater than 0.8). Gamma count rate is not an especially strong predictor of soil concentration of radium-226 for either function.

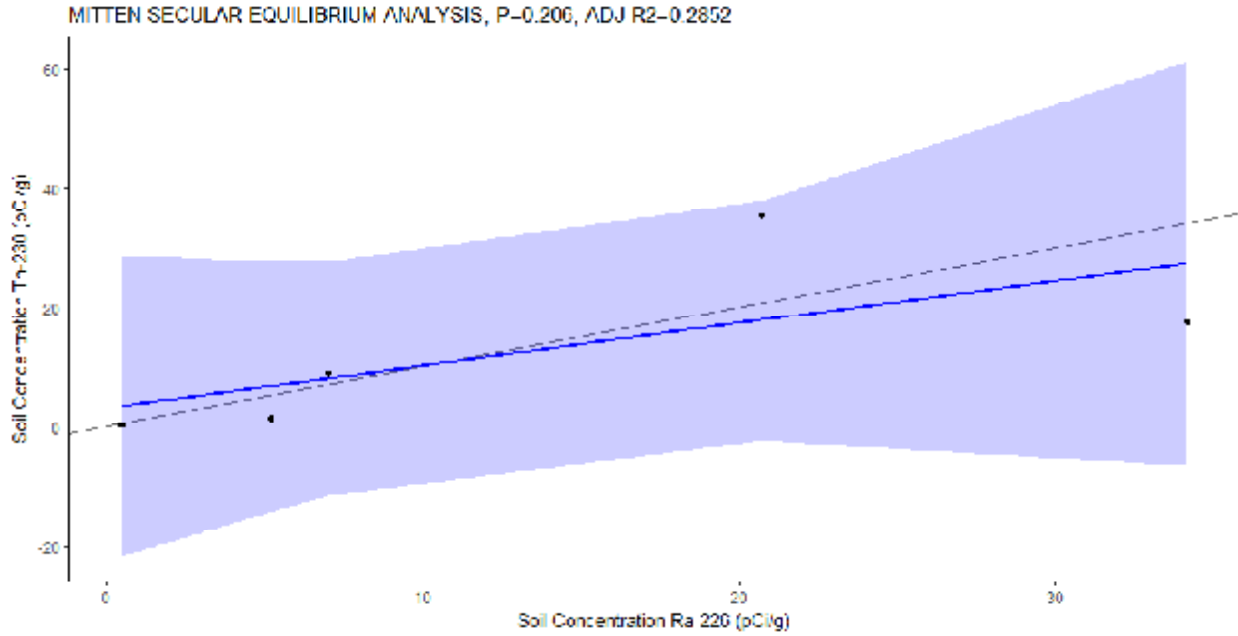
Figure 2. Result for Mitten secular equilibrium analysis, showing failure to meet p-value and adjusted R<sup>2</sup> criteria, i.e., the data are poorly correlated.

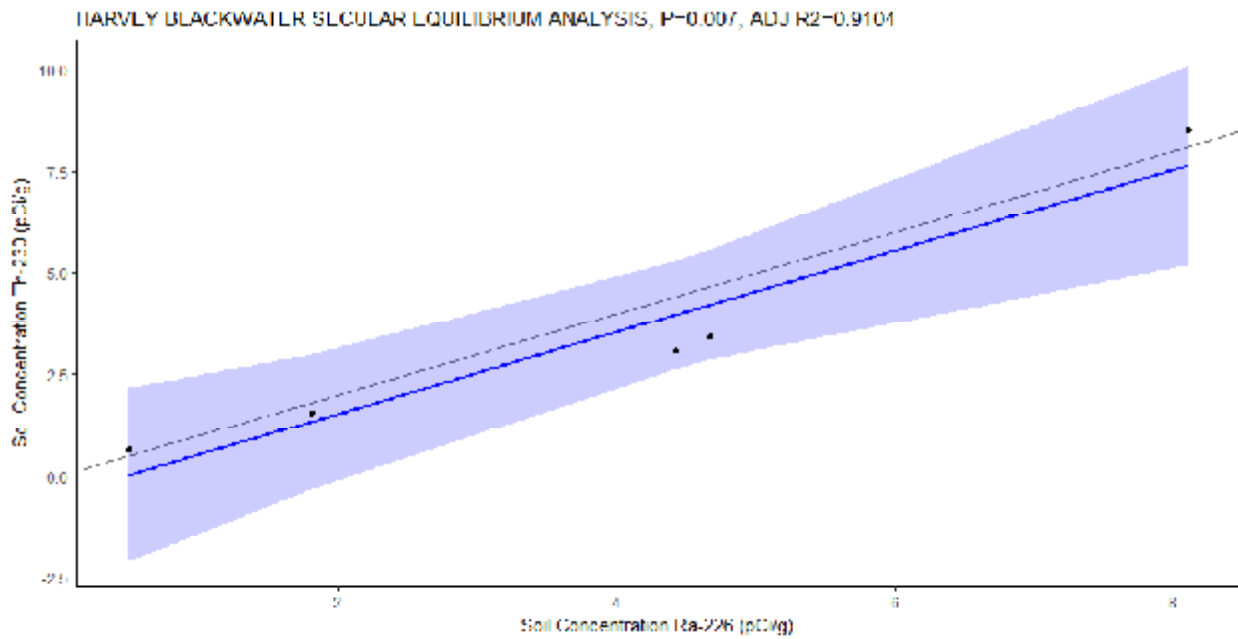
Figure 3. Result for Harvey Blackwater secular equilibrium analysis, showing excellent correlation between the data and the y=x line, i.e., Th-230 and Ra-226 are in secular equilibrium.

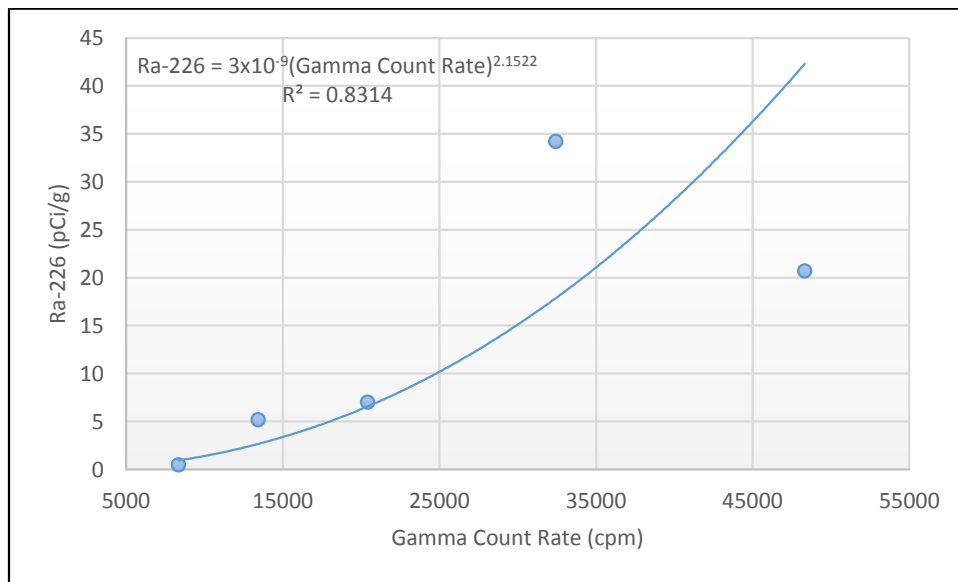
**Figure 8. Correlation of gamma count rates and concentrations of radium-226 in surface soils.**

Figure 9 shows the predicted concentrations of radium-226, the spatial and numerical distribution of which mirror those depicted in Figure 4.

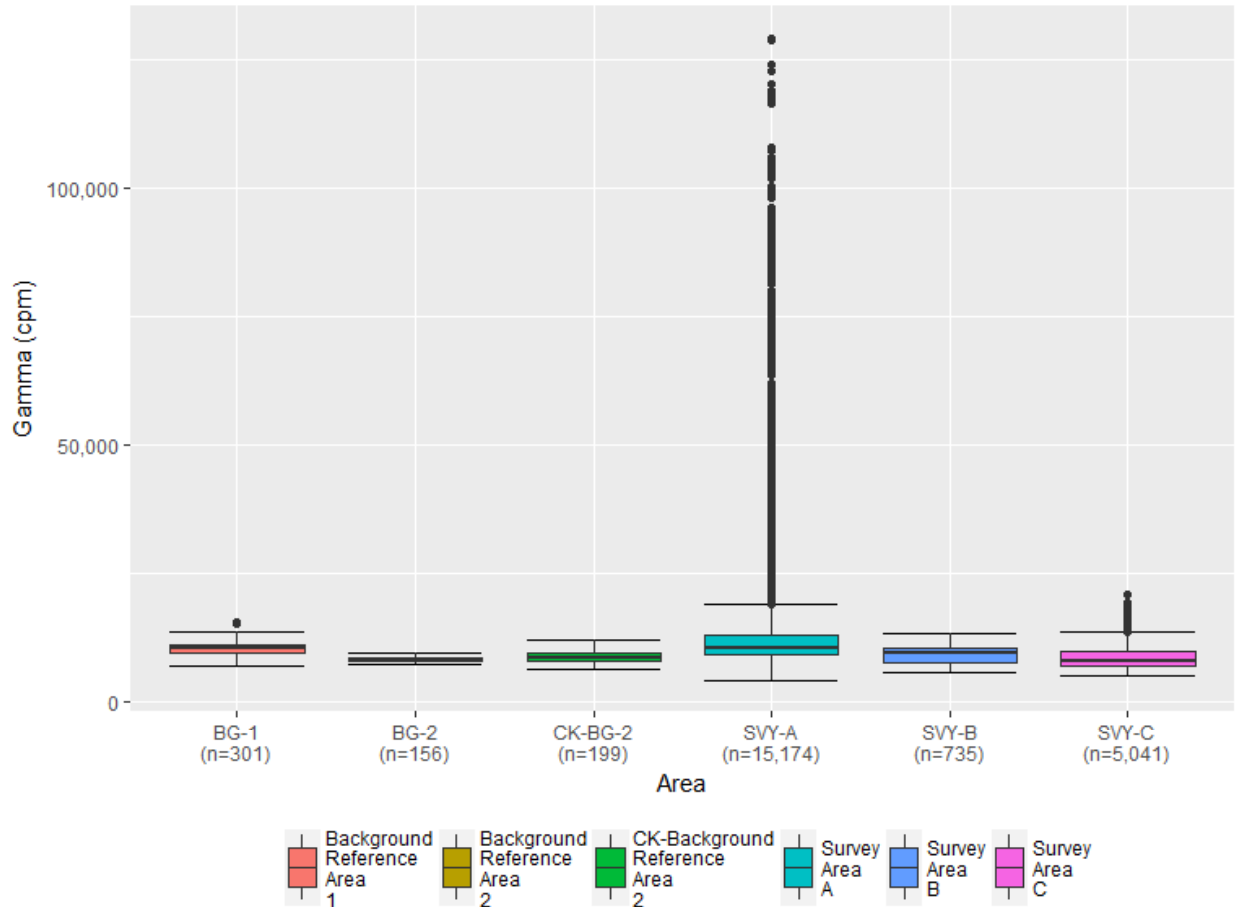
The gamma radiation survey results box plots shown on Figure 2A depict differences in the data distribution for gamma measurements between BG-1, BG-2, CK-BG-2 and Survey Areas A, B and C. The large number of potential outlier values in the Survey Area A and Survey Area C box plots indicate high skewness or possibly non-normally distributed data, instead of potential outlier values. Based on Site geology, the potential gamma radiation outlier values observed for the Survey Area data on Figure 2A represent localized areas of higher gamma radiation with respect to other parts of each of the Survey Areas, as would be expected in areas with varying levels of mineralization, naturally occurring radioactive material (NORM) and potential TENORM. Background reference area gamma radiation boxplots are shown in Figure 2B.

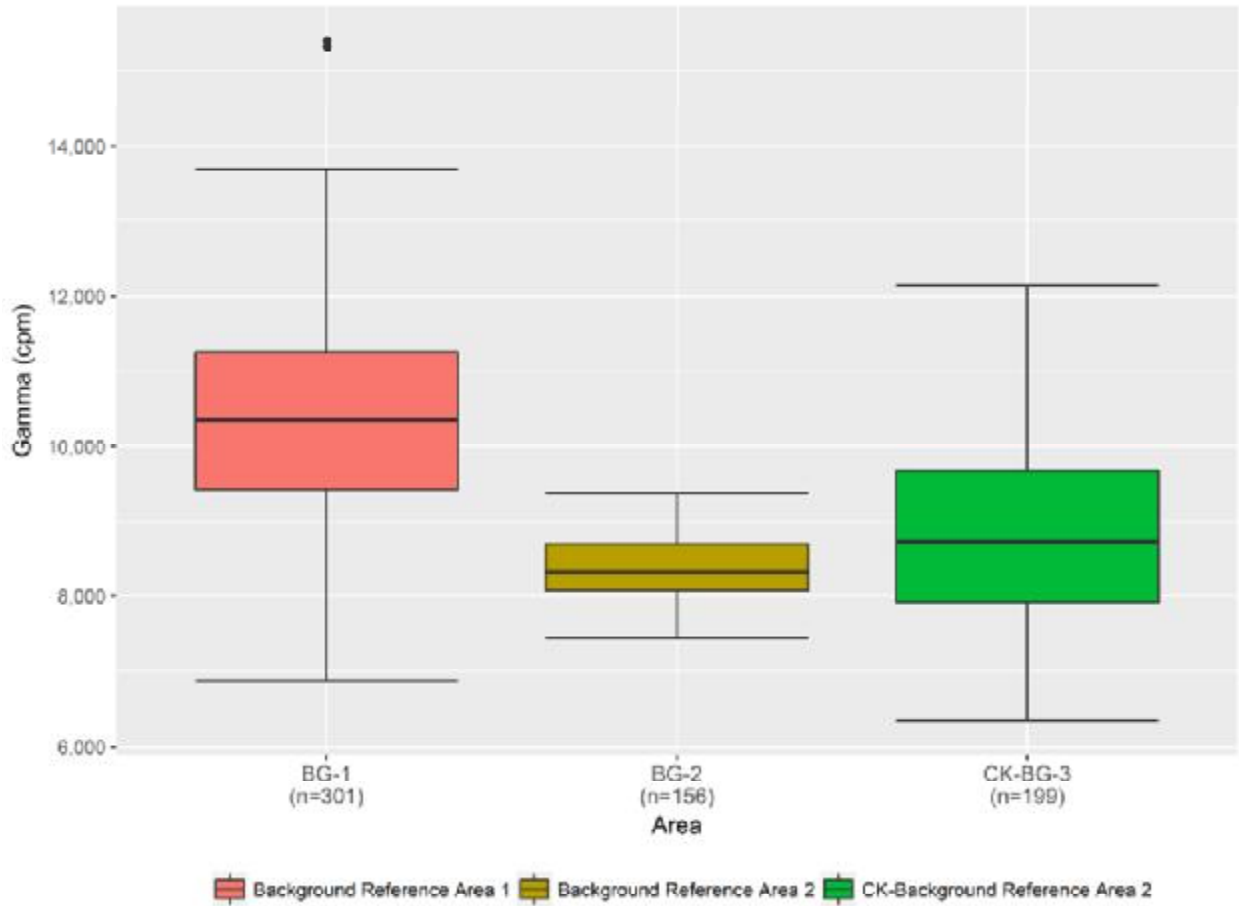
There are two potential outlier values shown for gamma data in the BG-1 dataset. These outlier values do not represent skewed data as do the Survey Area results, and the gamma data are shown to be more normally distributed in BG-1 and BG-2 than in CK-BG-2 and the Survey Areas. The potential outlier values shown for BG-1 are most likely representative of natural variation of gamma in this area. These observations are further evaluated with the use of probability plots in Section 3.1.2 and statistical testing in Section 3.1.4.
