# NA-0928 (#63) Removal Site Evaluation Report

Final | October 2, 2018

Navajo Nation AUM Environmental Response Trust  
– First Phase

Stantec Consulting Services Inc.

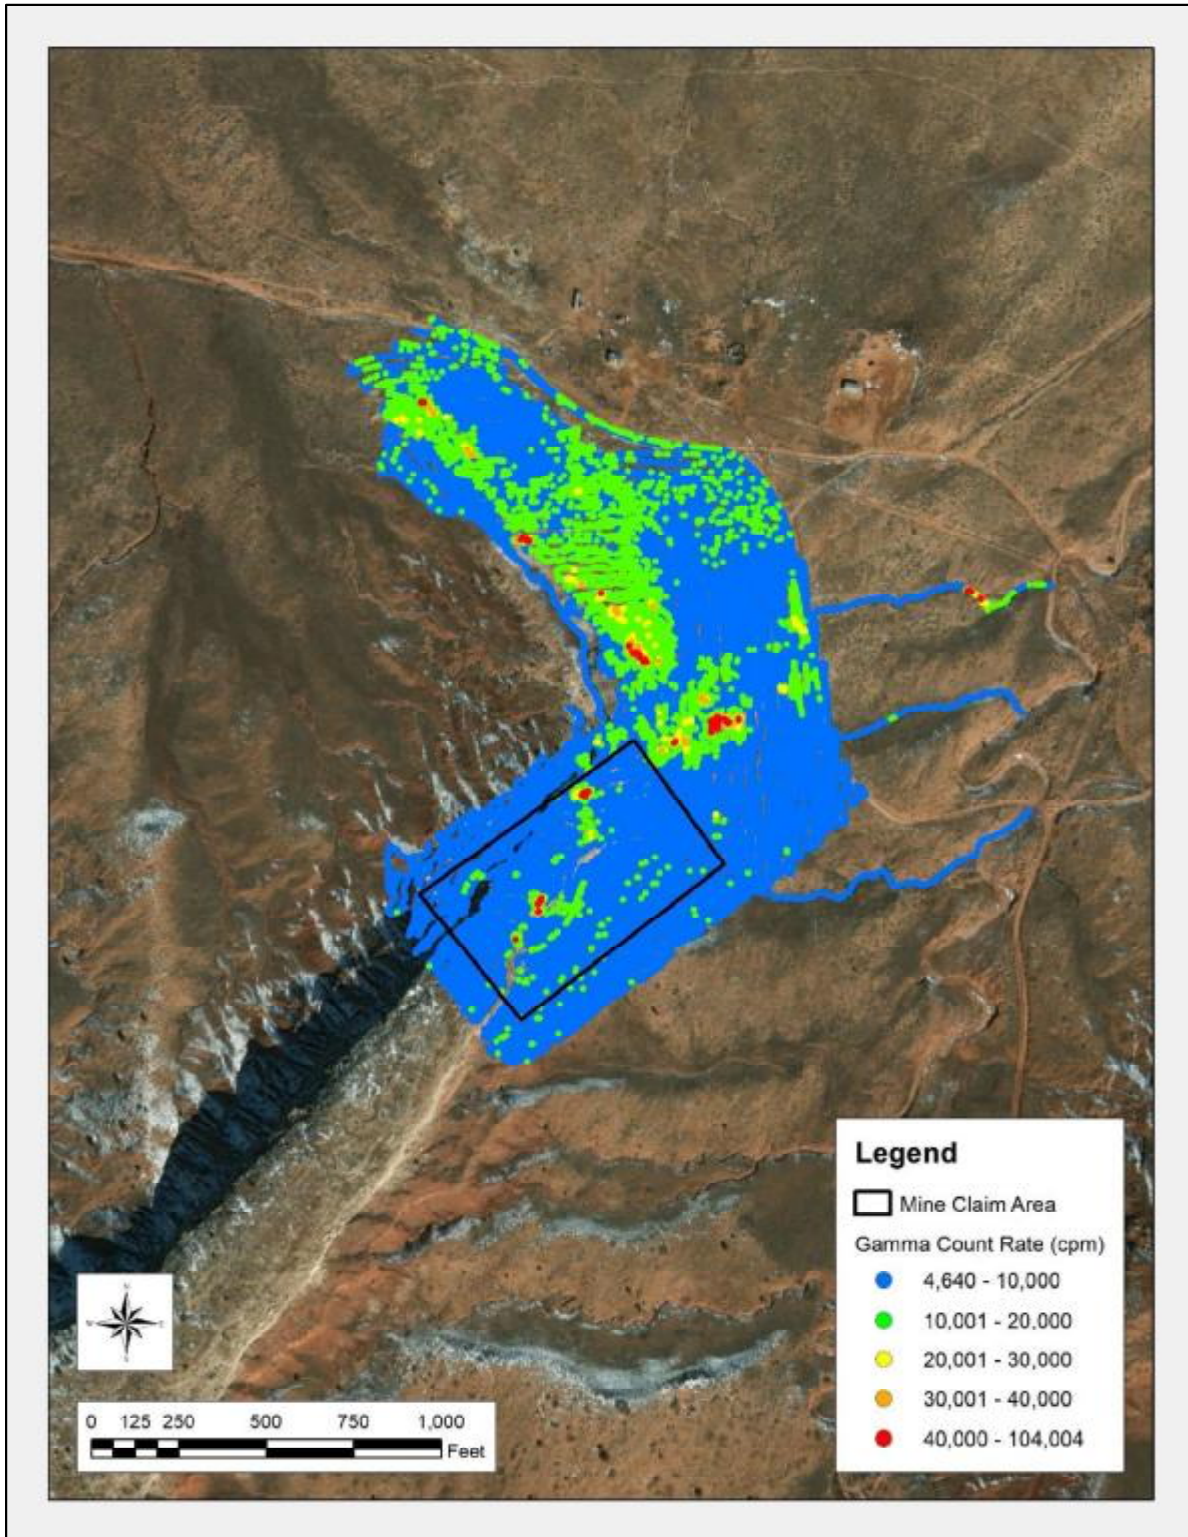
Figure 4. Gamma count rates in the Survey Area.

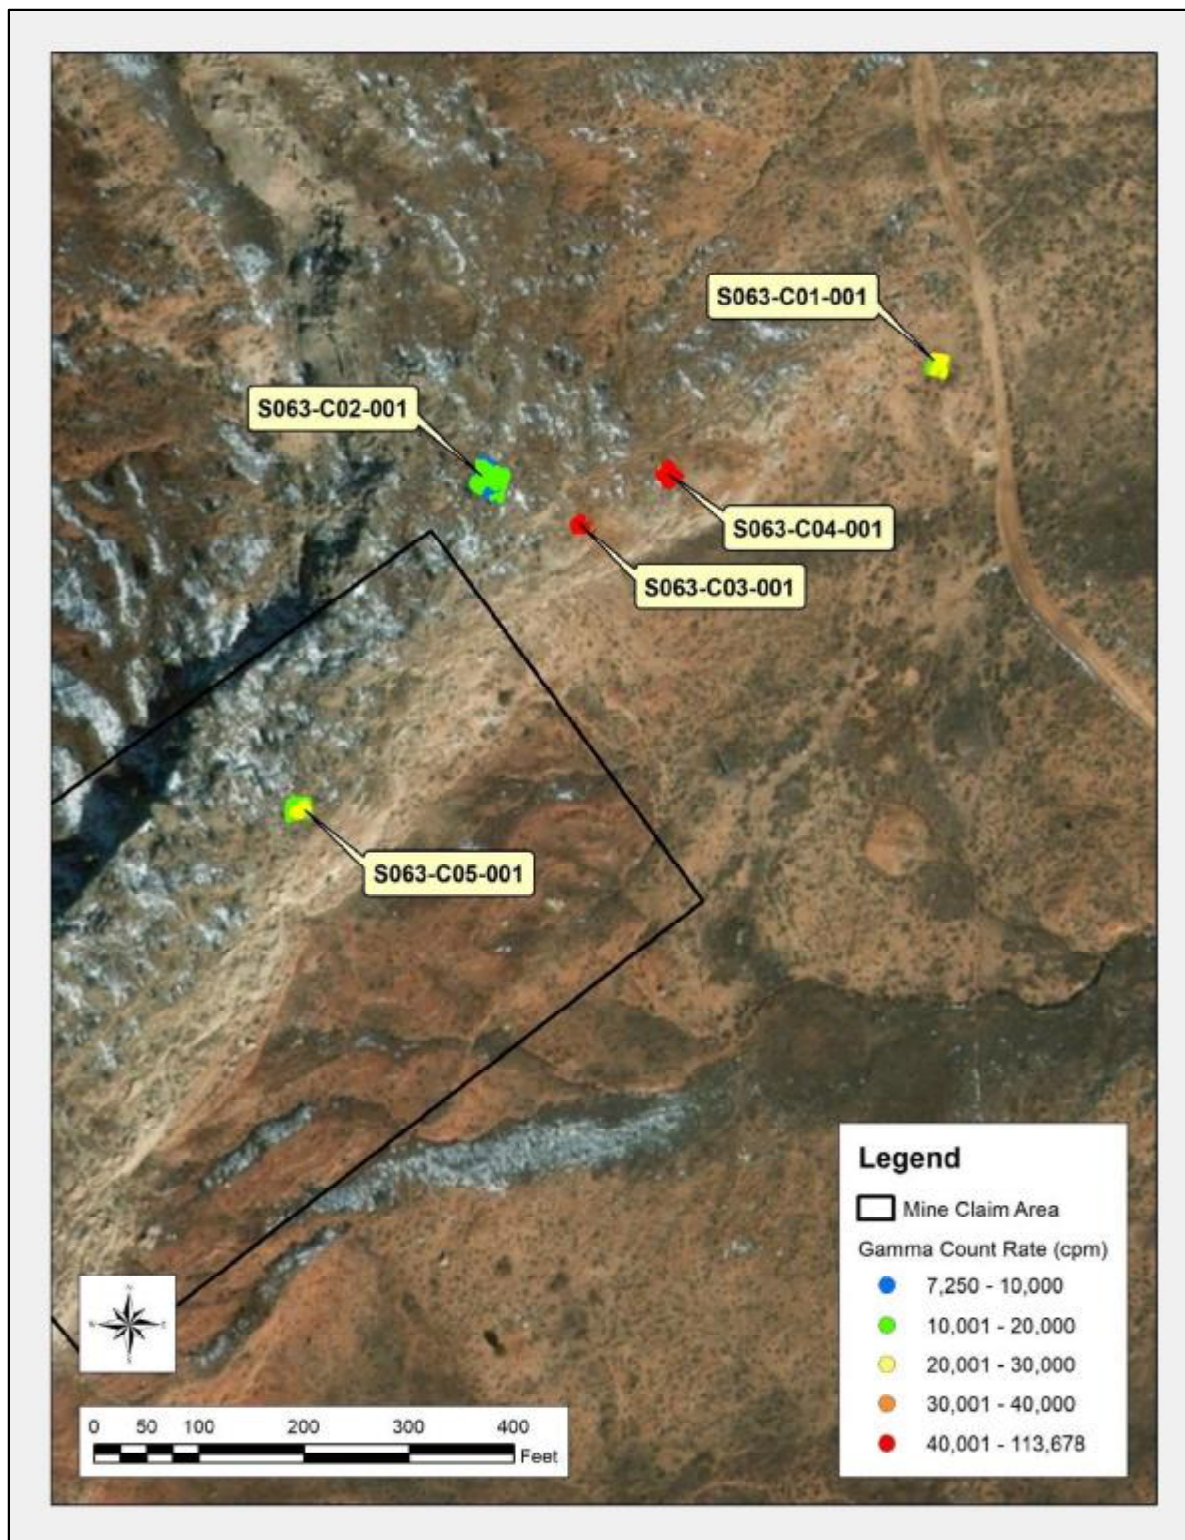
Figure 7. GPS-based gamma count rate measurements made for the correlation study.

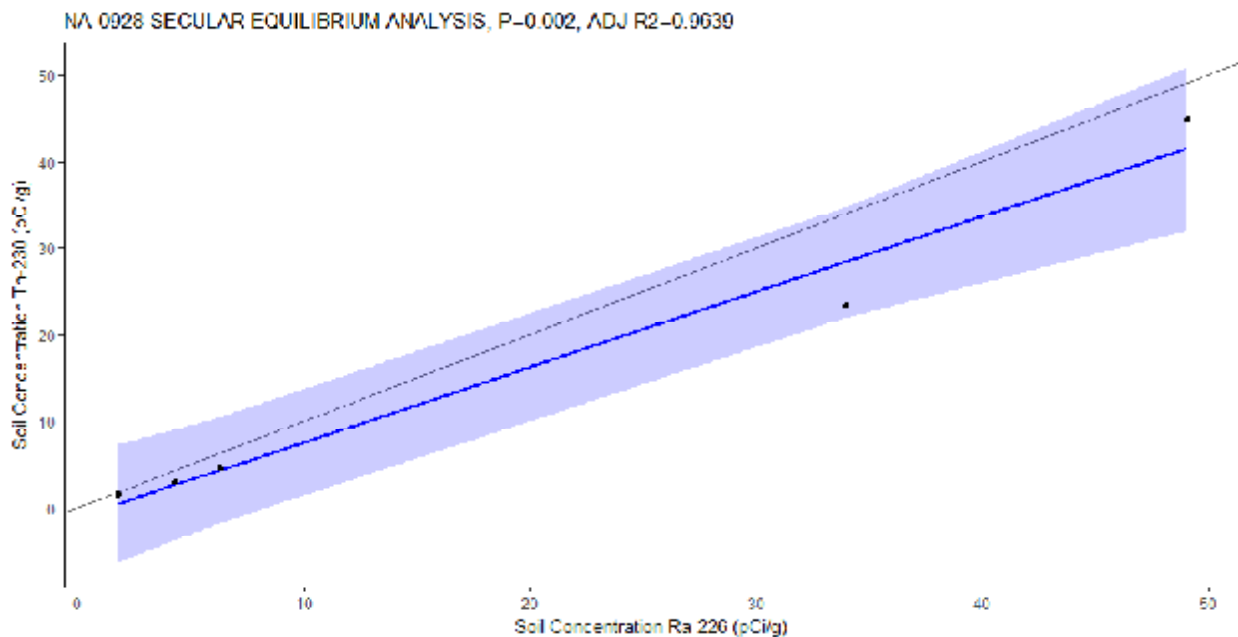
**Figure 10. Evaluation of secular equilibrium in the uranium decay series.**

Based on this method, ERG concludes there is evidence that thorium-230 and radium-226 are in secular equilibrium (Figure 10).

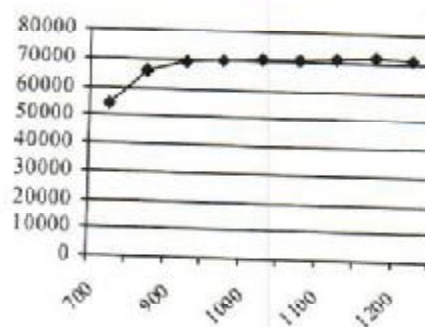
Comments: HV Plateau Scaler Count Time = 1-min. Recommended HV = 1000

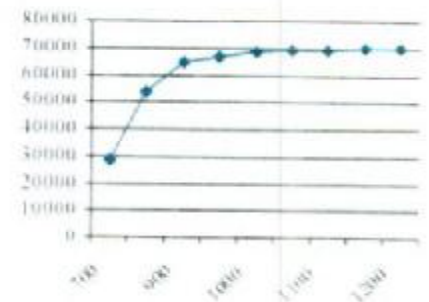
Comments: HV Plateau Scaler Count Time = 1-min. Recommended HV = 1100

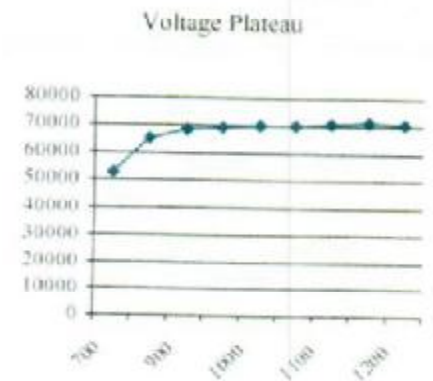
High Voltage	Source Counts	Background
700	52821	9111
800	65213	
900	68644	
950	69245	
1000	69492	
1050	69792	
1100	70472	
1150	71183	
1200	70571

Comments: HV Plateau Scaler Count Time = 1-min. Recommended HV = 1000

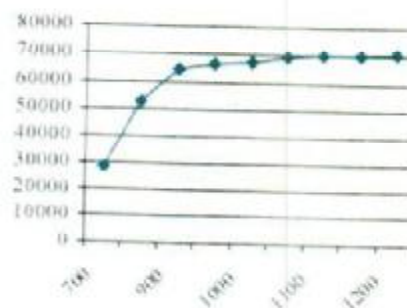
Comments: HV Plateau Scaler Count Time = 1-min. Recommended HV = 1100

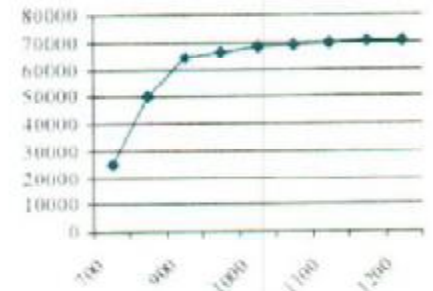
Comments: HV Plateau Scaler Count Time = 1-min. Recommended HV = 1050

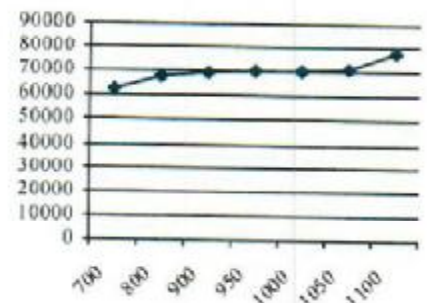
Comments: Comments: HV Plateau Scaler Count Time = 1-min. Recommended HV = 950

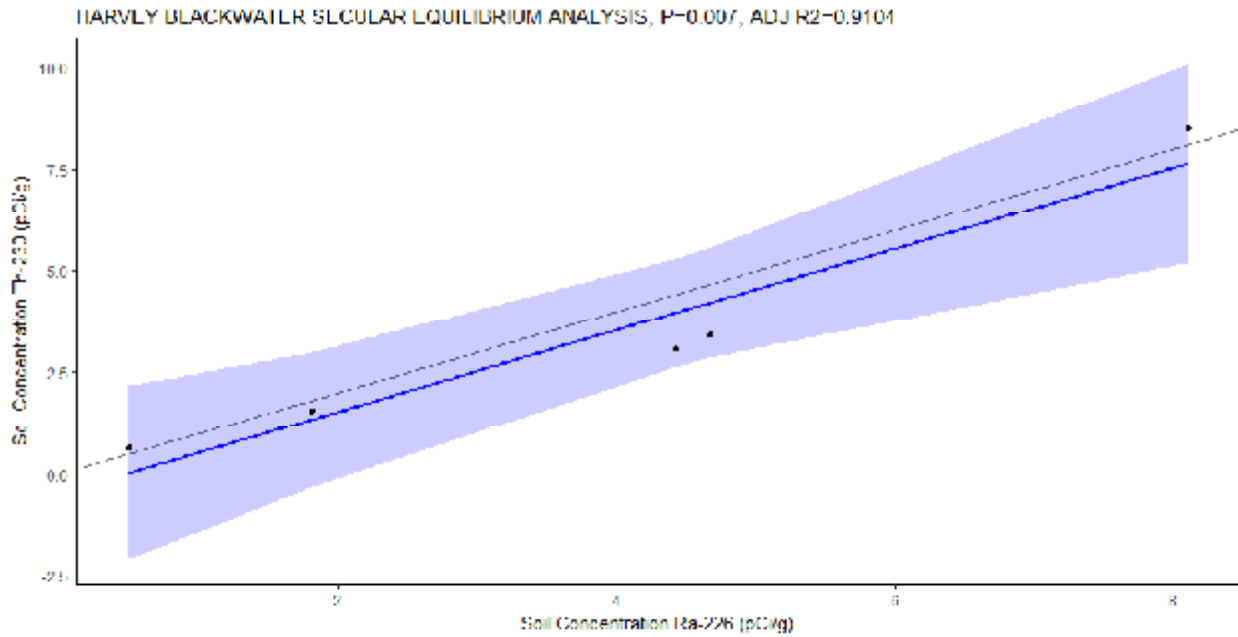
Figure 3. Result for Harvey Blackwater secular equilibrium analysis, showing excellent correlation between the data and the y=x line, i.e., Th-230 and Ra-226 are in secular equilibrium.

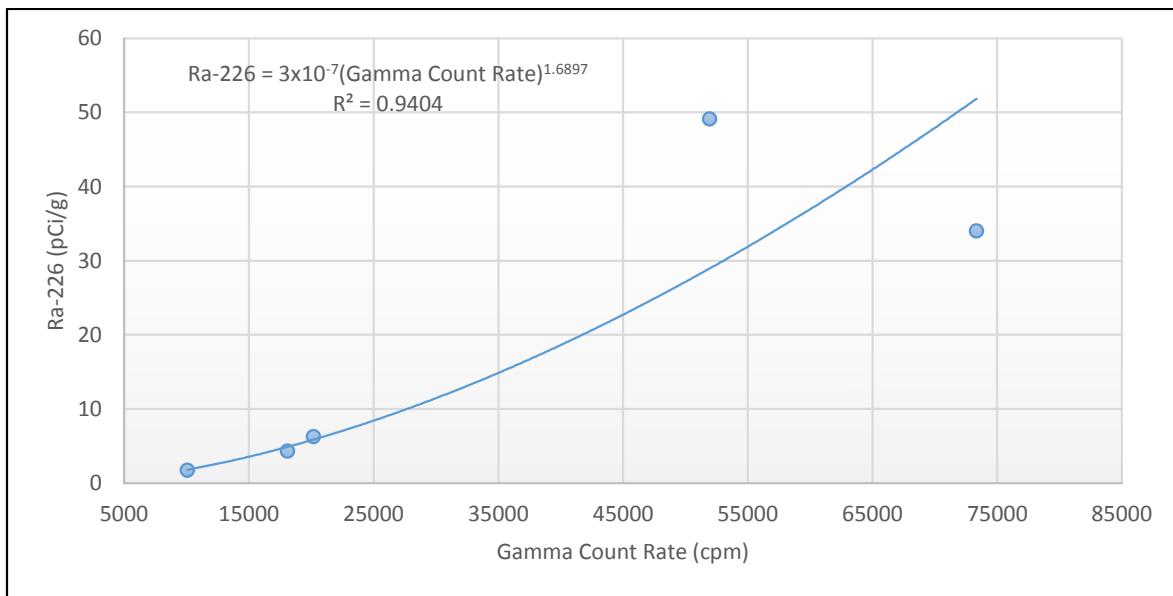
**Figure 8. Correlation of gamma count rates and concentrations of radium-226 in surface soils.**

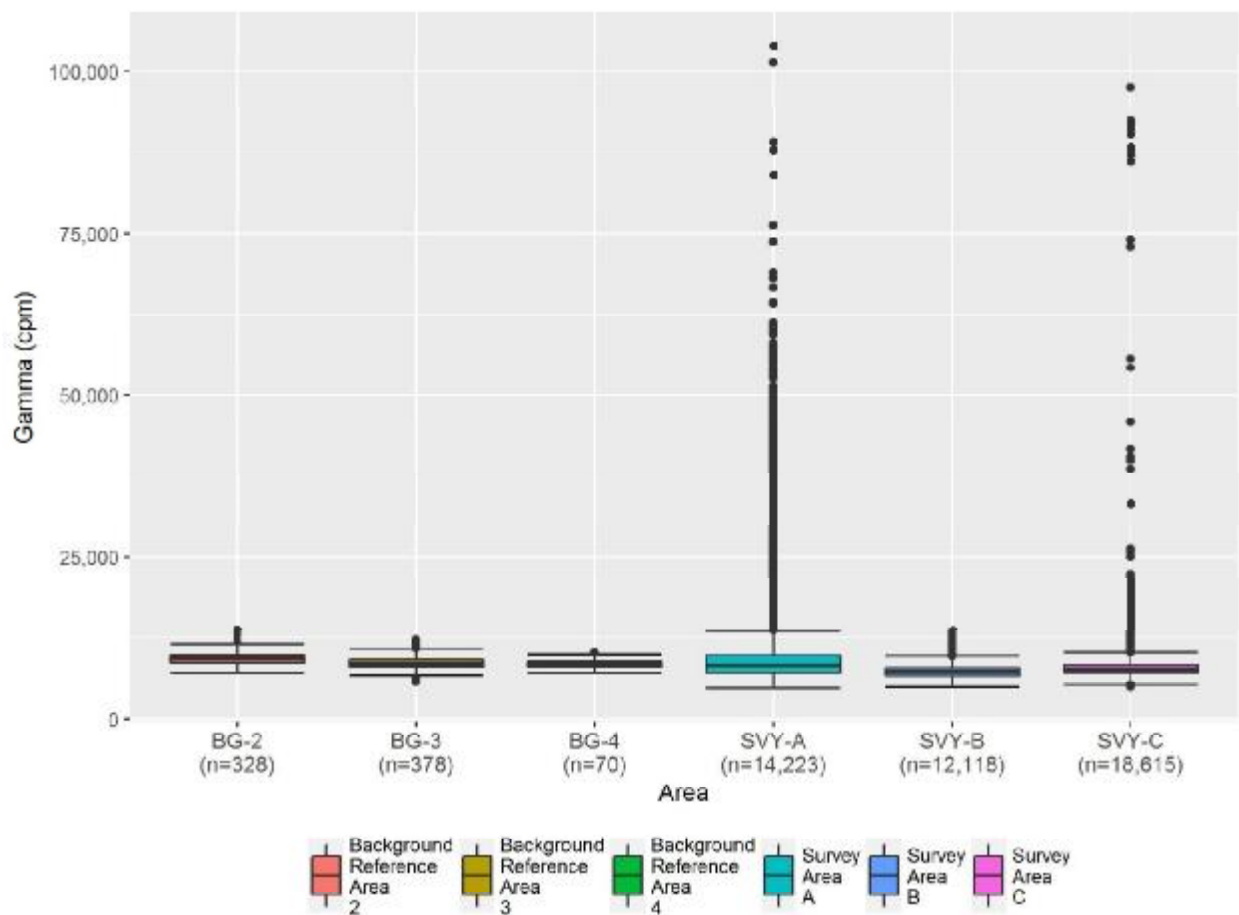
The gamma radiation survey results box plots shown on Figure 2A depict differences in the data distribution for gamma measurements between background reference areas and Survey Areas. There are a number of potential outlier values in the box plots for the Survey Areas, which may indicate skewness or possibly non-normally distributed data, instead of outlier values. This has been further evaluated with the use of probability plots in Section 3.1.2 and statistical testing in Section 3.1.4. Based on a review of the Site geology, the gamma radiation potential outlier values observed for the Survey Area data on Figure 2A represent localized areas of higher gamma radiation with respect to other parts of the Survey Areas, as would be expected in areas with varying levels of mineralization, naturally occurring radioactive material (NORM), and potential TENORM.

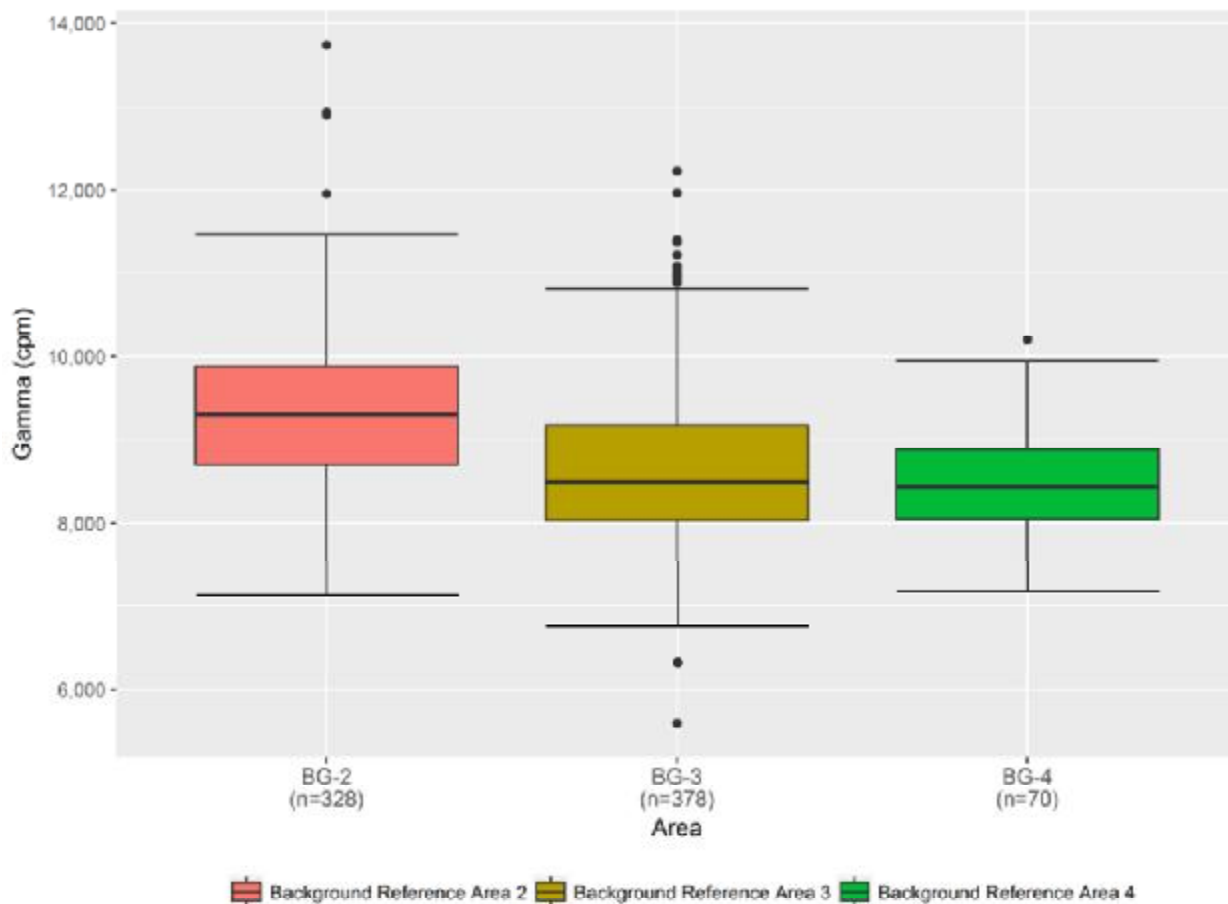
Additionally, there are four, 16, and one potential outlier values shown for gamma data in the BG-2, BG-3, and BG-4 datasets, respectively (refer to Figure 2B). However, these potential outlier values are not very high, represent a very small proportion of the total BG-2, BG-3, and BG-4 gamma datasets, and there is no other compelling rationale to reject these data based on the box plot evaluations alone.
