Standing Rock (#1006) Removal Site Evaluation Report

Final | September 22, 2018

Navajo Nation AUM Environmental Response Trust
– First Phase

Stantec Consulting Services Inc.

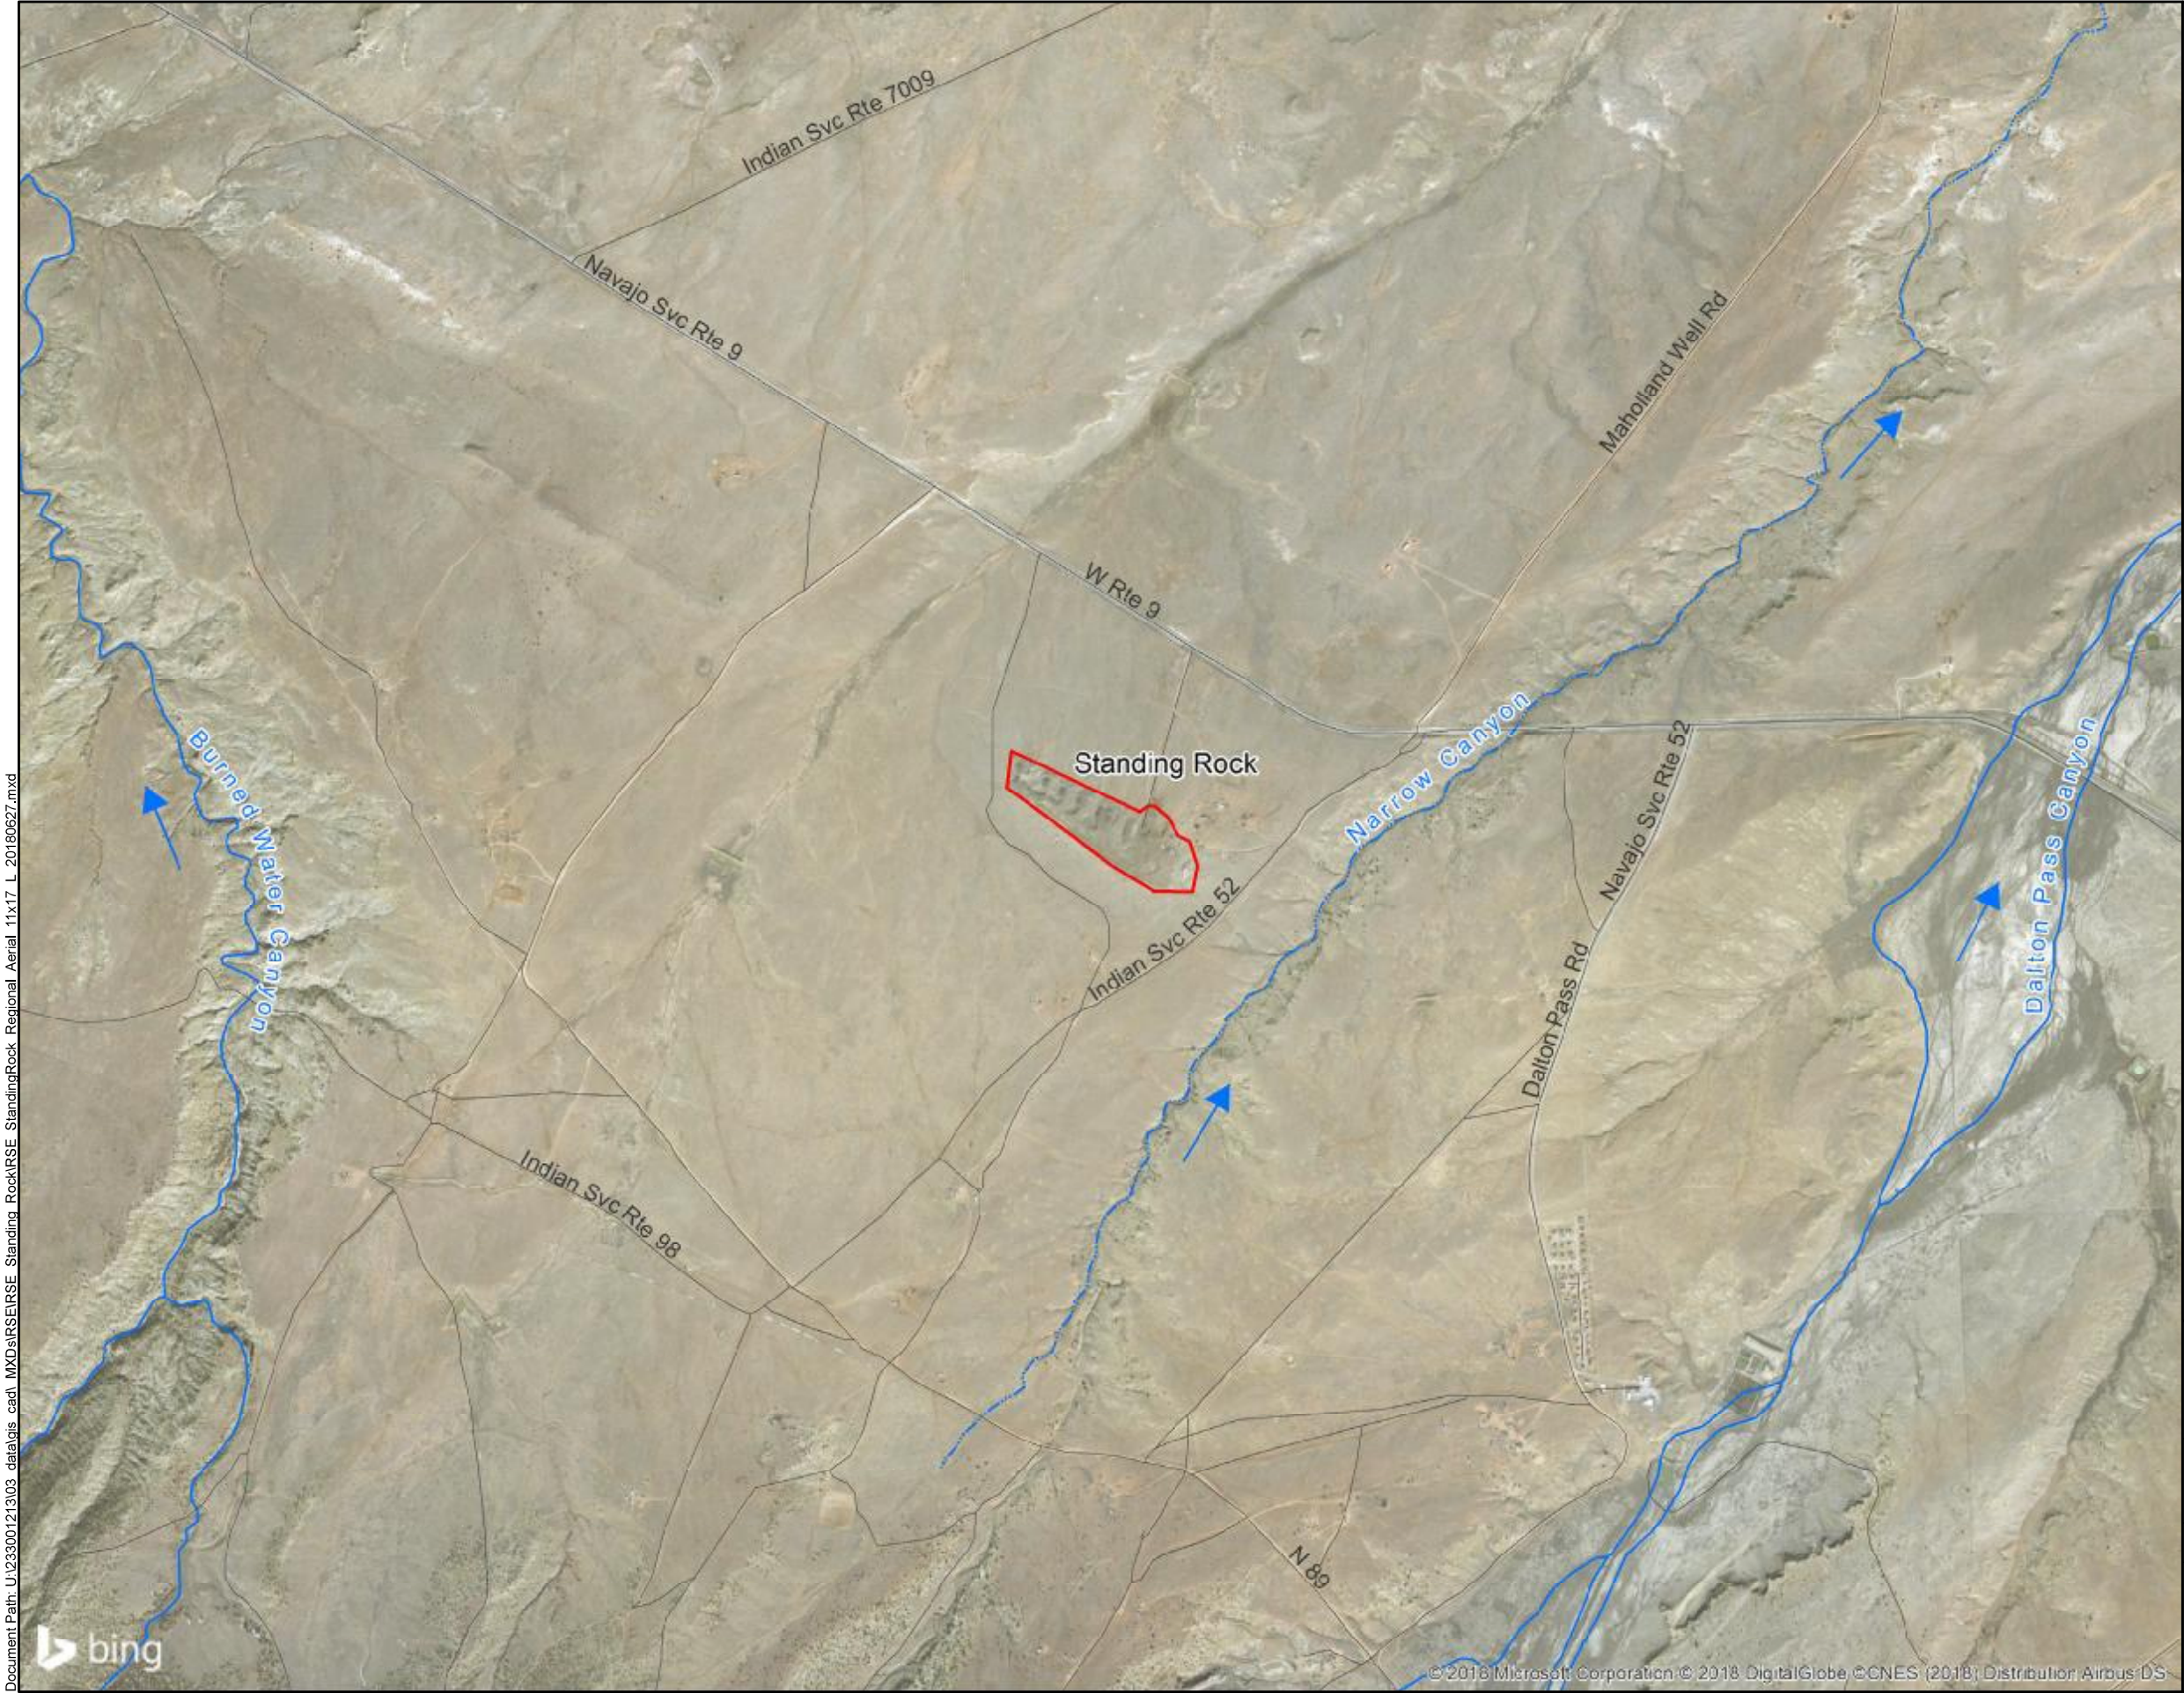
TITLE: Regional Topographic Map	
PROJECT: Removal Site Evaluation Standing Rock Mine Site	
DATE: 6/27/2018	DOCUMENT NAME: Removal Site Evaluation Report
AUTHOR: CBB	REVIEWER: EDZ
FIGURE: 2-1

In 1963 the USGS produced a 7.5 minute series topographic map of the area around the Site (USGS, 1963). The map showed Flat Top Hill and a gravel pit on Flat Top Hill. A portion of the 1963 USGS map is presented in Figure 2-1, showing the Site, which is coincident with Flat Top Hill and the USGS labeled gravel pit. Based on the creation date of the map, it can be assumed that the Site was used as a gravel pit (i.e., gravel quarry) before 1963.

The Site is located on the Navajo Nation approximately 30 miles northwest of Crownpoint, New Mexico (refer to Figure 1-1 inset), on Flat Top Hill (refer to Figure 2-1). Historical documentation of activities that occurred on-site were reported in 1957, 1961, 1963, and 1983 as described below.

quarrying-related impacts. Three of the six potential water features were sampled. The locations of these water features are shown in Figure 2-1 and included the following:

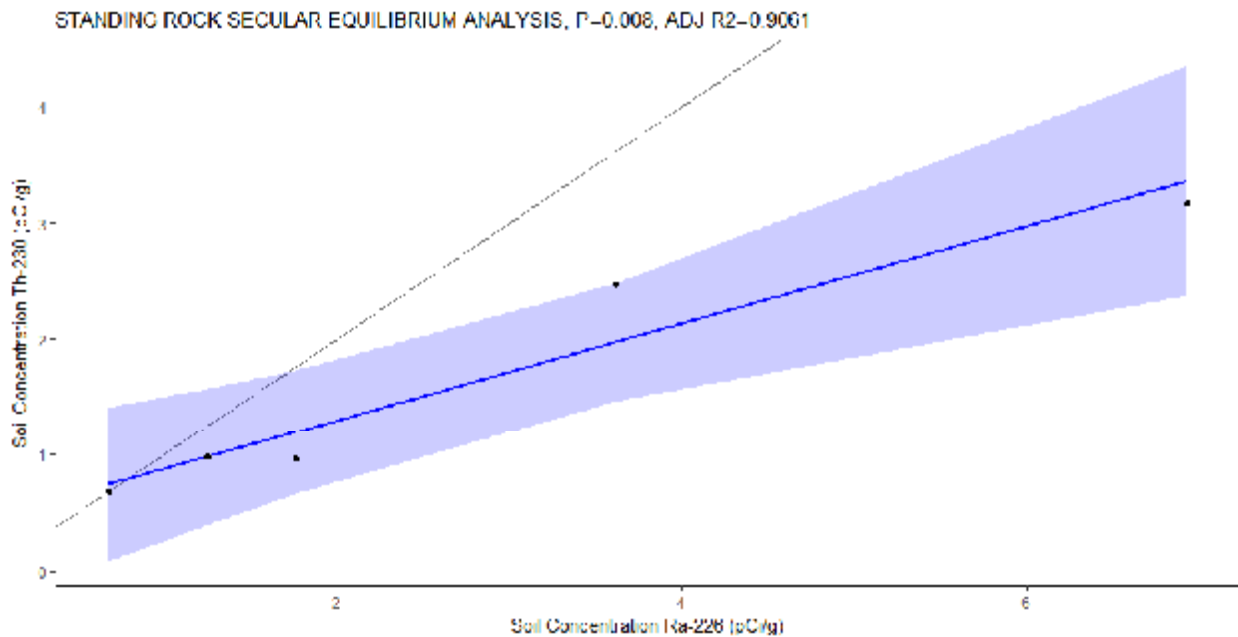
Figure 10. Evaluation of secular equilibrium in the uranium decay series

Based on this method, ERG concludes that there is evidence of equilibrium, but not secular equilibrium, among the uranium decay series radionuclides (Figure 10).

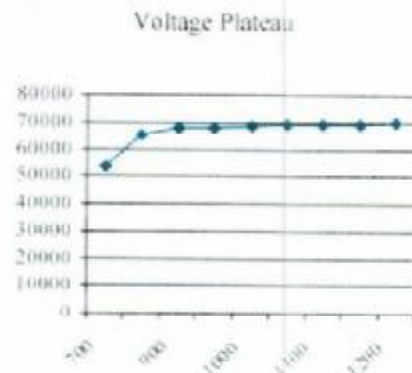
High Voltage	Source Counts	Background
700	53620	9542
800	64979	
900	67955	
950	67795	
1000	68536	
1050	69153	
1100	69331	
1150	69346	
1200	69492

Comments: HV Plateau Scaler Count Time = 1-min. Recommended HV = 1000

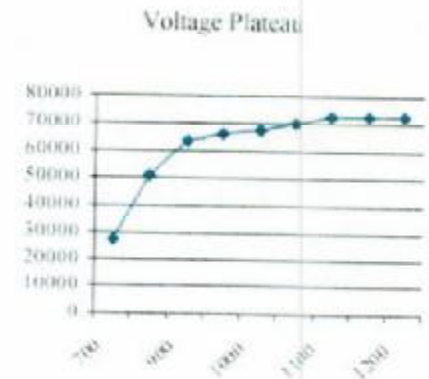
High Voltage	Source Counts	Background
700	26998	9216
800	51037	
900	63340	
950	65550	
1000	67410	
1050	70113	
1100	72217	
1150	72561	
1200	72337

Comments: HV Plateau Scaler Count Time = 1-min. Recommended HV = 1150

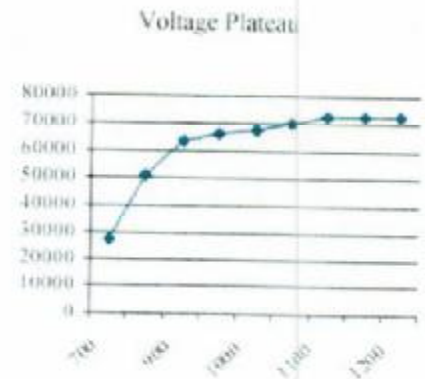
High Voltage	Source Counts	Background
700	26998	
800	51037	
900	63340	
950	65550	
1000	67410	
1050	70113	
1100	72217	
1150	72561	
1200	72337	9216

Comments: HV Plateau Scaler Count Time = 1-min. Recommended HV = 1150

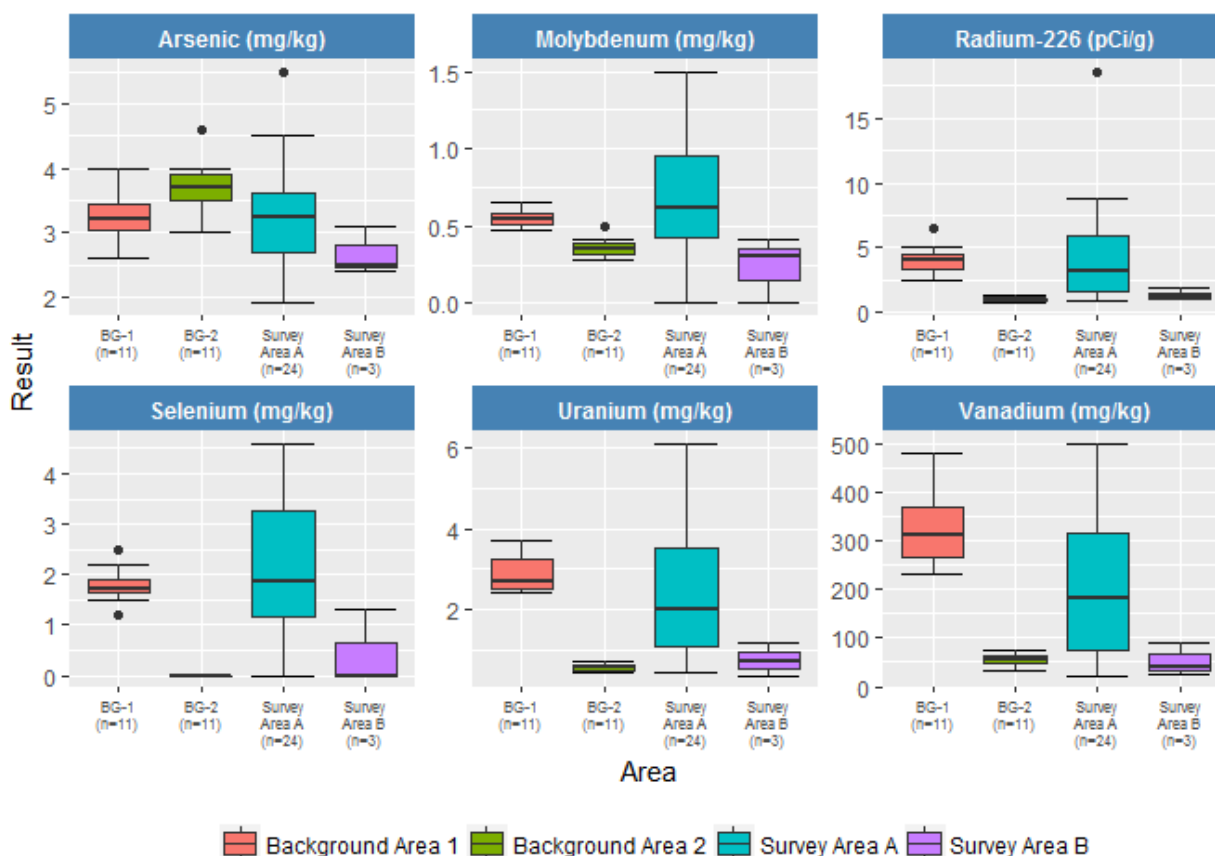
Figure 1A. Survey Areas A and B, and Background Reference Areas 1 (BG-1) and 2 (BG-2) Soil Sample Boxplots

The soil sample box plots shown on Figure 1A depict differences in the data distributions for analytical constituent concentrations between BG-1, BG-2 and Survey Areas A and B. Some potential outlier values are shown for BG-1, BG-2 and Survey Area A.

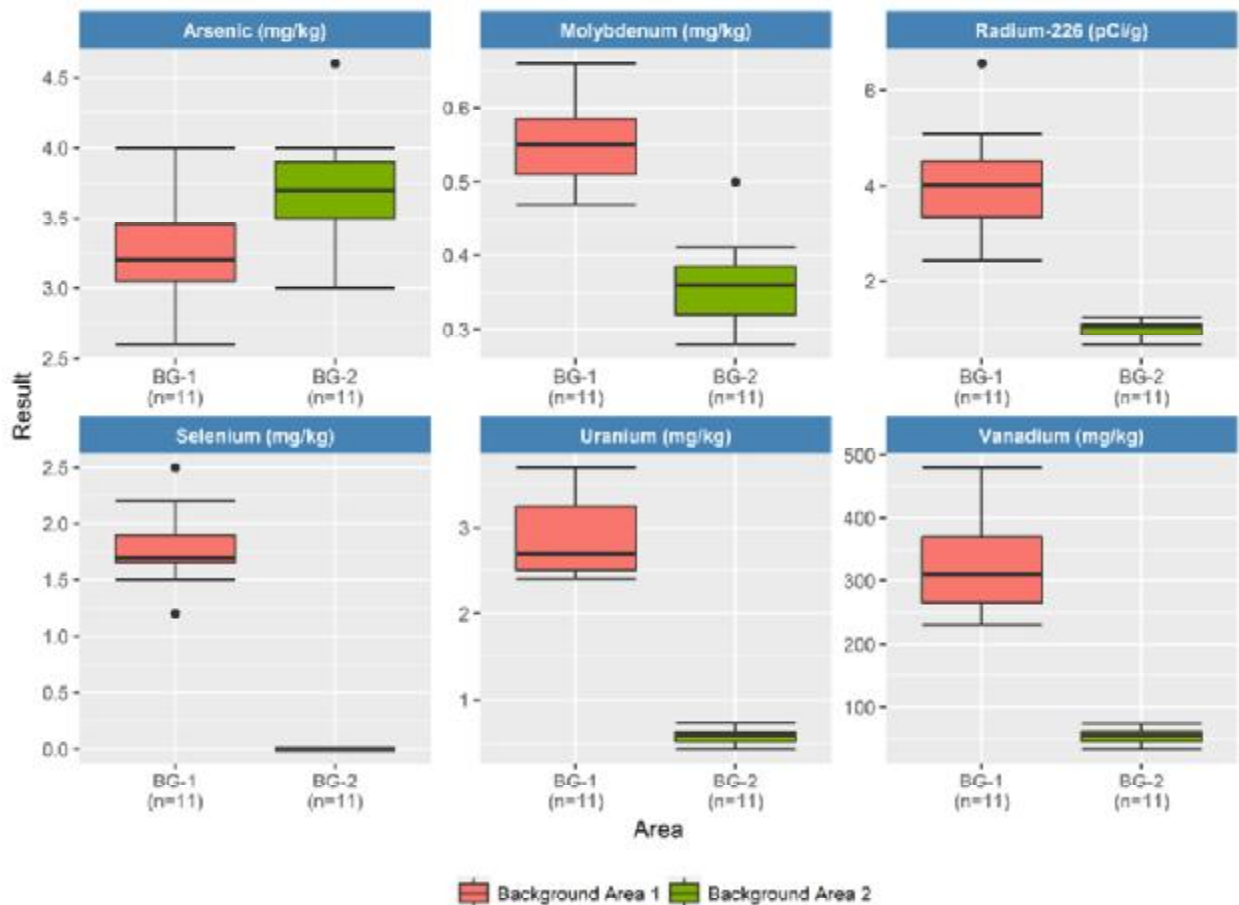
Figure 1B. Background Reference Areas 1 (BG-1) and 2 (BG-2) Soil Sample Boxplots

One value each for arsenic (As), molybdenum (Mo), and Ra-226, and two values for selenium (Se), are identified as potential outliers (i.e., values outside 1.5 times the interquartile range) in the boxplots shown in Figure 1B for the BG-1 and BG-2 datasets. These potential outlier values are further evaluated with the use of probability plots in Section 3.1.2 and statistical testing in Section 3.1.3.

One value each for arsenic and molybdenum were identified as potential outliers (i.e., values outside 1.5 times the interquartile range) in the BG-2 box plots in Figure 1B. When viewed in the probability plots in Figure 4, these values do appear to be higher than, and out of line with, the rest of their respective datasets. These potential outlier values are further tested for statistical significance in Section 3.1.3. All 11 soil samples at BG-2 were non-detect for selenium.

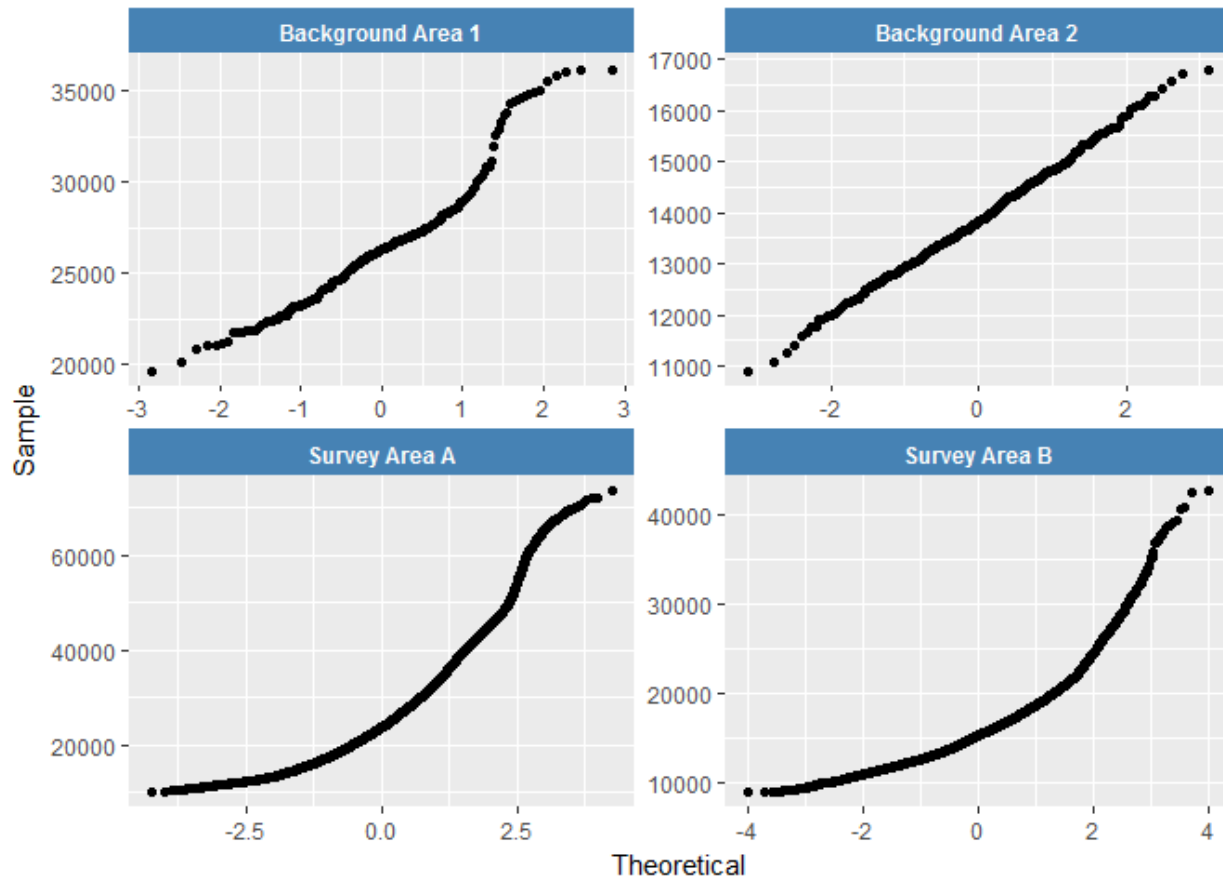
Figure 5. Survey Area and Background Reference Area Gamma Probability Plots

The BG-2 gamma probability plot in Figure 5 is linear, indicating normal distribution. The shape and smoothness of the probability plot for the Survey Area B gamma results confirms that the gamma radiation data are more normally distributed than the BG-2 gamma results. This suggests that these higher values in Survey Area B are not potential outliers, but rather are representative

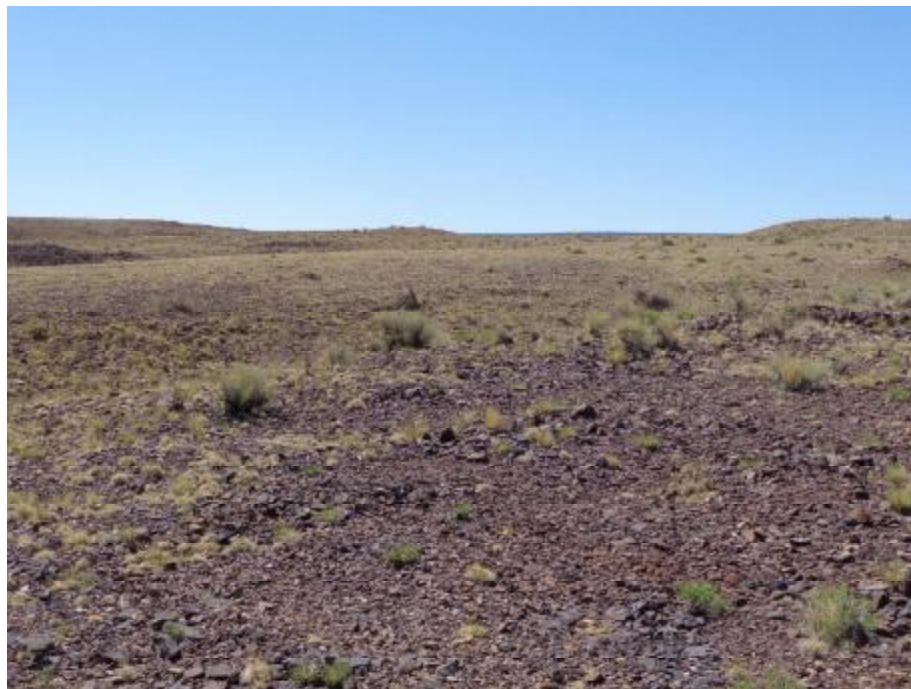
Photo #1—Overview of general landscape and plant community at Standing Rock.

The survey at Standing Rock on May 4 and 5, 2016 did not identify any of the three species that have been listed as potential species of concern for this site. The habitat at Standing Rock may not be appropriate for the occurrence of any of the three species because the primary plant community type of Pinyon-Juniper occurs outside of the Standing Rock site. In addition, the heavily grazed condition of the site would most likely impact the occurrence of these species if they were present at some time in the past.

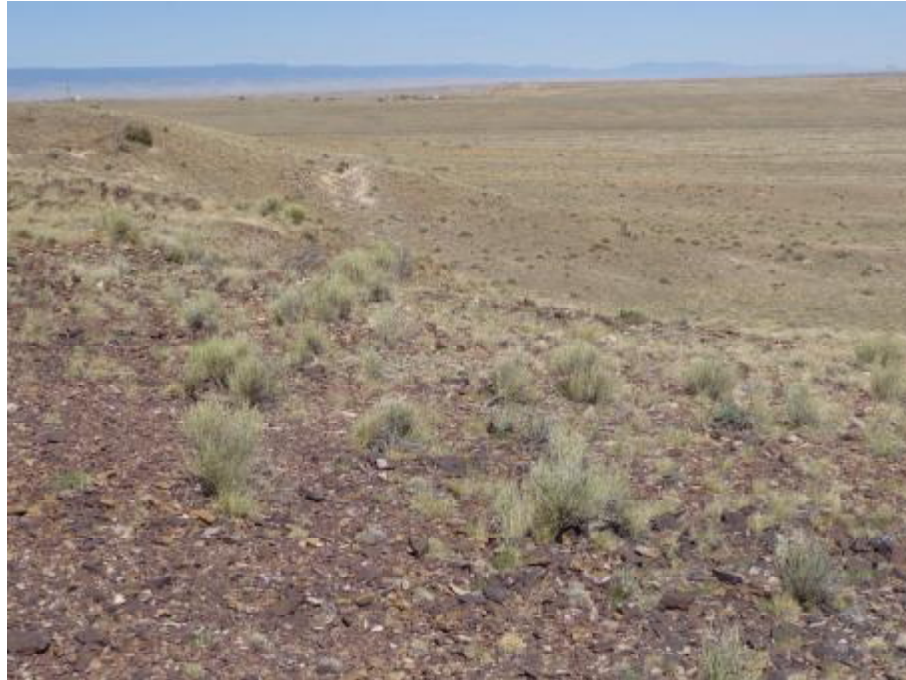
Photo #2—Overview of general landscape and plant community at Standing Rock.
